UNIVERSITY OF ALBERTA

GEOTECHNICAL ASPECTS OF LINED RESERVOIRS

A Thesis

Master of Engineering

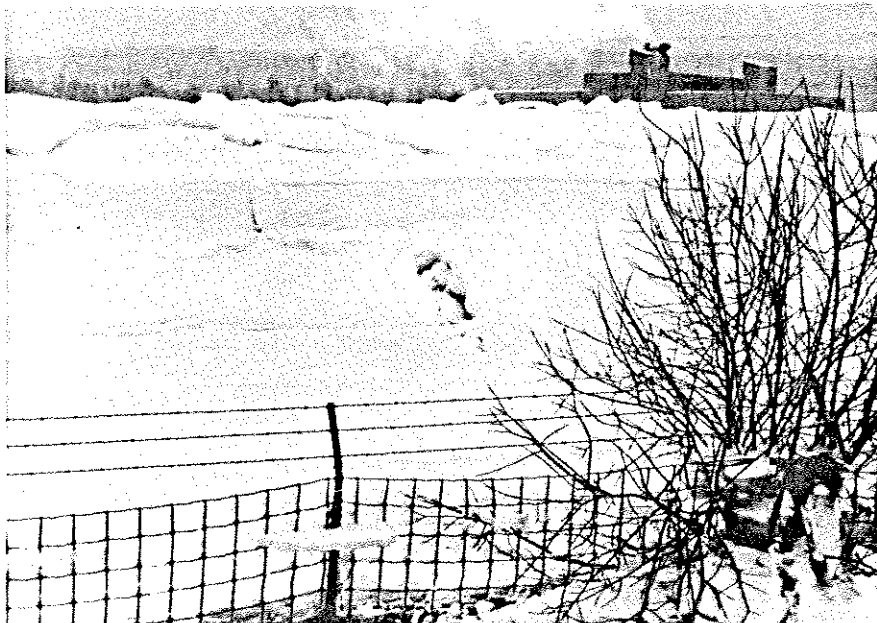
Photo 1

Major leak location immediately after failure.
Note the ice buildup on top of embankment.

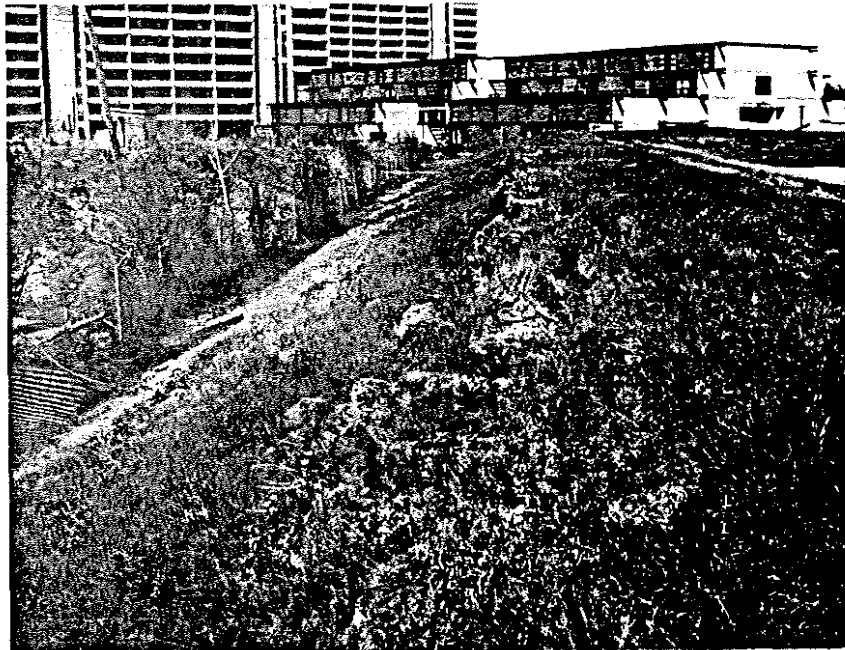
Photo 4

View along D/S edge of embankment in failure zone.
Note toppling of soil blocks near rim.

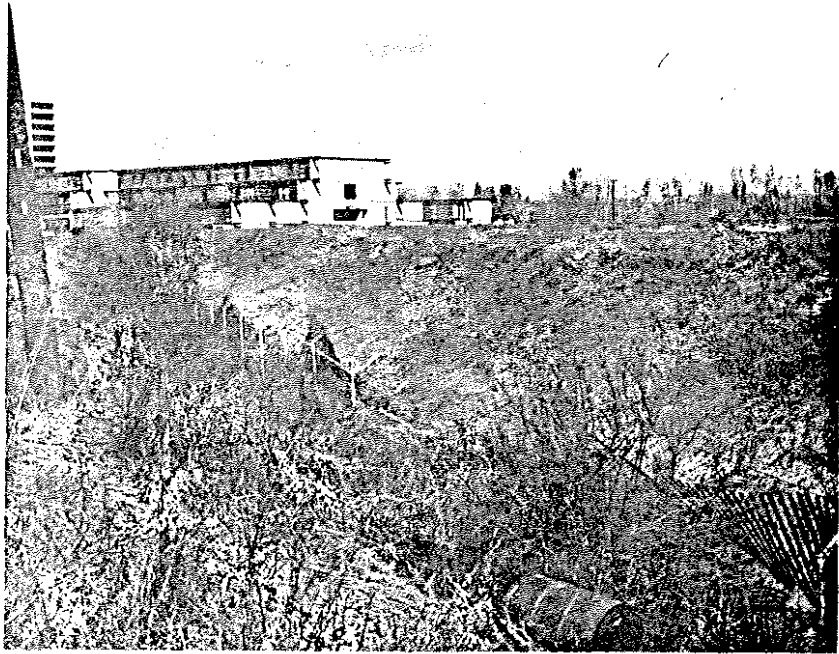
Photo 5

General view of failed embankment.
Toppled soil blocks and piping outlet are visible.

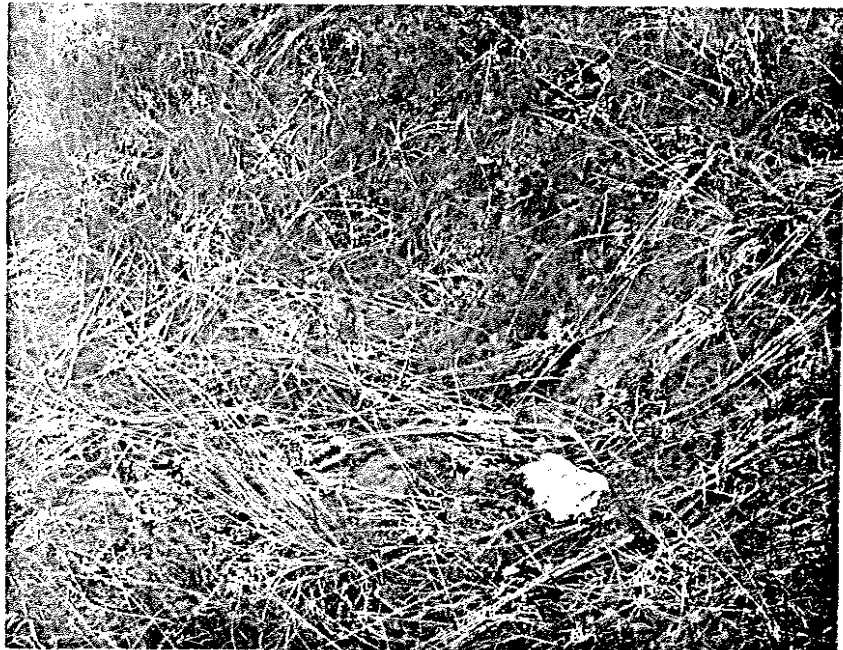
Photo 6

Closeup of piping outlet.

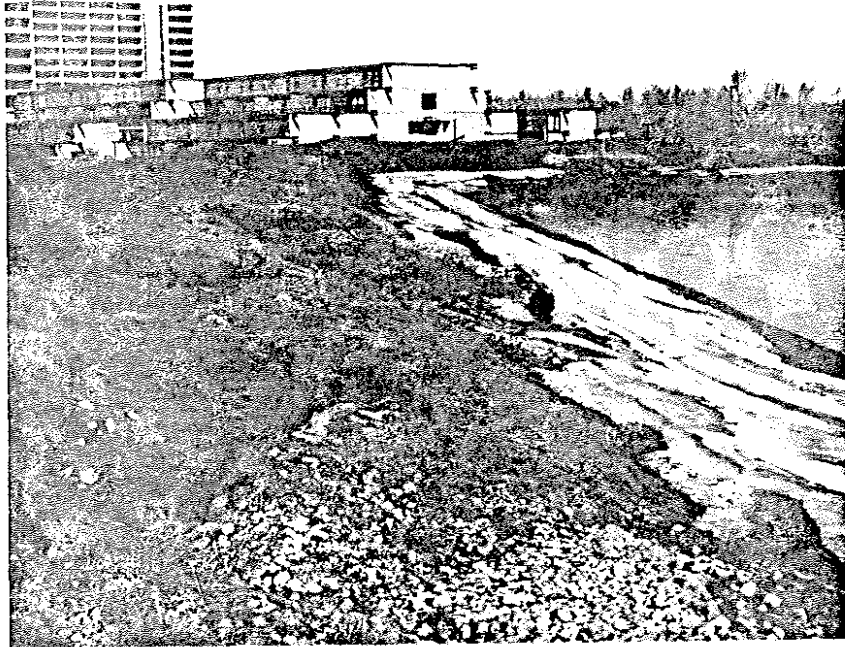
Photo 7

View of embankment U/S of piping failure outlet.
Note the slumping of grassed areas and the formation
of a beach.

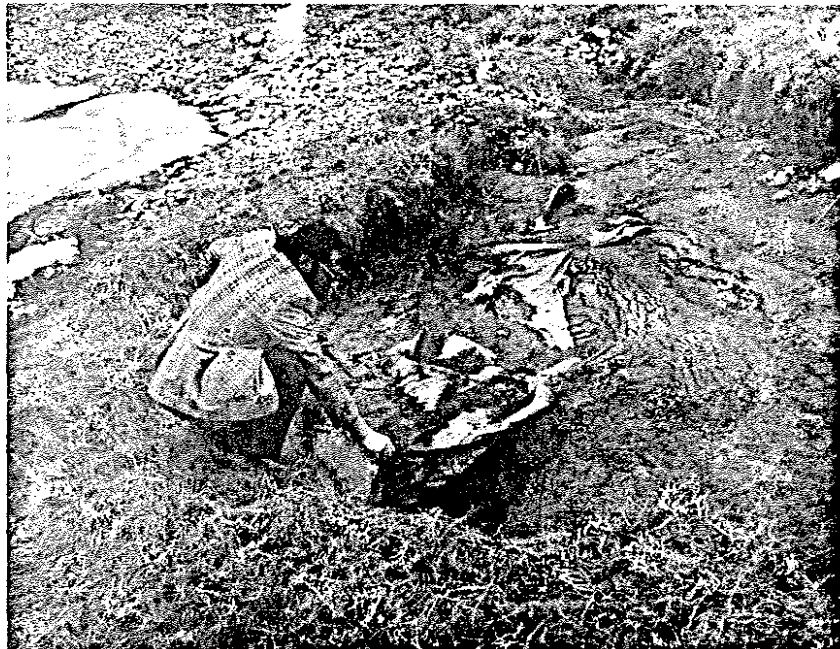
Photo 8

Damaged section of polyethene liner showing exposed
embankment material.

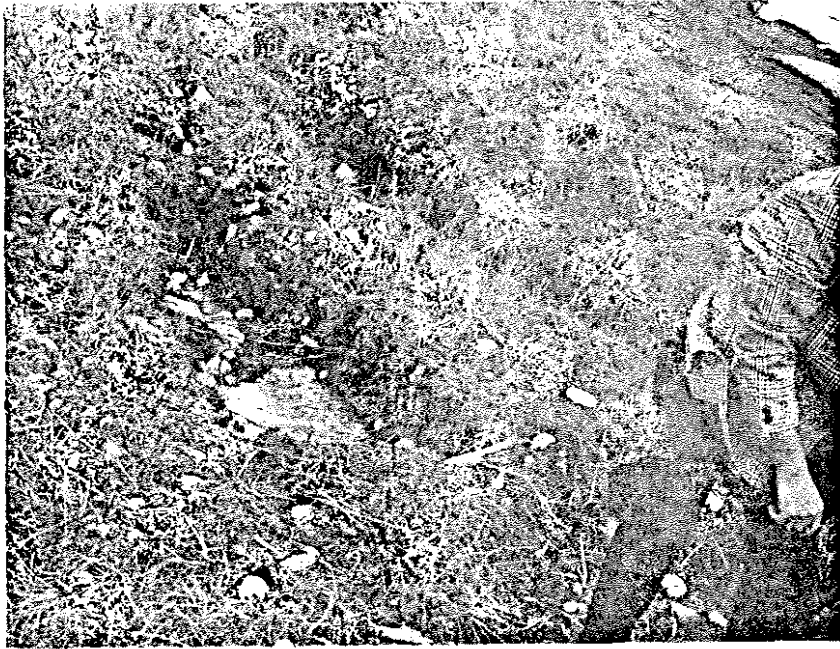
Photo 9

Slumping of soil cover on apparently intact polyethene liner.

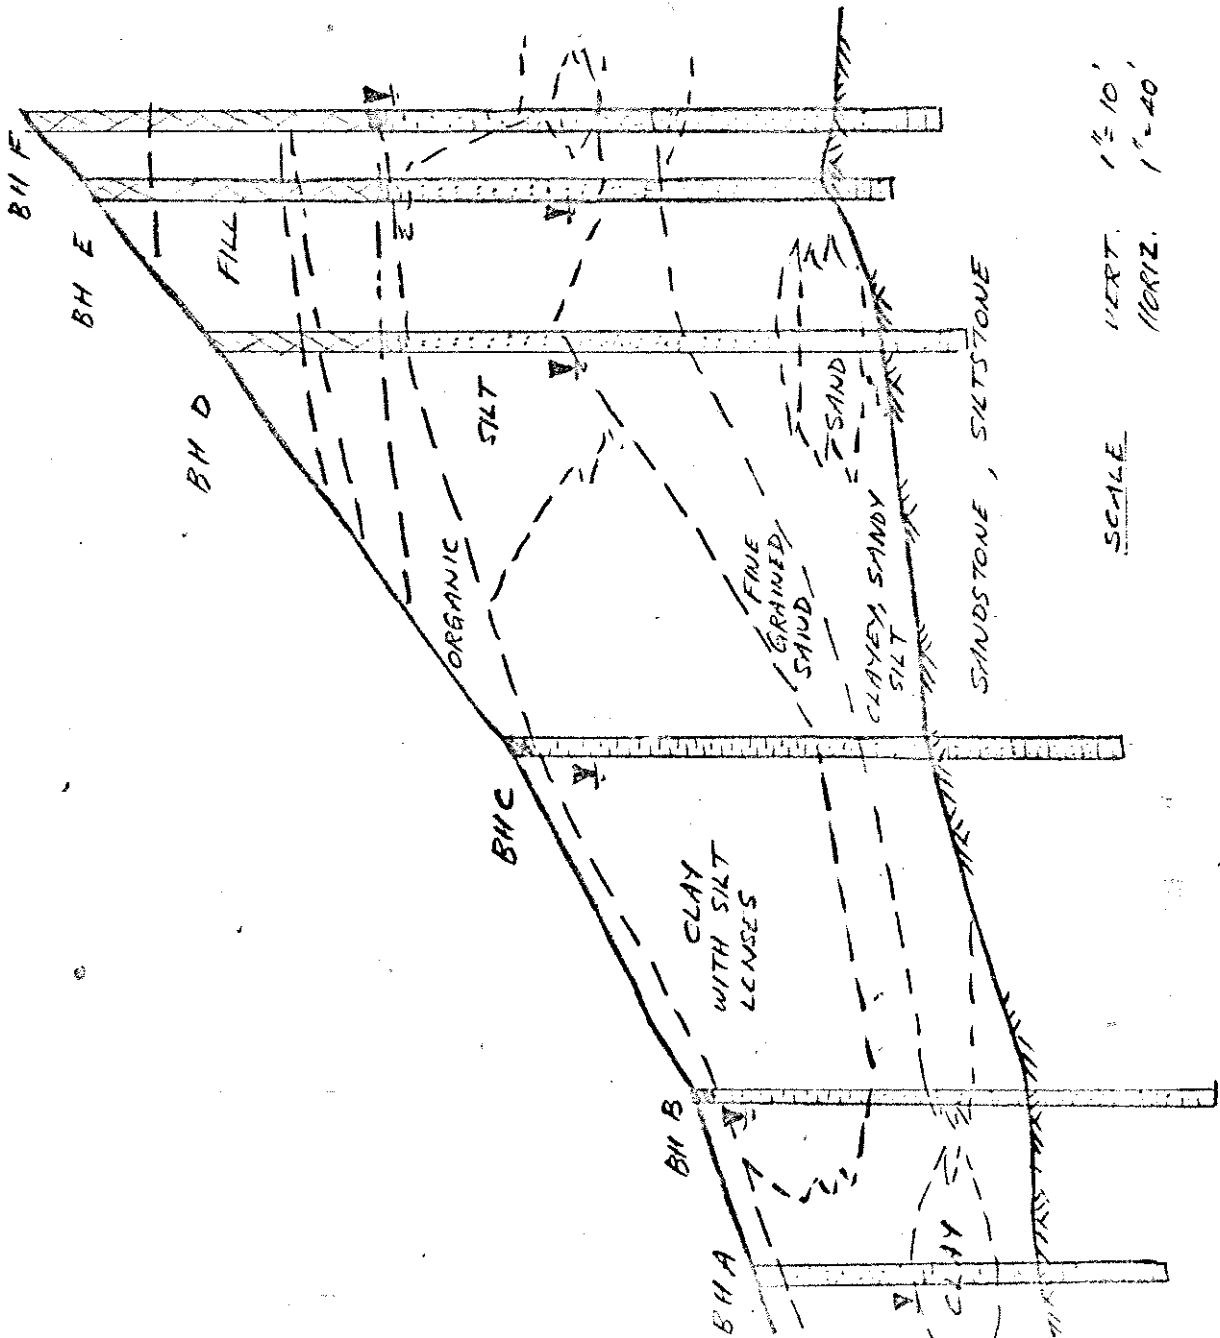
Figure 3.17 : TYPICAL SECTION OF SLOPE
(Case History C)

An aerobic cell for a sewage treatment facility was built on a terrace adjacent to a river valley wall in Central Alberta. The cell sustained minor damage due to beaver tunnelling which was readily repaired. Severe damage occurred when a slide of the river valley wall affected the cell embankment.

To have prevented the slope failure, seepage from the cell should not have been allowed to reach the slope. An impermeable liner, with an effective permeability of less than 10^{-8} cm/s, such as a plastic membrane could have been used, or seepage could have been prevented from reaching the slope by a deep continuous drain in front of the cell embankment, or the use of a cutoff between the top of the slope and the reservoir.

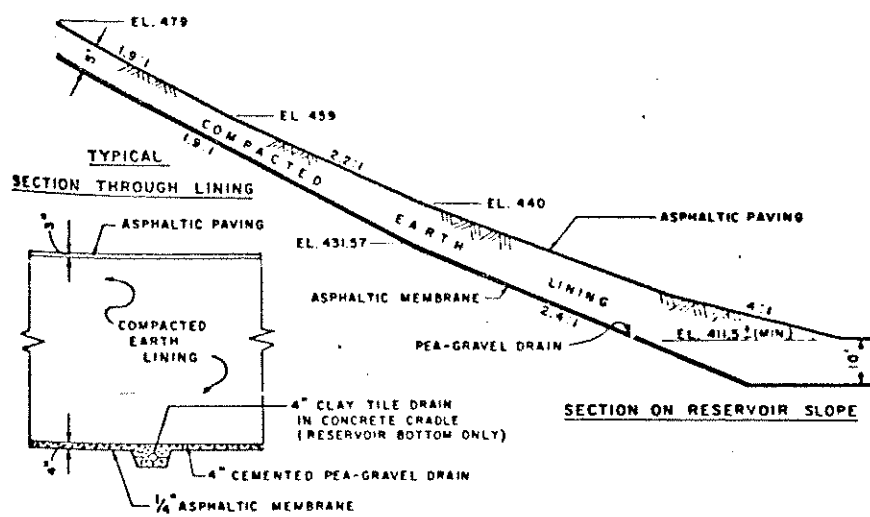
Figure 3.18 : TYPICAL SECTION
(Case History D)

The movements to which the reservoir were subjected are not uncommon, and would not harm most reservoirs and dams. However, the pea-gravel drain in this dam was brittle, and the differential movements of the faults caused distinct breaks in the drain, and the attached underlying asphaltic membrane, Once the membrane was broken, failure was inevitable. A suitable design would have had to allow sufficient flexibility to accommodate the movements which occurred.
