Cracking in Hot-dip Galvanized Welded Joints of Steel Platform
Structures

Abstract

In a recent construction project, a platform structure made up of 350W and 300W steel underwent a double dip galvanizing process. Prior to the galvanizing process, the platform was fabricated to completion, which included numerous welds throughout the design. After galvanizing, cracks were found originating in the welds and propagating into the base material. To the steel designer, this posed a new and curious problem. Previously, similar structures had undergone the same processing with no cracking.

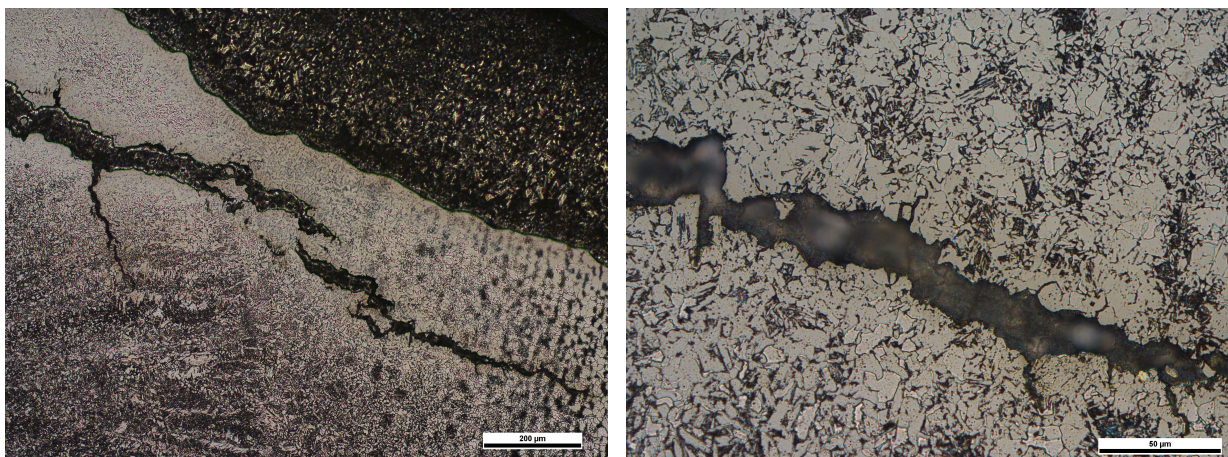
Fig. 2.10: Crack initiation site

When turning our attention towards the crack themselves, it is logical to first analyze the initiation site. Unfortunately, due to the crack opening in the galvanizing bath, the surface of the primary (macroscopically visual) crack's initiation is covered with zinc. However, Fig. 2.10 shows the crack initiation site and more specifically a secondary crack that microscopically formed alongside the primary crack, with a separation along the grain boundaries. This secondary crack is useful for analysis since the primary crack's initiation site cannot be seen. When zooming in on the secondary crack, as seen in Fig. 2.10(b), there is no deformation of the grains and the crack appears as if it could fit back together. It appears the crack is a result of separation along the grain boundary with no considerable plastic deformation. Each of these samples was sectioned and processed the same as the base material samples using a 5% nital etch. More images of the crack initiation site can be found in Appendix A. They are accompanied by images of the weld cross section, side view, and microstructure.

(a) Crack initiation site 10X

(b) Crack initiation site 50X

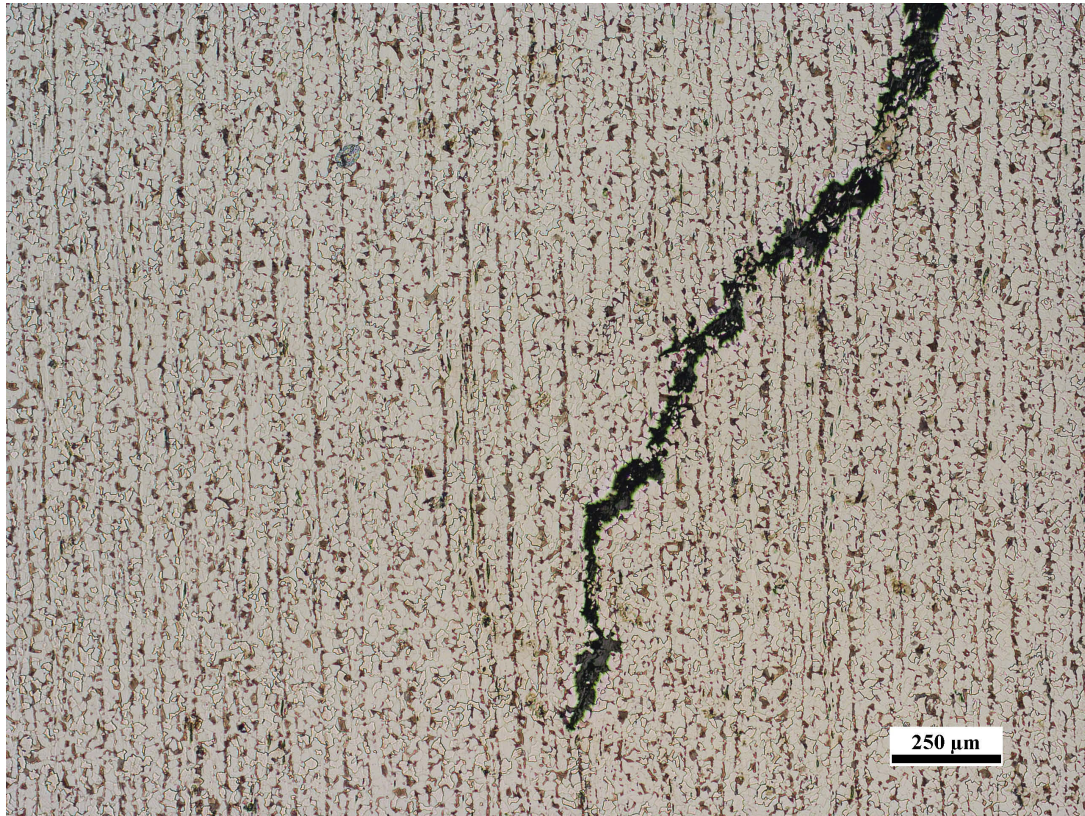
Fig. 2.11: Crack arrest site 5X

Along with the crack initiation site, the arrest site is also of interest. An image showing the crack arrest is shown in Fig. 2.11. It can be seen that the crack has the same feature of grain

boundary separation with little to no distortion. This would imply the mode of fracture stayed the same throughout the crack propagation. An EDS map was done directly at the crack arrest, where from the microscope image it looks as though there may be something in the crack. The EDS map results are shown in Fig 2.12.

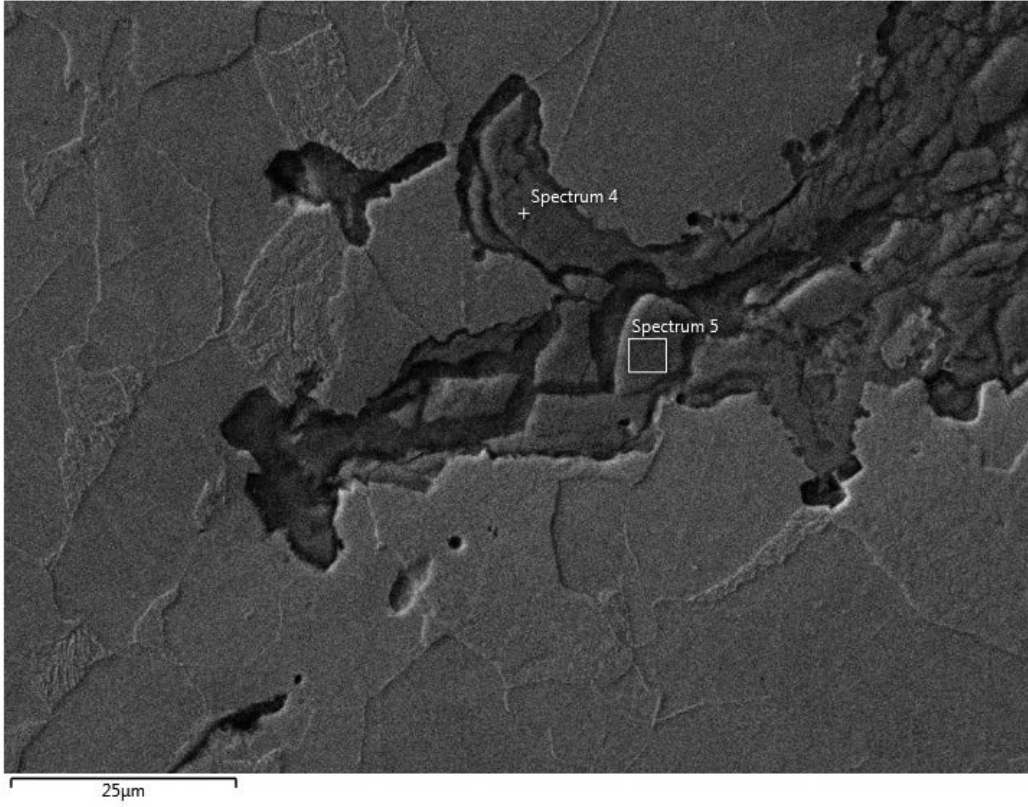
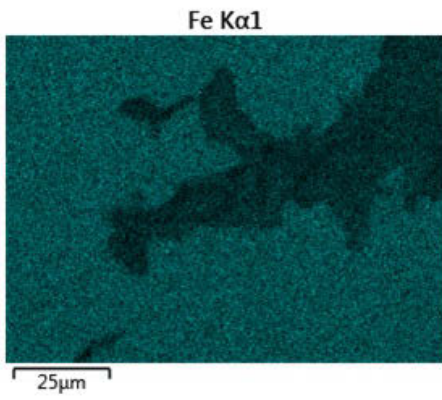
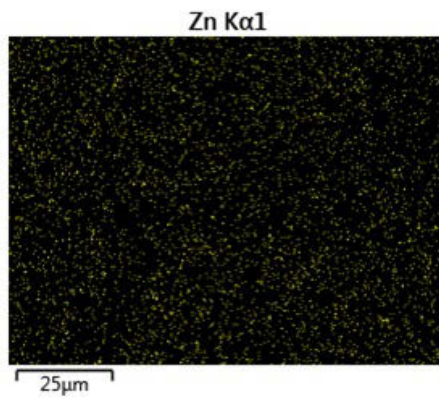
Fig. 2.12: EDS mapping of the crack arrest

The results shown in Fig. 2.12 do not show anything irregular or noteworthy. There is no increase of zinc content in the crack, which suggests LME may not be the embrittlement case [8, 25]. Also, there seems to be a build up of oxidation in the crack, which is the inclusion that was seen from the optical microscope images. This may be due to the water used while grinding the sample or from exposure to the air, but in either case it is not unexpected.

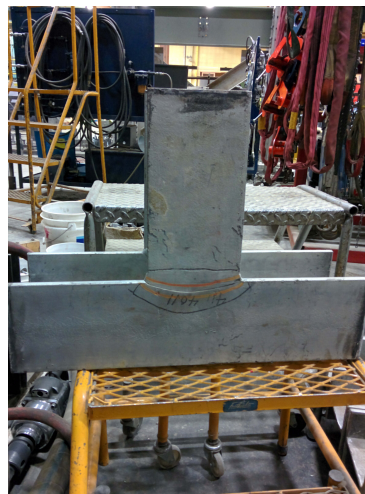
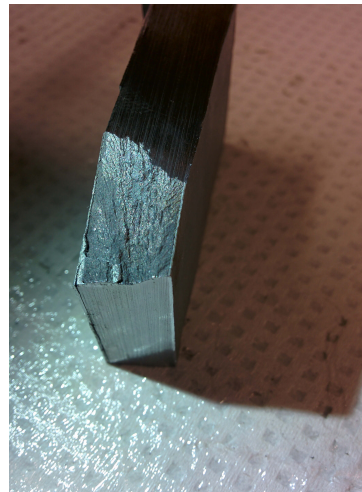
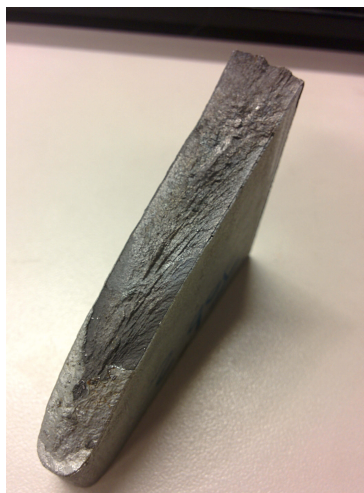
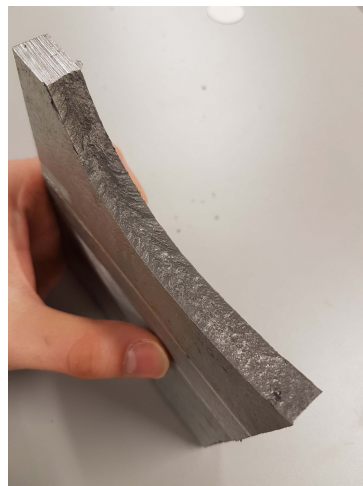
Fig. 2.13: As received fracture samples

The original cracked samples provided by the industry partner were cut and sectioned to expose the fracture surface. The surfaces show no signs of significant plastic deformation. They also showed brittle chevron markings, and some were covered with zinc while others were not. Images of three different fracture surfaces along with the overall sample can be found in Fig. 2.13.

Looking at the images of the provided samples, it can be seen there is little to no deformation of the steel on the fracture surface. It does not show any characteristics of ductile fracture, such as cup and cone features or plastic deformation. Furthermore, when examining the fracture surface under the SEM there is no evidence of deformation of the grains, the dimples seen are the same size as the grains ($20\mu\text{m}$), and the surface shows smooth areas between the grain boundaries. Even more explicitly in Fig. 2.15, microvoids can be seen across the surface. Given the distinction in these features, the difference in fracture mode can be seen directly when comparing Fig. 2.13 and Fig. 2.15. Given that 350W is expected to have very ductile behavior, the brittle fracture mode in the provided samples is critical to determining why the steel platforms cracked and supports the notion of an embrittlement factor present.

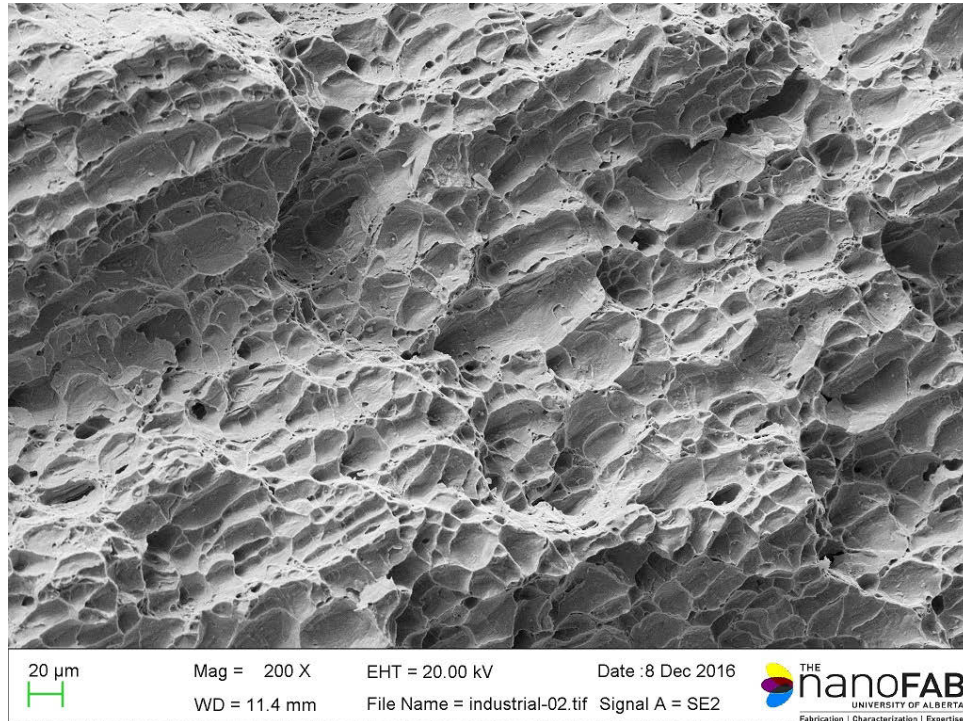
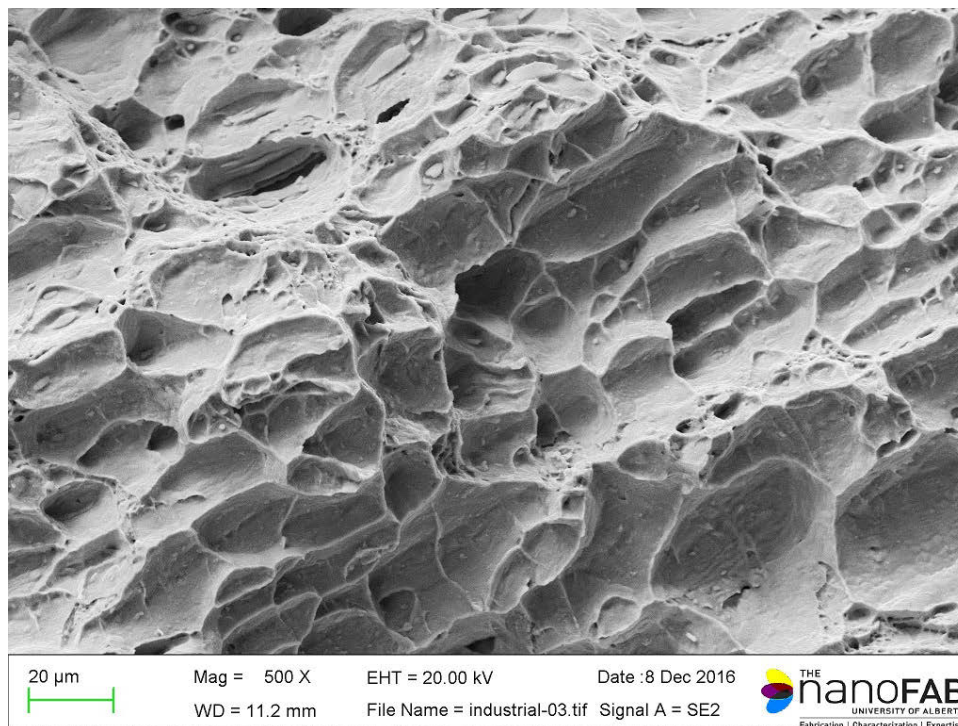
Fig. 2.14: SEM of received fracture surfaces

SEM images were also taken of the fracture surfaces. Images showing a 200X and 500X magnification of the fracture surface are given in Fig. 2.14. Fig. 2.14(b) shows dimple features on the surface in sizes of 20µm and up.

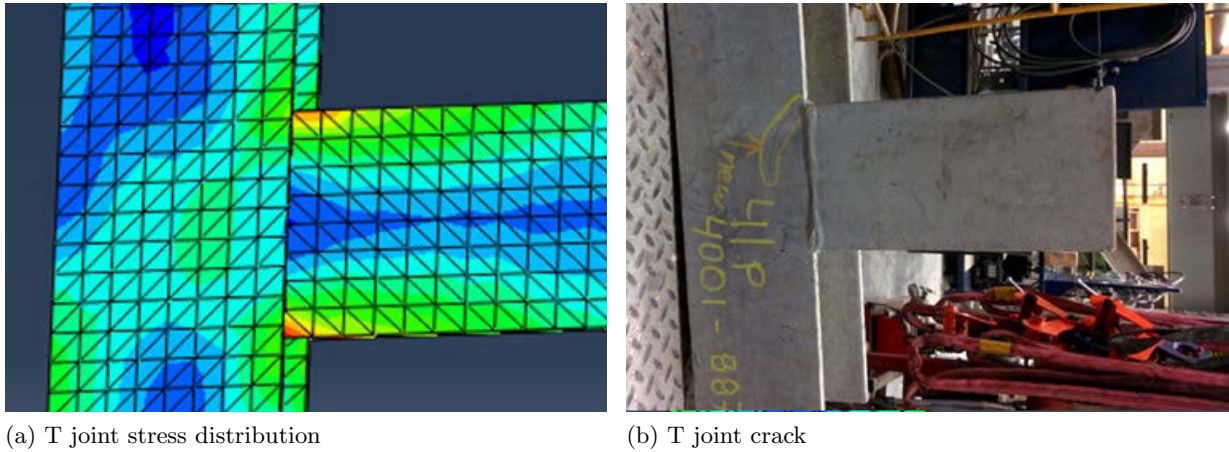
Fig. 3.11: T-joint stress distribution and actual crack location

The image shows the stress is mainly concentrated in the beams that are submerged in the galvanizing bath and their connections. Fig. 3.10 gives an idea of the stress distribution across the entire model, but for the area of interest a more magnified view is needed to get the exact stress distribution at the joints, and to determine if it matches the cracking that was found. The detailed contour images during peak stress along with an image of the actual crack locations is given in Fig. 3.11 and Fig. 3.12.

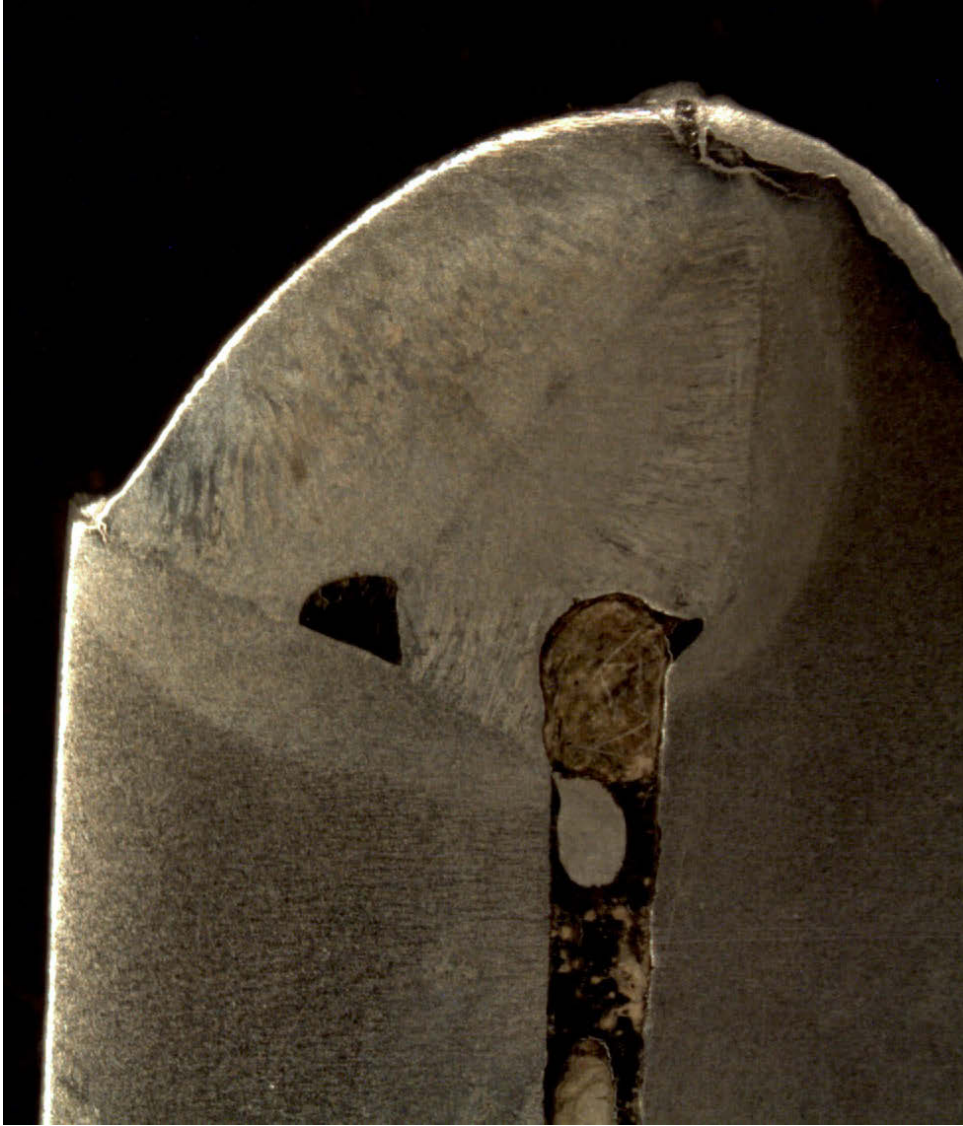
Fig. A.7: Side view of the corner joint weld

Images of the side view of the weld were also captured at the crack initiation site. As an extension to the images in Fig. 2.10, lower magnification pictures are shown in Fig. A.7, Fig. A.8, and Fig. A.9.

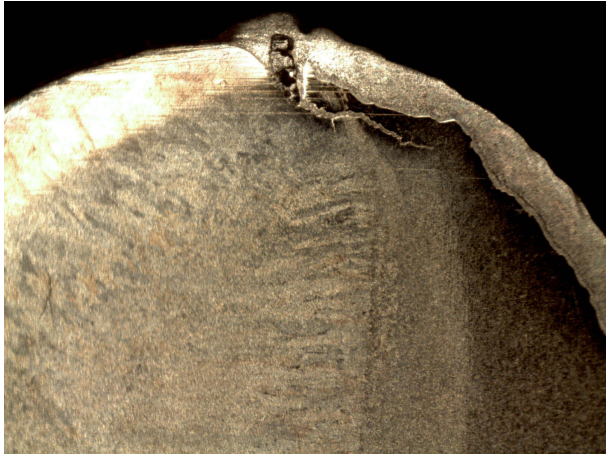
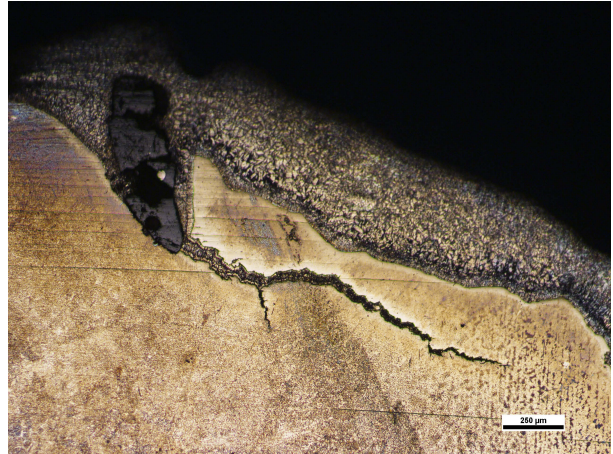
Fig. A.8: Side view of the upper cracks in the corner joint weld

(a) Crack initiation site and upper secondary crack

(b) 5X of upper secondary crack

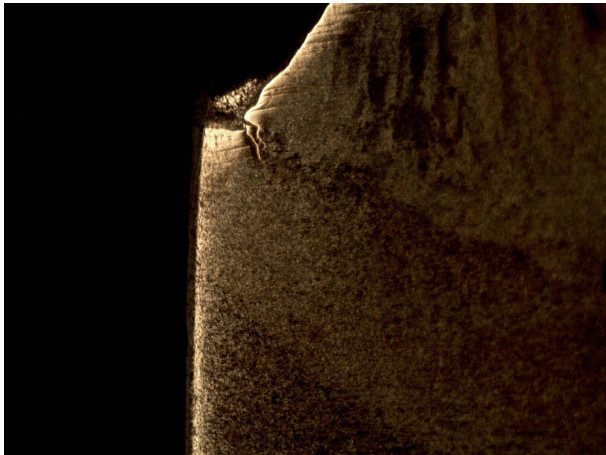
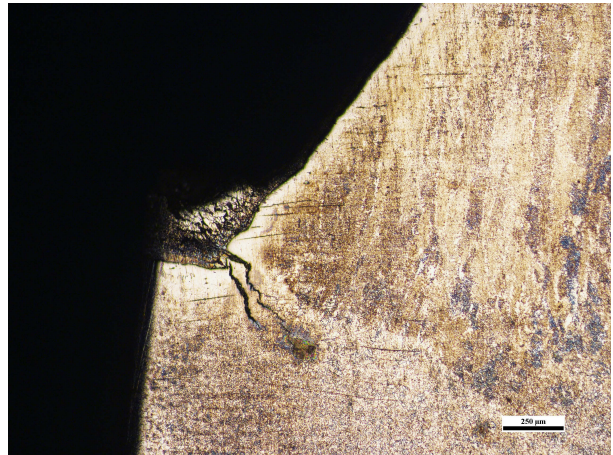
(a) Lower secondary crack

(b) 5X of lower secondary crack
