Structural Engineering Report No. 235

**BEHAVIOUR OF
DISTORTION-INDUCED FATIGUE
CRACKS IN BRIDGE GIRDERS**

December, 2000

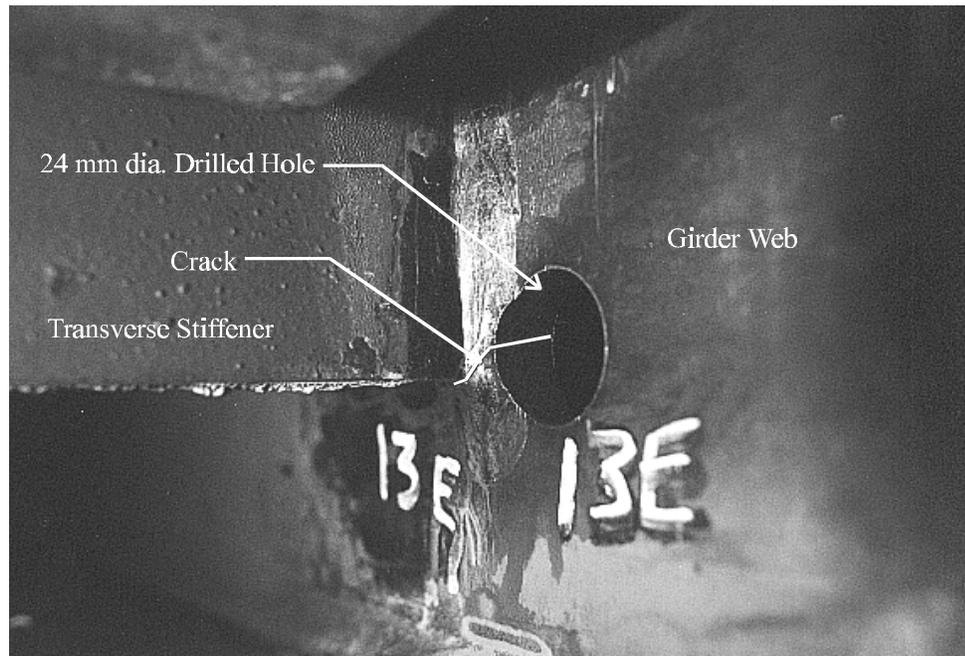
Figure 6-2 Initial Cracks and Stop Holes on East Face of Joint 13, Test Girder 1

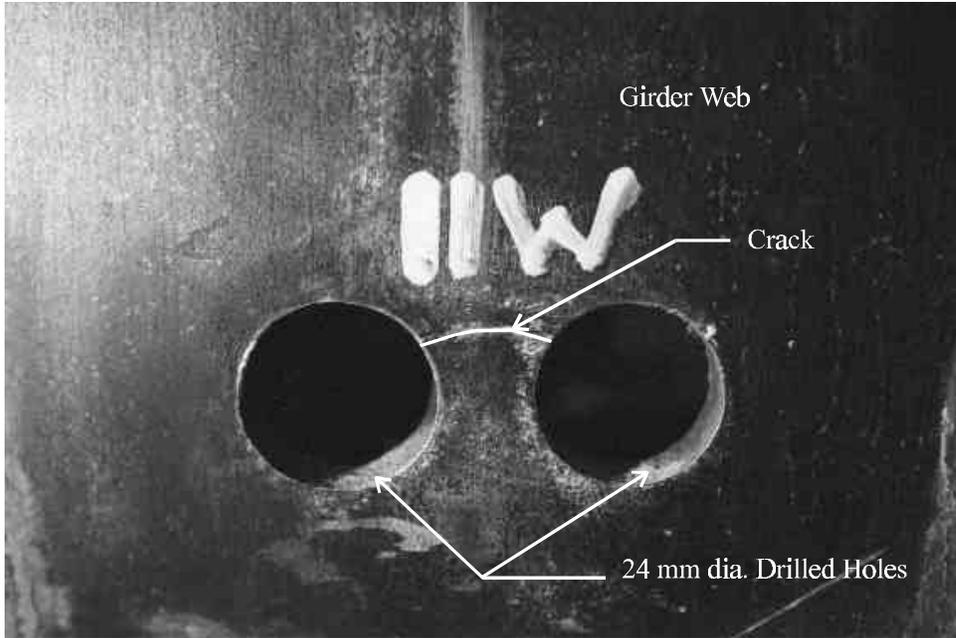
Figure 6-3 Initial Cracks and Stop Holes on West Face of Joint 11, Test Girder 1

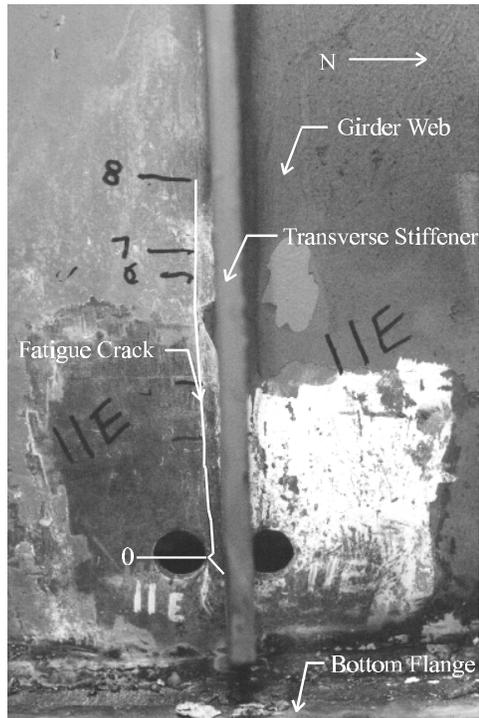
Figure 6-8 Fatigue Crack in Web on East Face of Joint 11, Test 1

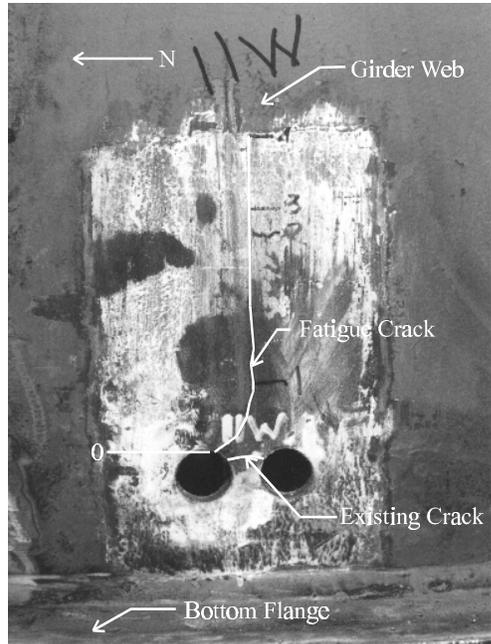
Figure 6-9 Fatigue Crack in Web on West Face of Joint 11, Test 1

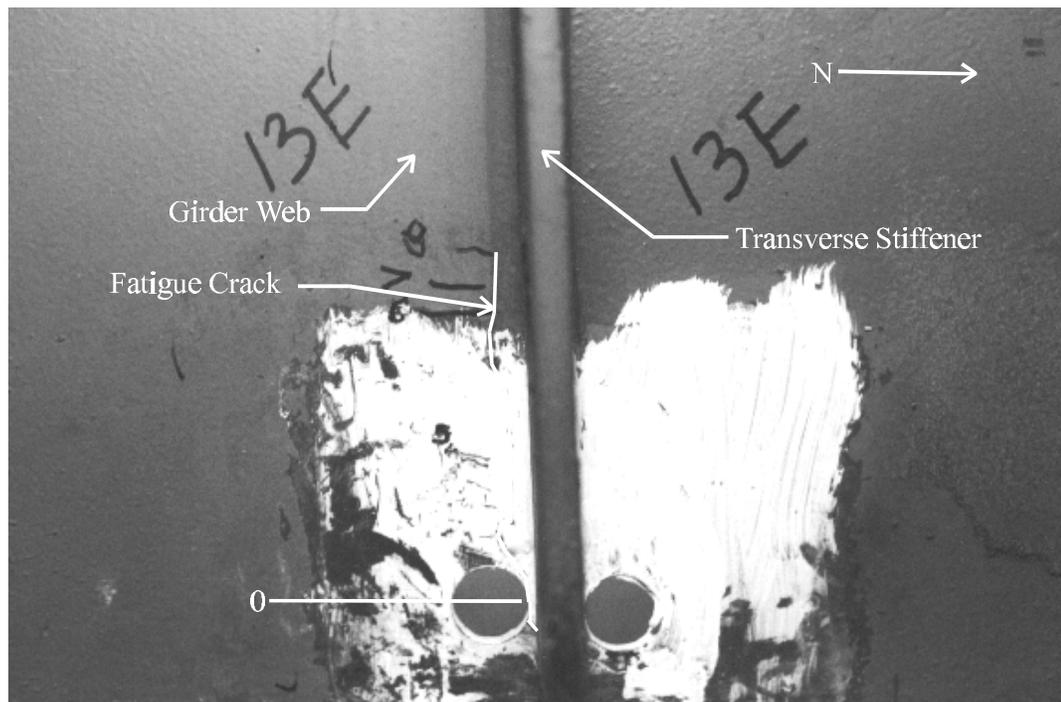
Figure 6-10 Fatigue Crack in Web on East Face of Joint 13, Test 1

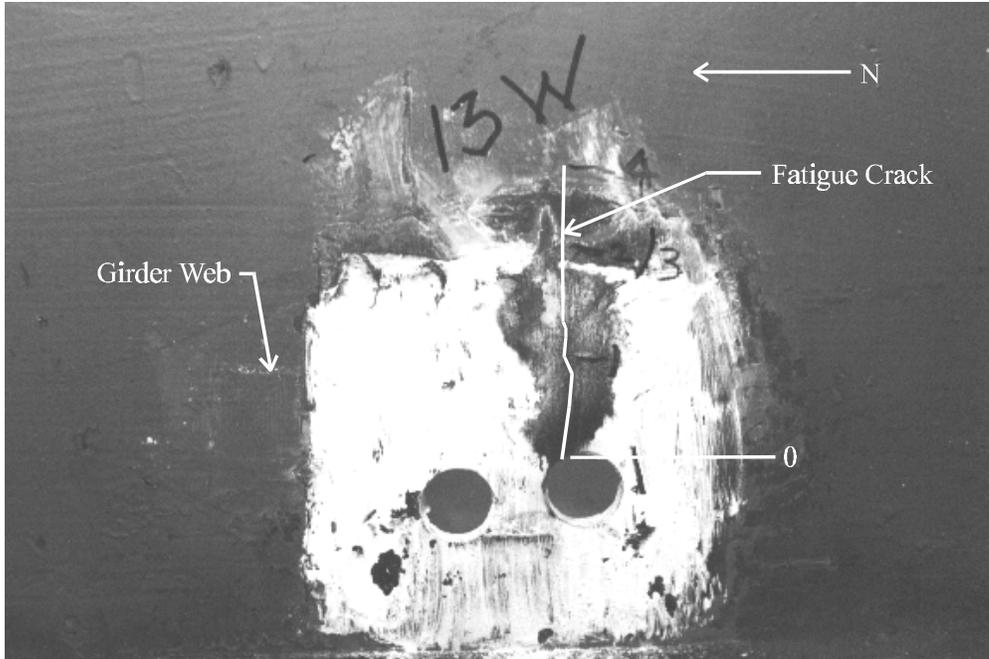
Figure 6-11 Fatigue Crack in Web on West Face of Joint 13, Test 1

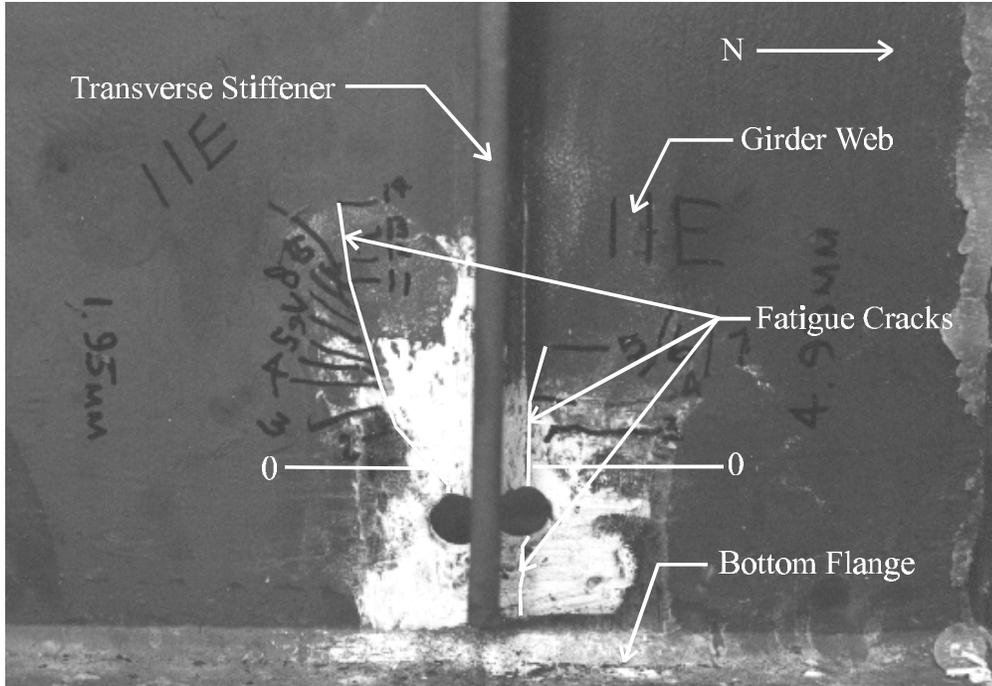
Figure 6-13 Fatigue Cracks in Web on East Face of Joint 11, Test 2

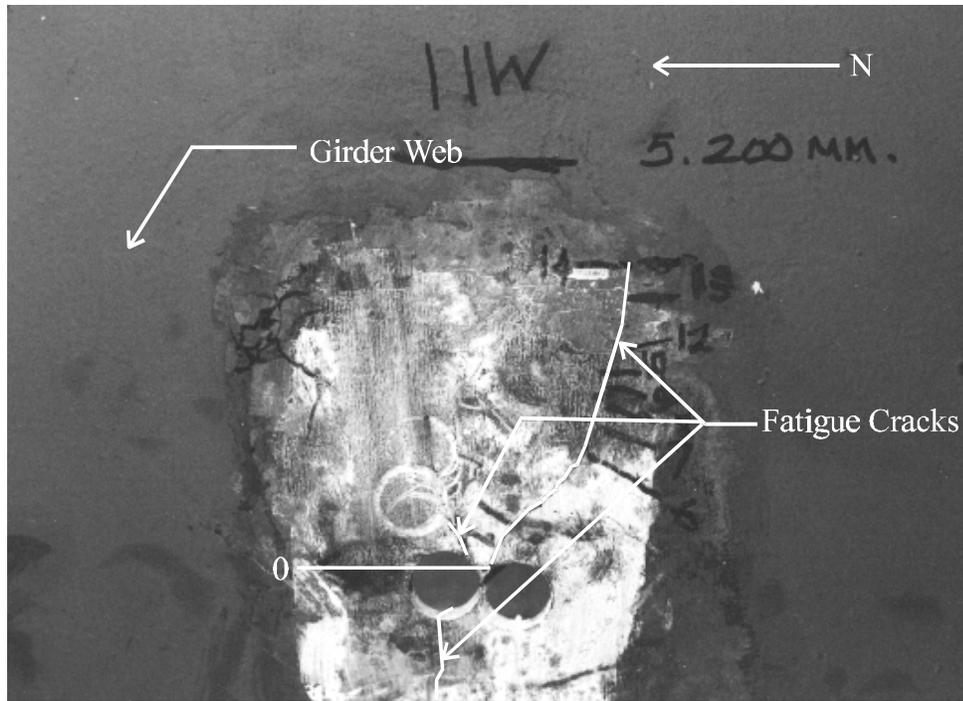
Figure 6-14 Fatigue Cracks in Web on West Face of Joint 11, Test 2

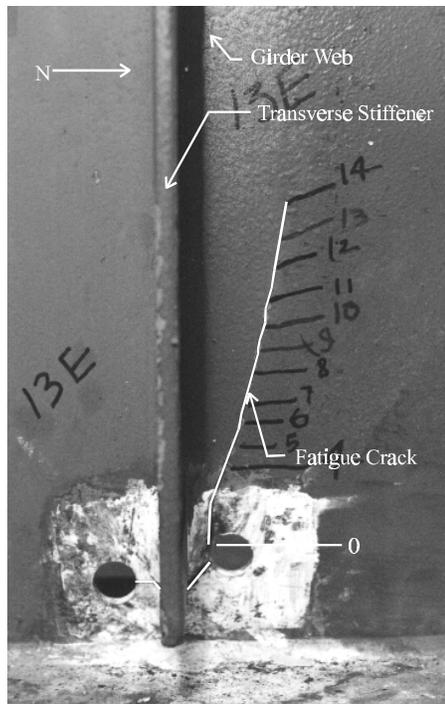
Figure 6-15 Fatigue Crack in Web on East Face of Joint 13, Test 2

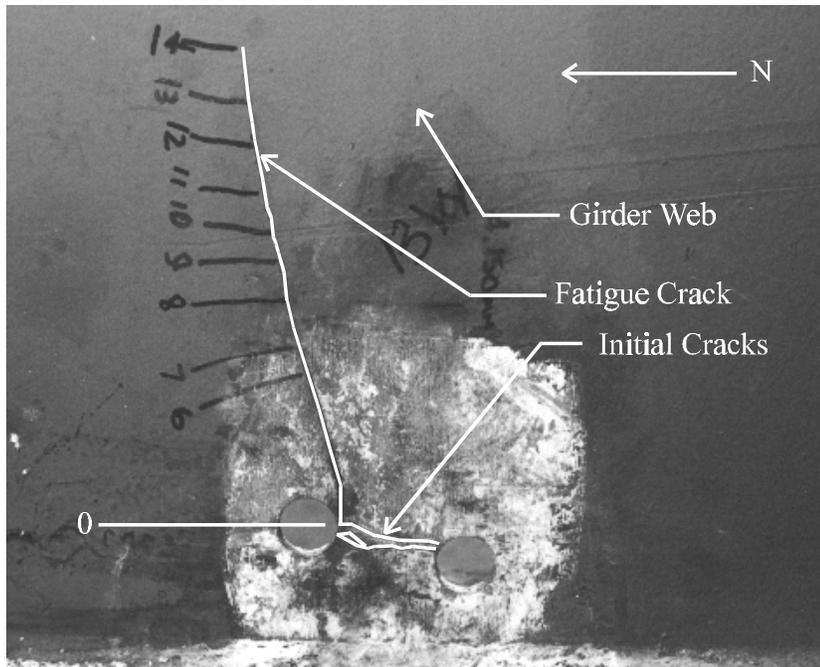
Figure 6-16 Fatigue Crack in Web on West Face of Joint 13, Test 2

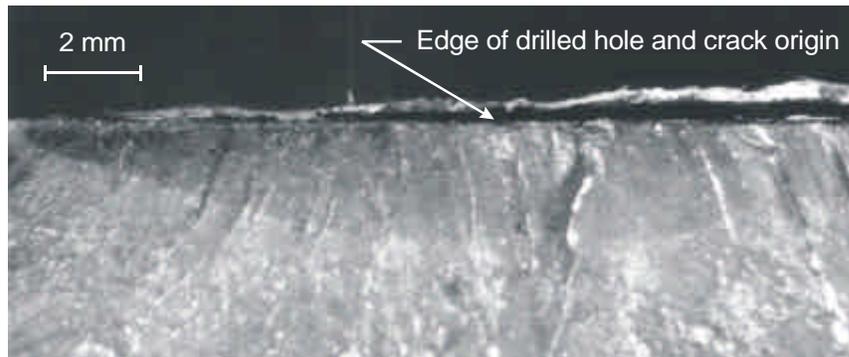
Figure 6-20 Origin of Fatigue Crack at Surface of Drilled Hole

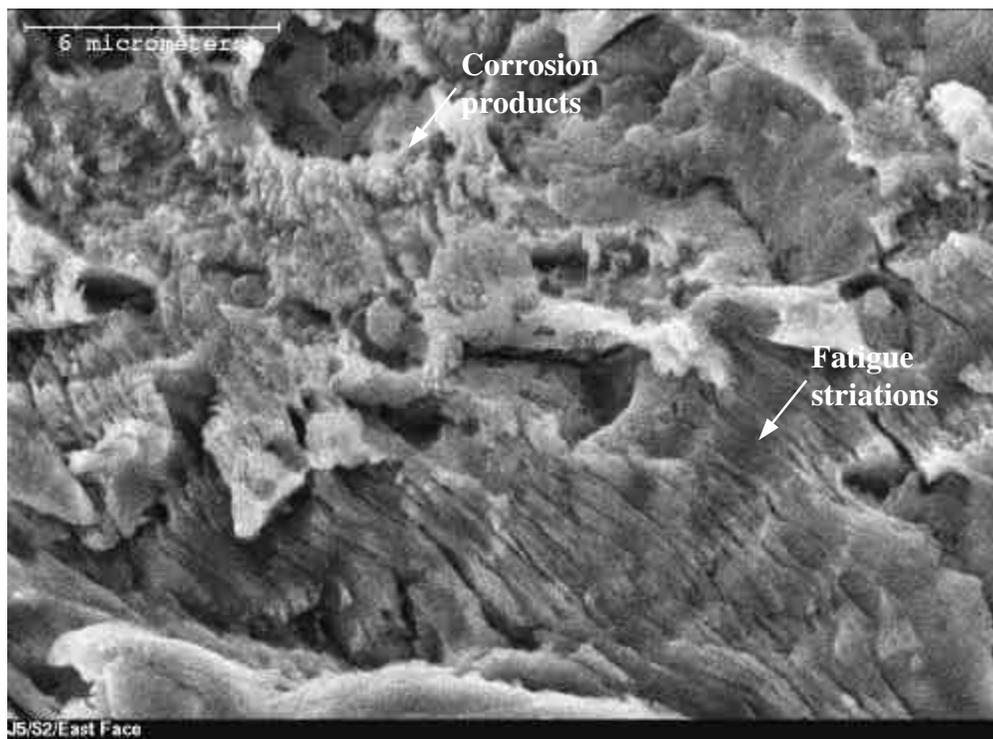
Figure 6-21 Fatigue Striations and Corrosion Products on Fracture Surface of Specimen 2
