**A Methodology for Evaluating Rainfall-induced Railway
Ground Hazards Encountered at Port Douglas, June 1998**

Submitted to the Faculty of Graduate Studies and Research
in partial fulfillment of the requirements for
the Degree of Master of Science
in Geotechnical Engineering

Fall 2006

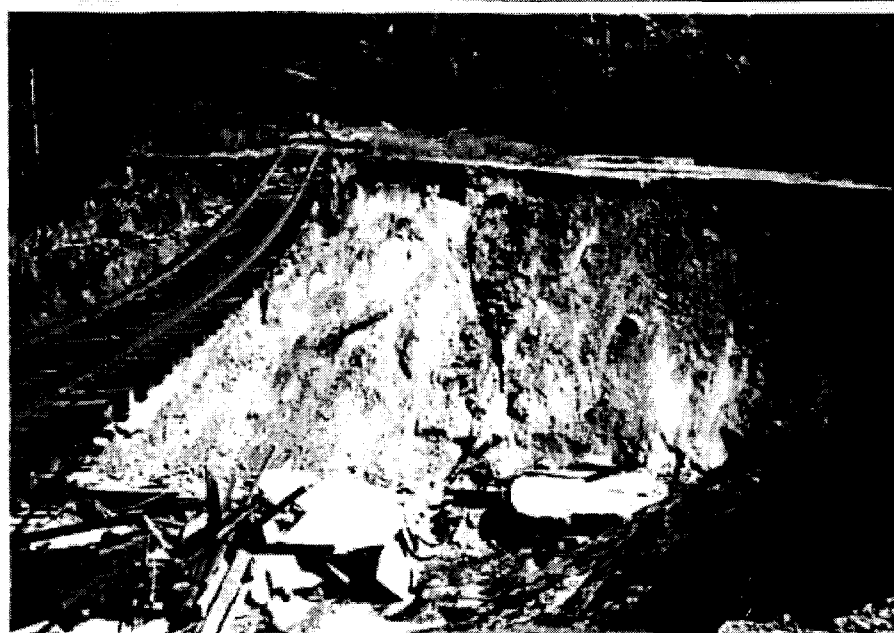
One of the major overland flow erosions occurred at Mile Post 154.47 where the earth embankment crossed a stream valley, with a stone box culvert 1.2 m wide and 0.9 m high through the base of the embankment to provide drainage. The embankment, composed of lacustrine silt with fine sand materials, was about 12 m high and had side slopes of approximately 1.4H:1V. On the night of June 27, 1998, the embankment and culvert were partially eroded (see Figure 2-12). The failure extended over a length of around 35 m at

the track level and the erosion depth was about 17 m. This overland flow erosion site was the largest in the Port Douglas event. The CPR's inventory recorded that this area endured previous overland flow erosion damage.

Figure 2-12 Embankment overland flow erosion at MP 154.47, looking south
(Canadian Pacific Railway, photograph taken in June 1998)

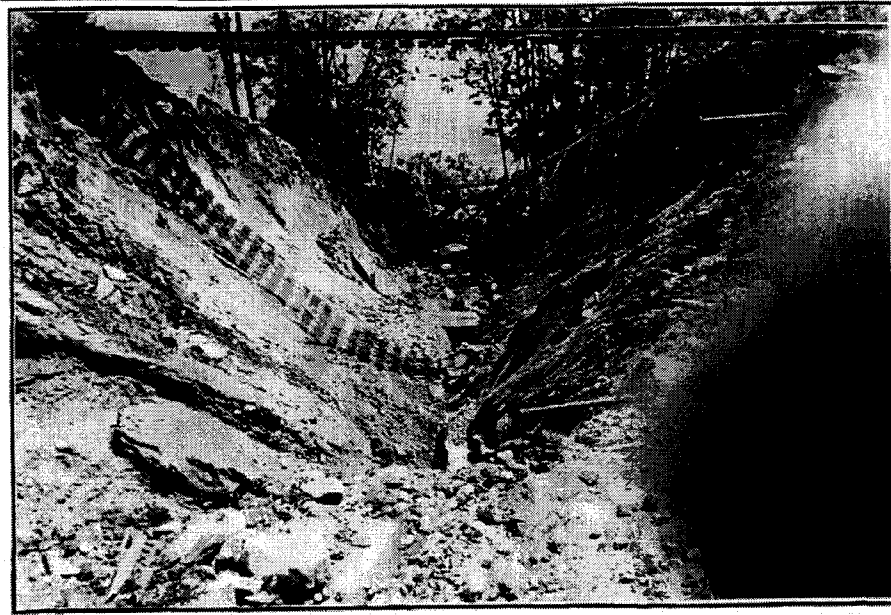
Close to the site 154.47, another embankment overland flow erosion was also investigated at MP 154.44 at the end of June 1998. At the site 154.44 a stream went through the earth embankment in a stone box culvert, which was 1 m wide and 0.9 m in height, to provide drainage. The embankment was built of local lacustrine silt and fine sand materials with a height of 12 m and side slopes of approximately 1.4H:1V. As shown in Figure 2-13, the erosion length at the track level was around 23 m and the failure depth was 12 m.

Figure 2-13 embankment overland flow erosion at MP 154.44, looking west
(Canadian Pacific Railway, photograph taken in July 1998)

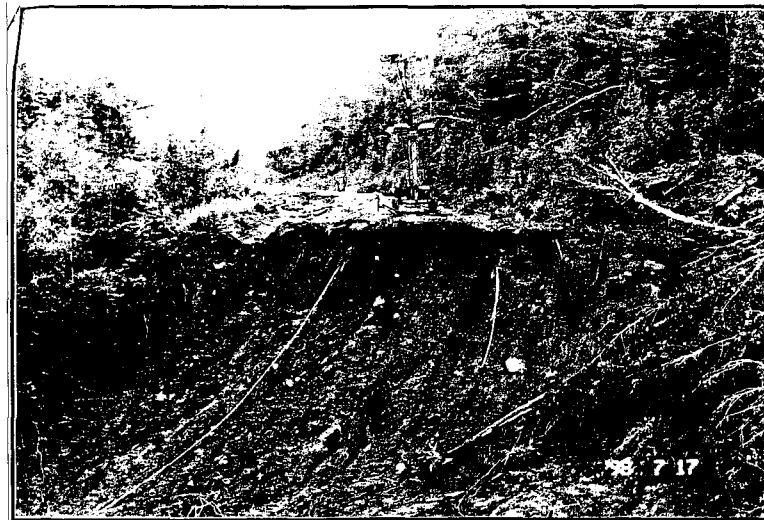
This landslide was immediately south of the derailment site at MP 150.17 (see Figure B-6 in Appendix B). The embankment was about 15 m high, and the east slope had a side slope 1.5H:1V. The east slope failed on July 5, 1998 at about 06:00am, while the MP

150.17 site was being restored. It was raining hard before and during the failure. A witness working on the restoration of MP 150.17 reported that the embankment appeared to fail from the bottom first and to slowly move in one piece. Figure 2-15 suggests a circular failure undermined the tracks. During inspection after the landslide event, multiple seeps were noted at the cut/fill interface, and seeps continued for weeks. Debris from the slide flowed approximately 120 m east of the track centerline, carrying a section of track with it.

Figure 2-15 Earth slide at MP 150.10, looking south
(Canadian Pacific Railway, photograph taken in July 1998)

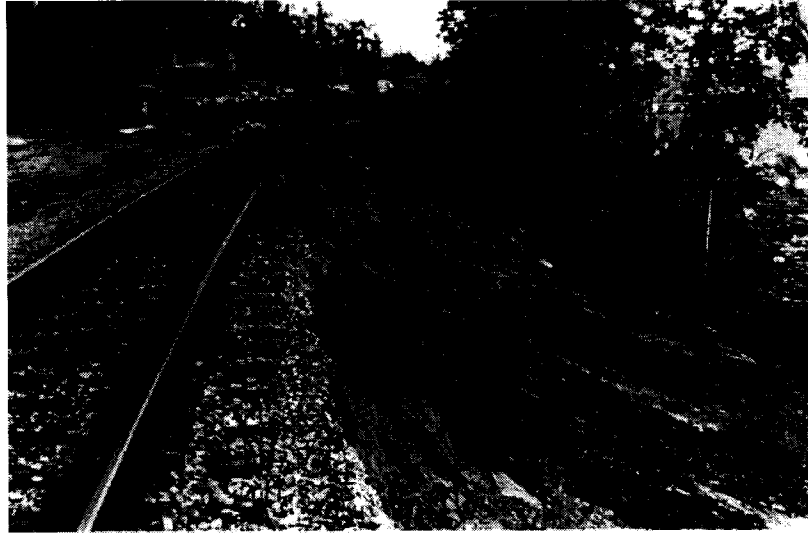
embankment had a height of 12 m and a east side slope estimated to be 1.4H:1V. The earth slide occurred on the east slope and appeared to be a circular failure, as shown in Figure 2-16. The failure length was measured to be as long as 60 meters.

Figure 2-16 Earth slide at MP 154.41, looking north
(Canadian Pacific Railway, photograph taken in June 1998)

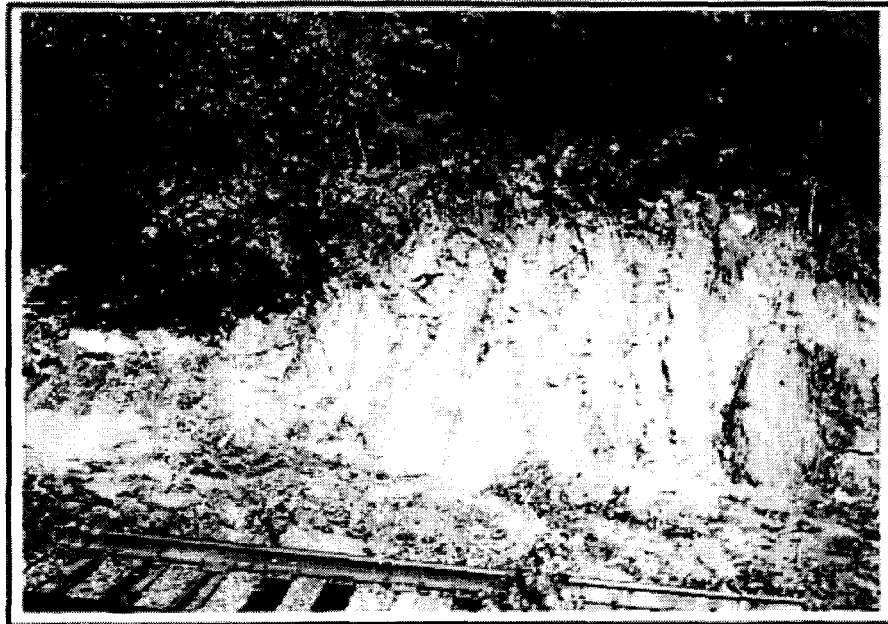
Several upslope surface earth slides (on the west side of the tracks and above the track level) were noticed on July 2, 1998. The debris blocked the drainage swale and flowed onto the tracks, affecting the safety of the railway operation. Figure 2-18 shows a photograph of an upslope embankment shallow earth slide. A review of the upslope earth slides is given in Table 2-3.

Figure 2-18 Upslope shallow earth slide at MP 151.30, looking west
(Canadian Pacific Railway, photograph taken in July 1998)

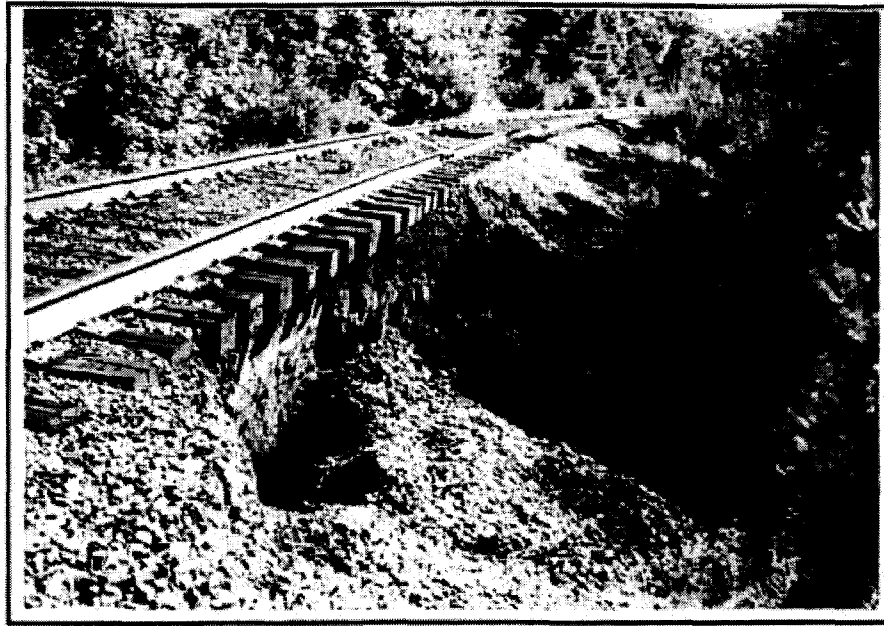
long and 0.6 m deep. The settlement was likely due to the subsidence of the existing culvert within the embankment.

Figure 2-19 Scarp due to settlement at MP 151.38
(Canadian Pacific Railway, photograph taken in July 1998)

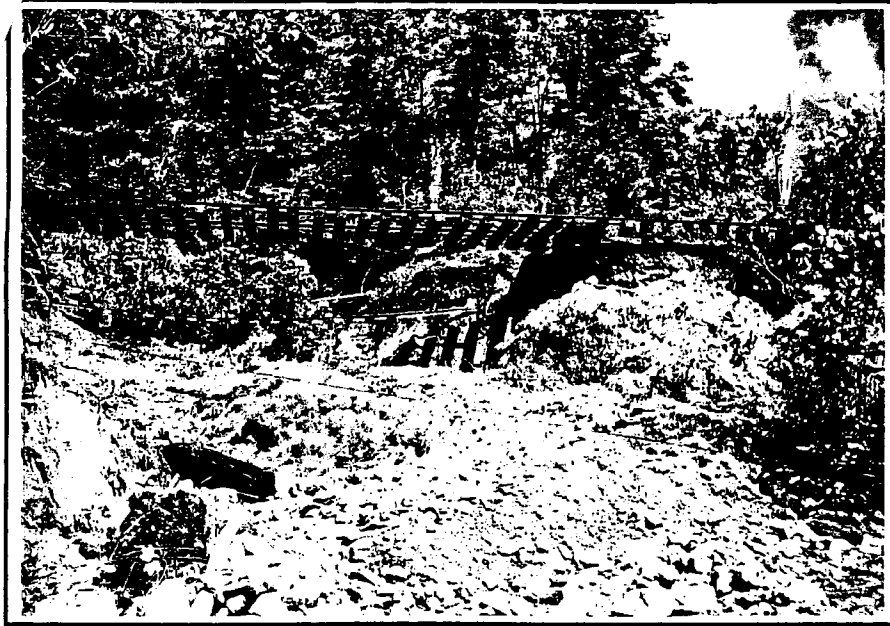
Figure A-2 Embankment erosion at MP 151.70
(Canadian Pacific Railway, picture taken in July 1998)

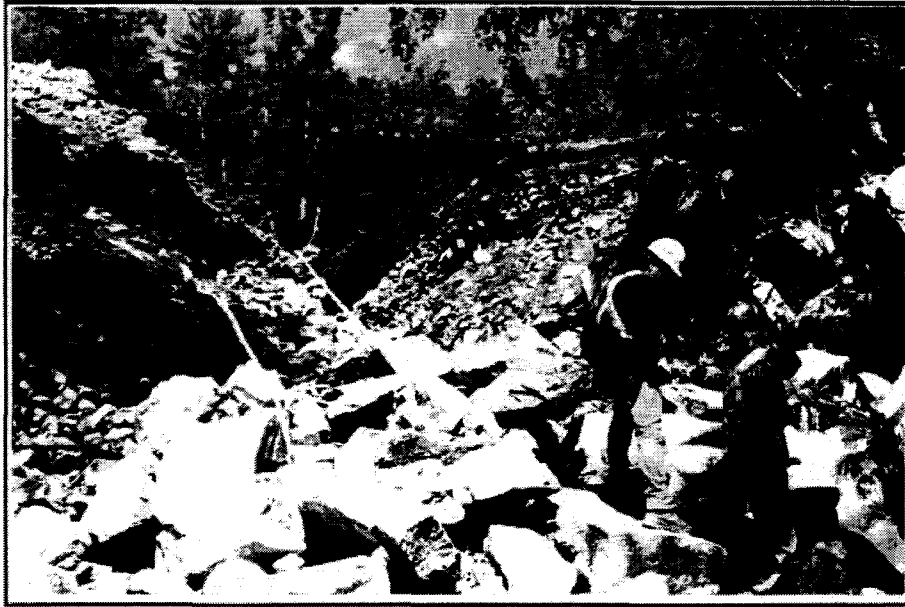
Figure A-3 Embankment erosion at MP 147.33
(Canadian Pacific Railway, picture taken in June 1998)
