TITLE OF THESIS/TITRE DE LA THÈSE An Investigation of the Edgerton Landslide, Wainwright, Alberta.

UNIVERSITY/UNIVERSITÉ University of Alberta.

DEGREE FOR WHICH THESIS WAS PRESENTED/ GRADE POUR LEQUEL CETTE THÈSE FUT PRÉSENTÉE M Sc

YEAR THIS DEGREE CONFERRED/ANNÉE D'OBTENTION DE CE GRADE Fall 1976

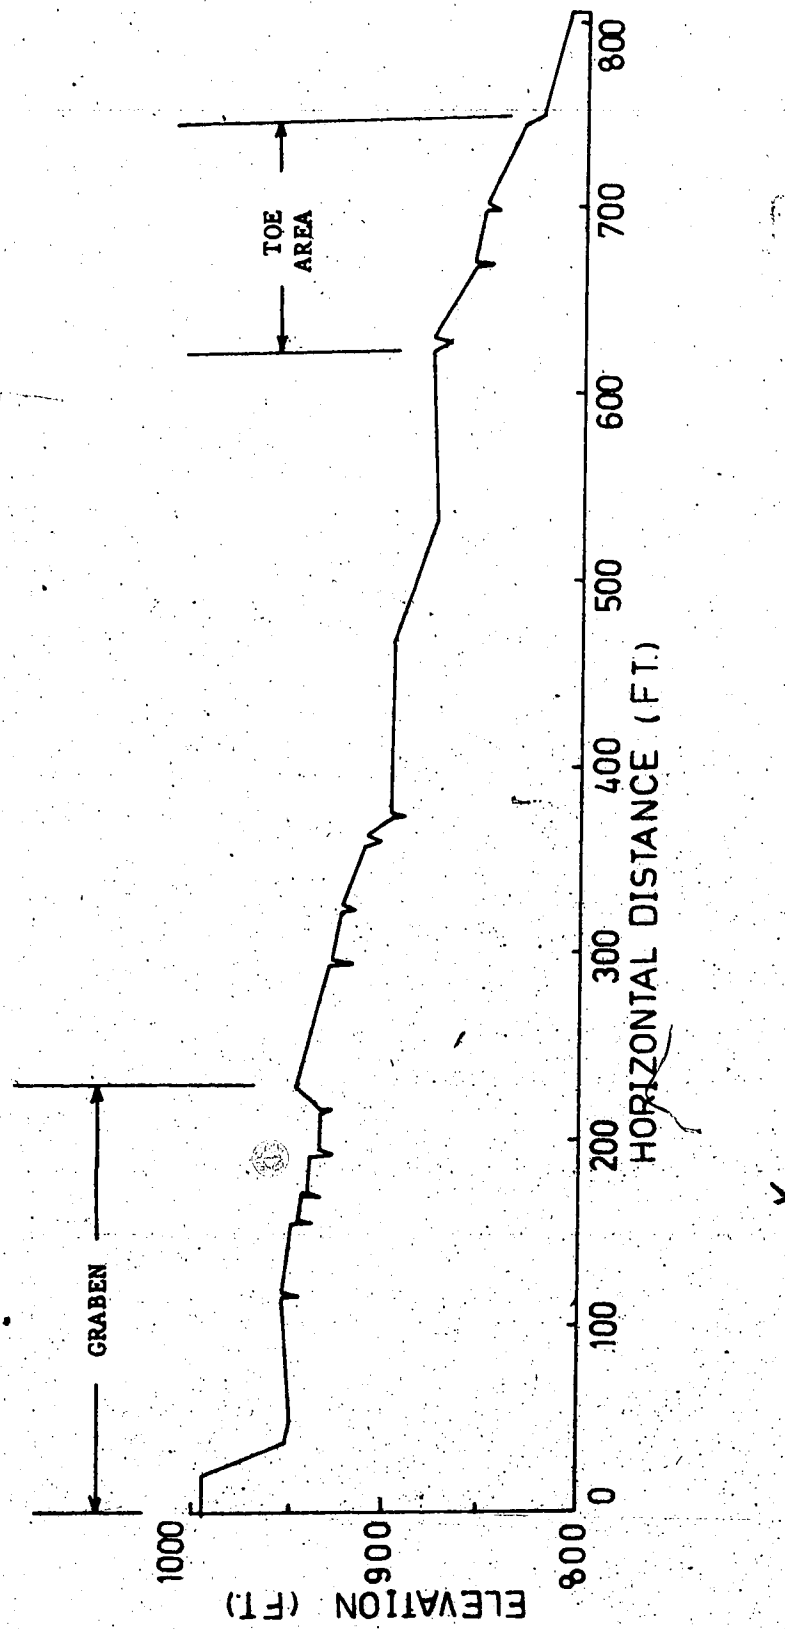
FIGURE 2.3 GENERAL PROFILE OF THE NORTH SLIDE

was inclined at approximately 70° to the horizontal at failure. The toe is approximately 180 feet below prairie level, and about 100 feet above the river level. This is significant in that it suggests that the river has not been instrumental in initiating the slide failure. The graben is clearly visible in the slide profile (Figure 2.3).

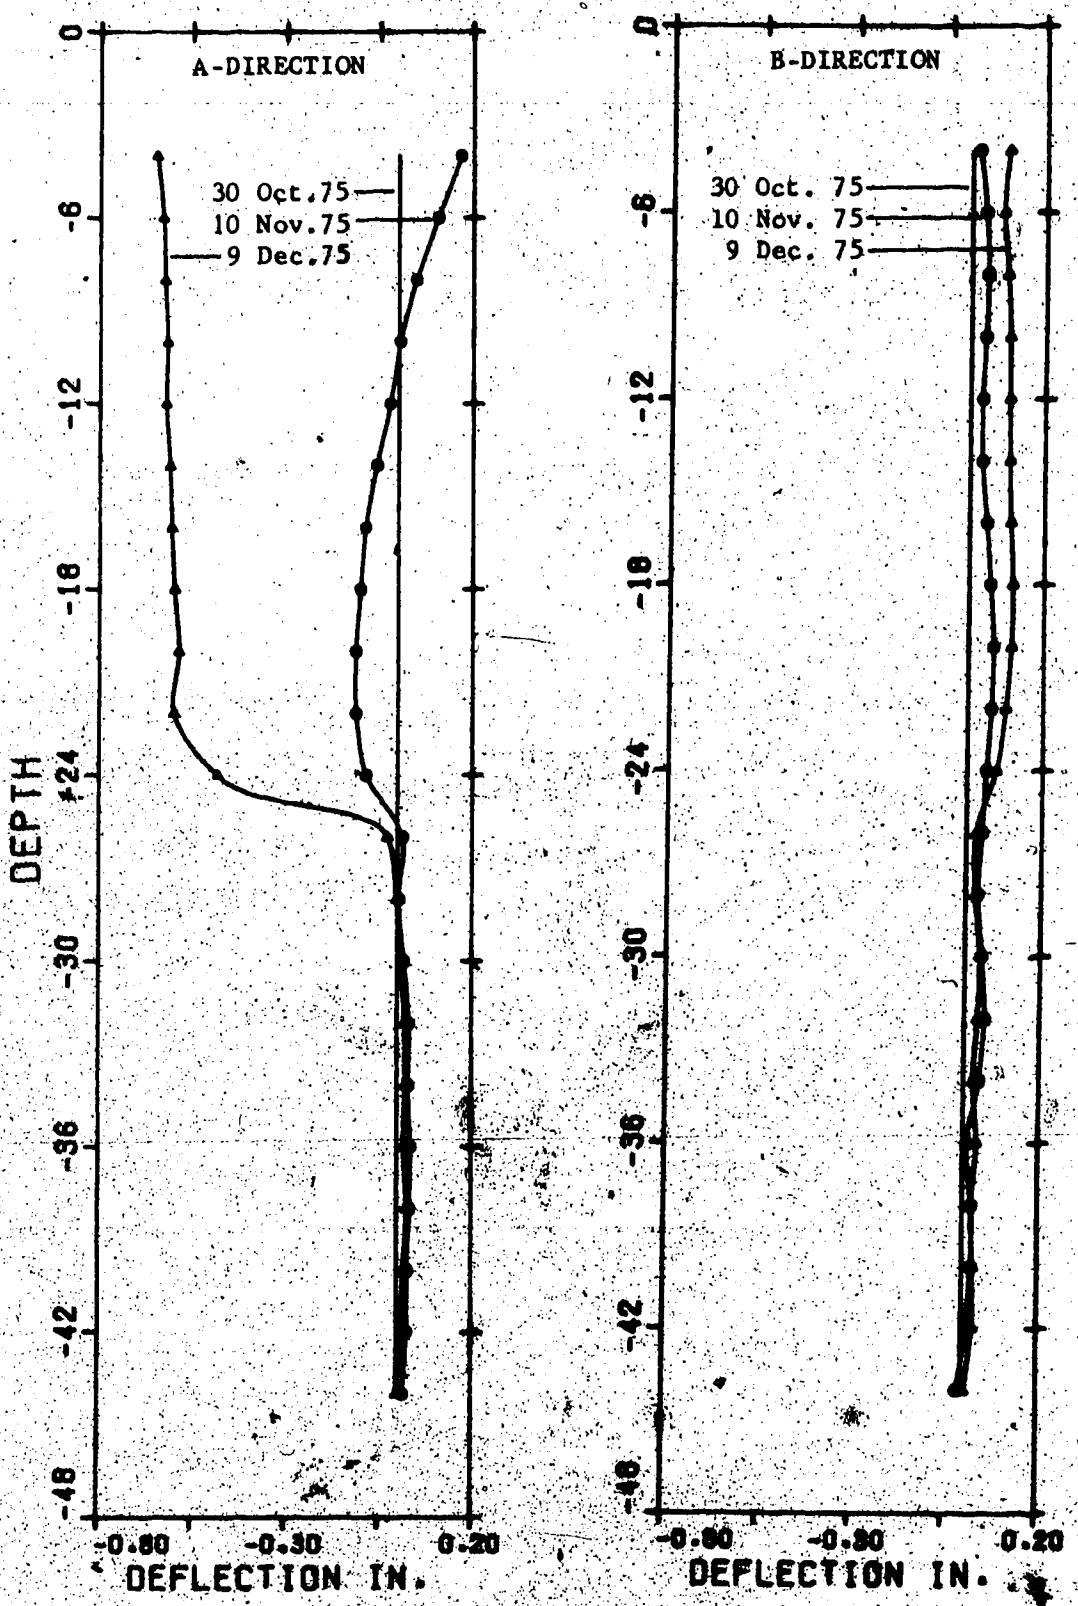
FIGURE 3.8 SLOPE INDICATOR READINGS FROM BH7

Slope indicator S7, was installed in BH7 near the toe of the South Slide in late October 1975, to locate the failure plane at this point. It also was monitored until early December 1975, and the failure plane was located at a depth of 26 feet below the top of the pipe (Figure 3.8).

When this indicator was read in early April, 1976, deformations during Spring thaw had caused the casing to block off at a depth of 22 feet.
