Corrosion of Aluminum Alloys in Wastewater Treatment Aeration Tanks

A thesis submitted in partial fulfillment of the requirements for the degree of

Materials Engineering

Severe localized corrosion was found throughout an aeration tank of a modular wastewater treatment plant. Specifically, pitting, crevice corrosion, galvanic corrosion, and intergranular corrosion (IGC) were observed on the 5000 and 6000 series aluminum alloys used in the tank's construction. One of the suspected environmental causes of corrosion was an aeration tank process additive, namely a coagulant – either aluminum sulphate (Alum) or polyaluminum chloride (PACl; Isopac). Laboratory scale corrosion cells were designed to isolate, simulate, and evaluate the corrosivity of the coagulants (in relevant quantities) on the metallic alloys of construction. Additionally, due to presence of deposit found throughout the tank (resulting in under-deposit corrosion), fabricated crevices were installed on the tested alloys to help simulate crevice corrosion environments. The solution conditions in the cells were monitored throughout the duration of the immersion testing in order to assess whether the cells were within nor

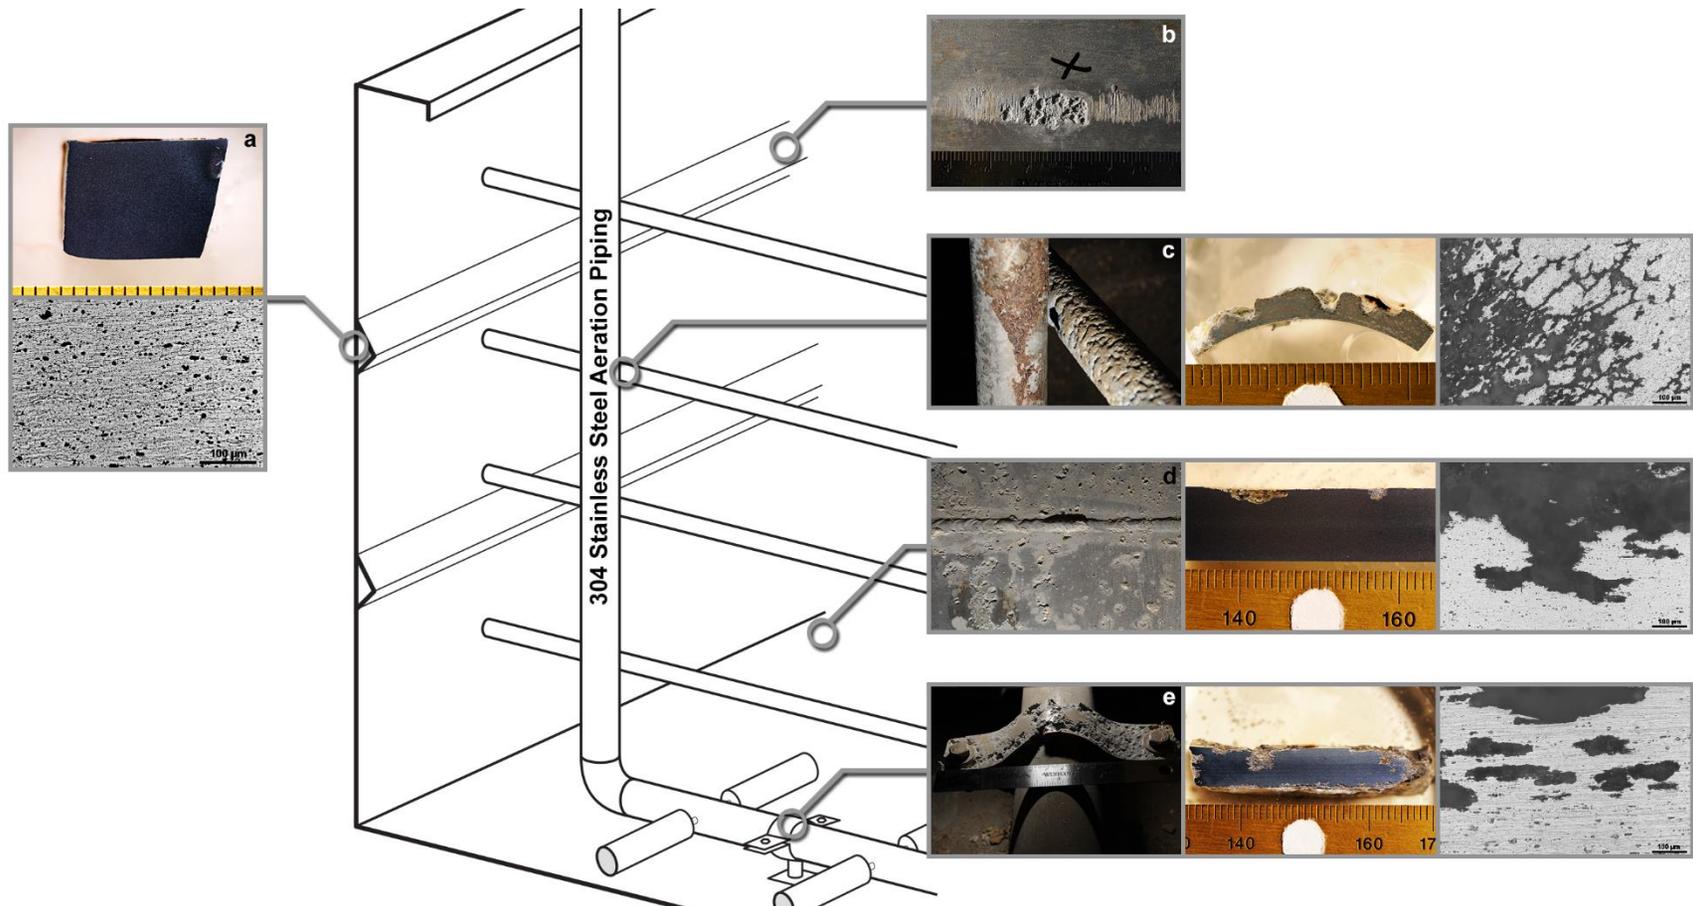
Figure 1-3: Partial schematic of the aeration tank, along with images (including macrophotographs, cross-sections, and micrographs) acquired from key locations/aluminum alloy components, namely: collected wall cross-section (a), pitting on wall tooling marks (b), tubular tie in contact with aeration piping (c), tank floor (d), and an aeration piping bracket (e). Four modes of corrosion (pitting, crevice, galvanic, and IGC) were identified. Deposit(s) were removed to aid in the macrophotography. Scale on ruler is in mm.

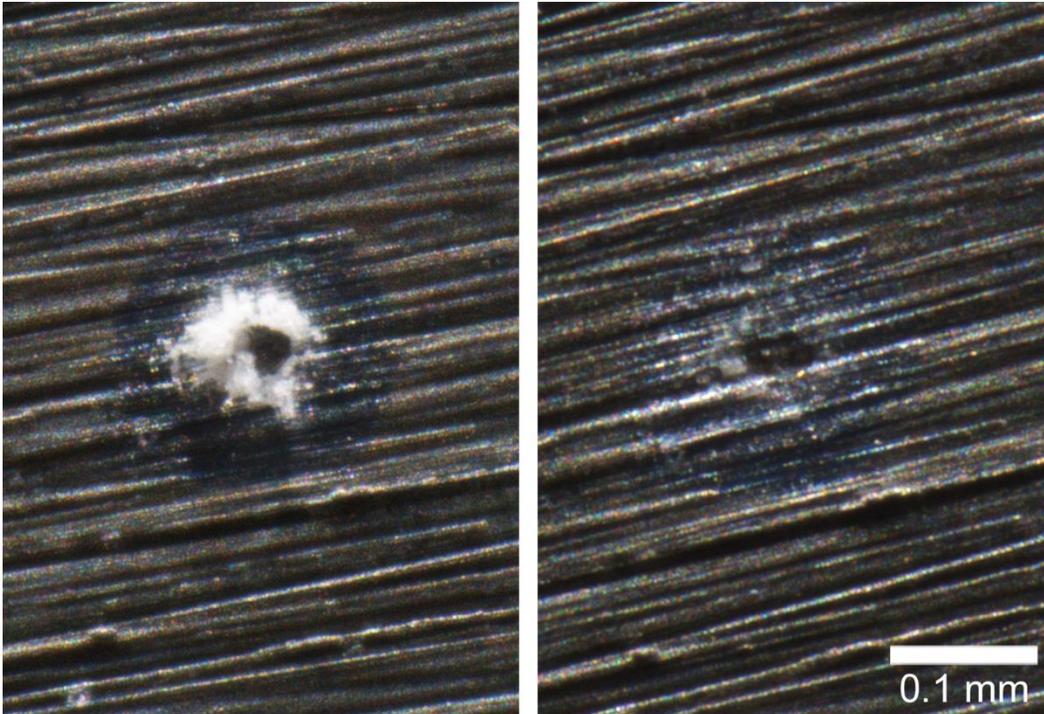
Figure 4-5: Representative image of a tubercle on a 5086/5083 coupon in DIUF, before (left photo) and after (right photo) removal. A small, round-shaped pit can be observed beneath the removed tubercle.

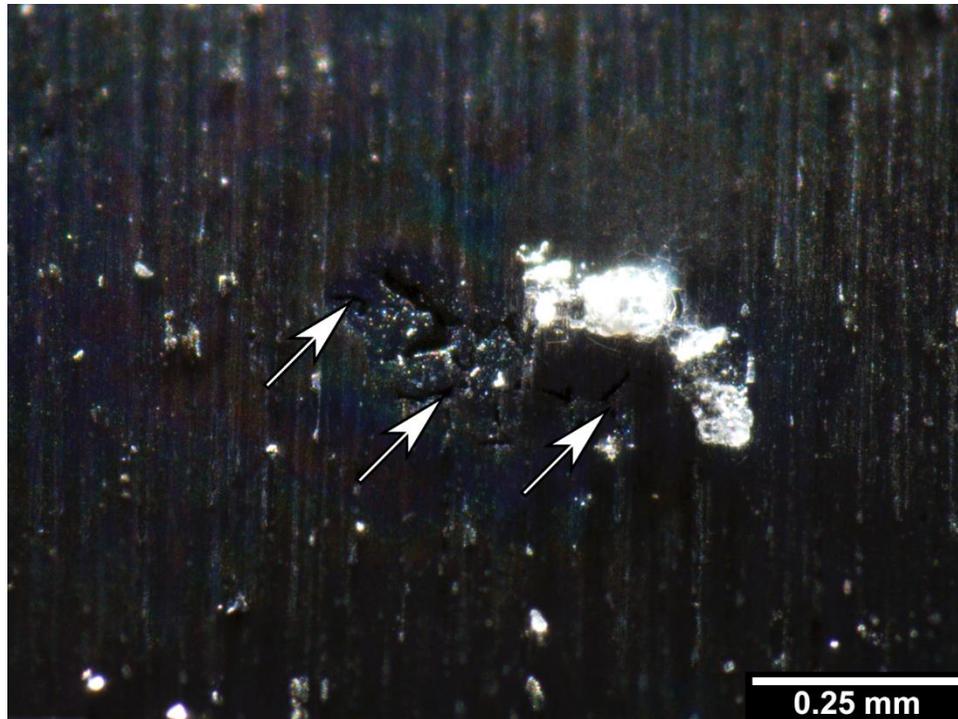
Figure 4-6: IGC (white arrows) identified on the surface of a 6061 coupon that was exposed to Isopac.

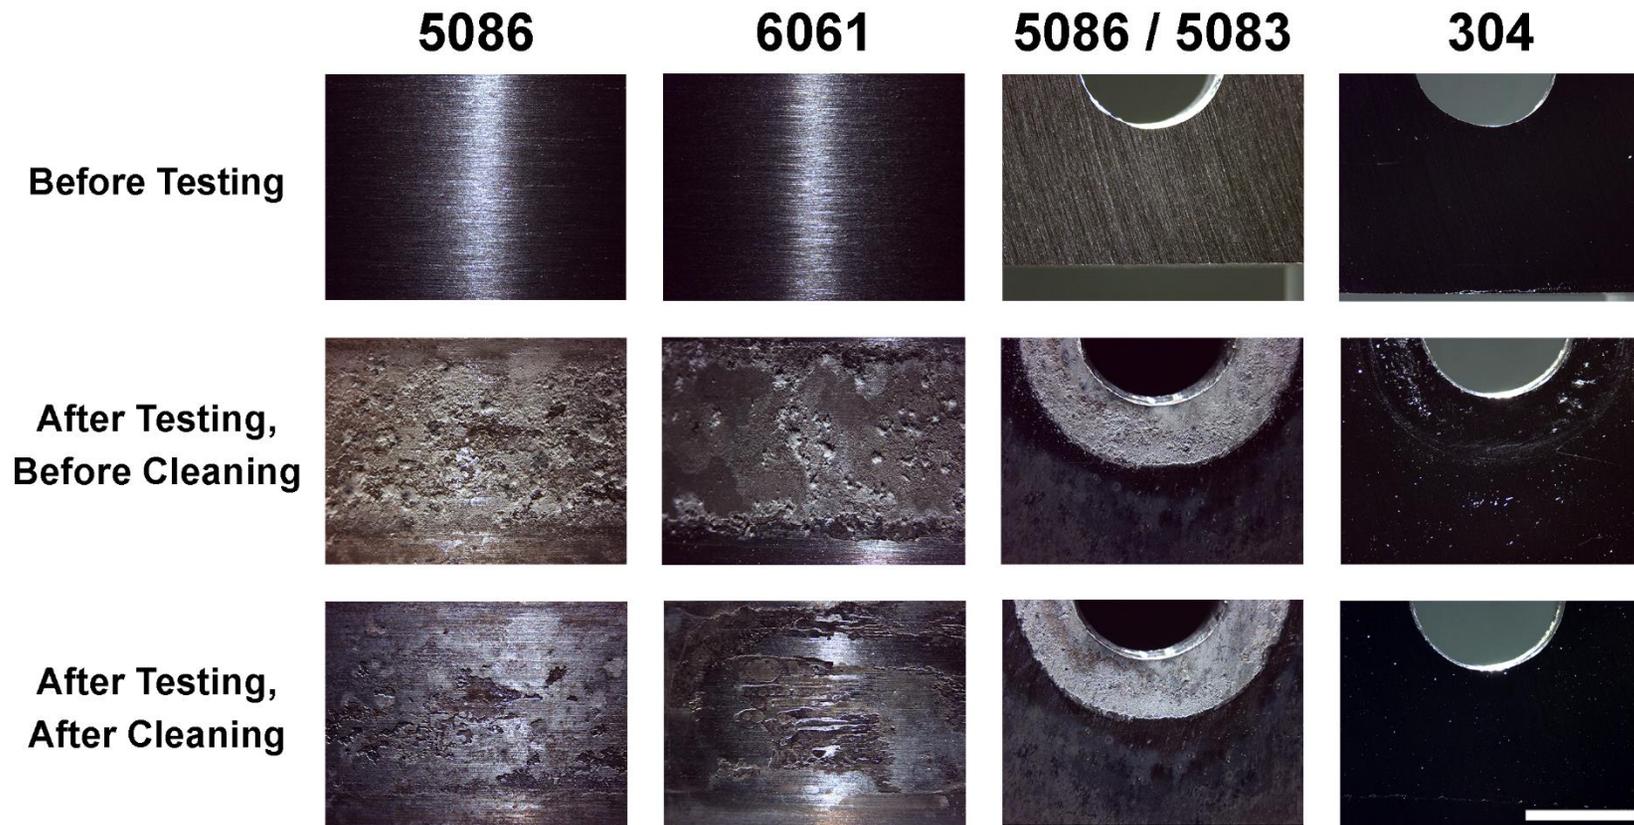
Figure 4-7: Composite images of four alloys before and after being immersed in Isopac solution, as well as after cleaning. Metal loss can be identified in the “After Testing, After Cleaning” images, and it appears as pits. Scale bar is 5 mm.

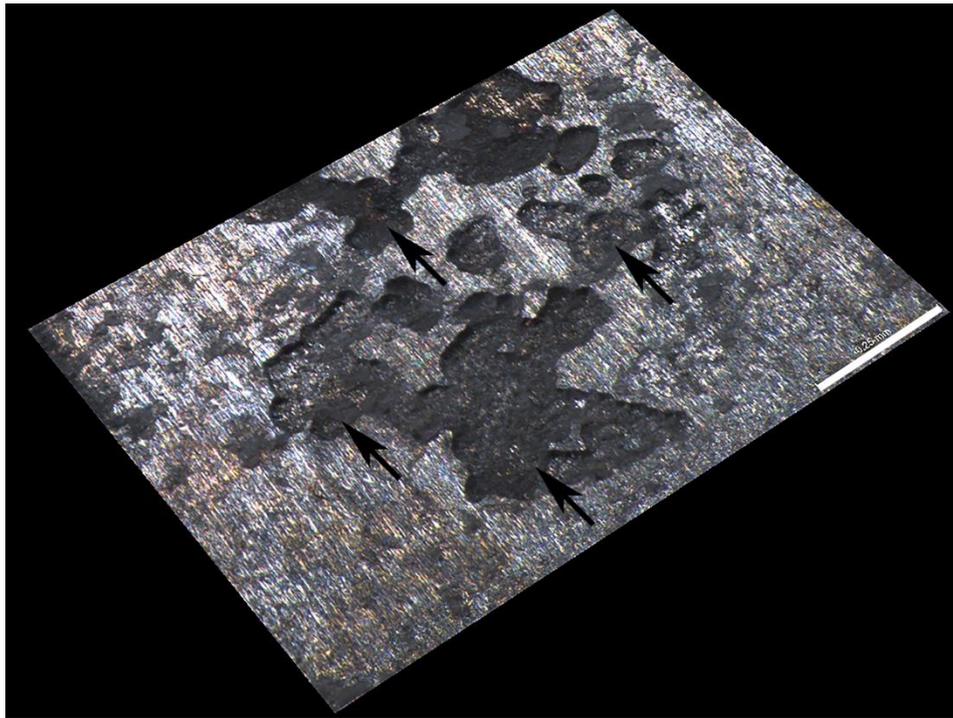
Figure 4-8: Corrosion (black arrows) on the crevice surface of 5086 alloy in Isopac solution. This metal loss signifies that crevice corrosion has occurred. Arrows are also oriented parallel to the grinding marks. Scale bar is 0.25 mm.

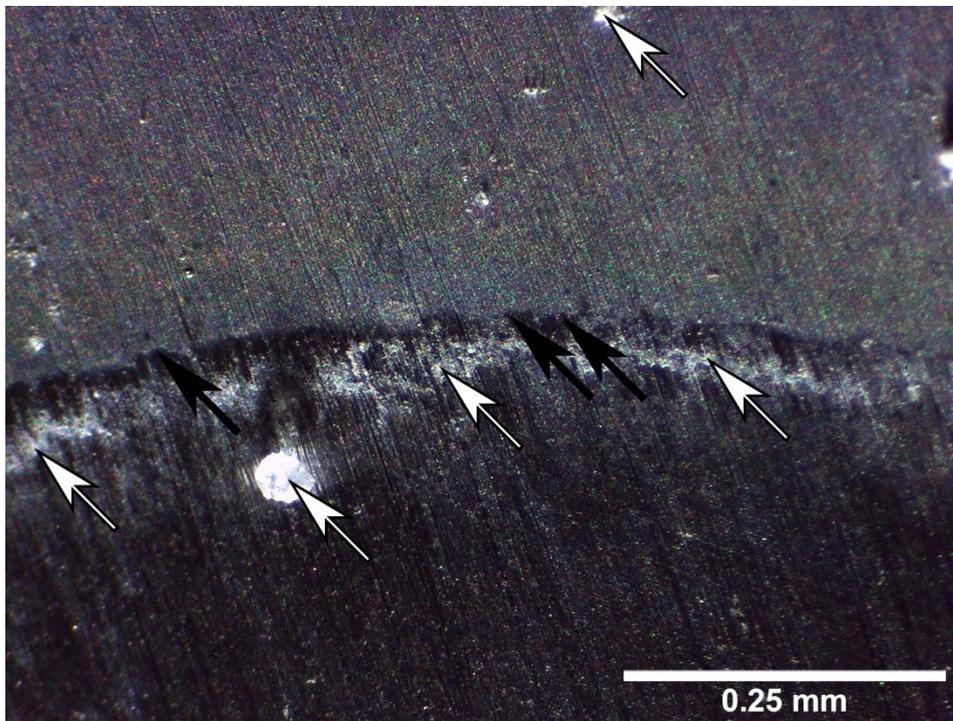
Figure 4-11: 5086/5083 alloy in Isopac solution; both of the exposed and crevice surfaces (top and bottom of picture, respectively). Deposit (white arrows) and corrosion damage (black arrows) is also observed.

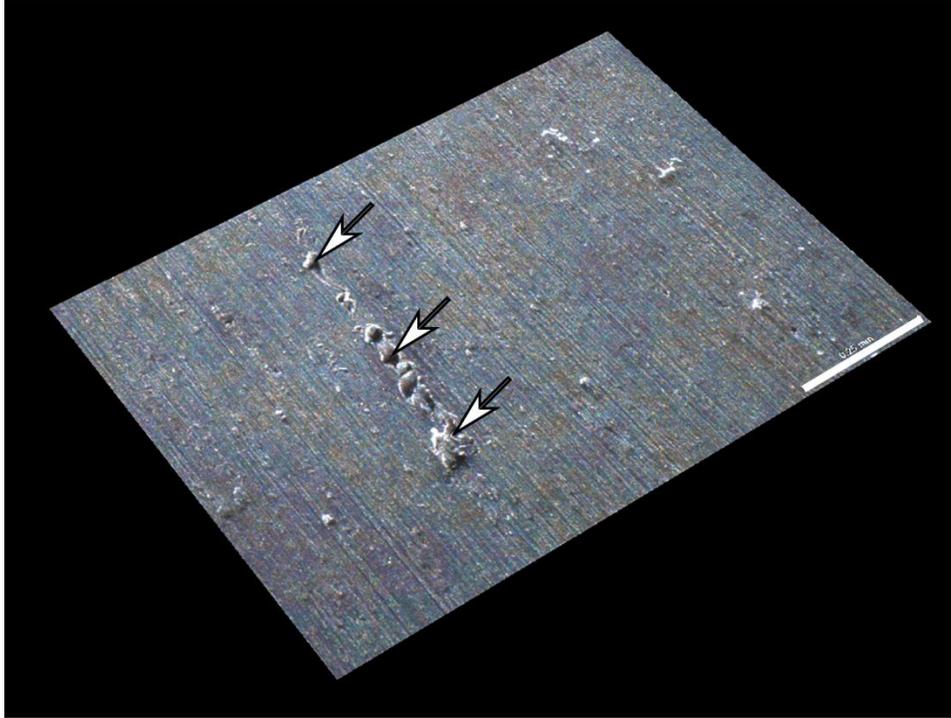
Figure 4-13: Representative image of gouging (white arrows) on the 5086 and 6061 alloy coupons, in all electrolytes, due to surface preparation using a lathe. Scale bar is 0.25 mm.

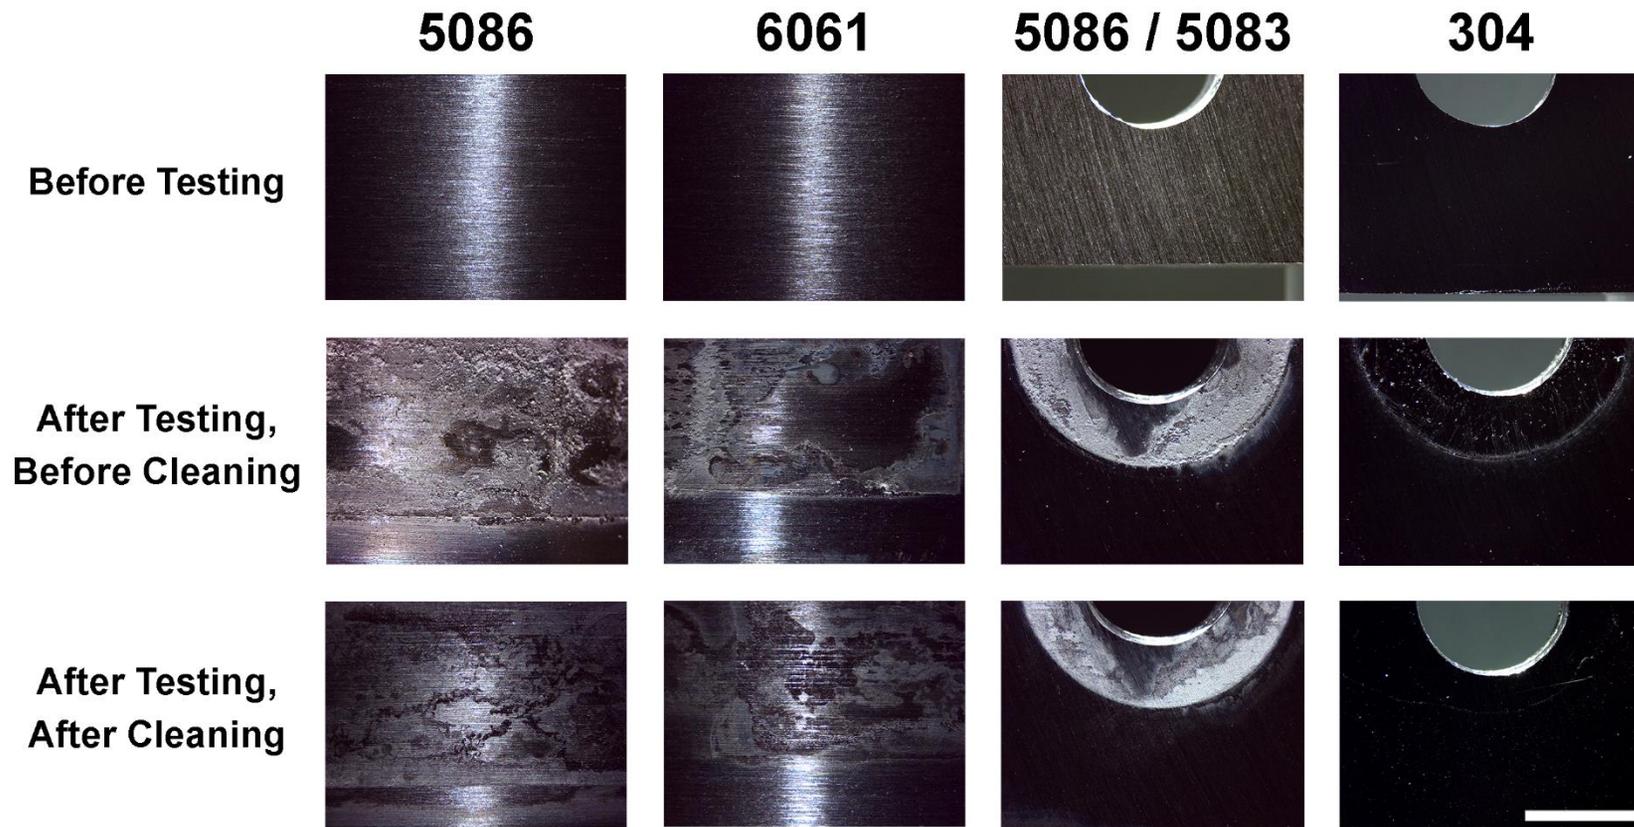
Figure 4-14: Composite images of alloys before and after being immersed in Alum solution, as well as after cleaning. Metal loss can be identified in the “After Testing, After Cleaning” images, and it appears as pits. Scale bar is 5 mm.

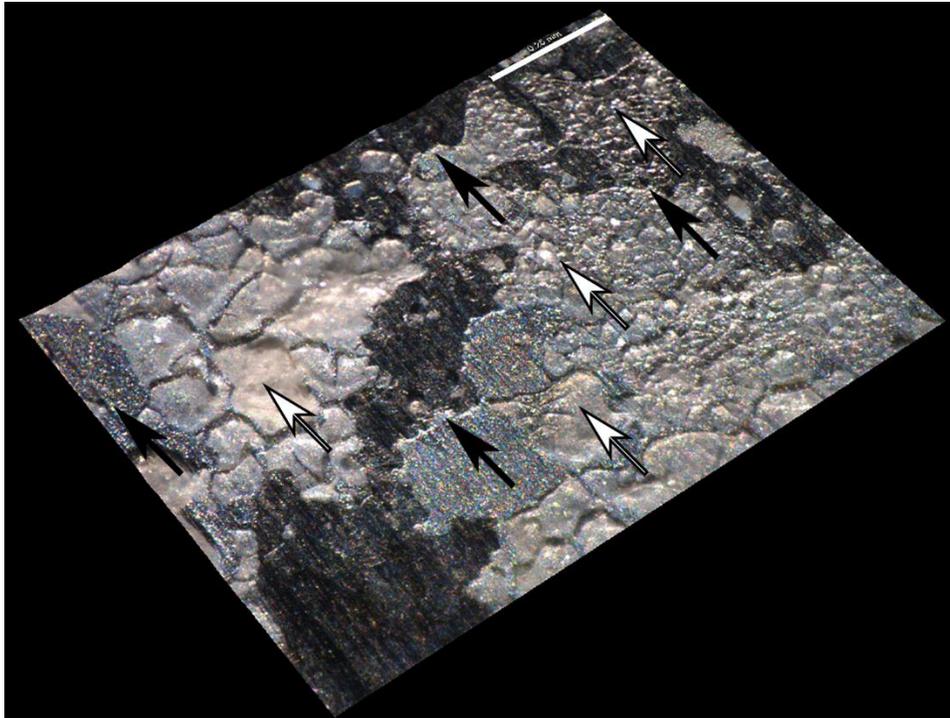
Figure 4-15: Corrosion damage (black arrows) and deposit (white arrows) on the 5086 alloy crevice surface in Alum solution. Arrows are also oriented parallel to the grinding marks. Scale bar is 0.25 mm.

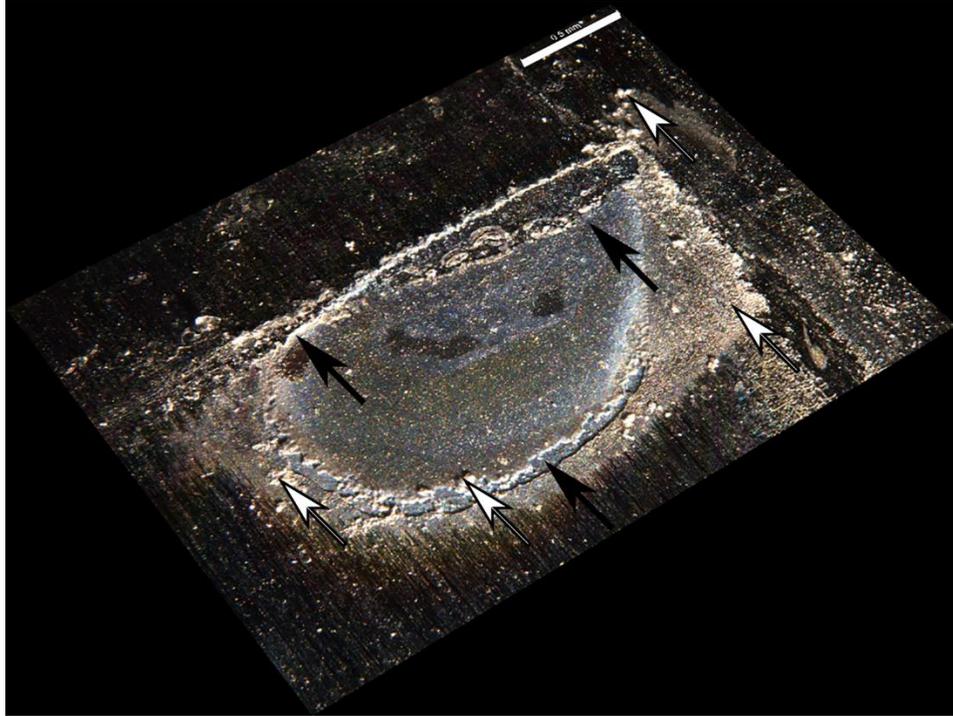
Figure 4-16: Corrosion damage (black arrows) and deposit (white arrows) on the 6061 alloy crevice surface in Alum solution. Arrows are also oriented parallel to the grinding marks. Scale bar is 0.5 mm.

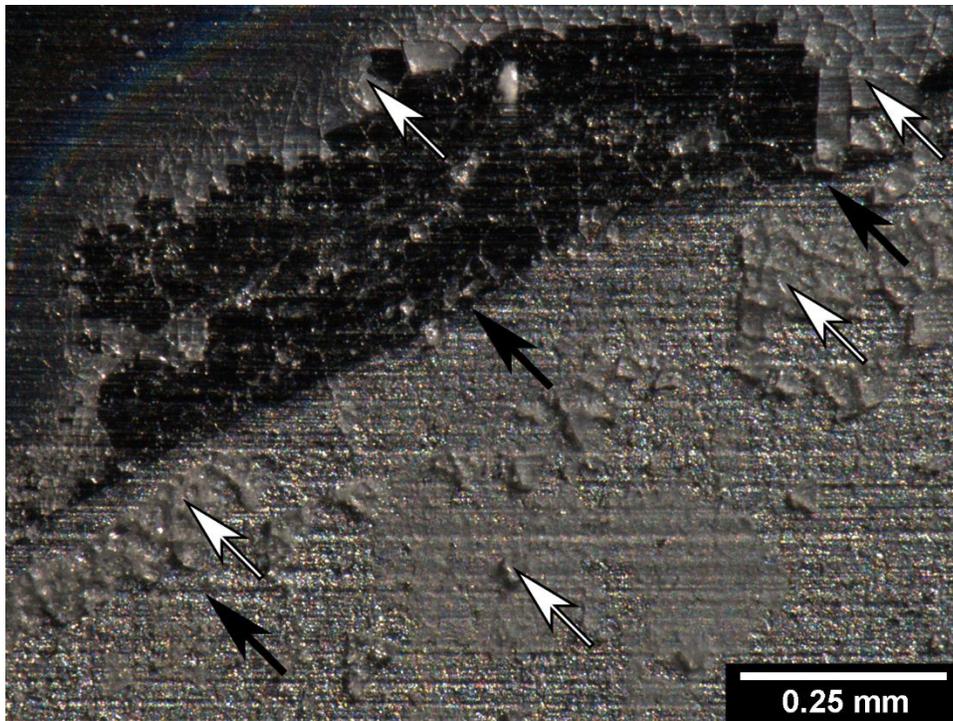
Figure 4-17: Corrosion damage (black arrows) and deposit (white arrows) on the 5086/5083 alloy crevice surface (bottom of picture) in Alum solution. Deposit (top white arrows) can also be observed on the exposed surface (top of picture).

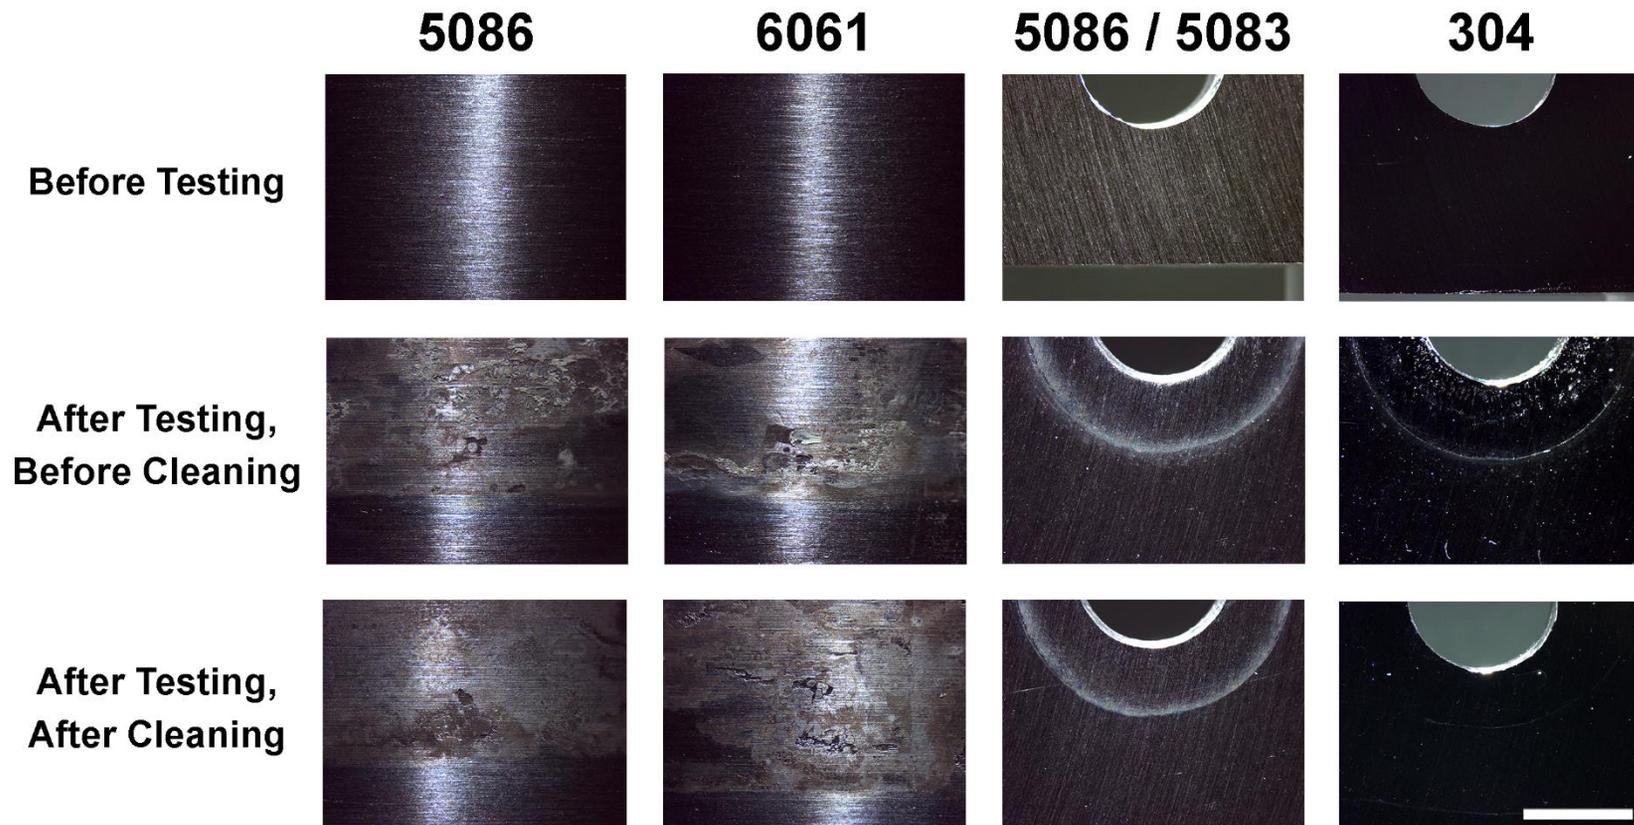
Figure 4-19: Composite images of alloys before and after being immersed in DIUF, as well as after cleaning. Metal loss can be identified in the “After Testing, After Cleaning” images, and it appears as pits. Scale bar is 5 mm.

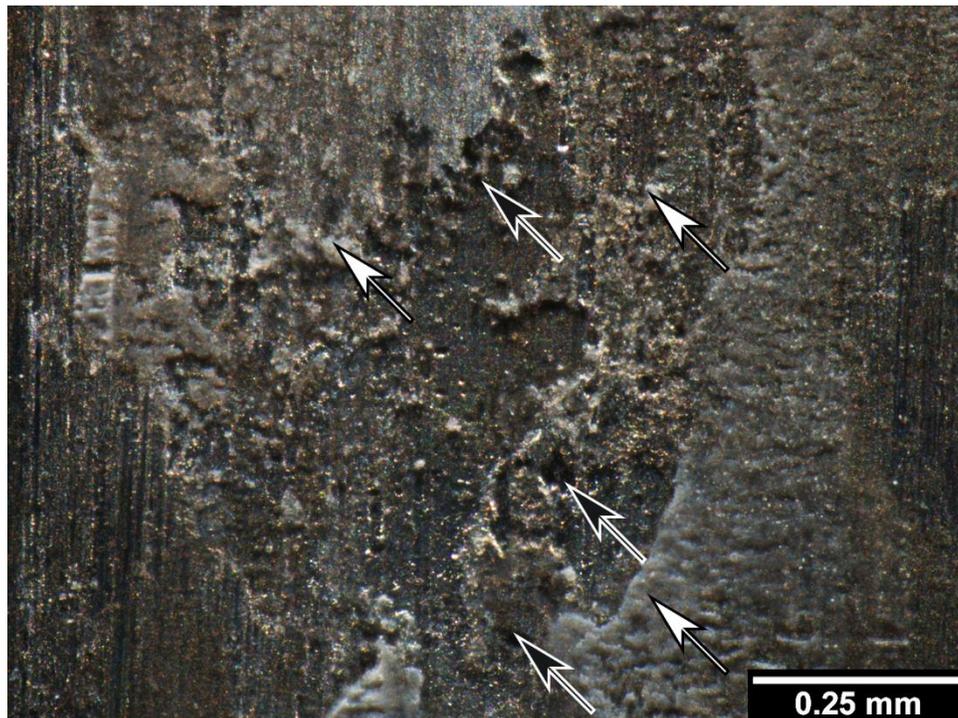
Figure 4-20: Corrosion damage (black arrows) and deposit (white arrows) on the 5086 alloy crevice surface in DIUF.

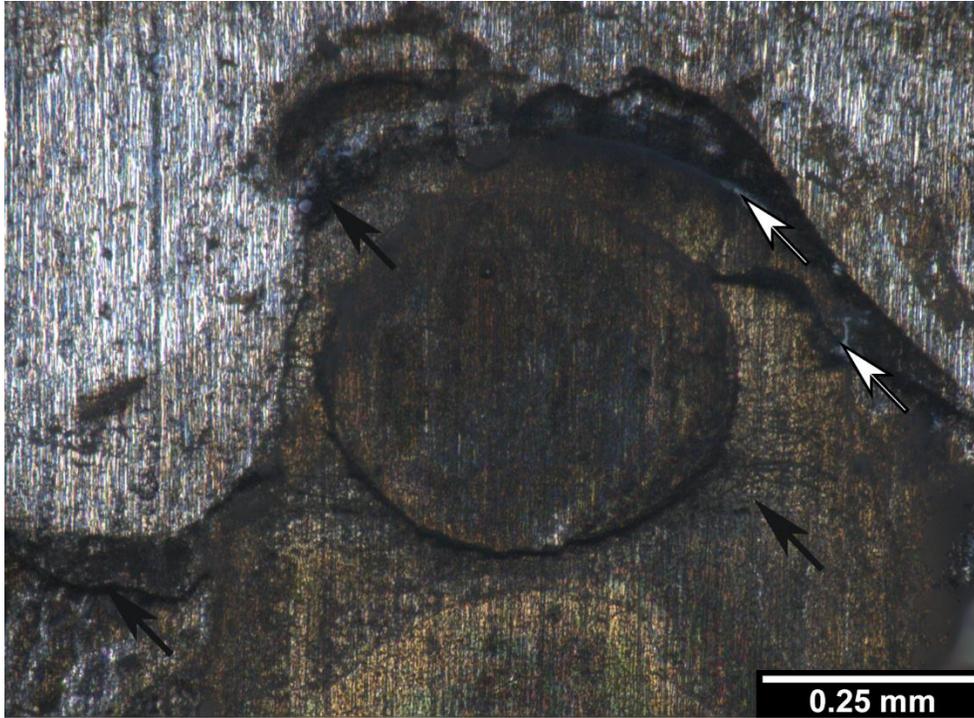
Figure 4-21: Corrosion damage (black arrows) and deposit (white arrows) on the 6061 alloy crevice surface in DIUF.

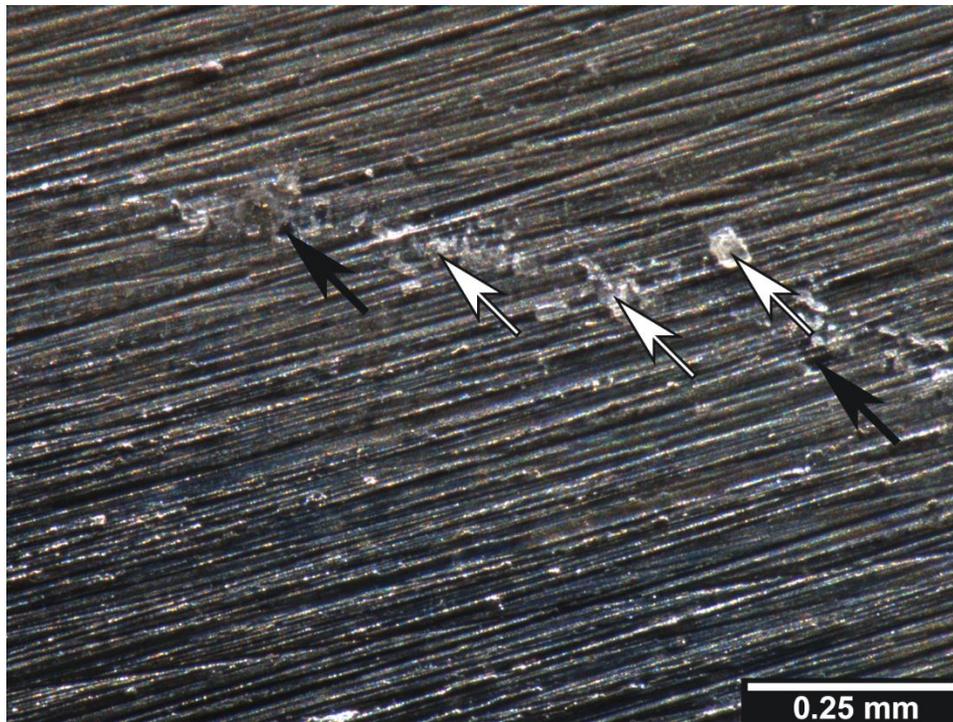
Figure 4-22: Corrosion damage (black arrows) and deposit (white arrows) on the 5086/5083 alloy crevice surface in DIUF. Above the deposit (top of image) is the exposed surface, while below the deposit (bottom of image) is the crevice surface.

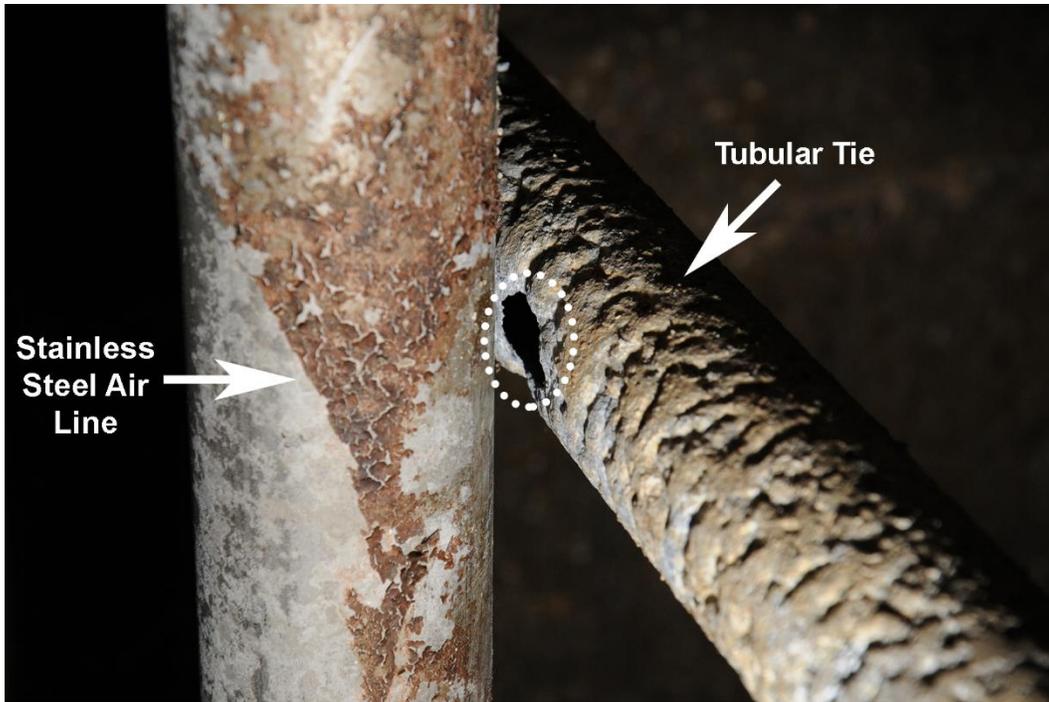
Figure A-1: Through wall corrosion (indicated by the dotted oval) of a tubular tie immediately adjacent to aeration piping [1].

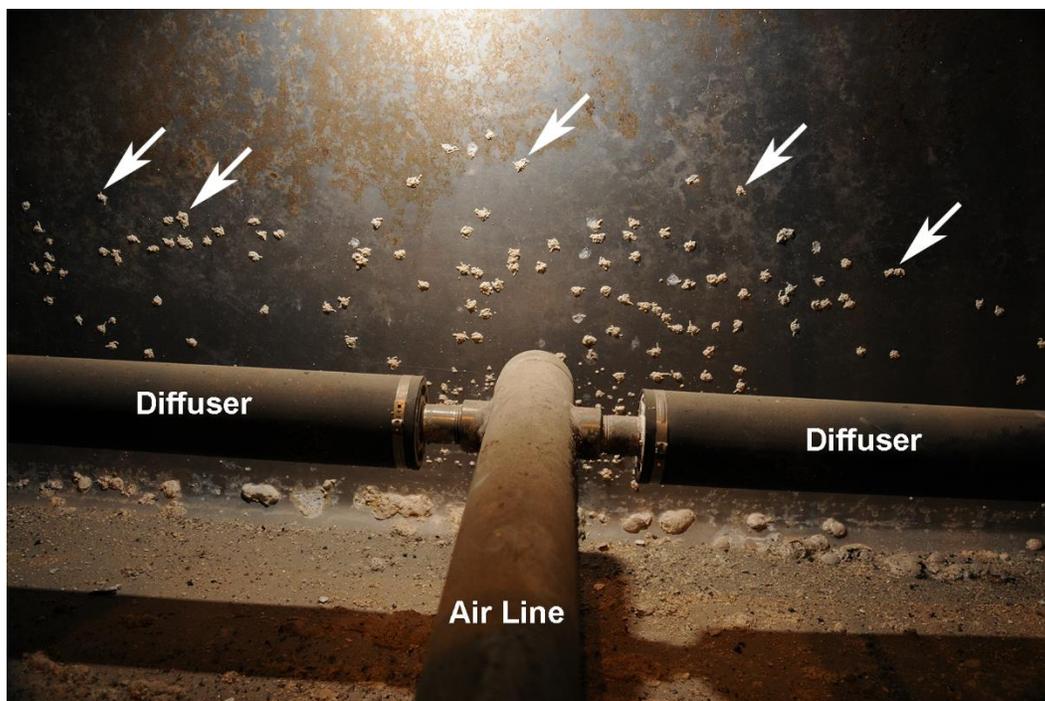
Figure A-5: "Crusty top hat" deposits (white arrows) on the tank wall in close proximity to the end of an aeration line and diffusers [1].

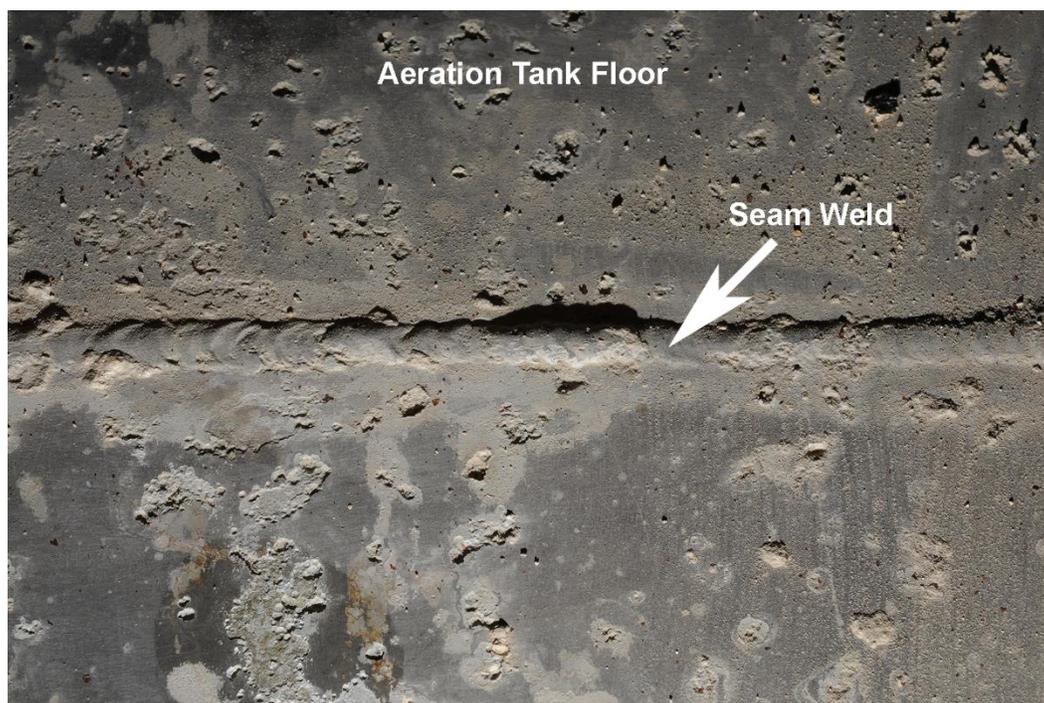
Figure A-7: First type of under-deposit corrosion identified on the floor and welds of the aeration tank (after brushing off the deposits) [1].

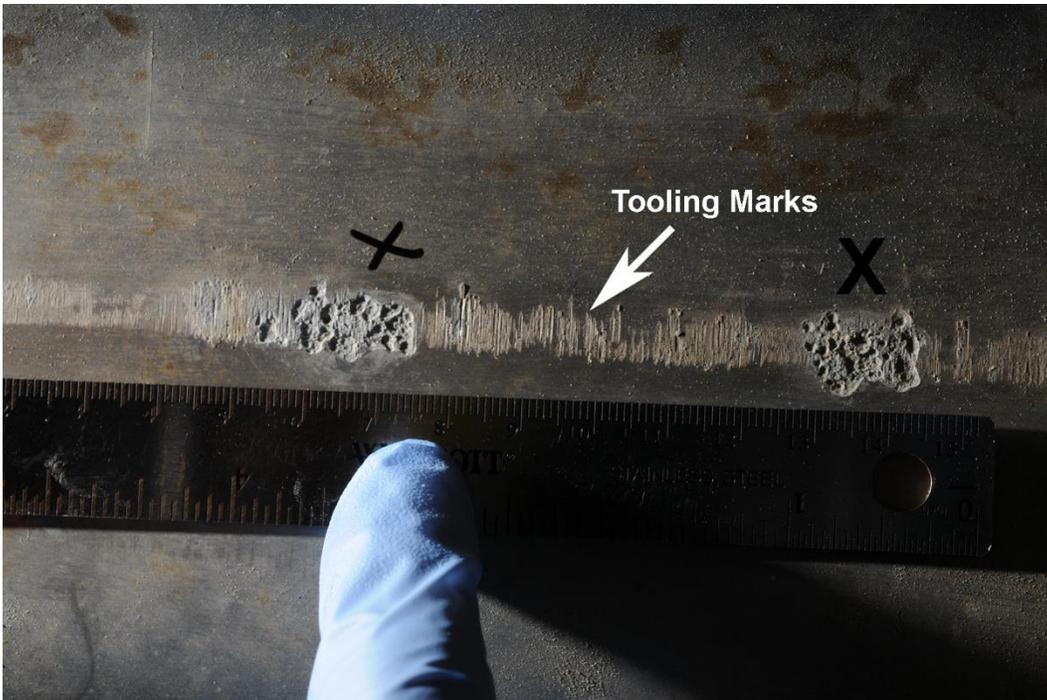
Figure A-8: Second type of under-deposit corrosion identified on tooling marks along a wall of the aeration tank (after brushing off the deposits) [1]. “Regions directly below “X” are pitting damage, showing multiple pits within pits. Vertical striations are the tooling damage discussed throughout.” [1]

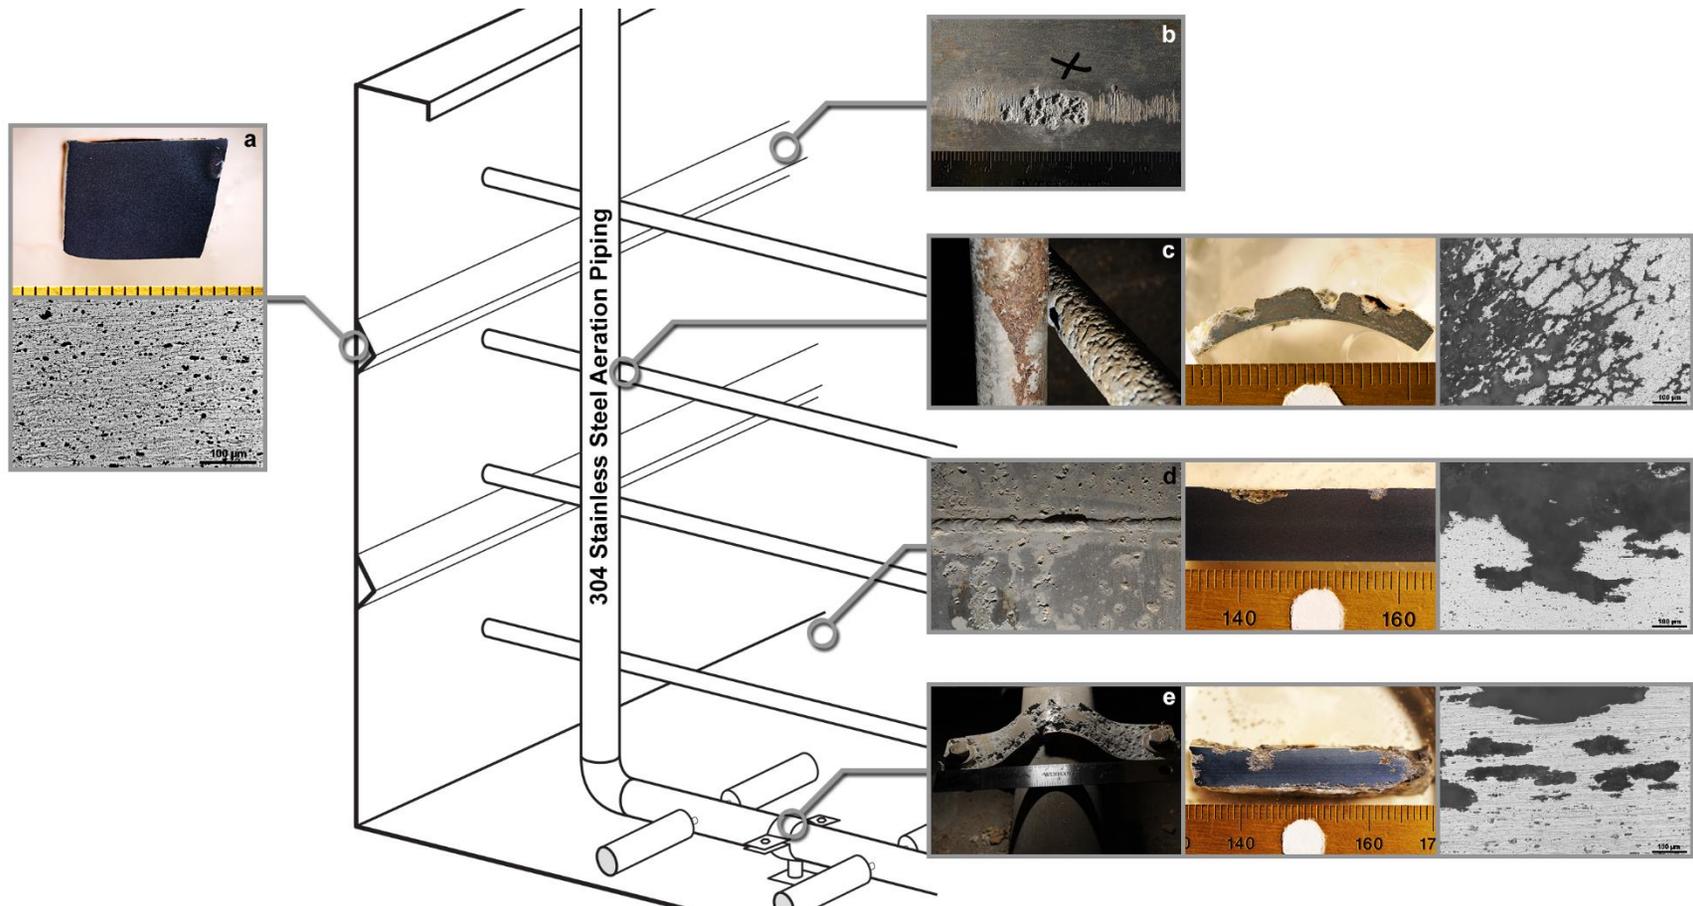
Figure A-13: Partial schematic of the aeration tank, along with images (including macrophotographs, cross-sections, and micrographs) acquired from key locations/aluminum alloy components, namely: collected wall cross-section (a), pitting on wall tooling marks (b), tubular tie in contact with aeration piping (c), tank floor (d), and an aeration piping bracket (e). Four modes of corrosion (pitting, crevice, galvanic, and IGC) were identified. Deposit(s) were removed to aid in the macrophotography. Scale on ruler is in mm.

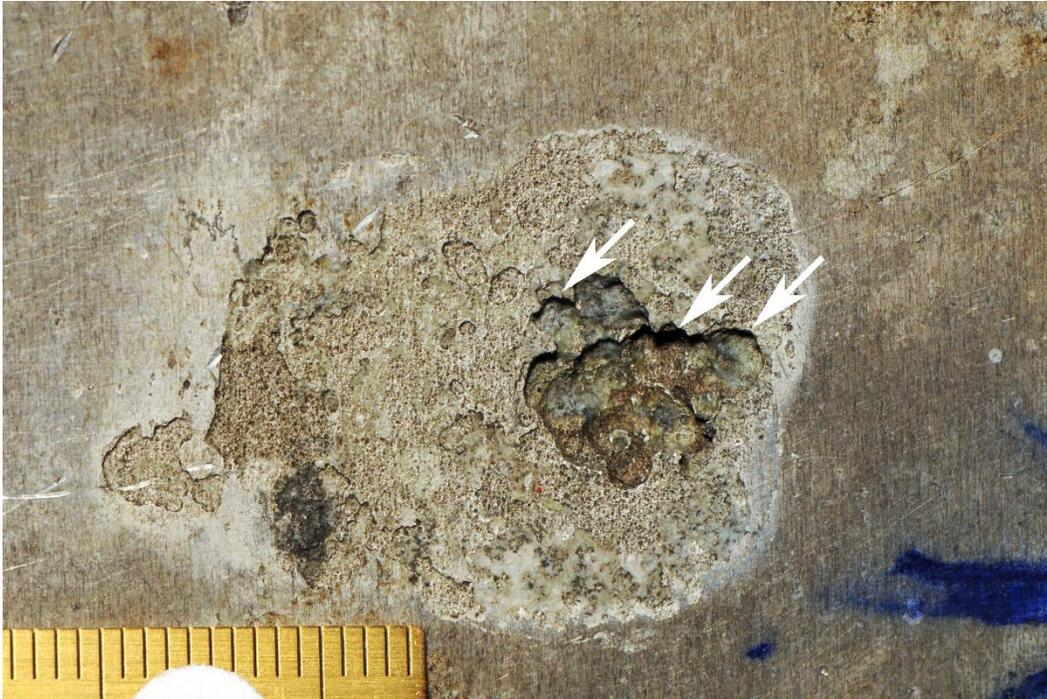
Figure A-16: Close-up of large pit. Round pits within pits and undercutting (white arrows) can be observed. Scale is in mm.

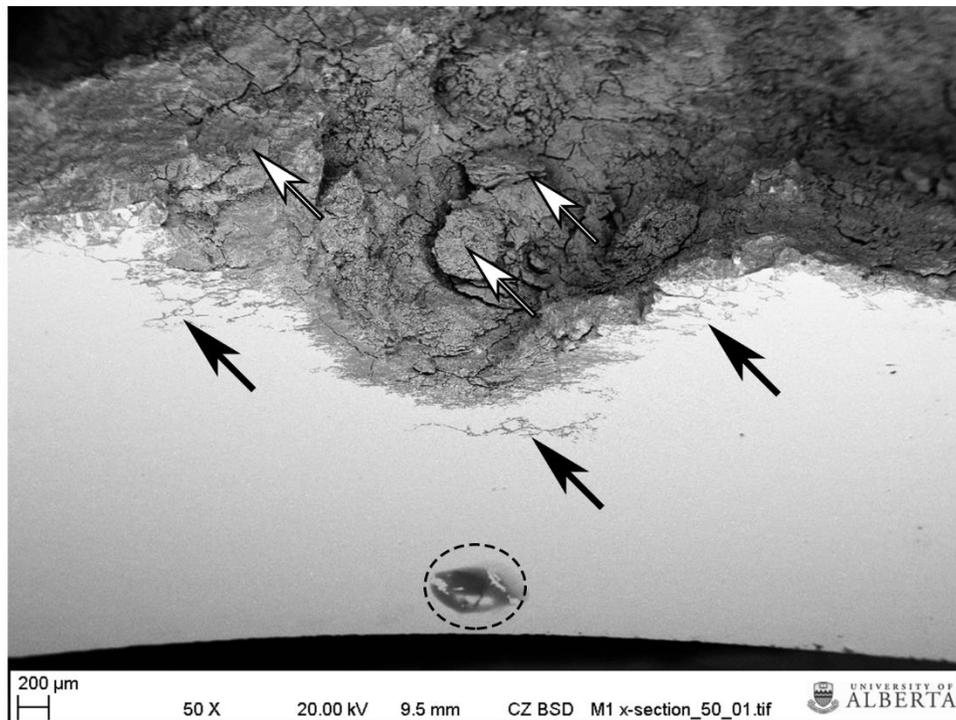
Figure A-48: BSE image of large pit on the outer circumference of the cross-section. Deposit (white arrows) and IGC (black arrows) are also present. Note the dot on the sectioned surface was made with a Sharpie® marker in order to identify location of interest (black dashed oval).

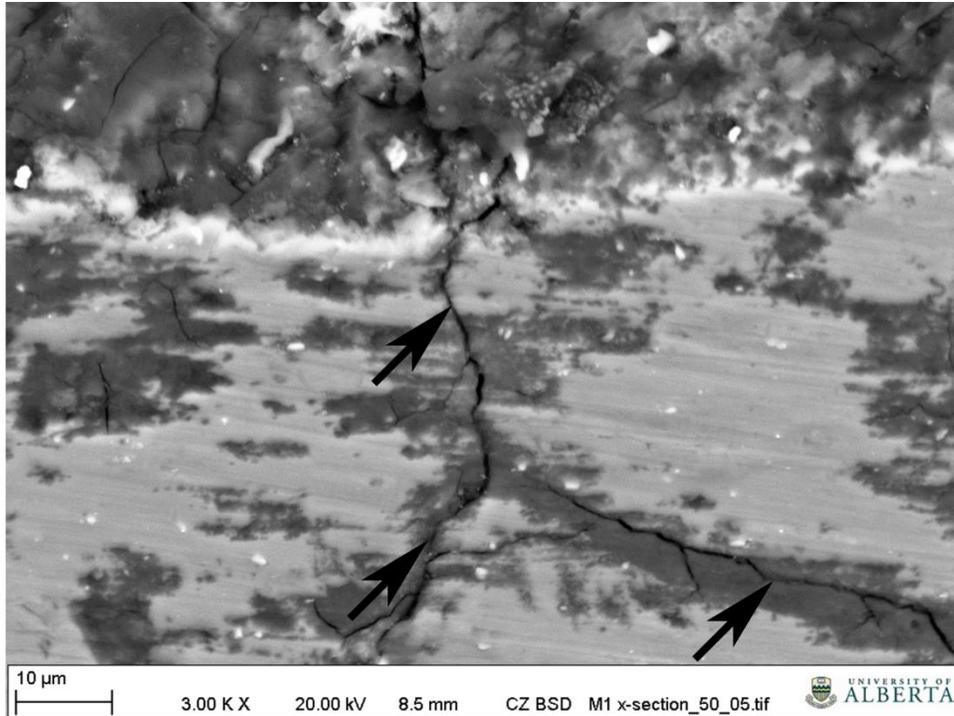
Figure A-53: Close-up on IGC (black arrows) in Figure A-52 (BSE image). Note the cracking within the corrosion product formed at metal grain boundaries.

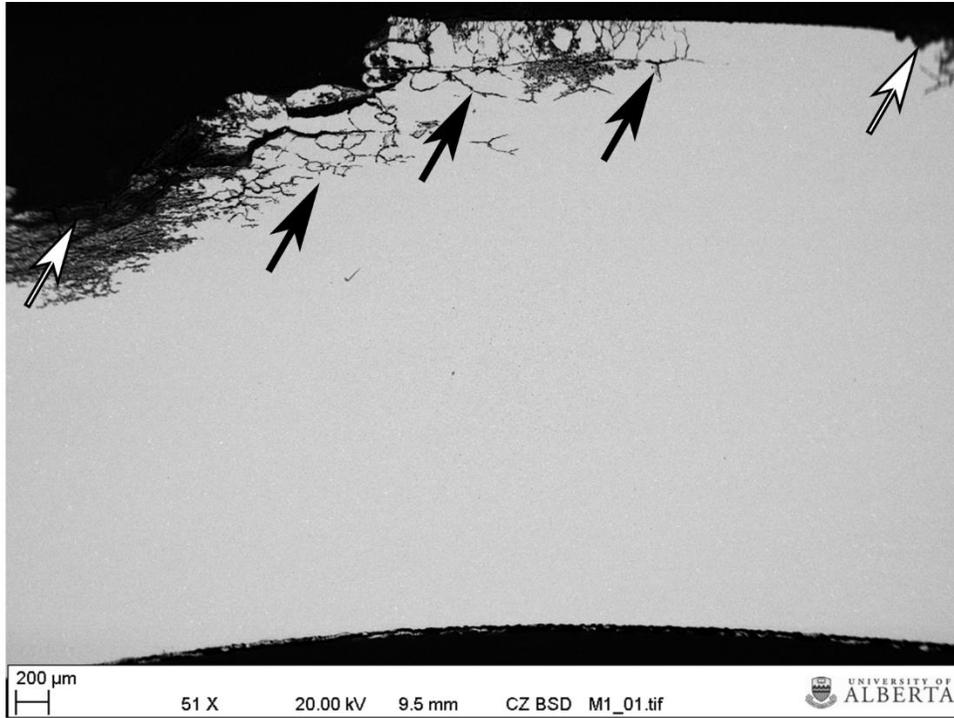
Figure A-54: BSE image of the mounted cross-section. Pitting (white arrows) and IGC (black arrows) observed on the outer circumference of the cross-section.

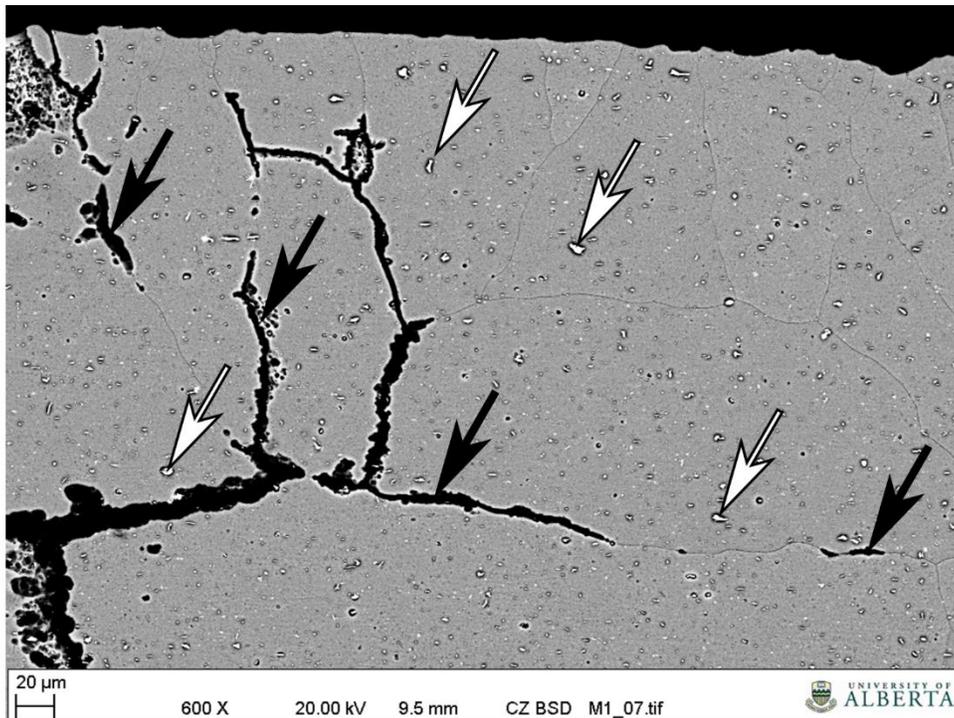
Figure A-55: Close-up on IGC (black arrows) at the tie surface (from Figure A-54; BSE image). Precipitates (white arrows) can also be observed.
