Corrosion of Aluminum Alloys in Wastewater Treatment Aeration Tanks

A thesis submitted in partial fulfillment of the requirements for the degree of

Materials Engineering

Severe localized corrosion was found throughout an aeration tank of a modular wastewater treatment plant. Specifically, pitting, crevice corrosion, galvanic corrosion, and intergranular corrosion (IGC) were observed on the 5000 and 6000 series aluminum alloys used in the tank's construction. One of the suspected environmental causes of corrosion was an aeration tank process additive, namely a coagulant – either aluminum sulphate (Alum) or polyaluminum chloride (PACl; Isopac). Laboratory scale corrosion cells were designed to isolate, simulate, and evaluate the corrosivity of the coagulants (in relevant quantities) on the metallic alloys of construction. Additionally, due to presence of deposit found throughout the tank (resulting in under-deposit corrosion), fabricated crevices were installed on the tested alloys to help simulate crevice corrosion environments. The solution conditions in the cells were monitored throughout the duration of the immersion testing in order to assess whether the cells were within nor

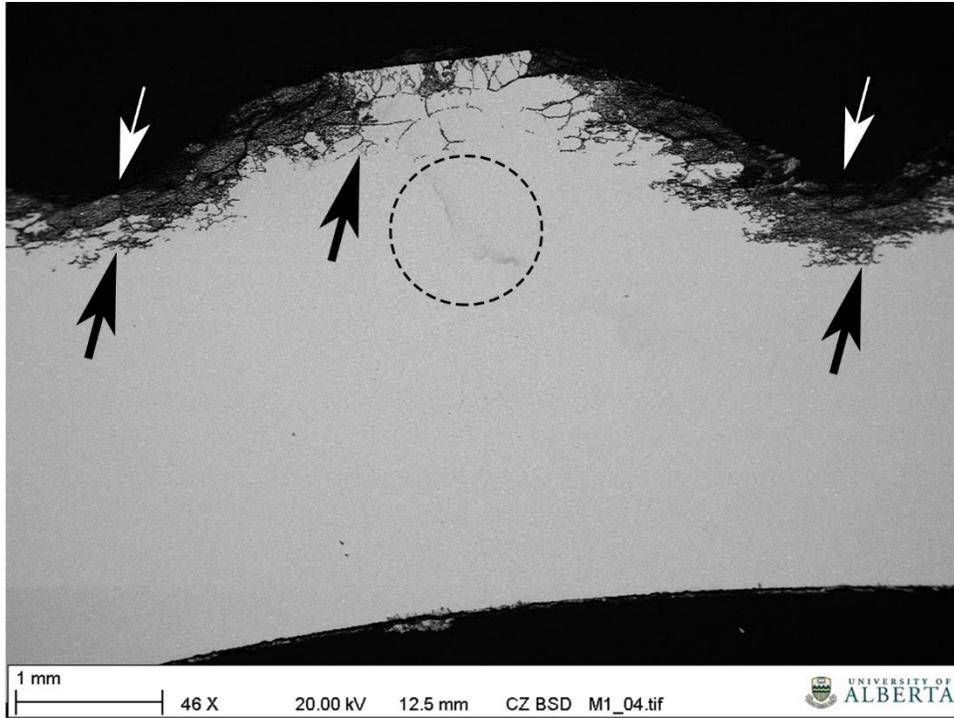
Figure A-56: BSE image of another location on the tubular tie exhibiting signs of pitting (white arrows) and IGC (black arrows). Some staining (black dashed oval) was found below the IGC. The staining is an artifact from the etching process.

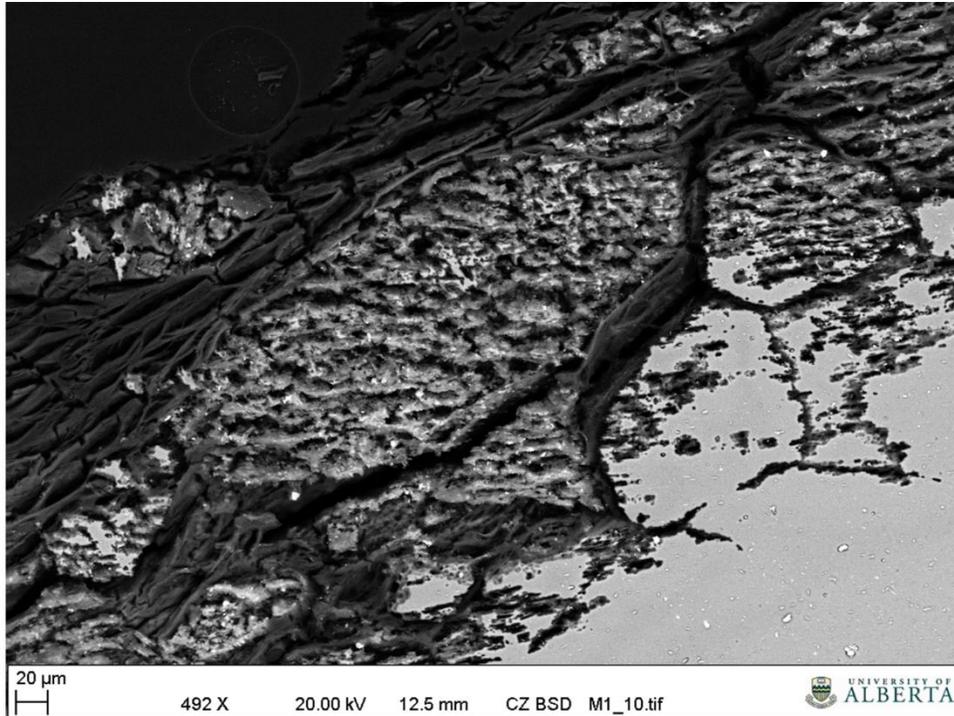
Figure A-58: Close-up BSE image of IGC and corroded grains (from Figure A-56). Figure demonstrates the progression of corrosion of the tie from initial IGC to entirely corroded grains which naturally drop out due to gravity or fluid motion.

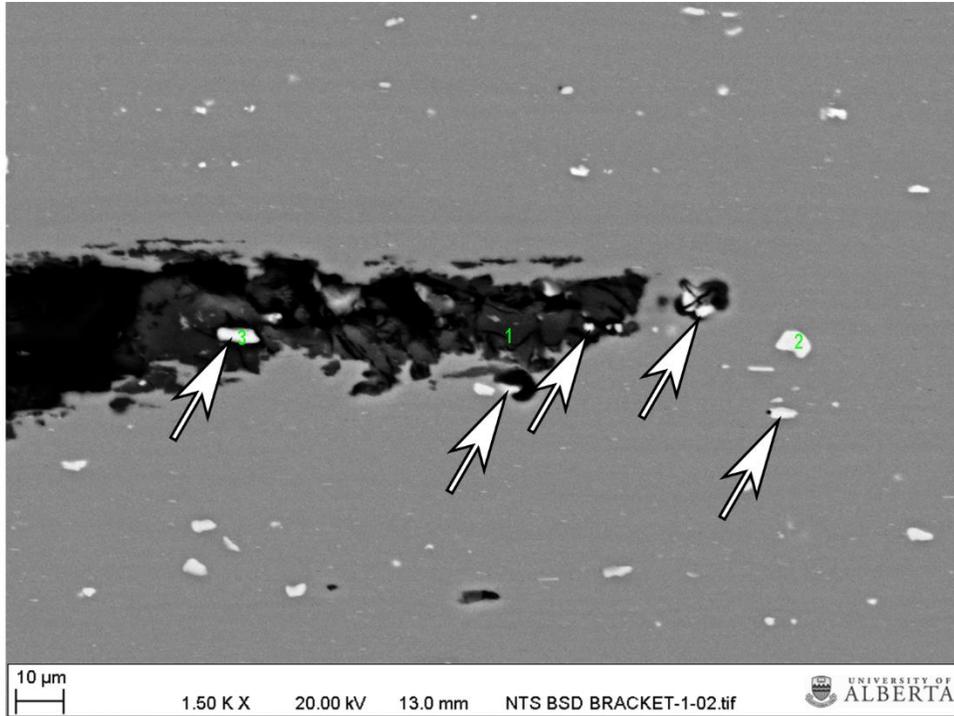
Figure A-66: Close-up on tunneling (from Figure A-65; BSE image). Numbers indicate where EDX data was collected. A local galvanic cell can be observed between the intermetallic inclusions (white arrows) and the surrounding matrix.

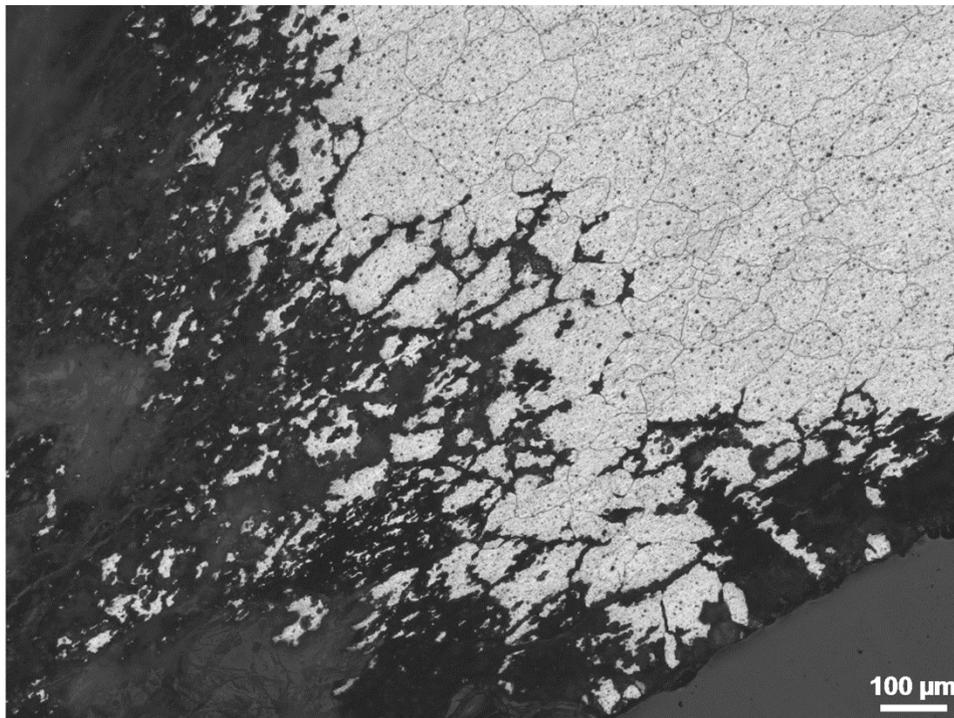
Figure A-86: IGC and pitting on portion of the tie immediately adjacent to the through-wall hole (from Figure A-85).

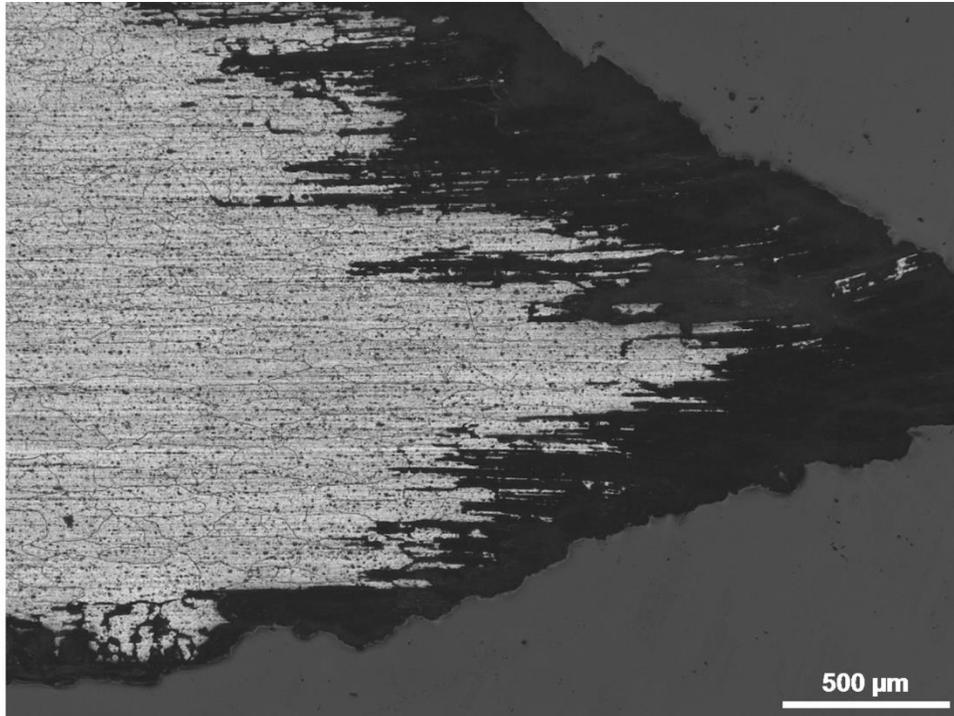
Figure A-97: Severe corrosion damage on portion of the tie immediately adjacent to the through-wall hole (from Figure A-94).

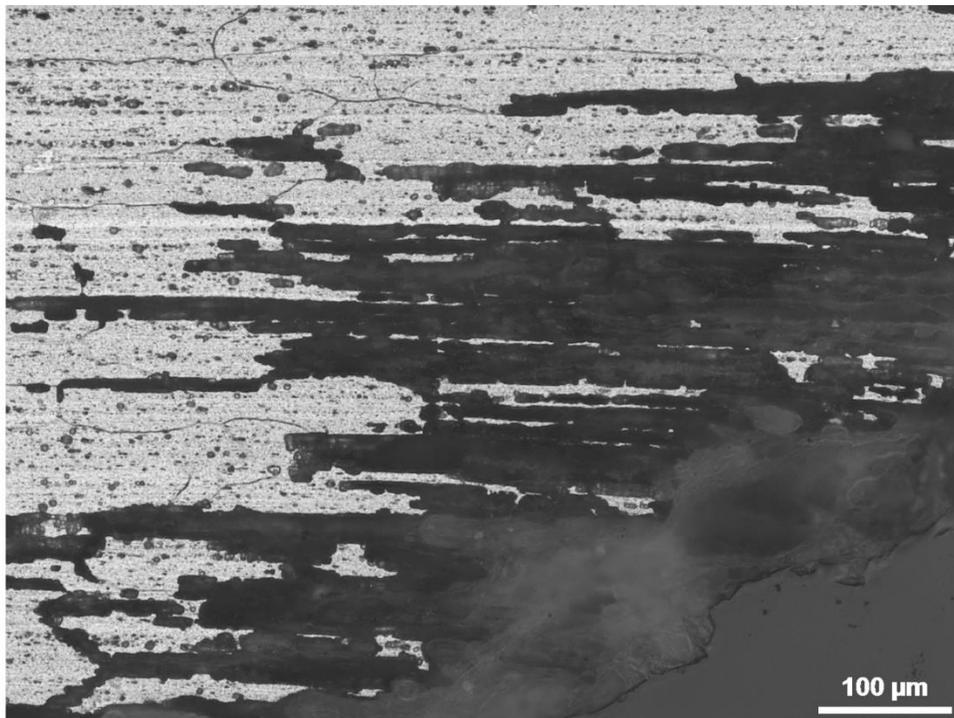
Figure A-98: Close-up on IGC, pitting, and preferential corrosion in the extrusion or drawing direction (from Figure A-97).

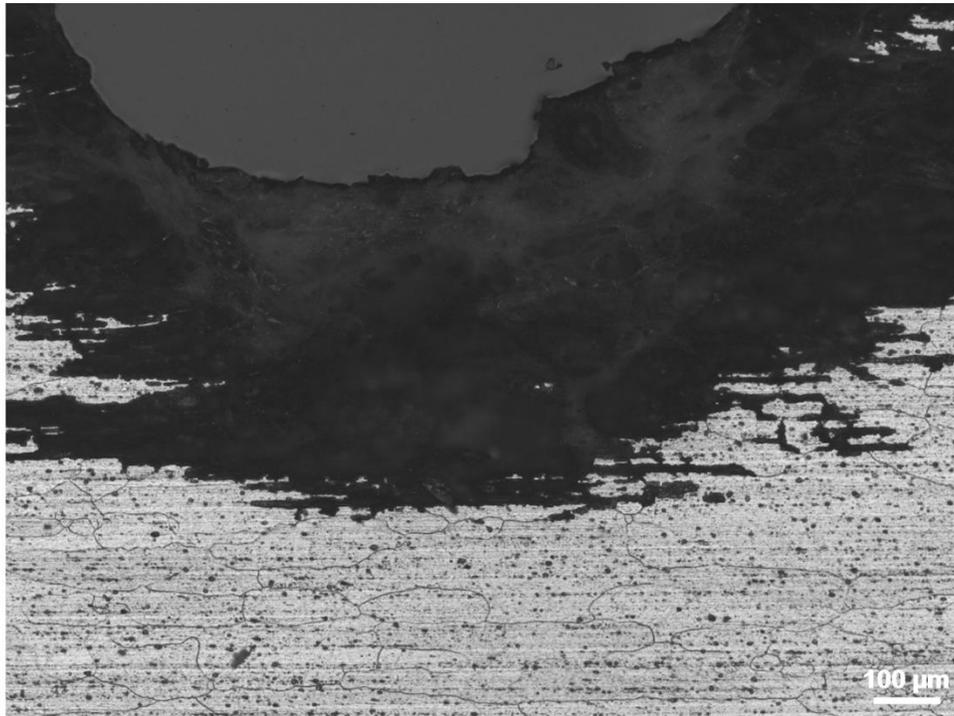
Figure A-100: IGC, pitting, and preferential corrosion in the extrusion or drawing direction at the bottom of the large pit (from Figure A-99).

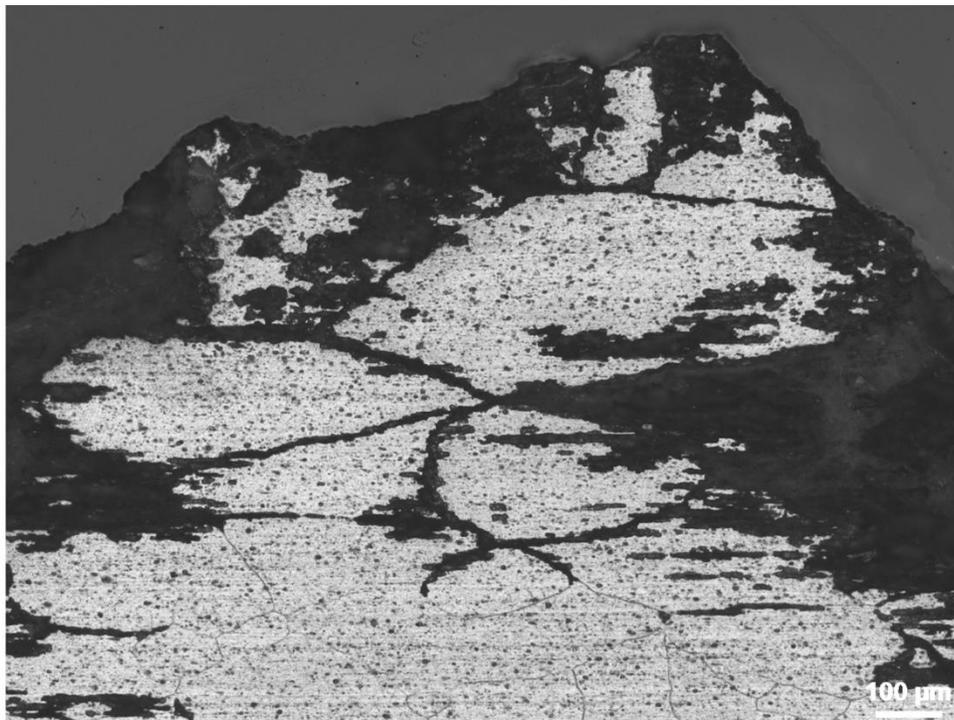
Figure A-102: IGC, pitting, and preferential corrosion in the extrusion or drawing direction on the outer diameter of the tie cross-section (from Figure A-99).

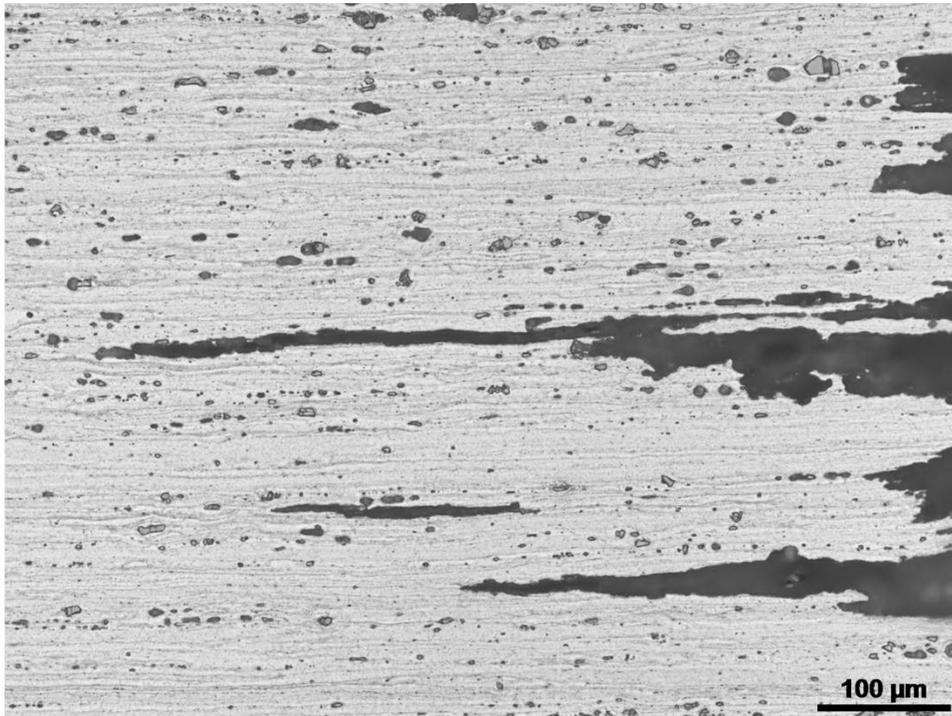
Figure A-111: Tunneling and preferential corrosion in the rolling direction on the left side of the large pit (from Figure A-108).

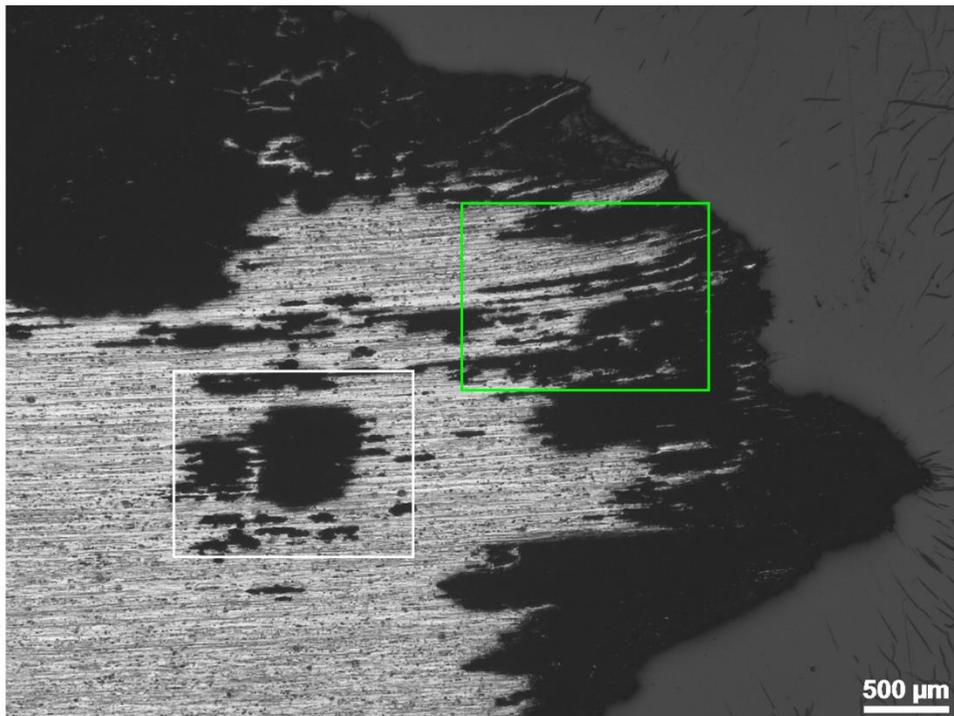
Figure A-115: Pitting, tunneling, and preferential corrosion in the rolling direction on the right side of the cross-section (from Figure A-107). The white and green boxes contain Figures A-116 and A-118, respectively.

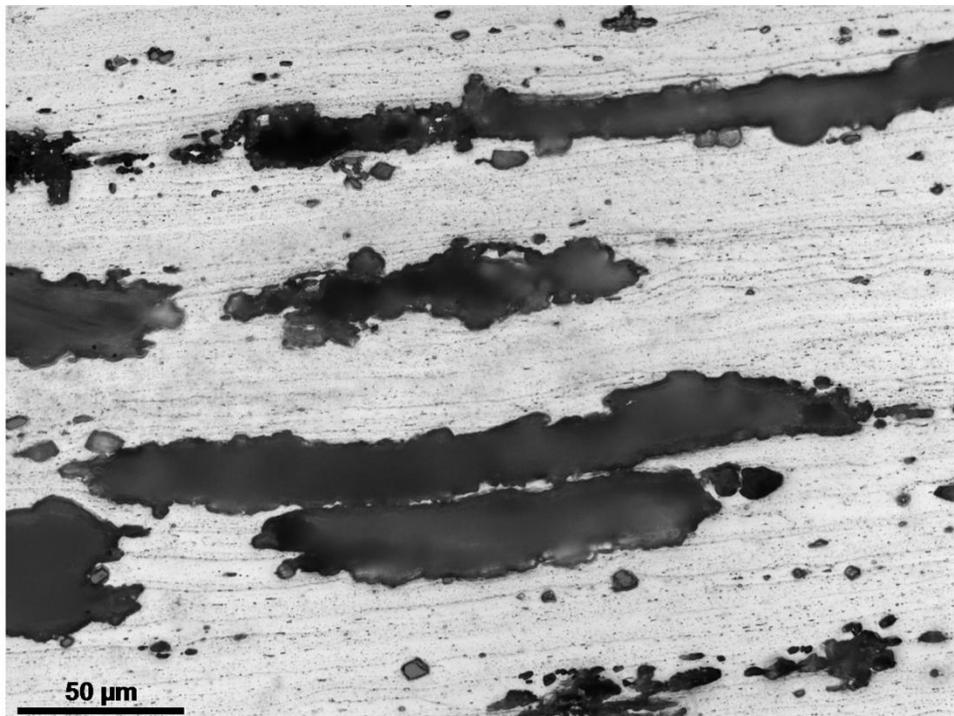
Figure A-119: Close-up on tunneling and crystallographic pitting (from Figure A-118).
