OBSERVATION OF THE DESIGN
AND PERFORMANCE OF THE
DEMPSTER HIGHWAY

SUBMITTED TO
THE UNIVERSITY OF ALBERTA
DEPARTMENT OF CIVIL ENGINEERING

APRIL 1985

B. E. LINGNAU

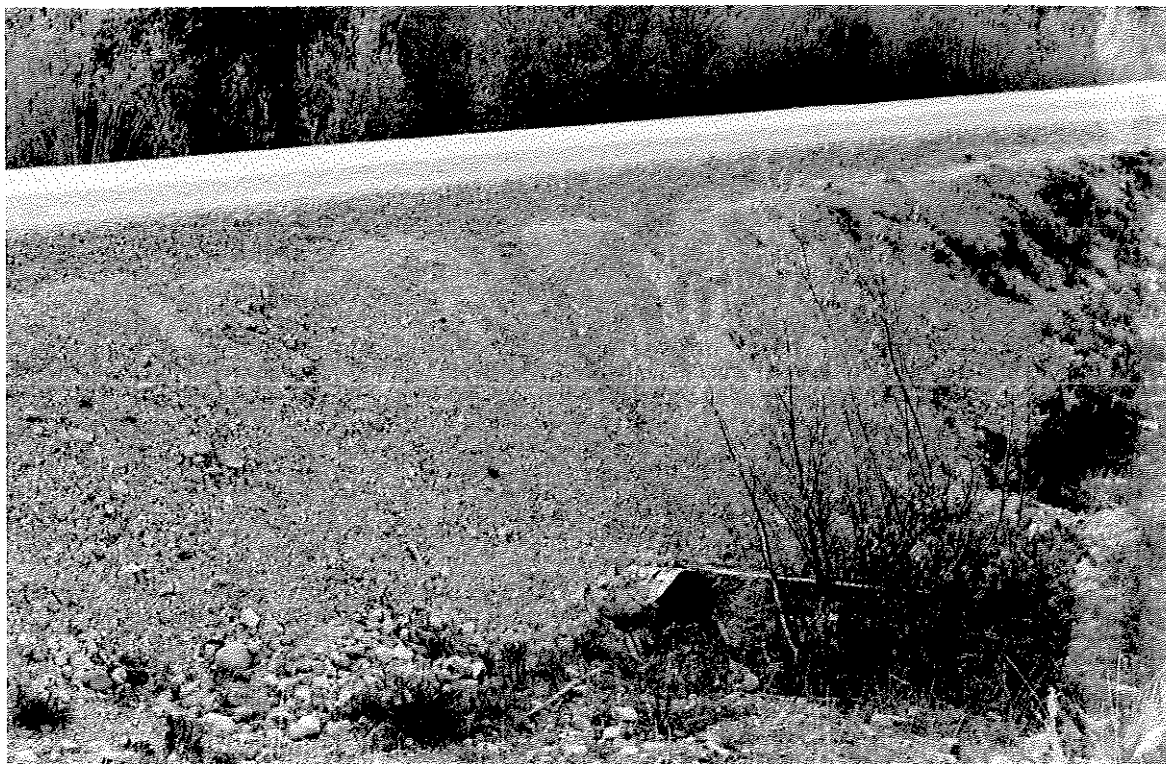
PLATE 1 : Reconstructed embankment, about 5m. high. Original culvert is slightly below ditch level and contains remnant aufeis (Kilometer 6).

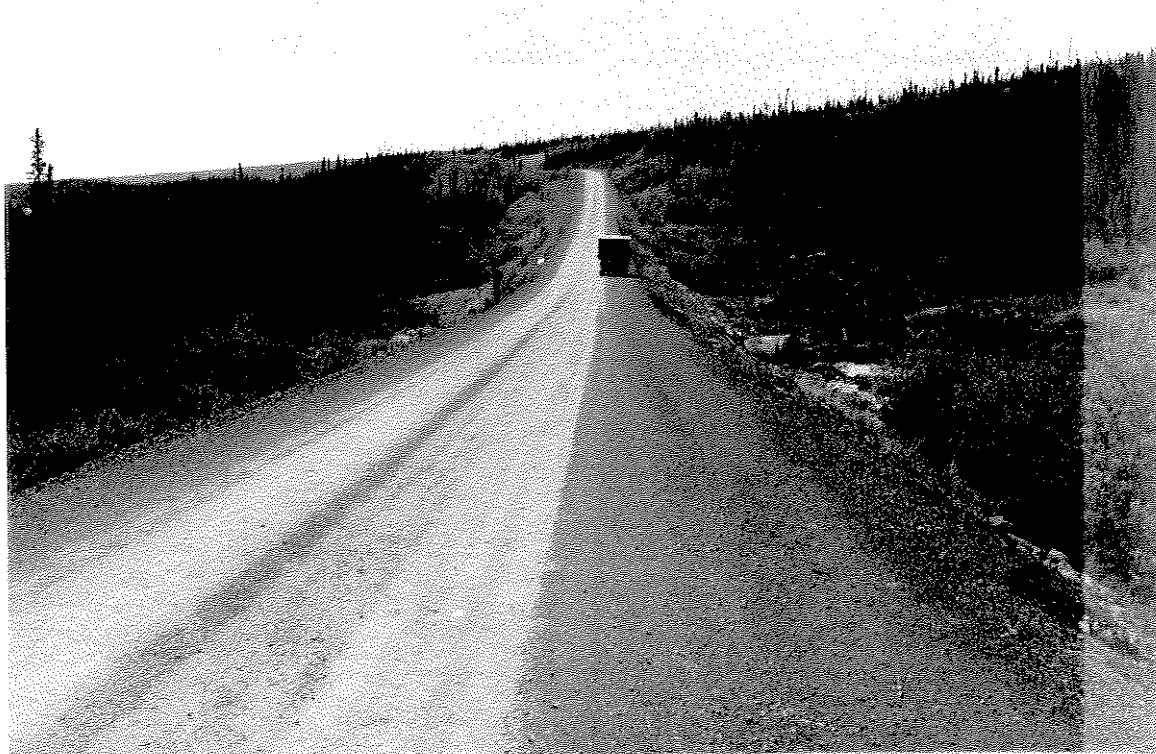
PLATE 2 : Spruce forest/sphagnum moss plant association. "Broken back" culvert in a deep fill (centre). Remnant aufeis and icing area visible (right).
(Kilometer 29)

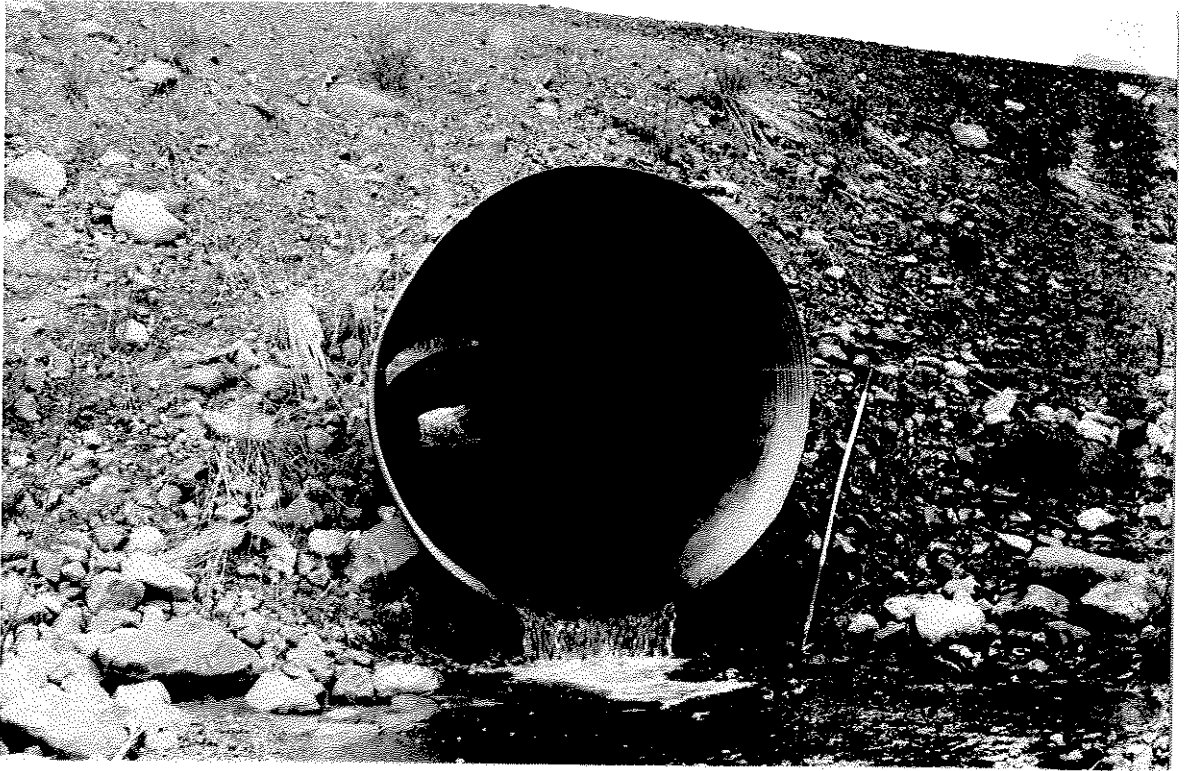
PLATE 3: Culvert uncoupled same culvert as in PLATE22. Culvert diameter is 2 m.; installed about 1960.

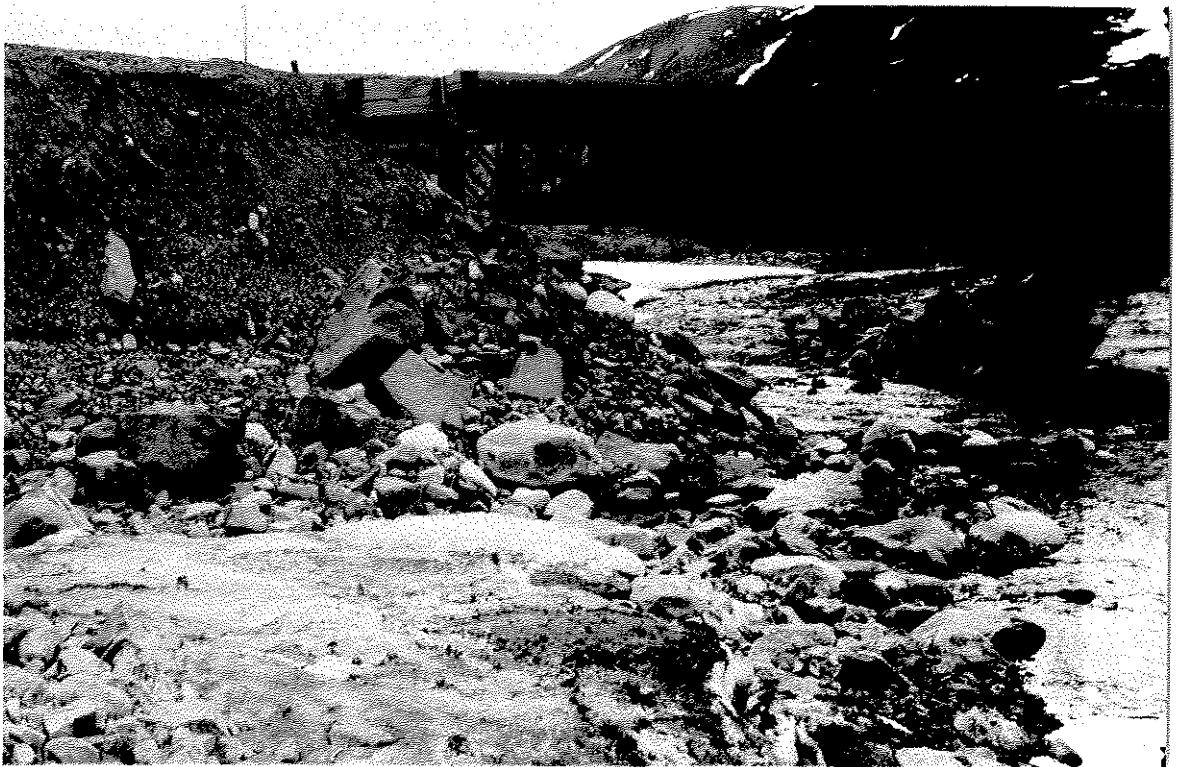
PLATE 4: Overdeck Bailey bridge at Blackstone River. Remnant aufeis (right) is almost at truss level. (Km. 78)

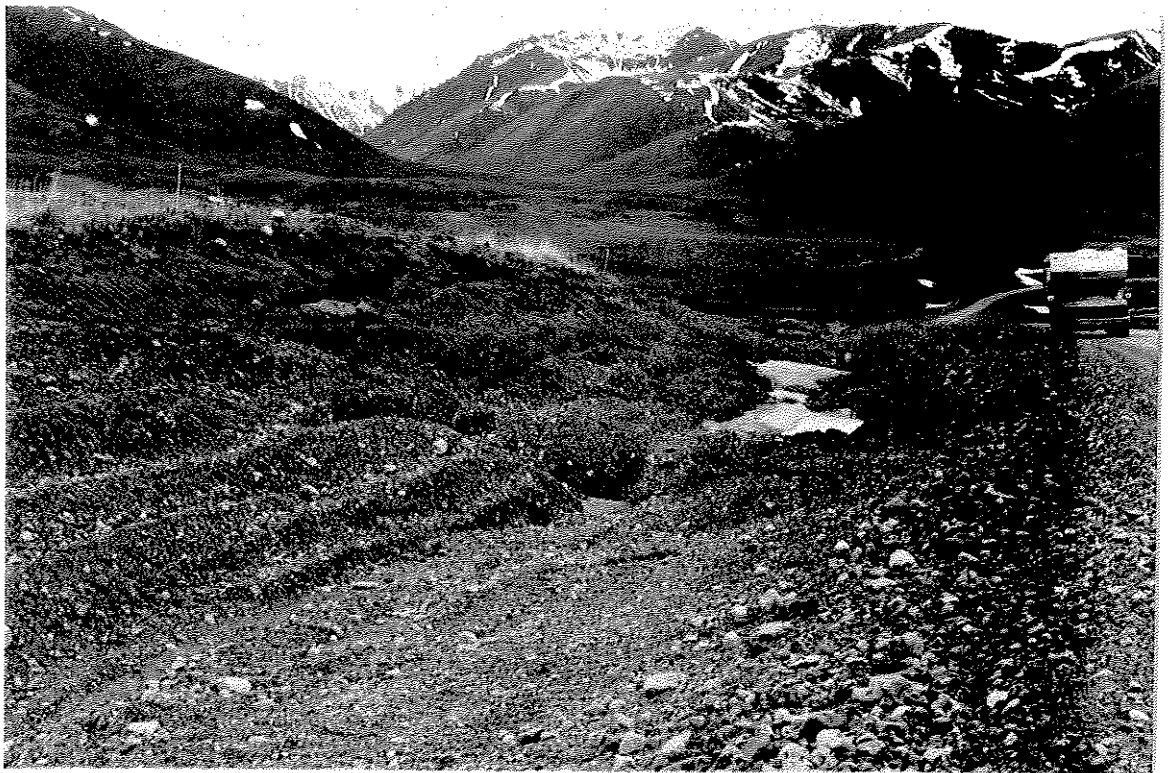
PLATE 6: Backslope cut at 28 degrees to the horizontal in silty sand. See Figure 14 for cross-section. (Km. 87)

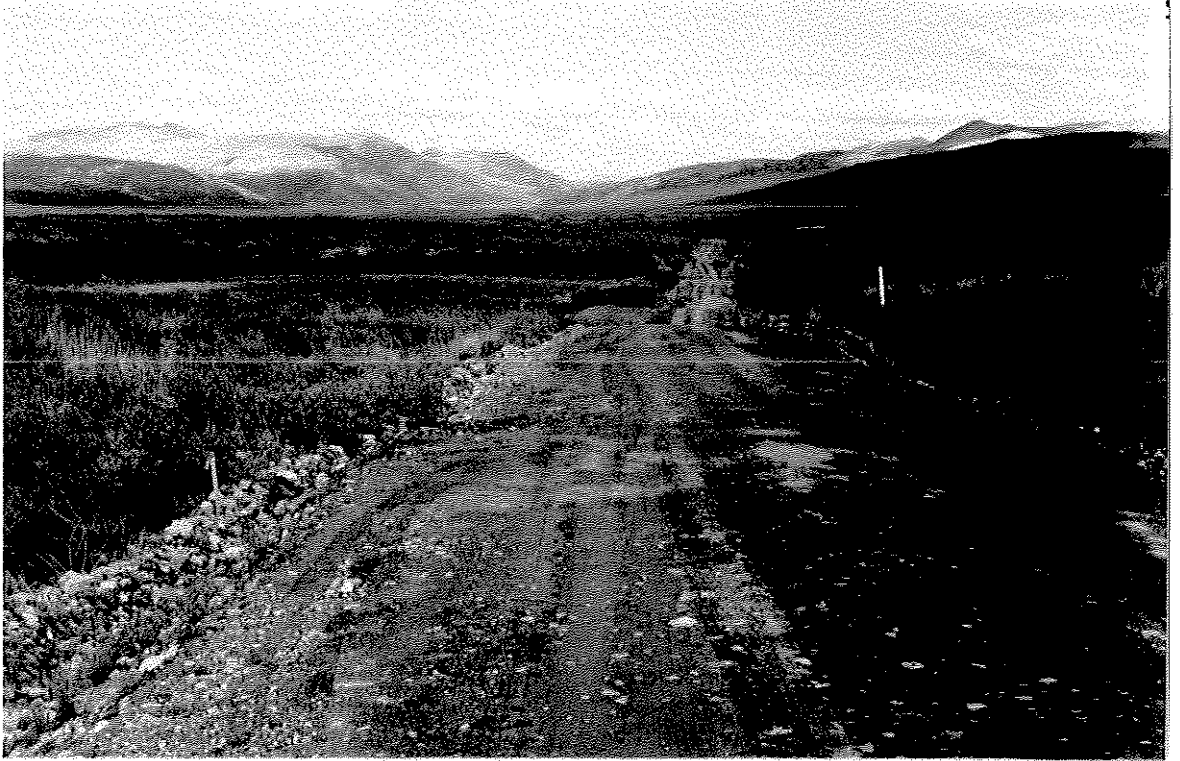
PLATE 7: Looking north from Km. 122 (Built 1962). Surficial soils consist of 0.1 - 0.5 m. of saturated organics overlying ice rich silts or sands.

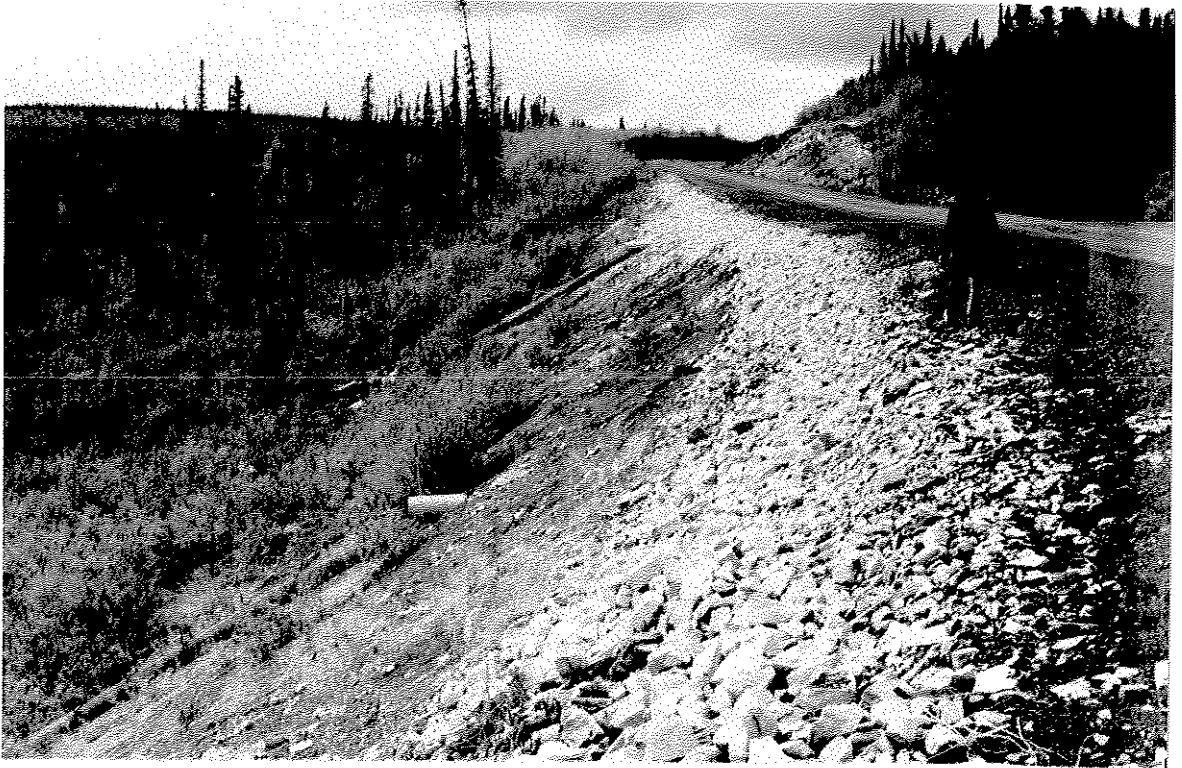
PLATE 9: Sideslope 16 m. high fill at 34 degrees to the horizontal. (Built 1976). Culvert in foreground collapsed. "Fluming" is intact (foreground).

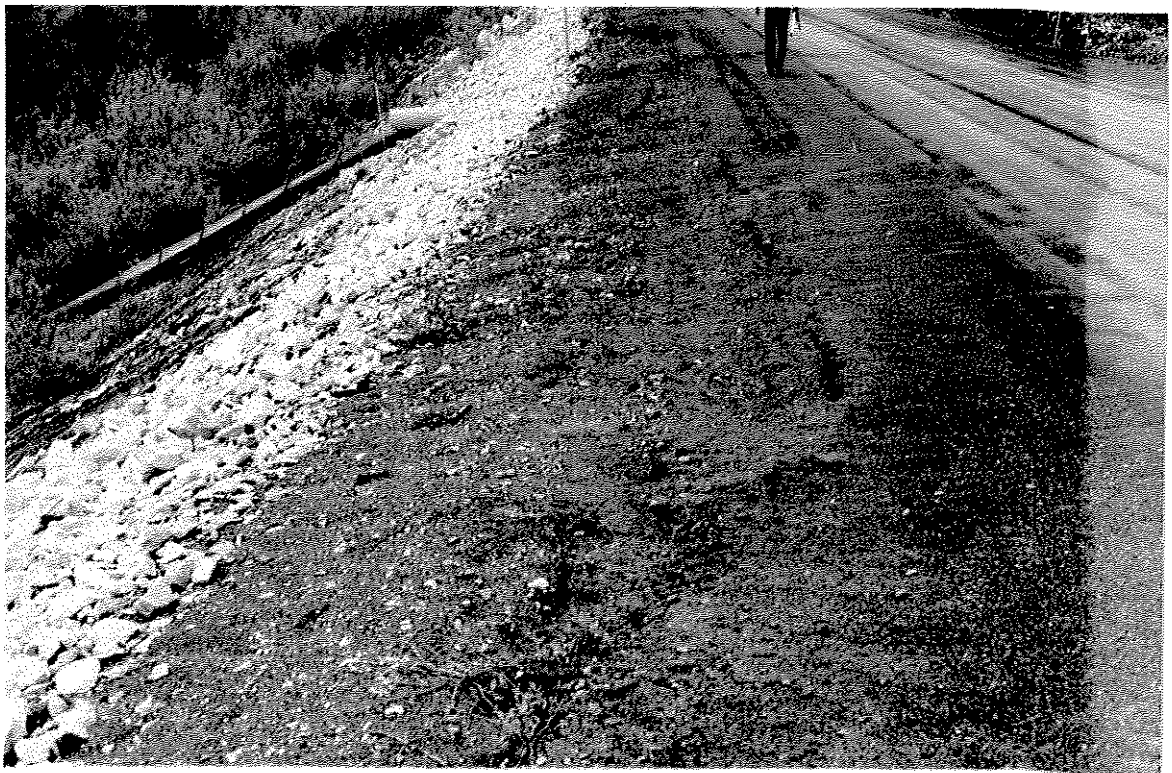
PLATE 10: Close -up view of PLATE 9 showing slumping shoulder. (Km. 352)

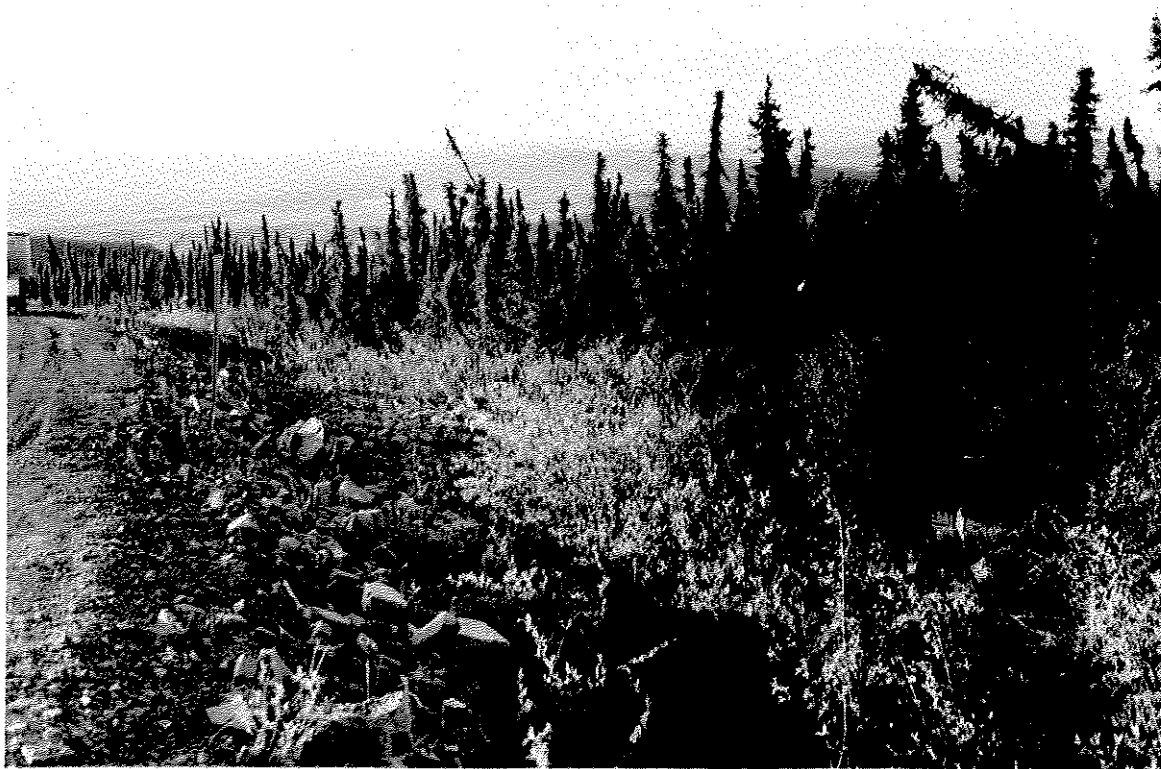
PLATE 12: Thaw of polygonal ground ice leaves water filled depressions 2 Km. north of Eagle Plains Lodge. Road alignment follows ridge crests (background).

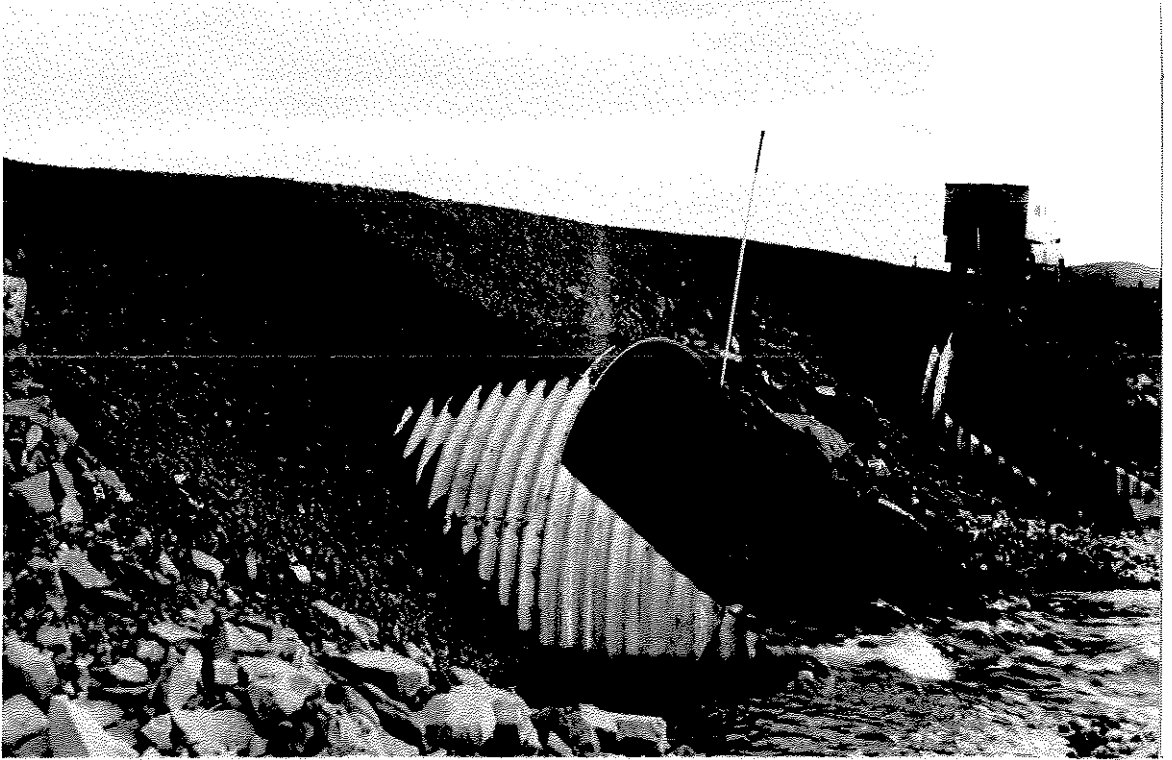
PLATE 17: Embankment erosion at culvert installation. (Km. 423)

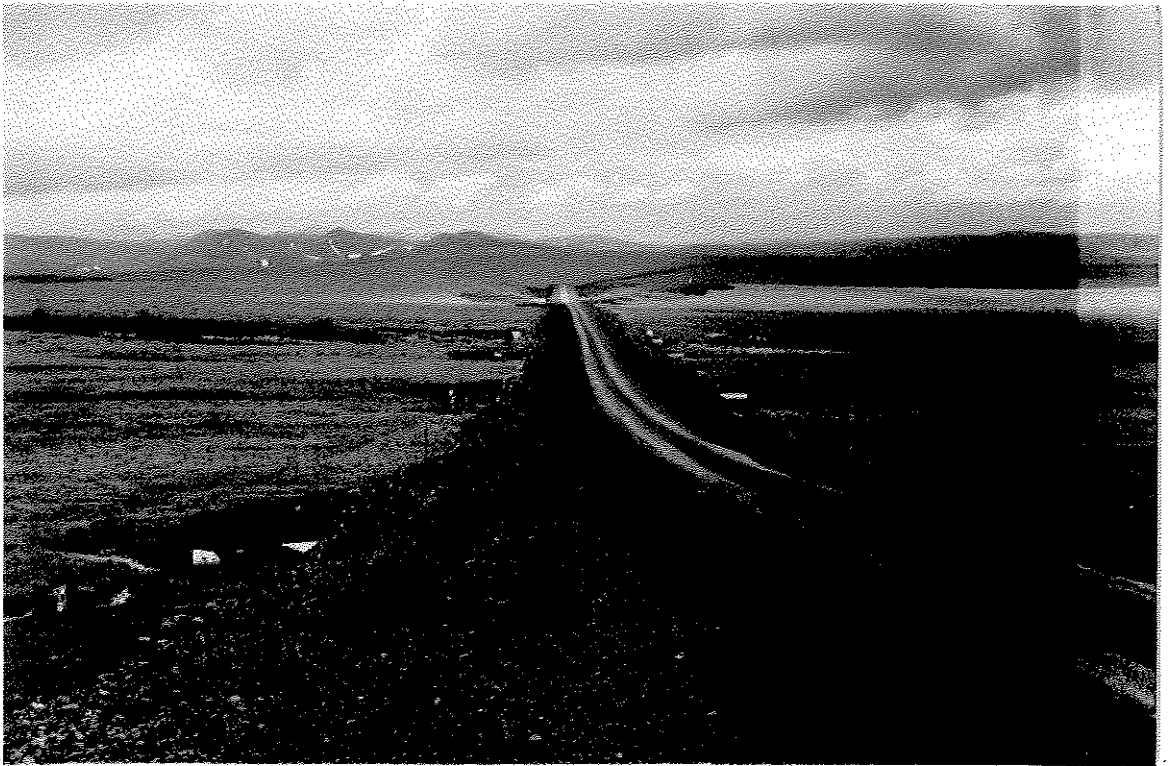
PLATE 18: Culverts and ditch blocks (foreground); cut in ice rich soil (background), Yukon.

PLATES 18 and 19 show a cut made in ice-rich fine-grained soil which has undergone minor slumping due to thaw degradation.

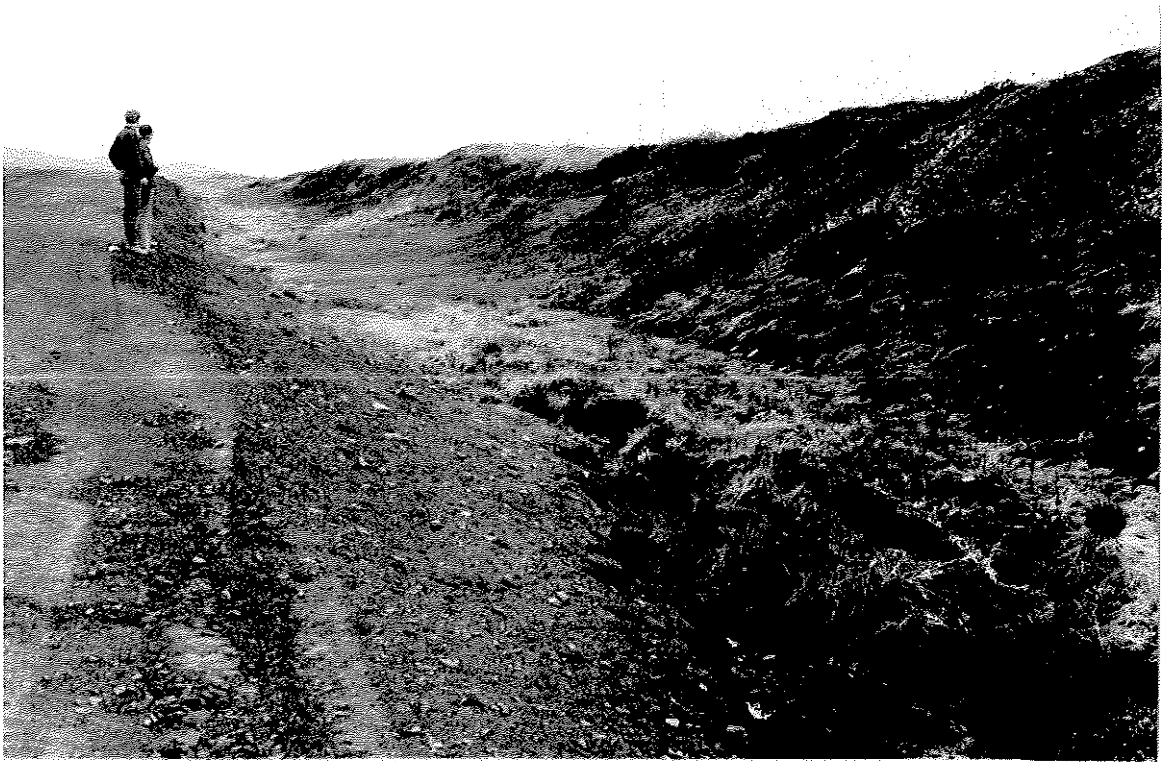
PLATE 19: Slumping of cut in ice-rich silt.

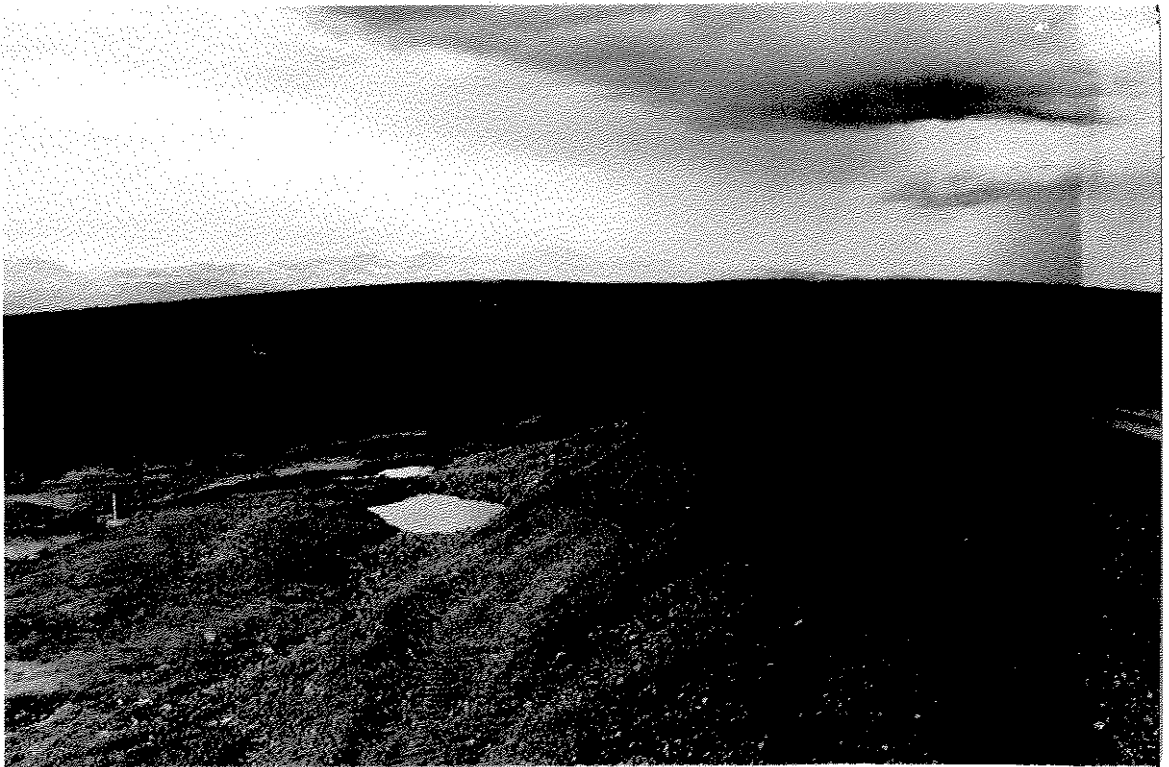
PLATE 20: Embankment failure 22 Km. west of Peel River, N.W.T.

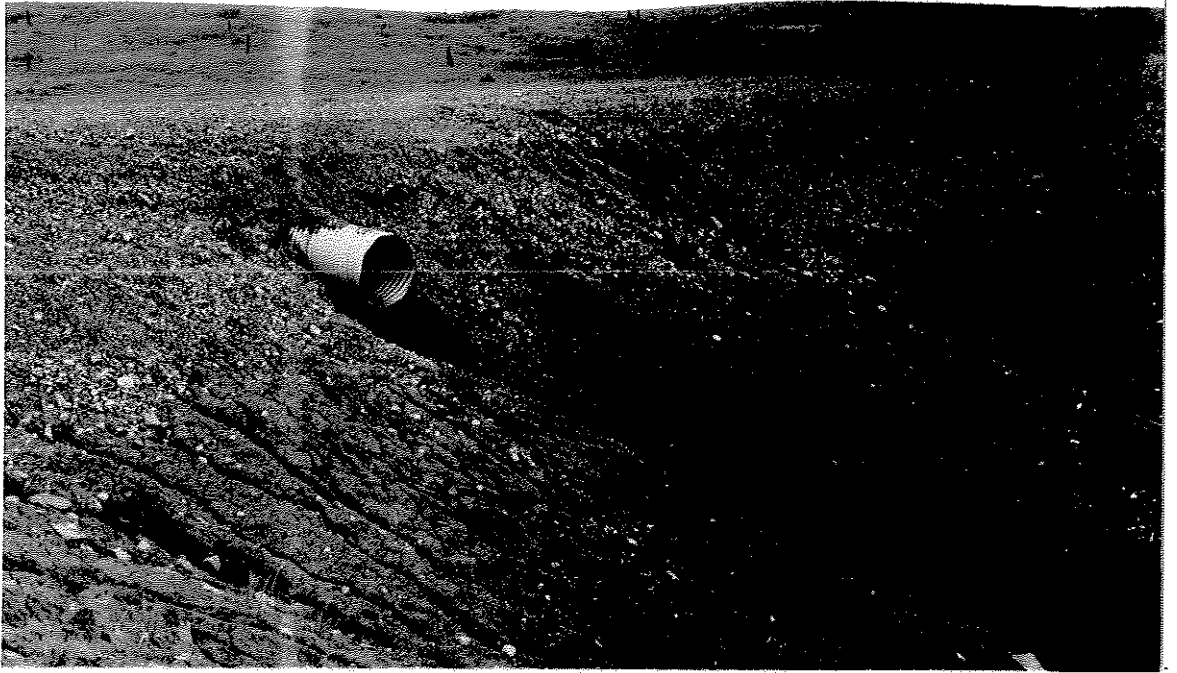
PLATE 21: No flume on culvert. Consequent erosion is considerable.
(Km. 510).

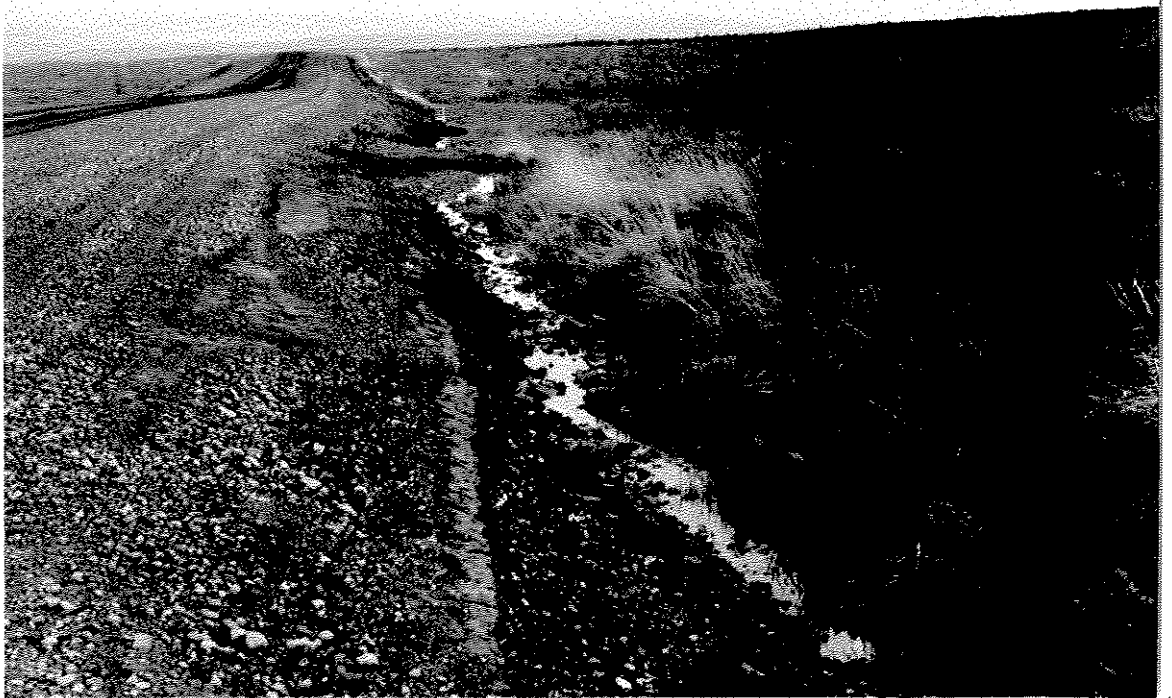
PLATE 22: Soft embankment shoulders at Km. 510.

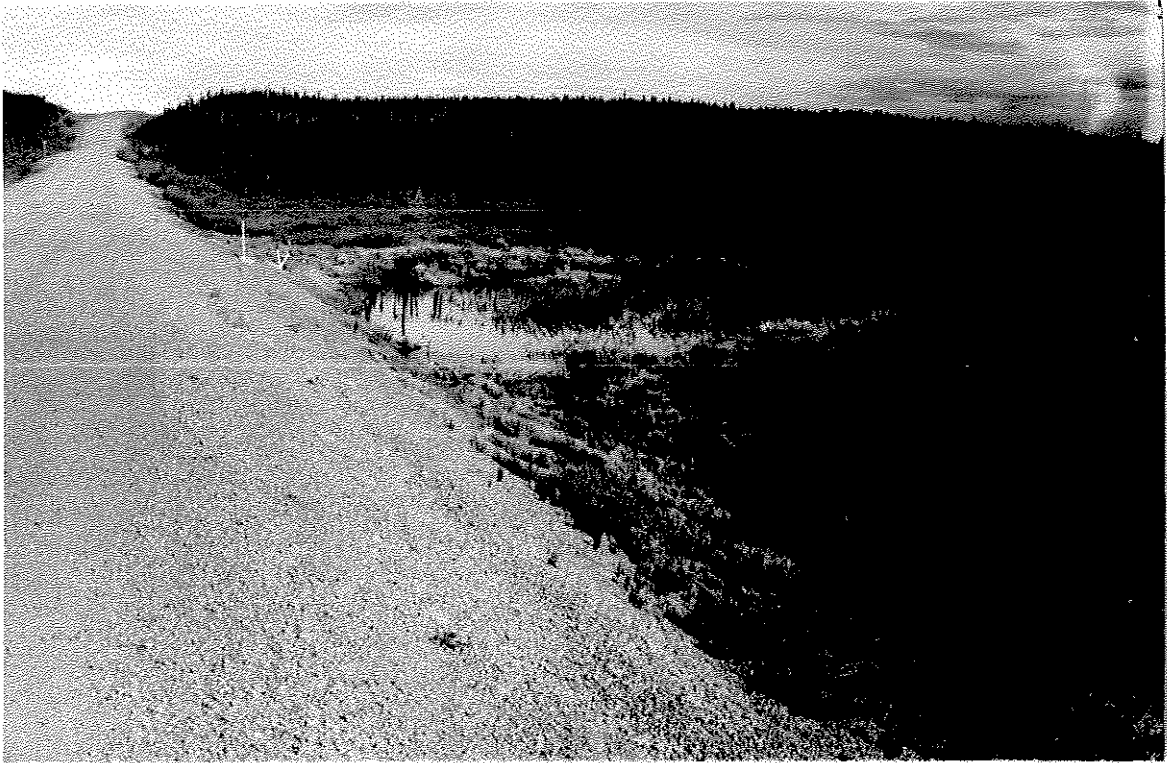
PLATE 23: Icing area (right centre).
(Km. 571)

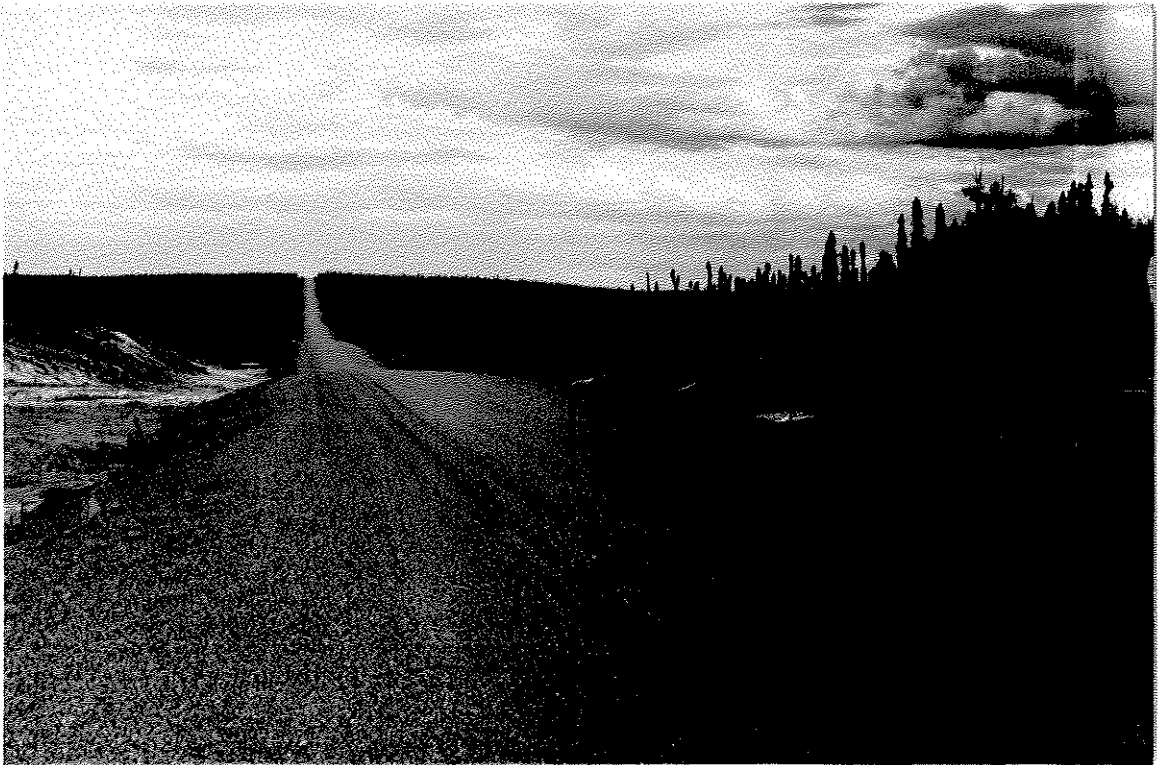
PLATE 24: Large cut at Km. 583 (Mile 343). Melt out of ice-rich silty till resulted in uneven backslopes. Leacheate has precipitated from groundwater seepage through a protective blanket of granular material.

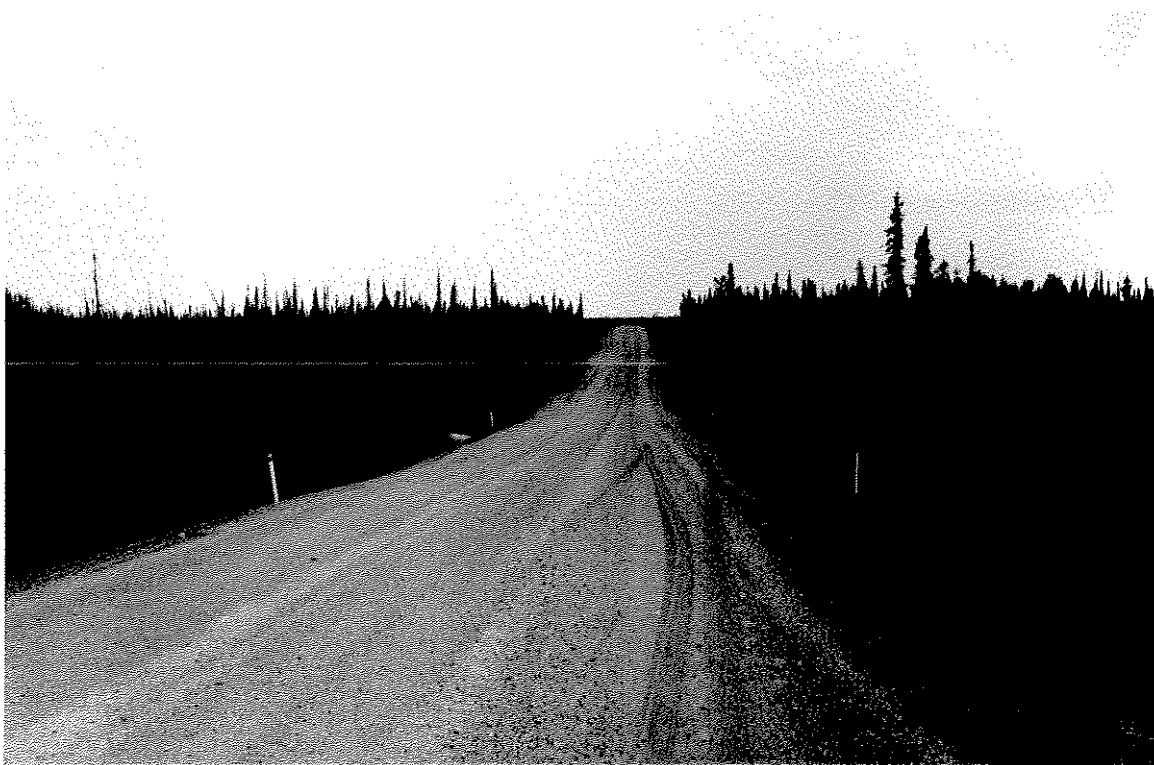
PLATE 25: Undulating embankment and subsided culvert (centre) at Km. 633.

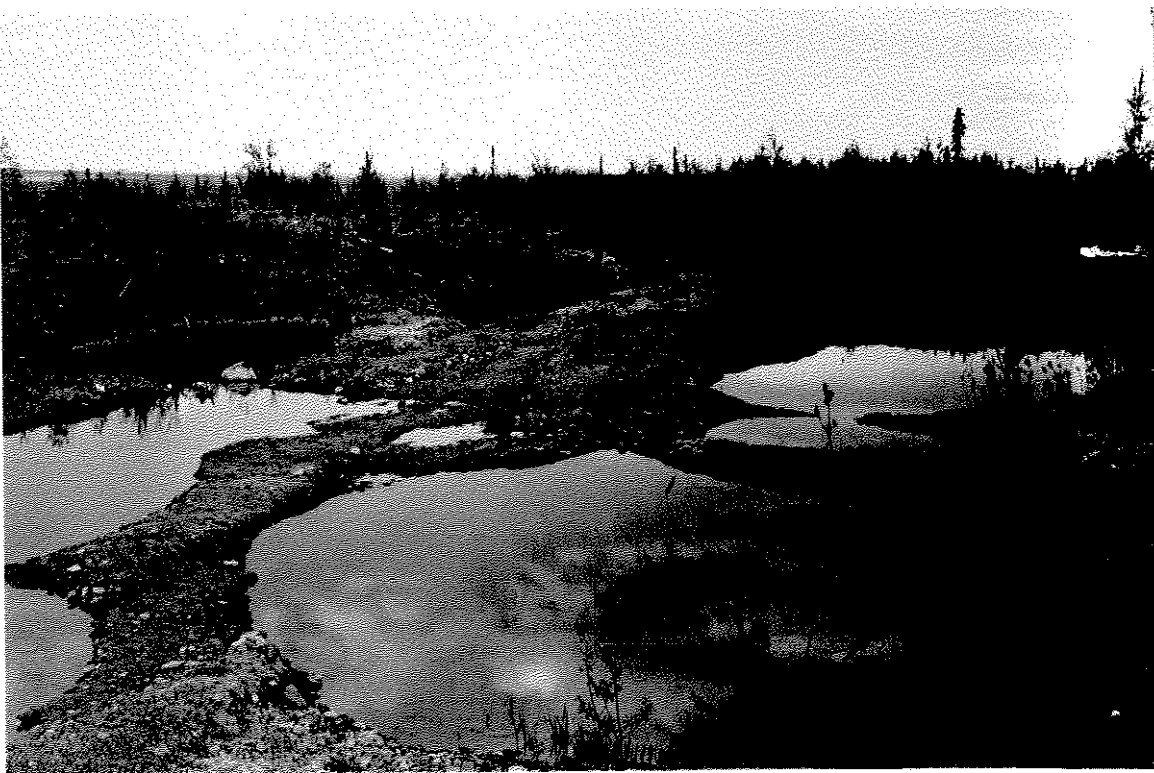
PLATE 26: Borrow pit at Km. 720. The sinkholes (about 5m. across) resulted from thaw of ground ice. A polygonal pattern has developed.

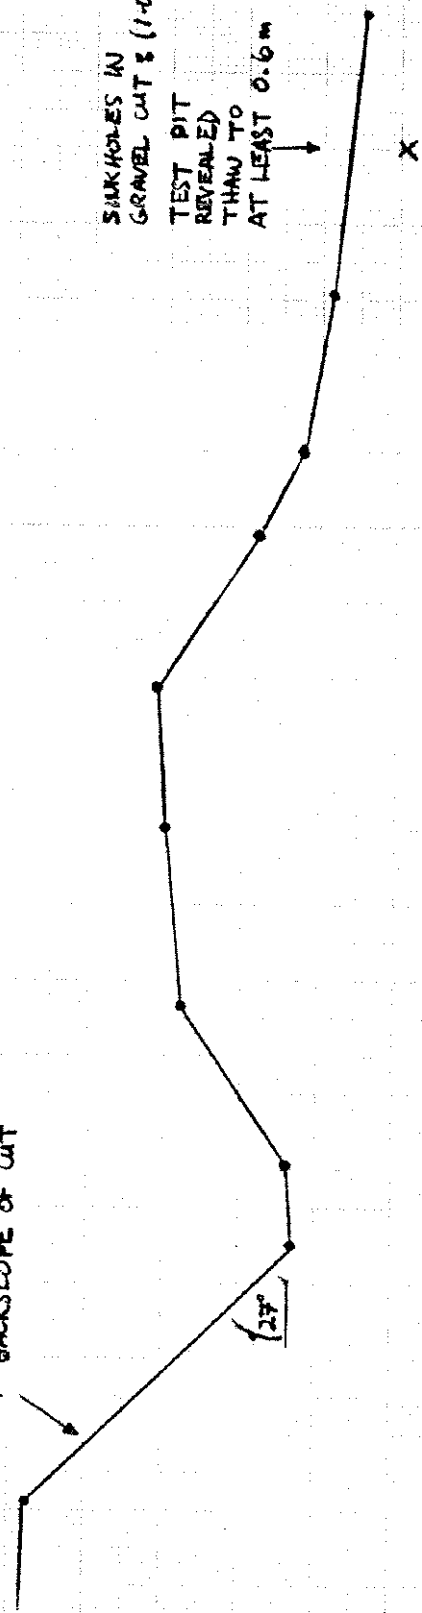
Figure 14 CROSS SECTION: DENPSTER HIGHWAY (KILOMETER 88)

CRACKING, SLOUGHING OF BACKSLOPE OF CUT

SINKHOLES IN GRAVEL CUTS (10 m DEEP)
TEST PIT REVEALED THAW TO AT LEAST 0.6 m

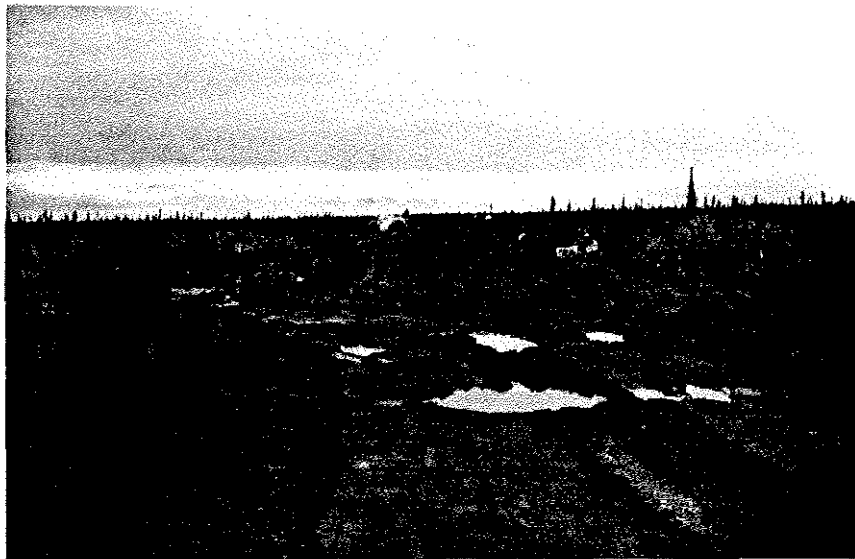
PLATE 31

MILE 955, MACKENZIE HIGHWAY, SEPTEMBER 7, 1972, LOOKING SOUTHERLY. THIS EMBANKMENT WAS CONSTRUCTED DURING DECEMBER 1971 WITH MATERIAL FROM THE PIT AT MILE 953.3. NOTICE HOW THE EMBANKMENT HAS SUBSIDED AND HOW THE MATERIAL IS IN AN EXTREMELY SOFT CONDITION. AT THIS SECTION, THE LOCATION FOLLOWED ALONG A SEISMIC LINE.

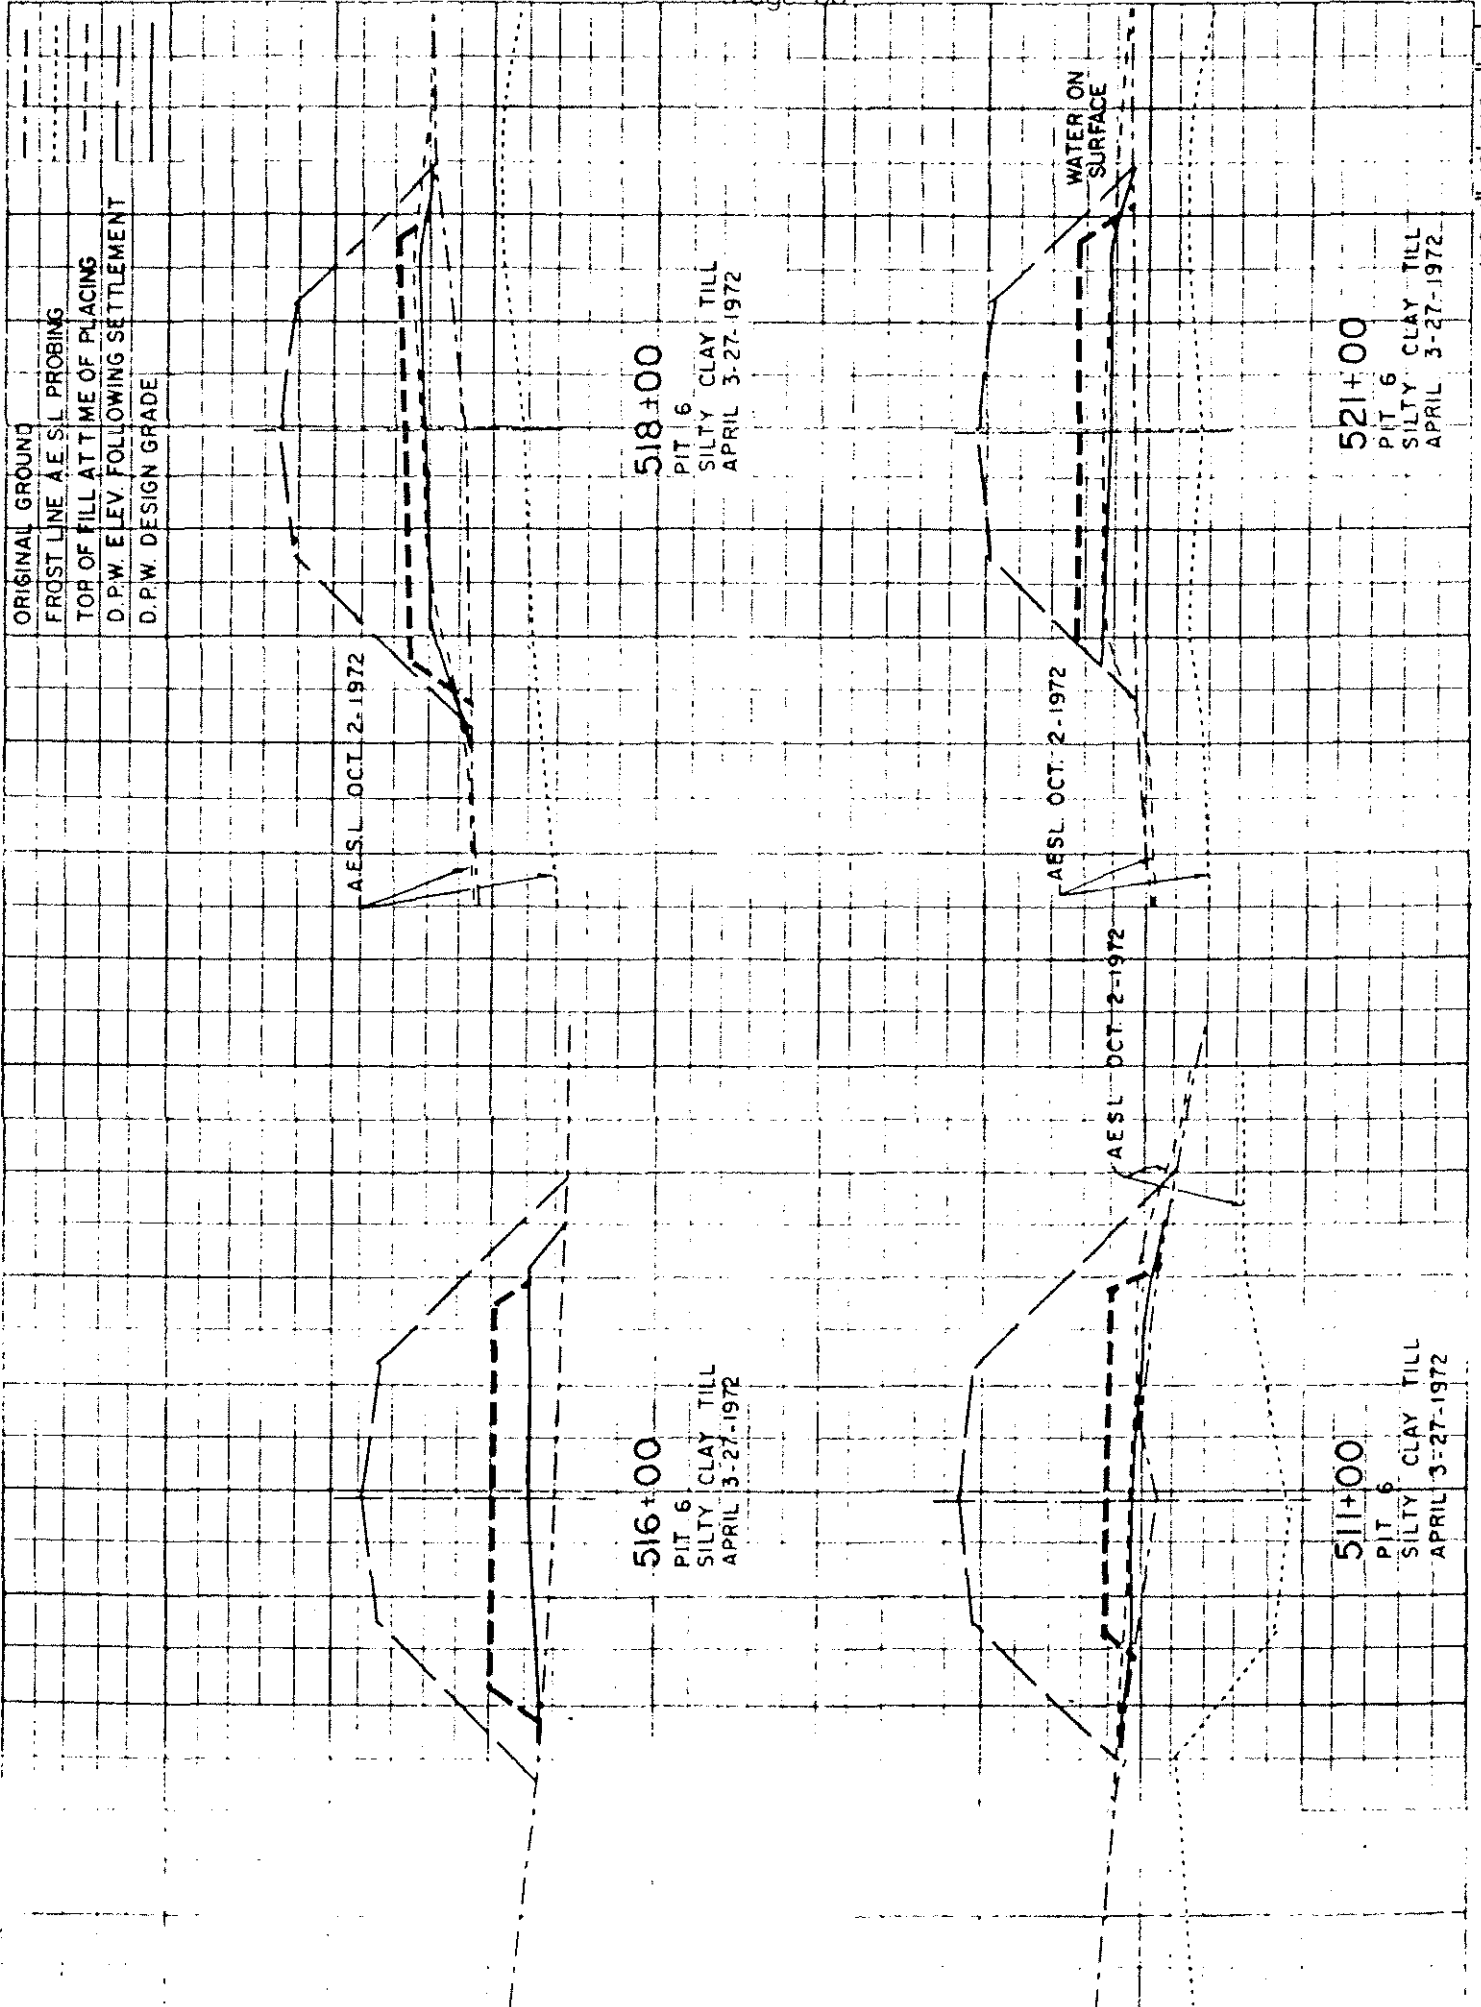
FIGURE 25 Cross Sections of the Dempster Highway (Mile 340.6 / Km. 580) (after A.E.S.L., 1977)

Thermal regime changes are apparent within the embankment near Km 580, shown in Figure 25. The permafrost degraded in some sections and not in other locations. The airphoto mosaic in Figure 26 shows polygonal ground patterns at stations 518 and 521 and thermokarst features south of the embankment. From borehole logs it is apparent that a minimum of 2.5 m of clayey silt overlies shale bedrock. The embankment was constructed with an initial 1 metre lift of saturated silty clay till in the winter of 1971. A shale cap was placed in the winter of 1972. The embankment shape and quality was very good when

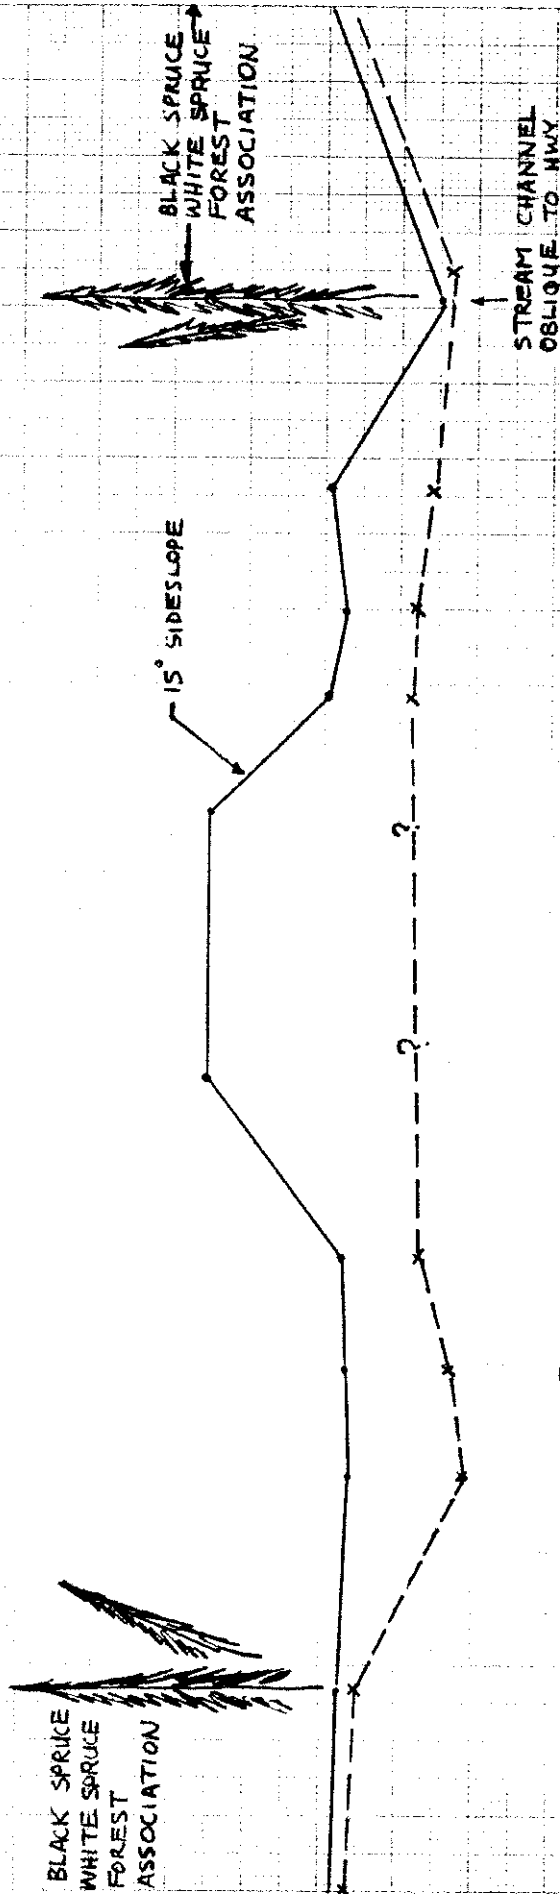
Figure 29. CROSS SECTION: DEMPSTER HIGHWAY
(KILOMETER 142)

thermally induced subsidence. The design sideslope for the embankment was 18 degrees, but 15 degrees was measured. Slope flattening such as this was likely a result of thaw of the subgrade and subsequent movement.
