OBSERVATION OF THE DESIGN
AND PERFORMANCE OF THE
DEMPSTER HIGHWAY

SUBMITTED TO
THE UNIVERSITY OF ALBERTA
DEPARTMENT OF CIVIL ENGINEERING

APRIL 1985

B. E. LINGNAU

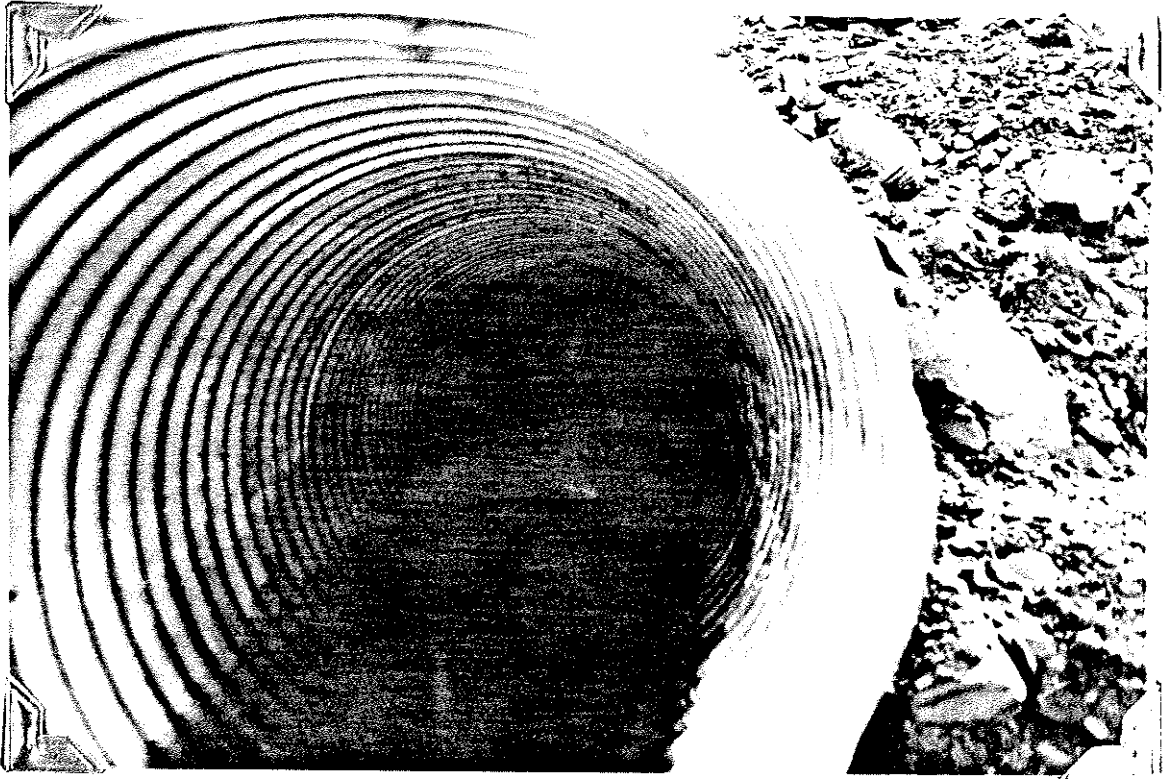
PLATE 33: Culvert Icing.
