Structural Engineering Report No. 240

# **BEHAVIOUR AND REHABILITATION OF DISTORTION-INDUCED FATIGUE CRACKS IN BRIDGE GIRDERS**

by  
Mark D'Andrea  
Gilbert Y. Grondin  
and  
Geoffrey L. Kulak

September 2001

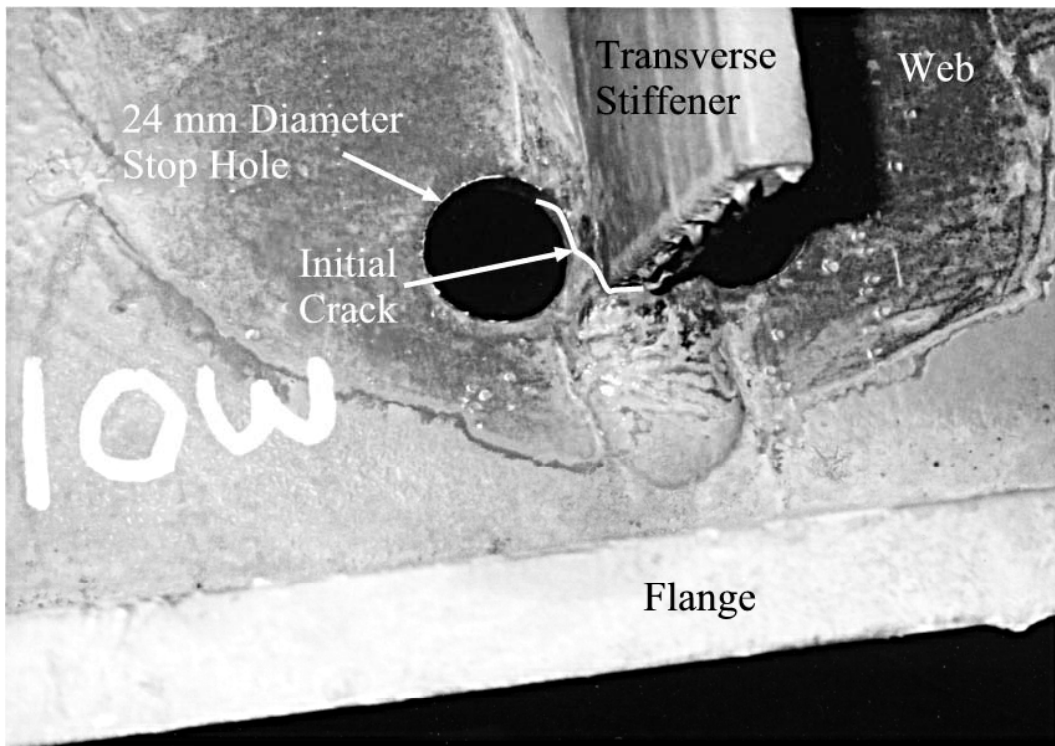
**Figure 4-2** Initial Crack and Stop Holes on West Face of Joint 10, Specimen 1

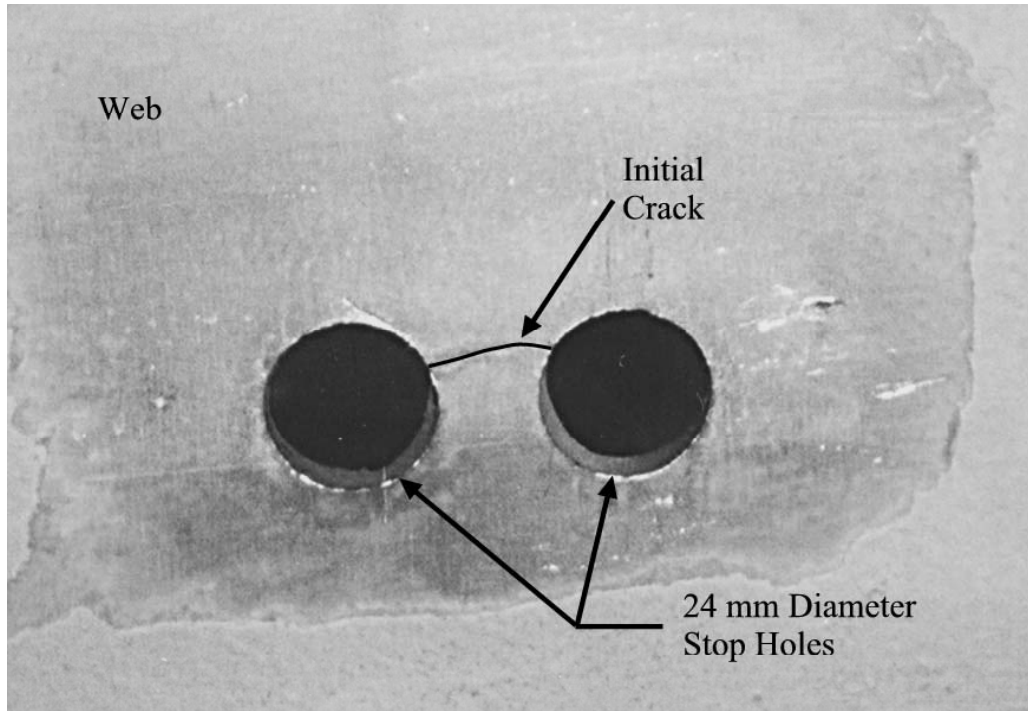
**Figure 4-3** Initial Crack and Stop Holes on East Face of Joint 10, Specimen 1

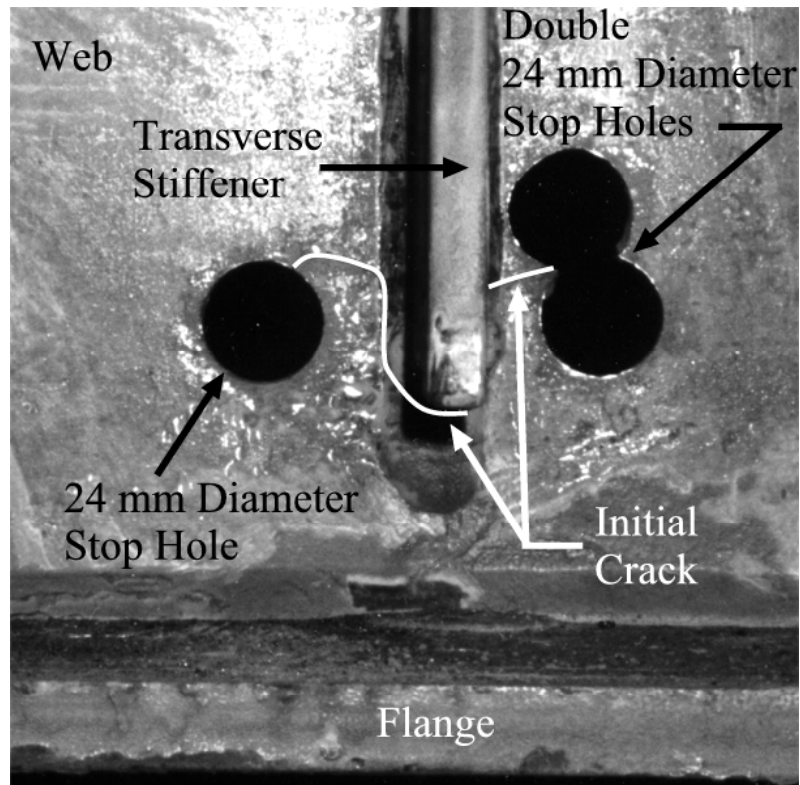
**Figure 4-4** Initial Crack and Stop Holes on West Face of Joint 12, Specimen 2

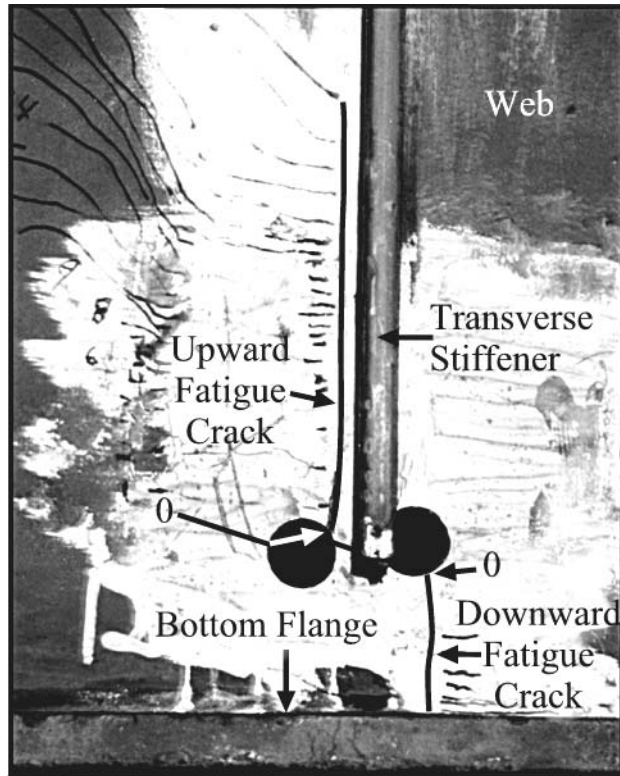
Figure 4-11 Fatigue Crack on West Face of Joint 12, Specimen 1

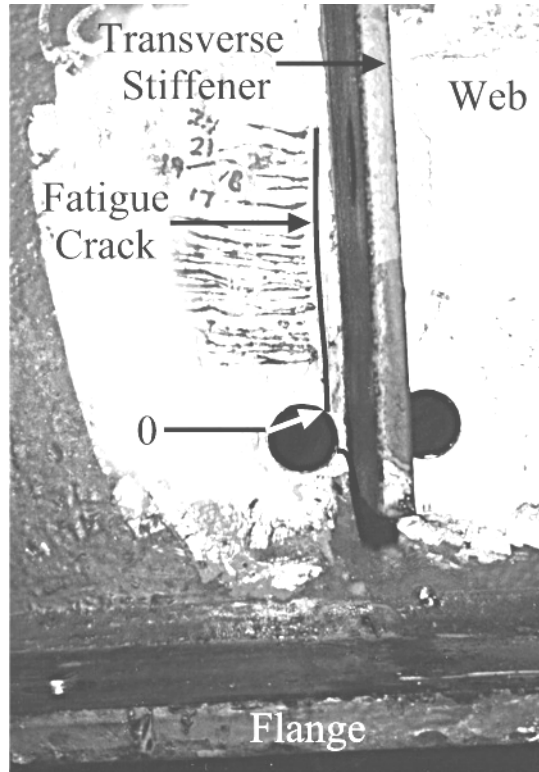
Figure 4-13 Fatigue Crack on West Face of Joint 10, Specimen 2

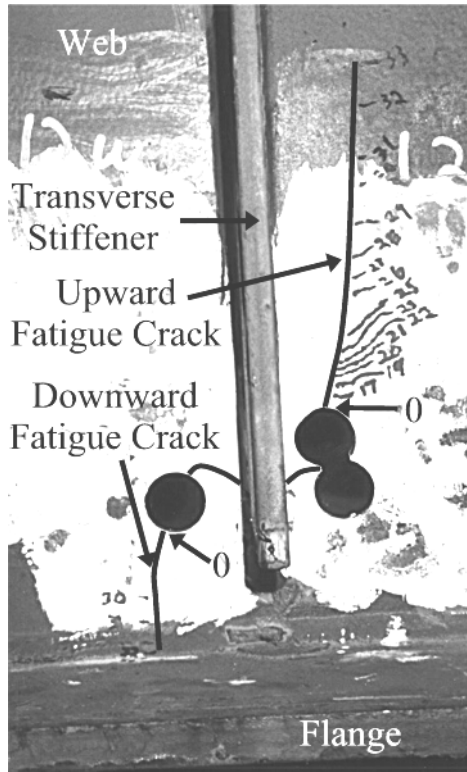
**Figure 4-15** Fatigue Crack on West Face of Joint 12, Specimen 2

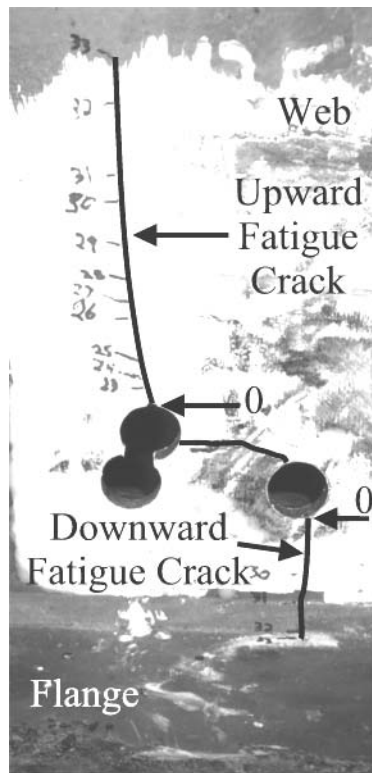
**Figure 4-16** Fatigue Crack on East Face of Joint 12, Specimen 2

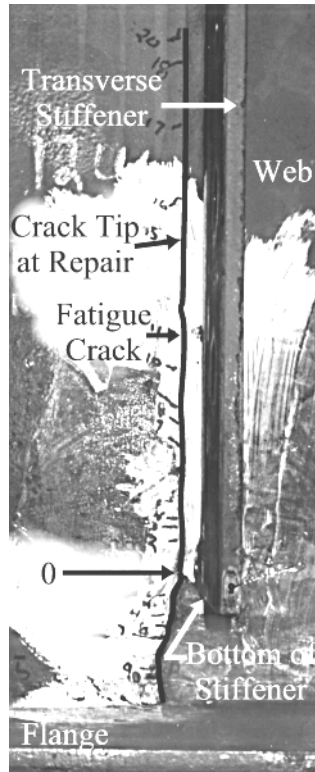
Figure 4-17 Fatigue Crack on West Face of Joint 12, Specimen 3

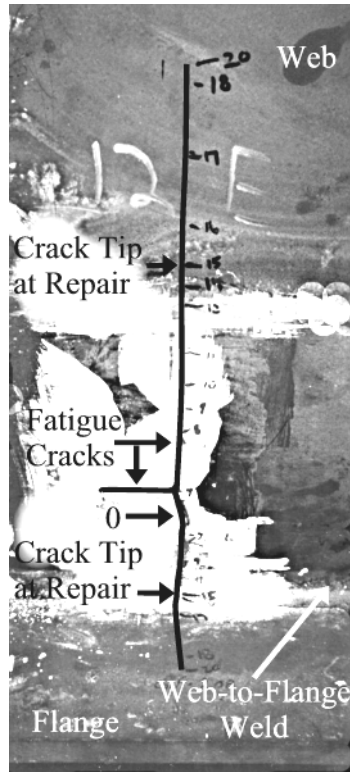
Figure 4-19 Fatigue Crack on East Face of Joint 12, Specimen 3

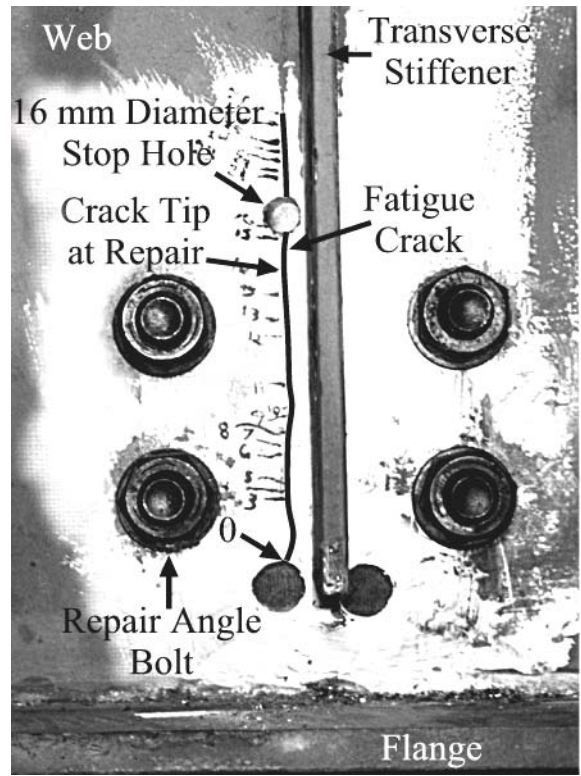
**Figure 4-21** Fatigue Crack on East Face of Joint 11, Specimen 4

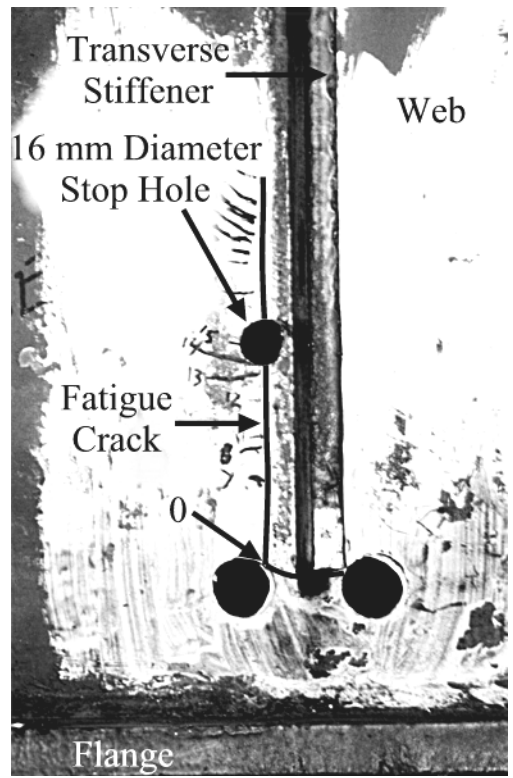
**Figure-22** Fatigue Crack on East Face of Joint 13, Specimen 4

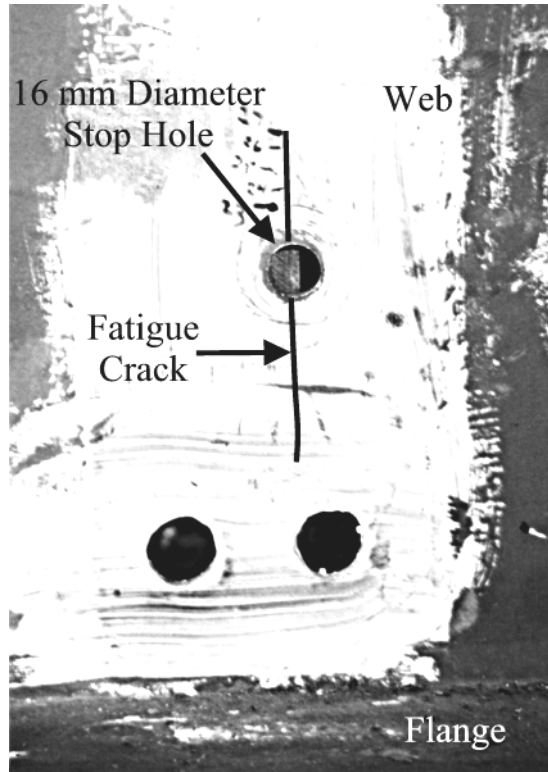
Figure 4-29 Fatigue Crack on West Face of Joint 13, Specimen 4

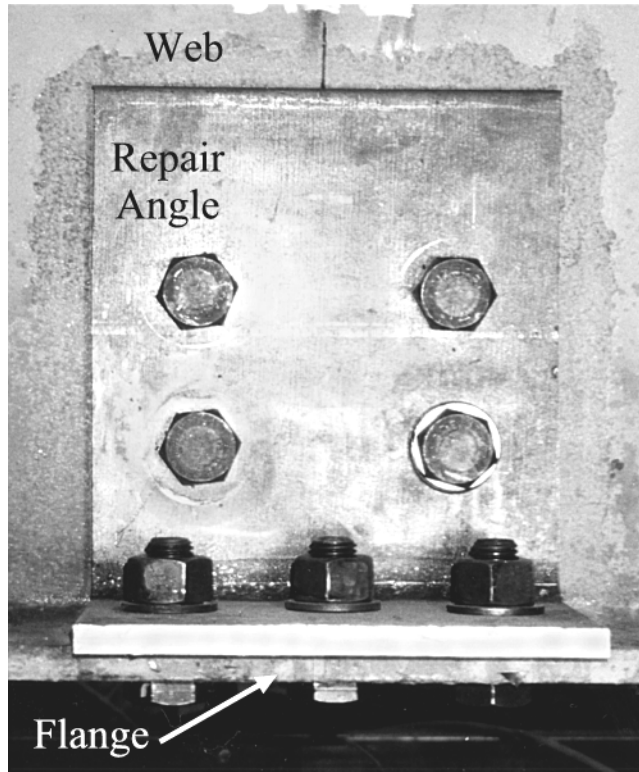
**Figure 4-33** Fatigue Crack on East Face of Joint 11, Specimen 5

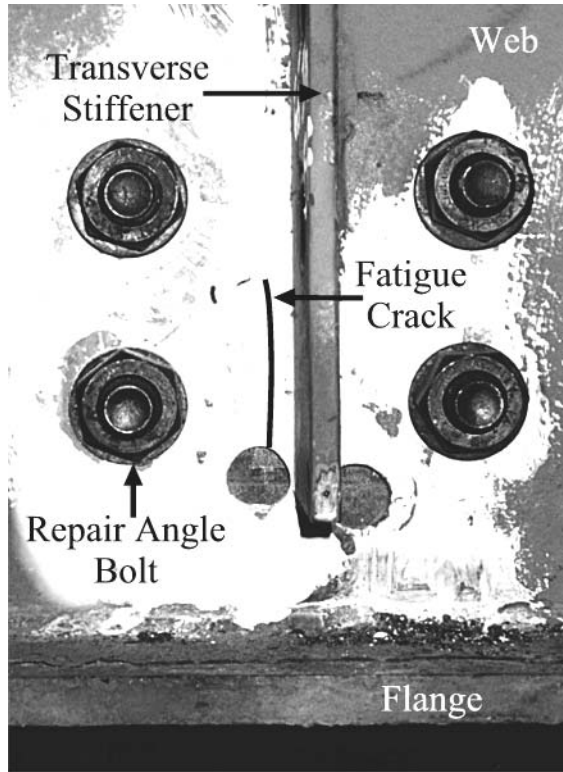
Figure 4-35 Fatigue Crack on West Face of Joint 12, Specimen 5

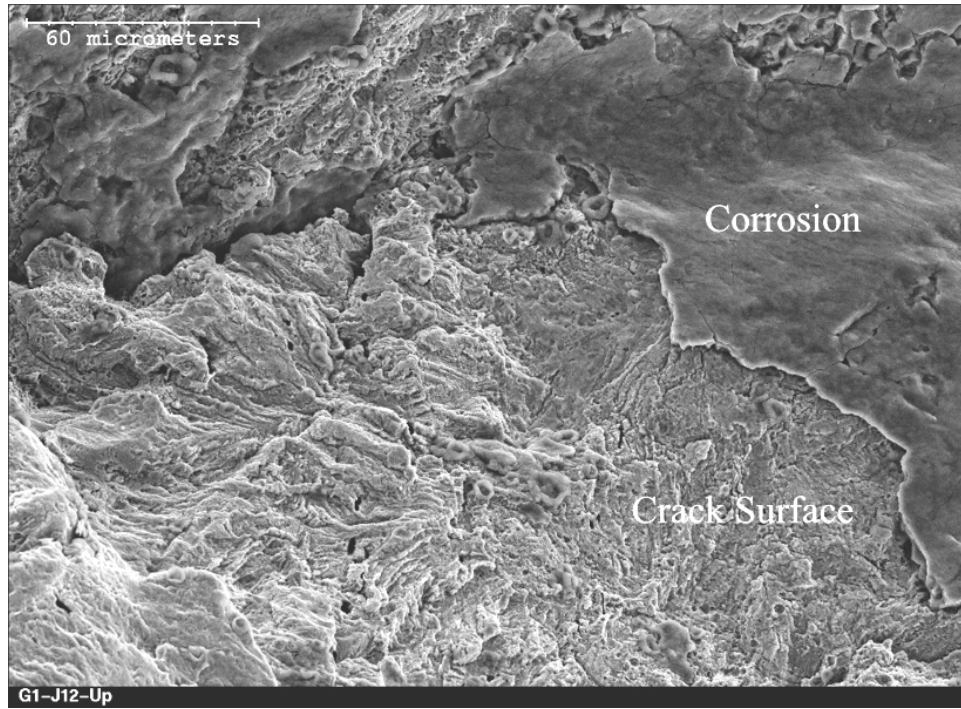
**Figure 4-38** Corrosion of Upward Fatigue Crack Surface at Joint 12, Specimen 1

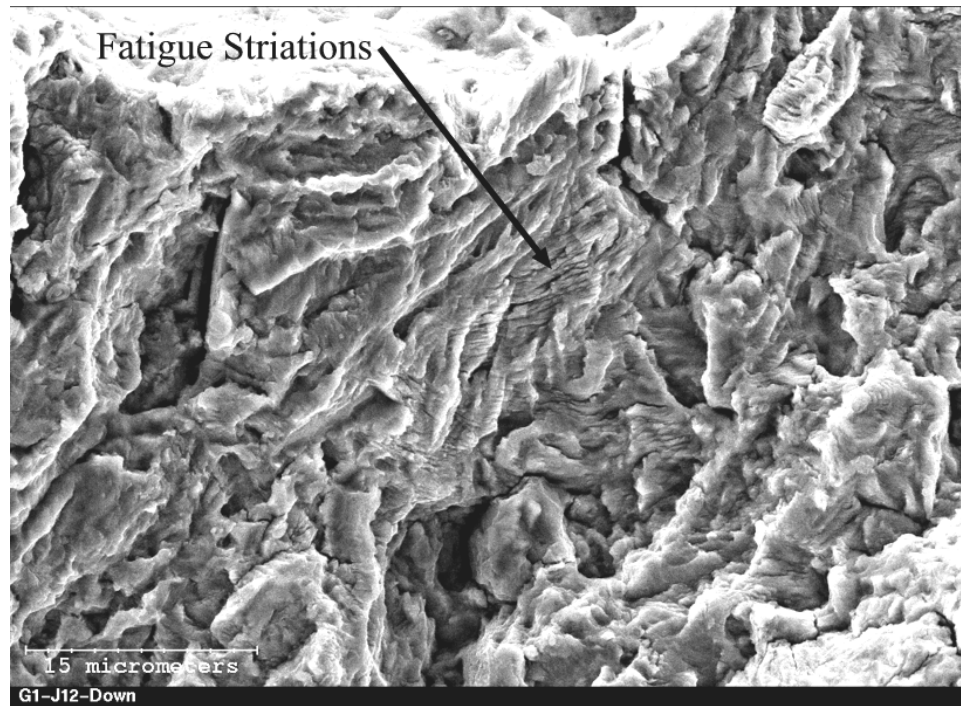
**Figure 4-39** Fatigue Striations on Downward Fatigue Crack Surface at Joint 12, Specimen 1

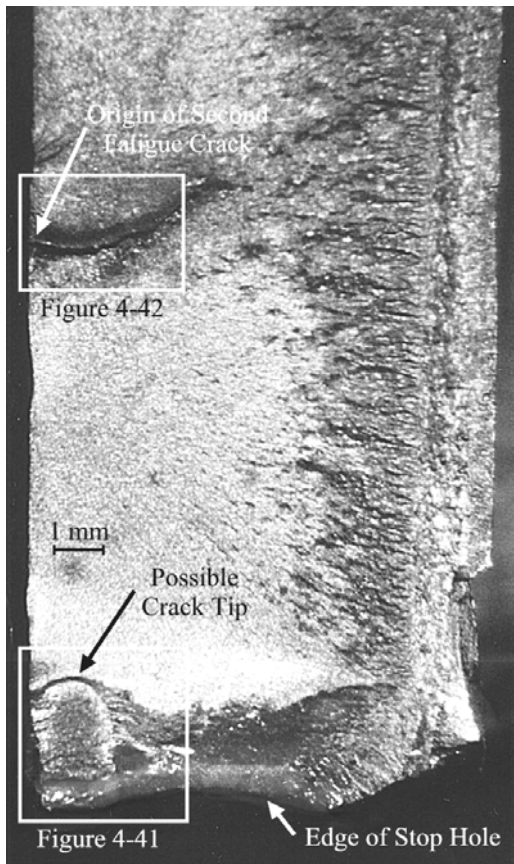
**Figure 4-40** Upward Fatigue Crack Surface at Joint 10, Specimen 2

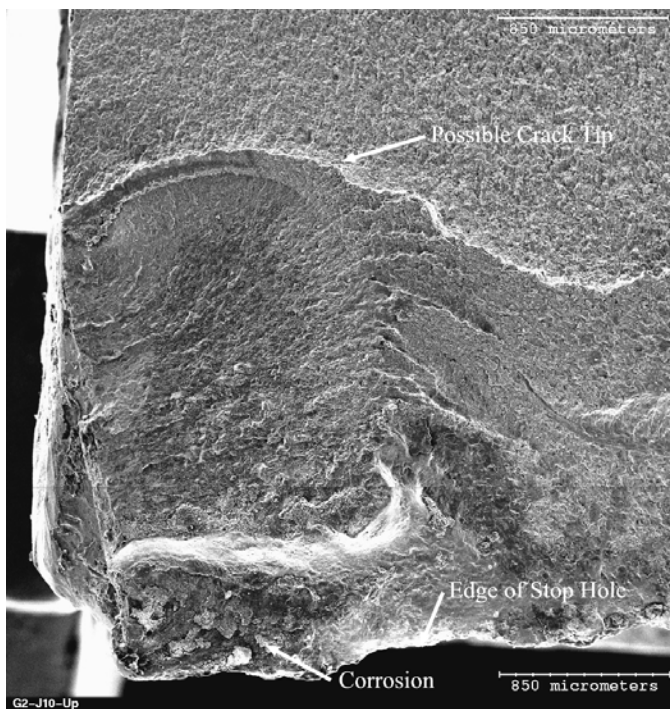
**Figure 4-41** Upward Fatigue Crack Surface at Edge of Stop Hole at Joint 10, Specimen 2

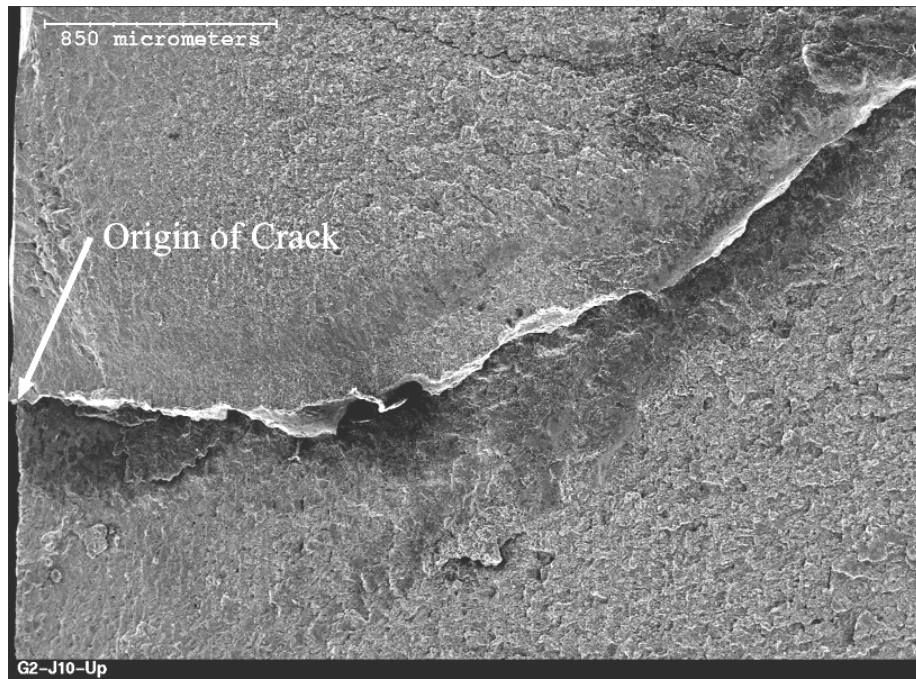
**Figure 4-42** Upward Fatigue Crack Surface 11 mm from Edge of Stop Hole at Joint 10,  
Specimen 2
