STURGEON RIVER

2018 Watercourse Crossing Assessment

Prepared for: North Saskatchewan Watershed Alliance

Date: January 24, 2019

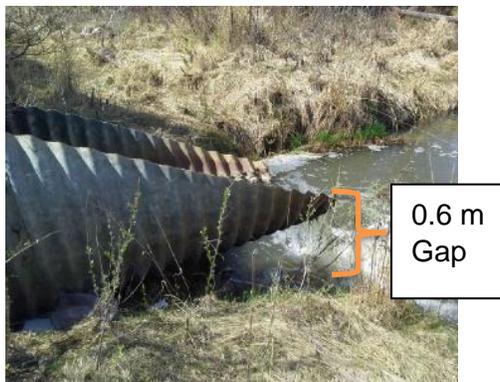
Photo 1: Culvert outlet gap at WC_0772 located on Highway 16 over Atim Creek.

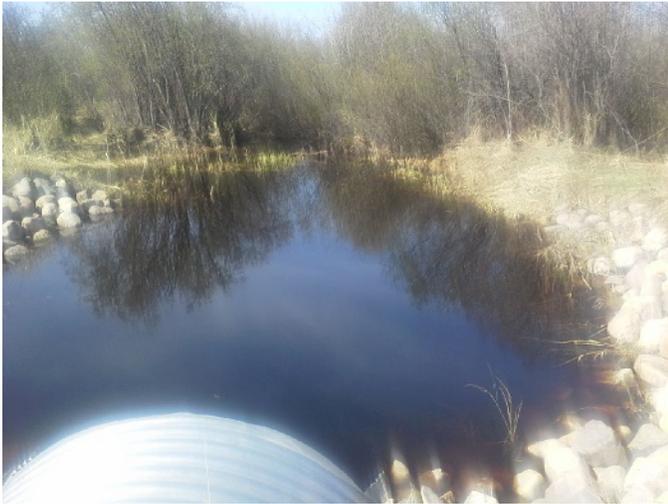
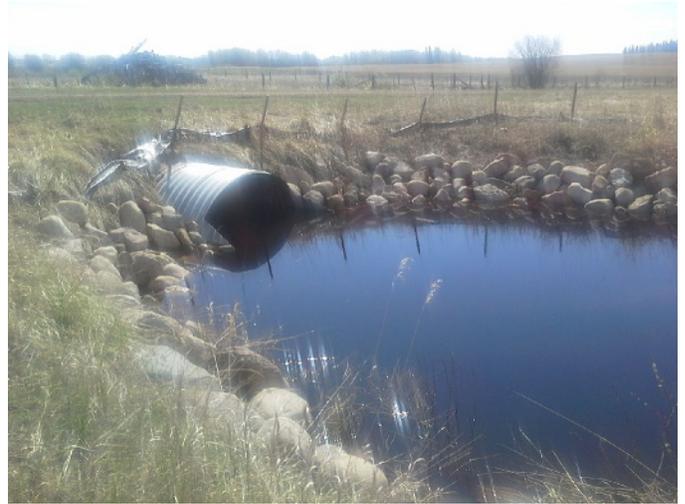
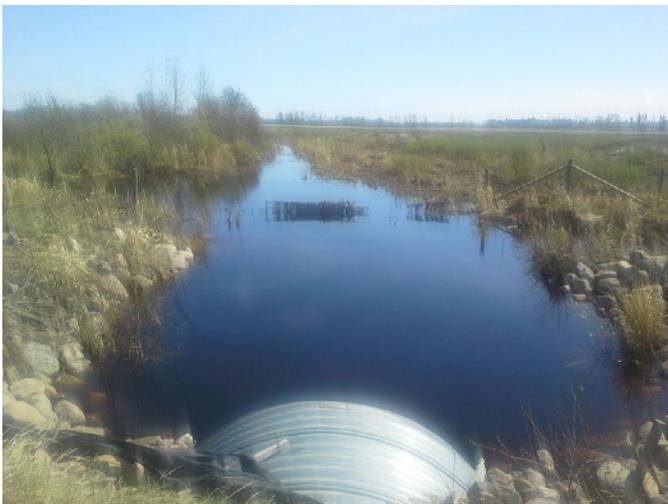
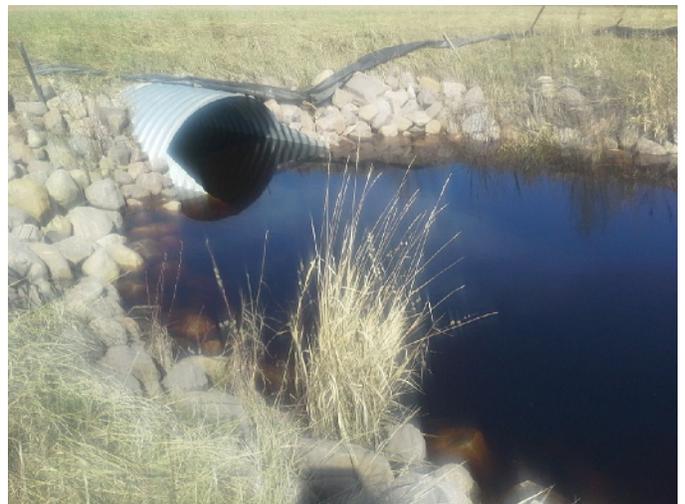
Crossing ID: WC_0036

Comments: pooling at inlet as outlet . no apparent cause. High beaver activity 0.8km up steam. Downstream spreads out into a wetland area. Could not measure pool depth at inlet or outlet due to safety concerns. Water was filling the culvert half way. The pool depth could be approximately 0.8m.

Crossing ID	Watercourse Name	Co-ordinates	Structure Type	Low Risk Issues	Comments/Recommendations
WC_0036	Riviere Qui Barre	UTM: 12 Easting: 305114 Northing: 5977877	Culvert - Single	Fish Passage: None Safety/Performance: Undersized culvert Erosion/Sedimentation: None	No major concerns as rip-rap is preventing erosion around inlet and outlet pools.
WC_0060	Little Egg	UTM: 12 Easting: 327675 Northing: 5971323	Culvert - Multiple	Fish Passage: None Safety/Performance: Undersized culvert Erosion/Sedimentation: None	Fill slope is very shallow and culvert edge is very close to road creating a higher potential for sedimentation. Pooling at inlet and outlet however no active erosion. Recommend engineer inspection.
WC_0072	Riviere Qui Barre	UTM: 12 Easting: 306425 Northing: 5972181	Bridge - Permanent	Fish Passage: None Safety/Performance: None Erosion Location (Inlet or Outlet): Outlet Erosion Source: Fill Slope Erosion Extent: Low Total Erosion Area: 2 m ²	Most of fill slope contains armour, except small area along bank that is unvegetated. Recommend seeding for continued armour.

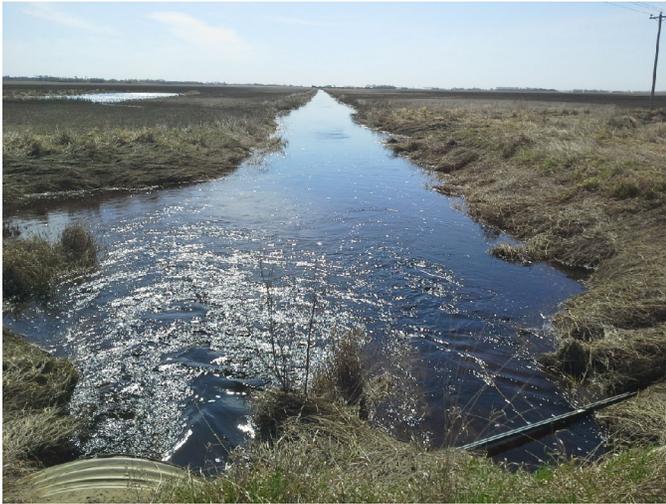
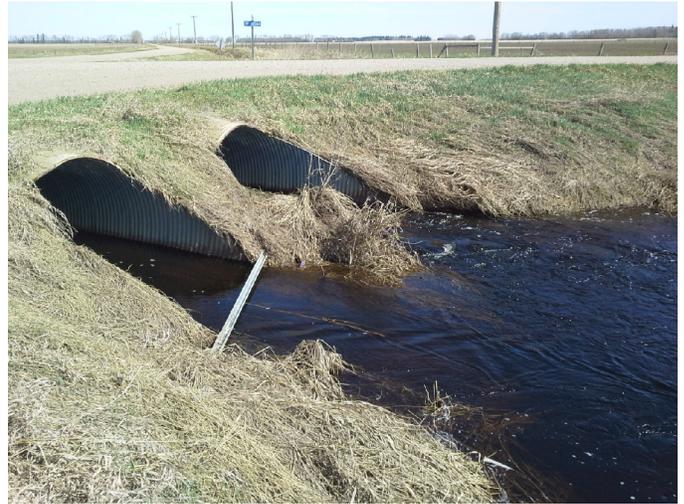
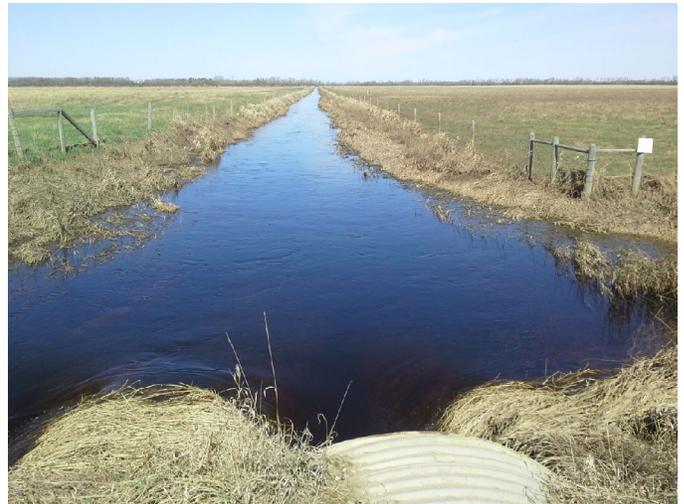
Crossing ID: WC_0060

Channel could have been historically diverted to where it is today. Channel is excavated in a straight line and runs diagonally across road. Pooling noted at inlet, sign that the culverts are undersized.

Photo No.: Photos-20180507-173419.jpg
Description: Veg Bunch In Outlet

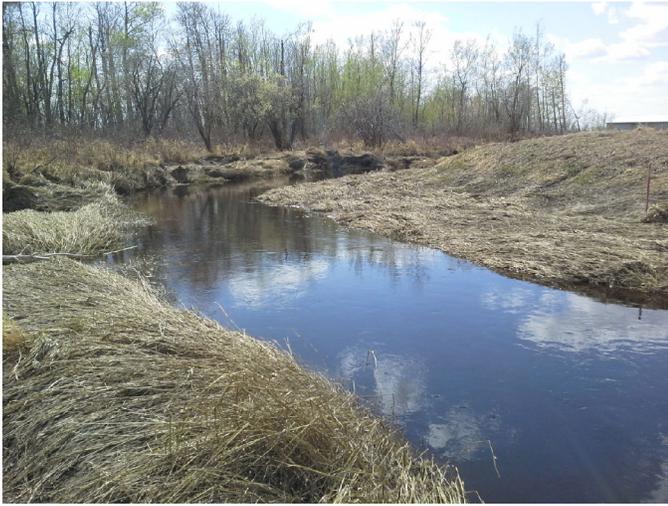
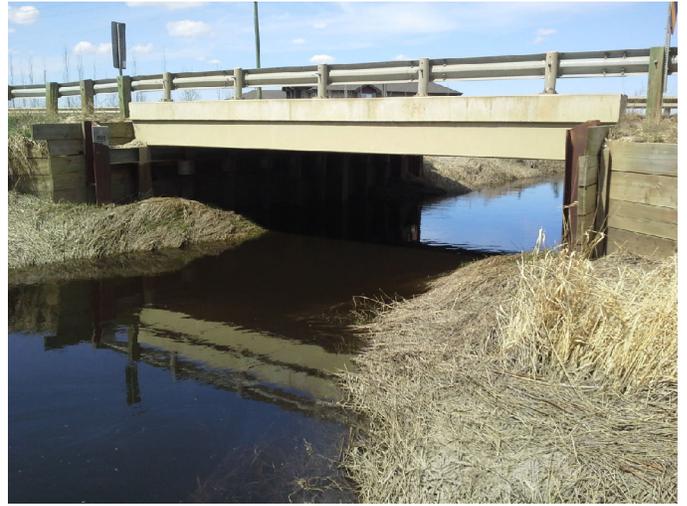
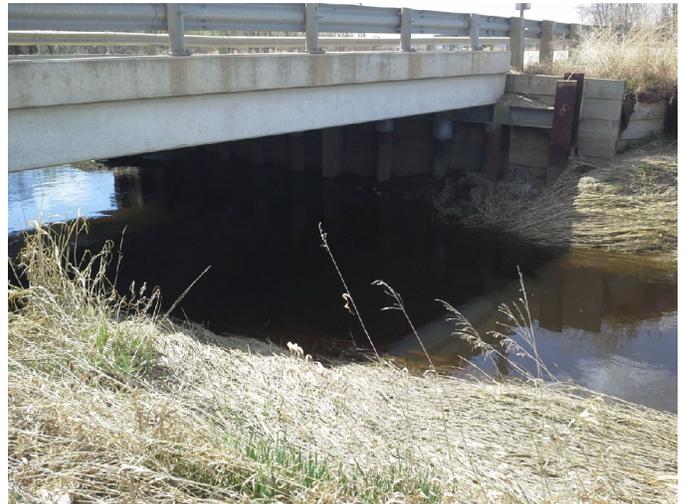
Crossing ID: WC_0176

Comments: No active erosion. Bank slumping coming around wingwalls noted. No armour present. Water is in contact with abutment walls. Structural integrity could not be determined.

Photo No.: Photos-20180507-202135.jpg
Description: Sediment Erosion

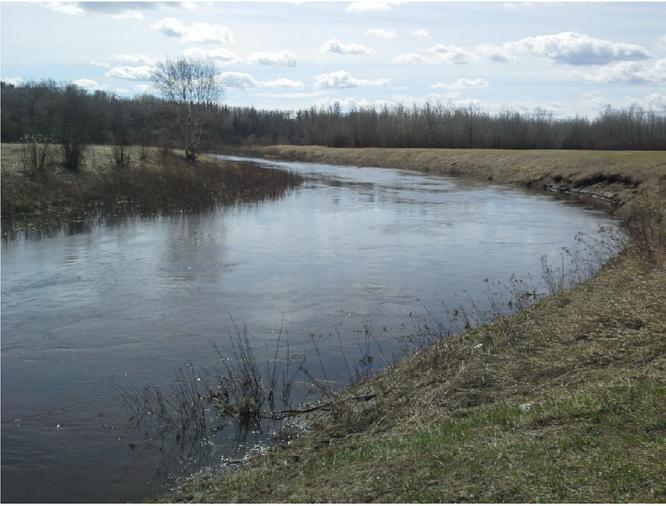
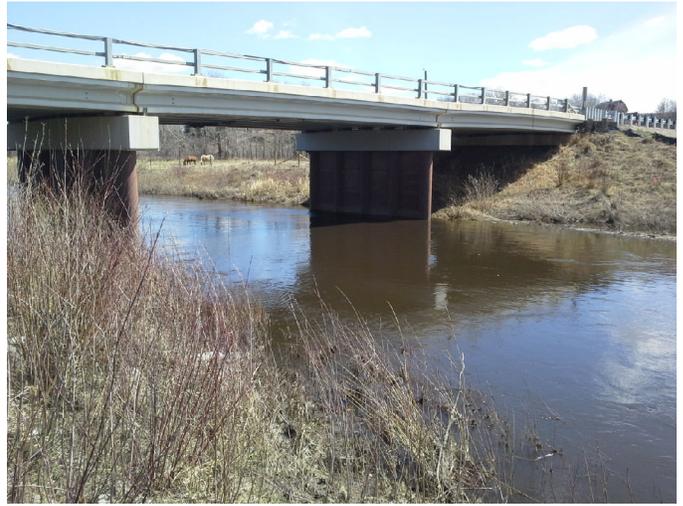
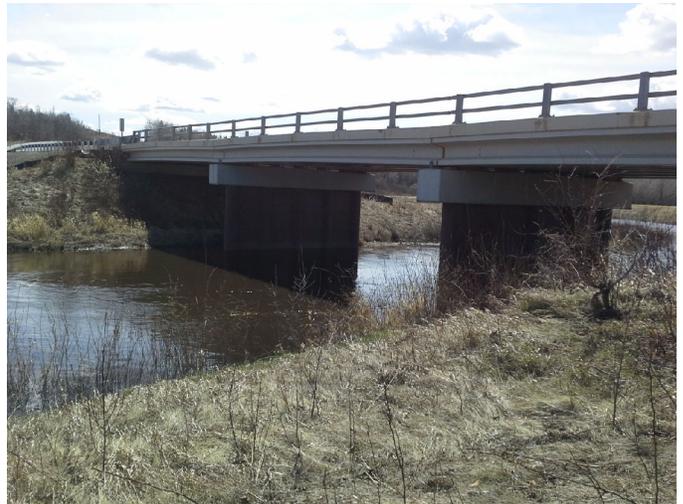
Crossing ID: WC_0195

Comments: Armour is only present on the west side. Vegetated fill slope is present however no other form of armour is present and could lead to erosion with higher water levels.

WC_0195	Sturgeon	UTM: 12 Easting: 338595 Northing: 5960027	Bridge - Permanent	Fish Passage: None Safety/Performance: None Erosion/Sedimentation: None	Armour present on west side only. Recommend armour on both sides.

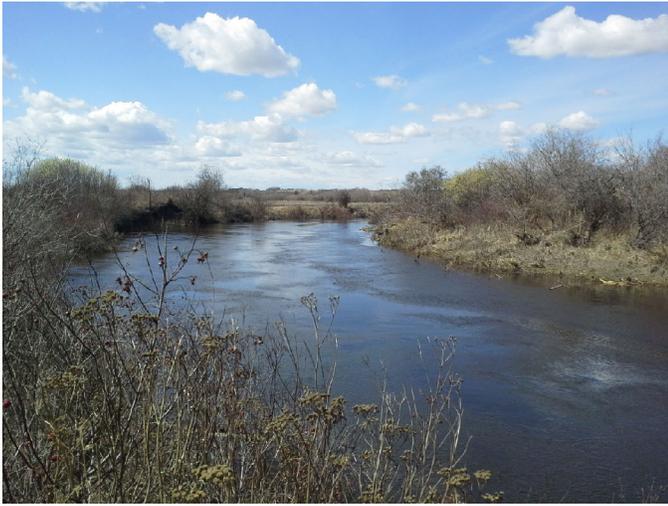
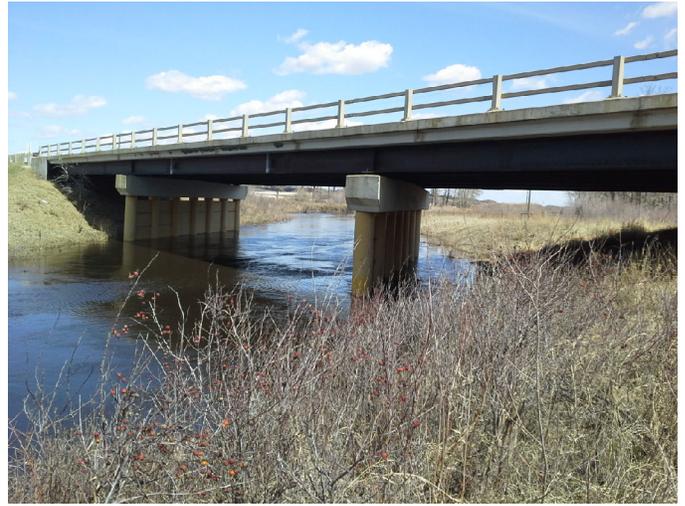
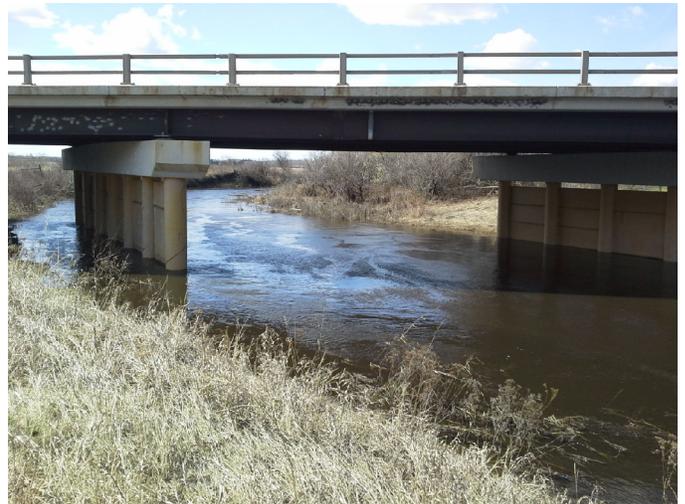
Crossing ID: WC_0262

Comments: Armour present in the form of vegetation. Potential erosion source during flooding.

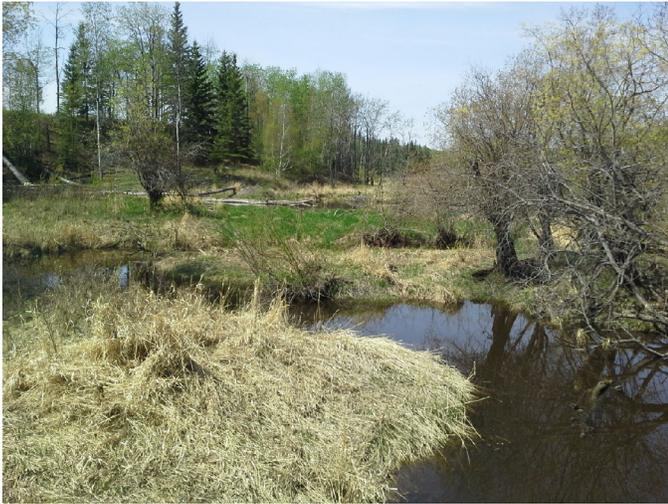
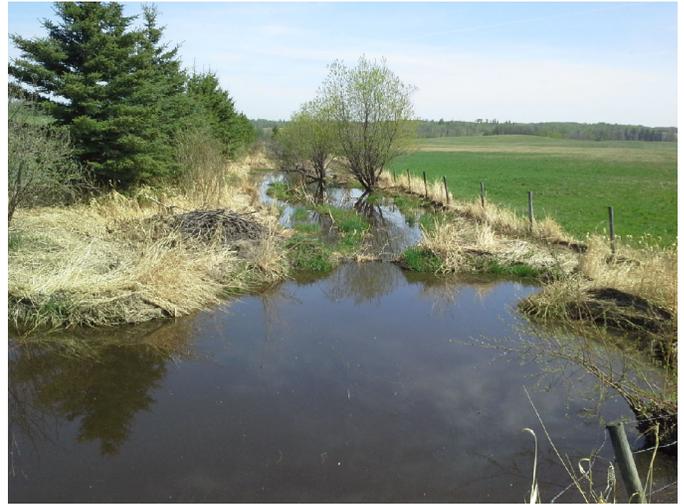
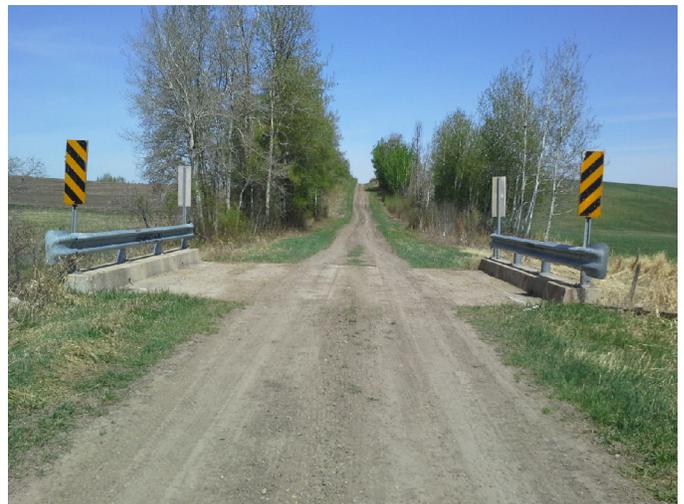
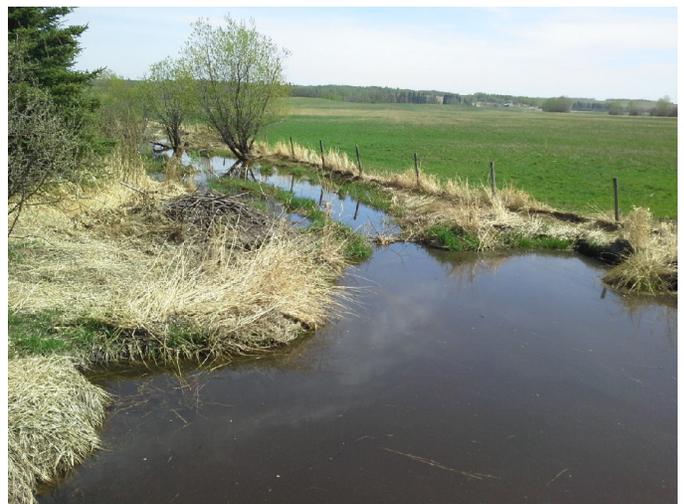
Crossing ID: WC_0266

Comments: Beaver dam noted 25m upstream. Beaver activity noted. Capacity of bridge has been reached and difficult to determine the integrity of structure. Stream is in contact with treated wood wingwalls and abutment walls.

Photo No.: Photos-20180514-190345.jpg
Description: Old beaver dam

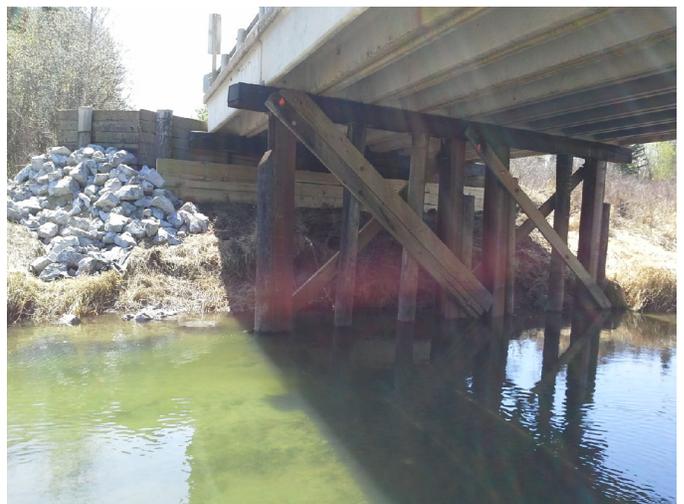
Photo No.: Photos-20180511-194307.jpg
Description: Rip rap

WC_0285	Sturgeon	UTM: 12 Easting: 679741 Northing: 5958455	Bridge - Permanent	Fish Passage: None Safety/Performance: None Erosion/Sedimentation: Potential due to partial armour	Recommended maintenance to complete placement of riprap on all fill slope areas.
WC_0326	Sturgeon	UTM: 12 Easting: 304240 Northing: 5957014	Bridge - Permanent	Fish Passage: None Safety/Performance: None Erosion/Sedimentation: Potential	Bridge curb has openings creating potential for sedimentation. Recommend closed bridge curbs to prevent sedimentation.
WC_0328	Sturgeon	UTM: 12 Easting:304240 Northing: 5957014	Bridge - Permanent	Fish Passage: None Safety/Performance: None Erosion Location: Both Erosion Source: Fill slope Erosion Extent: Low Total Erosion Area: 6 m ²	Sparsely vegetated fill slopes with rip-rap at the base of the slope and instream. Recommend seeding to strengthen armour on slopes.
