NSWA Sturgeon River Watercourse Assessment

## **Appendix 5: High Risk Watercourse Crossing Overview Map and Field Sheets**

**NWSA**  
**Sturgeon River Study**  
 Water Course Crossing

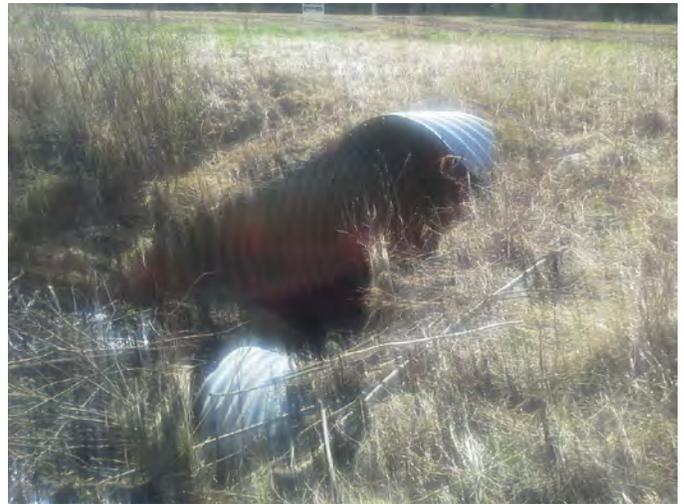
**Comments:** logs and sticks causing blockage are beaver removed and possibly flowed downstream collecting in culvert inlet . second culvert on north side of TS 572 fully exposed with outlet gap of 0.4m is aiding in collection of sticks. third culvert on south side of TS 572 is situation in the same fashion but not causing concerns. serious fish passage concerns due to pooling upstream from 90% blockage. blockage is at the tip of culvert. Possible breakage of blockage and flash flooding downstream

Photo No.: Photos-20180508-164626.jpg  
Description: Blockage

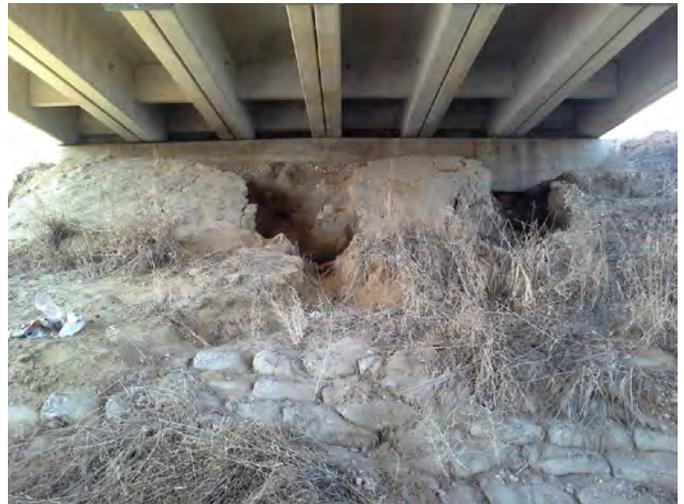
**Comments:** Active fill slope erosion due to water and animal destruction

Photo No.: Photos-20180504-160602.jpg  
Description: Erosion

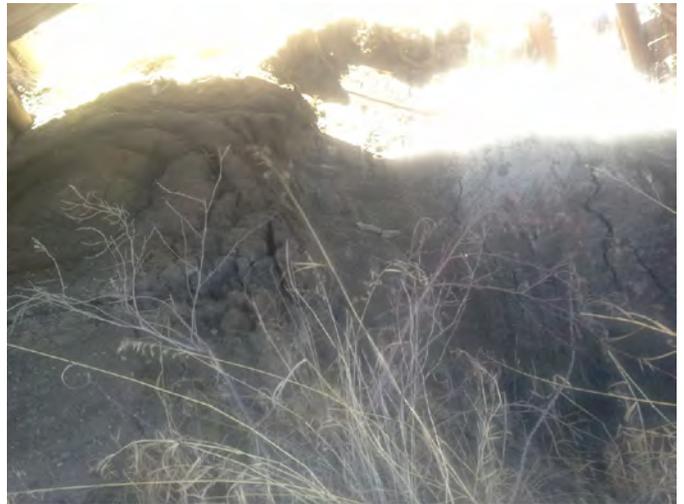
Photo No.: Photos-20180508-193835.jpg  
Description: Blockage Inlet

Photo No.: Photos-20180508-193856.jpg  
Description: Erosion

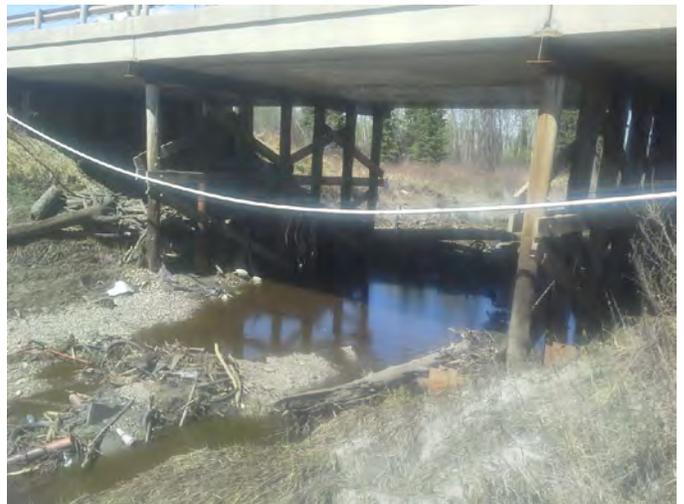
Photo No.: Photos-20180508-193923.jpg  
Description: Blockage

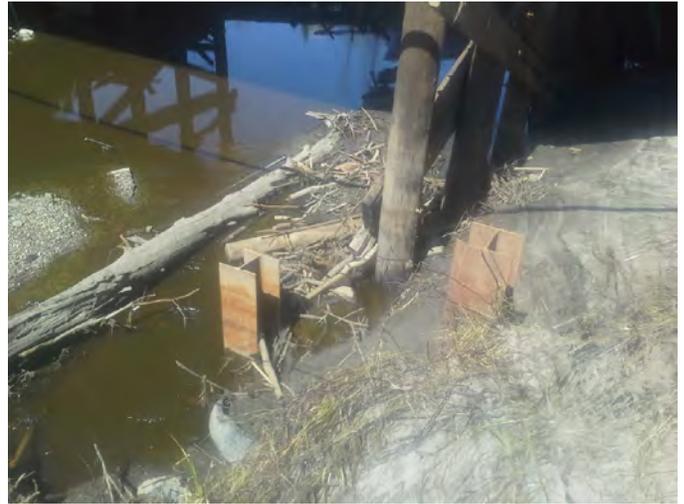
Photo No.: Photos-20180508-194319.jpg  
Description: Steel Beams in Water

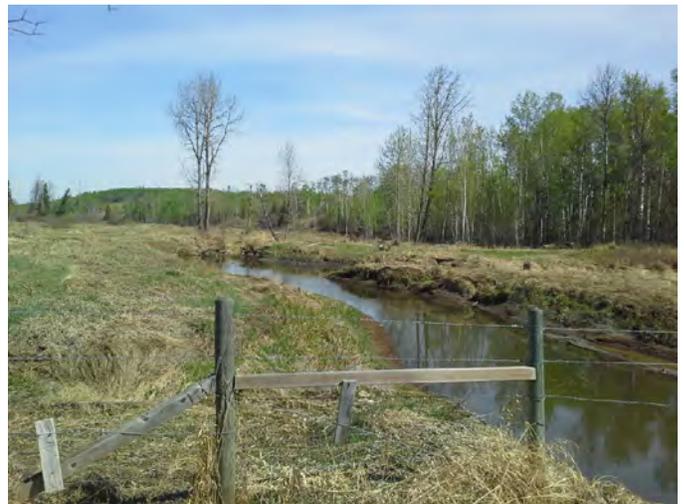
Photo No.: Photos-20180514-172915.jpg  
Description: Erosion

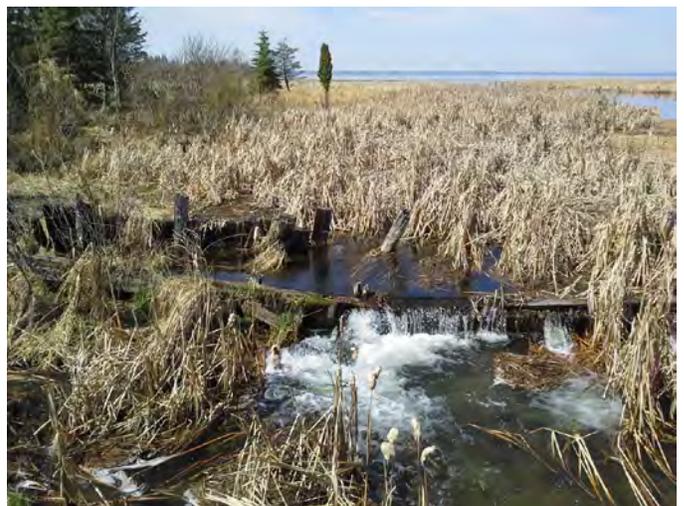
Photo No.: Photos-20180511-175107.jpg  
Description: Blockage

Photo No.: Photos-20180511-175125.jpg  
Description: Blockage

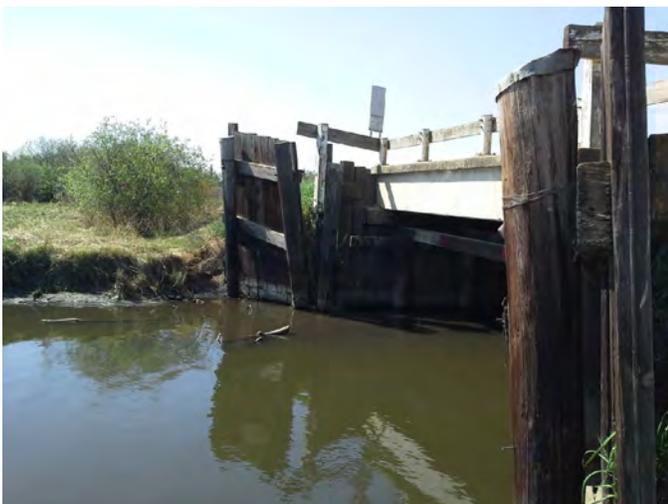
Photo No.: Photos-20180516-173632.jpg  
Description: Slumping

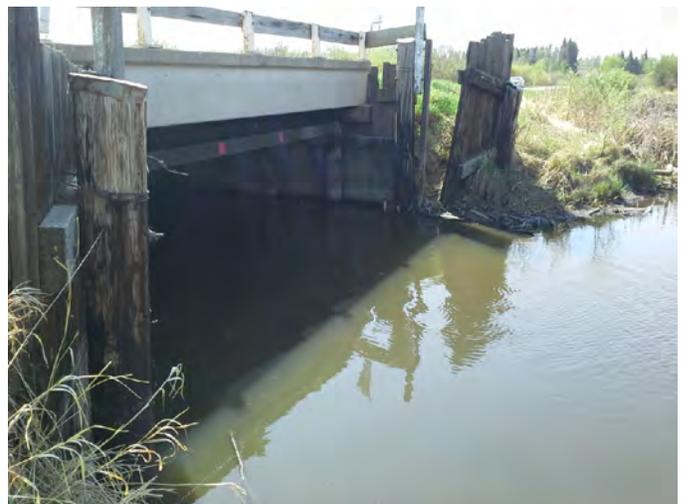
Photo No.: Photos-20180516-173650.jpg  
Description: Wing wall failing

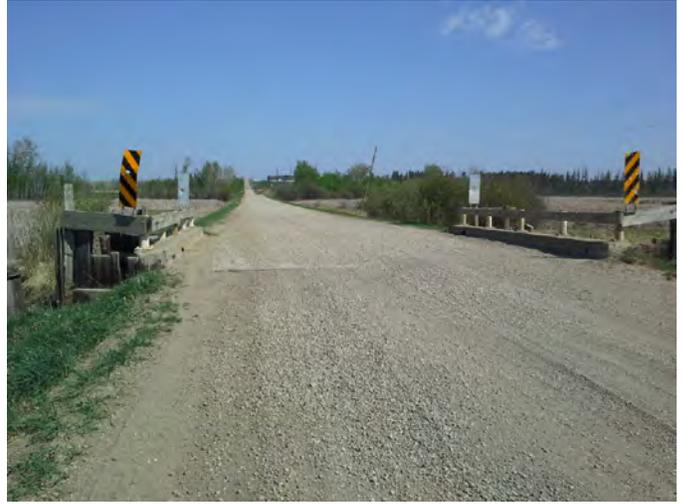
Photo No.: Photos-20180516-173759.jpg  
Description: Second wing wall failing

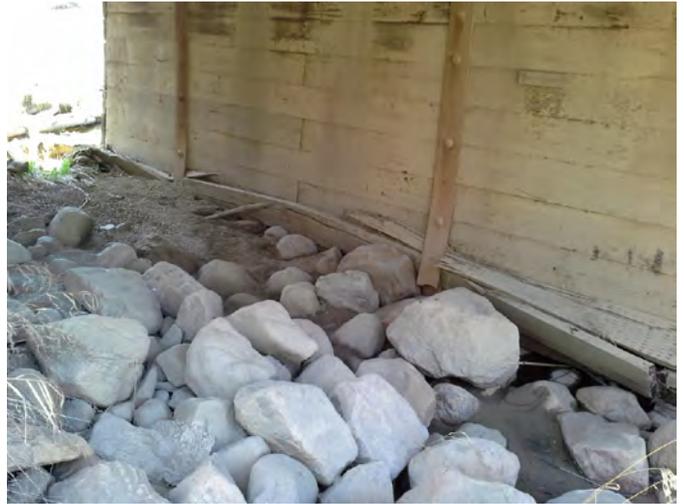
**Comments:** There is heavy debris build up of large logs at inlet. Damage to the south abutment lumber wall, possibly from large rip rap falling into wall.

Photo No.: Photos-20180514-204826.jpg  
Description: Damaged abutments

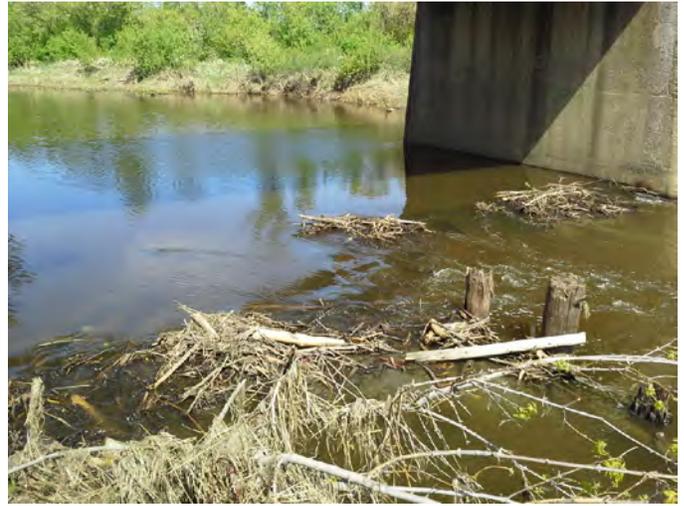
Photo No.: Photos-20180518-180915.jpg  
Description: Old Beaver Dam

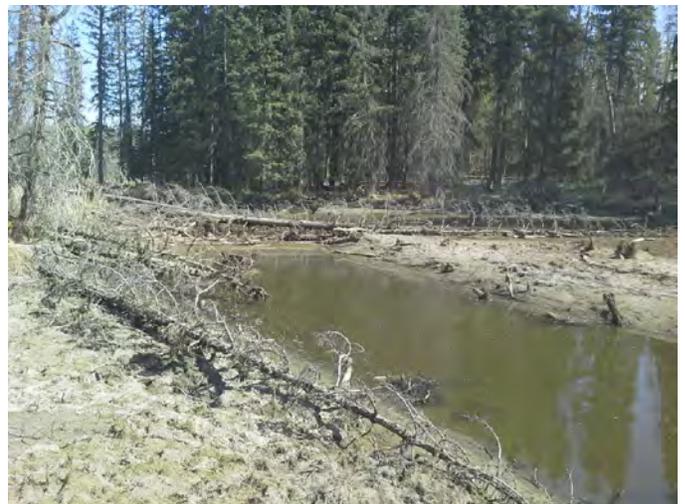
Photo No.: Photos-20180514-164405.jpg  
Description: Road material erosion
