**Management of Geohazards at Lihir Gold Mine
Papua New Guinea**

by
Mohan Singh

**Master of Science
in
Mining Engineering**

2 Investigation of Phase 12 Slope Failure

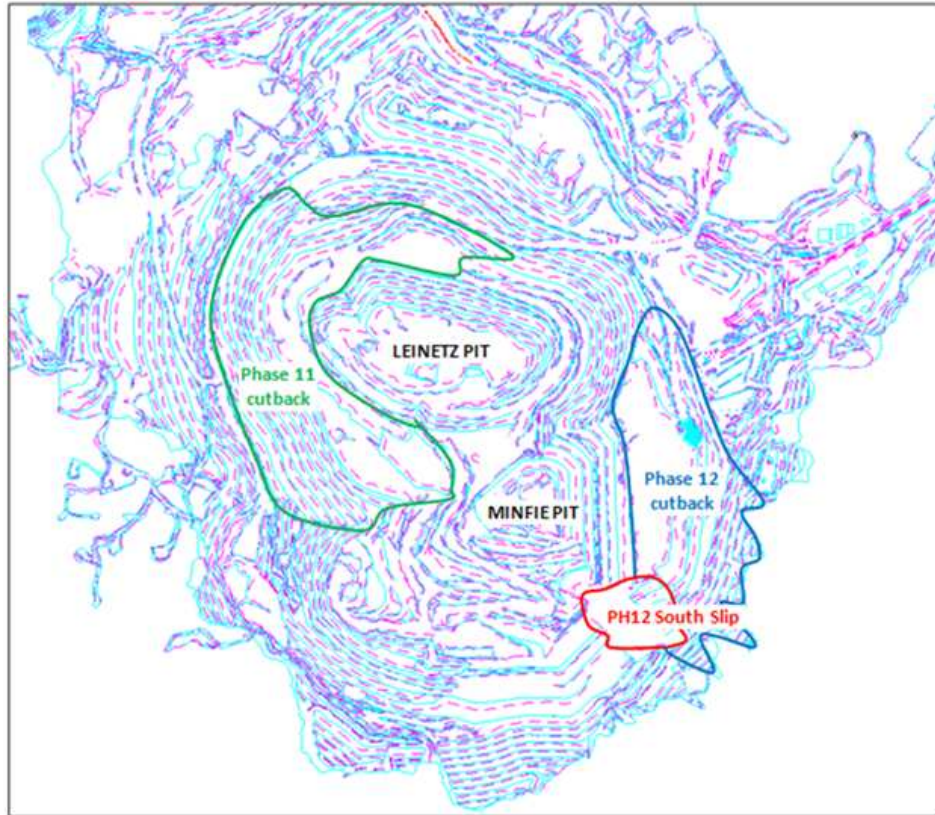
Figure 5: Location of Phase 12 South failure

At approximately 4:38 am on 01/10/09, a significant slope failure with a volume of between 246,000 bcm and 381,000 bcm occurred at the southern end of the Phase 12 mining area as illustrated in Figure 5. There was no injury to personnel but significant damage occurred to the plant, some of which was partially engulfed by the failure mass (light vehicle and shovel). Toe heave at the bottom of the failure resulted in a rollover of a parked haul truck. The failure incorporated part of the Phase 12 slope and a larger part of the adjacent older Minifie (Phase 4) slope. Initial observations indicate that the failure had a strong structural control which may have contributed to its rapidity of movement, which was in contrast to the slower moving failures experienced in recent years in the GW28, Phase 7 upper and Kapit 6 Slip areas.

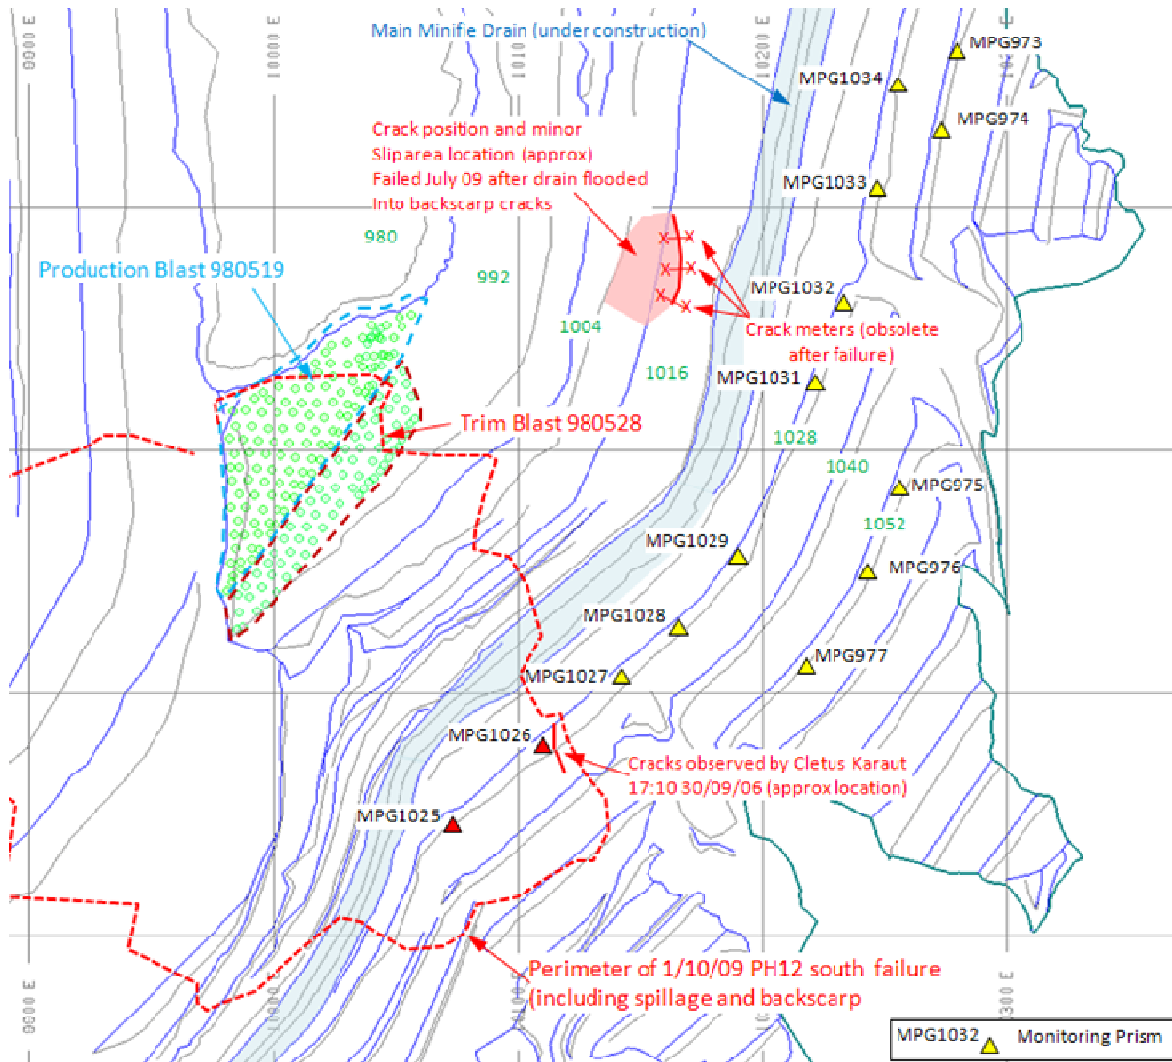
Figure 6: Southern end of PH12 prior to failure

Crack pins were installed across tension cracks associated with a minor structurally controlled batter scale failure located about 100 m north of the main failure (Figure 6). This area failed in July 09 when heavy rainfall overran the banks of the partially completed diversion drain and washed out the failed material. The crack pins were made obsolete after the area was washed out.

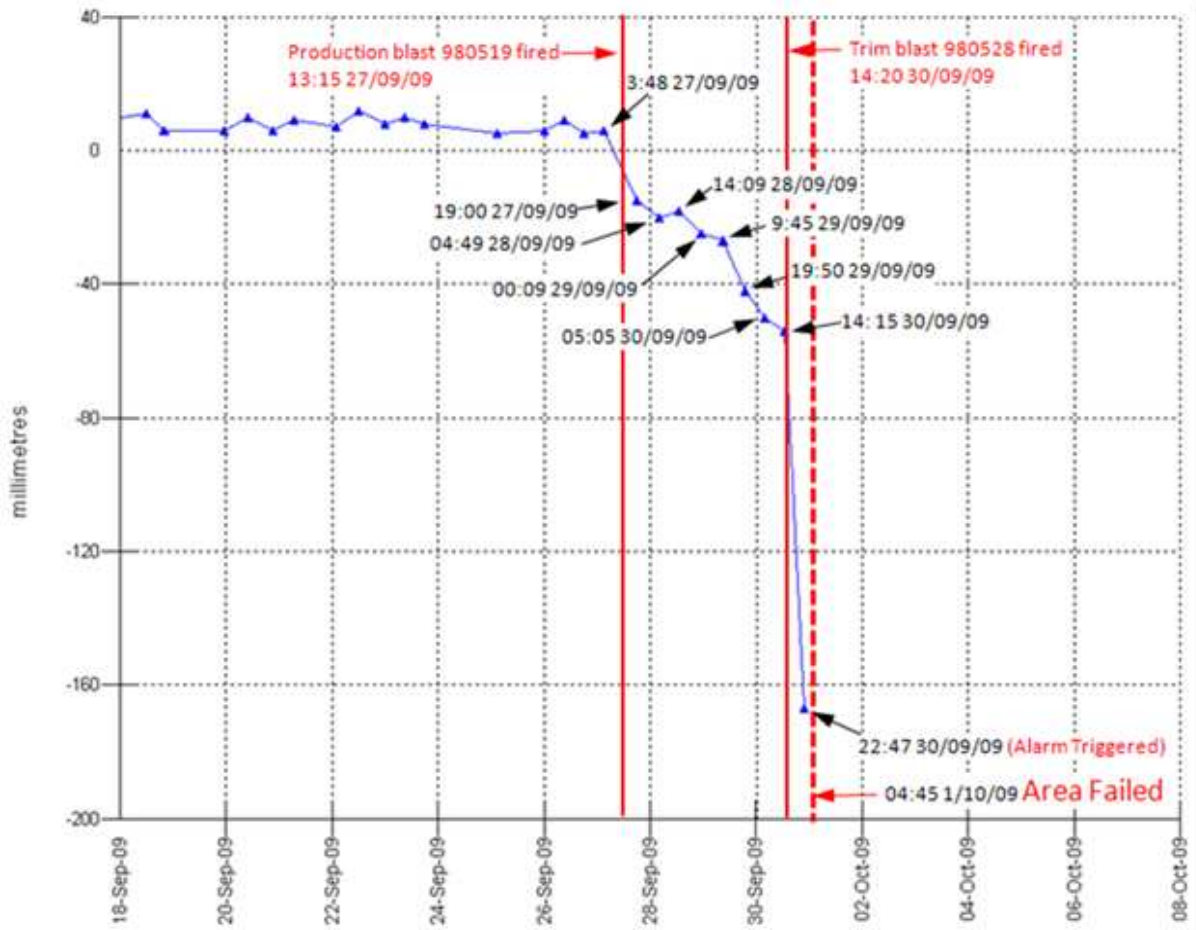
Figure 7: Prism monitoring results from MPG1025

Prism monitoring results indicated that displacement of two prisms (1025 & 1026) at the southern end of Phase 12 started to report significant displacement from the pickup at 19:20 on 27/09/09. No displacement was recorded by the preceding pickup at 03:48 on 27/09/09. Displacement started after production blast 980519 located at the toe of the slope was fired at 13:15 on 27/09/09. Displacement continued at a rate of approximately 14 mm/day while 9805 19 was excavated until the 14:15 pickup on the 30/09/09. At 14:20 on 30/09/09 trim blast 9805 28 was fired. The next prism pick up at 22:47 on 30/09/09 recorded a substantial increase in displacement sufficient to trigger the ATS alarm the threshold for which was set at 90 mm/day. The displacement history as recorded by prism 1025 is illustrated in Figure 7.

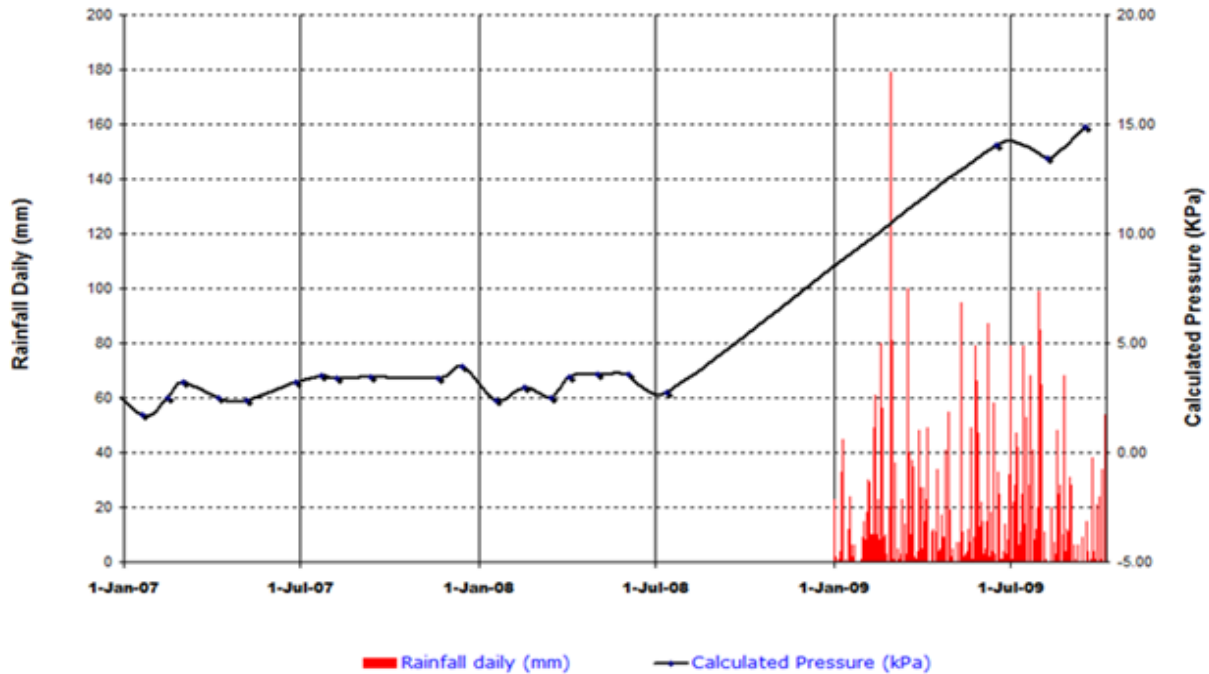
Figure 10: Ground water levels at VWP DDHL 885 (1078 mRL)

Groundwater levels at VWP DDHL 885 indicated an increase of 1.52 m in the months leading up to the PH12 failure as shown in Figure 10. This equated to a very small increase in pressure, some 14 kPa and was the only VWP adjacent to the PH12 failure to indicate increase in groundwater levels. The other VWPs DDHL 878 and 877 either showed no change or a decreasing trend.

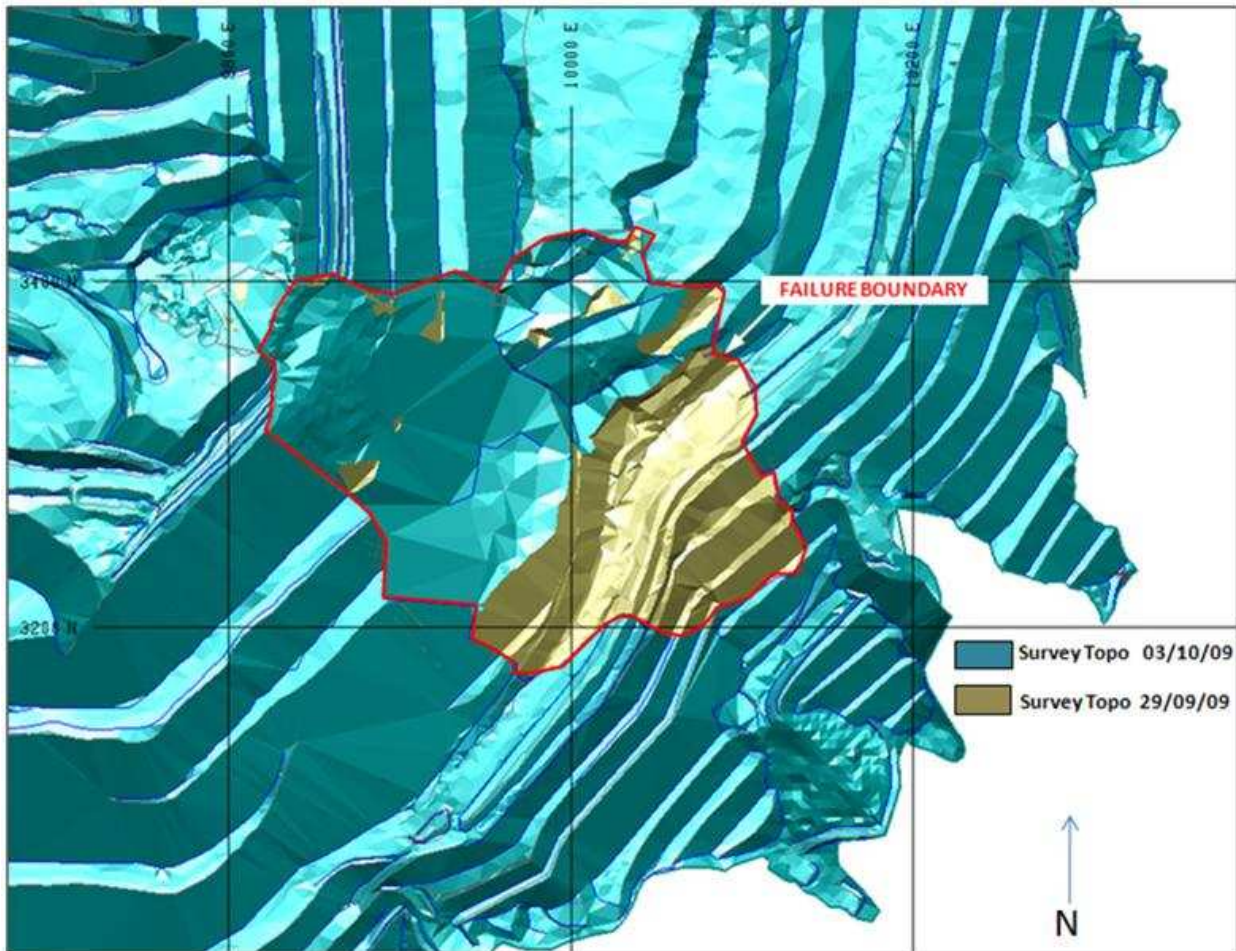
Figure 11: Plan of failure area

Approximately 5 berms were involved in the failure (1072RL~1000RL), a height of approximately 72 m from the 1052 berm down to the 980 bench. This included the major Phase 12 diversion drain (~5.0 m wide 1016 drainage berm). Post-failure the estimated failed length along the drainage berm was approximately 150 m, Figure 11.

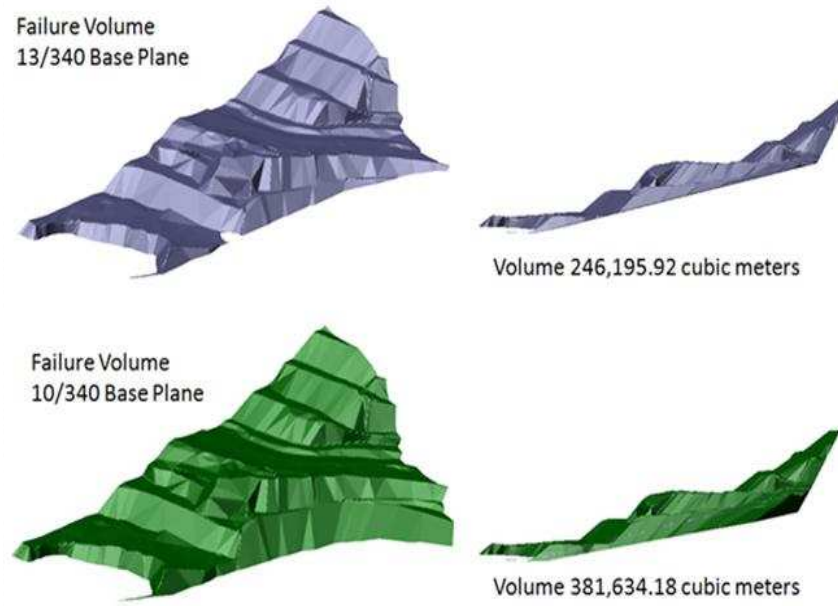
Figure 12: Failure volume

Volume of failure was estimated at between 246 Kbcm and 381 Kbcm, Figure 12. This range was based on failure models with postulated basal planes at 13° and 10° dip towards azimuth 340°.

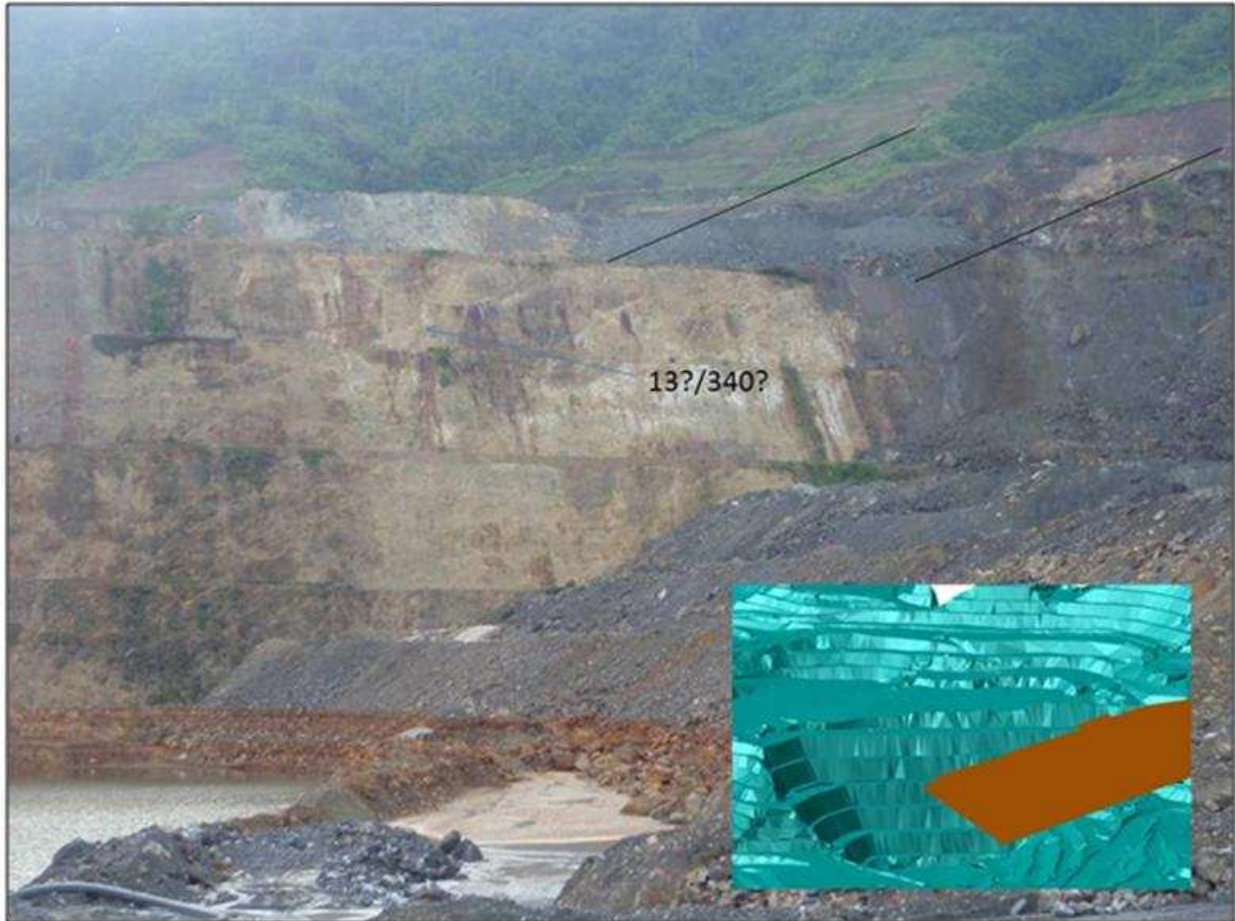
Figure 14: Minifie East wall - low angle structures below failure

low angle structures can be seen in Figure 15 although they have not been directly observed within the failure area itself. Figure 14 is a photograph looking East at the Minifie East wall immediately below the 980 bench (failure toe). As may be noted, the structures evidently tend to roll steeper to the North.

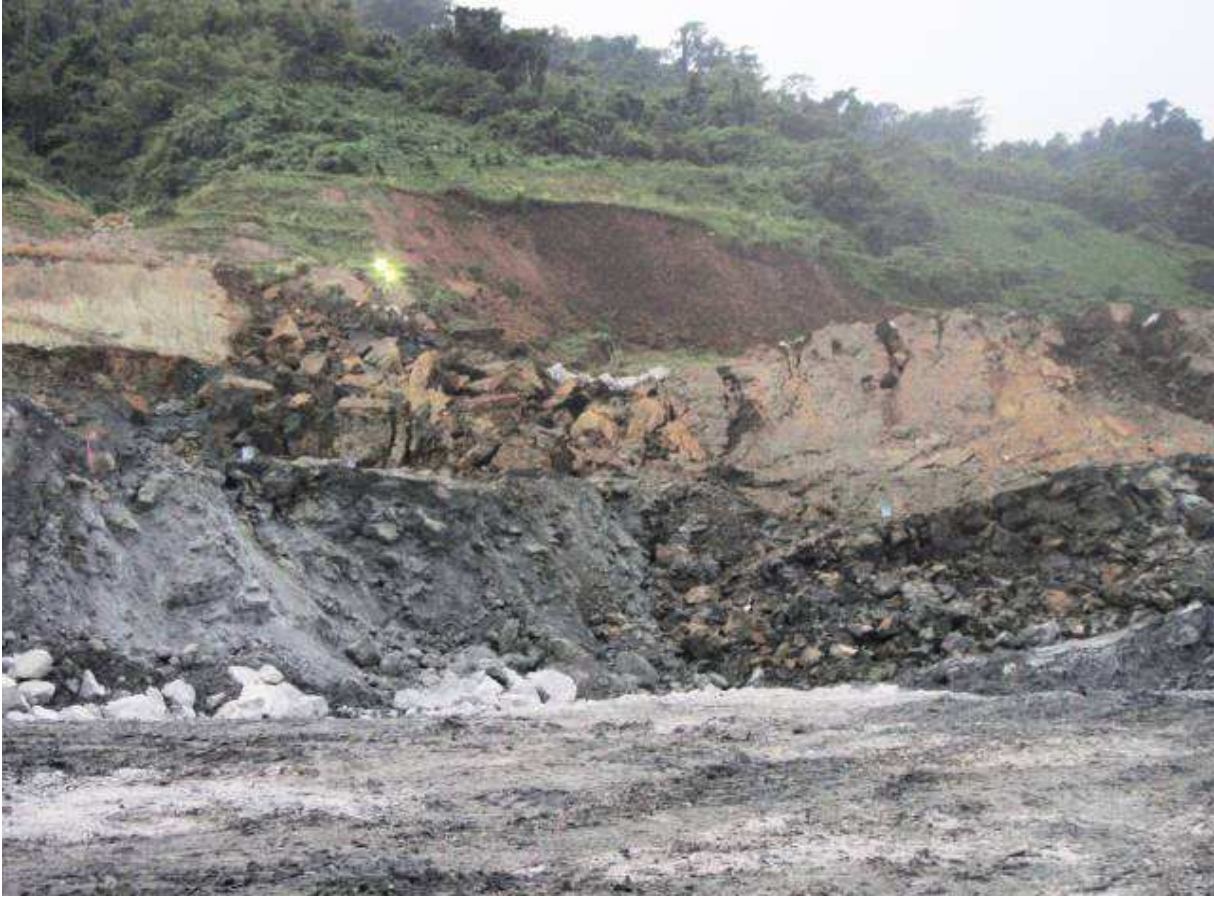
Figure 16: Northern failure margin

A northern bounding structure ($90^{\circ}/245^{\circ}$) was used to constrain the failure model. Observations in this area did not come up with a definitive structural control along this side and due to the blocky nature of the failure mass and the variable dip and strike of observed joint planes along this area, a component of shearing through rock mass was likely to have occurred, Figure 16.

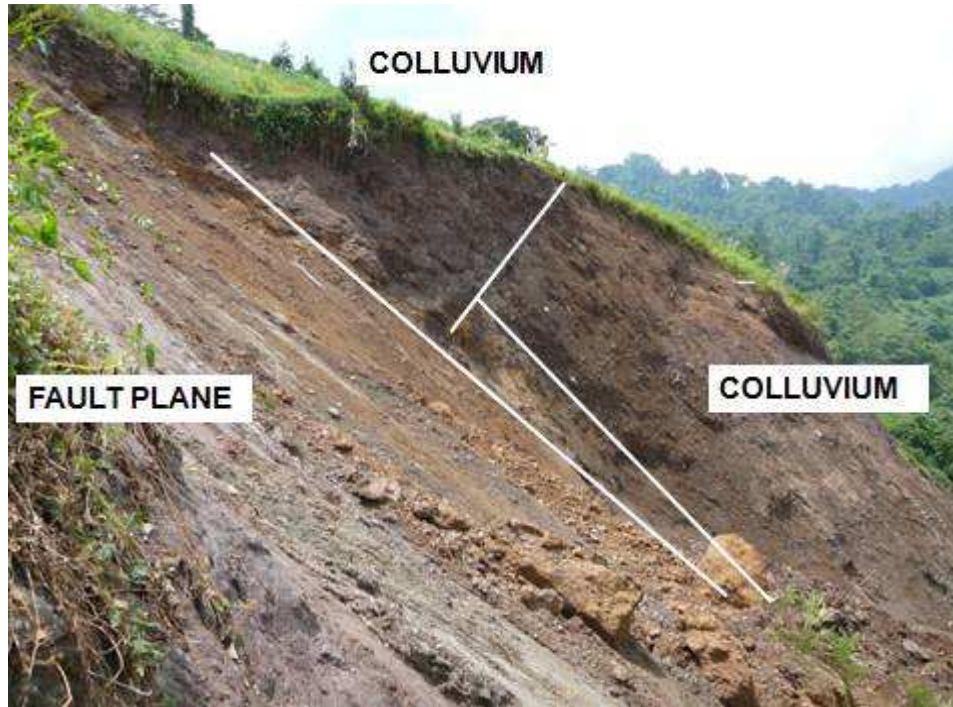
Figure 17: Failure back scarp

A steeply dipping back scarp structure was modelled. Portions of this surface developed along fault planes although some circular failure components through colluvium were also possible. An average orientation was used ($60^{\circ}/330^{\circ}$), Figure 17.

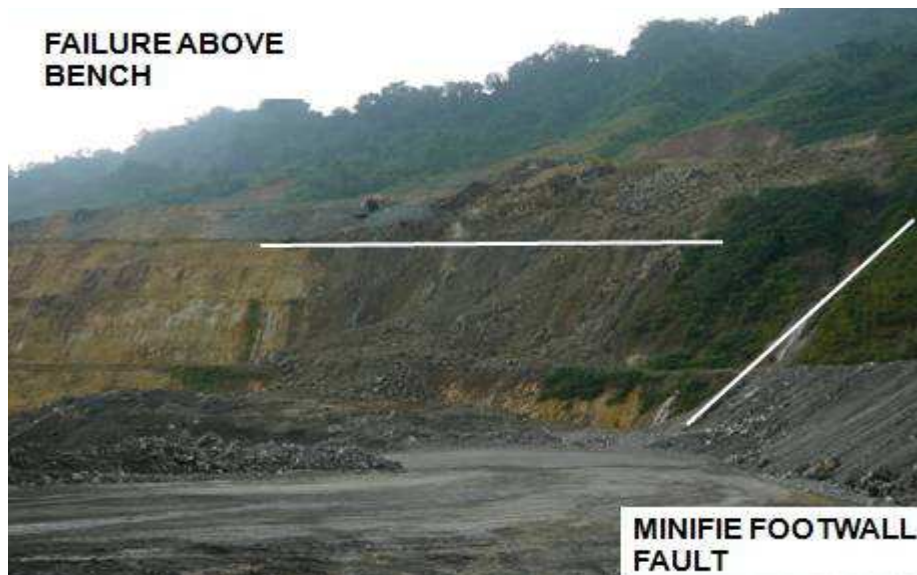
Figure 18: Southern failure bounding structure

The southern bounding structure ($40^{\circ}/340^{\circ}$) was based on mapped orientations of a joint plane below the end of the failed drain. This structure was interpreted to extend into Minifie where a similar structure existed known as the Minifie footwall fault, Figure 18. This structure was observed to be planar in nature and coated in clay.

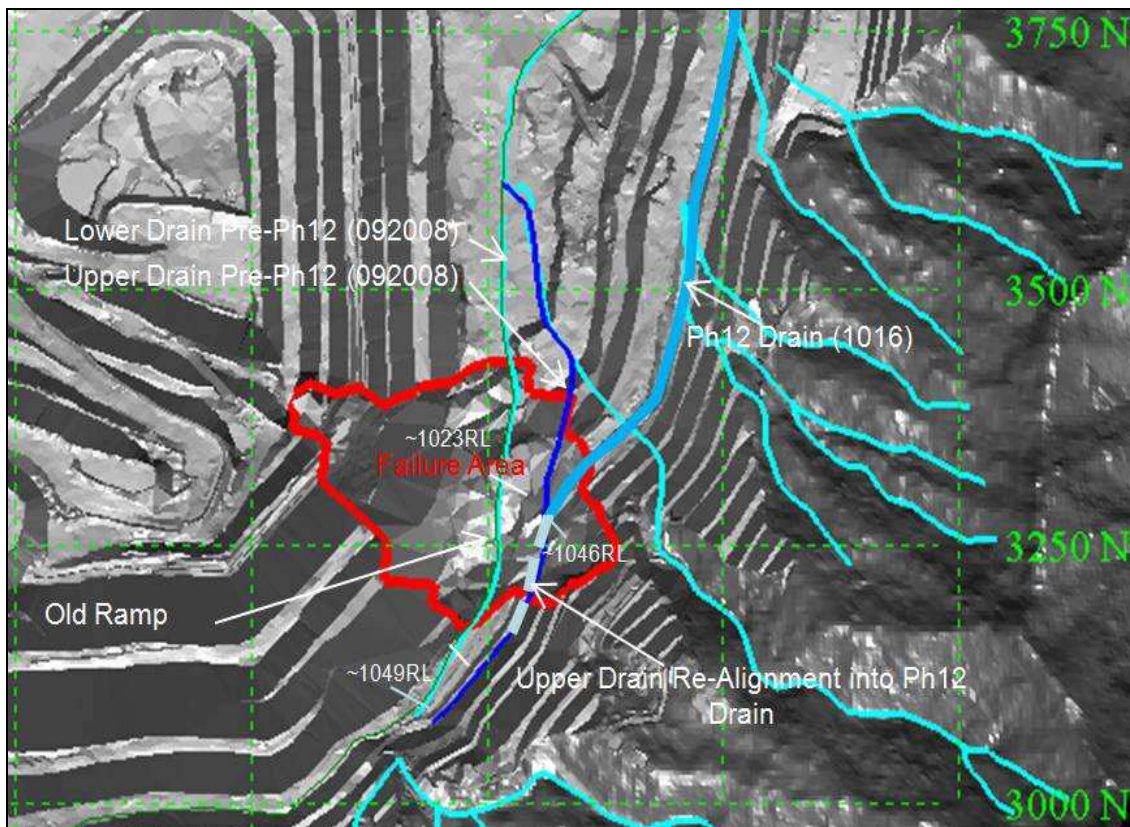
Figure 22: Old and new drain positions relative to the failure area

During early excavation (late 2008) of the upper benches in Phase 12, the existing upper drain was cut out and the lower drain was again used to divert all water back down onto the 980 bench, Figure 22.

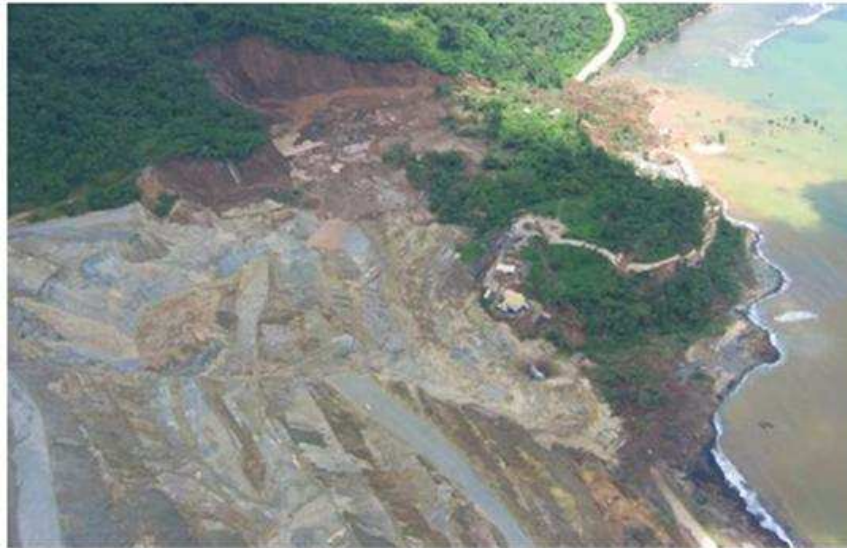
Figure 29: Kapit landslide, aerial view (Lihir Gold Ltd)

There was a geothermal outburst at the time of the rapid failure with groundwater springs gushed from the back scarp following failure. The landslide resulted in two fatalities, one from the capsizing of a boat in the surge wave.

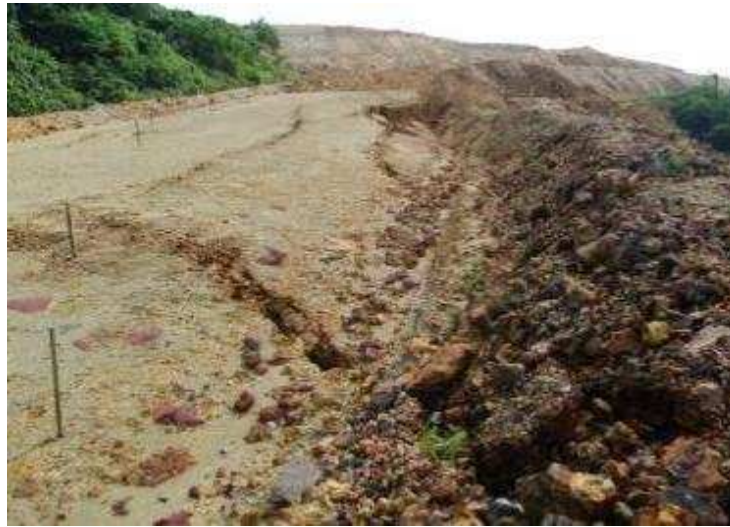
Figure 30: Cracking of Kapit 6 ramp haul road (Lihir Gold Ltd)

circular rock mass failure, it had been suggested that the geothermal regime was also an influence. Back-analysed material strengths, even for a fully saturated slope, appeared to be unusually low considering the material type.

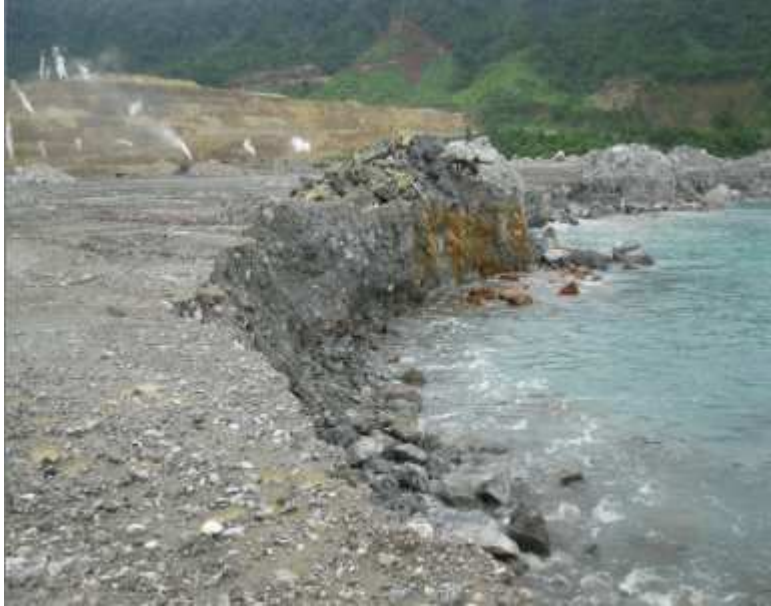
Figure 31: Harbour Base 501 waste dump failure (Lihir Gold Ltd)

On Thursday, the 8th October 2008, part of the Harbour Base 501 waste dump area failed into the sea. No one was injured and no equipment was damaged, Figure 31. Tension cracks had been observed approximately 20-30 m from the dump crest. When these cracks started dilating, the dump was closed prior to the subsequent failure 3 to 4 hours later.

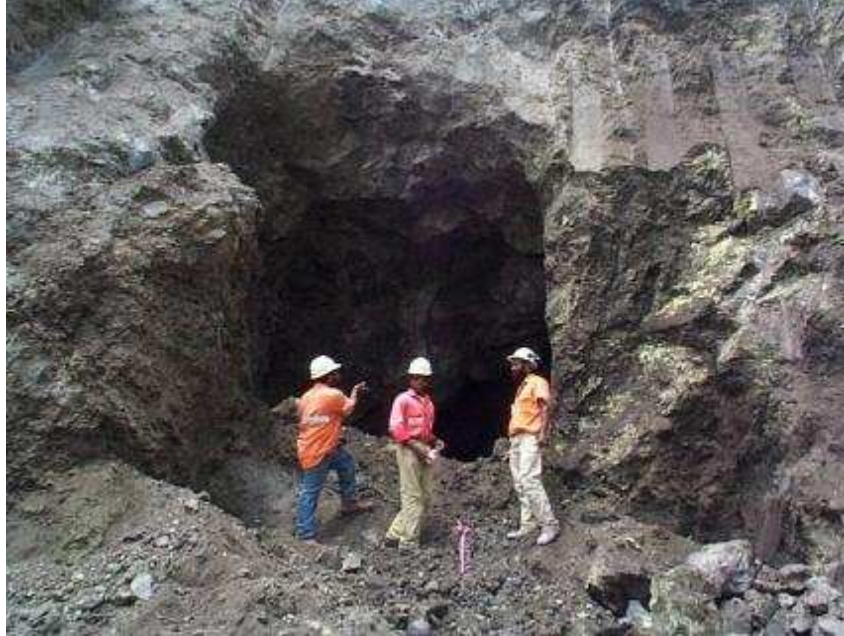
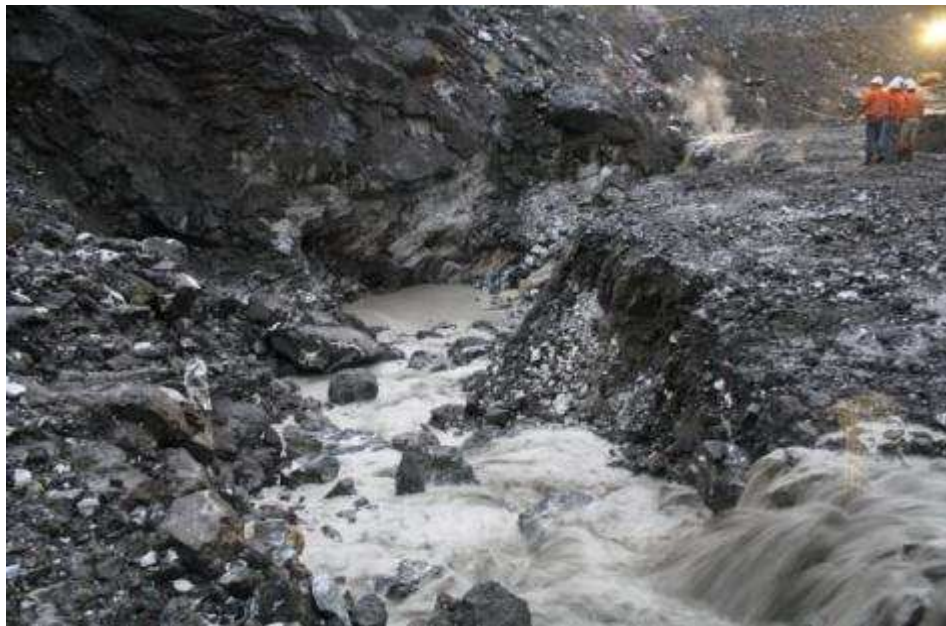
Cavities have been recorded throughout the development of the mine, with the majority occurring in the Lienitz pit, Figure 34 & Figure 35. Cavities range in size from 2-10 cm to 3-5 m.

Figure 34: Cavities observed in the Lienetz Pit (Lihir Gold Ltd)

Figure 35: Cavities observed in the Lienetz Pit (Lihir Gold Ltd)

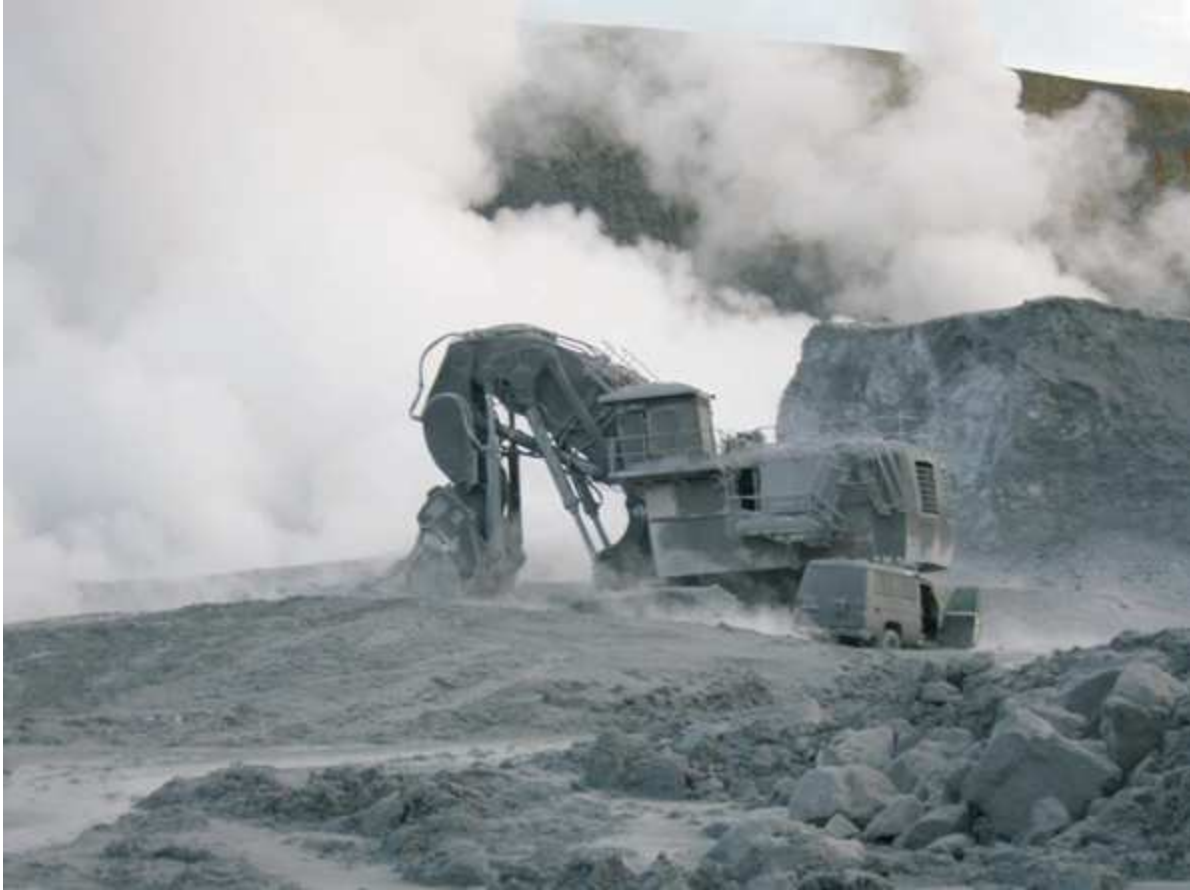
Figure 39: 2006 Phase 7 geothermal outburst (Lihir Gold Ltd)

The outburst occurred by partial removal of a low permeability Argillite cap overlying a dome of higher permeability rock (leached-soaked domain (LSD) and/or boiling zone (BZ) ore type rocks). This dome formed a trap for higher pressure gas and steam. Once the self weight of low permeability overburden rock was less than gas/steam pressure in the underlying boiling zone, the outburst occurred, Figure 39.
