THE UNIVERSITY OF ALBERTA

A REPORT ON SLOPE INSTABILITY ALONG THE OLDMAN RIVER AND TRIBUTARIES IN THE VICINITY OF LETHBRIDGE, ALBERTA

> Ъу A.F. RUBAN

SUBMITTED TO THE FACULTY OF GRADUATE STUDIES AND RESEARCH IN PARTIAL FULFILLMENT OF THE REQUIREMENTS FOR THE DEGREE OF MASTER OF ENGINEERING IN

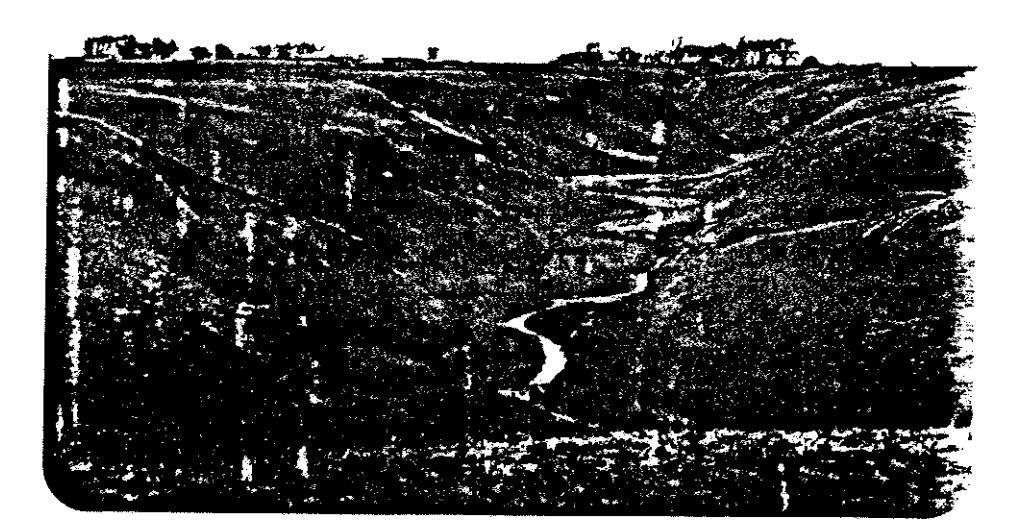
Photo 3:

Aerial and ground level views of typical sections along Six Mile Coulee. Note failures at almost every meander bend of the stream.

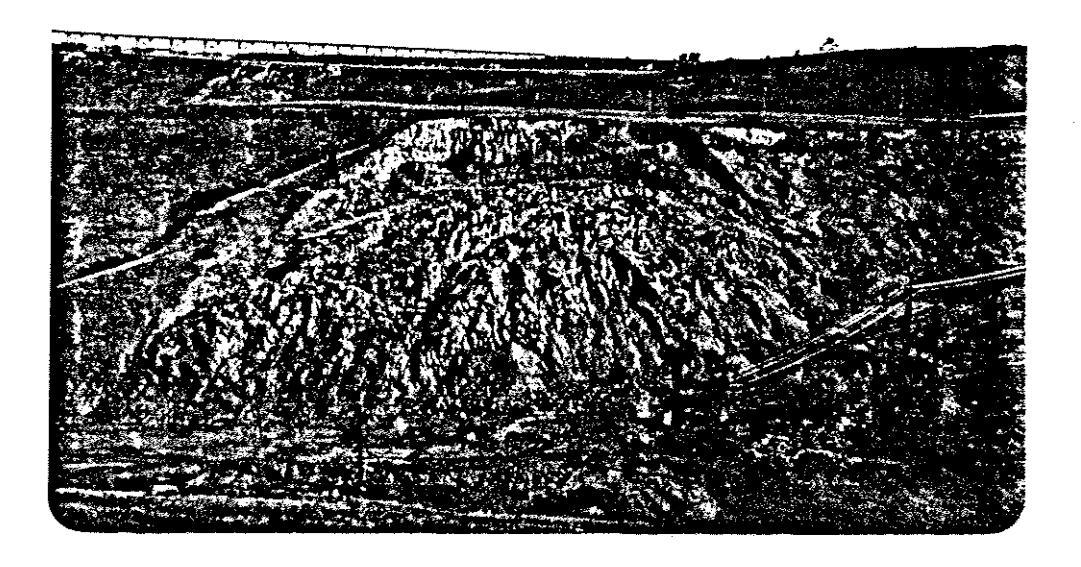
Photo 6: Ground level view of Slide No. 7. Note the flattened top of the coulee.

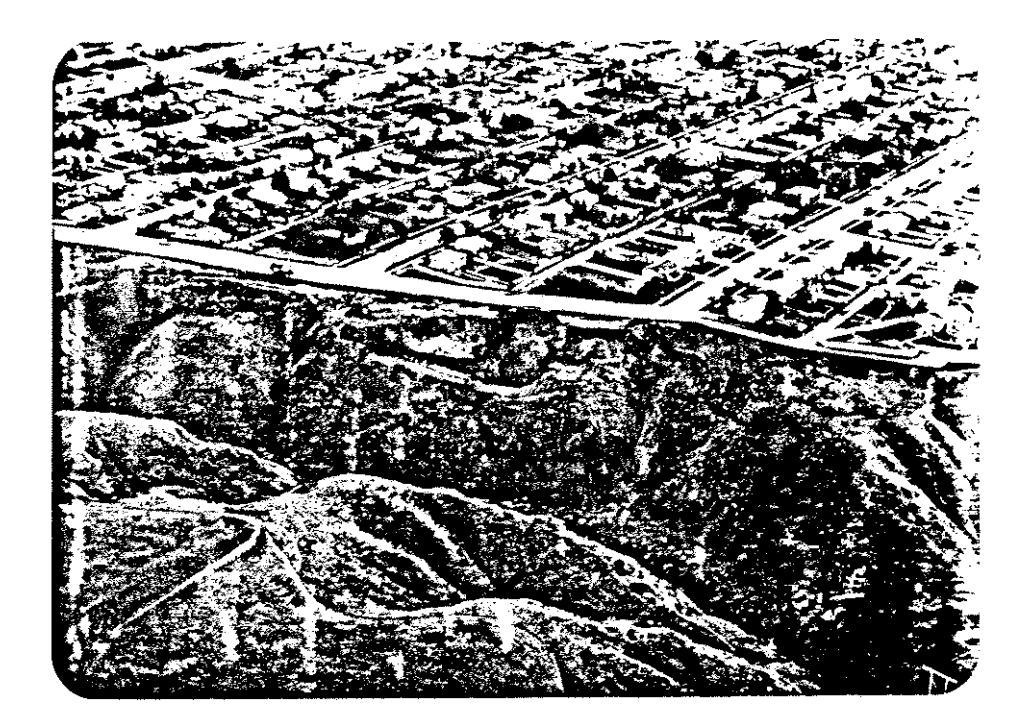
Photo 8: Aerial view (above) looking southeast, and ground level view (below) looking east at Slide Area No. 10. Note old inactive slide on left side of top photo and proximity of crest to Stafford Avenue. Lower photo shows recently placed fill at top of slope.

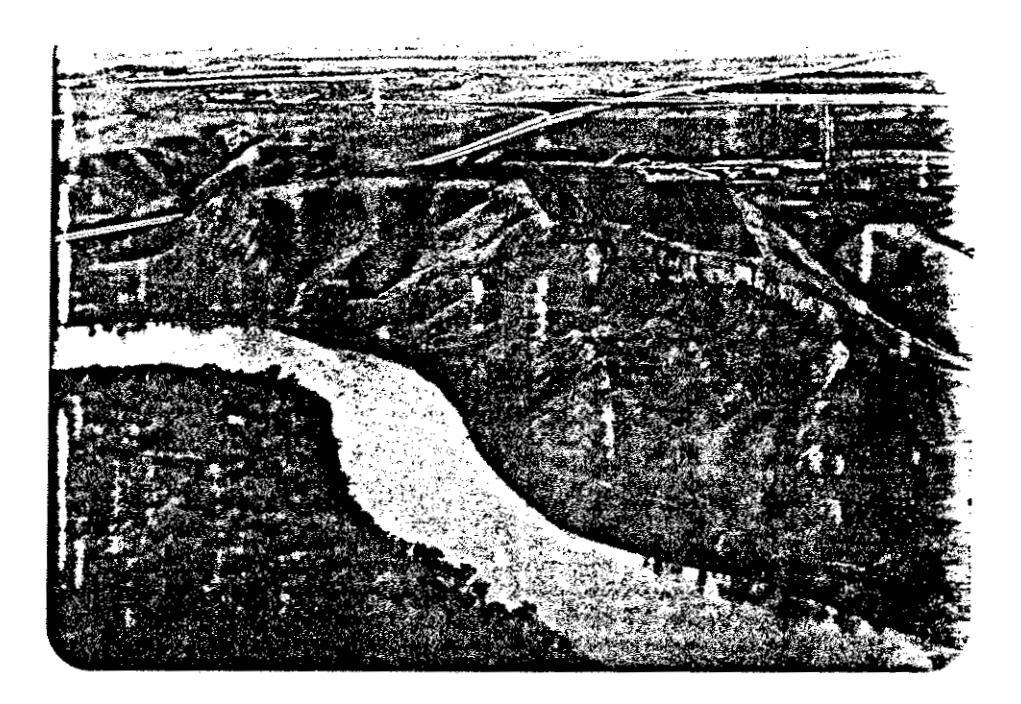
Photo 10: Aerial view of Slide No. 12 looking west.

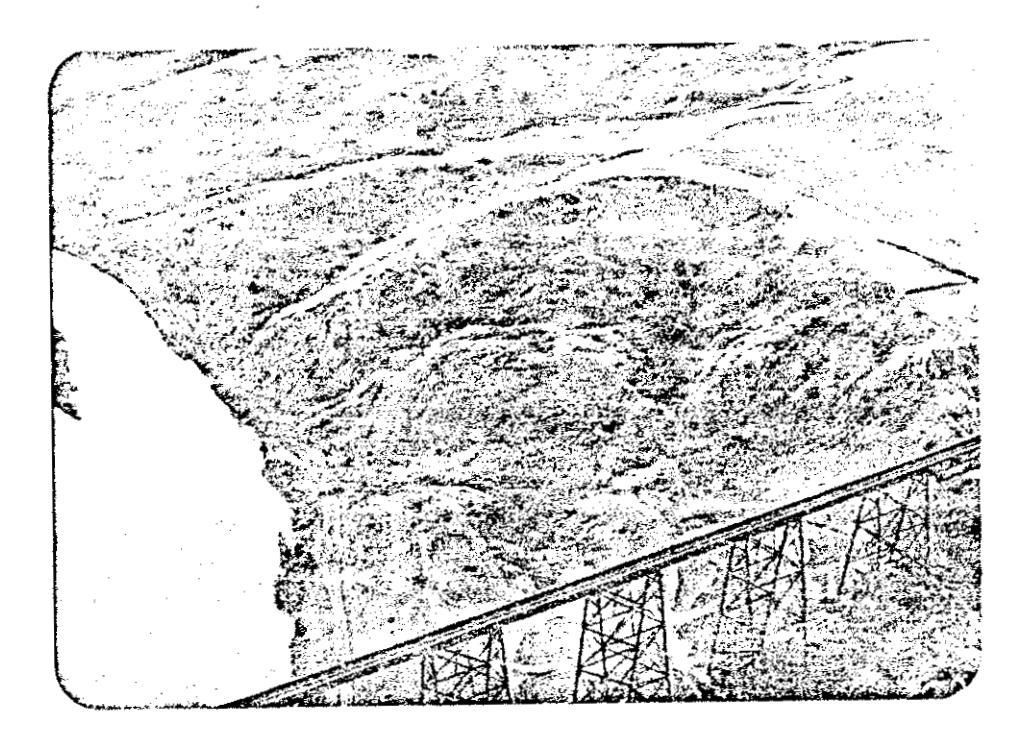
Photo 13: Aerial view of Slide No. 15, looking south. Slide is old and presently inactive. Note railway trestle crossing north end of slide.
