Experimental and Numerical Investigation of Fatigue Behavior of Pearlitic Rail Steels

A thesis submitted in partial fulfillment of the requirements for the degree of

Department of Mechanical Engineering University of Alberta

2. Experimental Failure Analysis of Pearlitic Rail Steels in Service

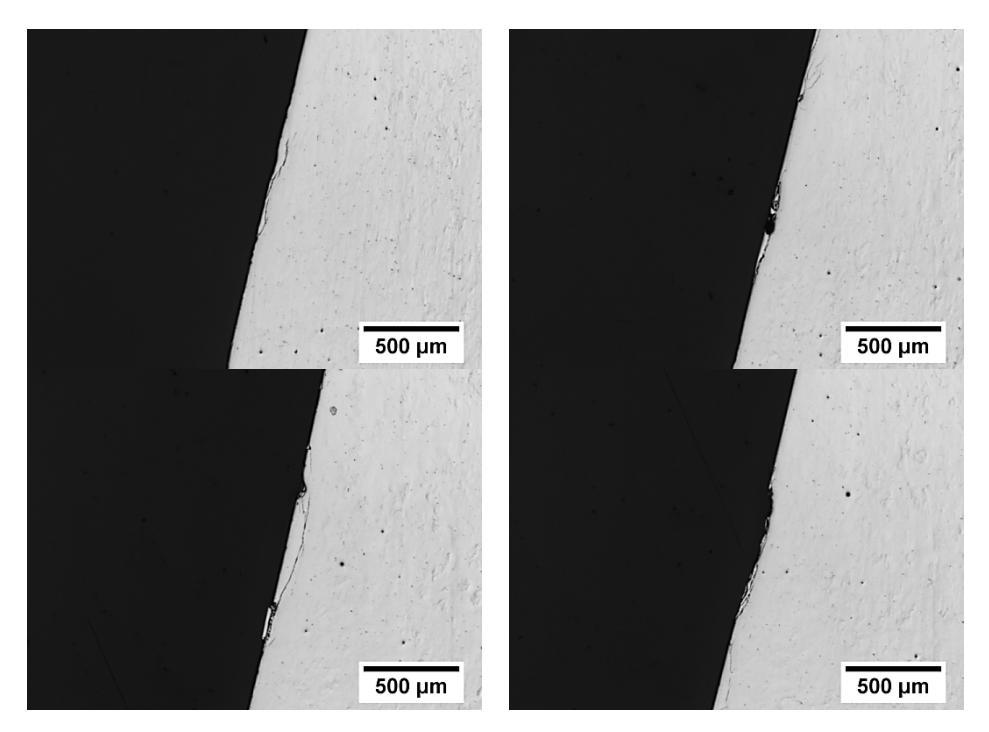
Rail 1: As shown in Figure 2.8, Examination of **Rail 1-TG** specimen revealed that *delamination* was the main damage process at the gauge. The damage mechanism can be divided into three (3) stages: First, the crack initiates at a very small angle relative to the gauge surface. Then, the crack propagates downward to its maximum depth (relative to the gauge surface). In the 3^{rd} stage, the crack changes its direction and propagates back toward the gauge surface. In some cases, the crack path reaches the gauge surface, so the material above the crack is no longer attached to the rail and it spalls from the surface. For Rail 1-TG specimen, the initiation angles were under 8° , the maximum depths were approximately between 50 and 80 µm and crack path length were mostly between 600 and 700 µm.

Figure 2.8 Delaminations at the gauge region of Rail 1 (Rail 1-TG).

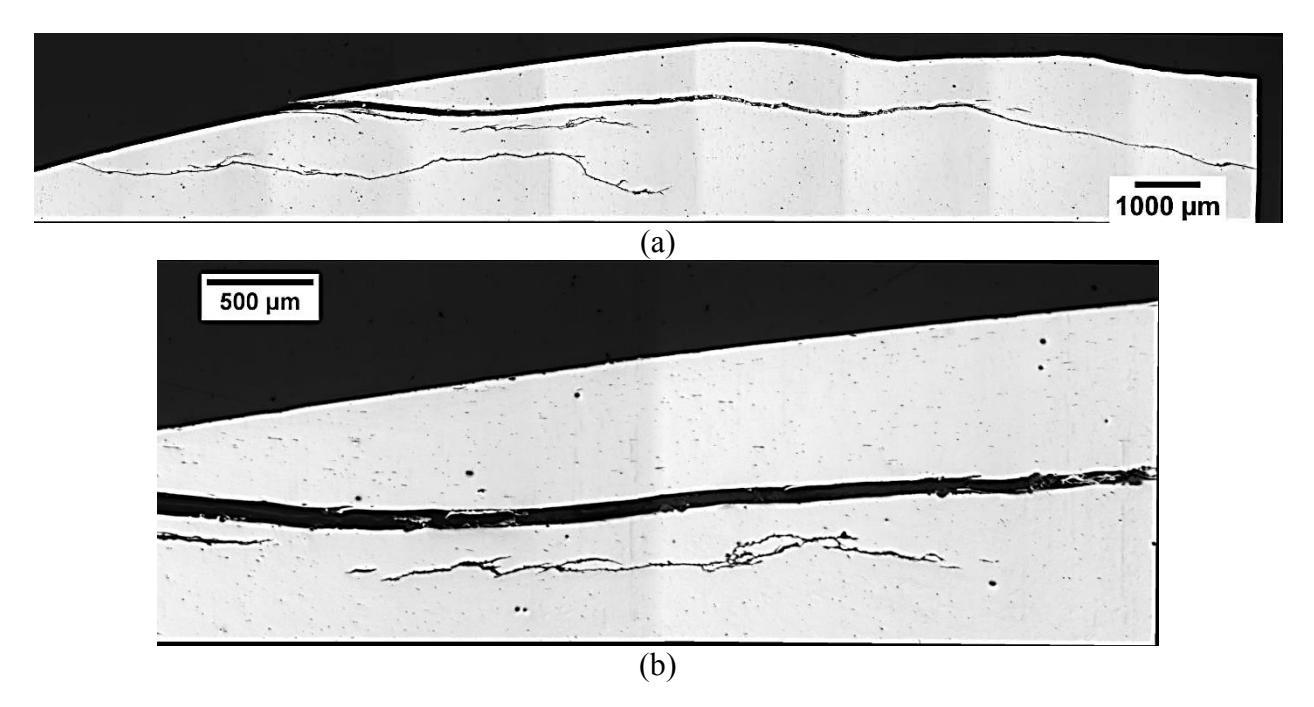
As demonstrated in Figure 2.9a, The **Rail 1-TG** specimen showed cracks that had initiated in the mid-gauge region and propagated horizontally toward the top of rail region. These cracks had angles between 14° and 17° relative to the rail running surface. The two (2) major cracks had (partial and total) lengths of 14846 and 9206 µm and their depths were 1377 and 2222 µm, respectively. *Crack shielding* might be the reason that propagation of one of the major cracks had been halted. Based on this concept, when two cracks initiate close to each other, only one of them will be able to propagate further because the other one will be in a stress relieved zone (Tillberg *et al.* 2008). Besides the major cracks, another crack that seemed to be a *subsurface crack* was observed (Figure 2.9b). It is known that sub-surface cracks in rail steels are mainly initiated by brittle inclusions. However, since the 1970's, rail steels are mostly free of these inclusions (Garnham *et al.* 2010). The possible explanation is that the observed sub-surface crack was a portion of a surface initiated crack and the whole crack path was not captured in this cross section.

Figure 2.9 (a) Cracks in the mid-gauge region of Rail 1 (b) Suspected sub-surface crack at higher magnification (Rail 1-TG).

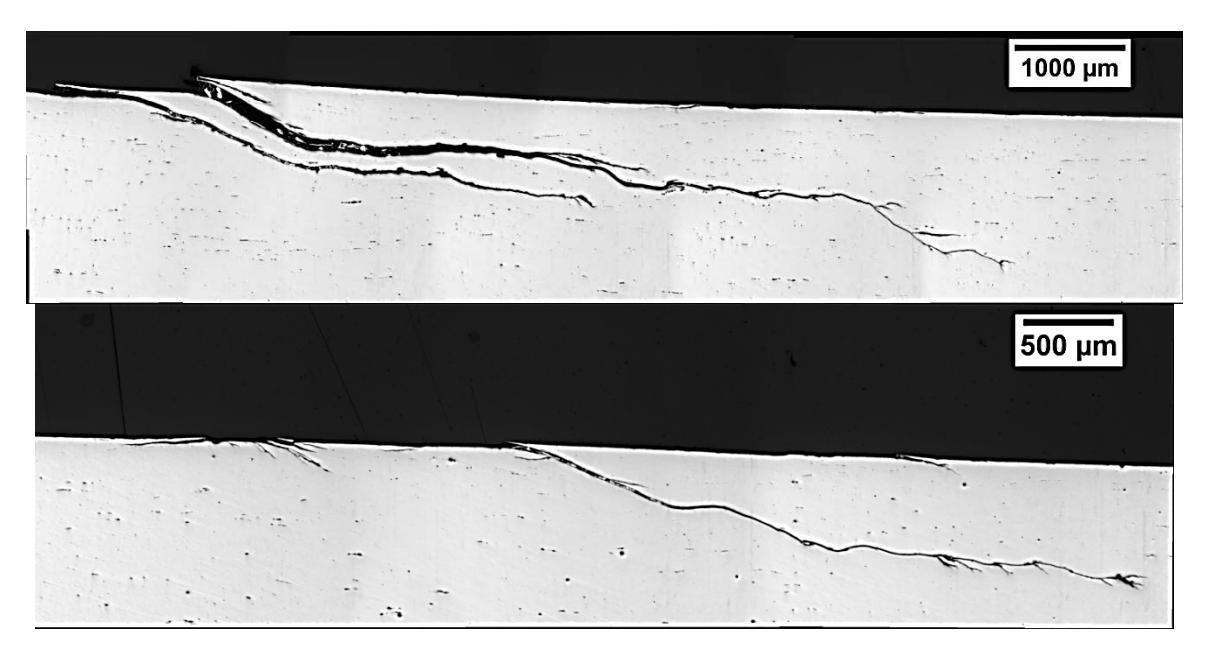
As shown in Figure 2.11, **Rail 1-LG** specimen showed cracks that mainly had angles between 8° and 17°. The three (3) major cracks had lengths of about 5004, 7484 and 3624 μ m and depths of 941, 1409 and 688 μ m, respectively. Again, it was observed that one of the major cracks had been shielded.

Figure 2.11 Crack in longitudinal section of the gauge region of Rail 1 (Rail 1-LG).

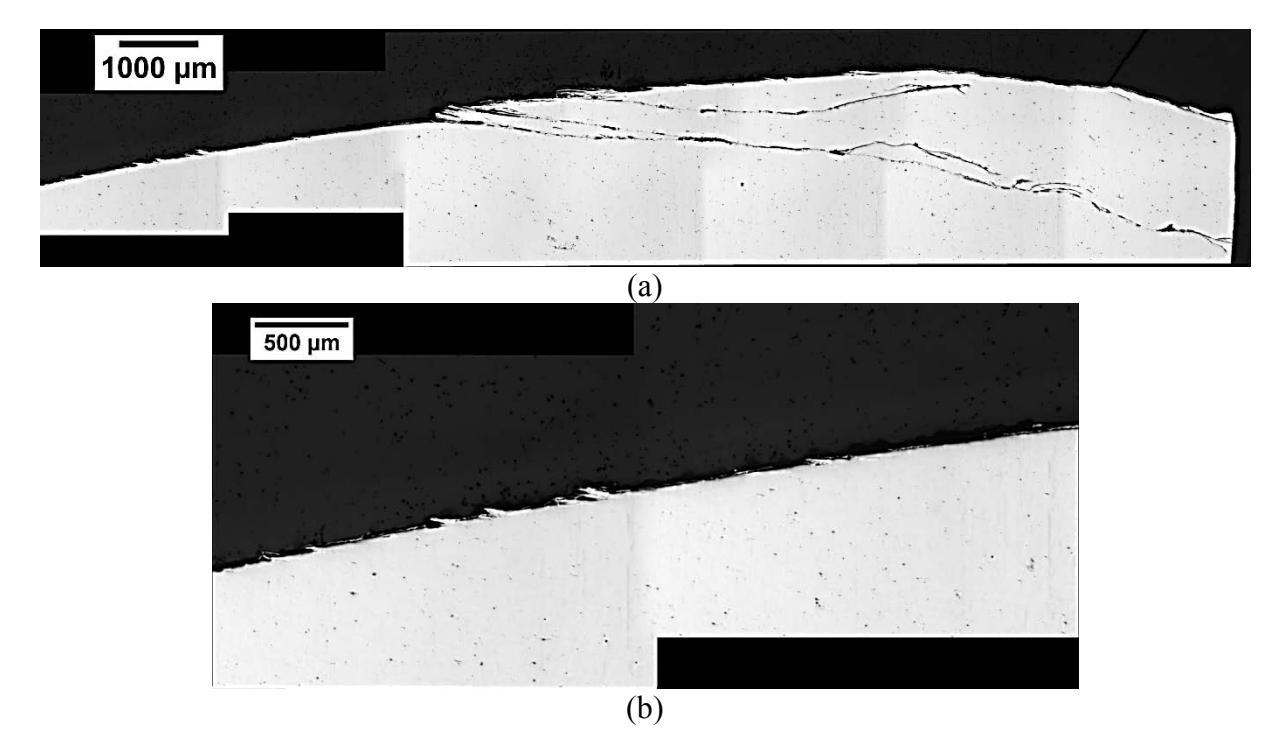
As shown in Figure 2.14a, **Rail 2-TG** specimen also revealed two (2) major cracks in the mid-gauge region with angles of 15° and 10°, (partial and total) lengths of 10185 and 5176 μ m and depths of 1773 and 420 μ m, respectively. The cracks had initially propagated horizontally but changed their growth direction in the middle of their path. The larger crack diverted downward while the other crack propagated upward to a point very close to the rail running surface. If it had reached the surface, then it would have resulted in a large spall.

Figure 2.14 (a) Cracks in the mid-gauge region of Rail 2 (b) shallow surface cracks (Rail 2-TG).

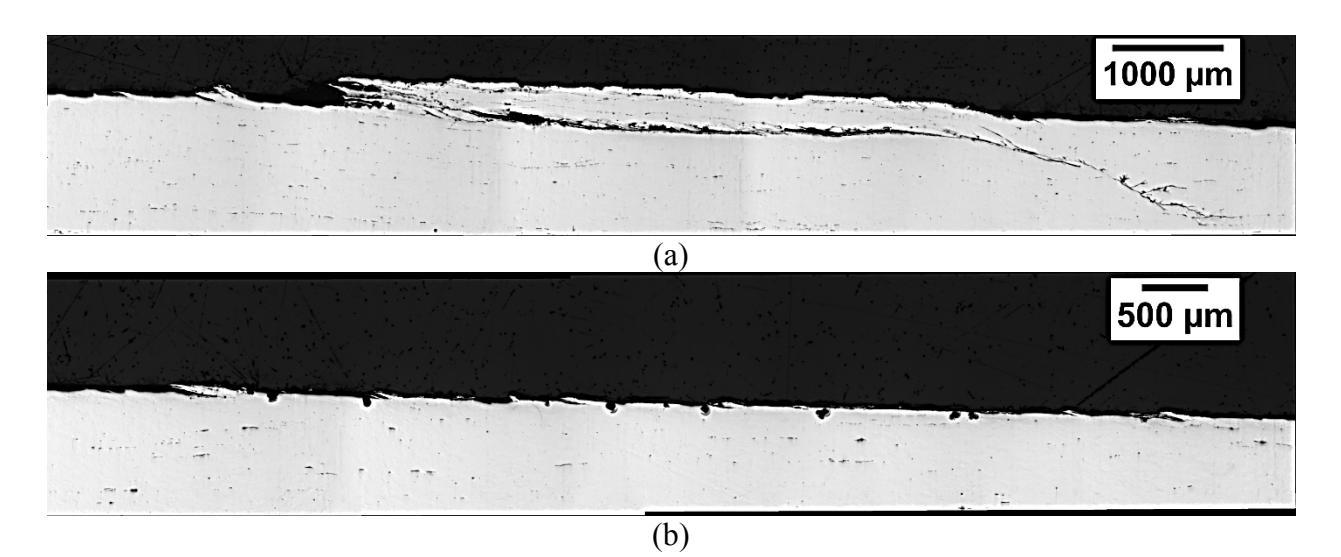
shallow surface cracks were observed on the running surface of the specimen (Figure 2.15b). In comparison to the shallow surface cracks found on Rail 2-TG specimen, these cracks were shallower (their angles were mostly between 10° and 15° and their depths were mainly between 20 and 30 µm) but had greater lengths (between 100 and 250 µm).

Figure 2.15 (a) Cracks in longitudinal section of the gauge region of Rail 2 (b) Shallow surface cracks (Rail 2-LG)

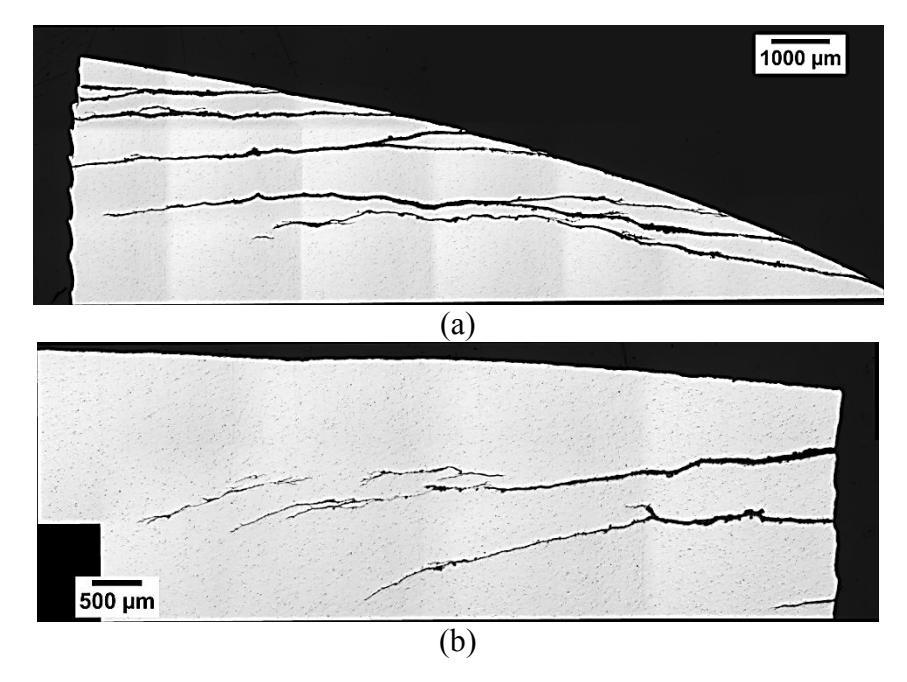
Rail 7: No trace of delamination or other types of damage was found at the gauge region of the **Rail 7-TG** specimen. This might have been due to the fact that the gauge of Rail 7 was smaller than to other rail samples. It was observed that five (5) cracks had initiated at gauge corner and mid-gauge regions and propagated horizontally toward the top of rail region (Figure 2.17a). This indicated *gauge corner cracking* (GCC) as the main cause of failure. The initiation angles of the cracks were between 10° and 20°. Total lengths of the two (2) major cracks that had initiated at the gauge corner region were 10218 and 11786 μ m and their depths were 2336 and 2610 μ m, respectively. The other three (3) major cracks had partial lengths of 8144, 5443 and 3470 μ m and their depths were 1877, 1063 and 711 μ m, respectively. **Rail 7-TT** specimen revealed two (2) major cracks that were continuations of cracks from the mid-gauge region (Figure 2.17b). Partial lengths of the cracks were 4747 and 6129 μ m and their depths were 2420 and 1751 μ m, respectively.

Figure 2.17 Cracks at the (a) mid-gauge and (b) top of rail region of Rail 7 (Rail 7-TG and TT, respectively).

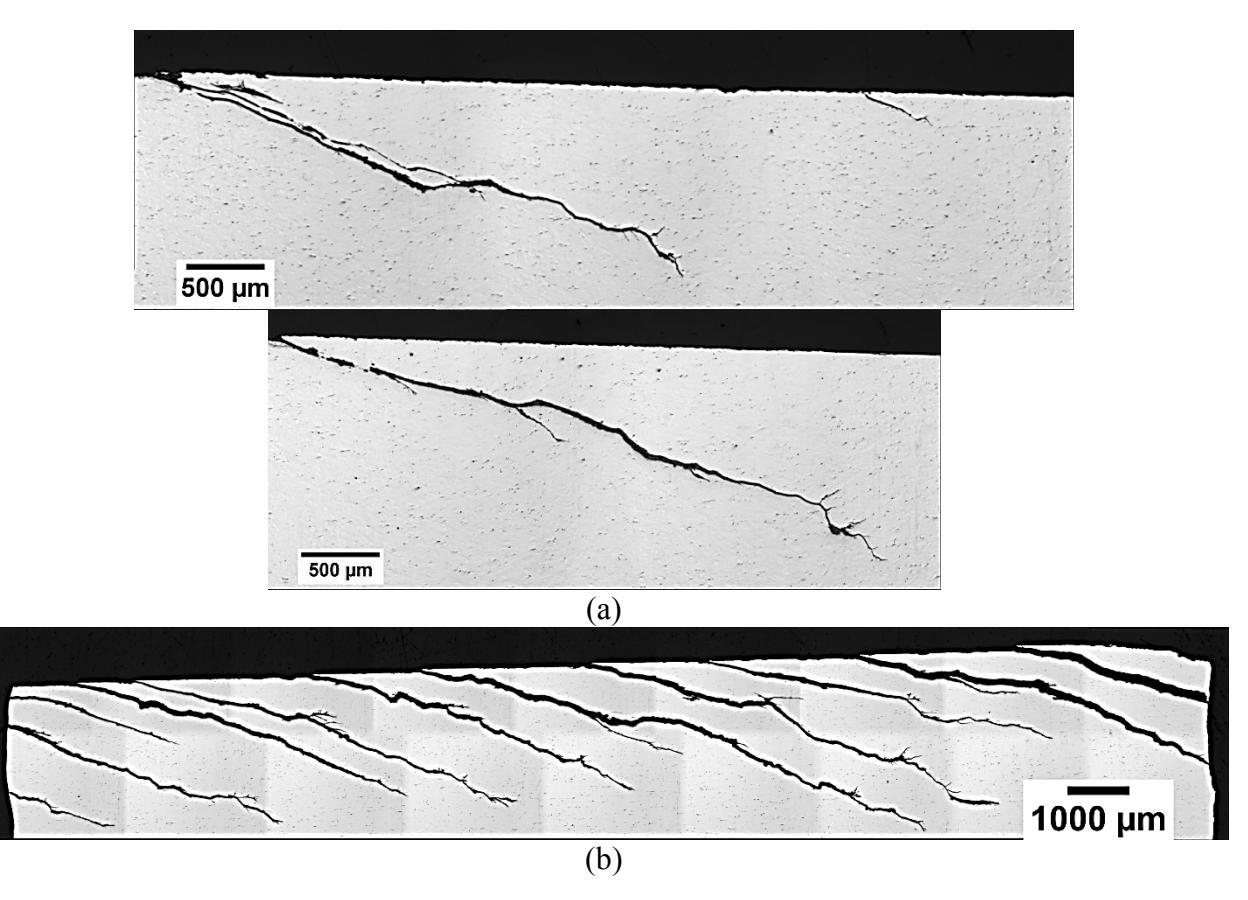
Five (5) cracks, which had angles between 20° to 25°, were observed at the surface of **Rail 7-LG** specimen. As shown in Figure 2.18a, the three (3) major cracks had lengths of about 1993, 3622 and 4132 μ m and depths of 721, 1216 and 1321 μ m, respectively. **Rail 7-LT** specimen showed a number of cracks which had average spacing of 2176 μ m and were parallel to each other (angles around 20°) (Figure 2.18b). Their lengths were between 1799 and 8525 μ m (average length of 5210 μ m) and their depths were between 940 and 2863 μ m (average depth of 1960 μ m).

Figure 2.18 Cracks in longitudinal section of the (a) gauge and (b) mid-gauge region of Rail 7 (Rail 7-LG and LT, respectively).

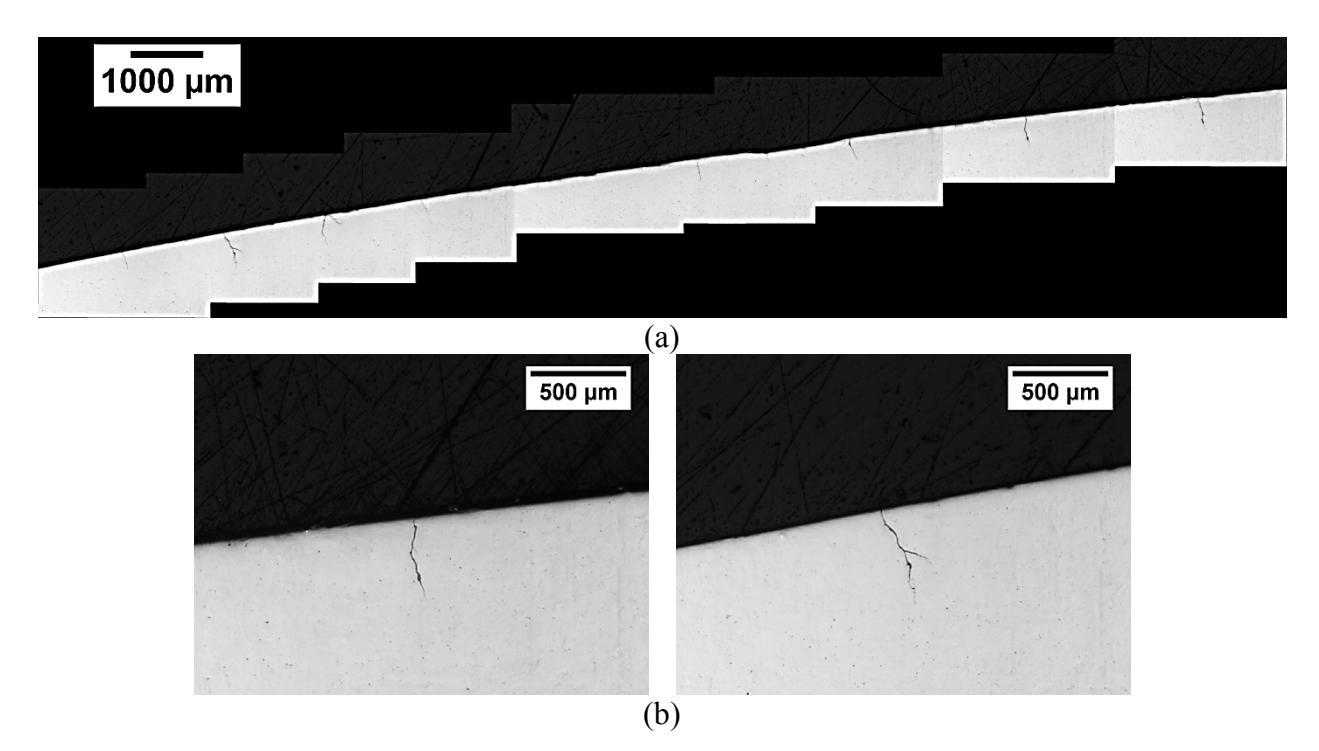
As demonstrated in Figure 2.21 and Figure 2.22, **Rail 10-TT** specimen revealed a number of major cracks in the top of rail region. Two distinct zones were observed in relation to the angles of the major cracks. In the first zone (Figure 2.21), which was close to the mid-gauge region, crack angles gradually increased from 35° to 70°. The maximum depth of major cracks in this zone was 586 µm. In addition, shallow surface cracks with geometrical characteristics similar to the ones from mid-gauge region were observed in this zone. In the second zone (Figure 2.22), the cracks are almost vertical to the rail running surface and they did not show traces of shallow surface cracks. These *vertical short cracks* are similar to cracks that occur due to presence of a brittle phase such as martensite (Steenbergen 2015; Najdahmadi *et al.* 2014). The measured maximum depth of cracks in this second zone was 509 µm.

Figure 2.22 (a) Cracks in the second zone of the top of rail region of Rail 10 (b) Cracks at higher magnification (Rail 10-TT).

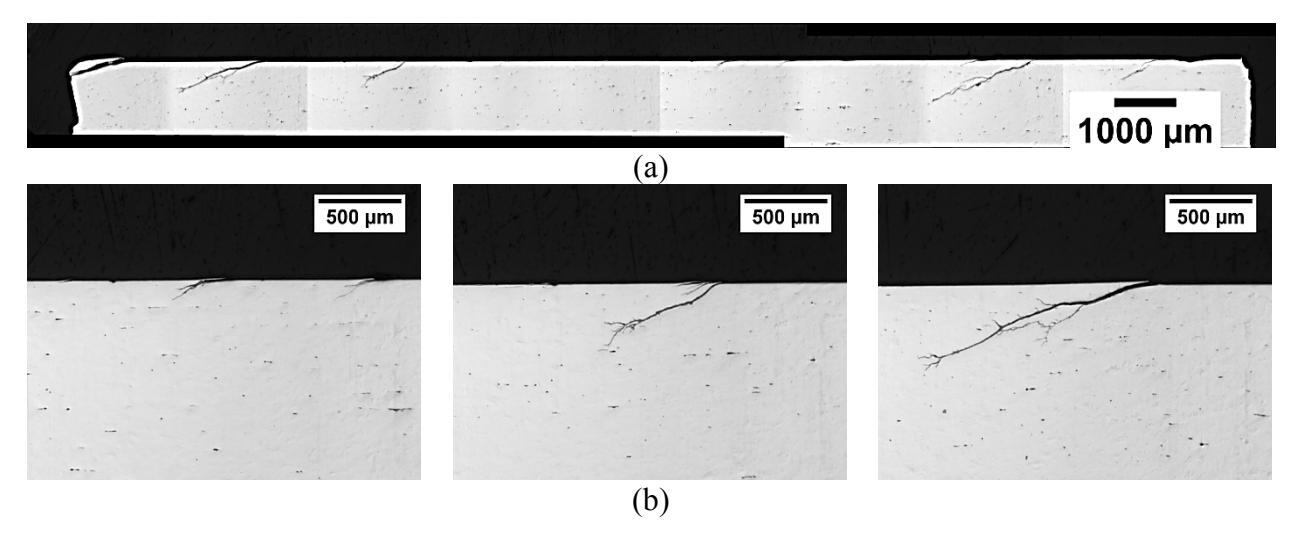
Figure 2.24 (a) Cracks in longitudinal section of the mid-gauge region of Rail 10 (b) Cracks at higher magnification (Rail 10-LT)

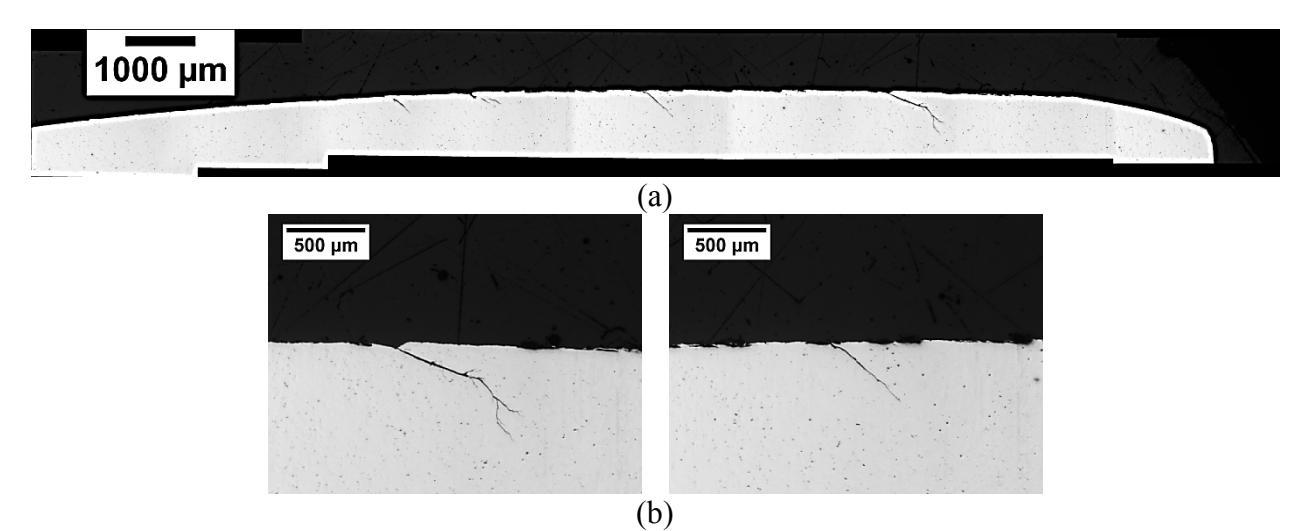
Figure 2.26 (a) Cracks in the mid-gauge region of Rail 12 (b) Cracks at higher magnification (Rail 12-TG)

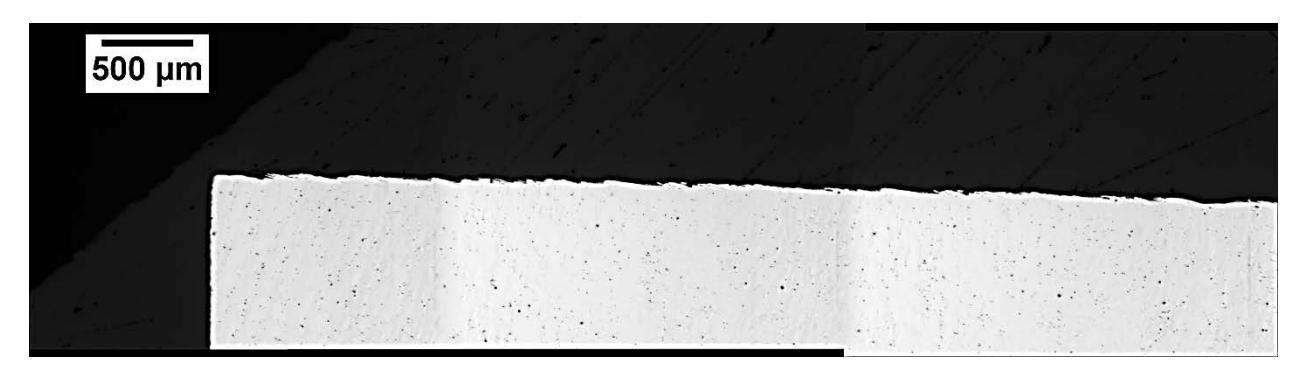
Figure 2.27 Shallow surface cracks in the top of rail region of Rail 12 (Rail 12-TT)

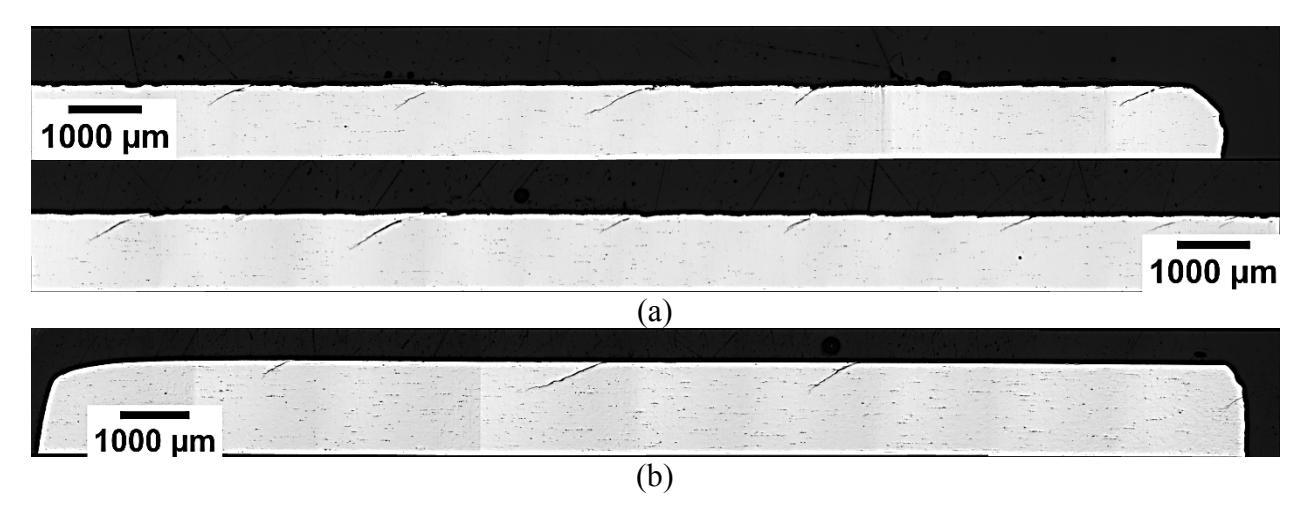
Rail 12-LG specimen showed a number of cracks which were evenly spaced (average spacing of 1,887 μ m) and parallel to each other (angles between 20° and 30°) (Figure 2.28a). Their lengths were between 117 and 1,250 μ m (average length of 568 μ m) and their depths were between 30 and 482 μ m (average depth of 222 μ m). As shown in Figure 2.28b, **Rail 12-LT** specimen exhibited three (3) major cracks with angles of 30°, 20° and 25°. The three major cracks had lengths of 820, 1199 and 599 μ m and depths of 420, 426 and 260 μ m, respectively. Several shallow surface cracks were also observed.

Figure 2.28 Cracks in longitudinal section of the (a) gauge and (b) mid-gauge region of Rail 12 (Rail 12-LG and LT, respectively).

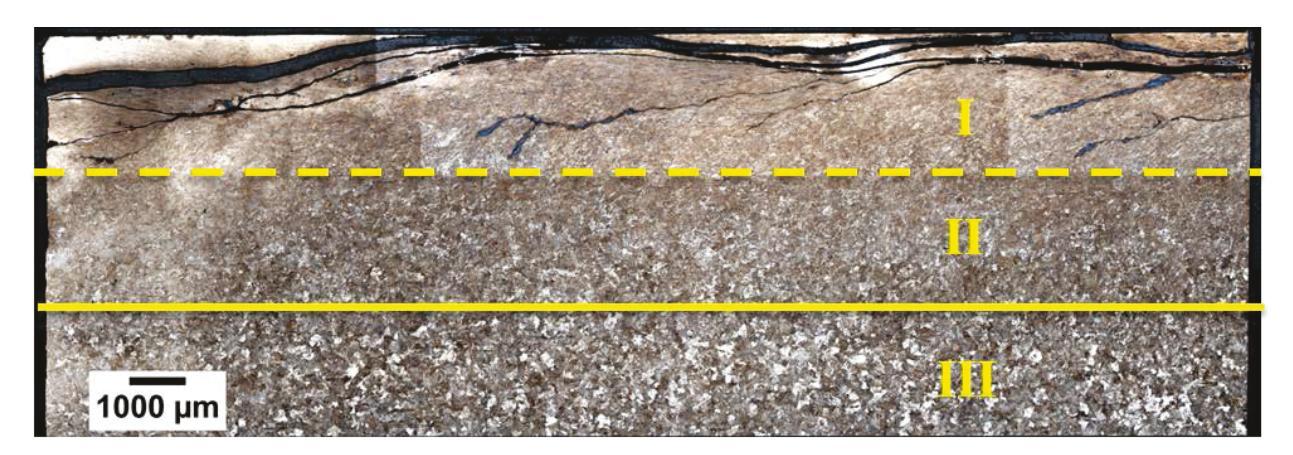
Figure 2.29 (I) Largely deformed, (II) Mildly deformed and (III) Undeformed regions in longitudinal section of the mid-gauge region of Rail 1 (Etched Rail 1-LT).

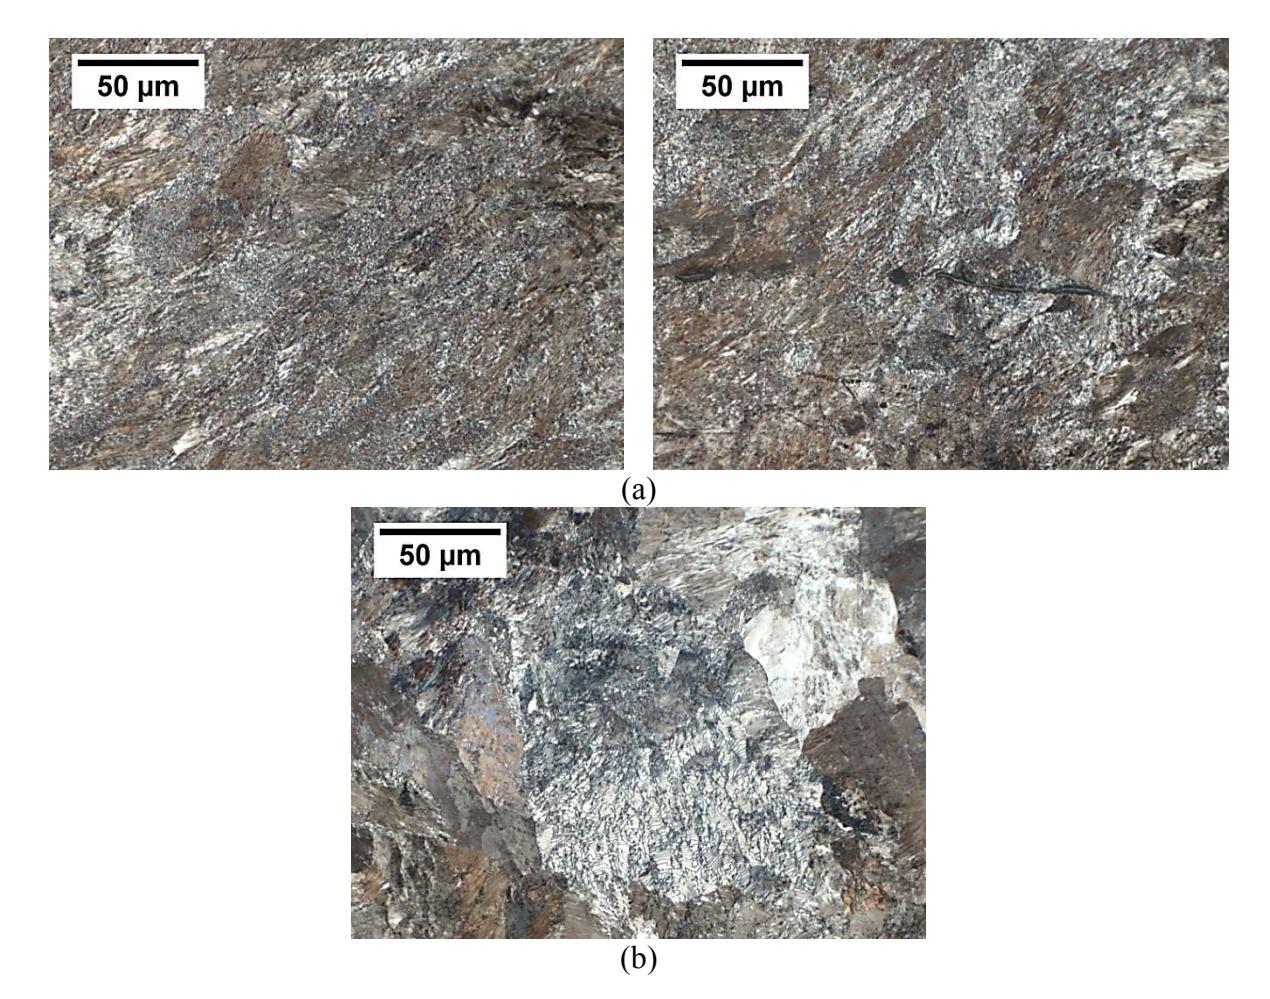
results in a distinct layer. Below this layer-like structure, deformation of pearlite colonies was observed (Figure 2.30b). It was also observed that the angle between the plastic deformation lines and the normal to rail surface (which indicates shear strain) (Tyfour *et al.* 1996) gradually decreased as the depth from the surface increased. The mildly deformed region (region II) which had experienced small shear strains was observed between the depths of 2505 and 4788 μ m (Figure 2.31a). No plastic deformation (region III) was observed in the microstructure below depth of 4788 μ m (Figure 2.31b).

Figure 2.31 (a) Mildly deformed region (region II) (b) Undeformed region (region III) at higher magnification (Etched Rail 1-LT).

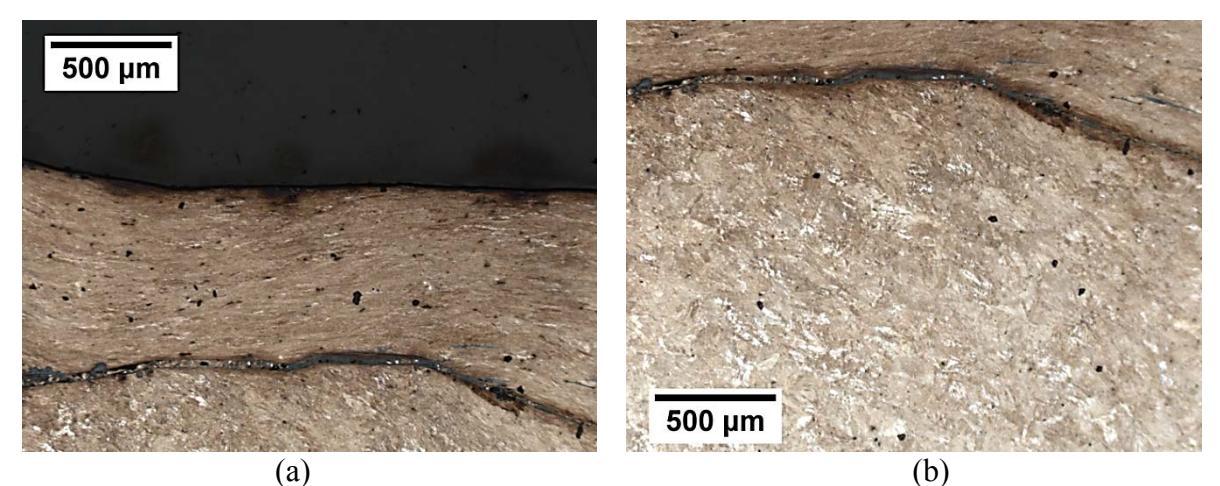
Figure 2.32 (a) Layer-like structure (b) Deformed pearlite colonies in the mid-gauge region of Rail 1 (Etched Rail 1-TG).

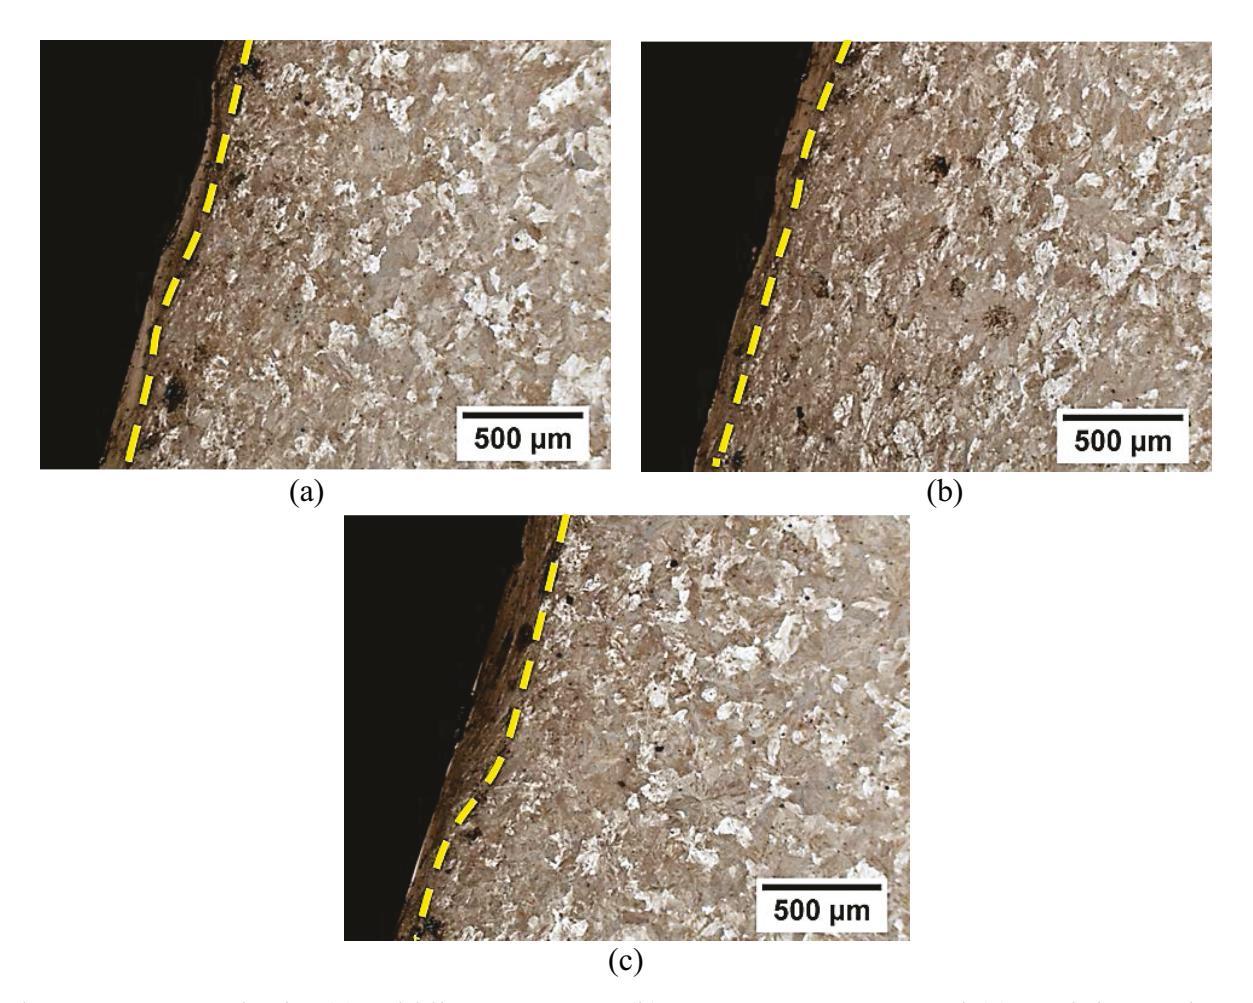
Figure 2.64 WEL in the (a) Middle gauge zone (b) Lower gauge zone and (c) Dark brown layer (Etched Rail 1-TG).

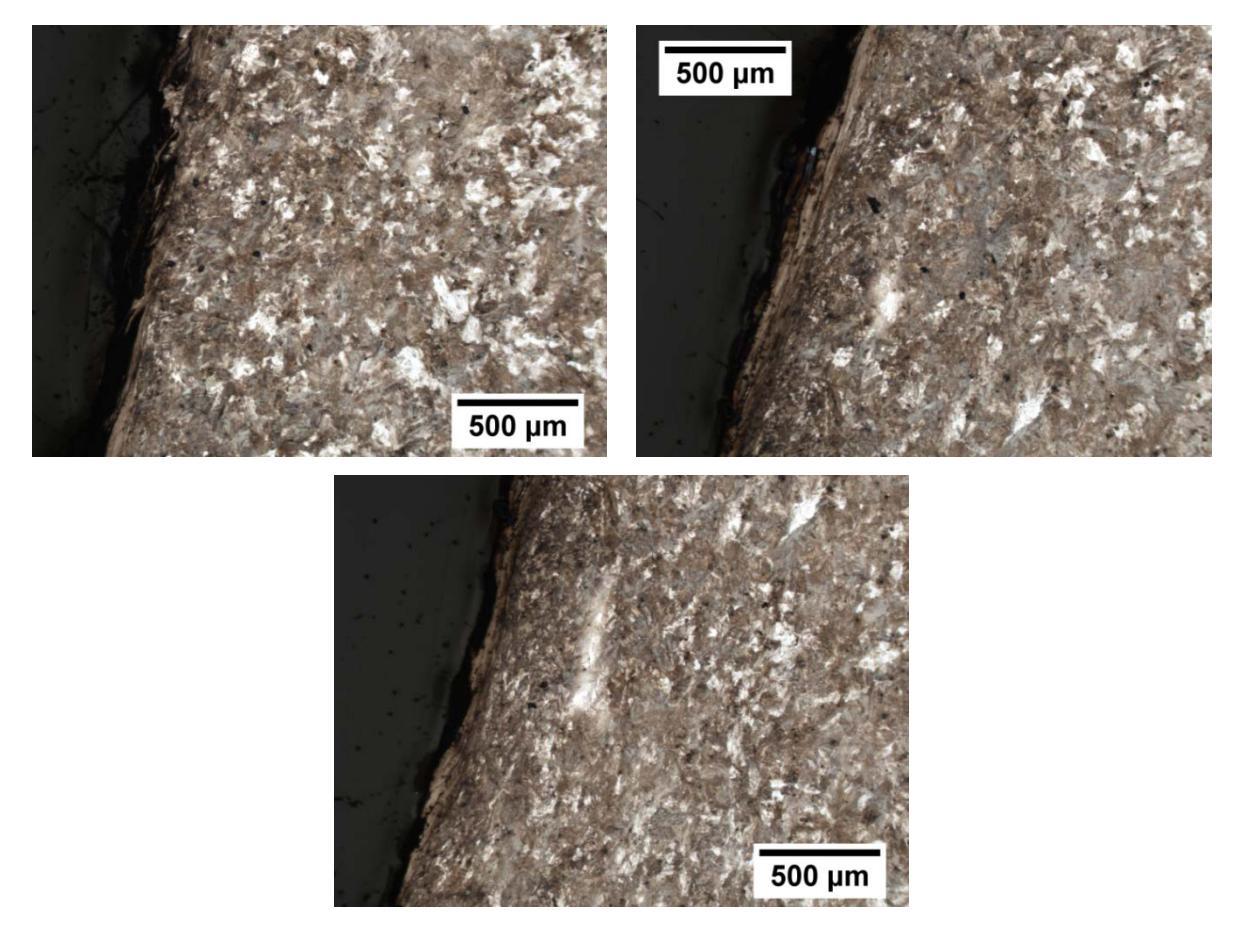
Figure 2.65 WEL at the middle and lower gauge zones (Etched Rail 2-TG).

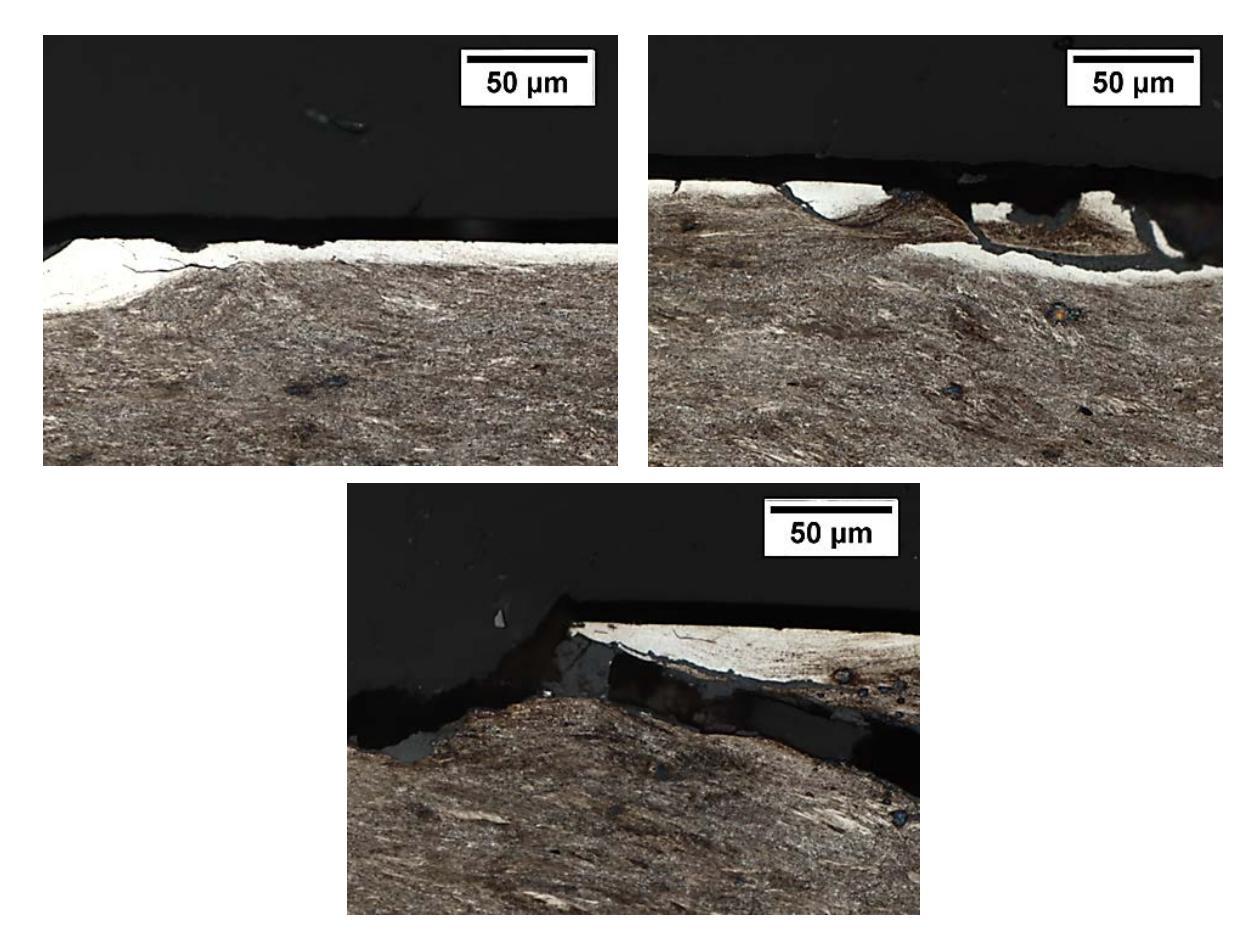
Figure 2.66 WELs at surface of longitudinal section of the mid-gauge region of Rail 7 (Etched Rail 7-LT).

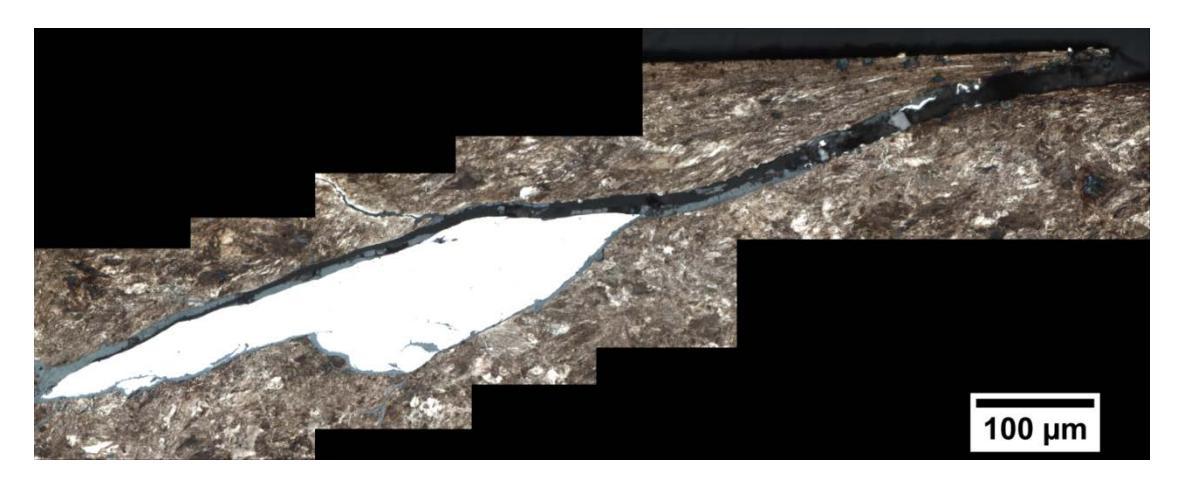
Figure 2.70 White etching material inside a crack (Etched Rail 10-LT).

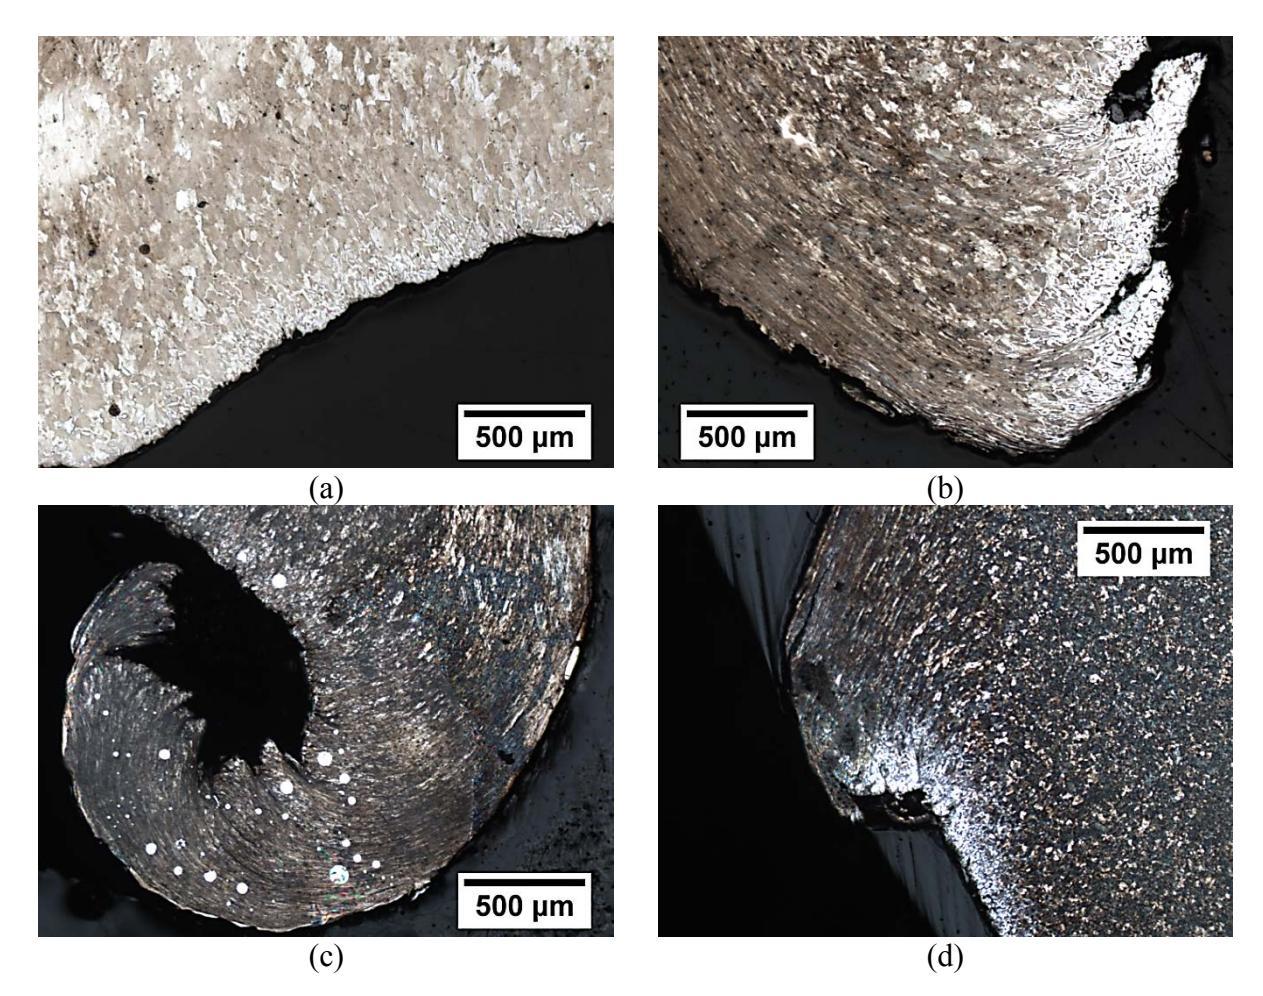
Figure 2.76 Decarburized layer at the plastic flow lip of (a) Rail 1 (b) Rail 2 (c) Rail 10 (Rail 12).
