**Landslide Risk to Railway Operations and Resilience in the Thompson River Valley
near Ashcroft, British Columbia**

by
Kristen Michelle Tappenden

Doctor of Philosophy
in
Geotechnical Engineering

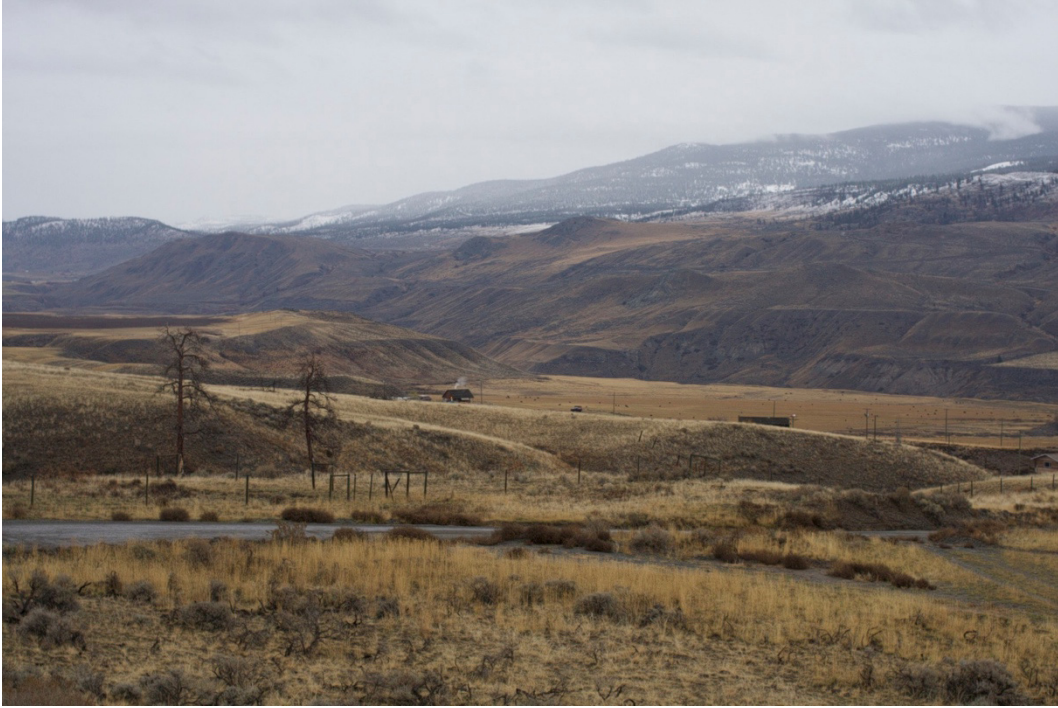
Figure 2.1: Characteristic semi-arid, terraced landscape used for ranching and farming along the Thompson River Valley, as seen looking east from Highway 1 between Ashcroft and Spences Bridge (November 2015).

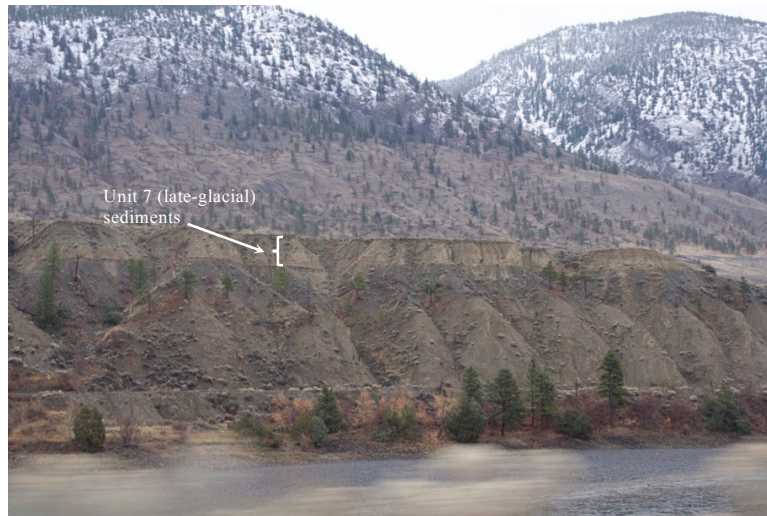
Figure 2.3: Characteristic exposure along the Thompson River Valley between Ascroft and Spences Bridge (looking east from Highway 1, November 2015). The surficial late-glacial lacustrine silt deposits (unit 7) are readily identifiable as the upper light-coloured band of sediment.

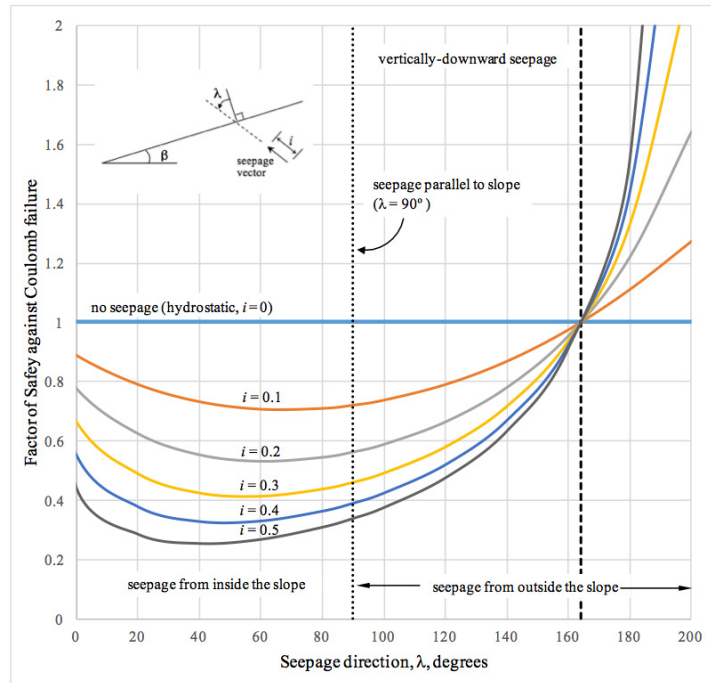
Figure 2.6: Effect of seepage gradient magnitude and direction on factor of safety for a hypothetical infinite cohesionless slope with $\phi' = \beta = 16^\circ$.

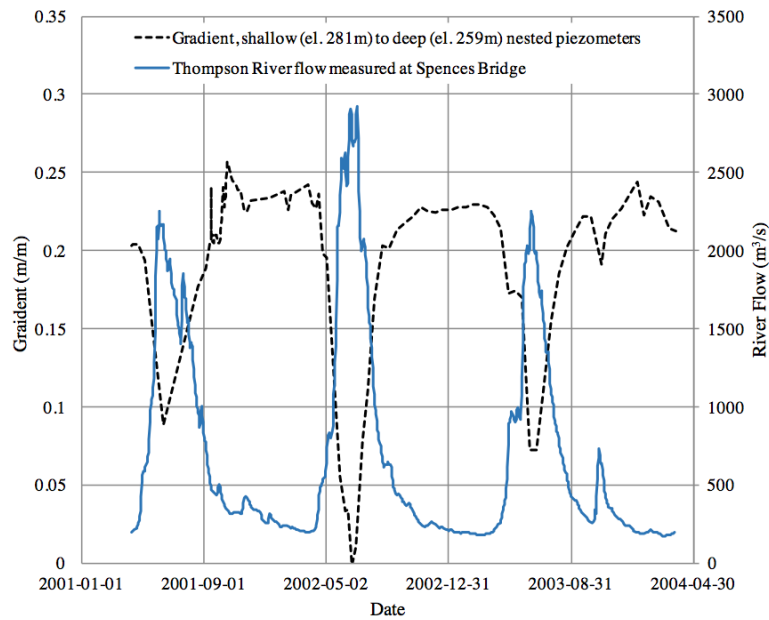
Figure 2.7: Vertical pore pressure gradients between deep and shallow piezometers measured at the toe of the CN 51 landslide, close to the Thompson River (modified from Quinn et al. 2012).

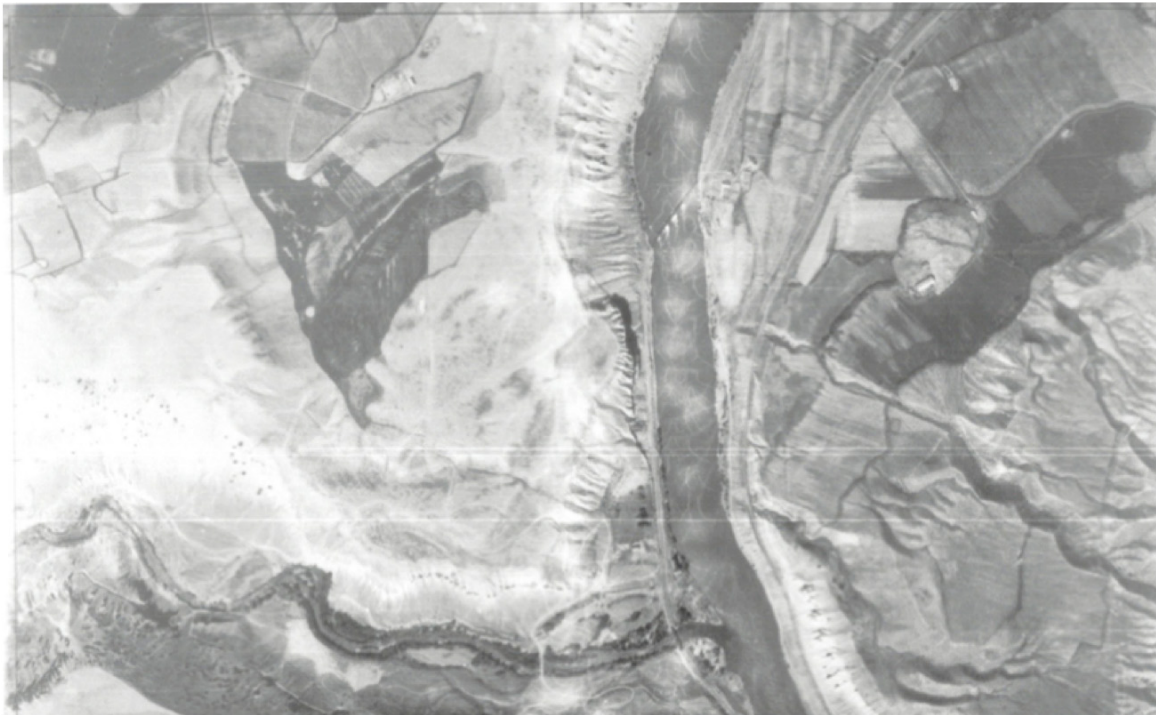
Figure 2.12: Aerial view of Bonaparte confluence north of Ashcroft, with evidence of historic irrigation practiced on river terrace above the confluence (NRC Roll A291, #69, July 15, 1928).

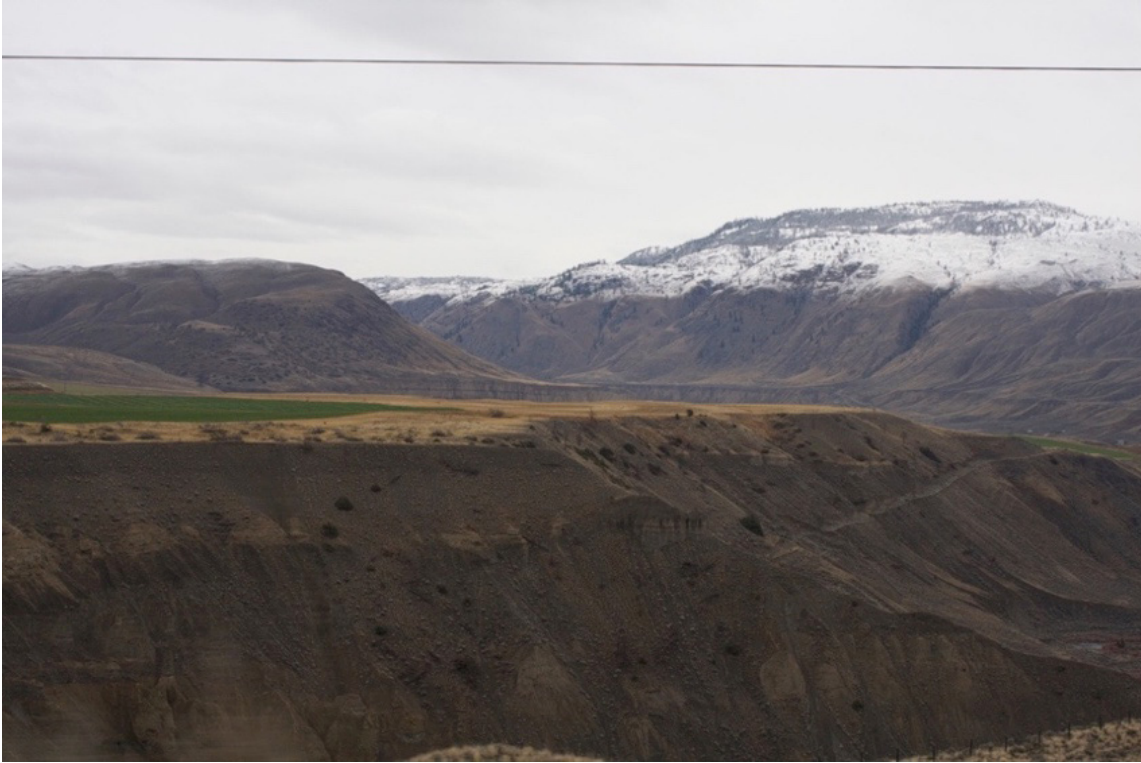
Figure 2.13: Irrigated field on the upper terrace of the Thompson River Valley north of Ashcroft at the Bonaparte River confluence (looking east from Highway 1, November 2015).

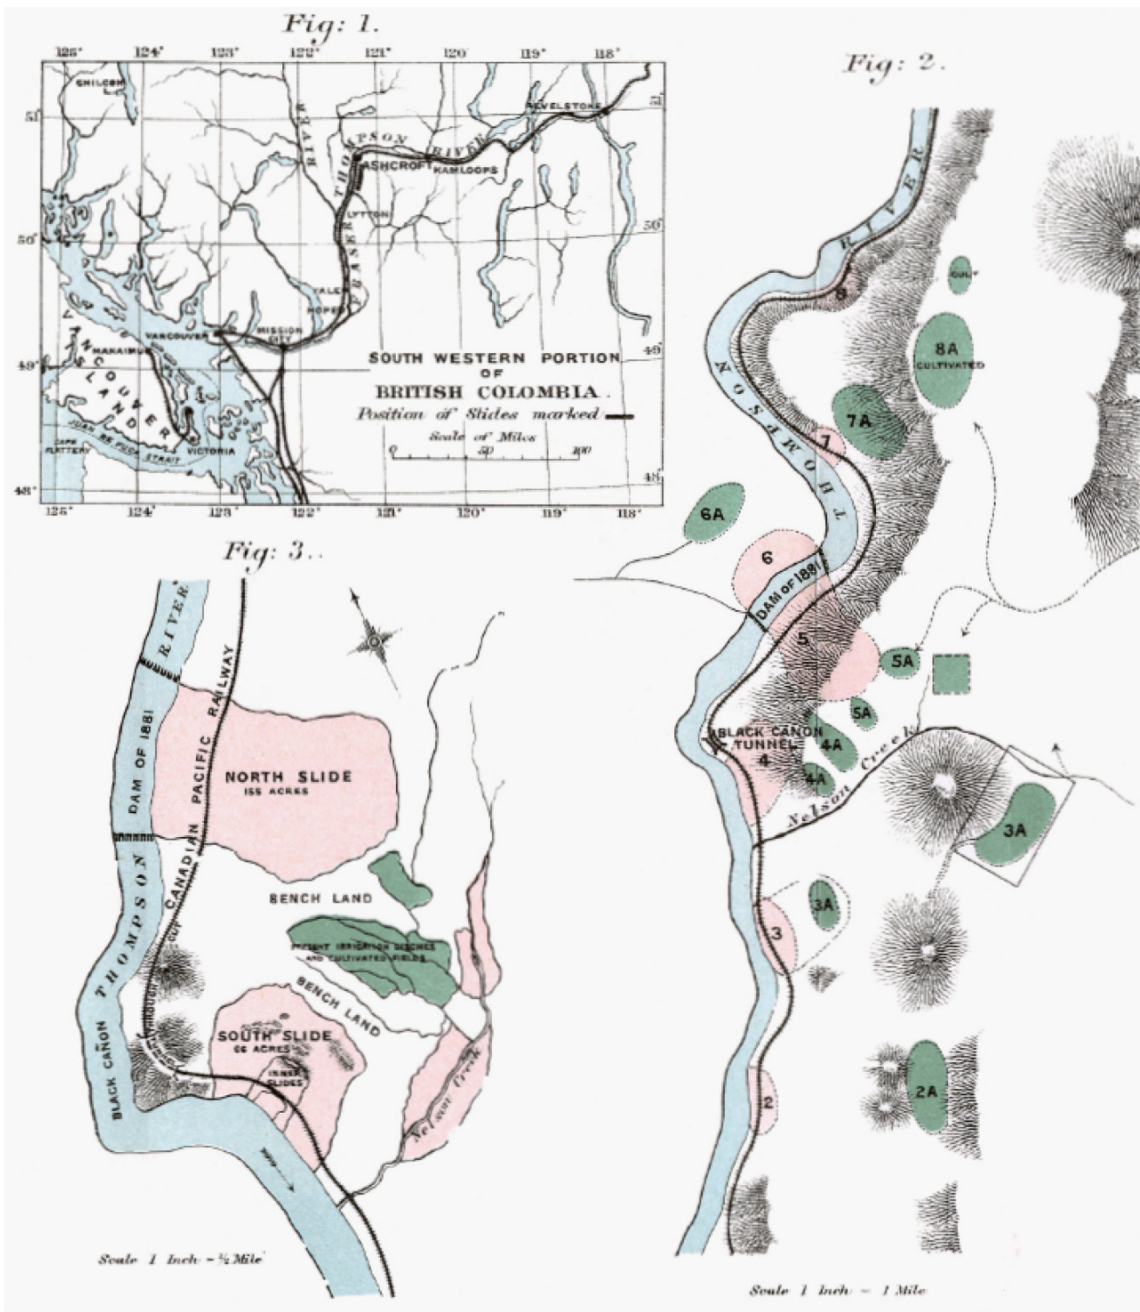
Figure 3.5: Stanton's (1898a) map of landslides in the Thompson River Valley south of Ashcroft.

landslides on the Canadian Pacific Railway in the Thompson River Valley as drawn by Stanton (1898a) is presented in Figure 3.5.

reactivation of the northern portion of this ancient slide (Eshraghian et al. 2007), which would not have been readily recognizable (at the time) without the assistance of aerial photography. Large swaths of ditch and furrow irrigation are evident above the Goddard slide in the 1928 aerial photo (Figure 3.7), as depicted on Stanton's (1898a) map of the area (Figure 3.5).

The *Daily British Colonist* reported on Wednesday, October 20, 1886, that "a large land-slide occurred near Ashcroft on Monday night [October 18], washing away a large quantity of track and leaving a deep gully. The engine, tender and baggage car of the Pacific express went off the embankment. The engineer was scalded and the fireman hurt" (1886). The article speculated that "owing to the exceptionally dry season, the high banks at this point near the track, which are of a very gravelly nature, would easily be moved by the first heavy rain that fell" (Daily British Colonist 1886). Stanton (1898a), however, implicated ditch-and-furrow irrigation on the upland areas as the cause of the 1886 Goddard landslide (and of all the others depicted on his map in Figure 3.5).

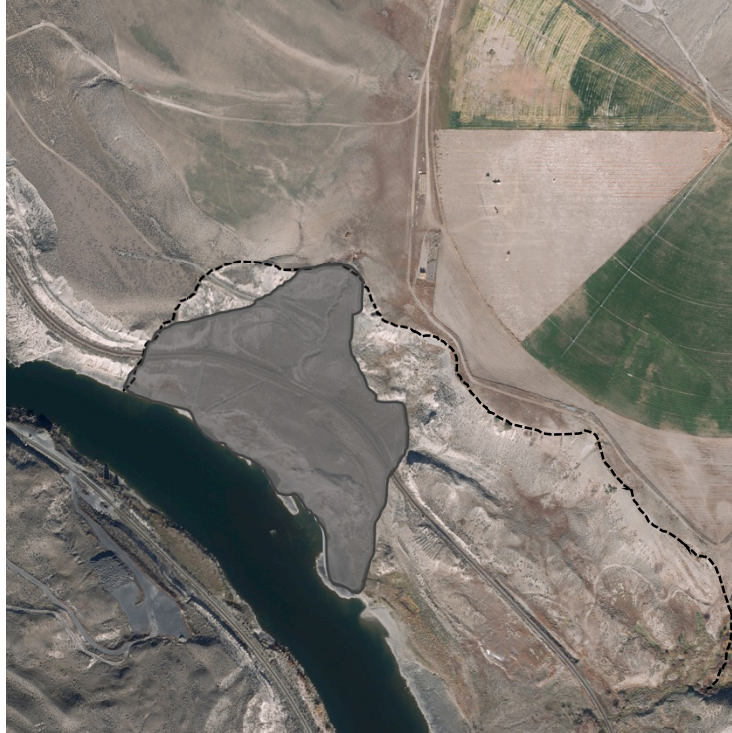
Figure 3.6: 2015 aerial photo of the Goddard landslide on the east bank of the Thompson River (courtesy of CN rail); shaded area corresponds to the limits of the 1982 reactivation (as per Eshraghian et al. (2007)), dashed line delineates broader extents of an older, possibly ancient landslide feature.

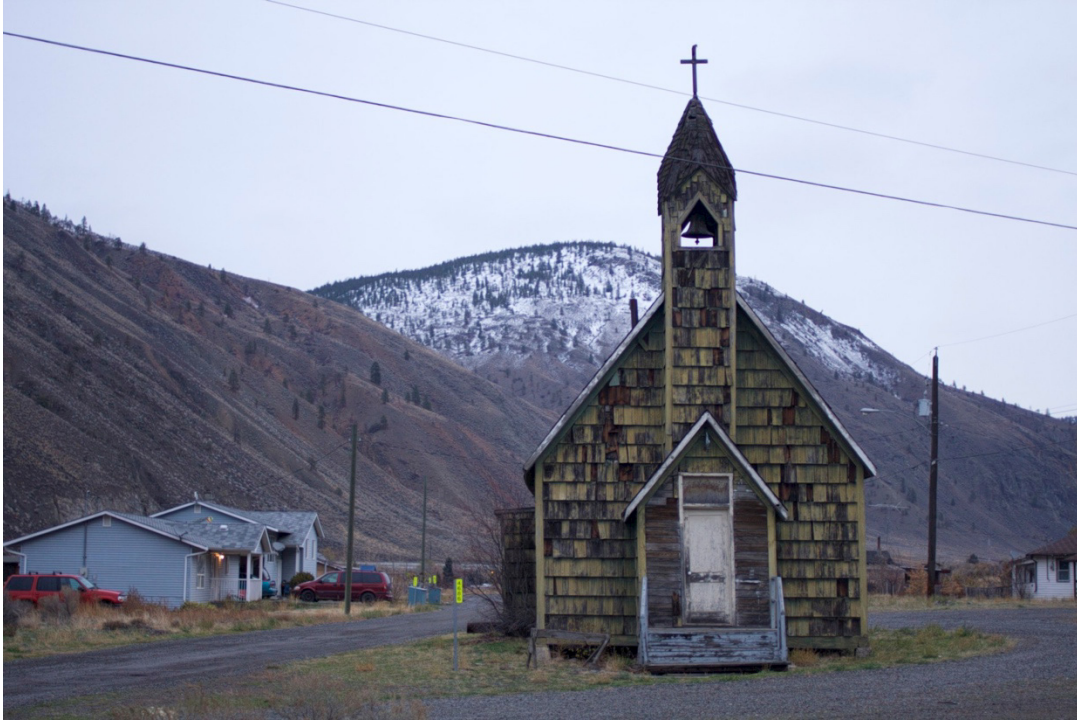
Figure 3.8: Photograph of The Anglican Church of St. Michael and All Angels (looking northeast from Highway 1); taken at Spences Bridge, B.C. in November 2015.

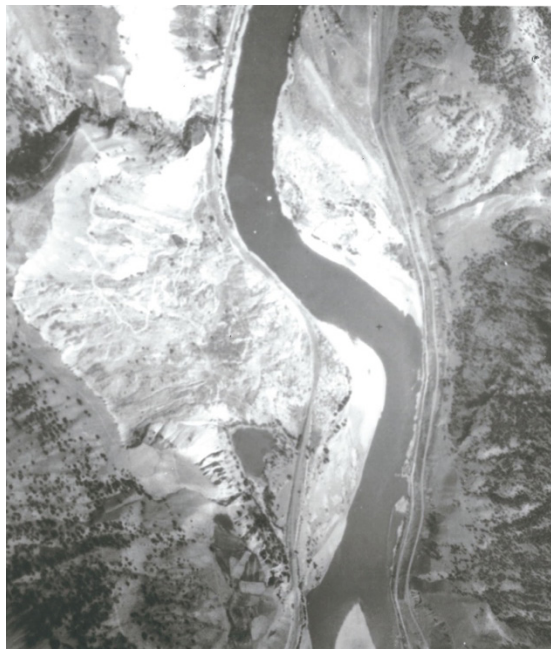
Figure 3.9: 1928 aerial photo showing the 1905 Spences Bridge landslide; Natural Resources Canada, Roll A682, No. 8.

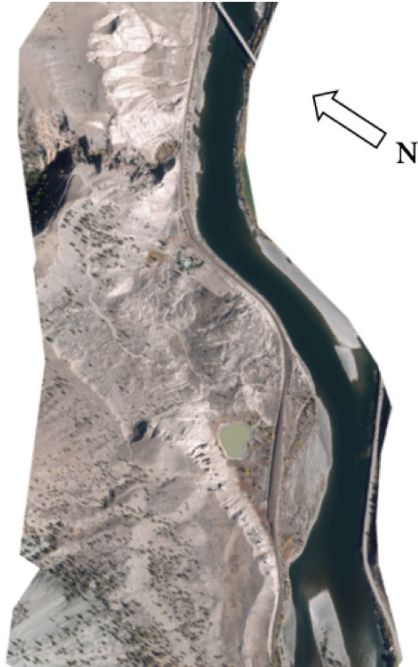
Figure 3.10: 2015 aerial photos showing the 1905 Spences Bridge landslide; courtesy of Canadian National Railway.

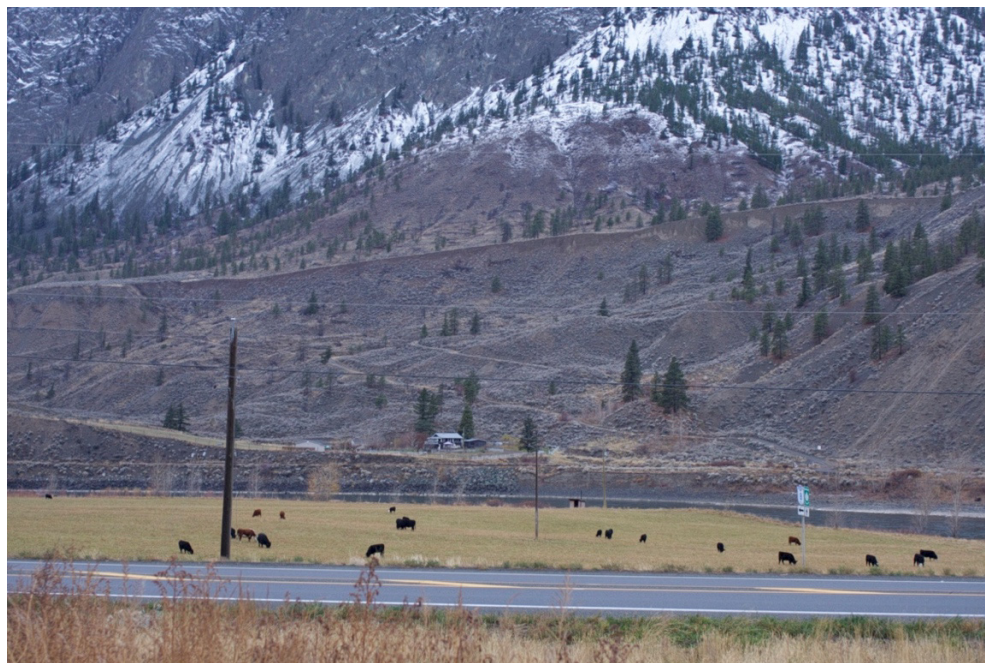
Figure 3.11: Photograph of the 1905 landslide south of the village of Spences Bridge, B.C. (looking west from Highway 1), taken in November 2015.

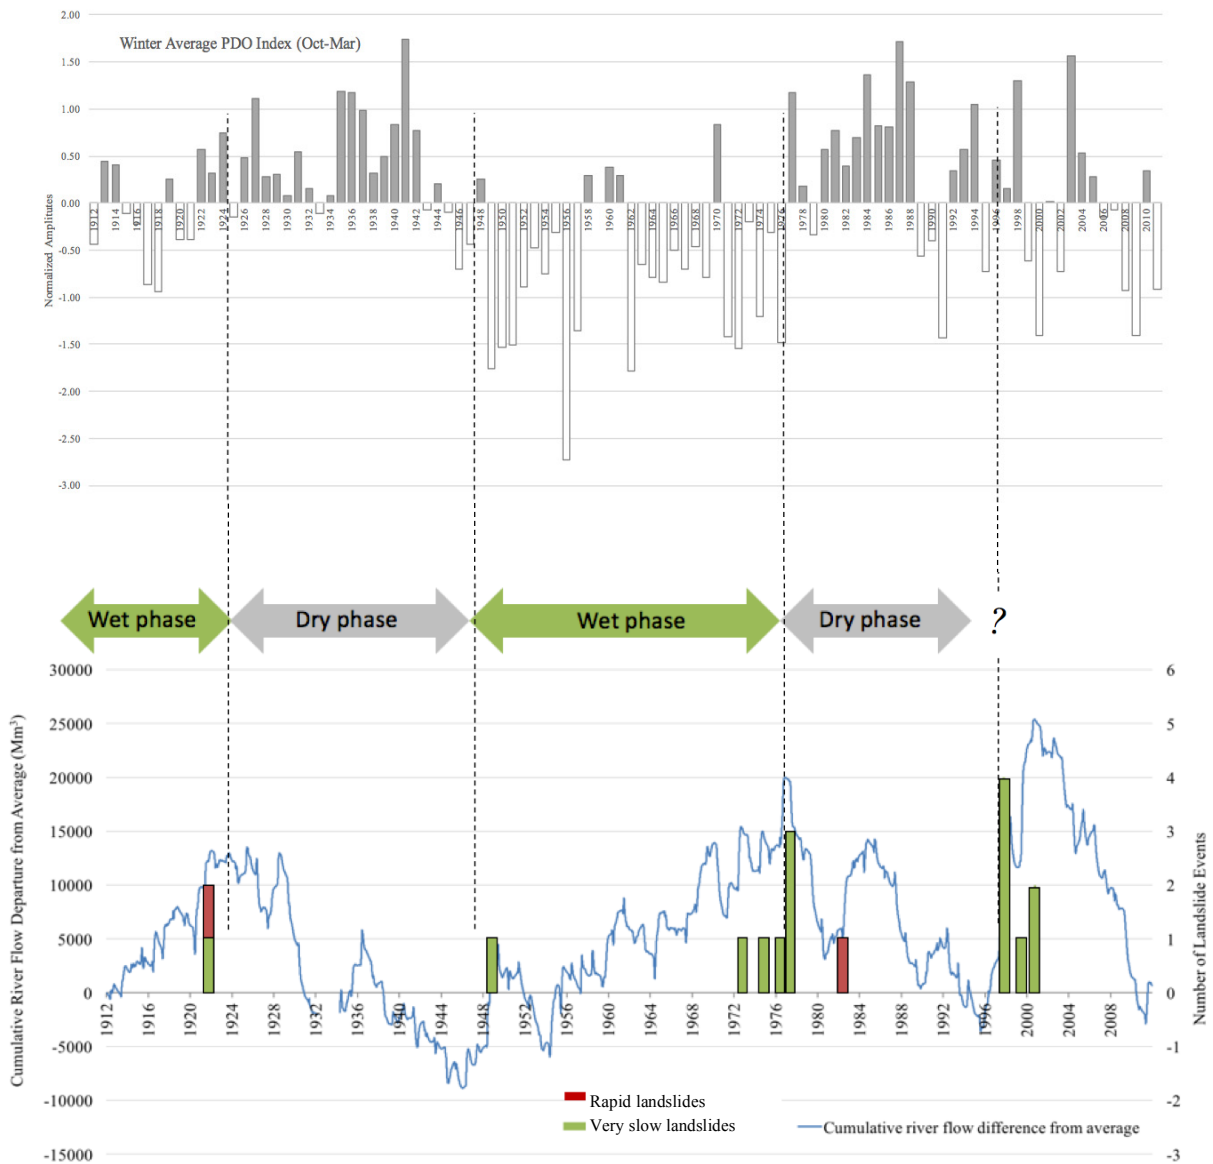
Figure 4.14: Comparison of Pacific Decadal Oscillation (PDO) index to Thompson River cumulative flow departure from normal at Spences Bridge, with number of landslides indicated; 1912-2011.

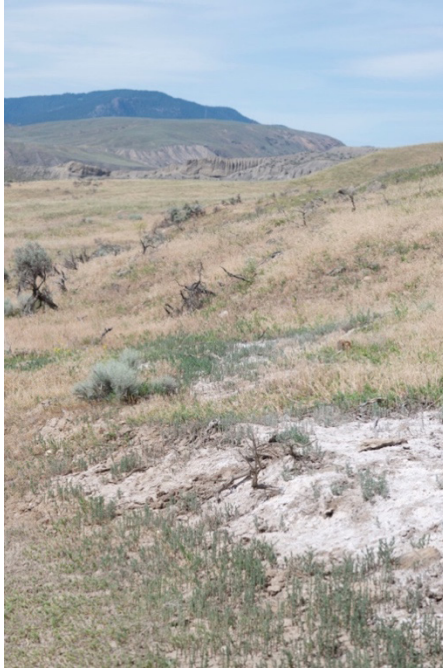
Figure 5.5: Carbonate (?) precipitates at slope face in seepage area south of the South slide; location shown in Figure 5.7 (June 2016).

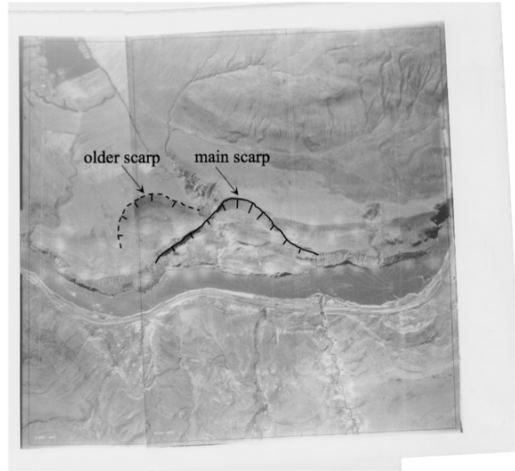
Figure 5.10: Composite image of the Red Hill slide in 1928 (centre of image), with older scarp visible to the left (south) of the main slide area. Photos courtesy of Natural Resources Canada (NRC), Roll A0291, No. 45 & 46.

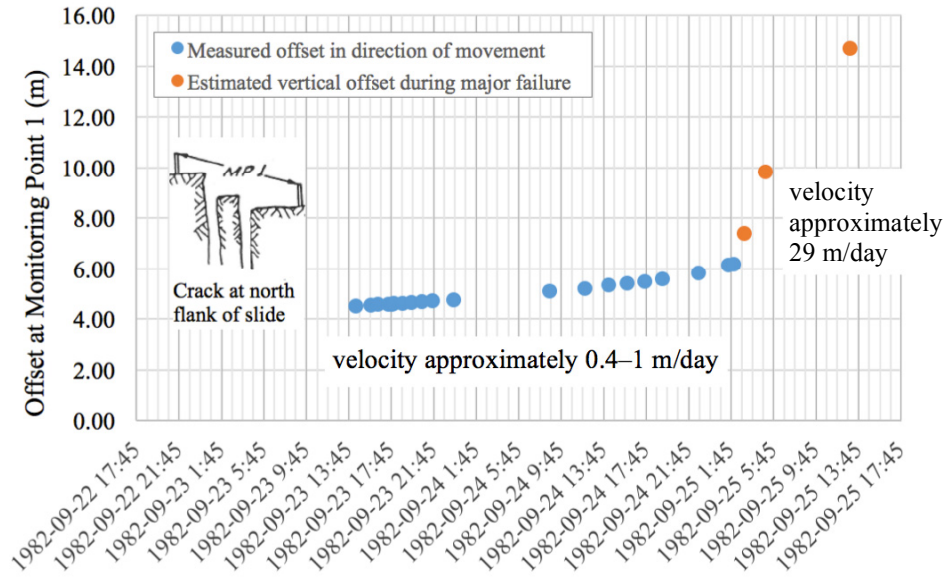
Figure 5.14: Cumulative surface displacement at north flank of 1982 Goddard slide, as determined from surface offset displacements recorded by Wood (1982); inset figure modified from Wood (1982).

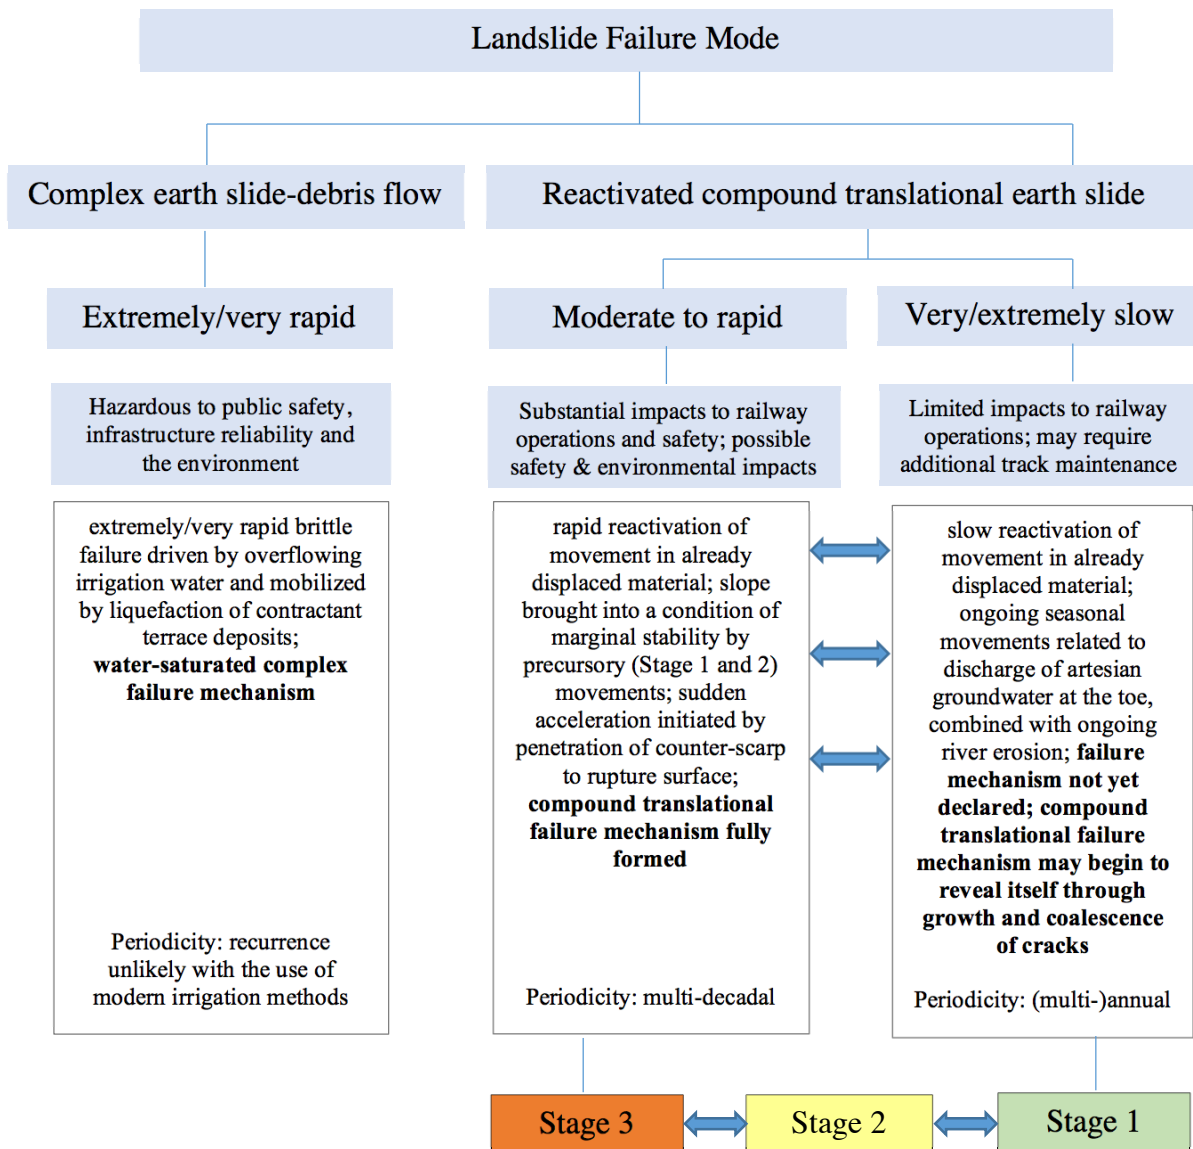
Figure 6.2: Landslide failure modes and attendant risk scenarios for the Ashcroft Thompson River Landslides.
