Structural Engineering Report No. 81

**Tests of Wall Segments  
From Reactor Containments  
Volume 1**

November, 1979

A Technical Report to the  
Atomic Energy Control Board  
Nuclear Plant Licensing Directorate  
P.O. Box 1046  
Ottawa, Canada  
K1P 5S9

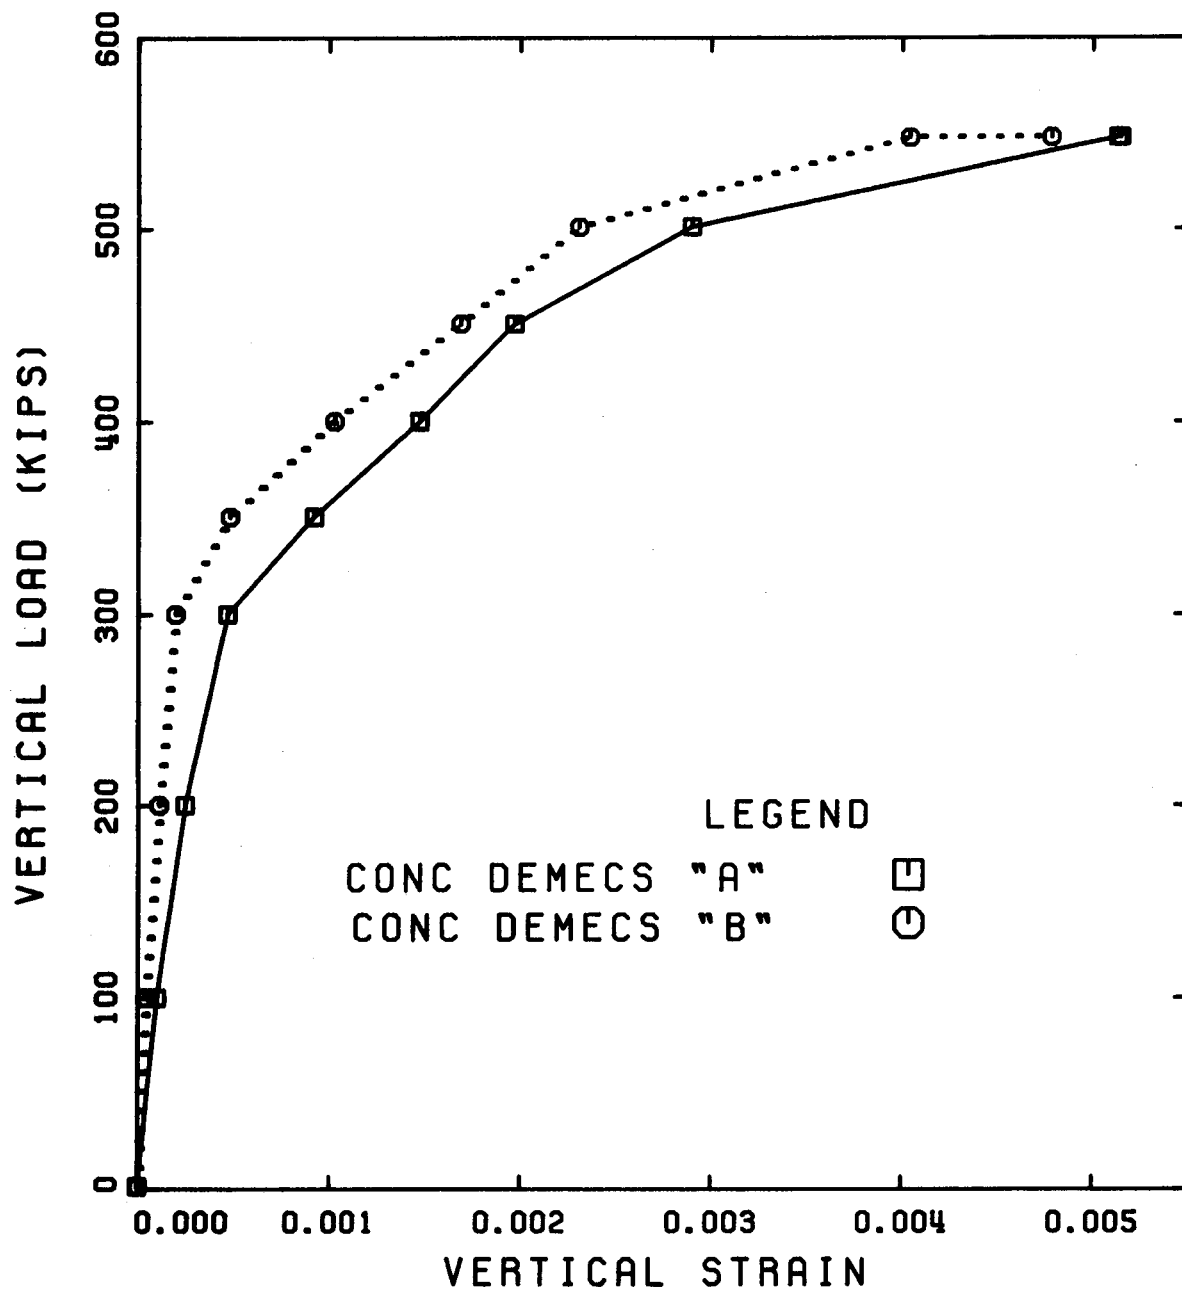
Figure 6.1.3 Load-Average Strain Curves, Segment 1

(a) Vertical Direction
