Near-neutral pH Stress Corrosion Crack Initiation under Simulated Coating
Disbondment

A thesis submitted to the Faculty of Graduate Studies and Research
in partial fulfillment of the requirements for the degree of

Materials Engineering

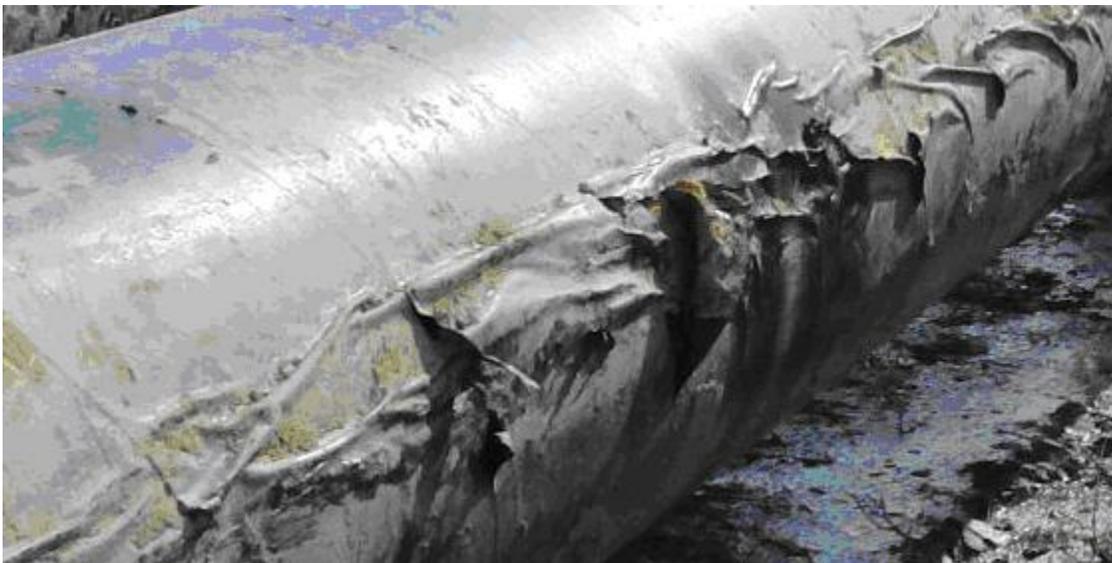
Figure 1.1: PE tape coating disbondments on a pipe surface [3].

Today, several thousand kilometers of major oil and gas pipelines suffer from near-neutral pH SCC. It has been responsible for a considerable number of pipeline failures during the past years [1]. The cracking is ten times more likely to occur under polyethylene tape (PE) coated pipelines than on asphalt or coal tar coated pipes [2]. It is most likely to occur in regions where the disbonded PE tape coating forms a long wrinkle shaped structure which could be filled with ground water (Figure 1.1).

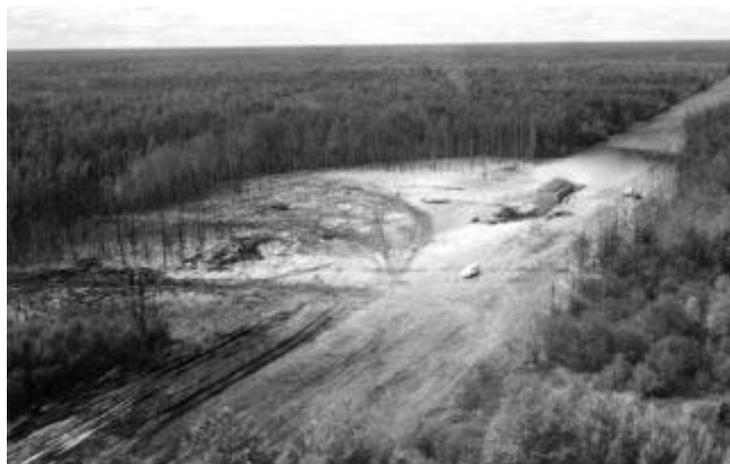
Figure 1.3: SCC pipeline failure site: Lowther, Ontario, August 1985 [1].

Stress corrosion cracks are not visible with the naked eye once initiated. They grow in both the surface and depth directions, and form colonies of cracks. If they reach a critical depth, they would cause pipeline leak or rupture. This might cost pipeline companies tens of thousands of dollar in repair and excavation costs, in addition to environmental damage and risk to the public. Figure 1.3, shows a SCC pipeline failure site [1].

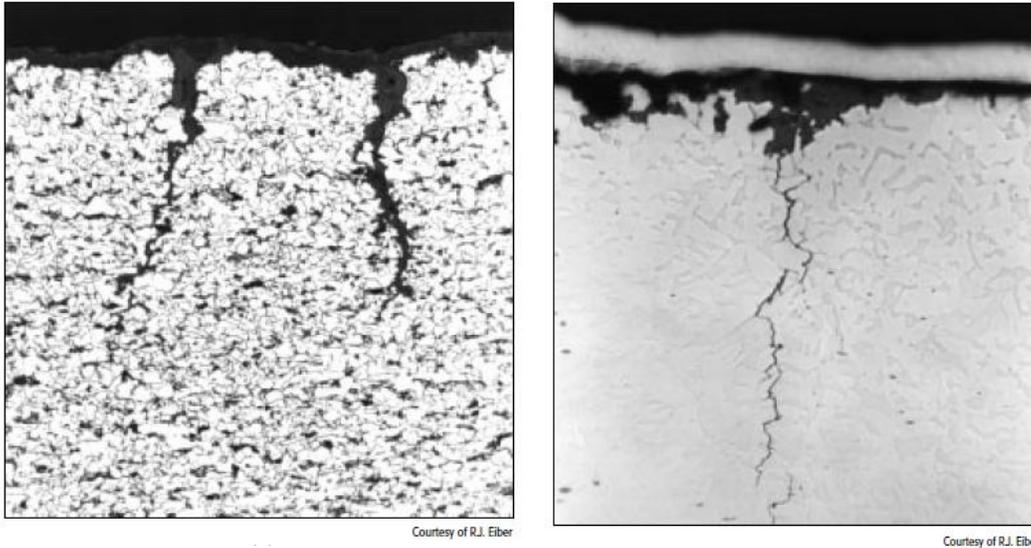
Figure 1.4: Typical cross sectional image of: (a) near-neutral pH SCC, (b) high-pH SCC [1].

microstructure with evidence of corrosion on the crack walls. Figure 1.4 shows typical cross sectional images of high-pH and near-neutral pH SCC cracks [1].

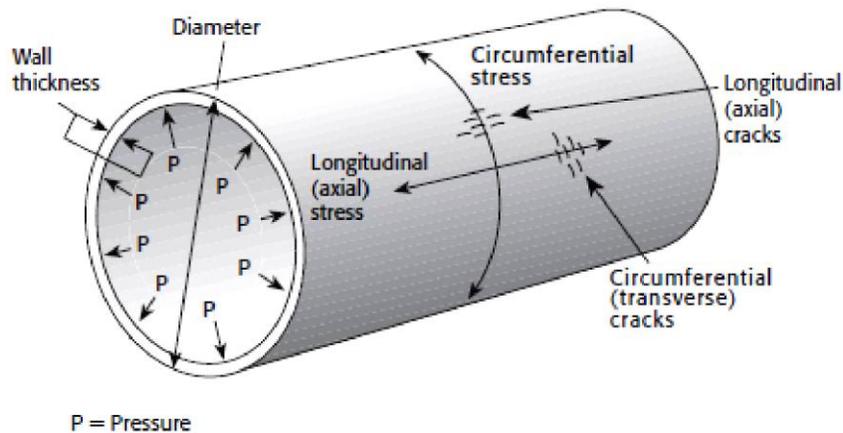
Figure 1.6: Stress and crack distribution on pipe body [1].

Stress exists on the pipe body in two main directions, i.e. longitudinal and circumferential. Near-neutral pH SCC cracks are usually observed perpendicular to these directions (Figure 1.6).

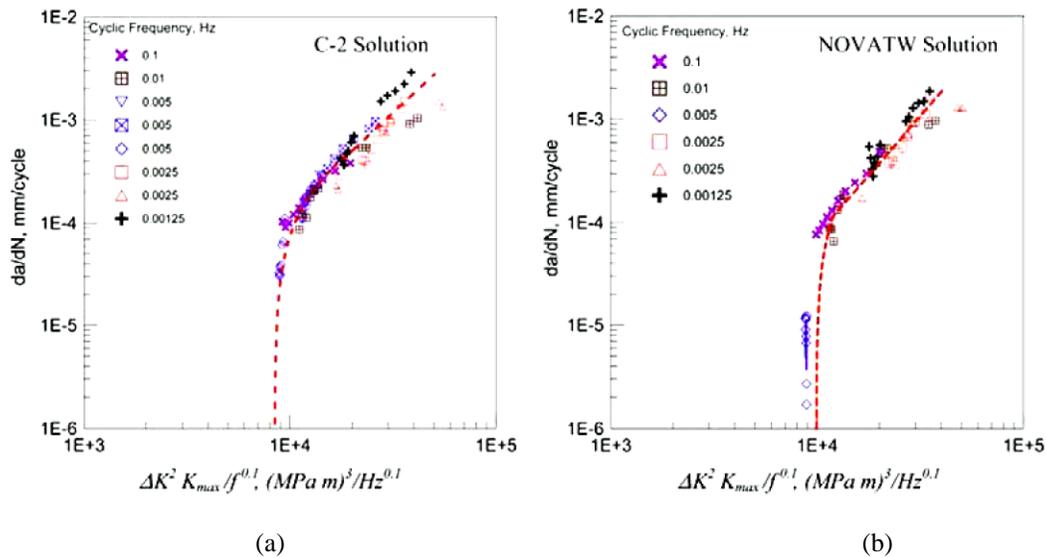
Figure 1.8: Crack growth rate da/dn as a function of $\Delta K^2 K_{\max} / f^{0.1}$ in two simulated soil solutions: (a) C2 solutions, and (b) NOVATW solution [36].

Where $\frac{da}{dn}$ is the crack growth per cycle, ΔK is the change of stress intensity over the stress cycle, K_{\max} is the maximum stress intensity during the cycle, f is the loading frequency, and α is a factor that depends on the corrosivity of the environment. In addition to predicting the crack growth rate, the Through Corrosion Fatigue Model is capable of determining a threshold as a function of loading and environment where crack dormancy could occur (see Figure 1.8).

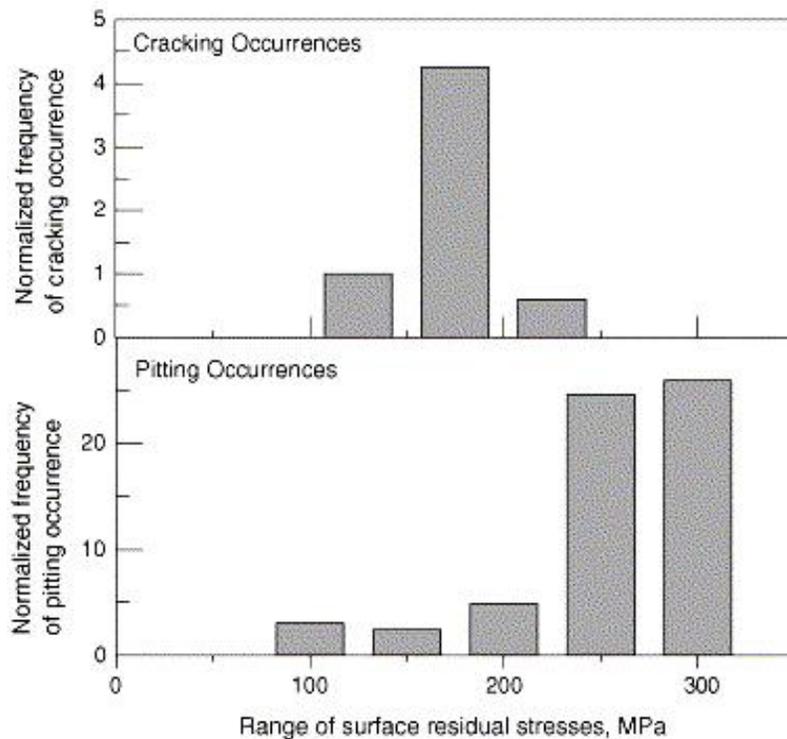
Figure 1.9: Surface residual stress versus normalized distribution of pitting and cracking after cyclic loading experiments [53].

residual stresses or in the region with the highest tensile residual stress. This suggested the value of residual stresses measured prior to neutral pH SCC testing may not be the only factor controlling the SCC initiation [53].

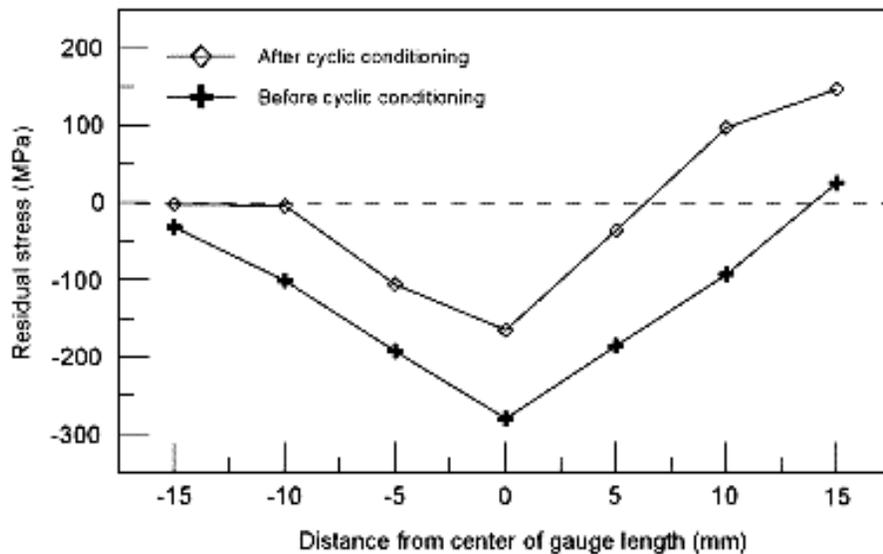
Figure 1.10: A comparison of axial residual stress along the gage length before and after cyclic loading in air [53].

Further investigations by Boven et al. showed cyclic loading could reduce both the maximum absolute residual stresses and the sharp variation of residual stresses (see Figure 1.10). The authors reported that in addition to variation of residual stresses in depth direction, this could be another reason explaining the different frequency of pitting and cracking on the specimen surface.

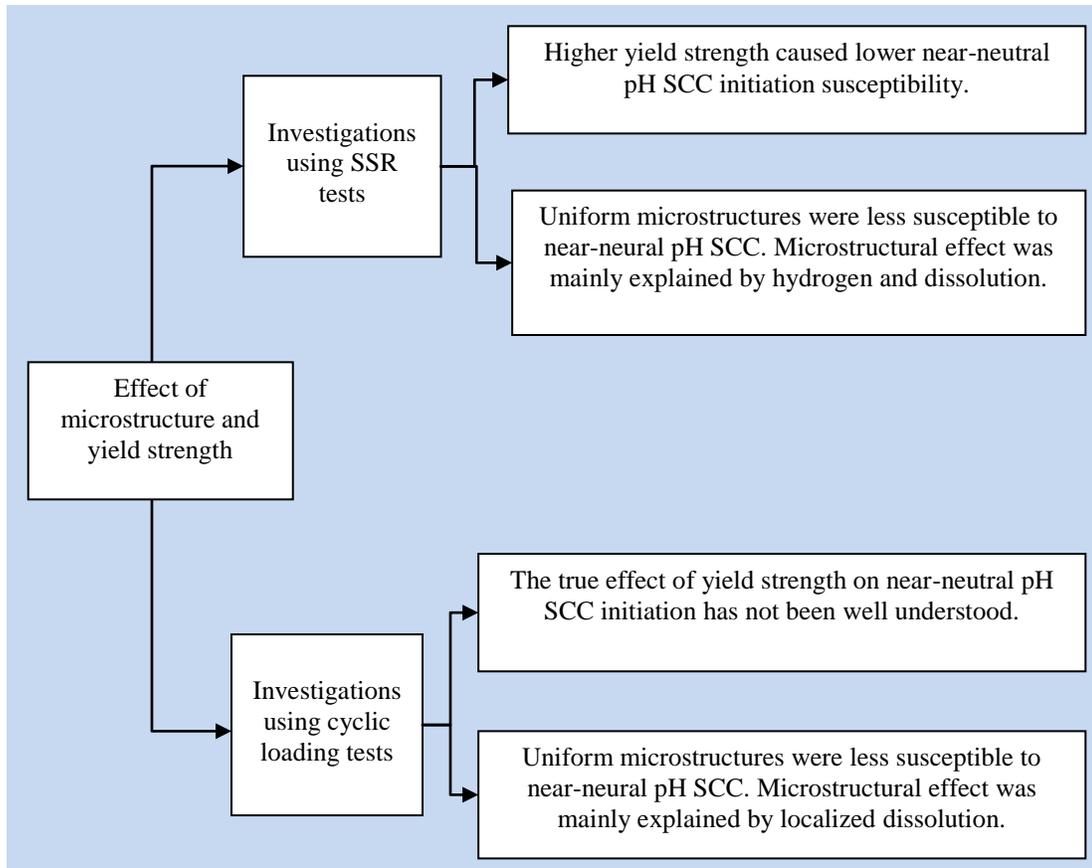
Figure 1.11: Summary graph showing effect of microstructure and yield strength on near-neutral pH SCC initiation, investigated by SSR tests and cyclic loading tests.

As determined by the two testing techniques (SSR test and cyclic loading tests), microstructural discontinuities increase the susceptibility to near-neutral pH SCC initiation. While SSR tests show steels with higher yield strength were more susceptible to crack initiation, there is no direct evidence about the effect of yield strength on near-neutral pH SCC using cyclic loading tests. The current understanding about the effect of microstructure and yield strength on near-neutral pH SCC initiation has been summarized in the chart below:

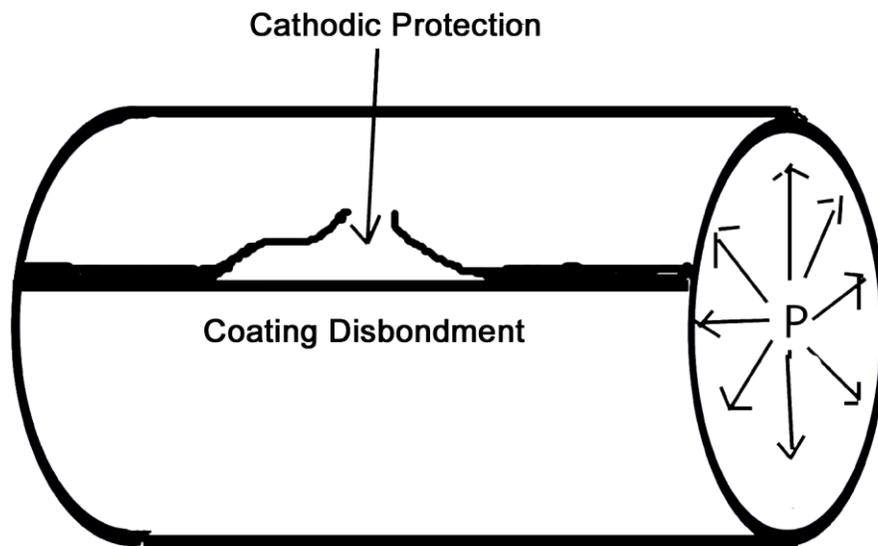
Figure 2.1: Schematic showing coating disbondment on a pipe section.

Considering field conditions, a schematic showing a coating disbondment on a pipe section was sketched (See Figure 2.1). Based on the schematic, a comprehensive test setup was designed and built. The main components of the test setup are the corrosion cell and the specimen. Each is briefly explained in the following subsections.

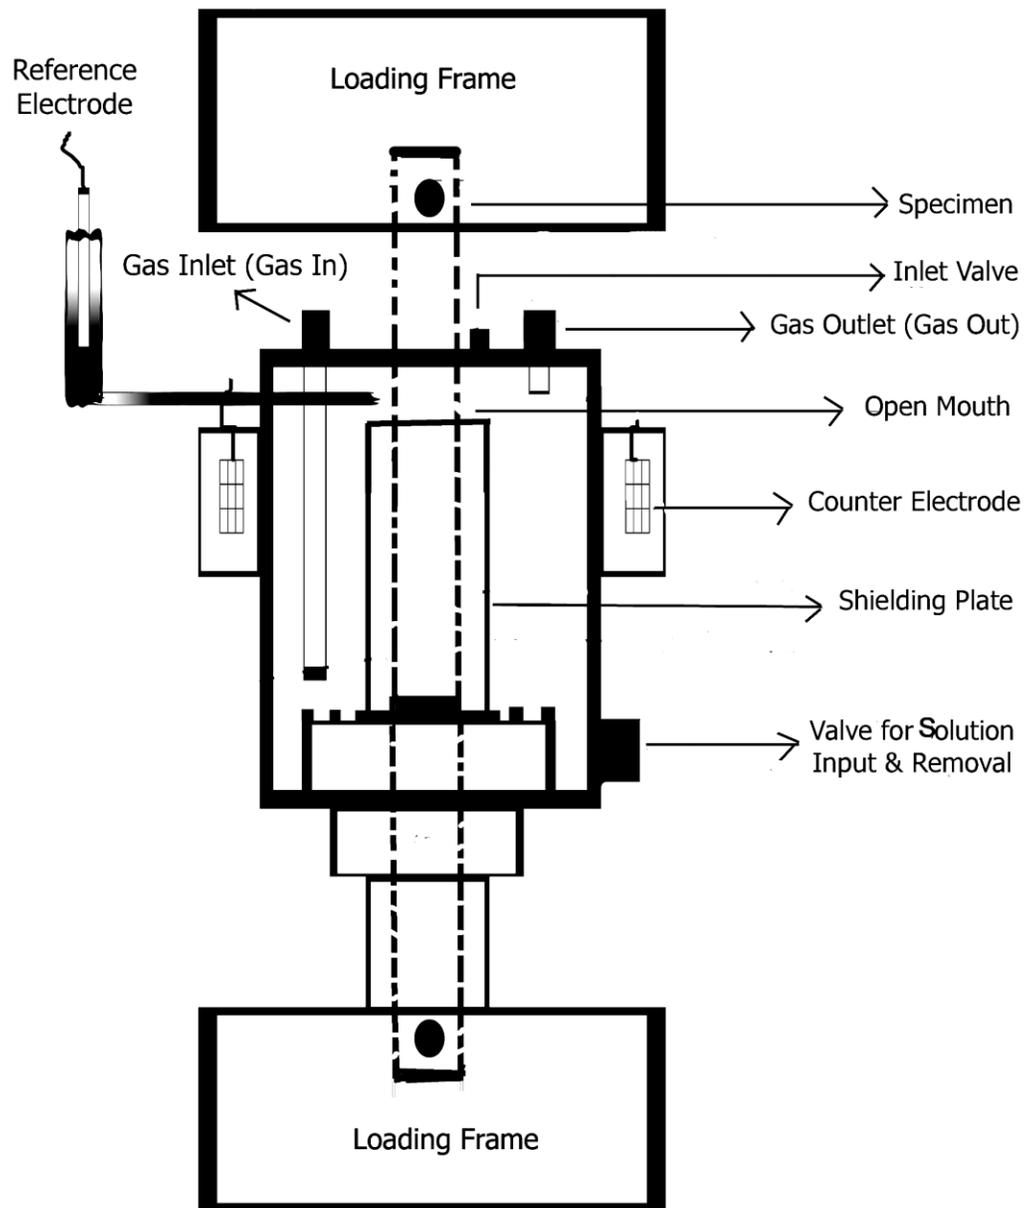
Figure 2.2: Schematic of the corrosion cell designed for simulating near-neutral pH SCC.

Figure 2.2 shows a schematic of the designed corrosion cell. The application of loading, coating disbondment, and CP have been considered in the designed corrosion cell.

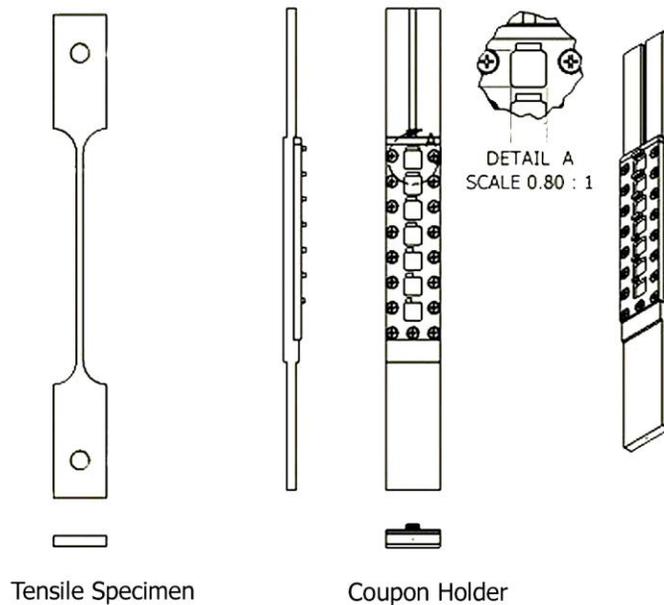
Figure 2.3: Schematic of the tensile specimen and coupon holder.

Near-neutral pH SCC is closely related to corrosion of the pipeline steel. Knowing the corrosion rate of the pipeline steel at different locations inside the coating disbondments in different environmental conditions could assist with a better understanding of near-neutral pH SCC initiation mechanisms. Therefore in order to be able to determine the corrosion rate of the pipeline steel at different positions from the OM inside the simulated coating disbondment a coupon holder was also designed and made¹. Similar to the tensile specimen the coupon holder could be sandwiched inside the simulated coating disbondment in the corrosion cell. A total number of 7 coupons made from the pipeline steel with the dimensions of (2×2×0.5) cm may be placed in the coupon holder. The coupons inside the coupon holder could be electrically connected to one another, while only their front surface would be exposed to soil solution when placed inside the corrosion cell. This would make determining the weight loss of the metal when there is a gradient of CP under the coating disbondment possible. Figure 2.3 shows a schematic of the designed tensile specimen and coupon holder.

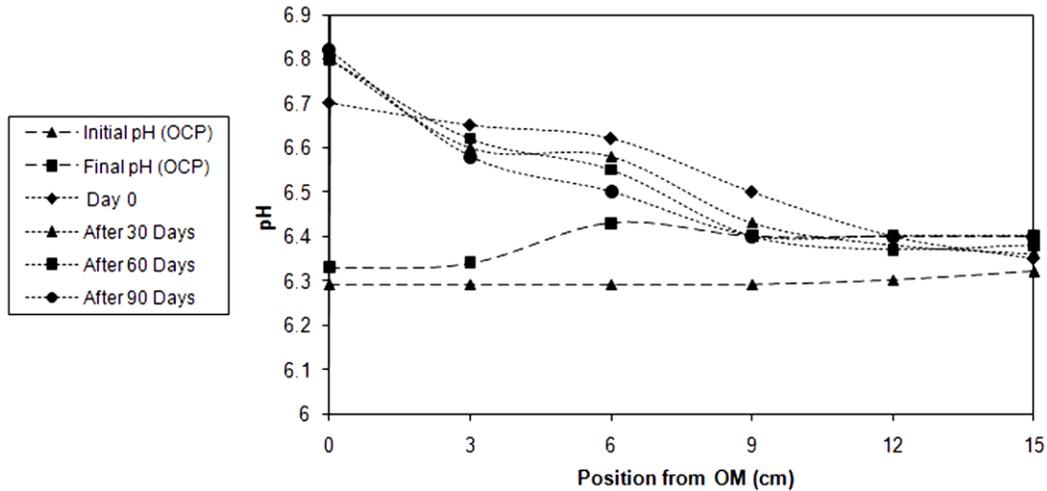
Figure 3.2: pH distribution of the soil solution inside the shielding at different positions from OM, at different time intervals.

Despite a significant potential difference at various positions from OM, section 3.3.2, only minor pH differences were observed. This can be explained by the mixing of the solution by the flowing gas 5%CO₂/N₂.

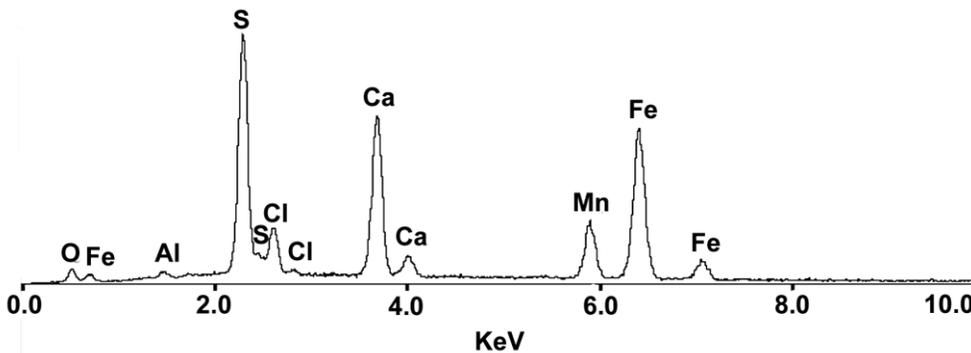
Figure 3.5: EDX spectra showing the composition of the non-metallic inclusion.

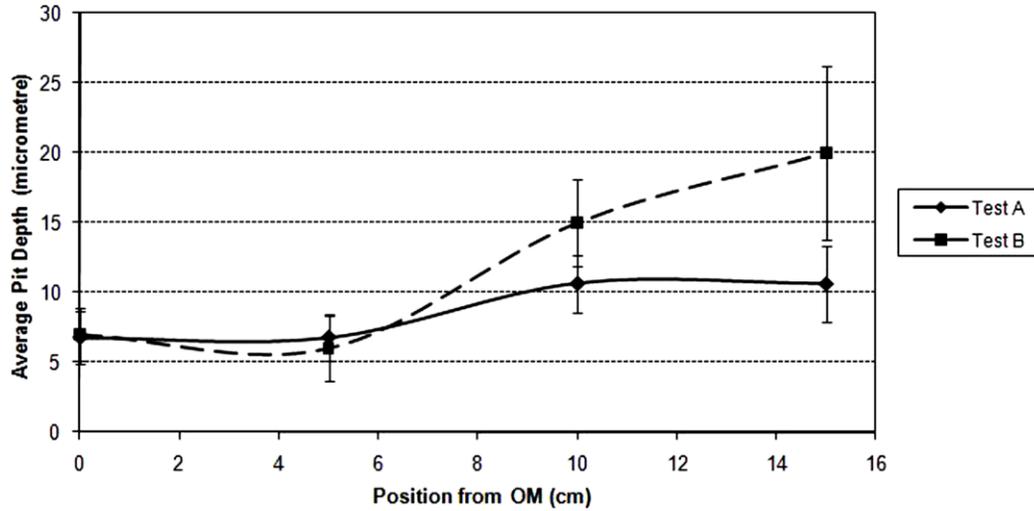
Figure 3.8: Average pit depth as a function of position from OM in Test A and Test B.

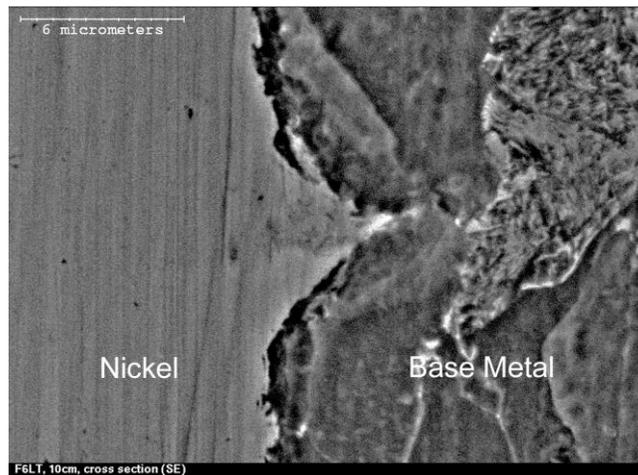
Figure 3.9: Secondary Scanning Electron Microscope (SEM) image showing the cross section of the sample after Test B, at 10 cm from the OM.

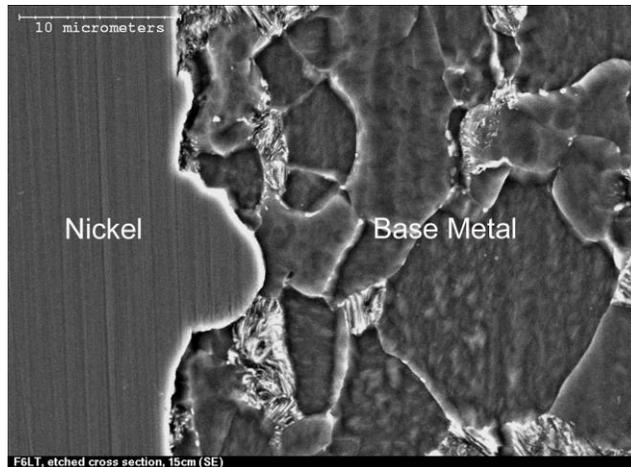
Figure 3.10: Secondary Scanning Electron Microscope (SEM) image showing the cross section of the sample after Test B, at 15 cm from the OM.

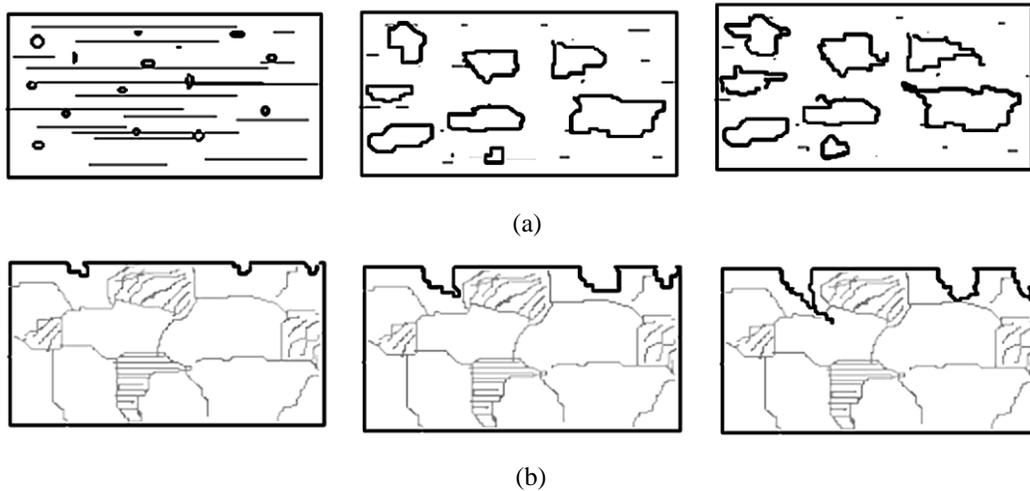
Figure 3.11: Schematic showing SCC initiation mechanism from: (a) surface of pits (surface view), (b) Bottom of pits (cross section view).

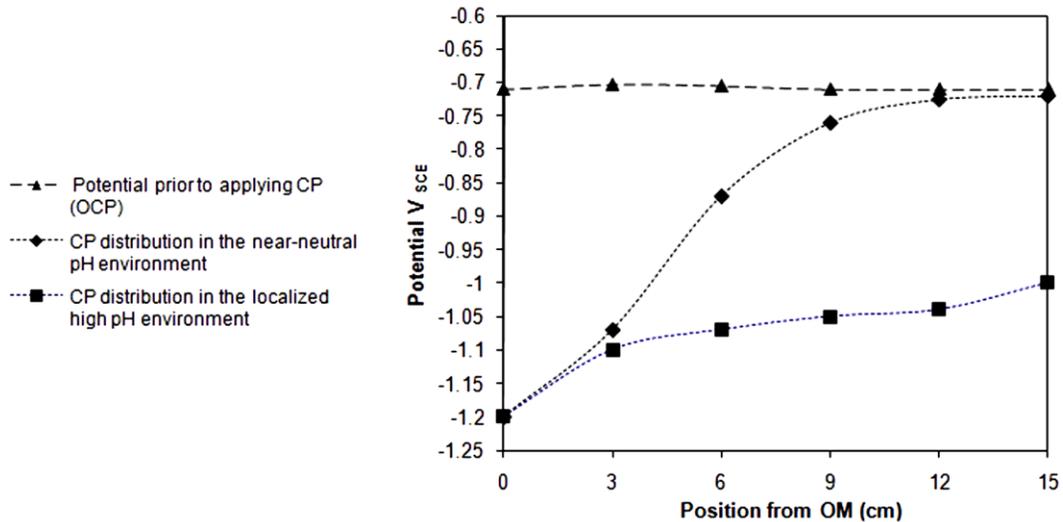
Figure 4.3: Potential distribution prior and after applying CP at different positions from the OM (cm).

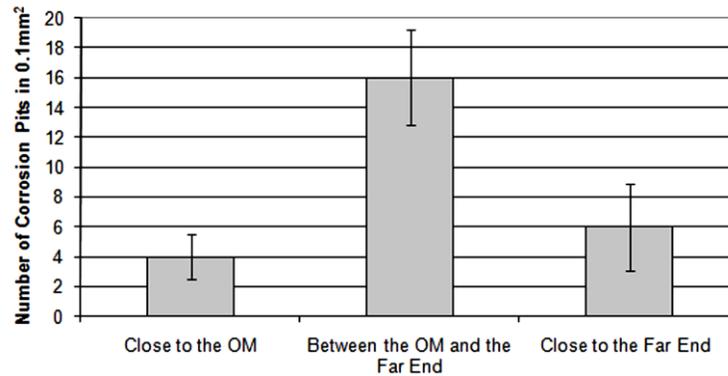
Figure 4.5: A semi-quantitative distribution of the number of corrosion pits at different positions from the OM after Test A.

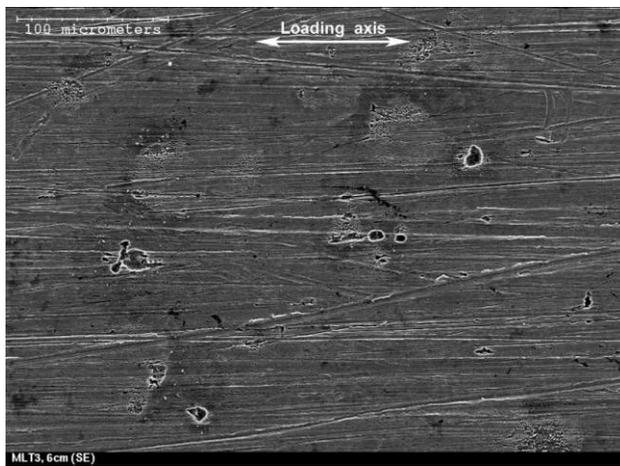
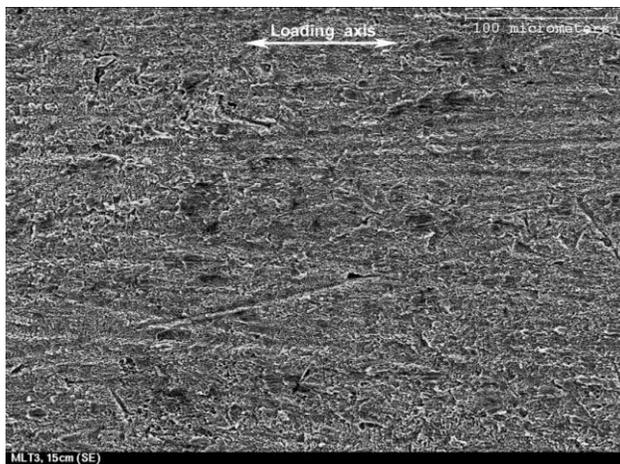
Figure 4.6: Typical surface morphologies of the tensile specimen after Test B at: (a) close to OM, (b) between the OM and the far end, (c) remote from the OM.

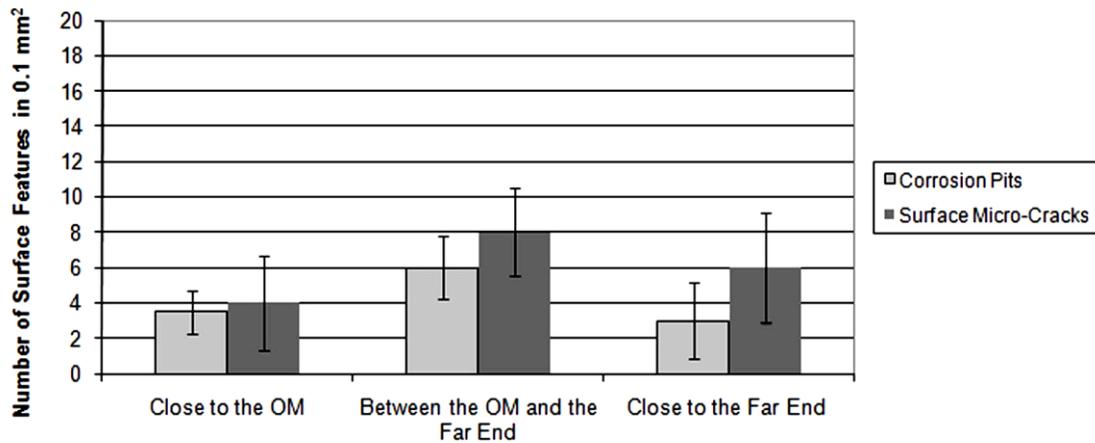
Figure 4.8: A semi-quantitative distribution of the number of corrosion pits and surface micro-cracks at different positions from the OM after Test B.

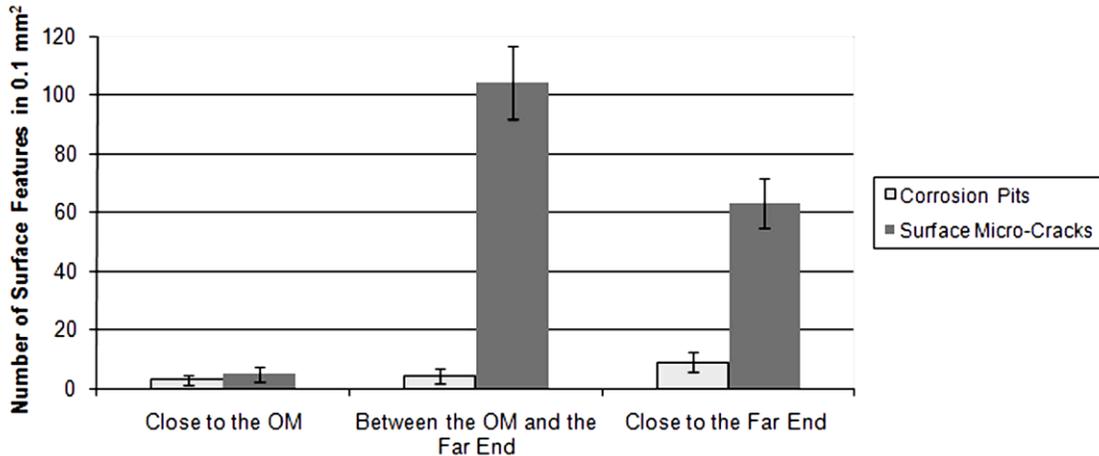
Figure 4.10: A semi-quantitative distribution of the number of corrosion pits and surface micro-cracks at different positions from the OM after Test C.

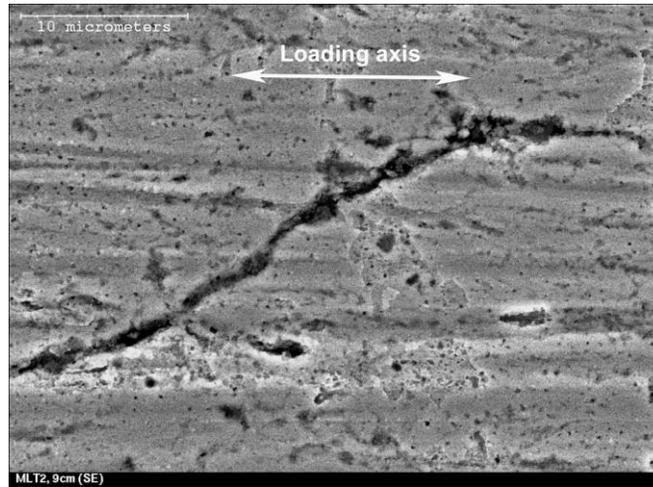
Figure 4.11: High magnification image showing the formation of several sub-micrometer pits in and around the surface micro-cracks after Test C.

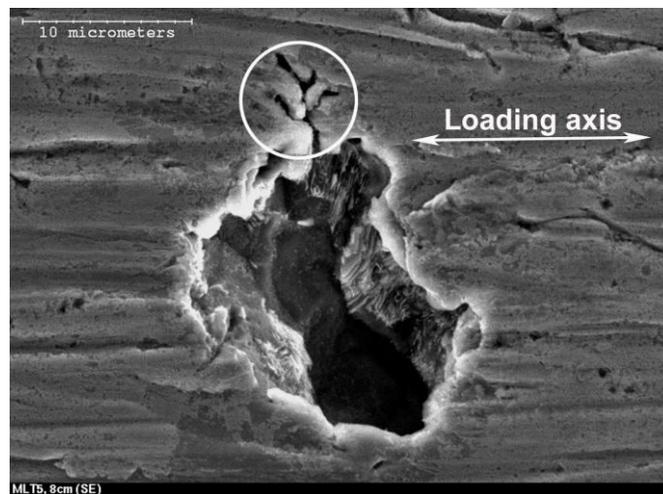
Figure 4.12: Typical image showing branched micro-cracks initiated at the mouth of a large pit after Test D. Circle shows branched micro-cracks which were initiated at and branched out from the mouth the pit during the test.

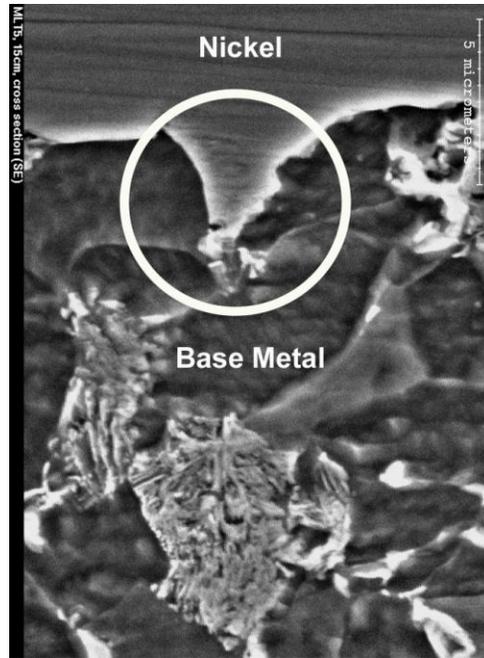
Figure 4.13: Typical image showing the cross section of the sample after Test D. Circle shows the cross section of a pit with a sharp tip formed during the test.

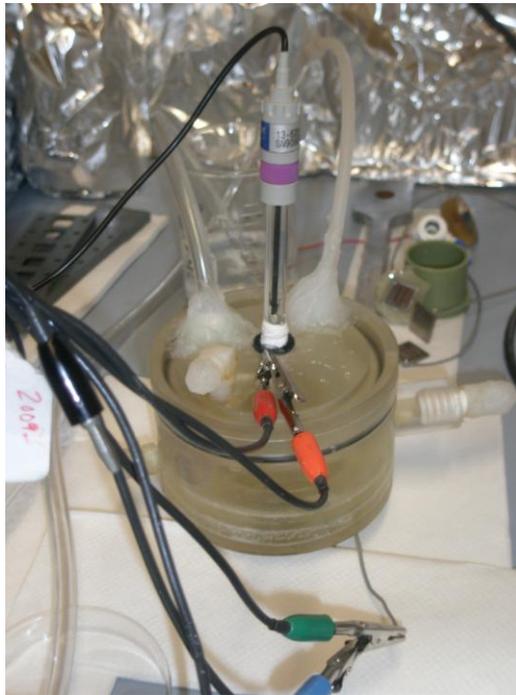
Figure 5.1: Digital camera image of the test setup used of electrochemical polarization tests.

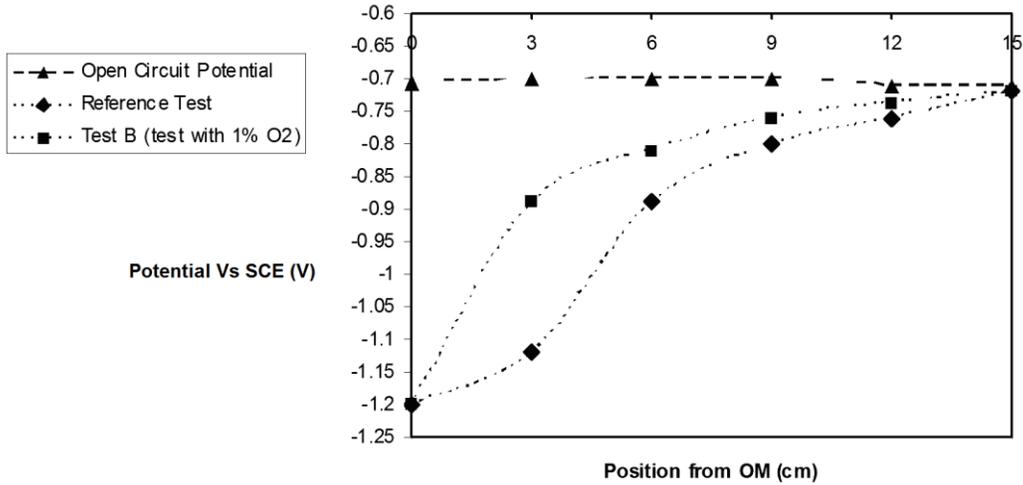
Figure 5.5: Open Circuit Potential and CP potential distribution at different positions from the OM, at the beginning of Reference Test and Test B (the test with 1% oxygen).

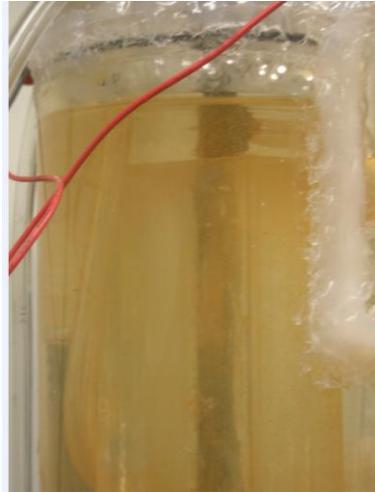
Figure 5.6: Digital camera image of the specimen inside the corrosion cell at the end of Test B (the test with 1% oxygen).

Figure 5.6 shows a digital camera image of the specimen inside the corrosion cell after Test B. As can be seen from this figure the solution inside the corrosion cell has a yellowish color compared to the relatively clear solution in the Reference Test (see Figure 5.4). The yellowish color of the solution in Test B should be due to formation of considerable amount of FeOOH during the test¹ (Equation 5-5 –

5-6), as a result of oxygen in the testing environment. Similar to the Reference Test, surface deposits mainly consisting of CaCO_3 were formed close to the OM.

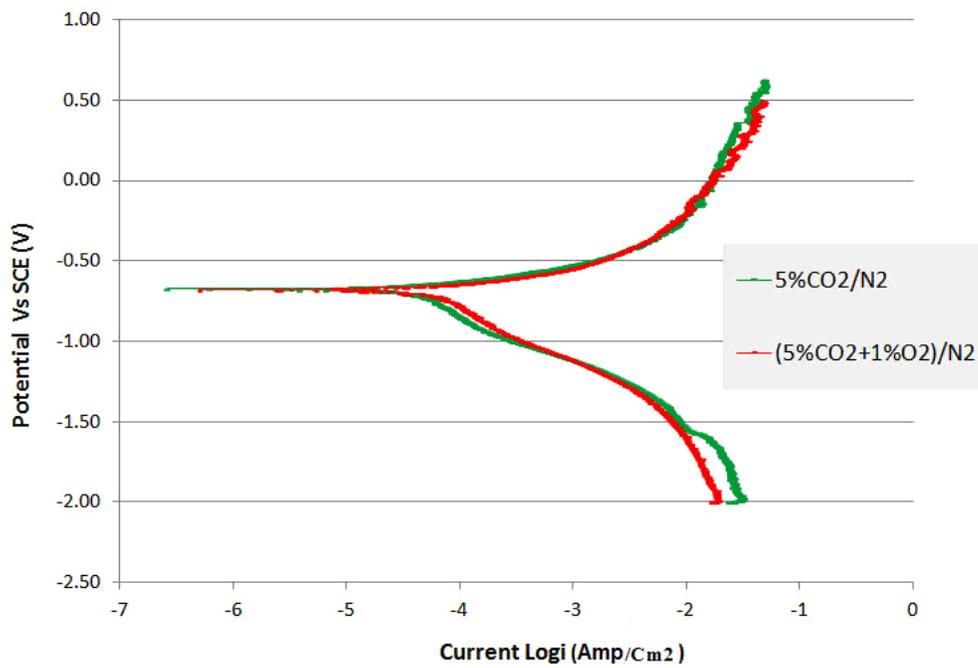
Figure 5.8: Potentiodynamic polarization curves for X-65 steel in test environments with and without any oxygen (C2 solution purged with (5%CO₂+1%O₂)/N₂ and C2 solution purged with 5%CO₂/N₂).

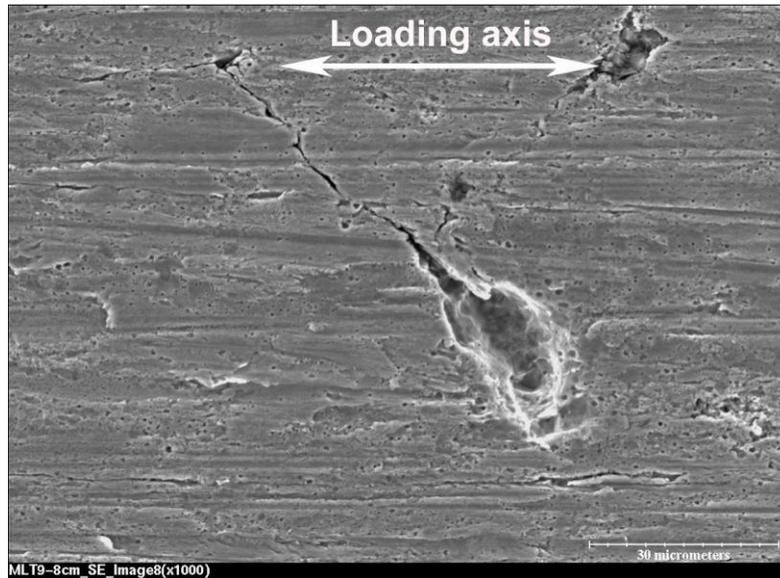
Figure 5.10: A relatively long micro-crack initiated from the mouth of a pit at 8 cm from the OM in Test B (the test with the effect of 1% oxygen).

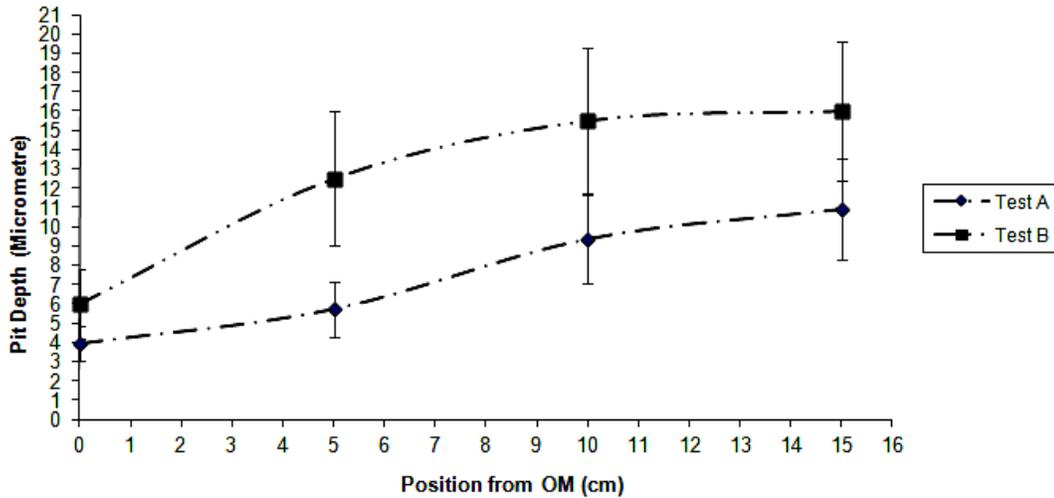
Figure 5.12: Average pit depth as a function of position from the OM in Test A (the Reference Test), compared to Test B (the test with the effect of 1% oxygen).

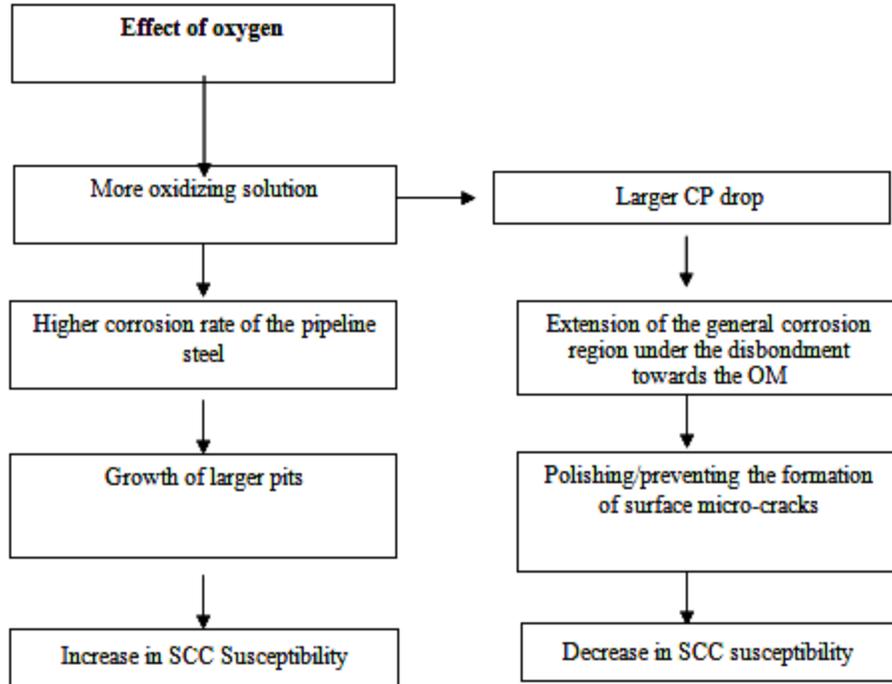
Figure 5.13: Effect of oxygen on crack initiation on pipeline steel surface under the coating disbondment.

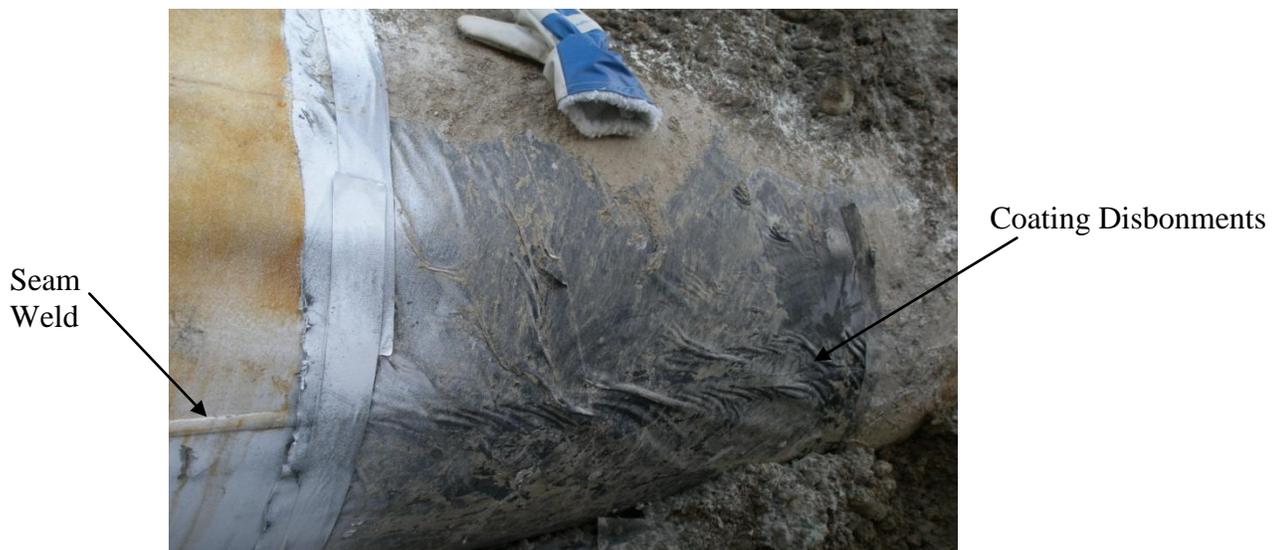
Figure 6.1: Typical image of coating disbondments formed on a seam weld of a pipe section.

Disbonded coatings (Figure 6.1) are one of the most common types of pipeline tape coating failures, which can form along the weld seam of some welds, particularly longitudinal DSAW (Double Submerged Arc Welds) [1]. Although there has been considerable research on different forms of corrosion of pipeline steels [2-6], there is limited research considering the effect of coating disbondments on external corrosion of pipeline steels. Having a better understanding of this issue could be important for pipeline integrity management and safe operation.

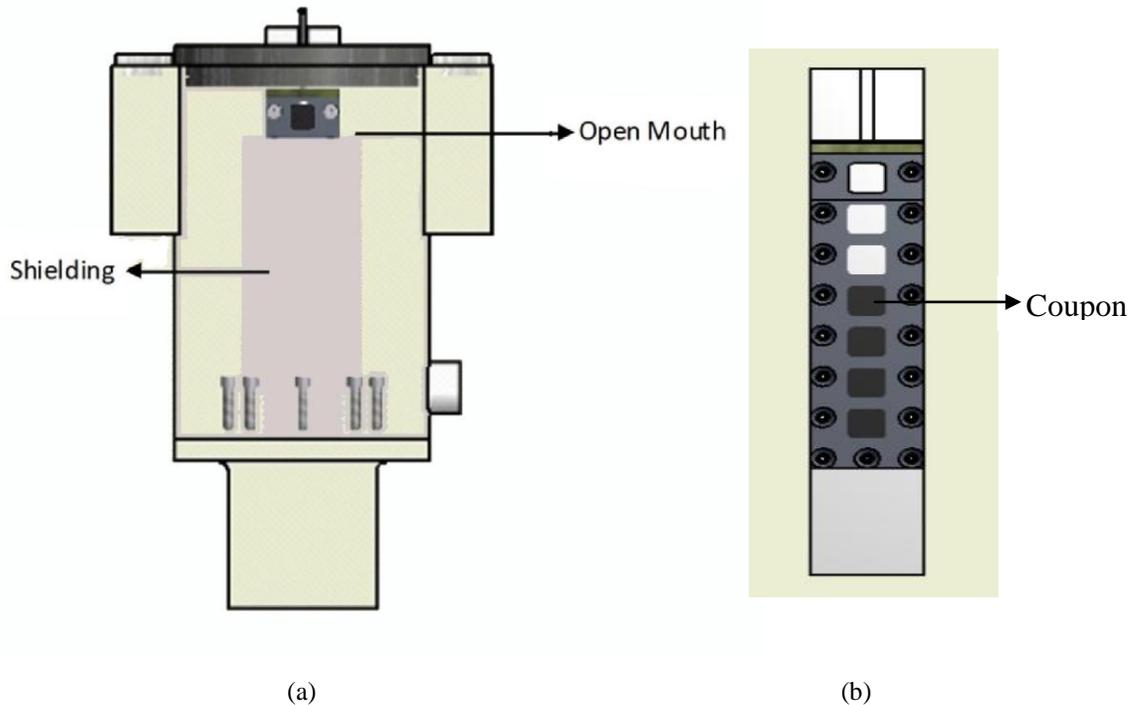
Figure 6.2: (a) Schematic of the corrosion cell with the shielding, (b) schematic of the coupon holder with coupons.

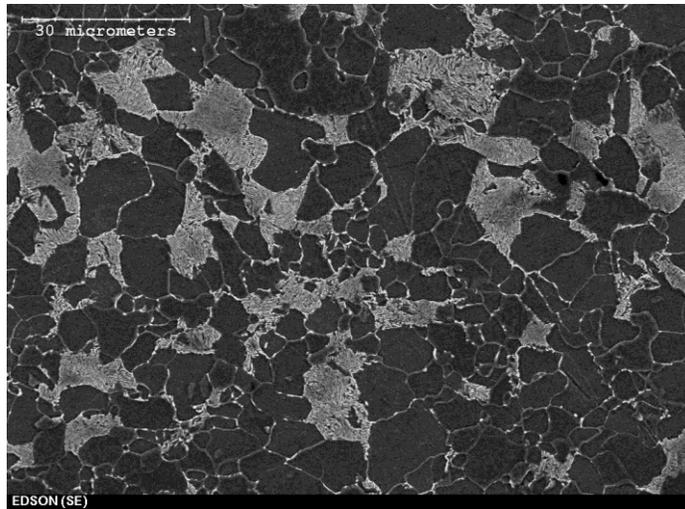
Figure 6.3: Typical microstructure of the X-65 pipeline steel investigated in this study.

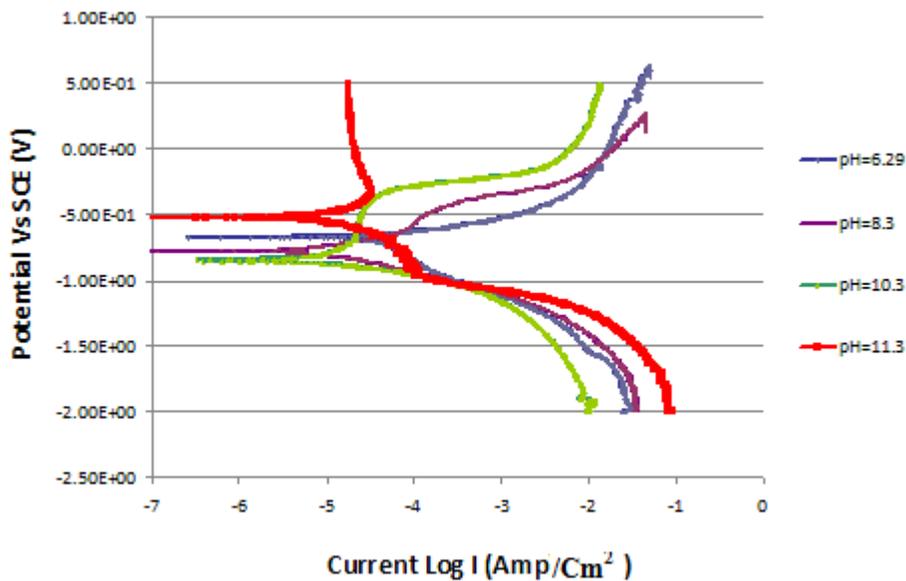
Figure 6.4: Diagram of the potentiodynamic scanning for the X-65 pipeline steel at different pH values.

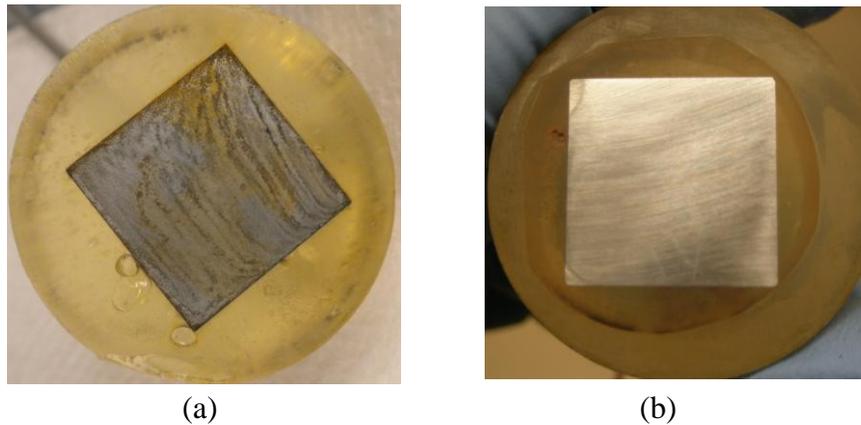
Figure 6.5: Digital camera image showing X-65 pipeline steel surface 3after the potentiodynamic polarization scan at different pH values: (a) at pH=6.29, and (b) at pH=11.

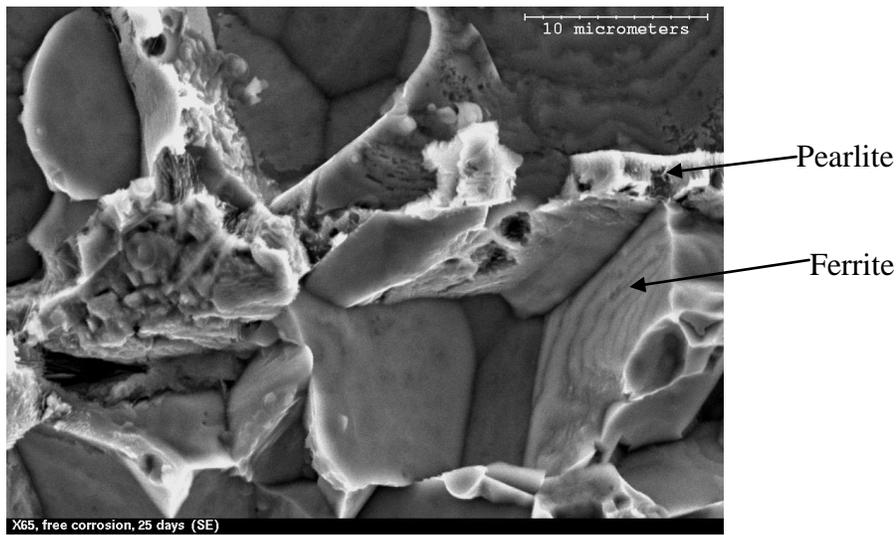
Figure 6.6: (a) Typical image of the steel surface after Test A (30 day test without considering coating disbondment at OCP), (b) high magnification image showing selective corrosion of ferrite after Test A.

A typical image of the steel surface after the 30 day weight loss test in the near-neutral pH environment is shown in Figure 6.6a. As can be seen from this figure, the steel surface has been corroded with pits on the surface. Different mechanisms could be responsible for the pitting corrosion on the steel surface in the simulated near-neutral pH soil solutions. Preferential corrosion of crystallographic planes having different orientations, galvanic coupling between different phases in the steel microstructure and dissolution of inclusions are some of the mechanisms identified in a previous study [18]. Figure 6.6b shows how ferrite could selectively be corroded around pearlite on the steel surface.

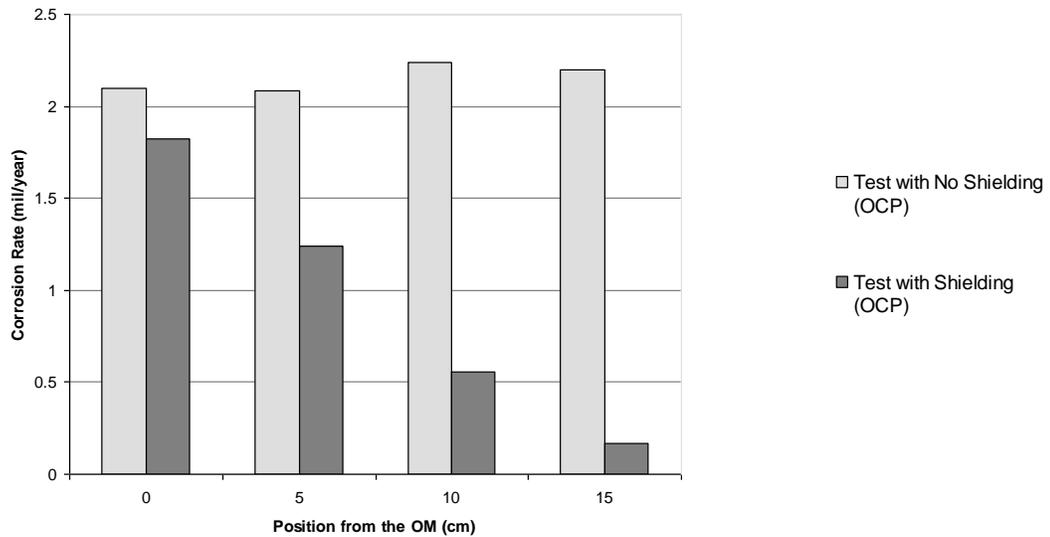
Figure 6.7: Corrosion rate of X-65 pipeline steel after the 30 day weight loss corrosion tests at OCP condition at different positions from the OM inside the simulated coating disbondment compared with test at OCP where no coating disbondment was used.
