Near-neutral pH Stress Corrosion Crack Initiation under Simulated Coating
Disbondment

A thesis submitted to the Faculty of Graduate Studies and Research
in partial fulfillment of the requirements for the degree of

Materials Engineering

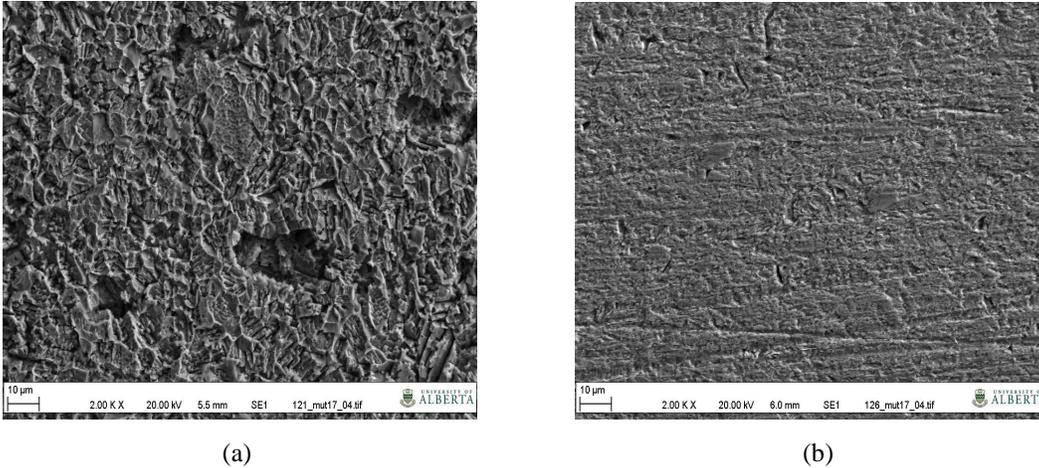
Figure 6.8: Typical images showing the X-65 pipeline steel microstructure at: a) close to OM, b) far end from the OM, after the 30 day weight loss corrosion test.

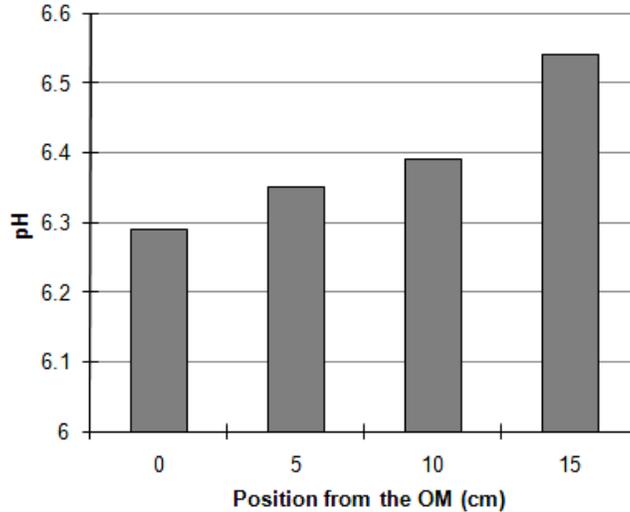
Figure 6.9: pH distribution under the simulated coating disbondment at different positions from the OM.

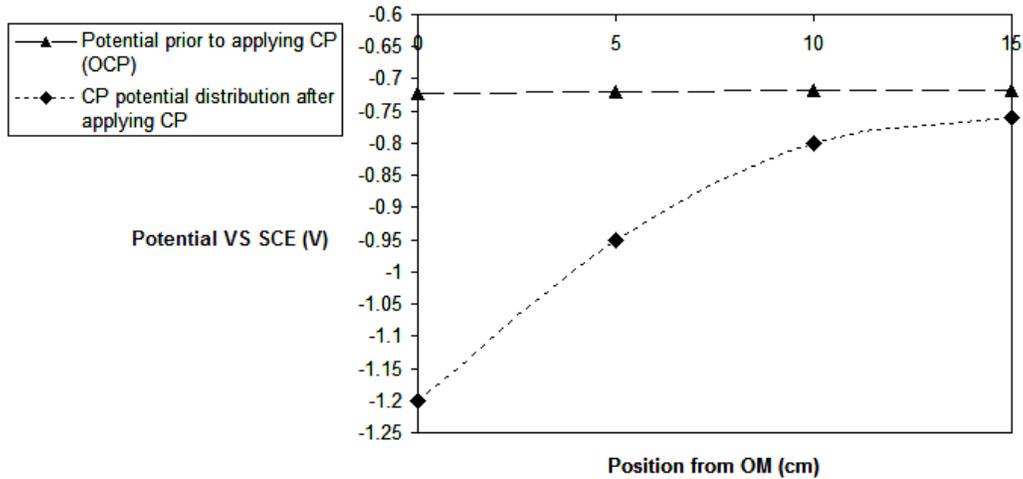
Figure 6.10: Potentials distribution at different positions from the OM, before and after a CP of $-1.2V_{SCE}$ was applied to the OM.

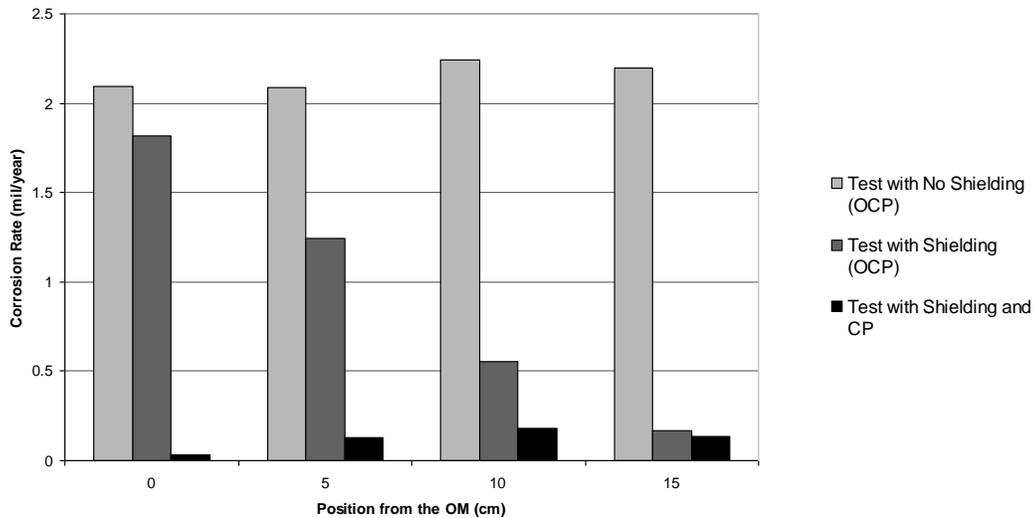
Figure 6.11: Effect of CP on corrosion mitigation under the coating disbondment at different positions from the OM, compared with OCP tests at situation with and without the shielding effect of the simulated coating disbondment after the 30 day weight loss corrosion tests.

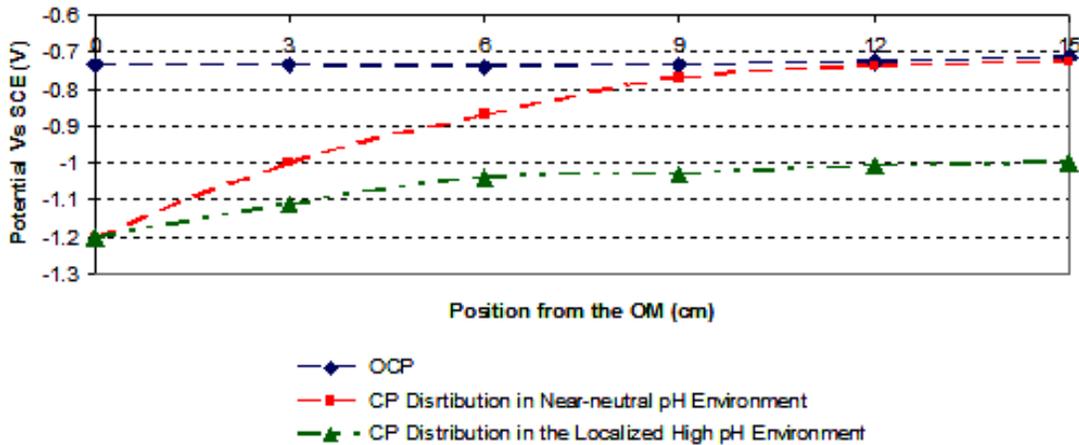
Figure 7.2: CP potential distribution in the Reference Test, at different positions from the OM in near-neutral pH and localized high and environment compared to the open circuit potential (OCP).

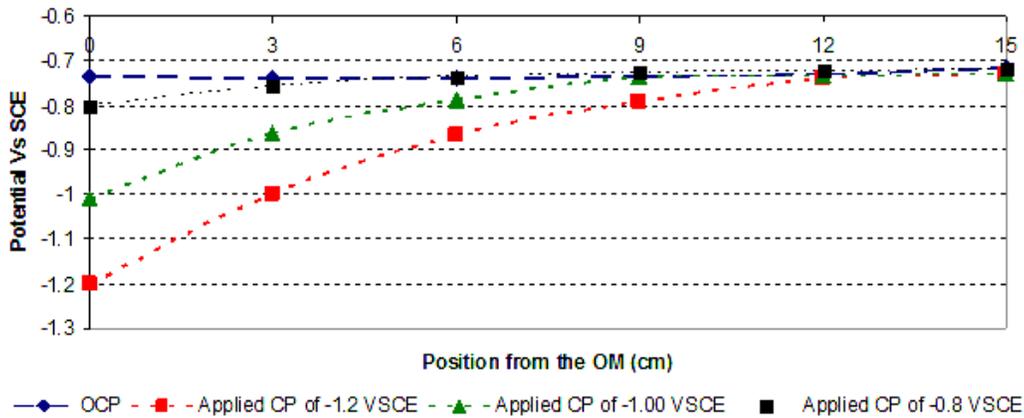
Figure 7.4: CP potential distribution at different positions from the OM in near-neutral pH environment, when CP potentials of $-1.2 V_{SCE}$, $-1.00 V_{SCE}$ and $-0.8 V_{SCE}$ were applied to the OM, compared to the OCP.

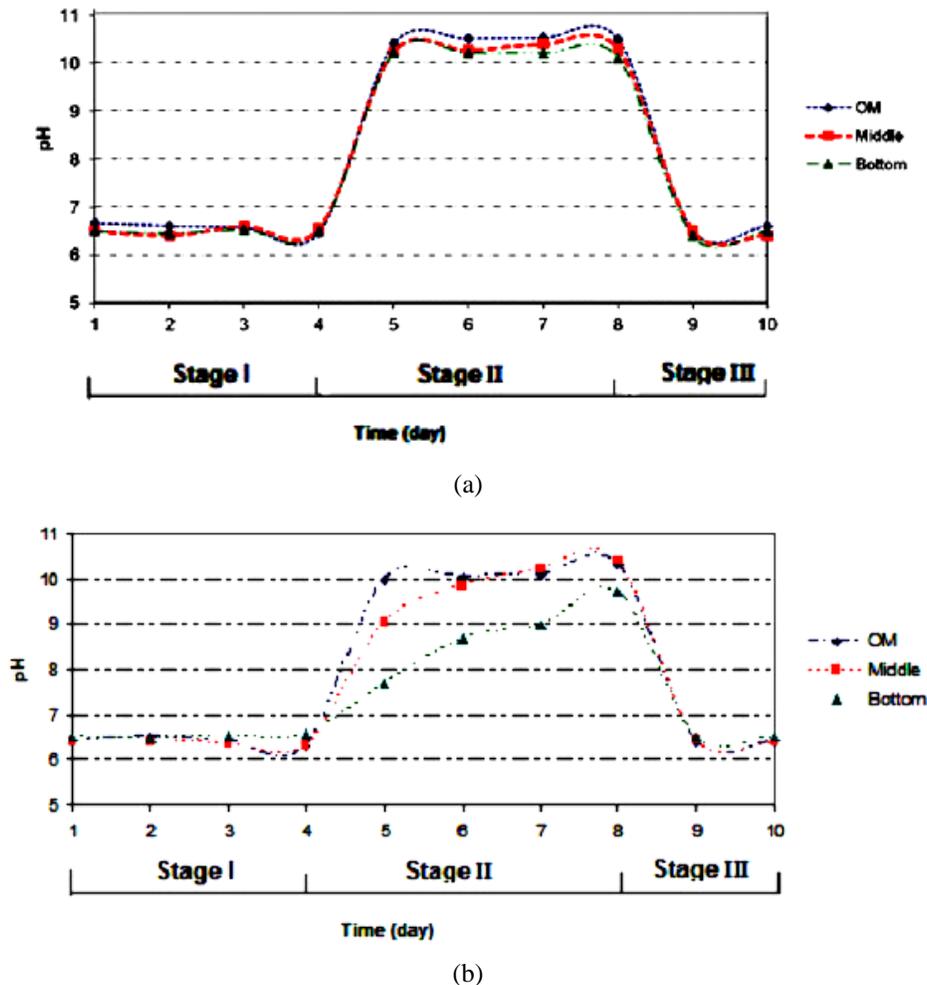
Figure 7.5: pH variation at different positions from the OM in: (a) the Reference Test, (b) the test with double exposed steel surface area. Gas containing 5% CO₂/N₂ is being supplied in stages I, and is turned off at the beginning of stage II, and turned on again in stage III.

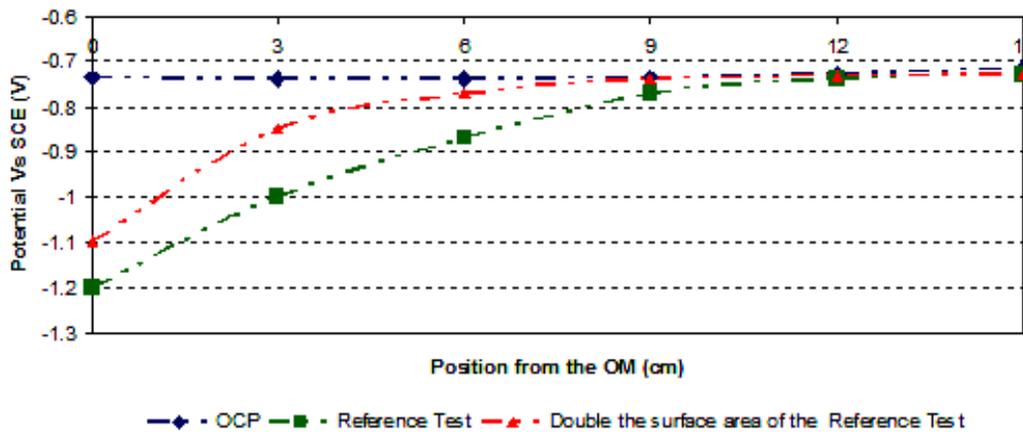
Figure 7.6: OCP and CP potential distribution at different positions from the OM in near-neutral pH environment in the test with double the surface area compared to the Reference Test².

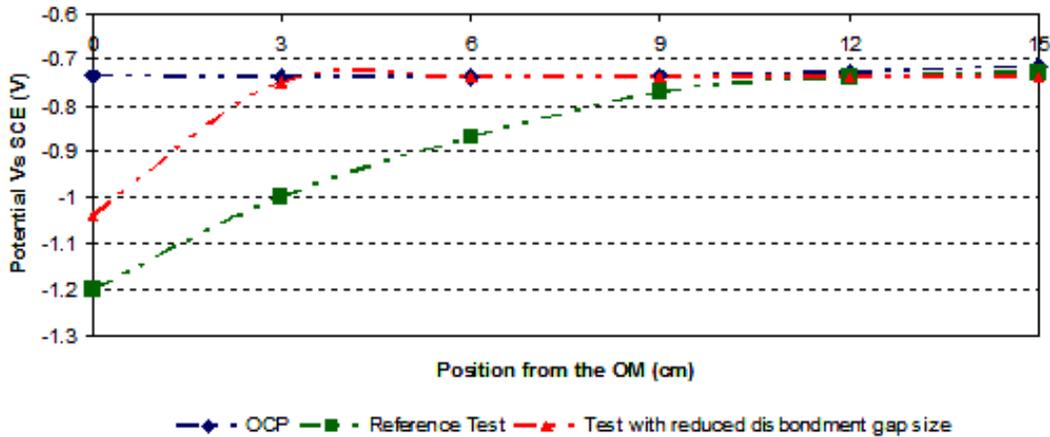
Figure 7.8: OCP and CP potential distribution at different positions from the OM in near-neutral pH environment in the test with reduced disbondment gap size compared to the Reference Test².

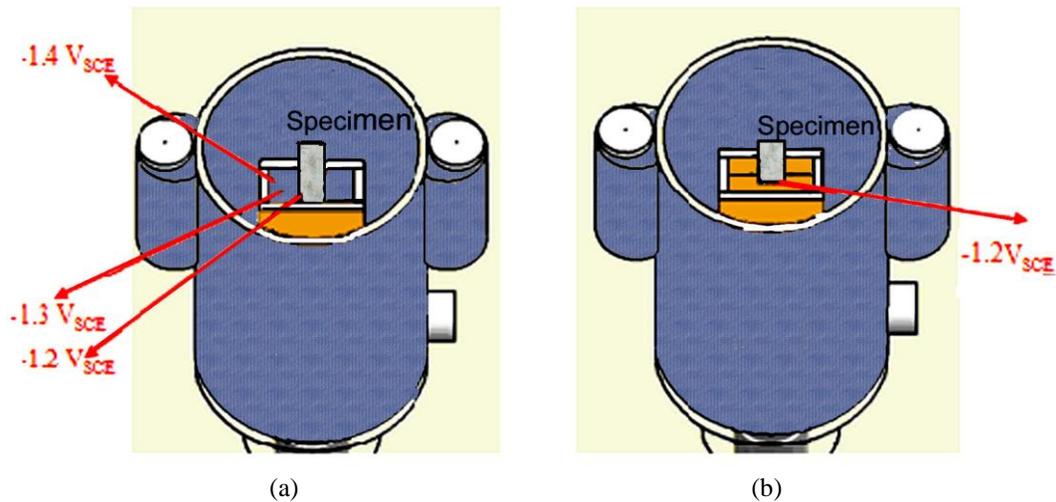
Figure 7.9: CP potential distribution around the OM of the simulated coating disbondment: a) in the Reference Test, b) in the test with reduced disbondment gap size.

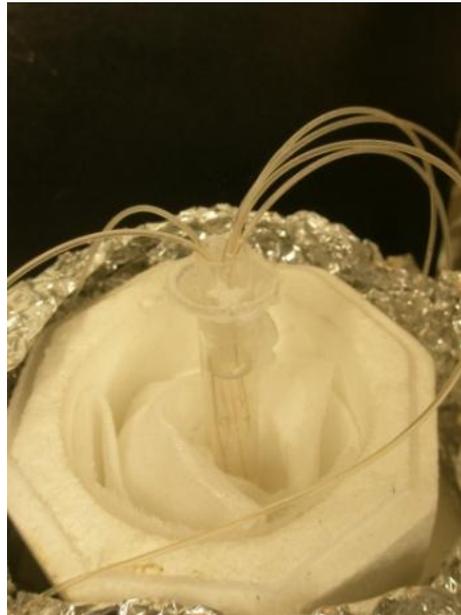
A.4. Micro-electrodes used for determining the pH inside coating disbondments

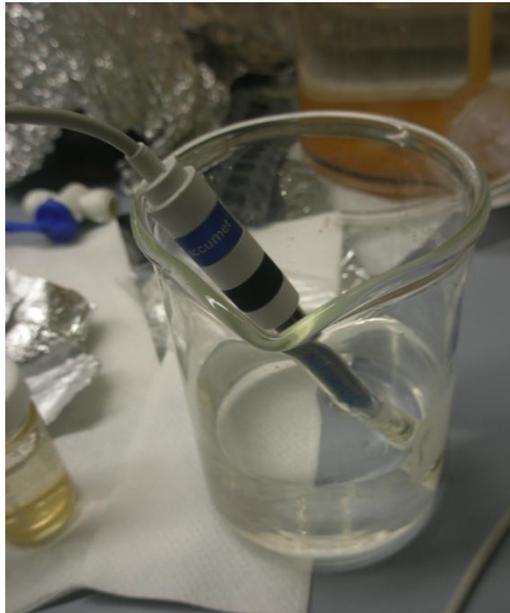
A.6. Conductivity probe used for determining the conductivity and resistivity of soil solutions
