**Rehabilitation of Unreinforced Masonry Walls With Externally Applied Fiber
Reinforced Polymers**

**A thesis submitted to the Faculty of Graduate Studies and Research in partial
fulfillment of the requirements for the degree of Master of Science**

Structural Engineering

Department of Civil and Environmental Engineering

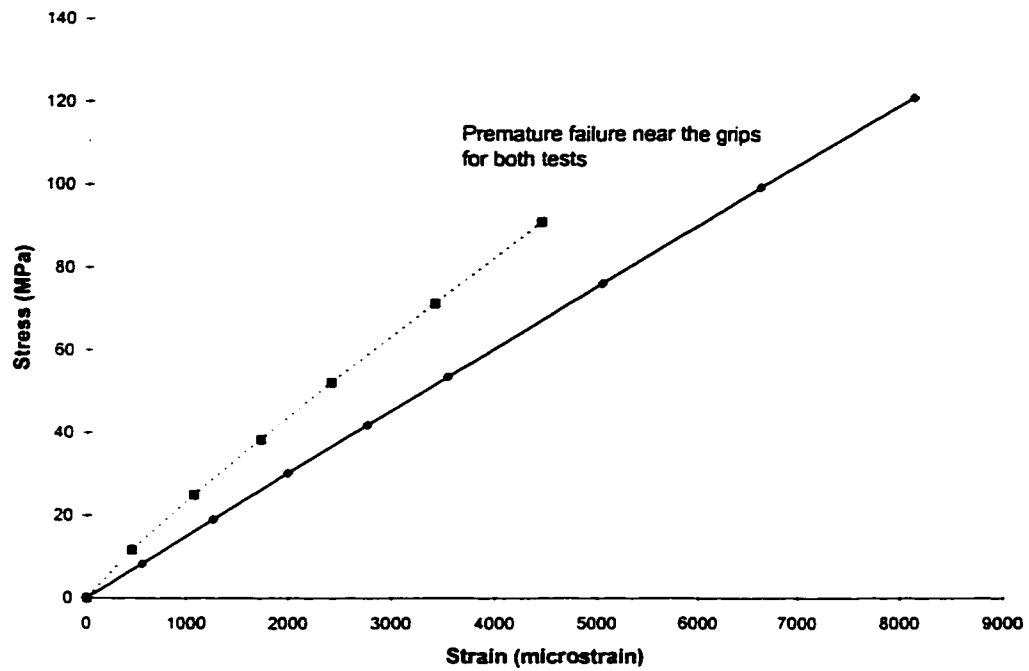
Figure 3.3 Glass Fiber Tension Test Behaviour

The glass sheet used was supplied by Fyfe LLC and had the brand name Tyfo S. The sheets were delivered in large rolls and had to be cut to size. Two coupons were constructed at the same time as the application of the glass fibers to Specimen MGST 5. Both glass fiber coupons failed near the grips.

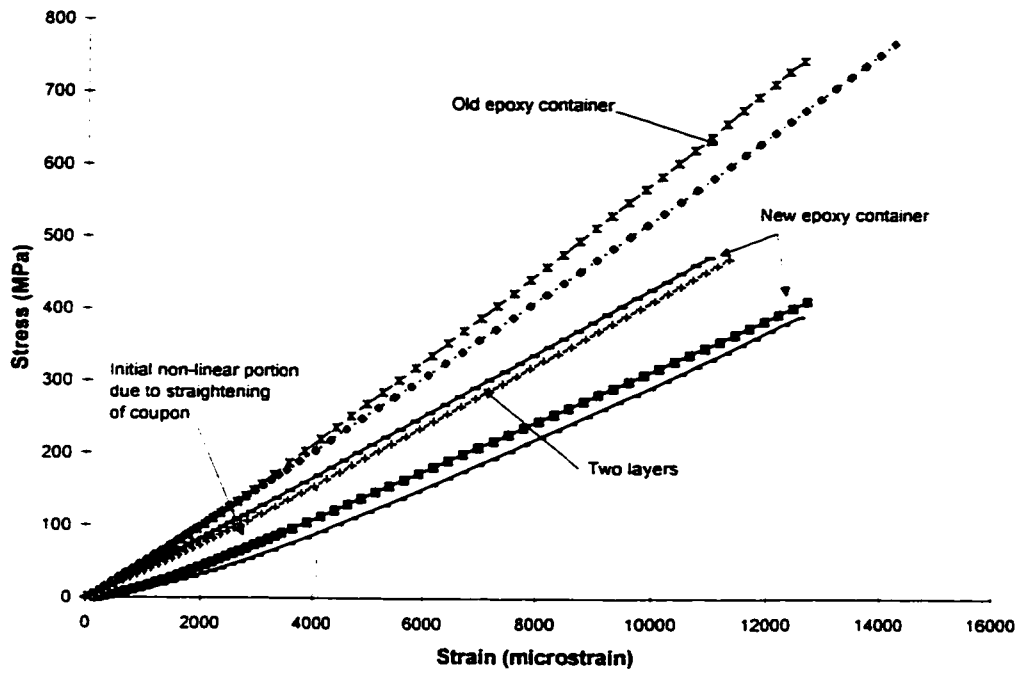
Figure 3.5 Carbon Sheet Tension Test Behaviour

Again, the variability in measured thickness is mainly the reason behind the inconsistent curves. The modulus of elasticity reported in Table 3.4 is calculated from a regression line fit to the data in Fig. 3.5 after 4000 microstrain. The lowest R^2 value, which is an statistical value used to determine the accuracy of a regression line with 1.0 indicating a perfect match, achieved from the regression analysis was 0.9991. The 4000 microstrain condition was imposed because the mounting of the extensometer caused some initial bending in the thin fiber coupons and is not representative of the true stiffness of the material.

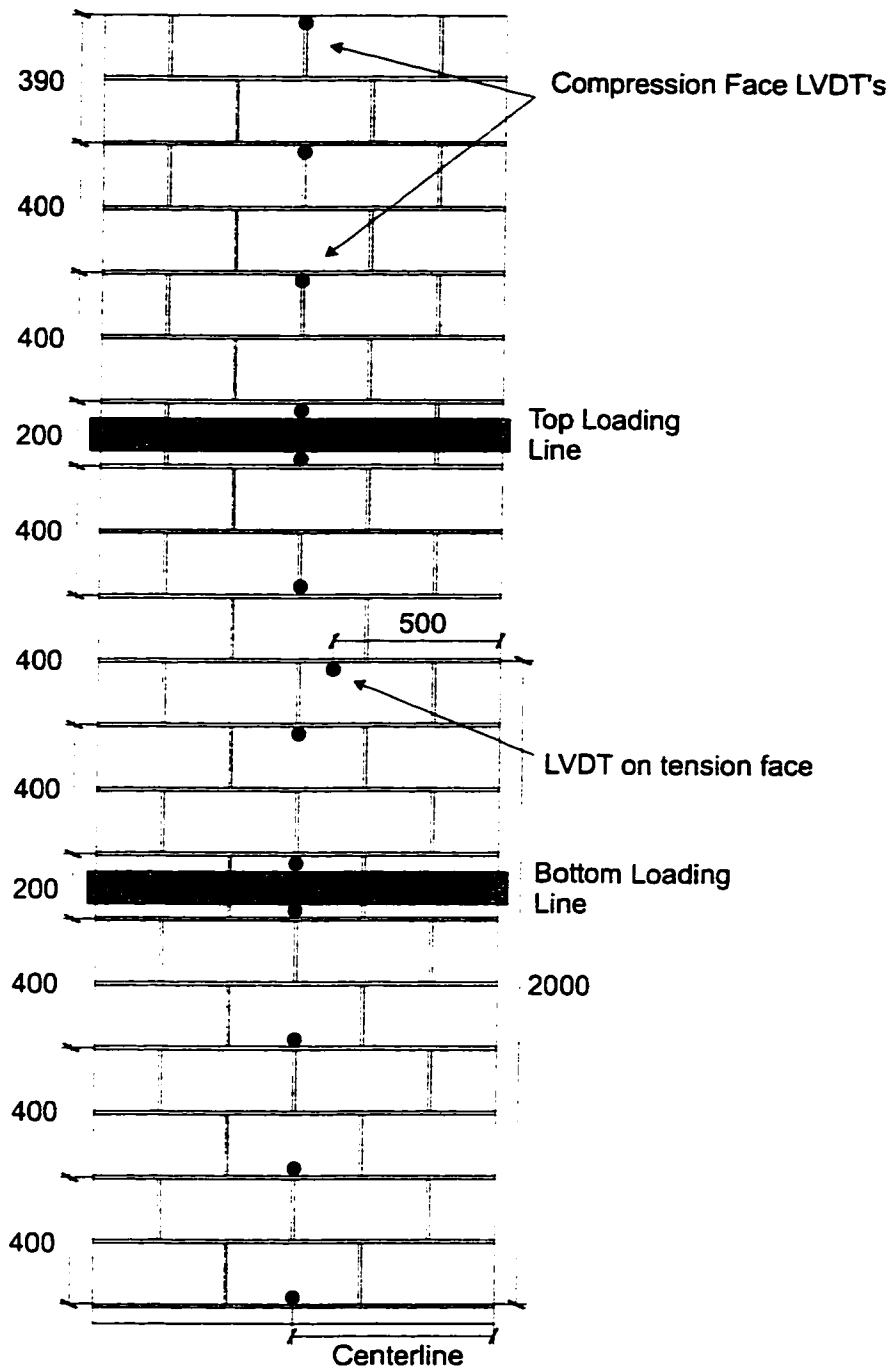
Figure 3.14 Deflection Measurement Positions

The deflection of the wall was measured using a series of 13 LVDT's placed at 400 mm intervals along the height of the wall and 200 mm intervals around loading points. Figure 3.14 shows the positions of the LVDT's along the centerline of the specimen. It should be noted that the change in height of the Series Two walls did not change the location of the LVDT's. In most cases, the positioning of an individual LVDT changed only by 10 or 20 mm. The deflection measurements were taken on the compression side to minimize fluctuations in the readings due to separation of the mortar joints on the tension face. Because the loading frame prevented measuring of the mid-span deflection on the compression face, it was measured on the tension face.

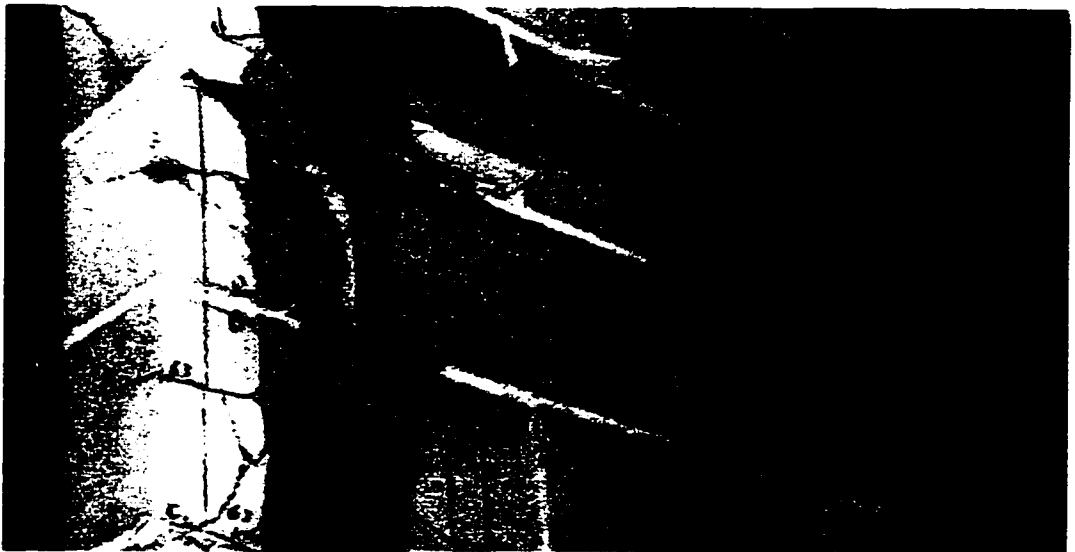
Figure 4.26 Rupture of Reinforcement - Specimen ICST 10

The final mode of failure was rupture of the fiber reinforcement, a form of flexure failure. Two specimens, ICST 10, reinforced with two 125 mm carbon sheets, and ICST 12, reinforced with ten 125 mm angled carbon sheets, failed in this manner. In both cases the reinforcement ruptured along one or two of the horizontal joints in the constant moment region. Flexure-shear cracks did not develop. Figures 4.26 and 4.27 show the failed joint for specimens ICST 10 and ICST 12 respectively. In Fig. 4.26 it can be clearly seen that the masonry is firmly bonded to the failed strip of reinforcement. Also, a crack pattern can be seen around the reinforcement. This will be explained further in the next section. Specimen ICST 12 failed at the joint which had the least surface area of reinforcement crossing it. The width of the separation in the joint, although somewhat amplified by the final failure, is evidently quite large.
