EFFECTS OF CONSTRUCTION TOLERANCES ON EXTERIOR WALLS

MATTHEW ALEXANDER AUGUSTUS MIS

A THESIS

STRUCTURAL ENGINEERING

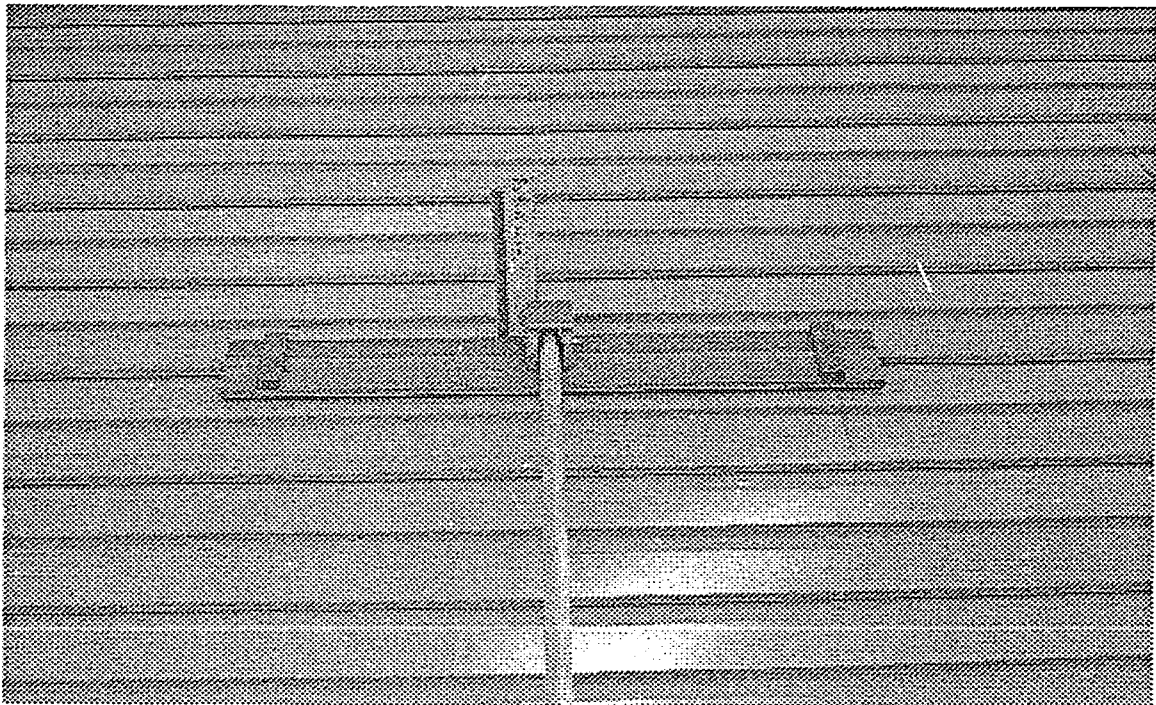
Figure 3.8 Laser plumb measuring aid.

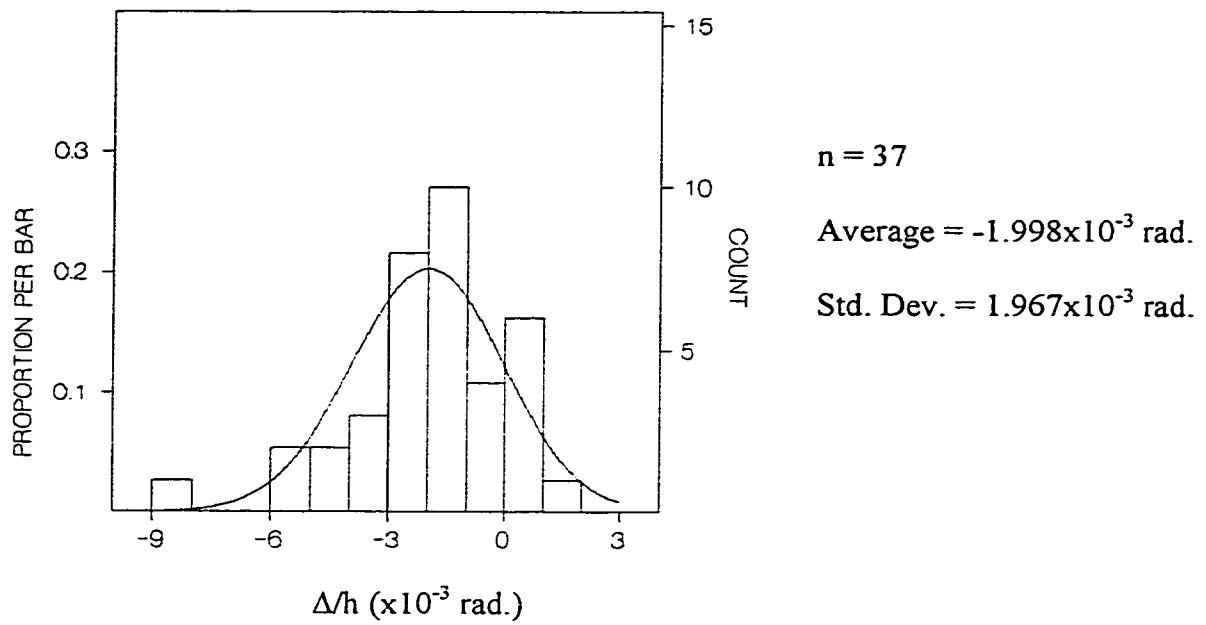
Figure 4.4 Steel column out-of-plumb distribution for Building A.

If one views the histogram in Figure 4.4 , the mean plumbness value is -1.998×10^{-3} Rad., with a standard deviation of 1.967×10^{-3} Rad. By comparing this data to the data gathered by Beaulieu and Adams (Table 2.1), one can see if the size of the deviation is above or below their findings. Their mean and standard deviation values were found to be -0.044×10^{-3} Rad. and 1.62×10^{-3} Rad. for two of the steel buildings that were 27 and 34 storeys in height. This indicates that the columns from their structures had less deviation from vertical, and the entire sample was less spread out.

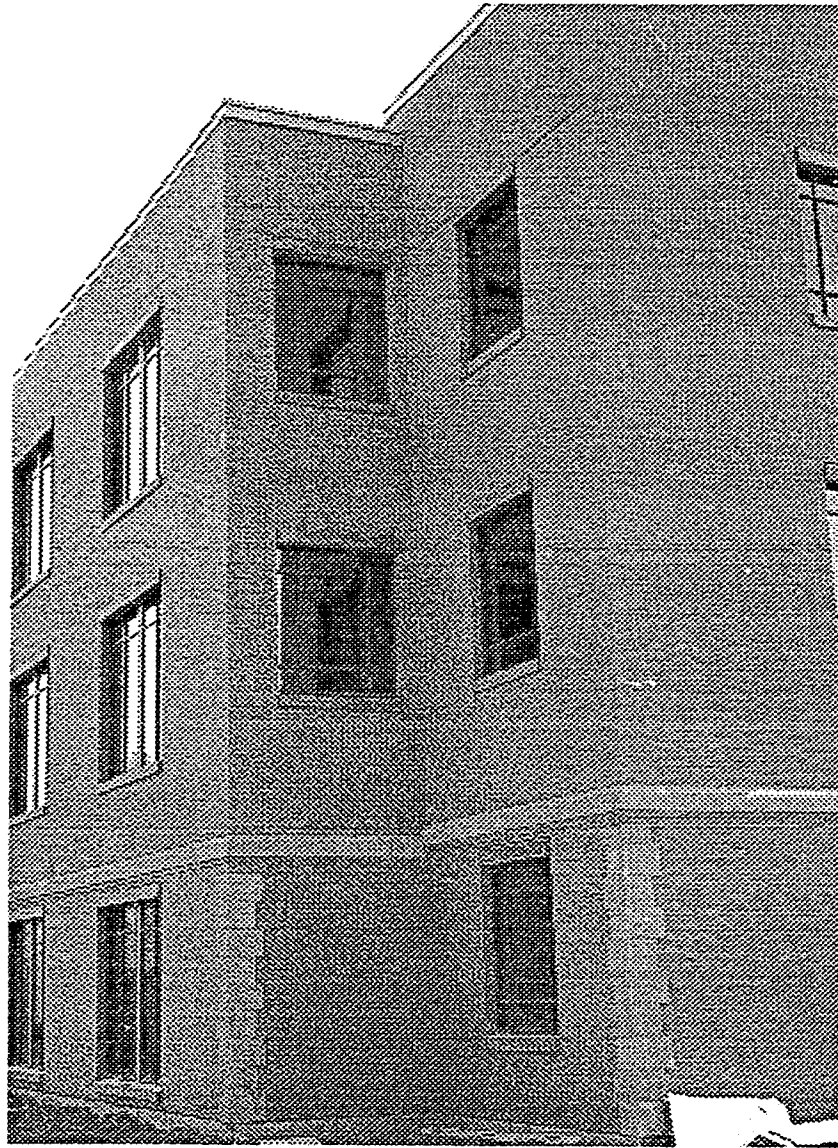
Figure 4.27 Building A nearing completion.

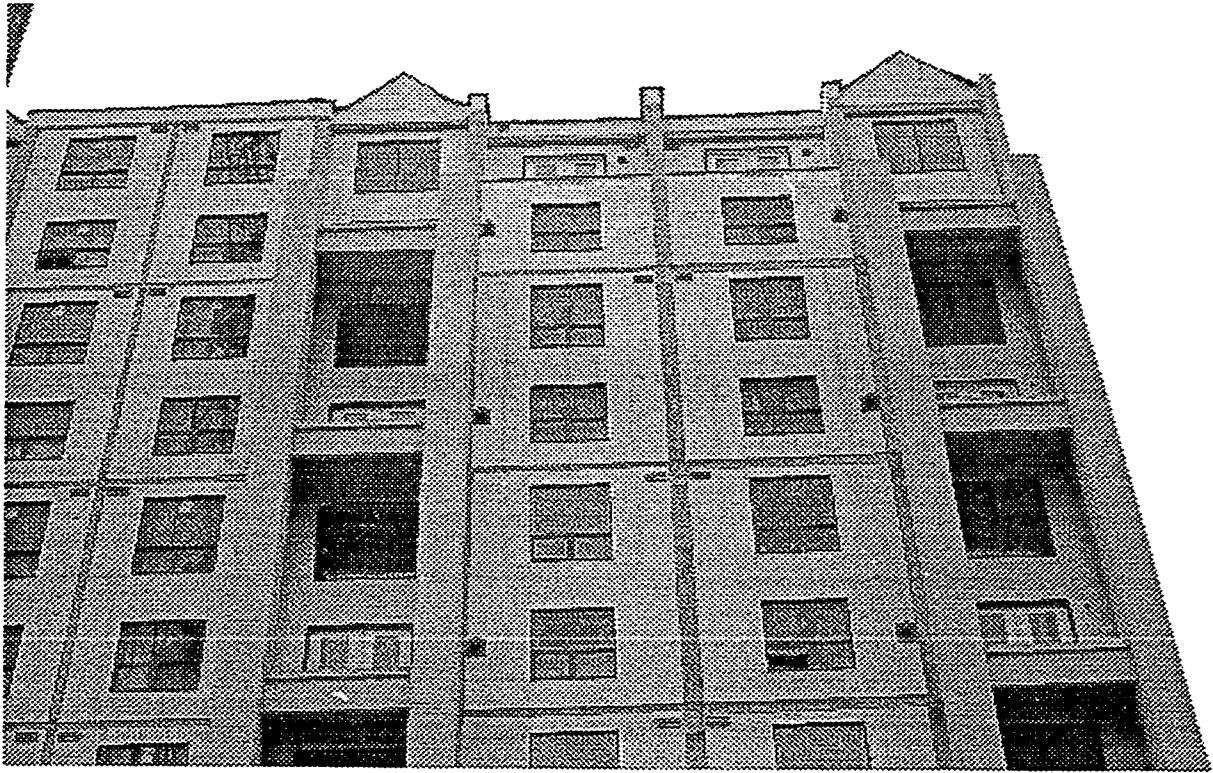
Figure 4.29 Close-up of Building B.

Figure 4.28, 4.29 and 4.30 show outside and inside views of the 33000 mm condominium during construction. Referring back to Figure 3.4 in Chapter 3, the three visible measurement locations are the concrete column plumbness, the steel stud wall plumbness and the floor-to-ceiling height distance. Data regarding this structure is presented in Figures 4.2, 4.14 to 4.18 and Tables 4.2 and 4.4.
