*Design of Crack Resistant Thermoplastic Roadway Markings*

A thesis submitted to the Faculty of Graduate Studies and Research in partial fulfillment  
of the requirements for the degree of *Master of Science*

Department of *Chemical and Materials Engineering*

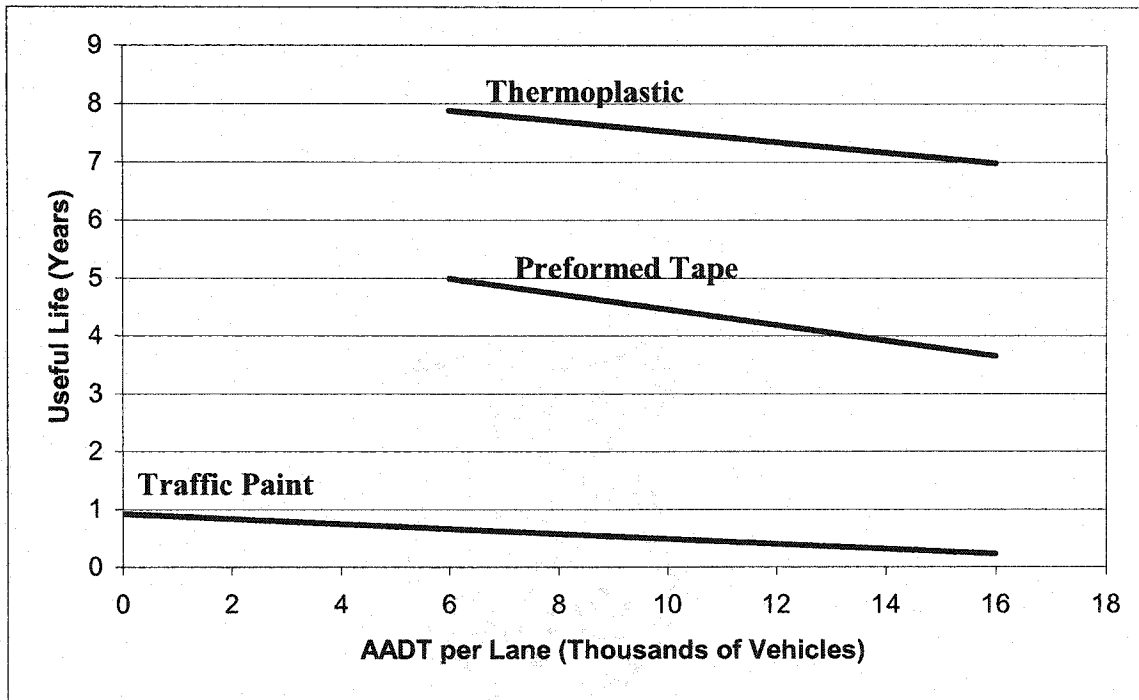
Figure 1.1: Life Expectancy on Asphalt Concrete for 6-36" Snowfall

Figure 1.1 had been adapted to show the comparison of traffic paint, preformed tape and thermoplastic on asphalt concrete when subjected to 6-36" snowfall. (Dale, 1988) The graph shows the expected lifetime of the markings when subjected to various traffic flows, recorded as annual average daily traffic (AADT). Thermoplastic roadway markings have the longest expected lifetime and are thus the choice marking for use in areas with significant snowfall at any rate of traffic flow.

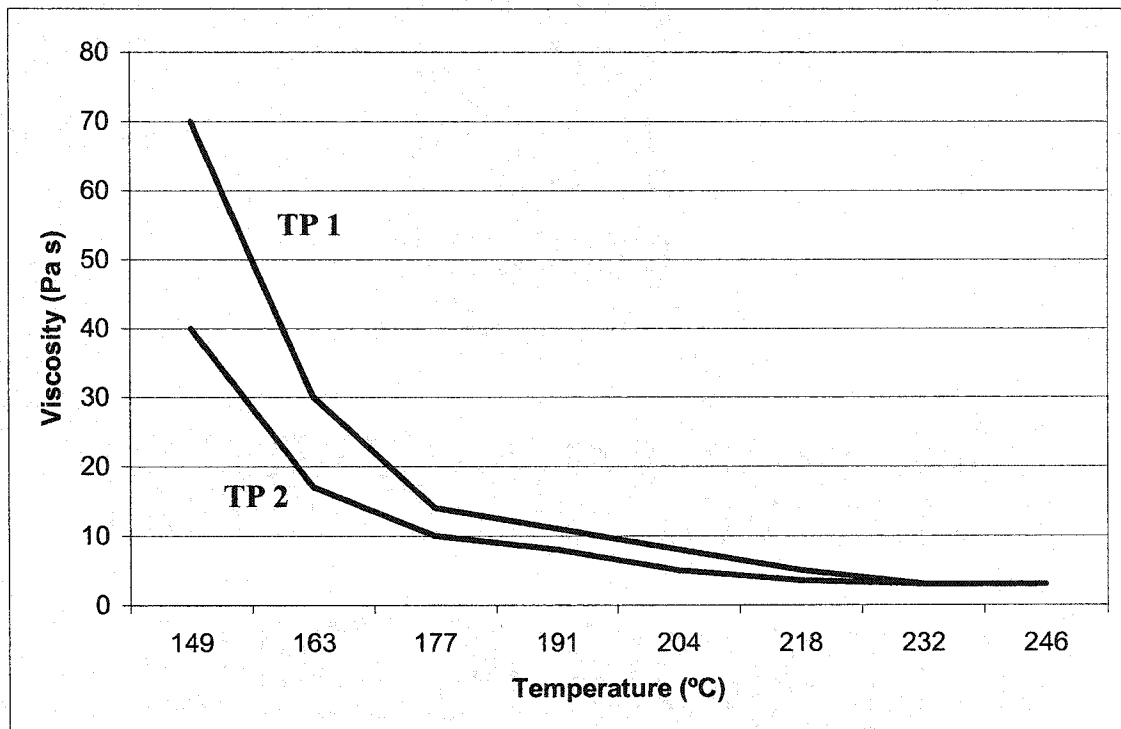
Figure 1.2: Brookfield Viscosity versus Temperature

From Figure 1.2, the viscosity at application temperature of  $200^{\circ}\text{C} \pm 20^{\circ}\text{C}$  is below 10 Pa.s. This allows the mixture to flow from the heating tank to the roadway surface. However, it is not too low that the marking will not hold its shape after extrusion onto the roadway.

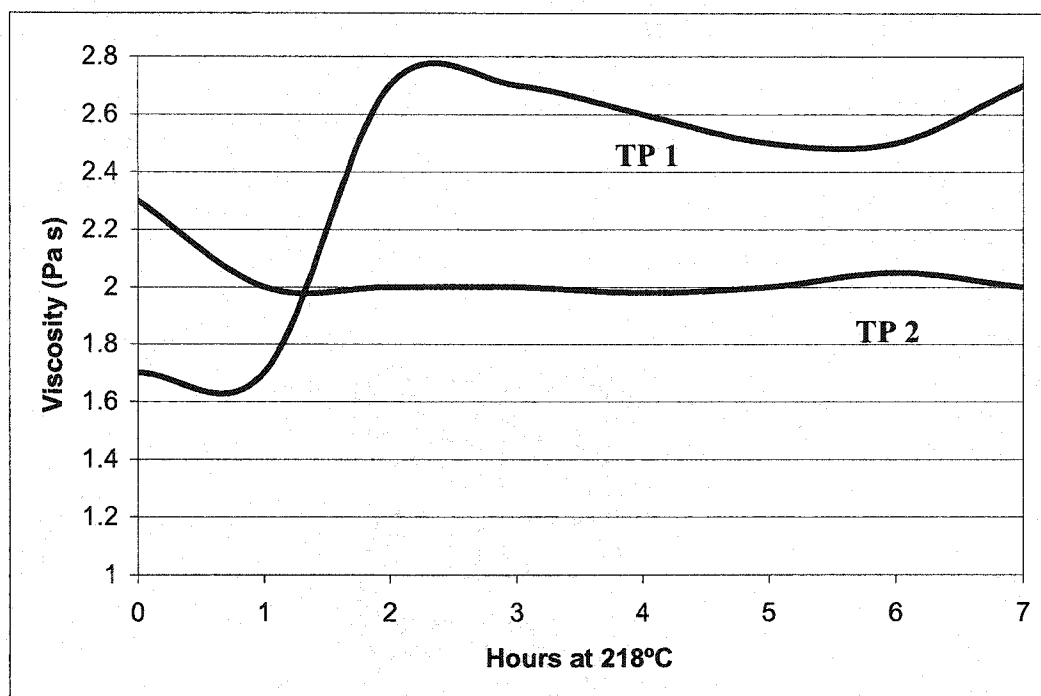
Figure 1.3: Viscosity at 218°C versus Time

Differences in performance will be observed depending on the specific amount and type of polymer used in the formulation. Figure 1.3 indicates that there is some variation in viscosity over time. TP 1 shows an initial increase in viscosity, possibly due to the cross-linking of the polymer molecules, followed by a maximum after approximately 2 hours, and continuing fluctuations at higher viscosities with increasing time. TP 2 shows an initial decrease, possibly due to the degradation of the polymer molecules, followed by a leveling trend after approximately 1 hour. Any trend observed is highly dependent on the formulation tested.

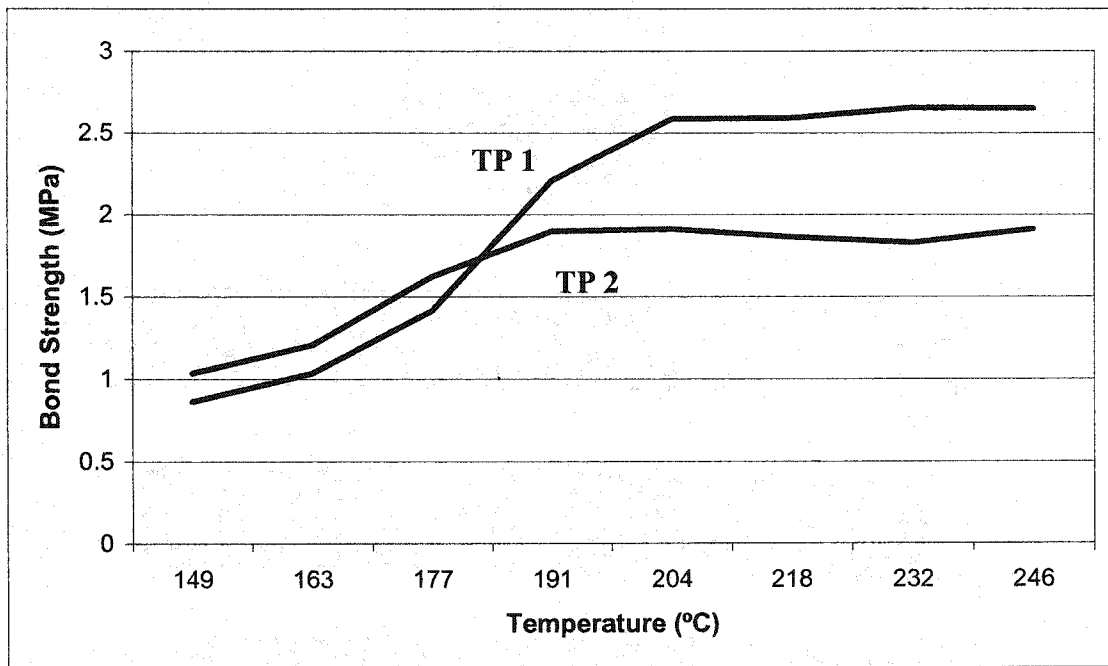
Figure 1.4: Bond Strength versus Application Temperature

temperatures to ensure that the formulation is not adversely affected when exposed to extreme temperatures. However, for optimal adhesion of the marking to the asphalt concrete, it is important that the mixture be heated to application temperatures. Figure 1.4 is a representation of the bond strength as a function of application temperature. (Dale, 1988) Optimal temperatures range from 190°C to 200°C, depending on the formulation.

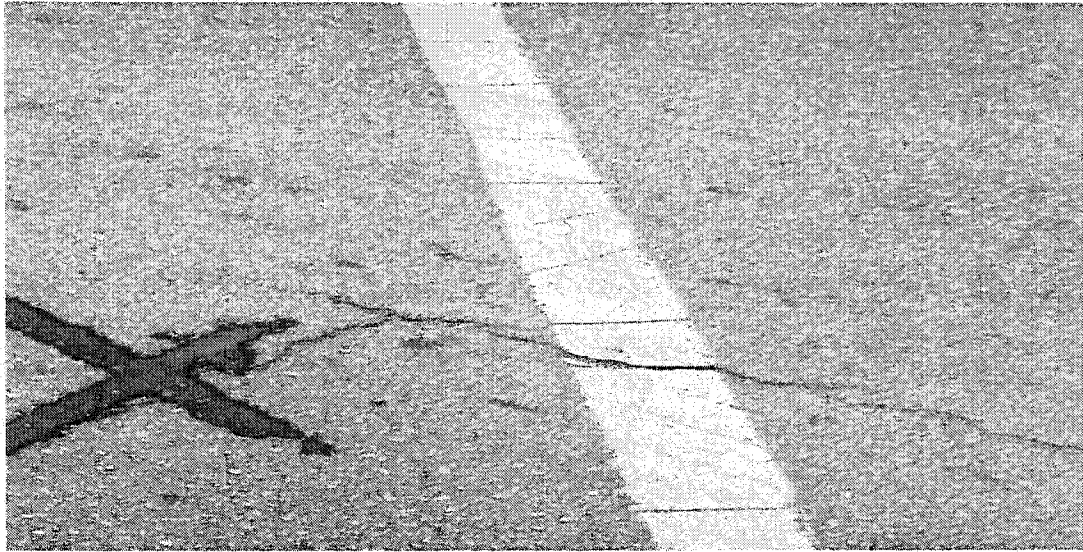
Figure 1.5: Transverse Cracking of Thermoplastic Roadway Marking

Two different modes of failure have been observed. The first is the transverse cracking of the marking as seen in Figure 1.5. This occurs across the smallest cross section of the line and occurs consistently in intervals of 10-15 cm. In markings with a greater cross section, cracking is noticed in both the transverse and the longitudinal directions resulting in the formation of rectangles or squares that measure 10-15 cm.

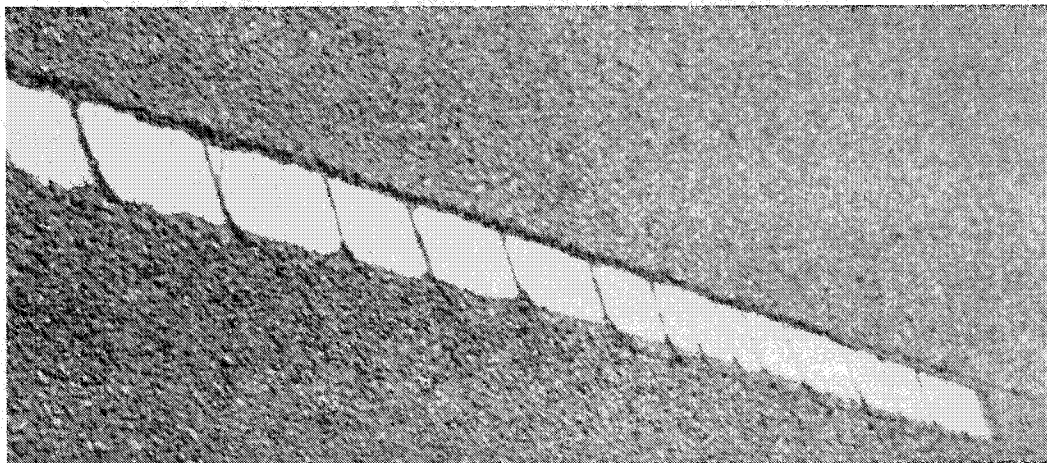
Figure 1.6: Raveling and Chipping Along the Edges

The second mode of failure is raveling and chipping along the edges of the markings as seen in Figure 1.6. This is noted to progress more rapidly as the marking ages and is also noted along the cracked edges over time.

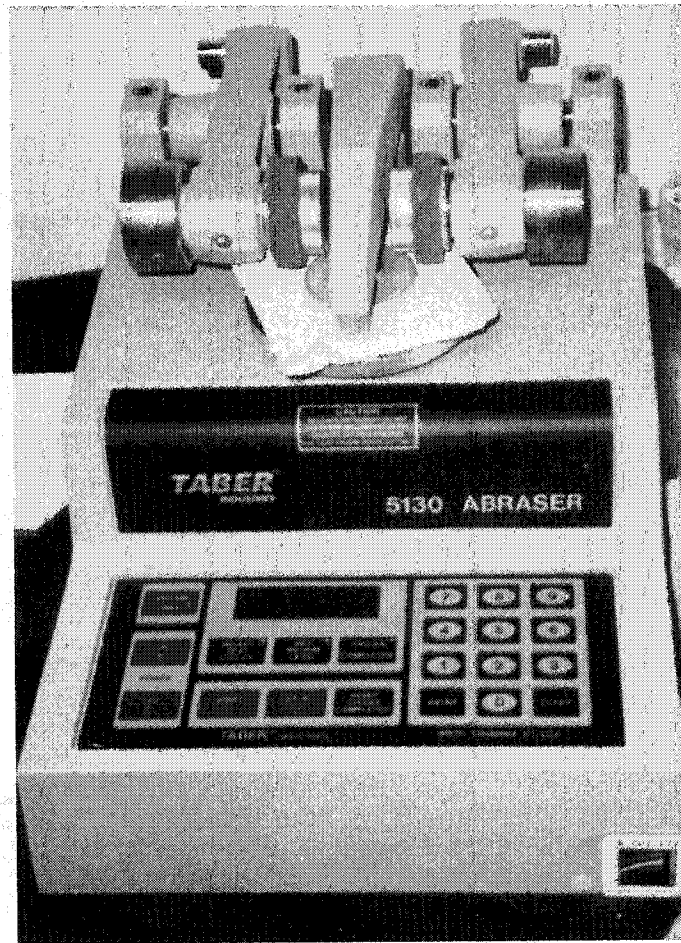
Figure 2.1: Taber Abrasion Tester – 5130 Abraser

Taber abrasion testing was used to determine the abrasion resistance of a material when subjected to conditions that mimic the environmental conditions experienced on a daily basis. Figure 2.1 is a photograph of the 5130 Taber Abraser used in these studies.

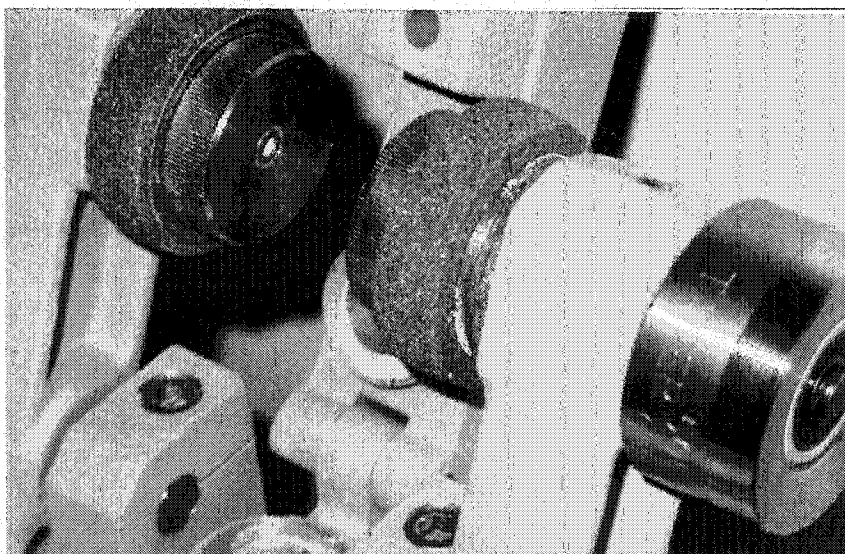
Figure 2.2: H-22 Calibrate Wheels

The extent of wear observed during testing was dependant on the type of abrading wheels used. Figure 2.2 is a photograph of a set of H-22 Calibrade wheels which were used in this study. The H-22 wheels are among the hardest and most abrasive of the wheels available and were chosen to simulate the conditions experienced on a winter road in the Edmonton area where sand is frequently applied to increase traction in road icing conditions.

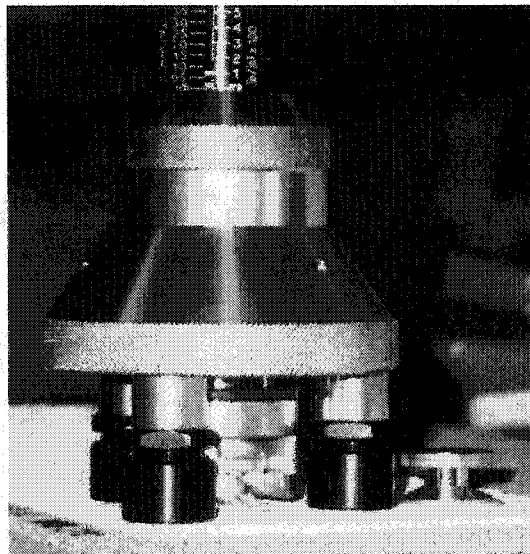
Figure 2.3: Elcometer 106 Adhesion Tester

In-lab studies of adhesion were conducted using the Elcometer 106 Adhesion Tester. Figure 2.3 is a photograph of the testing apparatus.

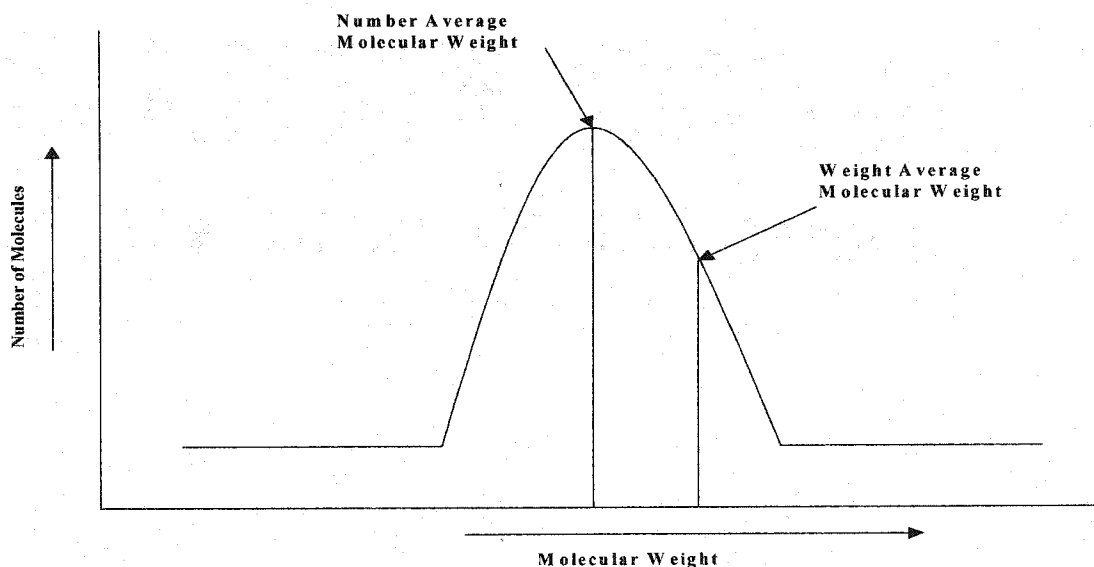
Figure 2.4: Molecular Weight Distribution Curve

There are a number of molecular weight averages that can be used to describe a polymer. Two of these were used in this study. Figure 2.4 is a representation of the location of the weight and number average molecular weights in relation to the molecular weight distribution.

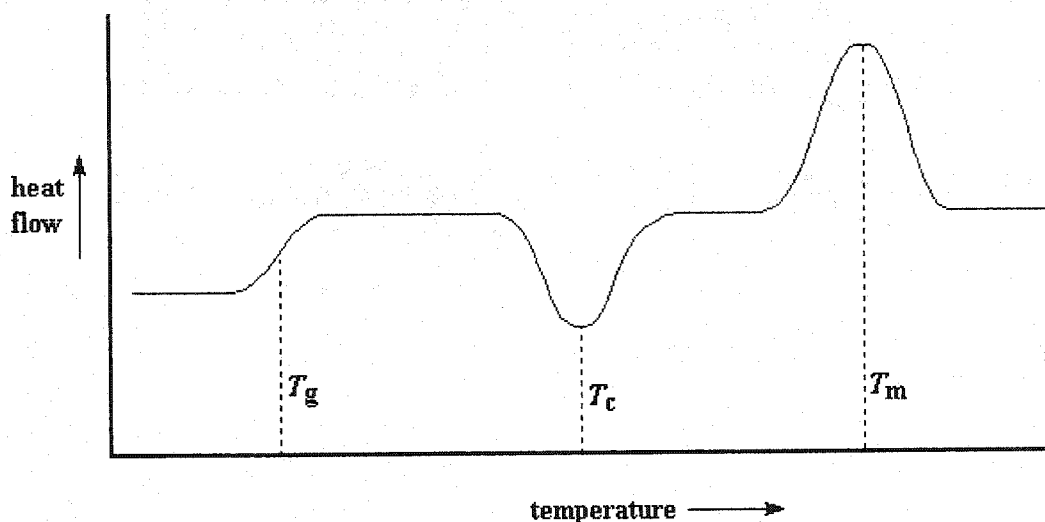
Figure 2.5: Common Features on a Differential Scanning Calorimetry Thermograph

Three transitions are commonly noted in a polymer sample. The glass transition temperature ( $T_g$ ) occurs when the polymer transitions from a higher heat capacity above the  $T_g$  to a lower heat capacity below. Secondly, the crystalline temperature ( $T_c$ ) occurs when the polymer reaches a high enough temperature above the  $T_g$  at which point it has sufficient energy to become ordered, or crystalline. Finally, the melting temperature ( $T_m$ ) occurs when the polymer is heated above its  $T_c$  to a temperature at which there is too much heat in the system causing the crystals to fall apart, or melt. Figure 2.5 is a representation of each of these transitions as they would be seen on a DSC thermograph.

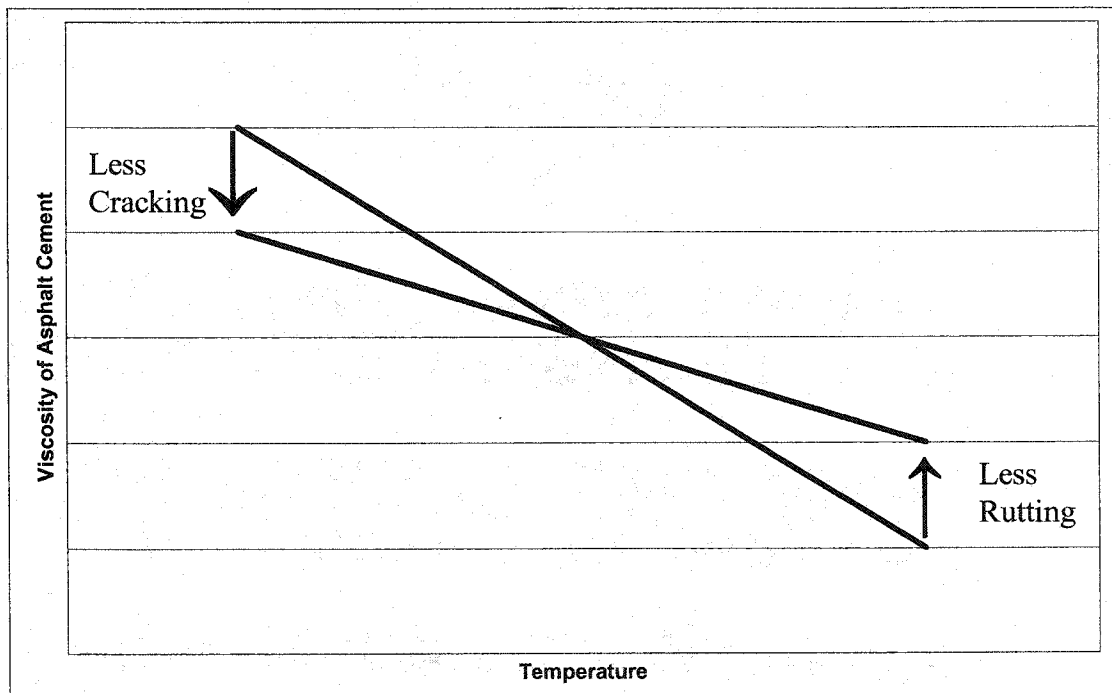
Figure 3.1: Viscosity Dependence on Temperature

The properties associated with viscoelastic asphalt cement are temperature dependent as is expected for a thermoplastic material. This temperature dependence can be linked to changes in viscosity. The greater the rate of change of viscosity with temperature, the greater the asphalt cement's dependency on temperature. Figure 3.1 is a representation of this dependency. The greater the rate of change of viscosity with temperature, the greater the probability of cracking at low temperatures and rutting at high temperatures. (Young et al, 1998)

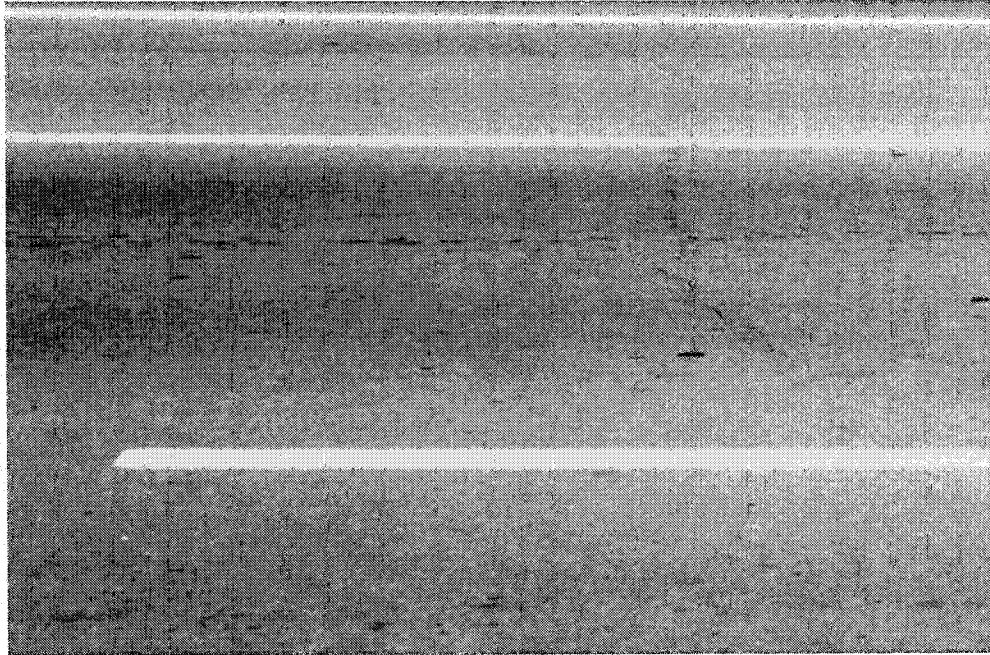
Figure 3.2: Transverse Cracking with Adequate Adhesion

completely functional. If the mechanisms of transverse cracking cannot be eliminated, the alternative is to ensure that the adhesion is adequate enough to result in a marking that will remain functional for a long period of time. Ensuring adequate adhesion will also reduce chipping and erosion along the outside and crack edges.

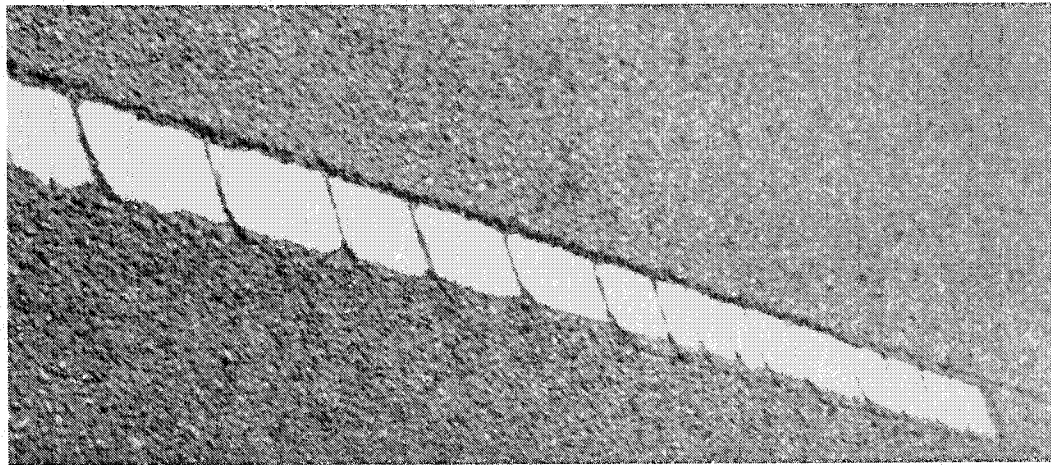
Figure 3.3: Aged and Chipped Marking

As a marking remains on the roadway, it is subject to numerous conditions that ultimately result in its deterioration. Figure 3.3 represents an aged and severely cracked marking. It is important to note that although this marking is severely cracked, it is still functional, once again, due to adequate adhesion to the asphalt concrete. The outside and crack edges show chipping due to erosion of the asphalt concrete-marking bond, which occurs over time as water and dirt migrate under the marking.

The upper edge of the marking in Figure 3.3 exhibits extreme deterioration at the marking-asphalt concrete interface. Cracking of the asphalt concrete along the edges of the marking occurs since the marking is a white stripe on a black surface. The marking reflects the sun's heat while the asphalt cement absorbs it. This creates an extreme in the thermal expansion properties of the asphalt cement, which is not shared with the marking, causing a crack to develop in the asphalt cement. (Dale, 1988)

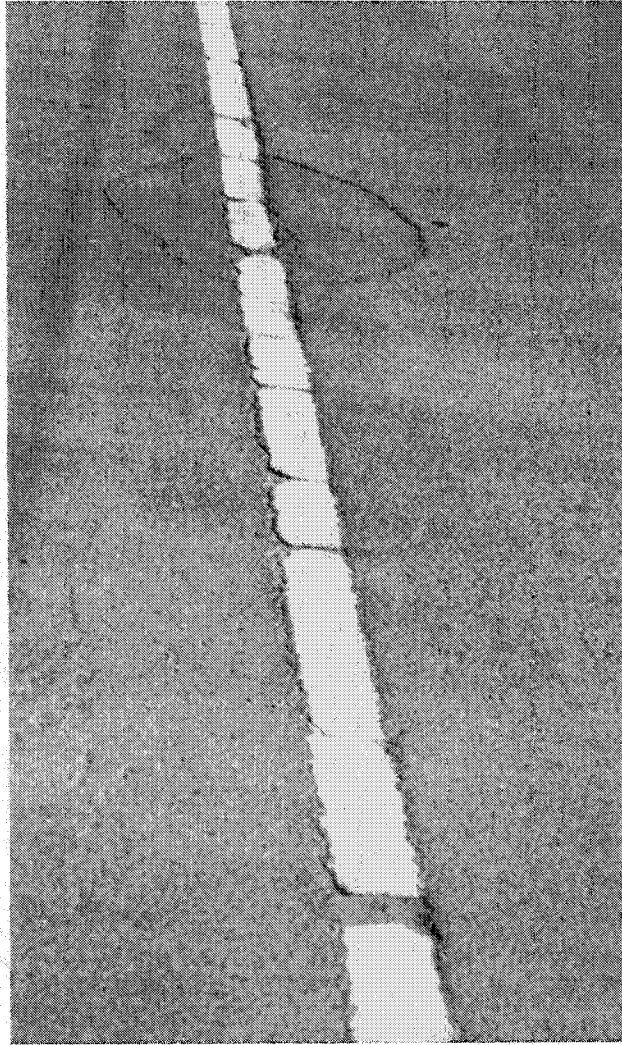
Figure 3.4: Inlaid Marking

photograph also illustrates advanced stages of cracking and chipping along the outside and crack edges. This also contributes to the erosion of the adhesive bond by increasing the area for dirt and water to settle.

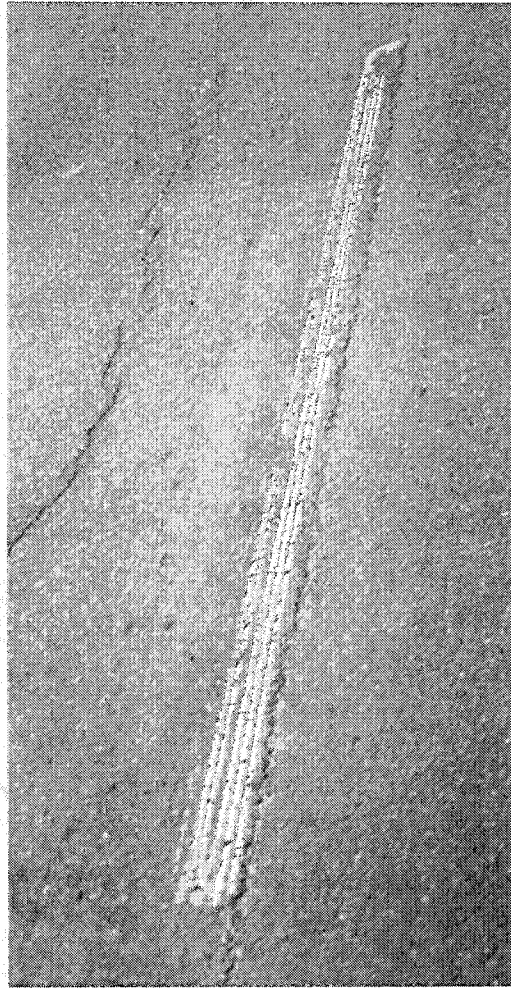
Figure 3.5: Severe Abrasive Damage

function to separate lanes, and was not completely removed. However, the marking is now much more susceptible to chipping and lesser abrasive forces.

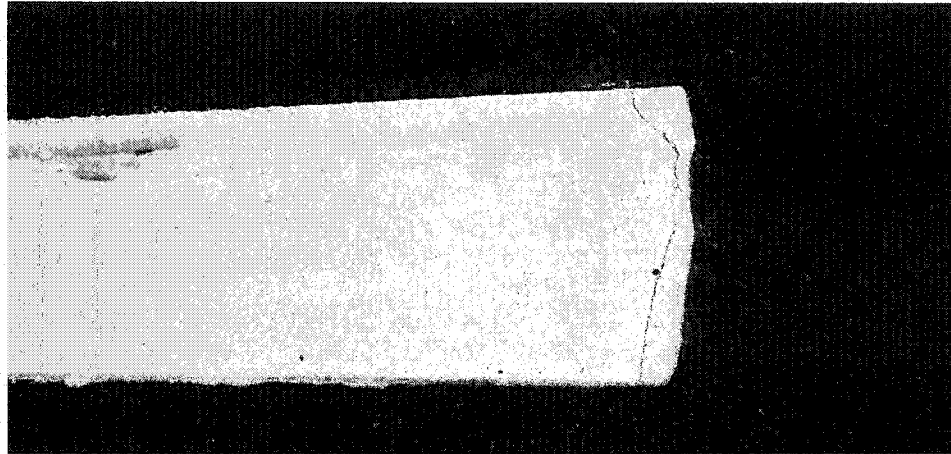
Figure 3.6: Air Void Cracking at the Leading Edge

be compressed causing the marking to fracture. Figure 3.6 illustrates this phenomenon, showing cracking along the leading edge.

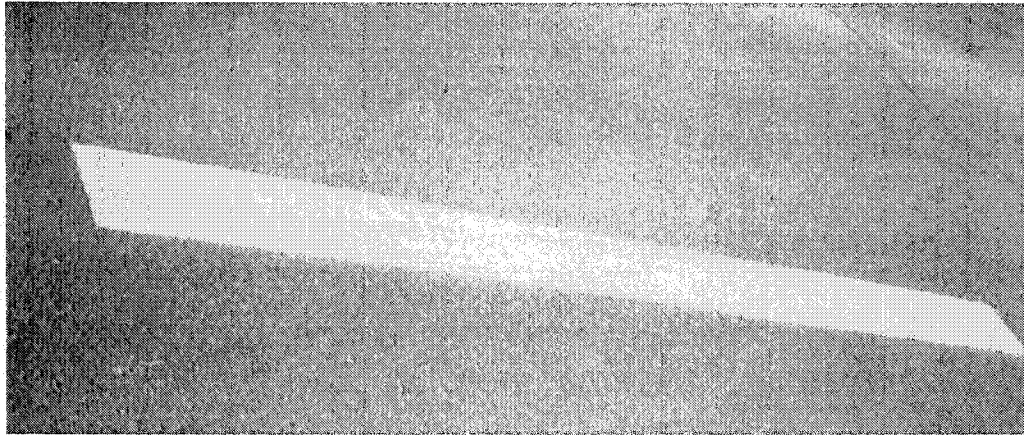
Figure 3.7: Marking After One Year Exhibiting No Transverse Cracking

This marking has been through one complete winter cycle where temperatures were extremely low ( $-35^{\circ}\text{C}$ ) for extended periods of time. However, due to the location of the marking, traffic volume was minimal. This is an indication that transverse cracking occurs via multiple mechanisms and that cold temperatures alone are not sufficient to cause cracking. Traffic volume above a threshold limit must also be present.

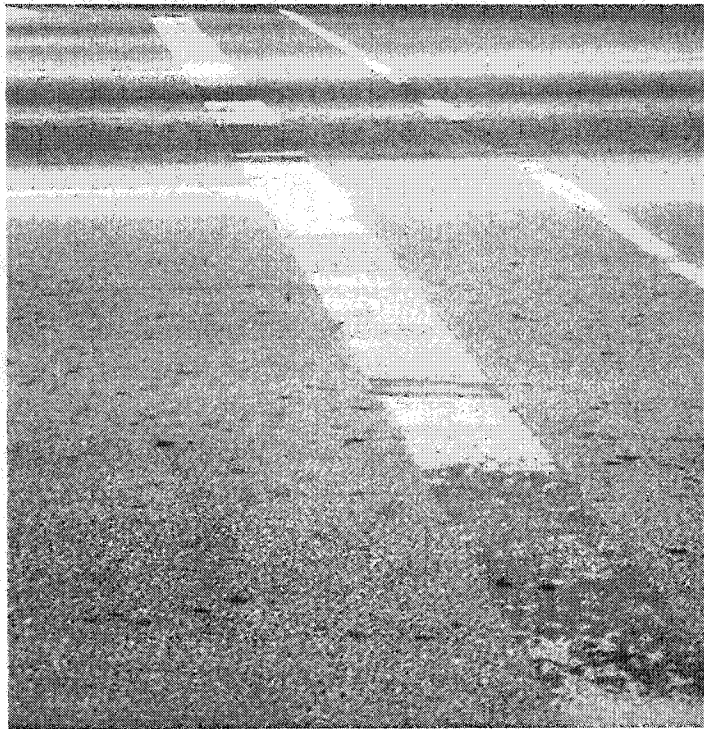
Figure 3.9: Abrasive Wear of Transverse Lines at Low AAWT rates

Abrasive wear of transverse markings in low traffic areas can be seen in Figure 3.9. Wear patterns in the areas of highest traffic concentration are distinct with complete abrasion of the markings in some instances.

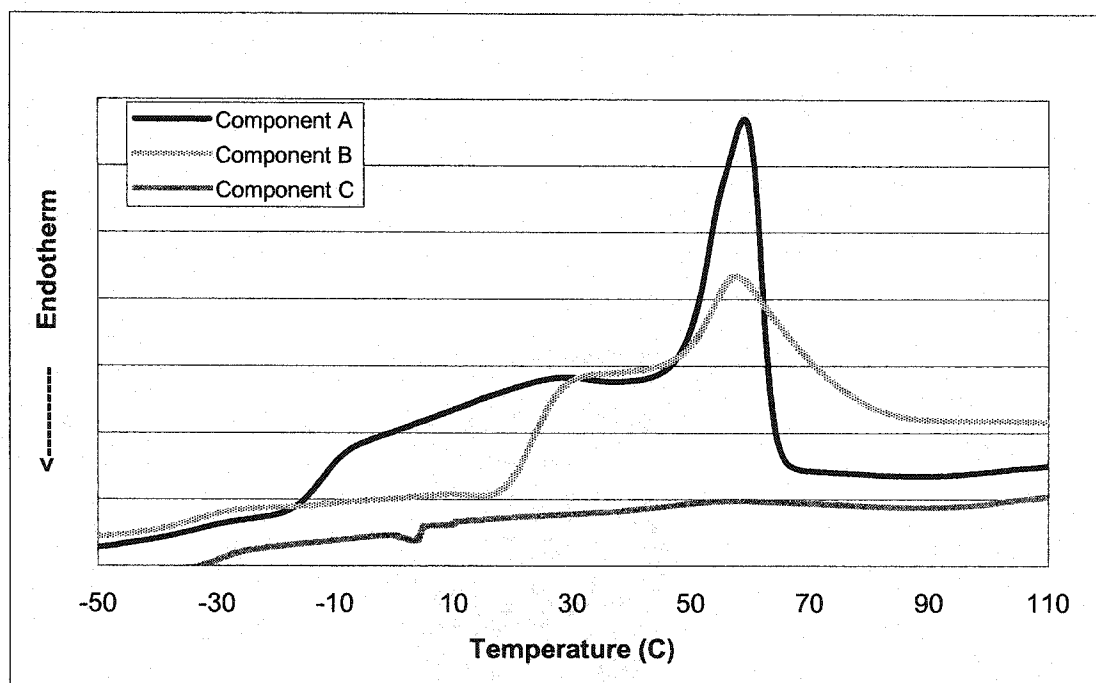
Figure 3.10: DSC Cooling Curve for Components A, B, and C

Differential scanning calorimetry (DSC) was used to determine values for  $T_g$ ,  $T_c$ , and  $T_m$  for the various polymer components and the thermoplastic polymer resins. Figures 3.10 to 3.13 illustrate these transitions for the major polymer components as well as the resin of formulations 0320 and 0333.

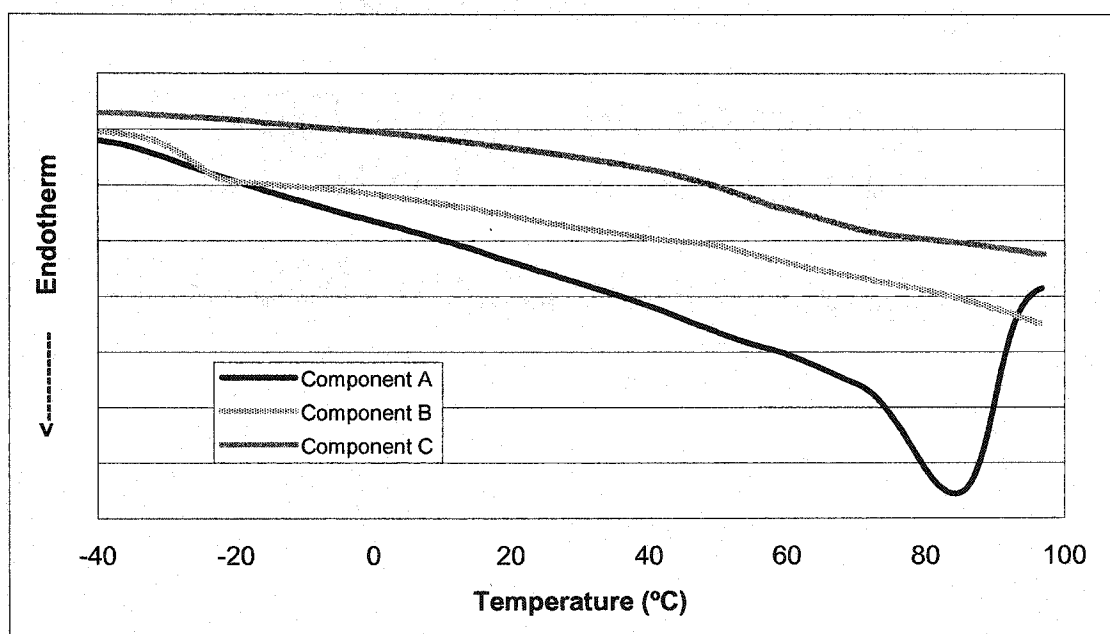
Figure 3.11: DSC Heating Curve for Components A, B, and C

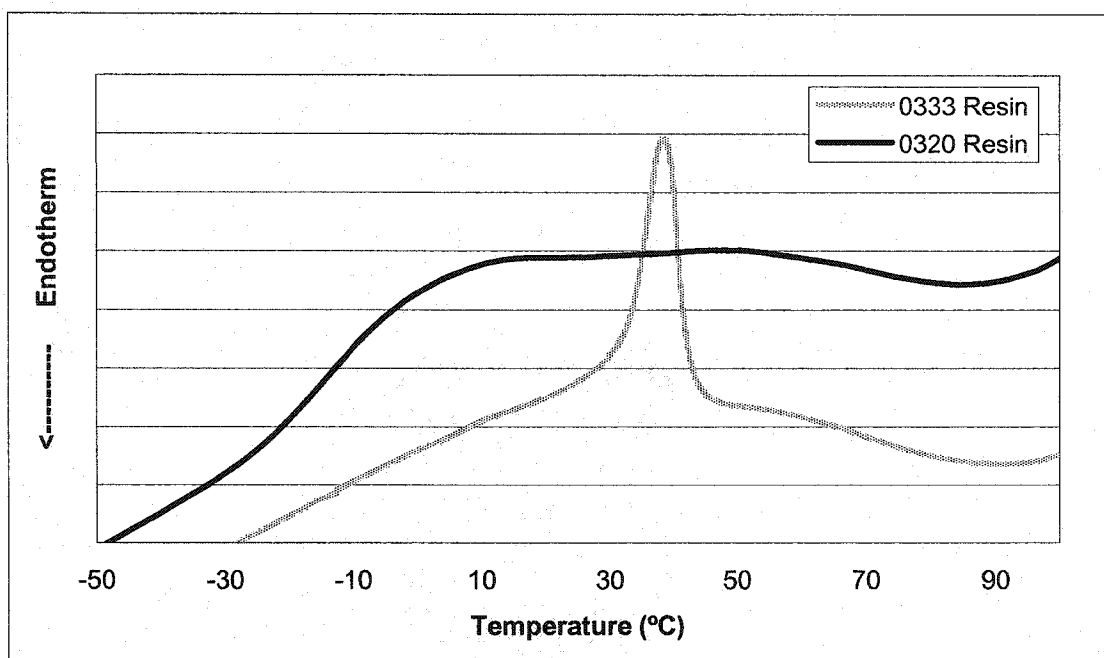
Figure 3.12: DSC Cooling Curve for Resins 0320 and 0333

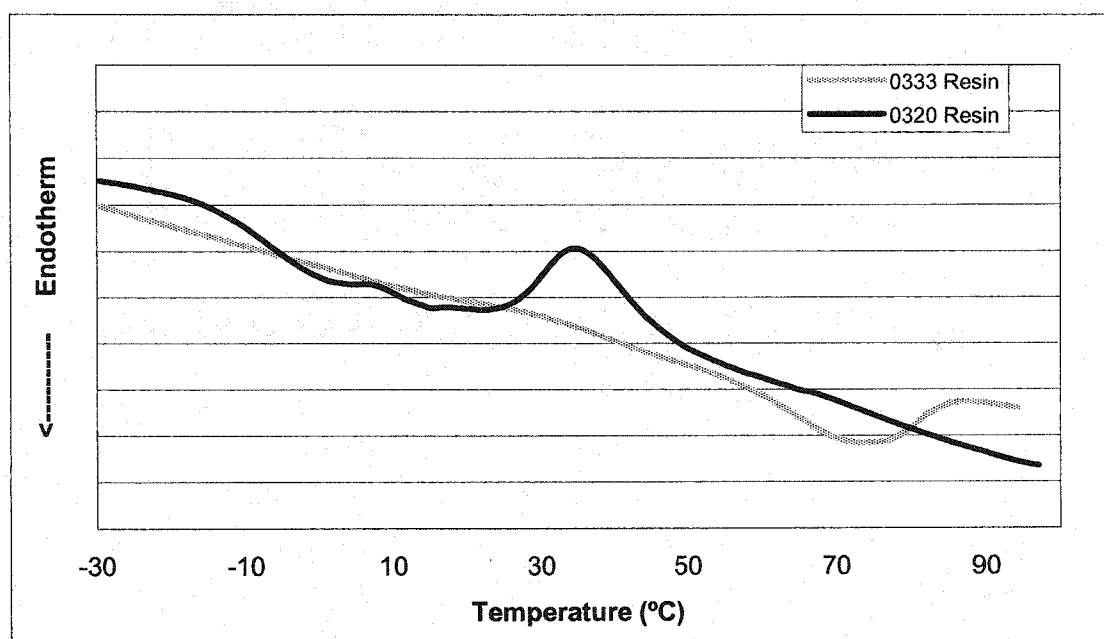
Figure 3.13: DSC Heating Curve for Resins 0320 and 0333

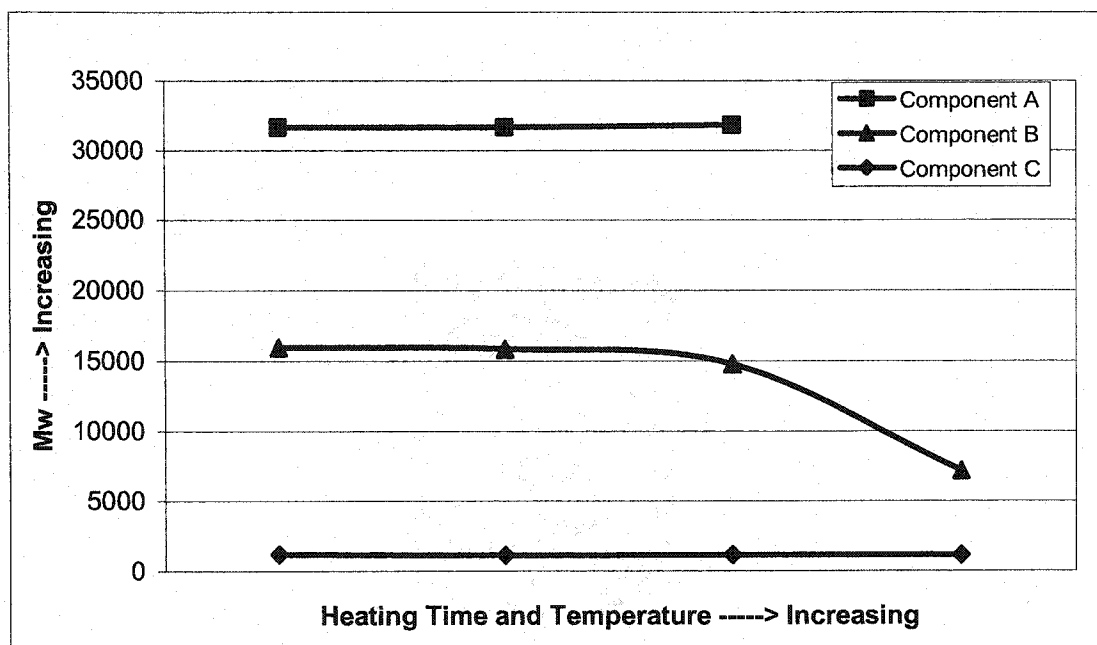
Figure 3.14: Weight Average Molecular Weight ( $M_w$ ) of Components A, B, and C

Figure 3.14 shows the weight average molecular weight ( $M_w$ ), which is the average weight of the species in the sample. (Walker, 1999)

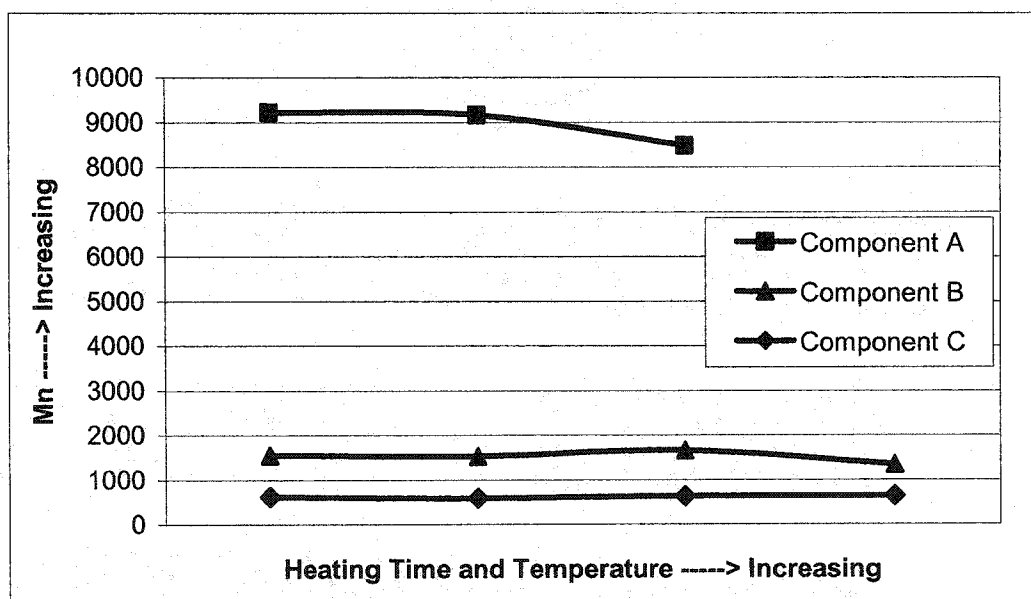
Figure 3.15: Number Average Molecular Weight ( $M_n$ ) of Components A, B, and C

from the virgin polymers to those heated to application temperatures. However, as the temperatures were increased above application temperatures, both showed a slight increase in  $M_n$ . Component B once again showed a decrease as extreme temperatures were applied. Component C continued to show an increase. This indicates that some modification to the polymer components with increased temperatures is occurring. To ensure optimal performance of the markings, temperatures should remain low and every effort made to ensure application temperatures are not exceeded.

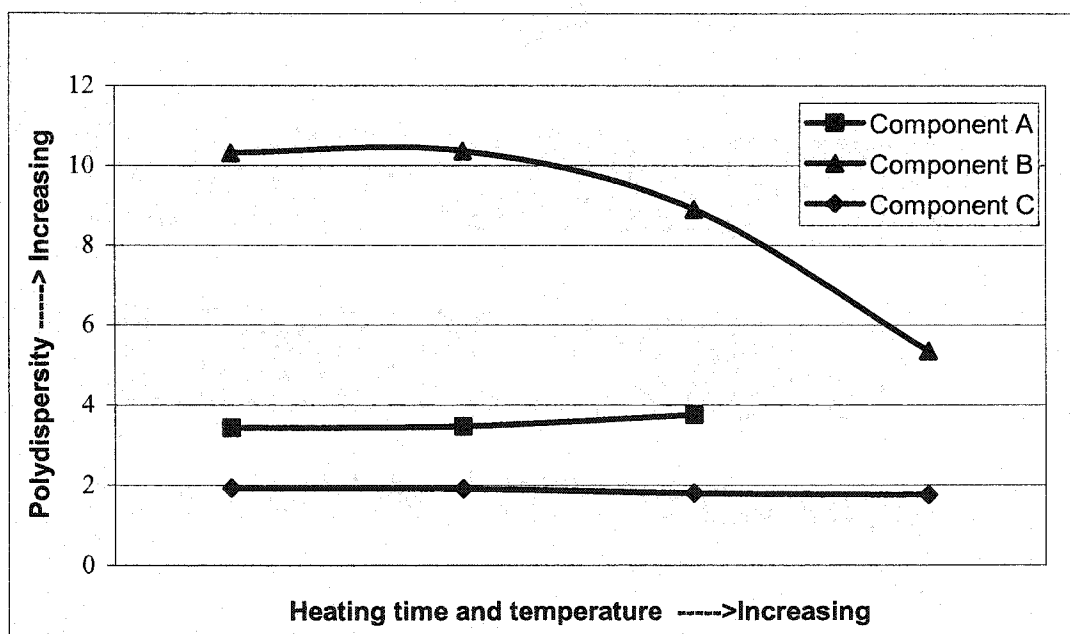
Figure 3.16: Polydispersity of Components A, B, and C

higher temperatures, a greater range of molecular weight components were being generated, possibly due to the break up of the existing components. Component B shows steadily decreasing polydispersity which was an indication that there was some activity in the rearrangement of polymer molecules. It was possible that as the polymer was exposed to higher temperatures, a certain degree of crosslinking occurred. This would lead to a reduction in the smaller molecular weight species. Component B appeared to be particularly susceptible as temperatures were increased above application temperature.

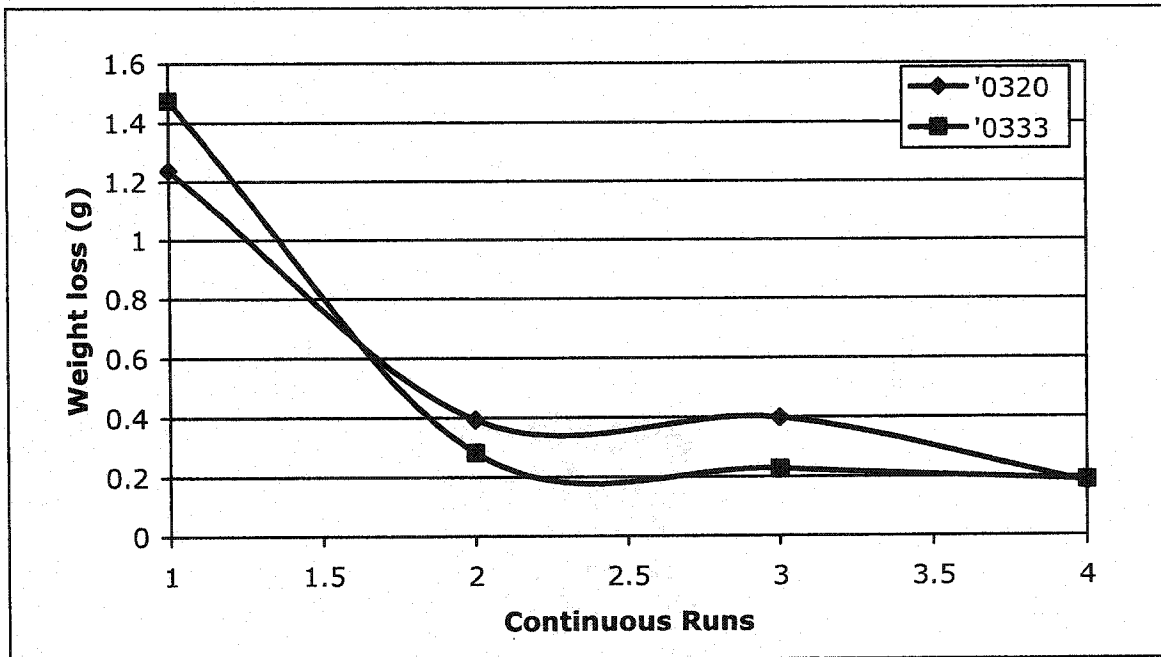
Figure 3.17: Abrasion Resistance of Original Formulations

Abrasive wear is also dependant on the type of polymer components utilized in a formulation. Figure 3.17 shows the different weight loss experienced by the two original formulations, 0320 and 0333. It is important to note that the first data point for each formulation represent abrasion testing on beaded surfaces. These results are clearly higher than the City of Edmonton specification of 0.6 g weight loss. Therefore, subsequent testing was conducted on bead free surfaces. As the testing continues into the depth of the samples, the abrasive wear becomes constant with 0333 showing a slightly lower weight loss than 0320.

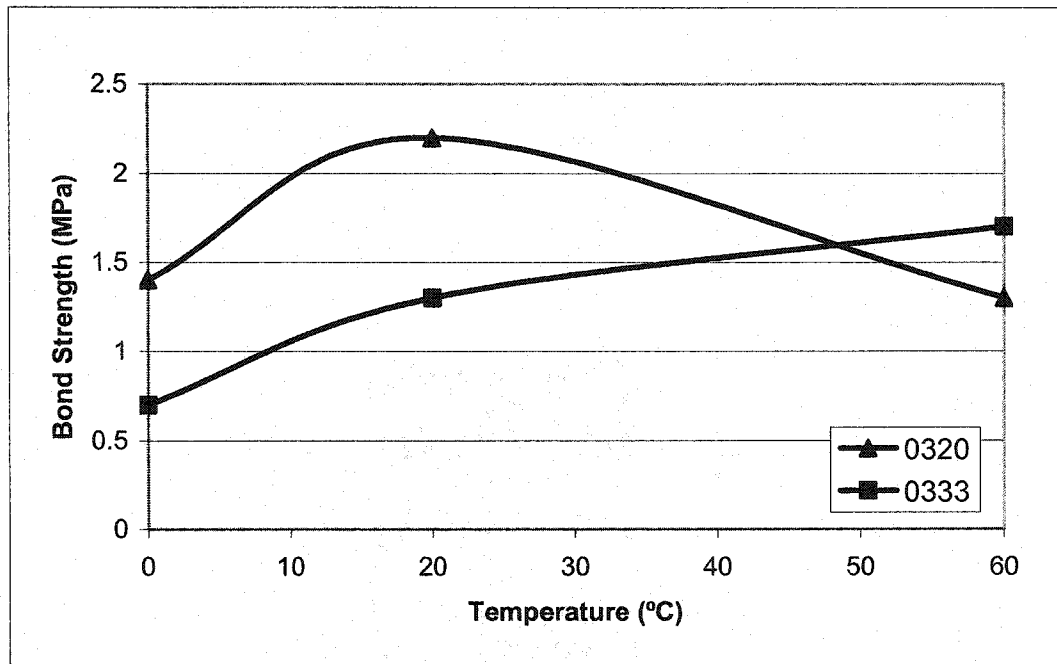
Figure 3.18: Optimal Adhesion Temperature on Concrete

The optimal adhesion temperature varied depending on the formulation and the substrate upon which the markings were applied, as can be seen in Figures 3.18 and 3.19.

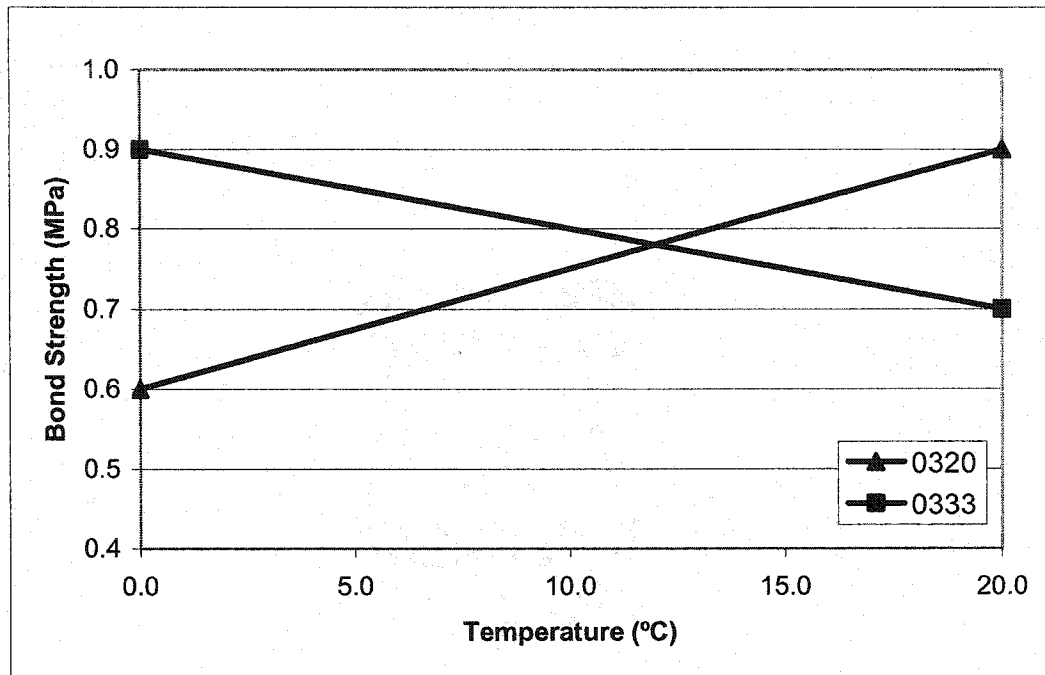
Figure 3.19: Optimal Adhesion Temperature on Asphalt Concrete

Typically, three tests were conducted for each formulation at each temperature with results obtained  $\pm 0.25$  MPa. Formulation 0320 showed the highest adhesion when applied to concrete at 20°C, Figure 3.18. Whereas, formulation 0333 showed steadily increasing adhesion to the concrete substrate over the temperature range studied. However, when testing was completed on the asphalt substrate (Figure 3.19) the reverse was noted, with 0333 showing steadily decreasing adhesion. 0320 shows no maximum adhesion temperature, but instead a steadily increasing trend. It must be noted that the majority of samples studied on the asphalt substrate resulted in cohesive failure of the asphalt. Thus, the results are likely affected by the asphalt cohesive strength dependence on temperature.

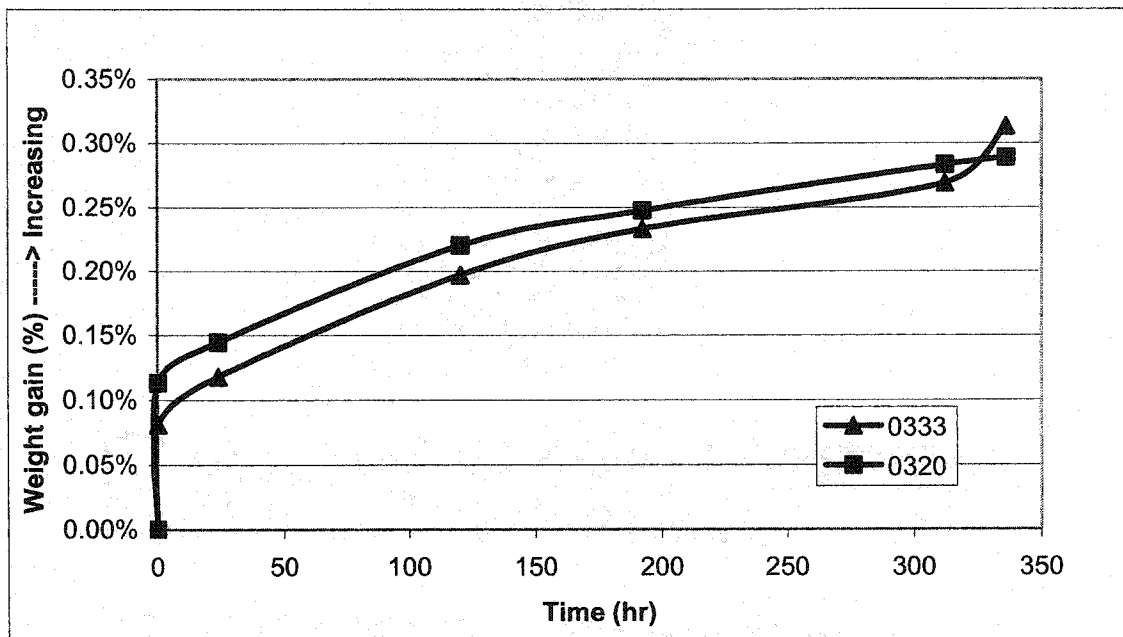
Figure 3.20: Water Absorption of Formulations 0320 and 0333

exposure to water. A maximum was not reached such that the graph would level off within the 350 hours for which the study was run. However, Figure 3.20 does show a slowing of the rate of absorption over the study. It is possible that over an increased time study, the maximum absorption would be reached.
