*Design of Crack Resistant Thermoplastic Roadway Markings*

A thesis submitted to the Faculty of Graduate Studies and Research in partial fulfillment  
of the requirements for the degree of *Master of Science*

Department of *Chemical and Materials Engineering*

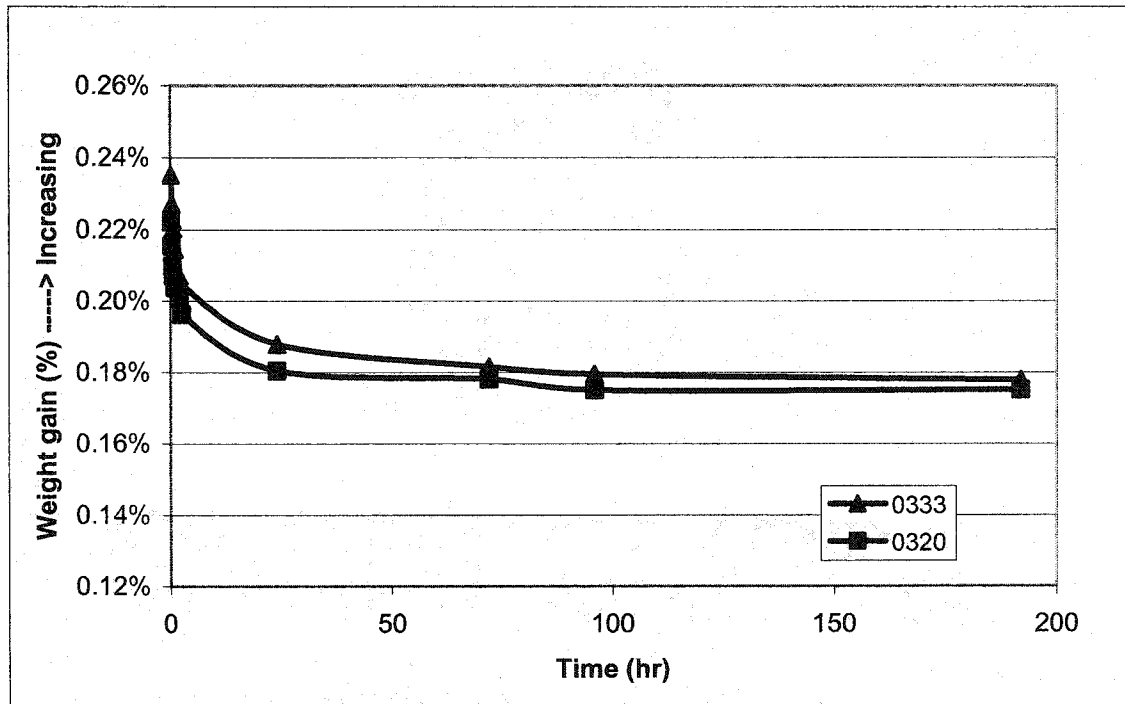
Figure 3.21: Water Elimination of Formulations 0320 and 0333

and expands. Also, with this retention of water in the system, a greater opportunity will exist for the water molecules to attack and possibly deteriorate the resin – aggregate bonds.

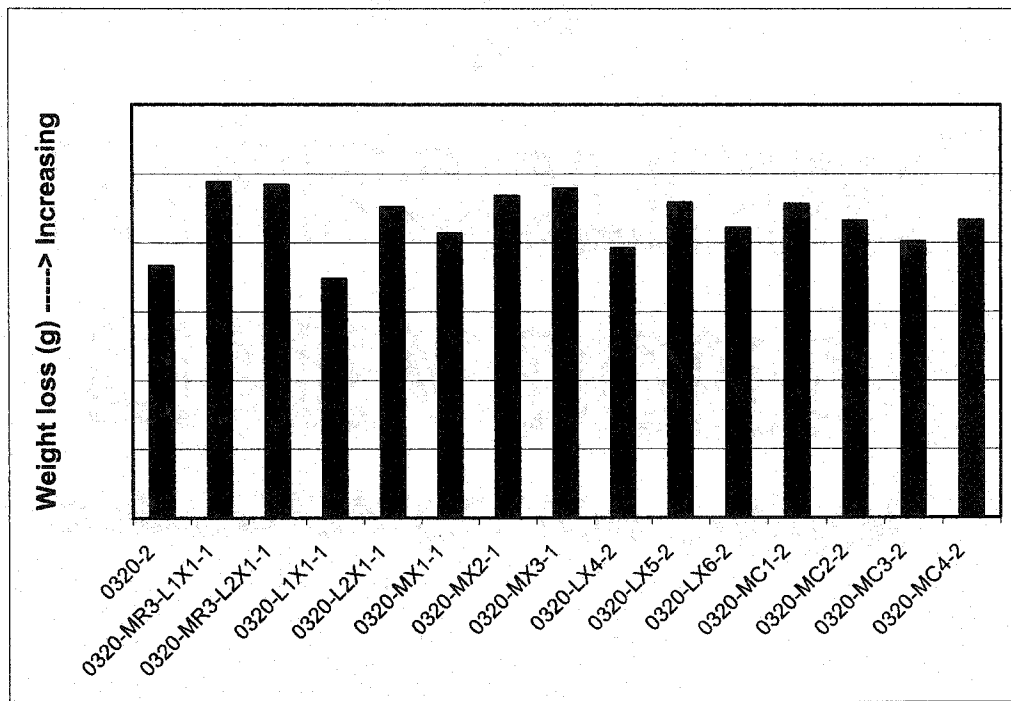
Figure 4.1: Taber Abrasion Analysis of Additional Components to Formulation 0320

abrasion resistance testing was conducted to determine if indeed the addition of the new components resulted in a formulation that met the City of Edmonton standards for abrasion as it is a determining factor in the formulations success. Figures 4.1 and 4.2 are a representation of the data shown in Tables 4.5 and 4.6. Weight loss varied depending on both the type and amount of component added. Formulations 0320-L1X1-1 and 0333-MR3-1 show slightly lower abrasion resistance when compared to the original formulations. However, due to these formulations being observed to be incomparable with the original formulations, as seen in Tables 4.2 and 4.4, further analysis was not conducted.

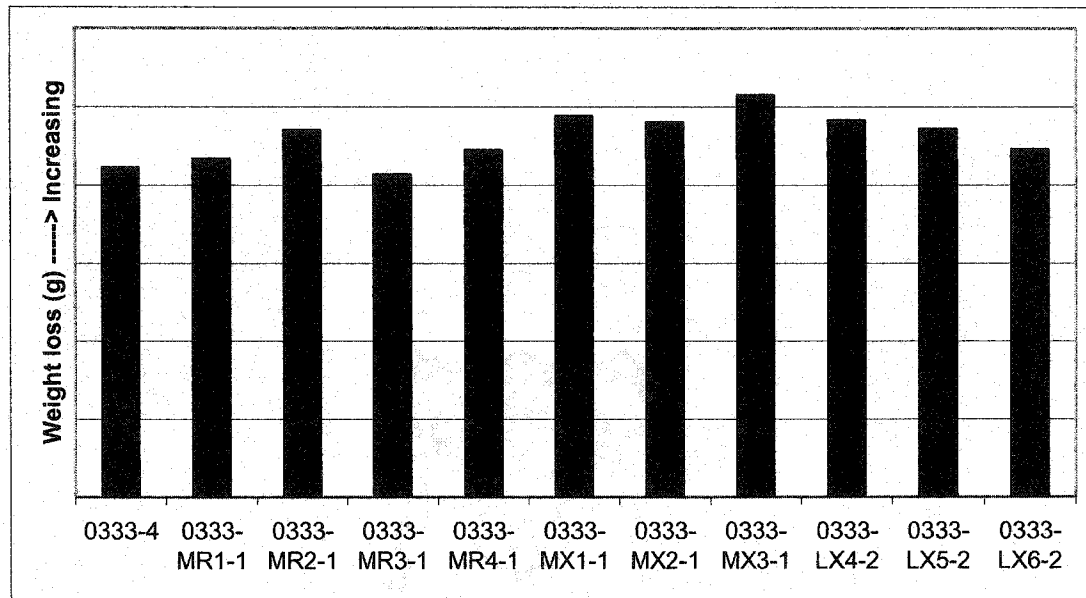
Figure 4.2: Taber Abrasion Analysis of Additional Components to Formulation 0333

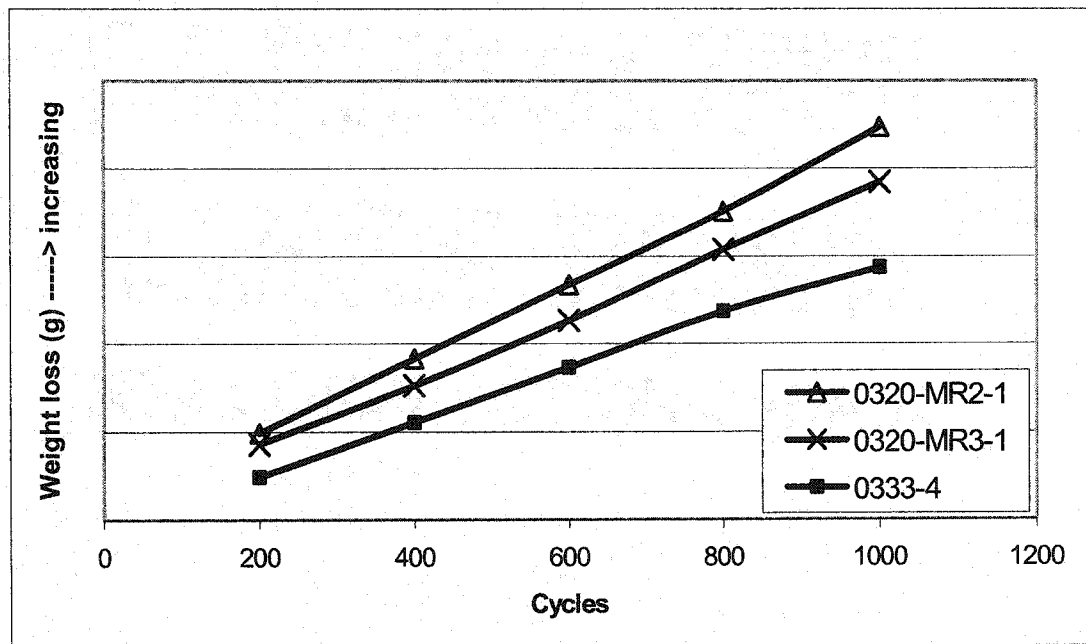
Figure 4.3: Taber Abrasion Depth Study

Taber abrasion as a function of the depth in the sample was tested to ensure that as the line wore, adequate abrasion resistance was maintained throughout the samples. Figure 4.3 shows that wear was uniform throughout the depth of the sample. This also indicates that mixing was adequate to create a homogeneous mixture. There was no settling of heavy aggregates or fillers.

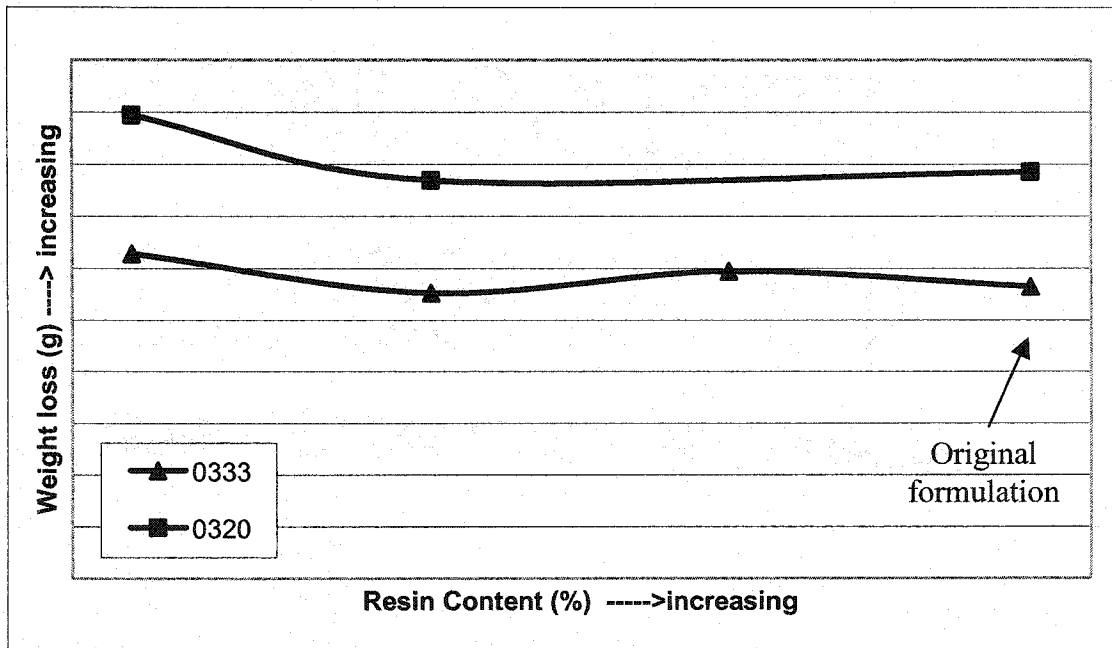
Figure 4.4: Taber Abrasion Weight Loss as a Function of Resin Content

Abrasion as a function of resin content was studied to determine if the percentage of resin could be reduced without adversely affecting the abrasive wear of the formulation. Figure 4.4 shows that the formulations as designed currently offer the highest abrasion resistance, or lowest abrasive wear. The decrease in wear is minimal for formulations with a resin content slightly lower than the original; however, formulations with resin contents much lower than the original show an increase in abrasive wear.
