Structural Engineering Report No. 256

CFRP Sheets Application to Masonry Shear Walls with Openings

by
Honglan Miao
A.E. Elwi
J.J.R. Cheng

February, 2005

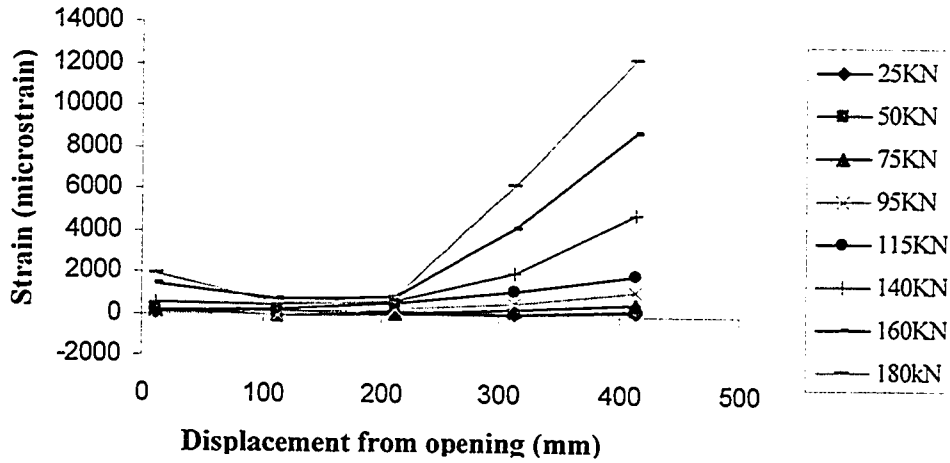
Figure 4-5 Strain Behaviors of Wall 1

Vertical Strain Behaviour of Region 2 (Wall 1)

Horizontal Strain Behaviour of Region 2 (Wall 1)

Vertical Strain Behaviour of Region 3 (Wall 1)

Horizontal Strain Behaviour of Region 3 (Wall 1)

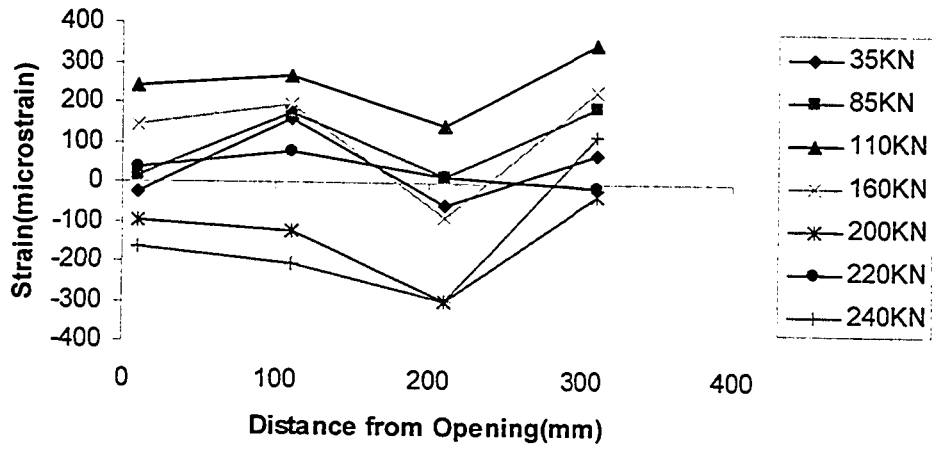
Figure 4-7 Strain Behaviors of Wall 3

Horizontal Strain Behaviour of Region 2 (Wall 3)

Vertical Strain Behaviour of Region 3 (Wall 3)

Horizontal Strain Behaviour of Region 3 (Wall 3)

Vertical Strain Behaviour of Region 4 (wall 3)

Horizontal Strain Behaviour of Region 4 (Wall 3)

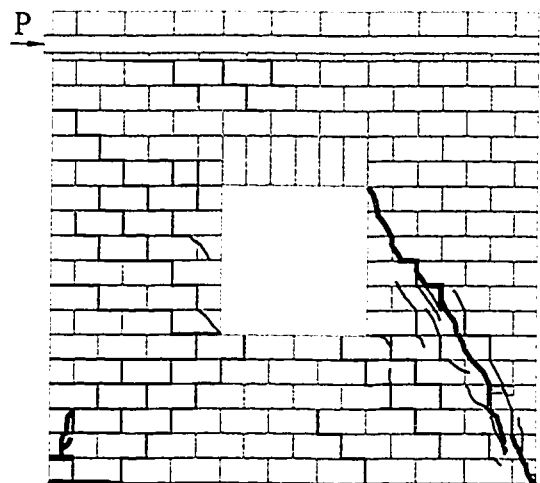
Figure 4-9 Crack Patterns of Wall 1

P = 220kN (failure load) (Wall 1)
