**Analysis and Comparison of Experimental Tests of Barrier-Deck Slab Overhang
Structures Using Steel and GFRP Reinforcement**

Structural Engineering

University of Alberta

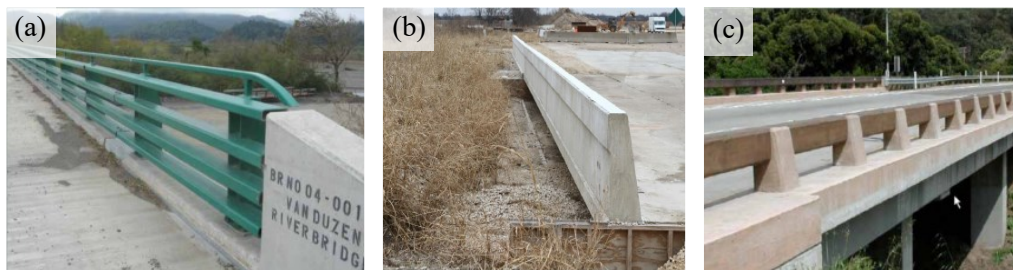
Figure 2.1 Types of bridge barriers. (a) Steel barriers (Caltrans), (b) Continuous concrete barrier (Sheikh et al. 2011), and (c) Concrete barrier with openings (Caltrans).

Bridge barriers are elements located on a bridge superstructure to delineate roadway edges or lanes in opposing directions (i.e., edge or median barriers) (CSA S6 2019). They contain and redirect errant vehicles into a safe stop position without posing hazard to others (MASH, 2009). Barriers are designed to resist vehicle impact forces, prevent vehicle overturning, and dissipate impact energy (Fadaee and Sennah, 2017). Fig 2.1 presents some common barrier types that include steel rails, concrete walls, and concrete posts with beams.

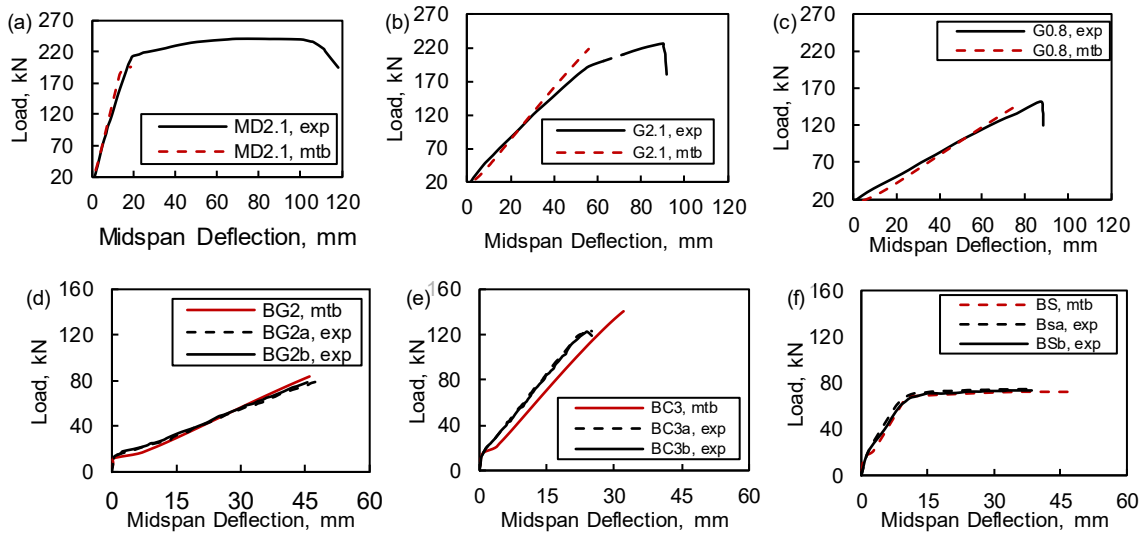
Figure 3.10 Load deflection curves obtained by model (subscript *mtb*) and those reproduced from original data (subscript *exp*). Lau and Pam (2010): (a) MD2.1-A90, (b) G2.1-A90, and (c) G0.8-A90 beam tests. Al-Sunna et al. (2012): (d) BG2, (e) BC3, and (f) BS beam tests.

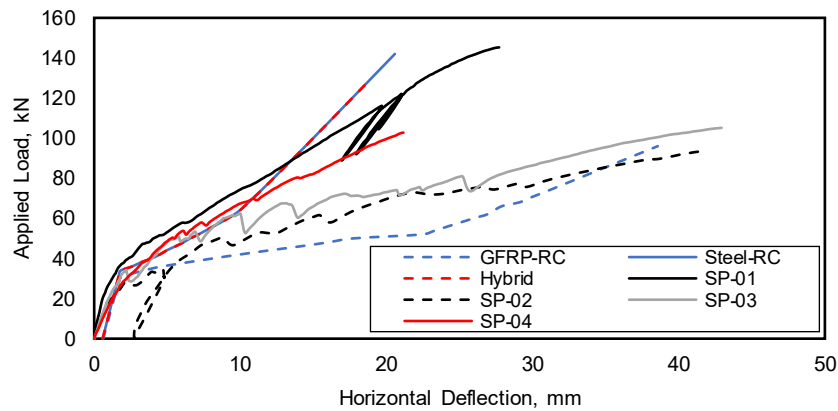
Figure 3.13 Load-deflection curves up to peak load from analytical model and sensors from tests at 775 mm above deck slab.

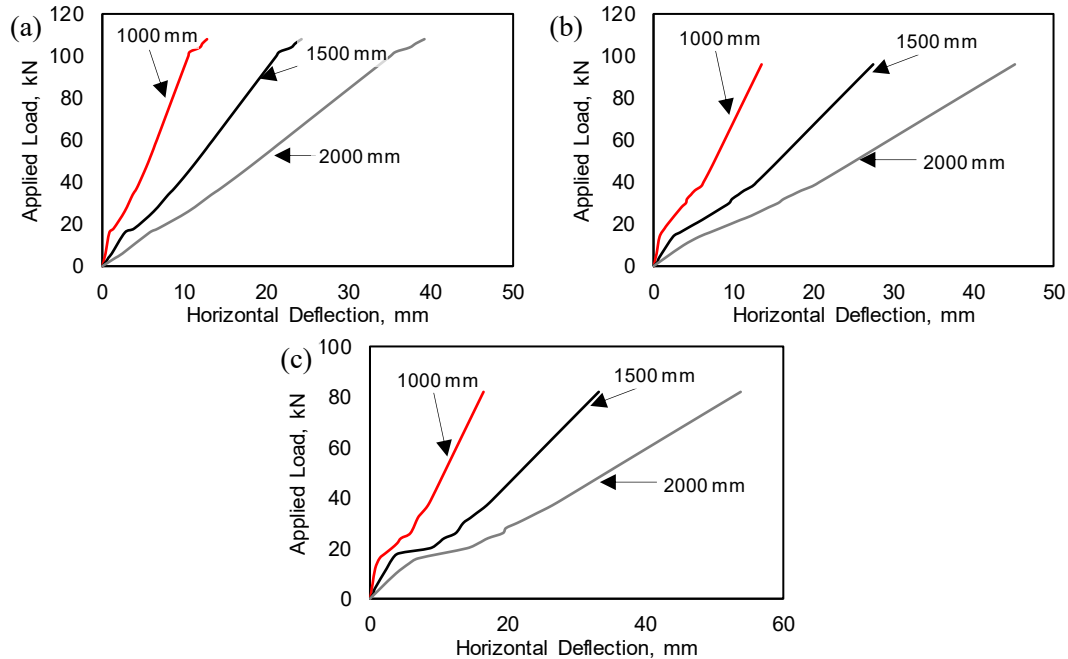
Figure 3.16 Load-deflection curve for (a) GFRP-xxxx- 100, (b) GFRP-xxxx- 150, and (c) GFRP-xxxx- 200. Overhang length effect assessment.

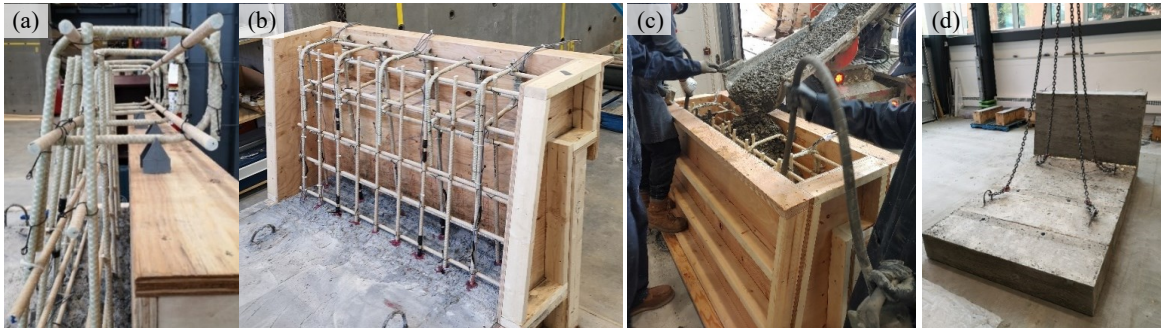
Figure 4.5 Barrier fabrication process for control specimens (SP-01 and SP-02). (a) barrier rebar assembly connected, (b) typical barrier formwork installed, (c) concrete pouring for barriers, and (d) formwork stripping after curing process finished.

For specimens SP-01 and SP-02, barrier reinforcement assemblies followed layouts shown in Figs. 4.2(a) and (b), and 4.3. Barrier fabrication was relatively easy since vertical bars were already anchored into the deck. Horizontal bars were placed, leveled, and tied at the

designed spacing (Fig. 4.5(a)). For the front bar assembly, the horizontal bar at the base was tied as close to the deck's top fibre. Barrier wall formwork was constructed (Fig. 4.5(b)), concrete cast on April 20th, 2023 (Fig. 4.5(c)), and formwork stripped after 7 days of curing under plastic with daily watering (Fig. 4.5(d)).

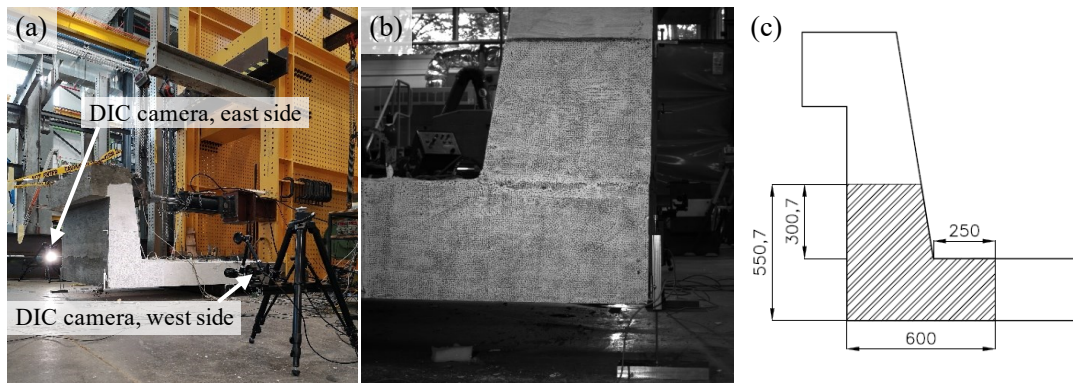
Figure 4.12 (a) DIC setup, (b) dotted area under analysis, and (c) DIC area dimensions.

Figure 4.12 shows the zone captured by a 3D Digital Image Correlation (DIC) camera system. DIC data was captured on either side of each specimen with focus on barrier-deck junctions where large stress concentrations were expected (Fig. 4.12(a)). DIC cameras had a 5 MP resolution (2448-pixel width) which takes photos at a desired frequency (1 Hz here) to produce time-lapse images that are then processed to measure distributed strains and displacements. Tracking was enabled through a dotted texture drawn using a special roller and paint (Fig. 4.12(b)). Dot size was 1.27 mm and selected considering the camera resolution and field of view (i.e., size of region being captured) size to ensure good resolution of results (i.e., 5+ pixels per dot (Correlated Solutions, 2021a)). The area included the joint itself and one element depth away from the joint in both the deck and barrier (Fig. 4.12(c)). This area was chosen as a D-region was probable to form given the geometry discontinuity and large stress of the knee joint connecting both elements until failure. DIC images were processed with VIC DIC 3D-9 software using default options of the program to obtain concrete surface strains, displacements, and crack widths as discussed later. Program was

calibrated using speckle images with a calibration board provided by manufacturer which allowed DIC camera system to map the area of interest prior further analyses were performed. Calibration scores for each specimen was: 0.031 (SP-01), 0.029 (SP-02), 0.034 (SP-03), and 0.028 (SP-04). These values represent the mean distance between extracted and predicted location of calibration points from calibration board expressed in hundredths of pixels (Correlated Solutions, 2021b). Score values below 0.1 are acceptable calibration scores with those closer to zero more precise.

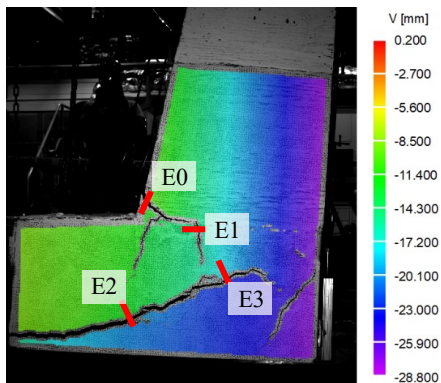
Figure 4.19 Typical location and label of markers to track crack development during tests.

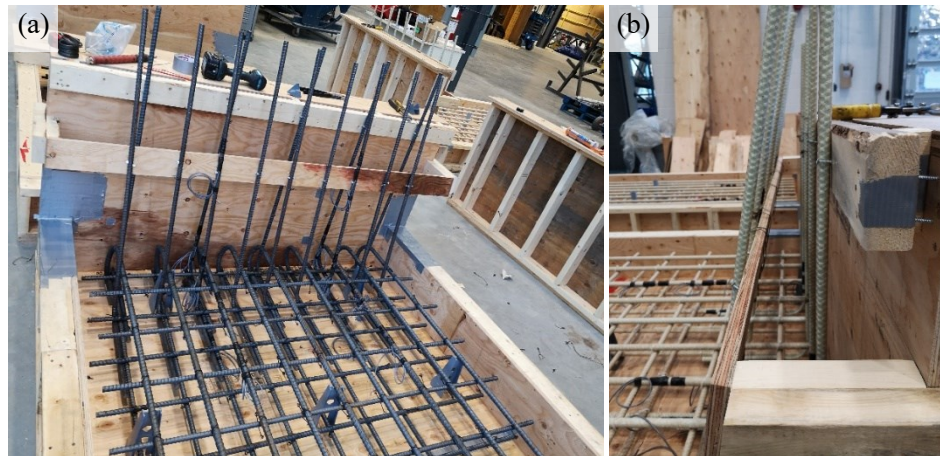
Figure A 1 Vertical reinforcement installation process for control specimens (a) front view of bars showing 2x4 in. sticks as guides, and (b) lateral view of wood guides used in SP-02.

All reinforcement was tied with steel rebar ties or zip-ties, depending on the type of reinforcement used (i.e., steel rebar used metallic ties, whereas GFRP used zip-ties). After mat installation, vertical reinforcement for barriers in SP-01 and SP-02 was placed and connected using the same ties. Vertical reinforcement was placed using wooden guides to maintain designed bar inclination and concrete cover (Fig. A.1).

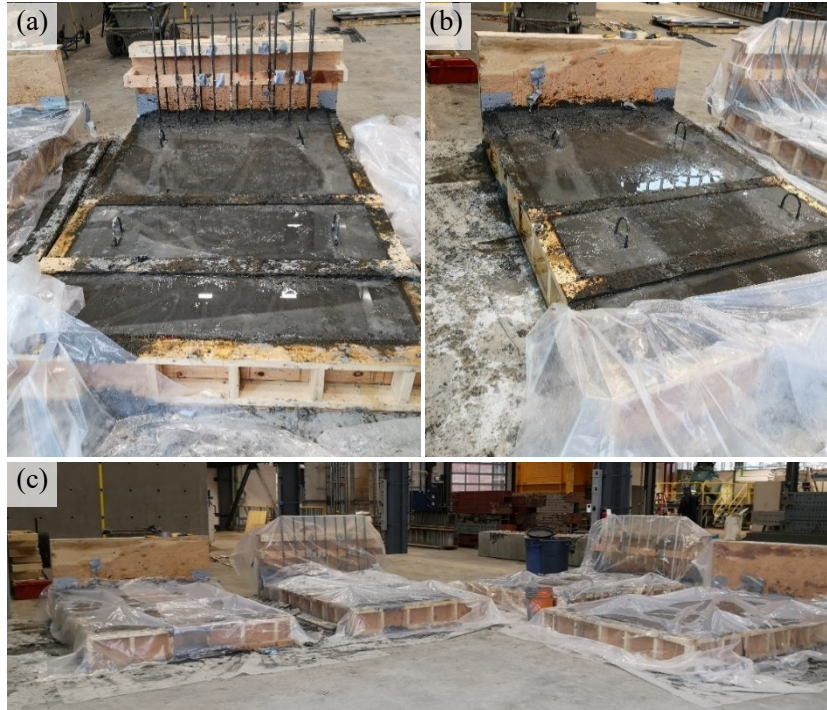
Figure A 7 (a and b) final product for SP-01 and SP-04 respectively, and (c) general photo of all specimens during curing.

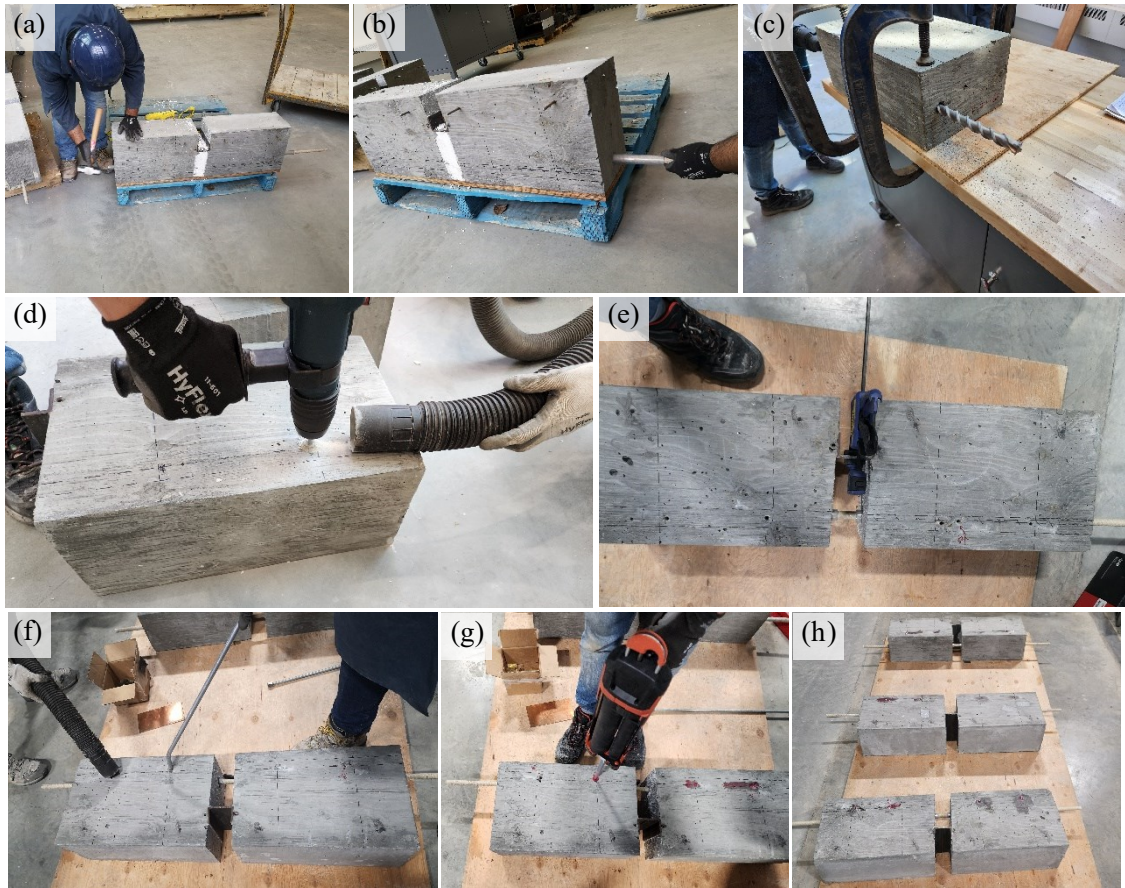
Figure B 2 (a) and (b) GFRP bar removal from hardened concrete, (c) hole wall roughening with rotary jack hammer, (d) lateral holes drilling, I beam segments positioning and levelling, (f) holes cleaned with pumped air, (g) epoxy resin injection into lateral cavities, and (h) specimens curing after epoxy injected.

Step 8: Fig. B.2(g) shows epoxy injection. Epoxy resin is injected through the lateral holes drilled in **Step 4**. Epoxy nozzle is inserted in one cavity and resin pushed into the hole until it comes out from opposite lateral cavity. This pushes air out from the longitudinal hole and ensures that the hole is adequately filled. Excess epoxy was then cleaned off.

Step 8: Let resin cure according to manufacturer's recommendations (6.5 hours). In this case, at least 7-days were used to cure the resin and move to testing stage (Fig. B.2(h)).

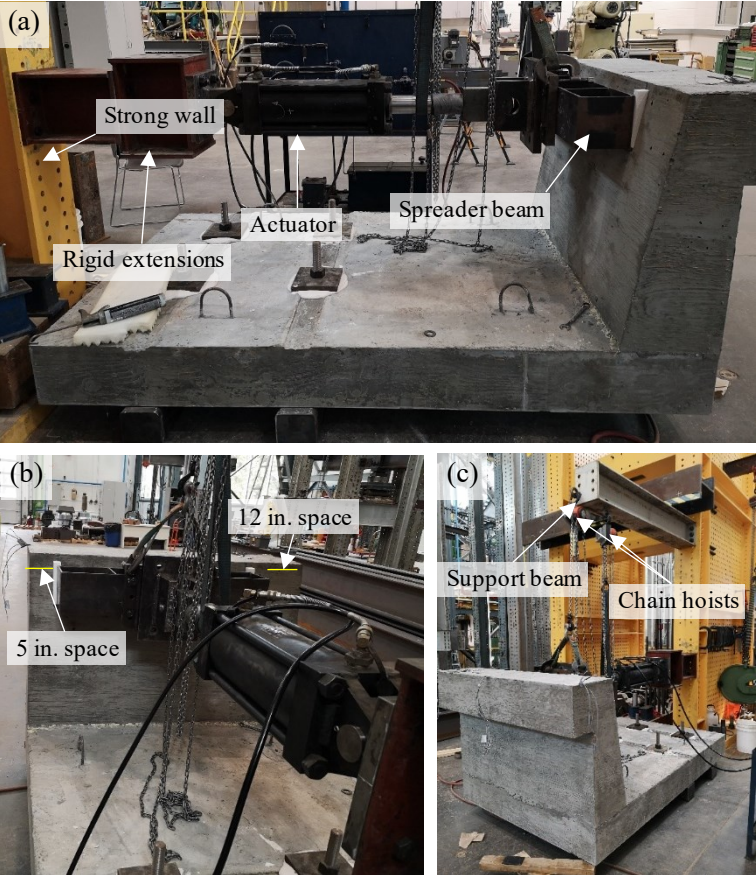
Figure C 2 Final test setup, (b) Spreader beam position along specimen's width, and (b) upper supporting structure composed of beam and chain hoists to maintain in a horizontal level the actuator.

The position of the specimen was fixed by concrete anchors. To keep specimens and loading systems horizontal and plumb prior to testing, chain hoists were used to adjust the actuator with a level. Fig. C.2(a) shows the final setup; Figs. C.2(b), and (c) shows relevant details. As observed in Fig. C.2(b), the actuator was not centred in the middle of the specimen

width due to the strong floor's hole location relative to their position on each specimen. This resulted in the actuator centre being offset 3.5 in. (88.9 mm) towards the west side of each specimen.
