**Motor Vehicle Collision Injury Analysis:
Design and Development of an Injury Analysis Team Collaborating with Expert
Police Collision Reconstructionists**

A thesis submitted to the Faculty of Graduate Studies and Research in partial fulfillment
of the requirements for the degree of **Master of Science**

Medical Sciences – Public Health Sciences

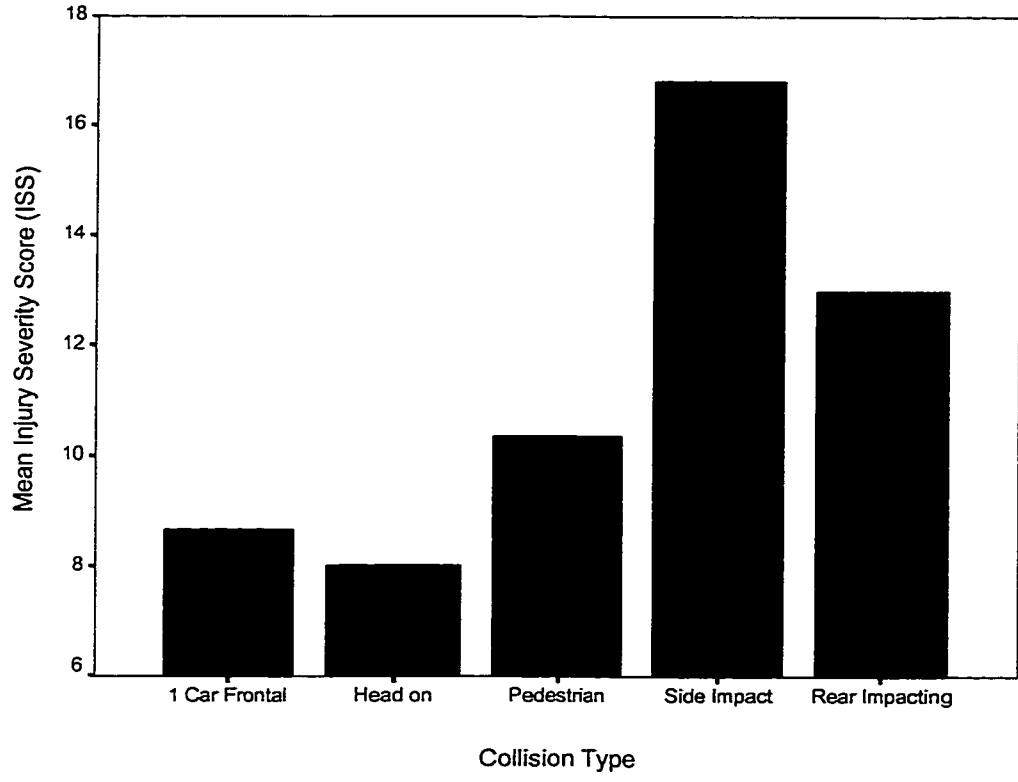
Figure 4.50-Mean Injury Severity Score and Collision Type
