Damage Investigations of Glass Fibre/Epoxy Resin Composite Laminates Under Cyclic  
Loading

A thesis submitted to the Faculty of Graduate Studies and Research in partial fulfillment  
of the requirements for the degree of Master of Science

Department of Mechanical Engineering

Spring, 2000

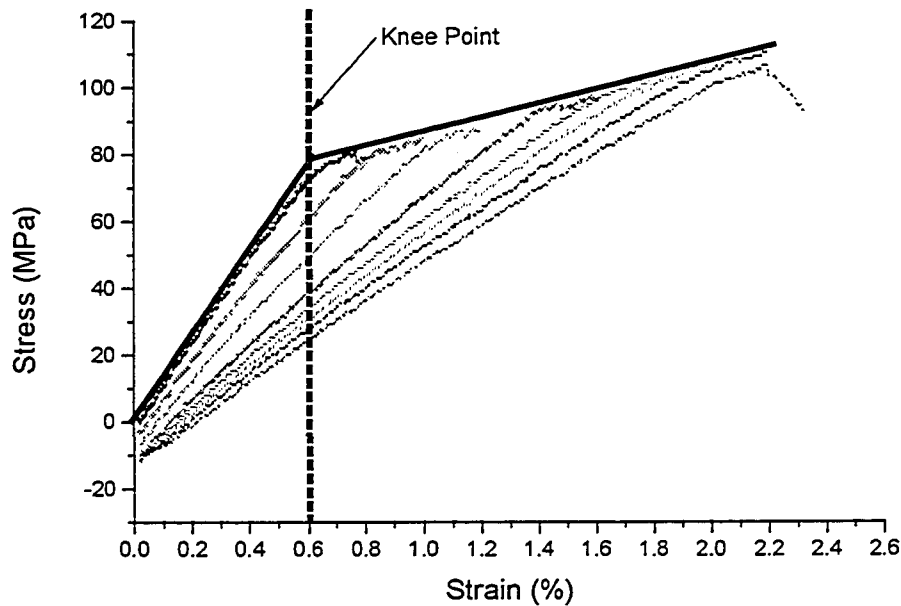
Figure 3.1: Stress-strain curve for  $(\pm 45/90_3)_s$  specimen loaded quasi-statically under strain control (Each line represents a subsequent loading ramp)

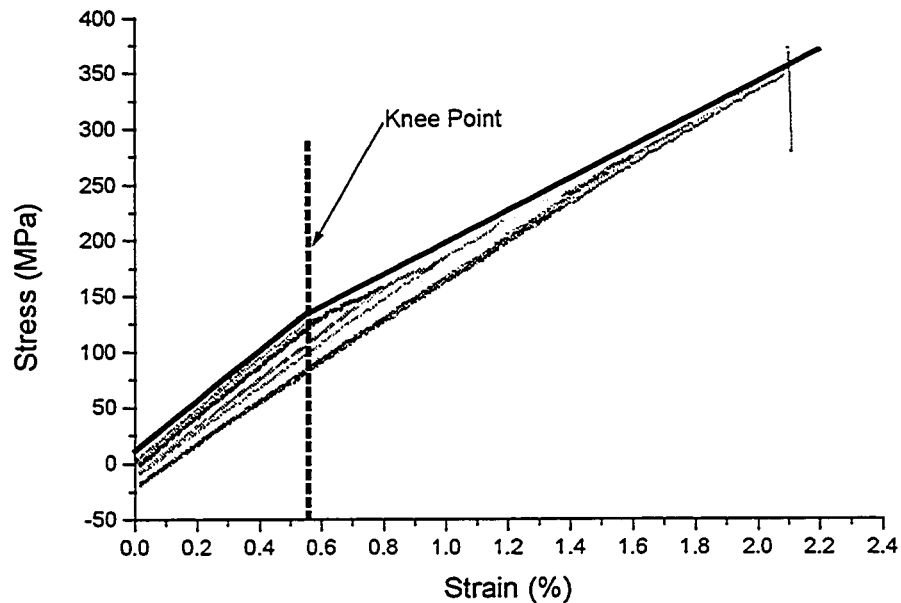
Figure 3.2: Stress-strain curve for  $(0_2/90_3)_s$  specimen loaded quasi-statically under strain control (Each line represents a subsequent loading ramp)

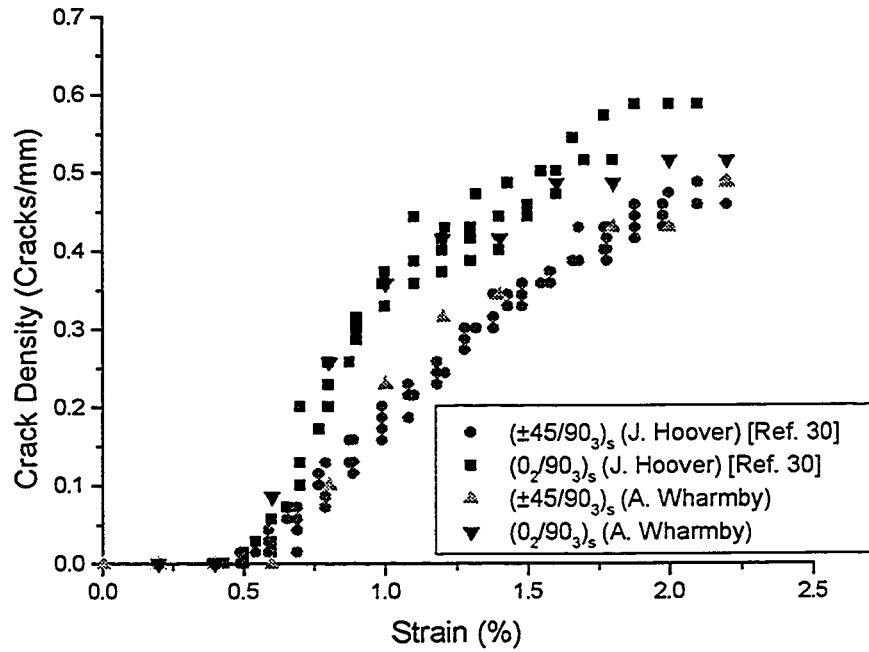
Crack density vs. strain curves were produced for both specimen types examined and are shown in Figure 3.3. Crack initiation for both orientations was at 0.6% strain, the same strain where large stiffness reductions were first seen. Both types of specimens followed similar crack density curves throughout their lives, although the  $(0_2/90_3)_s$  specimen produced slightly more cracks as the strain increased. This is due to larger stress gradients between the  $0^\circ$  plies and the  $90^\circ$  plies than that seen between the  $45^\circ$  plies and the  $90^\circ$  plies, resulting in more load transfer and more matrix cracking.

Figure 3.3: Crack density vs. strain for  $(\pm 45/90_3)_s$  and  $(0_2/90_3)_s$  specimens under quasi-static strain controlled loading (Courtesy of Hoover [30])

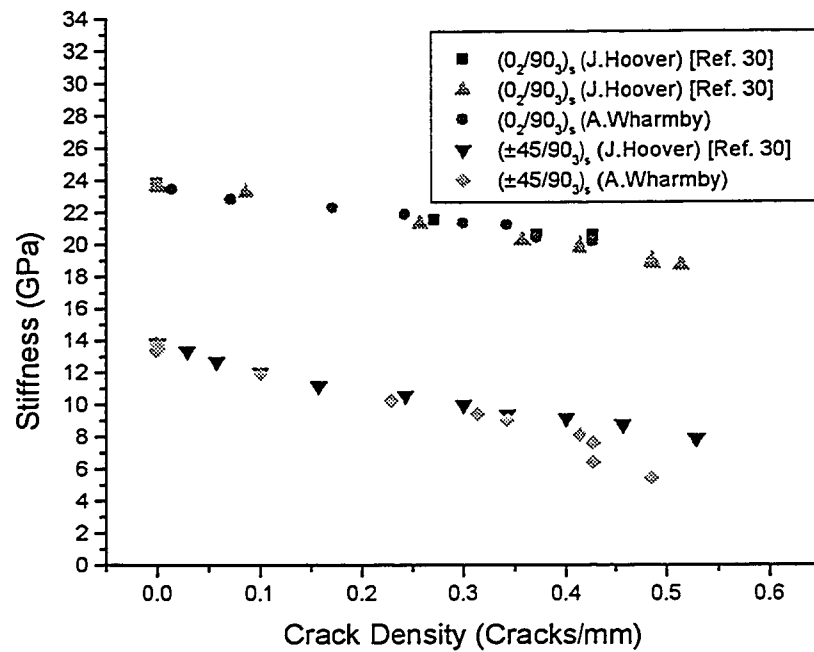
Figure 3.4: Stiffness reduction vs. crack density for  $(0_2/90_3)_s$  and  $(\pm 45/90_3)_s$  coupon specimens under quasi-static loading
