Structural Engineering Report No. 105

# FATIGUE STRENGTH OF TWO STEEL DETAILS

by  
K. A. BAKER  
and  
G. L. KULAK

DEPARTMENT OF CIVIL ENGINEERING  
THE UNIVERSITY OF ALBERTA  
EDMONTON, ALBERTA

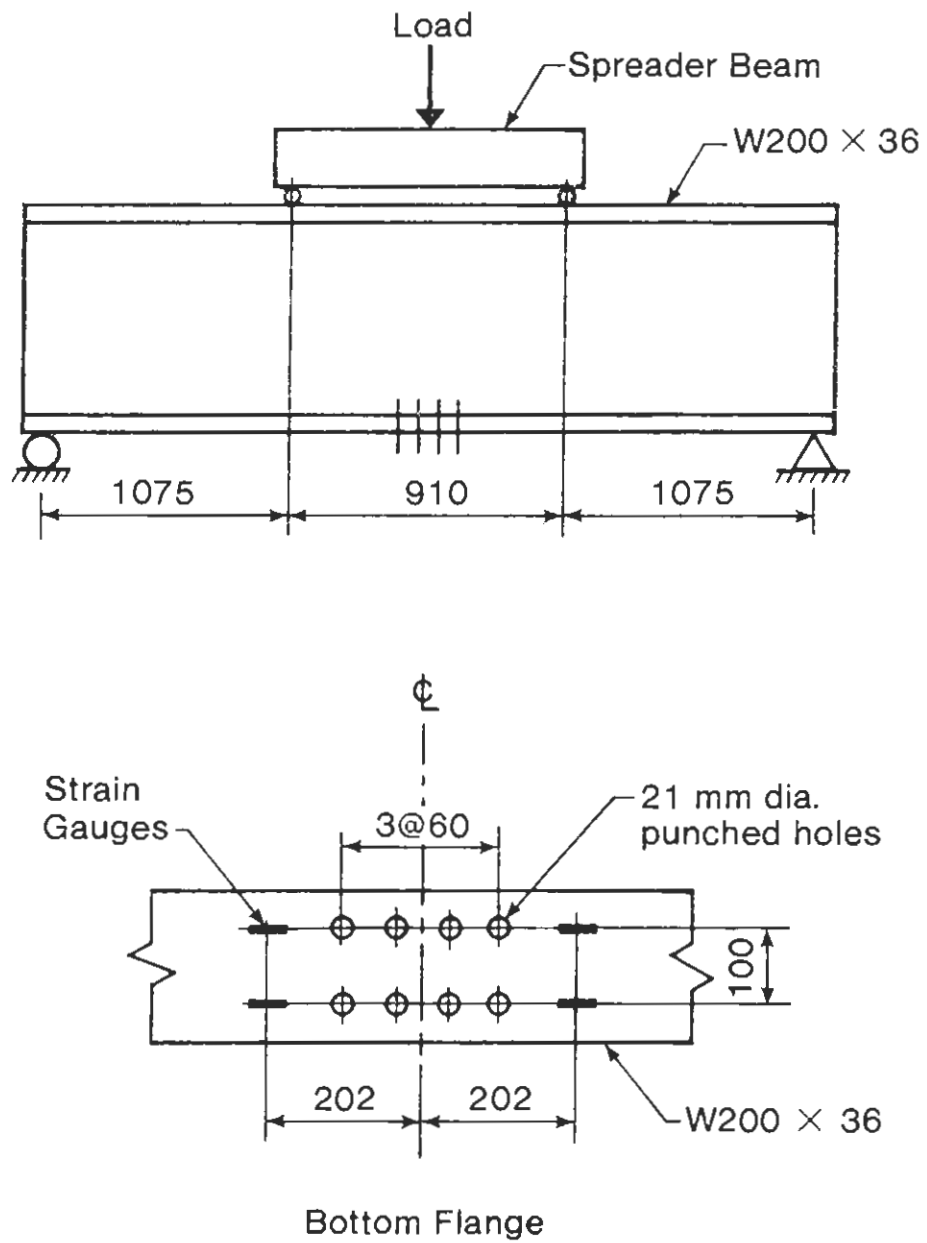
Figure 3.1 Specimen Details for Test Beams

The joints with loose rivet connections were simulated by simply punching holes in a plain beam. The holes were punched rather than drilled as fatigue can be expected to be more critical in punched holes. This condition was intended to represent the lower bound of riveted joint behavior, that is, the rivet is completely loose. Obviously this model neglects the beneficial effects of any clamping force the rivet could provide. On the other hand the detrimental effects of fretting or corrosion under a rivet head that might be present in the prototype are also neglected.

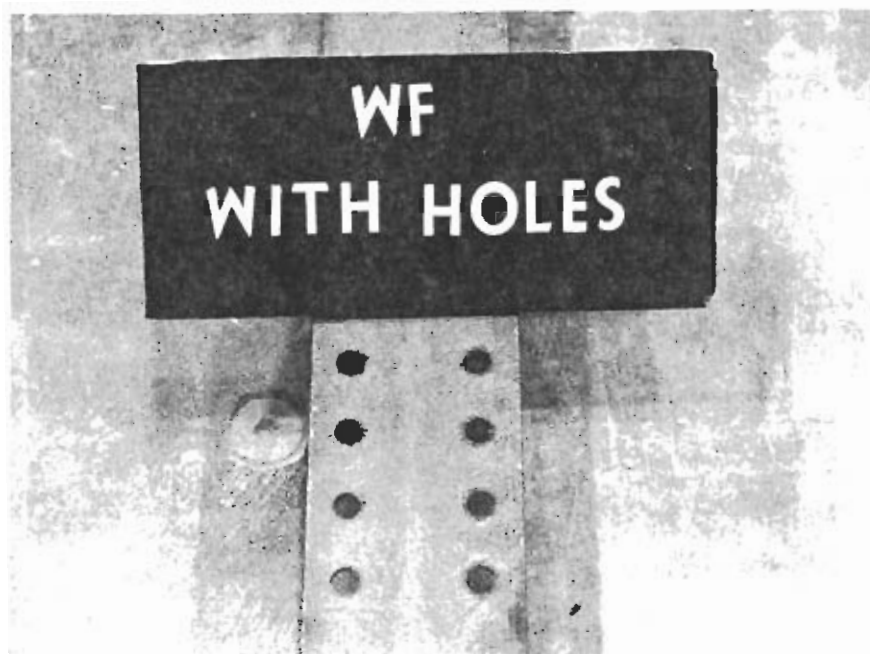
Figure 3.2 Typical Test Specimens of Beams with Holes and Beams with Bolts

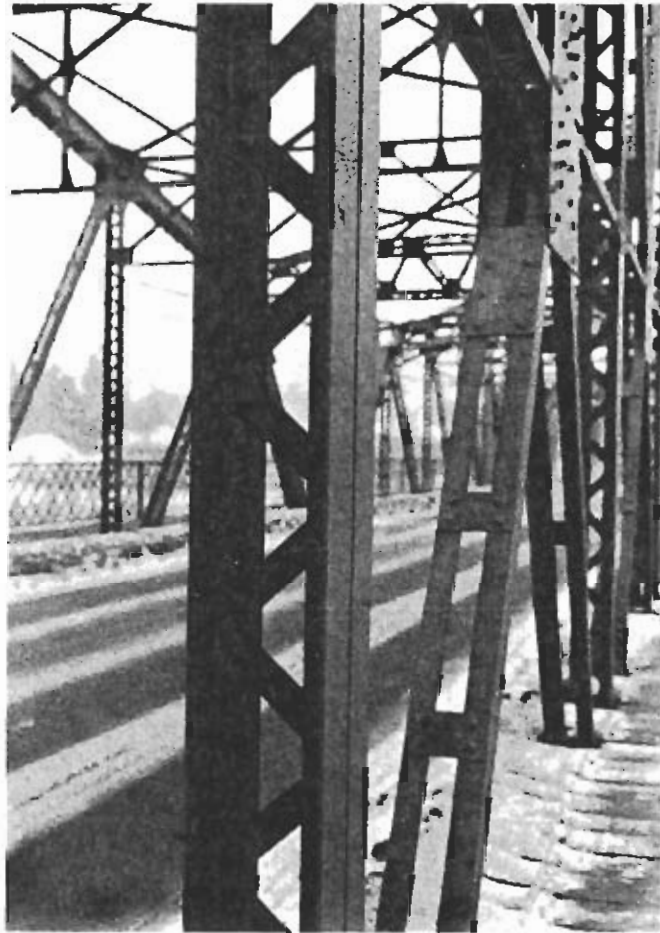
Figure 3.3 Typical Bridge Member

The riveted specimens were obtained from a section which was being replaced in a seventy-year-old highway bridge (Fig. 3.3). The condition of the bridge members was excellent. There was no evidence of flaking paint or corrosion of the surfaces. Each member consisted of either two 3 in. x 5 in. x 0.375 in. angles (76 mm x 127 mm x 10 mm) or two 3.5 in. x 6 in. x 0.375 in. angles (89 mm x 152 mm x 10 mm). The short legs were placed back-to-back, with a

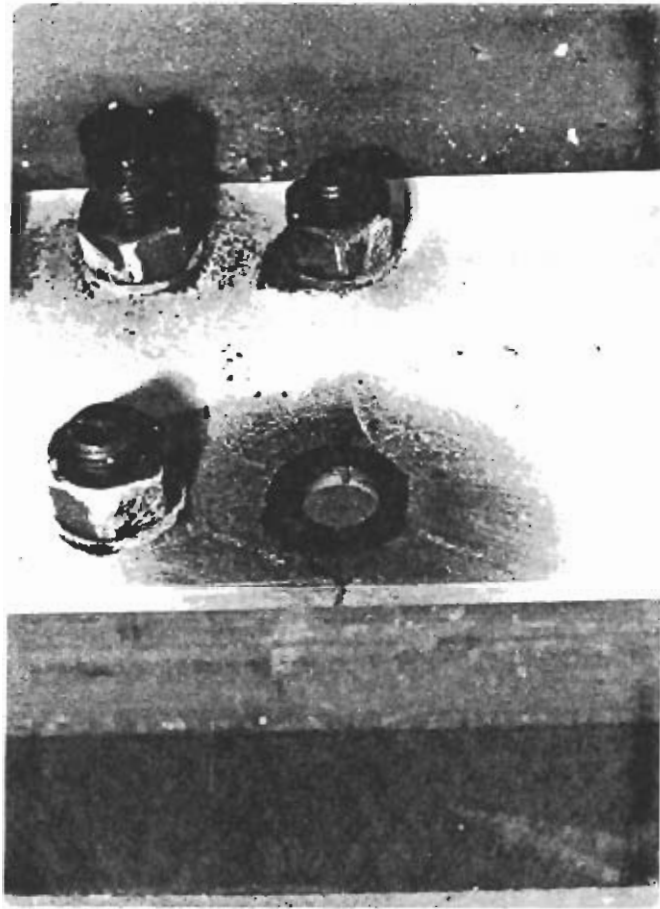
Figure 4.1 Failure Crack in Bolted Test Beam

In five of the six tested specimens, three with open holes and two with holes containing bolts, the crack initiation and growth patterns were similar. Initial cracking began at the extremity of one of the end holes and proceeded to grow out towards the flange tip (Fig. 4.1). Before the crack had progressed from the hole completely through to the flange tip, another crack started on the opposite side of the same hole and progressed in towards the web. In the sixth specimen, the crack started at the extremity of an interior hole and grew out towards the flange tip.

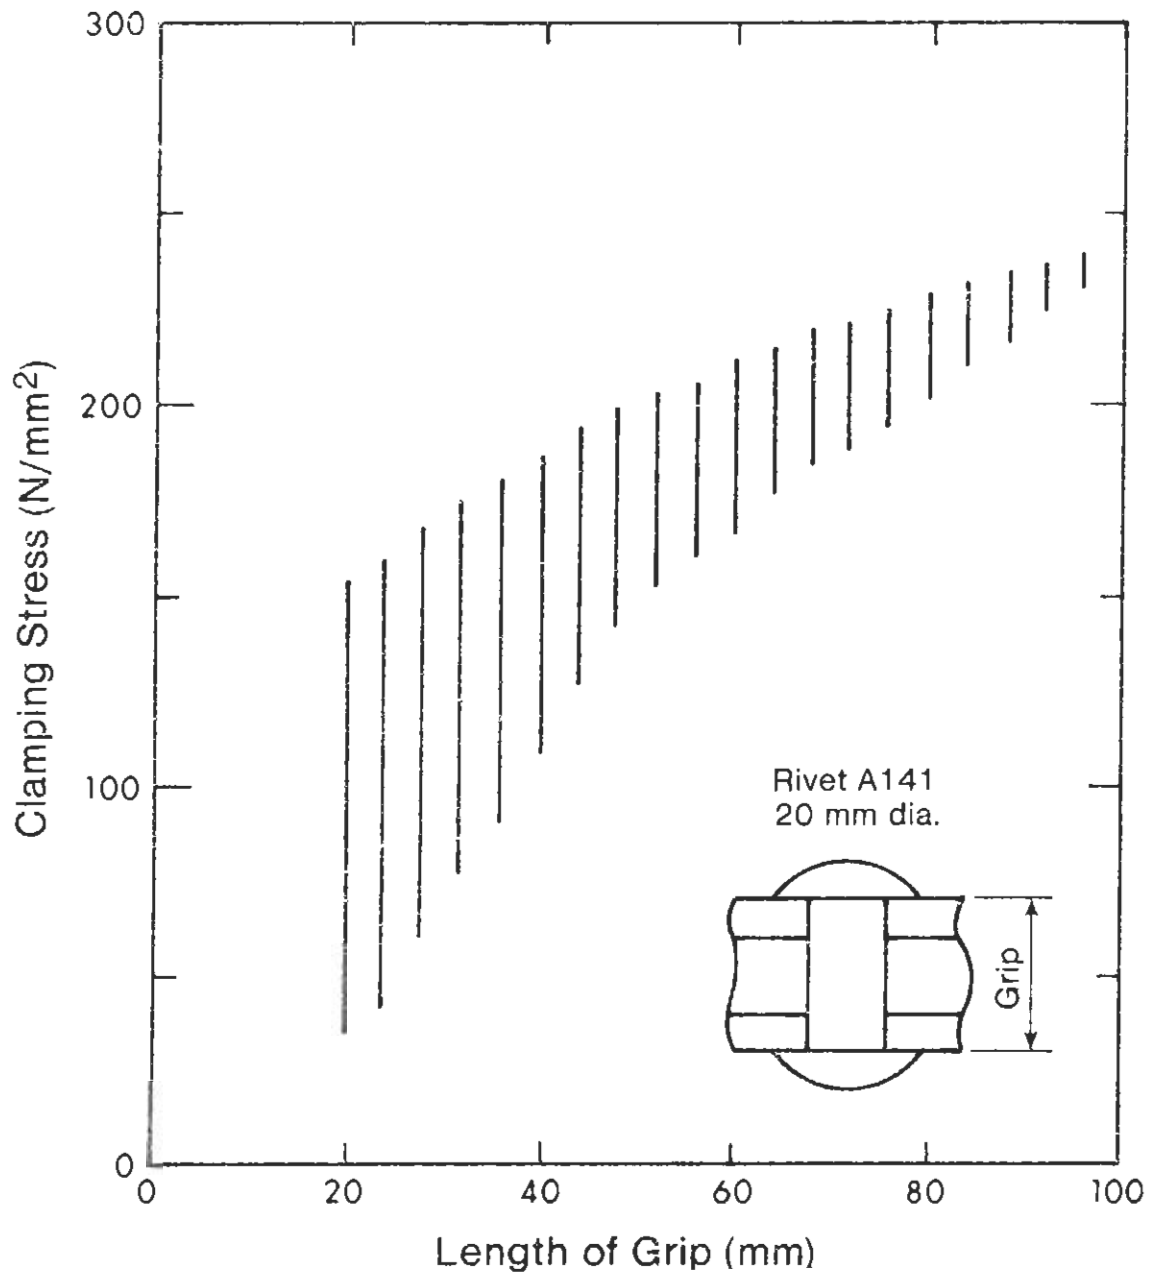
Figure 4.4 Clamping Stress versus Length of Grip (Ref. 6)

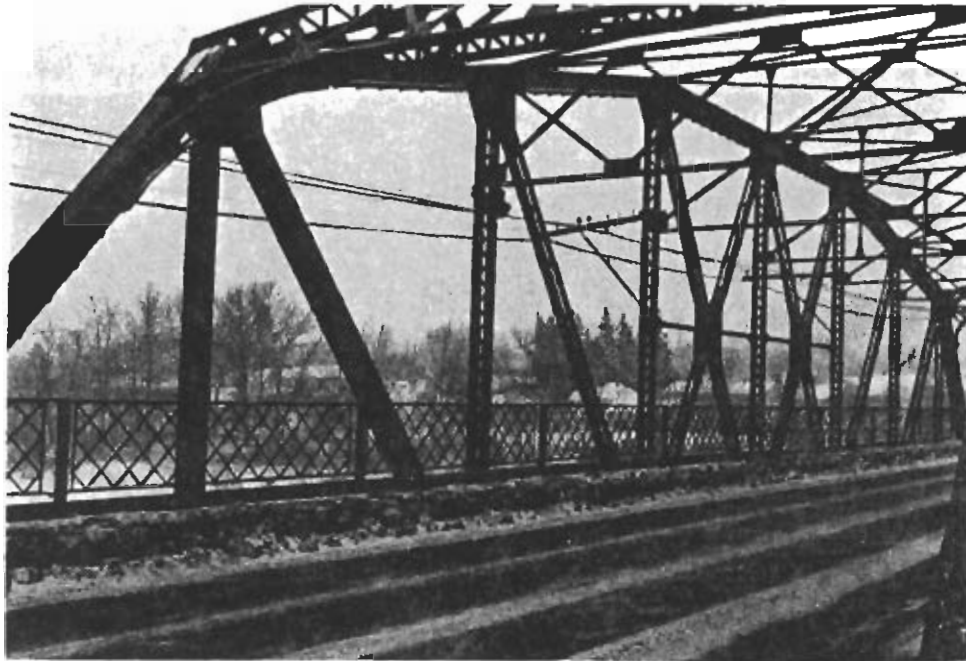
Figure 4.5 Bridge Geometry and Location of Actual Riveted Members Tested

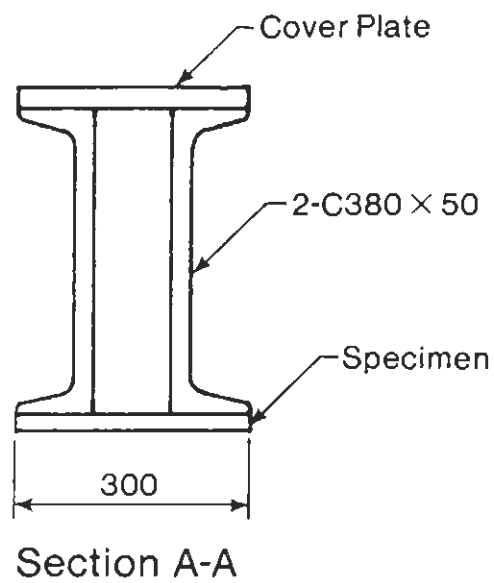
Figure 6.3 Test Set-up Details

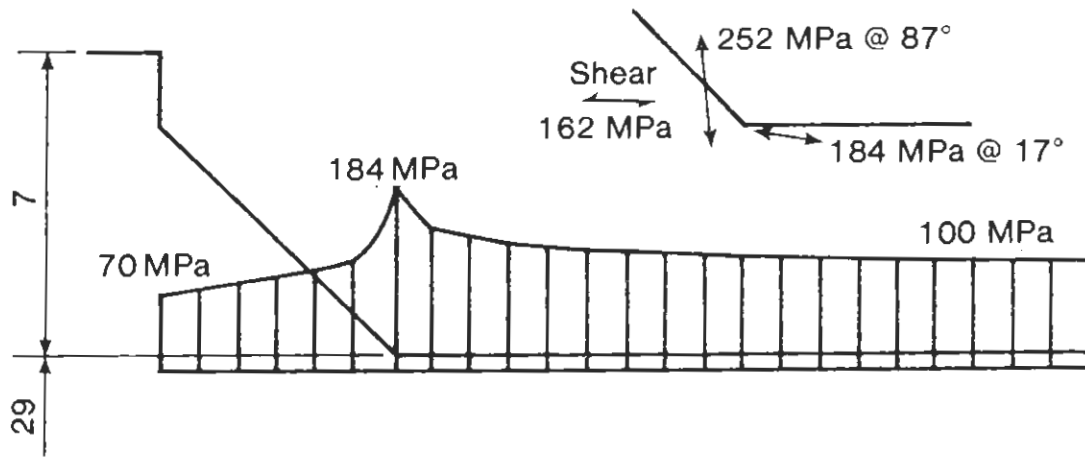
Figure 7.3 Regions of High Stress for the Groove Weld with Backing Bar

The output shows that the highest stress concentrations are located at the fillet weld toe. They are, however, very localized. The observed magnitude of stress at the toe line, on the main plate, was 184 MPa and this did not vary with changes in the plate thickness. The stress concentrations in the weld itself at the toe were even higher. They varied

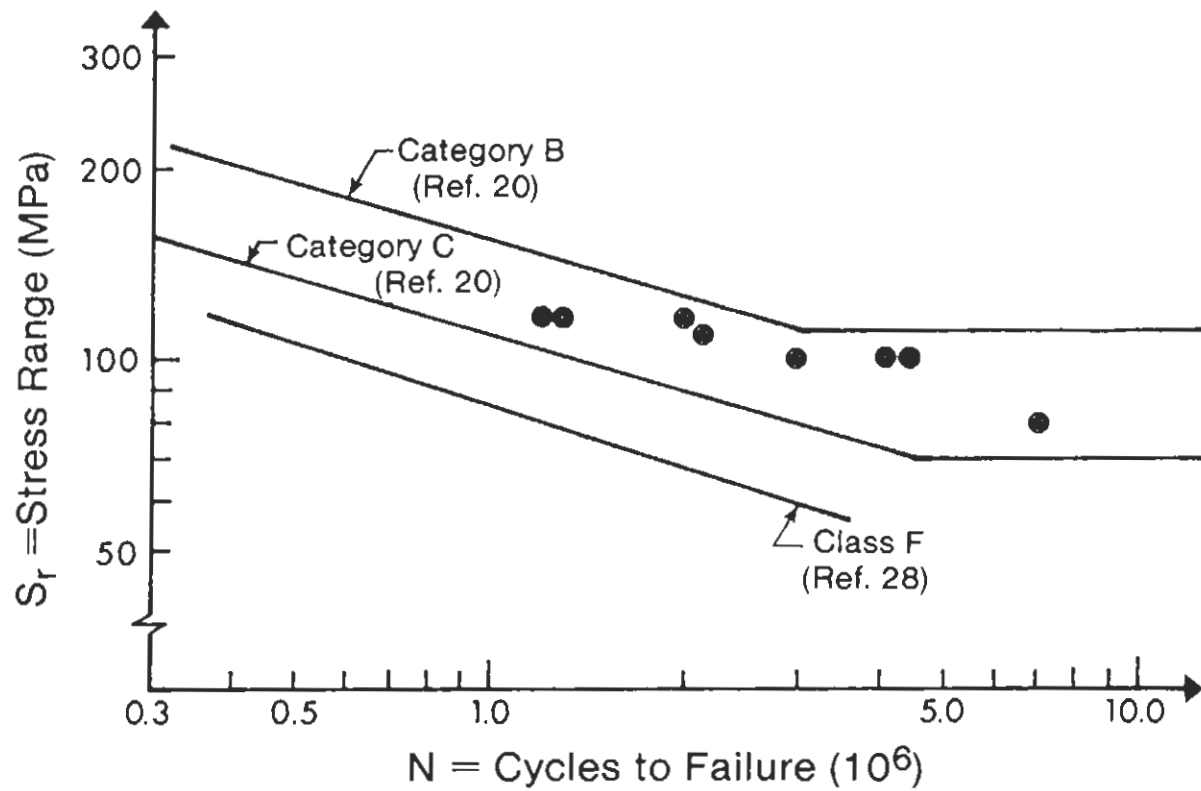
Figure 7.5 Groove Weld with Backing Bar-Test Results

The test data for the groove weld with backing bar specimens tested are presented in Table 7.1 and are plotted in Figure 7.5. Each data point on the graph represents a separate fatigue crack.

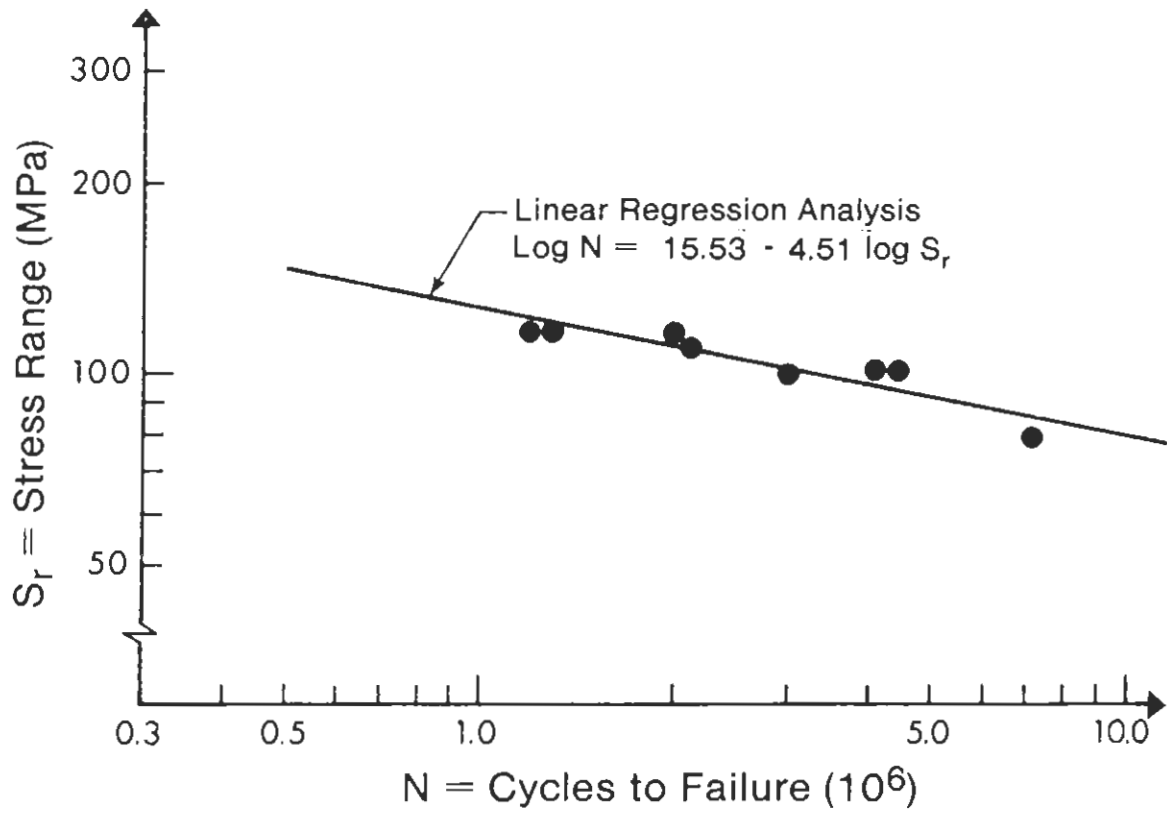
Figure 7.6 Groove Weld with Backing Bar-Test Results
