The undersigned certify that they have read, and recommend to the Faculty of Graduate Studies and Research, for acceptance, a thesis entitled "LANDSLIDES IN LAYERED VOLCANIC SUCCESSIONS WITH PARTICULAR REFERENCE TO THE TERTIARY ROCKS OF SOUTH CENTRAL BRITISH COLUMBIA" submitted by Stephen George Evans in partial fulfilment of the requirements for the degree of DOCTOR OF PHILOSOPHY.

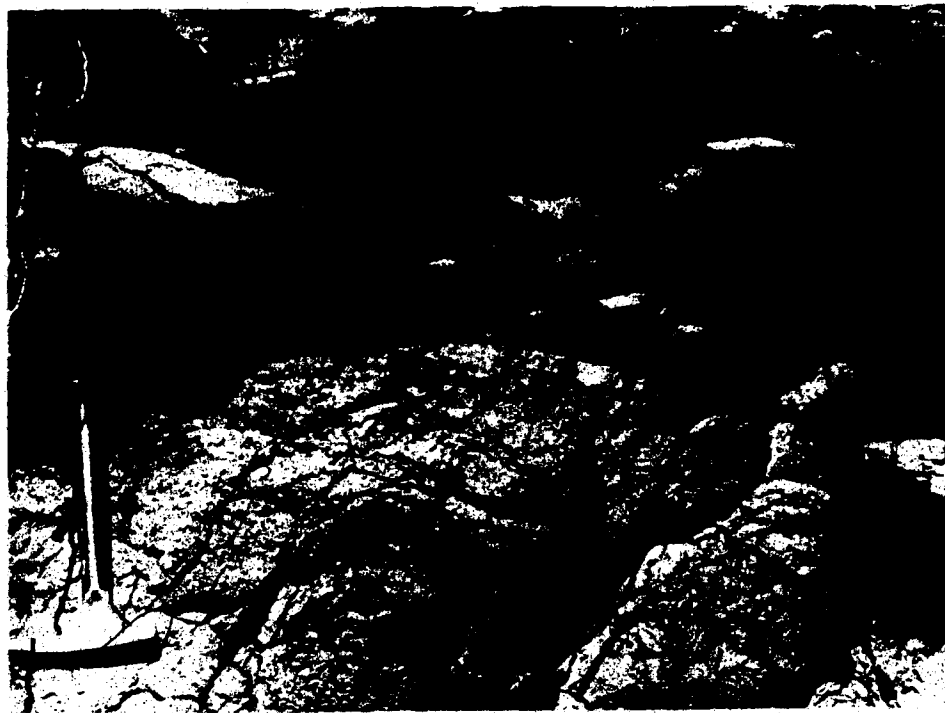
Plate 4.5 Salmon River Tuff-Tuff Breccia exposed at the west margin of the Jupiter Creek landslide. Note filled discontinuities, spheroidal-type alteration or weathering and basaltic blocks (B).

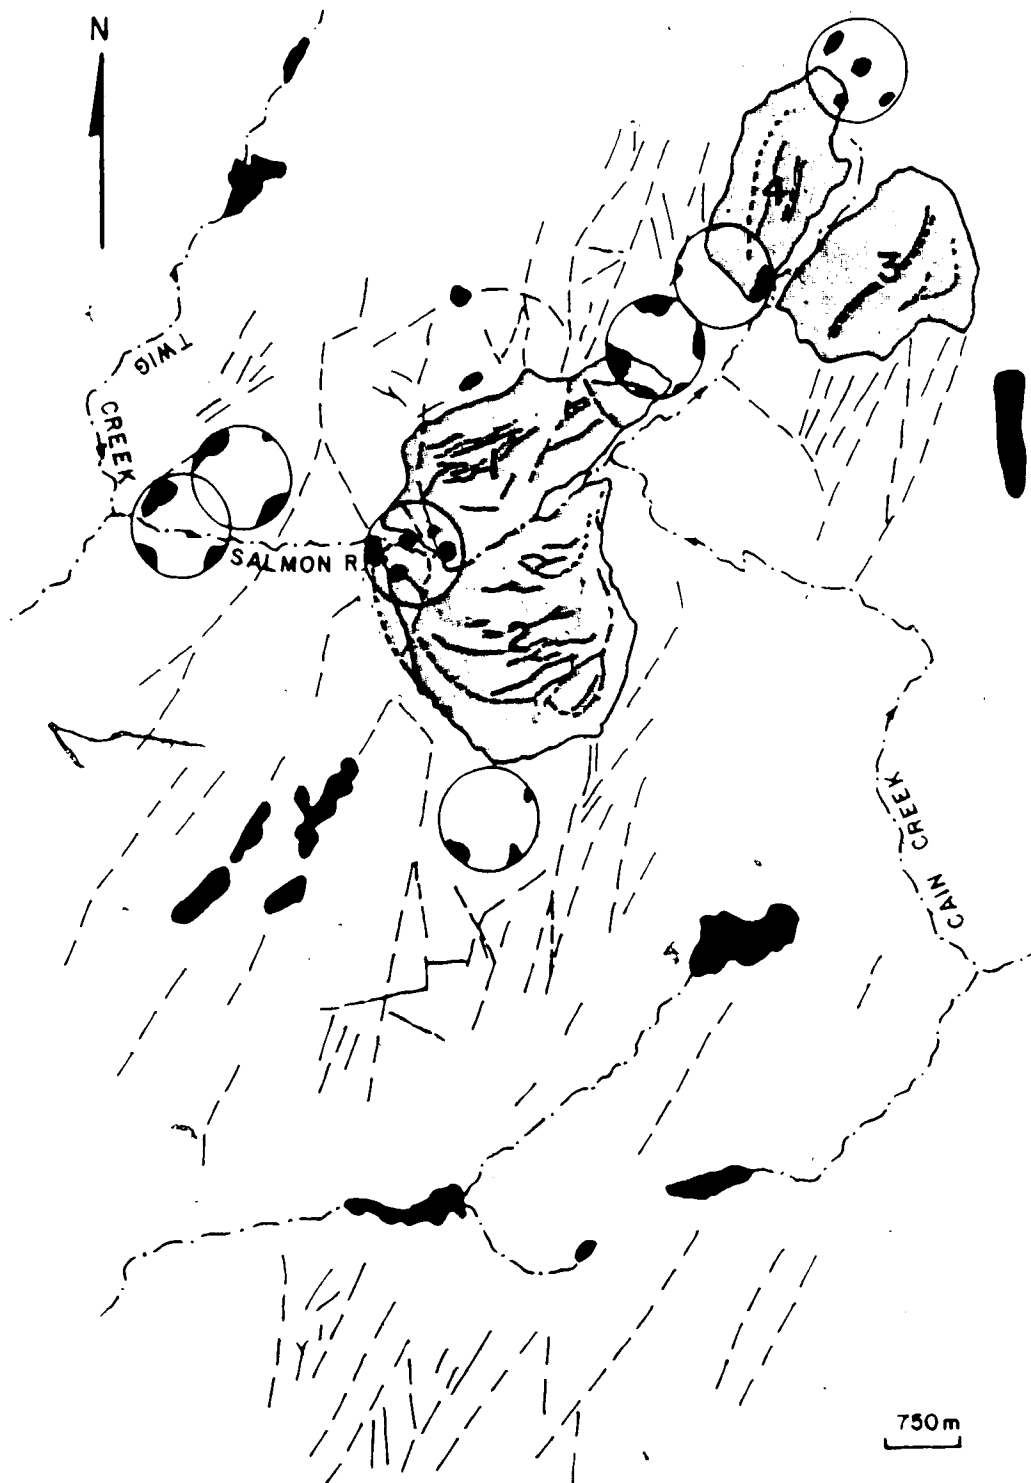
- 1 JUPITER CREEK LANDSLIDE
- 2 SHELL CREEK LANDSLIDE
- 3 ADELPHI CREEK LANDSLIDE
- 4 STEPHEN'S LAKE ROAD LANDSLIDE

Figure 4.6 Structural lineaments evident on air photograph BC 5377-33 and pole concentrations from discontinuity surveys in the vicinity of the Salmon River landslides.

Field observations indicate that the vertical separation on some faults are in the order of 320 m. Ewing (1981a) has commented on the complexity of faulting processes and fault zone morphology in the Paleogene rocks of the Thompson Plateau. Splaying and secondary shearing can be observed in the linearment patterns in Figure 4.6.

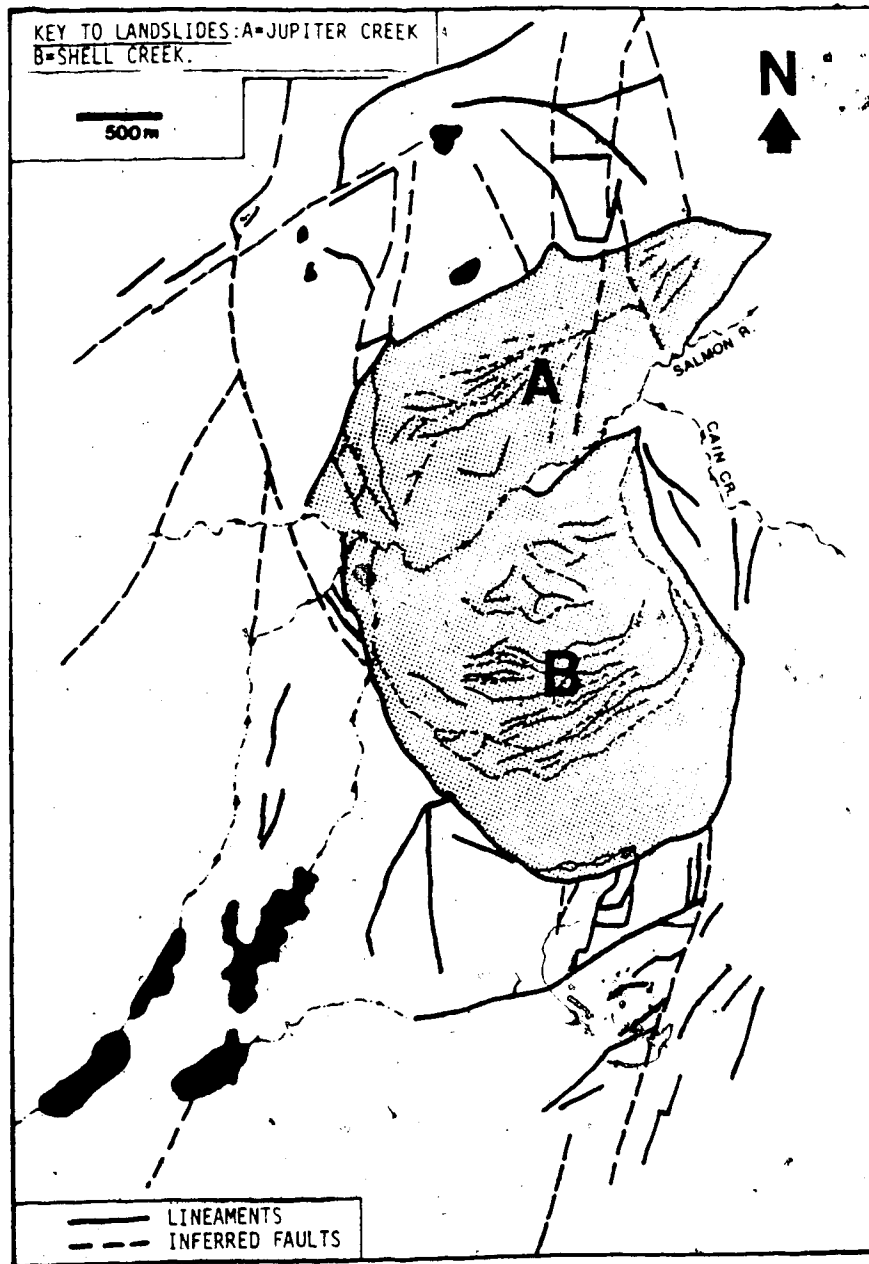
Figure 4.11 Relationship of Jupiter Creek and Shell Creek landslides to macrostructural elements in Paleogene rocks, Salmon Valley, as observed on B.C. air photos 5187-137 and field traverses.

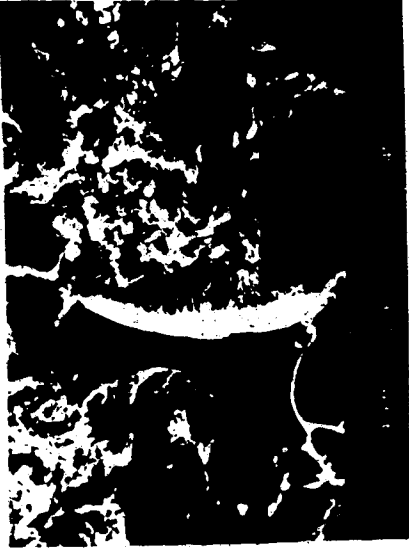
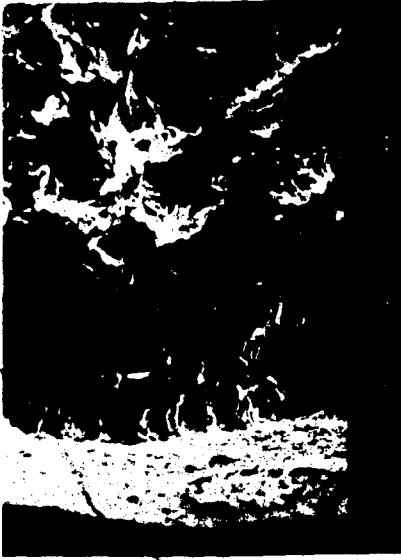
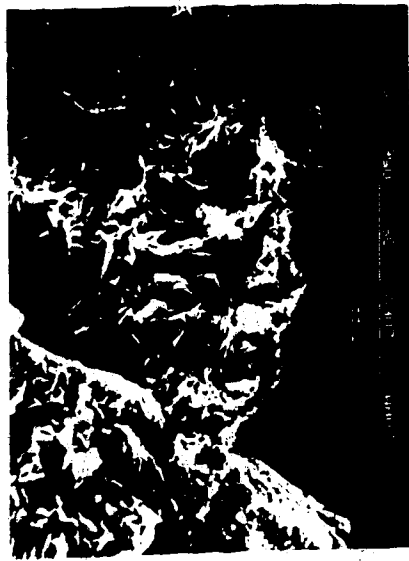
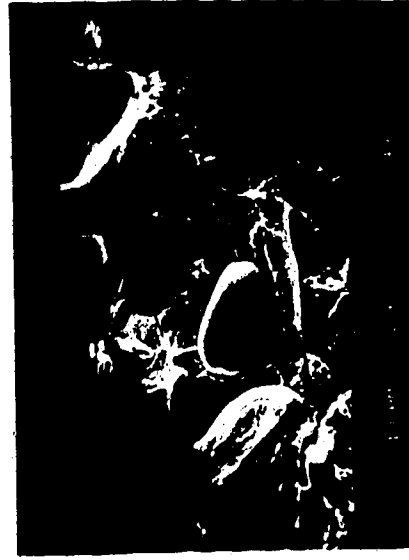
Plate 5.6 SEM micrographs of unweathered Salmon River Tuff (SR4)

In the SEM microphotograph in Plate 5.6, pyroclastic particles of all shapes with vesicles and tubes are noted. These particles make up the grain component of Domain C in the Salmon River Tuff and are up to 400  $\mu$  in diameter. Bubble replacement textures are common and are illustrated in Fig. 5.17. Most clay particles are montmorillonite and are in edge-to-edge and edge-to-face contact. Montmorillonite also occurs as grain coatings.

A. EXAMPLE OF GLASS BUBBLE REPLACEMENT IN SALMON RIVER TUFF. INSIDE OF BUBBLE FILLED WITH MONTMORILLONITE WITH MINOR KAOLINITE.

B. CLOSE UP OF BUBBLE WALL IN A. BUBBLE WALL REPLACED BY MONTMORILLONITE. NOTE SURFACE PITS RETAINED ON REPLACEMENT SURFACE.

C. REPLACEMENT FEATURE SHOWING MONTMORILLONITE AND RELICT SURFACE ON GLASS BUBBLE.

D. MATRIX-SUPPORTED NATURE OF SALMON RIVER TUFF. MATRIX IS DOMINANTLY MONTMORILLONITE.

In Domain C grains consist of silt size volcanic dust (< 75 micrometres > 2 micrometres) which are fragments of minerals (e.g. mica), euhedra (Plate 5.7) and lithic materials. In Paleogene rocks no glass fragments were directly observed, all having been replaced by montmorillonite (e.g. Plate 5.6). However, in Neogene material glass fragments make up a substantial proportion of the grain in this domain (e.g. Plates 5.11,

The montmorillonite originates from the alteration of volcanic glass and feldspar crystals as well as being precipitated from groundwater. Plates 5.6, 5.11 and 5.15 show volcanic glass replacement structures whilst in Plates 5.7 and 5.8 feldspar crystals are shown partially replaced by montmorillonite. Lace-like trails of montmorillonite (Plate 5.15) and grain coatings (Plate 5.2) are evidence of direct precipitation from groundwaters. Diagenetic silica has contributed to intergranular cement in the case of the Red Tuff as mentioned above.

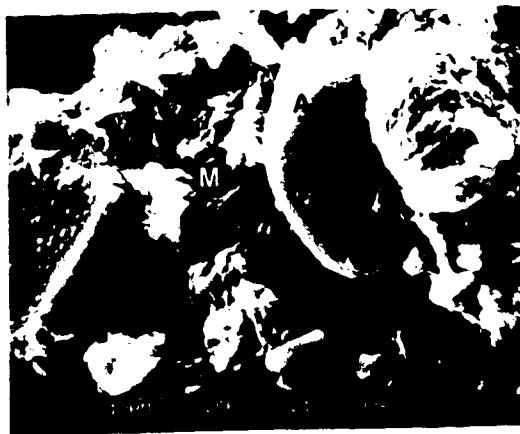
B. AMORPHOUS GRAIN (A) IN A MONTMORILLONITE MATRIX (M). NOTE CHARACTERISTICS OF INTRA-ASSEMBLAGE PORE SPACE.

A. GRAIN-MATRIX RELATIONSHIPS IN DR6. NOTE MATRIX-SUPPORTED NATURE OF MICROFABRIC. MATRIX IS DOMINATED BY MONTMORILLONITE.

B. MICA GRAIN IN MONTMORILLONITE MATRIX

C. NOTE DISTORTION OF MONTMORILLONITE PARTICLES AROUND BASE OF GRAIN AND PRESENCE OF GRAIN FRAGMENTS.

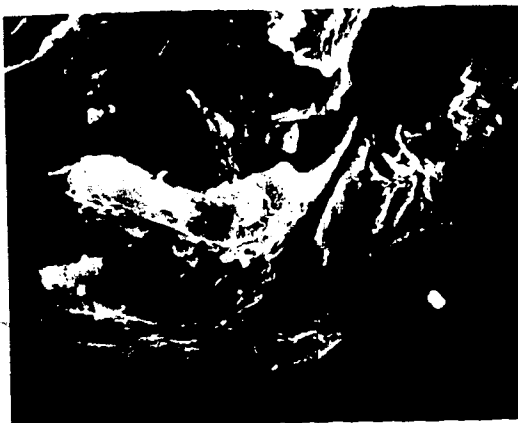
B. WISPS OF CLAY INDICATING MICROSTRUCTURE DISTURBANCE IN DOMAIN C.

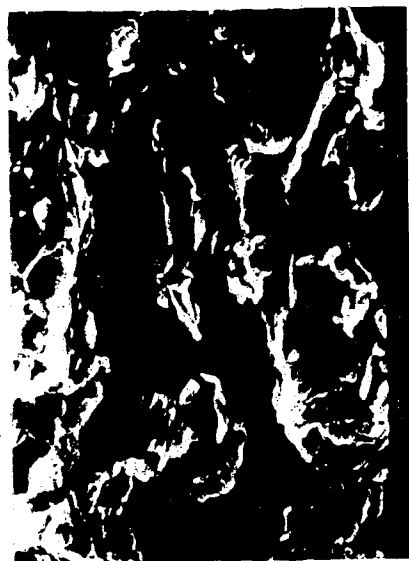
A. LAYERING OF CLAY PARTICLES PARALLEL TO THE DIRECTION OF MOVEMENT.
