Investigation of Pavement Management Practices and Pavement Material Performance in
Alberta, Canada

A thesis submitted in partial fulfillment of the requirements for the degree of

Department of Civil and Environmental Engineering
University of Alberta

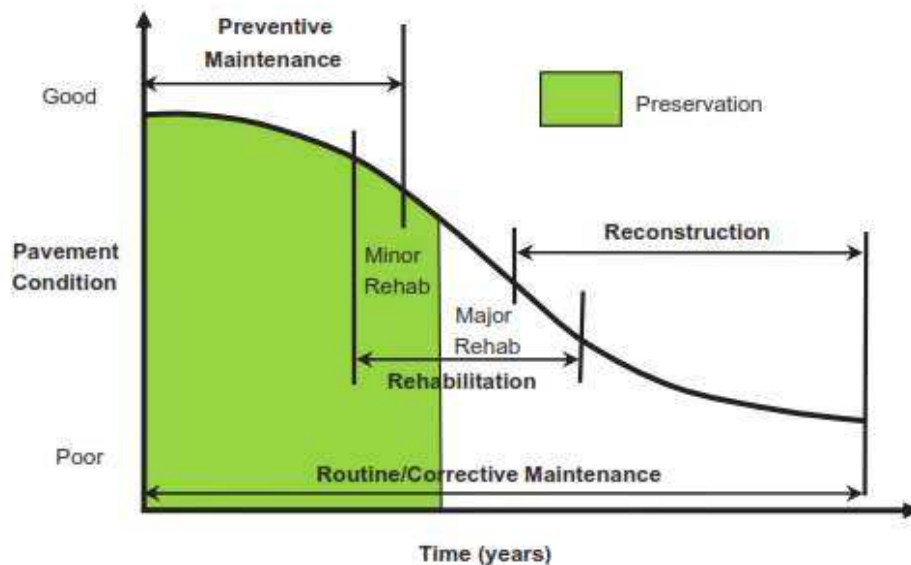
Figure 1 - Pavement Condition Relationship to Pavement Treatments [4]

Figure 1 shows the overall life cycle of a roadway, when preventative maintenance can be implemented, and when rehabilitation work must proceed. This rehabilitation is expanded upon in Figure 2, which demonstrates the effects on cost over time if preventative maintenance is employed, as opposed to waiting for the roadway to deteriorate completely.

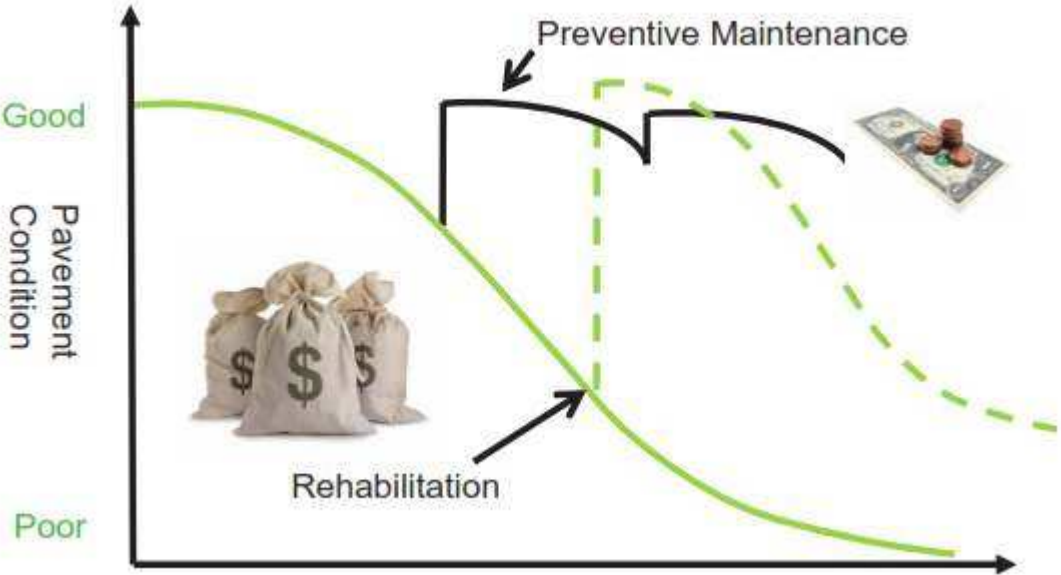
Figure 2 - Pavement Condition with Investment Over Time [4]

Figure 2 uses a graph to demonstrate that more iterative and preventative maintenance on transportation facilities presents fewer costs to agencies and owners over time compared to simply allowing the asset to fall into a rehabilitation treatment. It is not immediately obvious, but this approach also limits impacts to users as preventative activities usually take less time to construct in comparison to rehabilitation treatments.

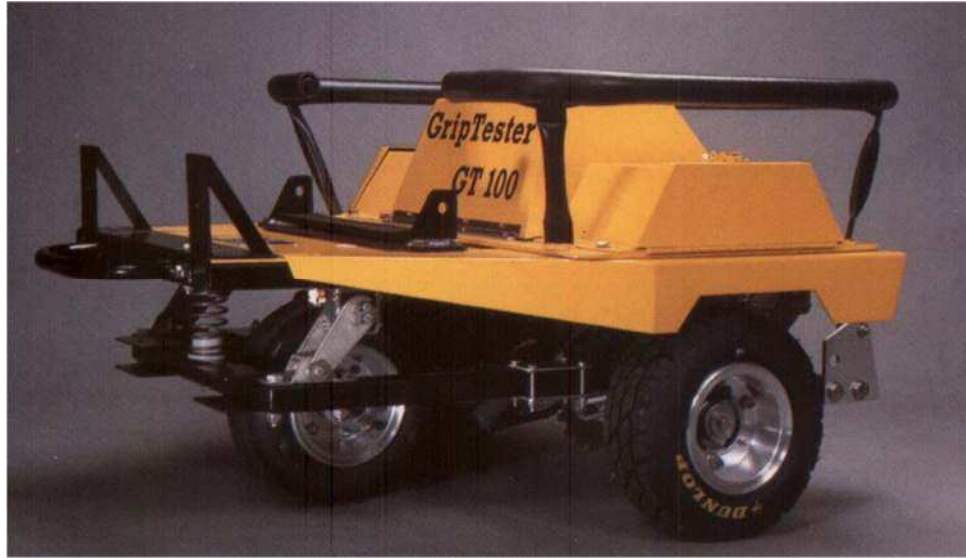
Figure 5 - Grip Tester [13]

To determine the continuous grip between the road and tire of an entire section, one potential option is to use a Grip Tester. As previously stated, the Grip Tester follows behind a vehicle and continuously measures the friction interaction between the tire and pavement. Figure 5 below shows a photo of the tester.

The output of a Grip Tester is a grip number (GN) of the pavements. This grip number describes a relationship between the fraction of tractive drag force (F_D) and the load force (Q) and this coefficient is known as the grip number (GN) [16]. The relationship can be found in the equation below:

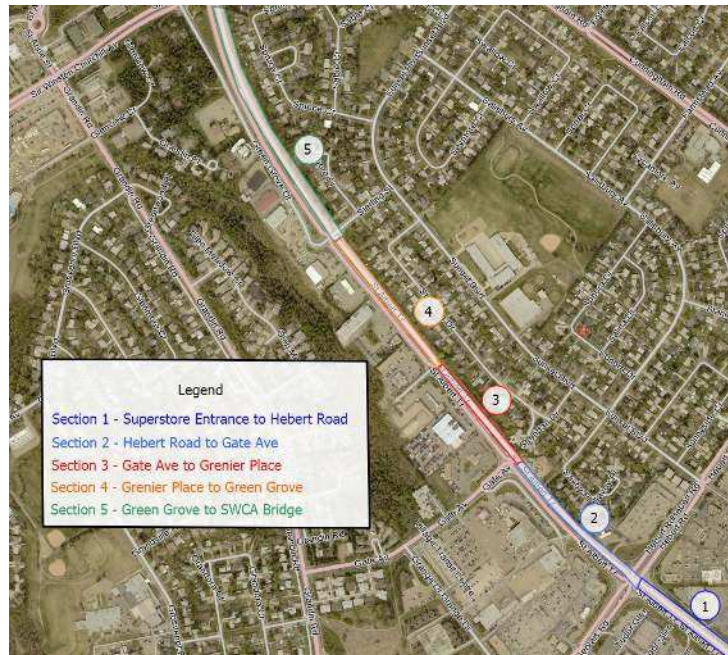
Figure 11 - St. Albert Trail Test Section

The project area is 1.5 km's in length down a major roadway in St. Albert, St. Albert Trail, see Figure 11 below:

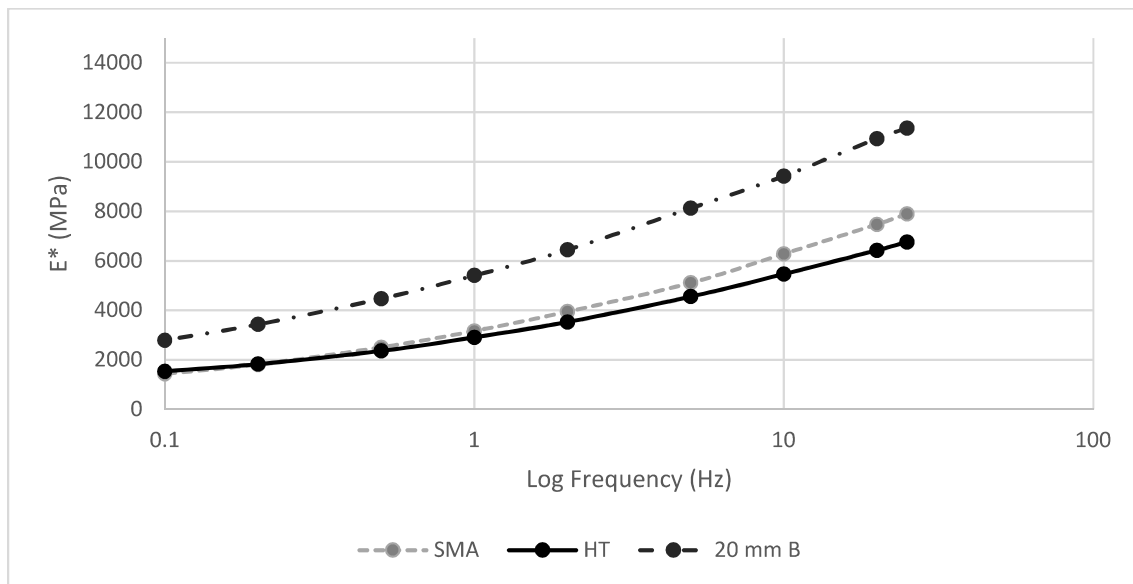
Figure 14 - Dynamic Modulus Results at 20C

The layer coefficient (a) values were calculated using dynamic modulus test at the University of Alberta. The results were able to produce accurate layer coefficient results*. Figure 14 below shows the results of each material at 20 °C

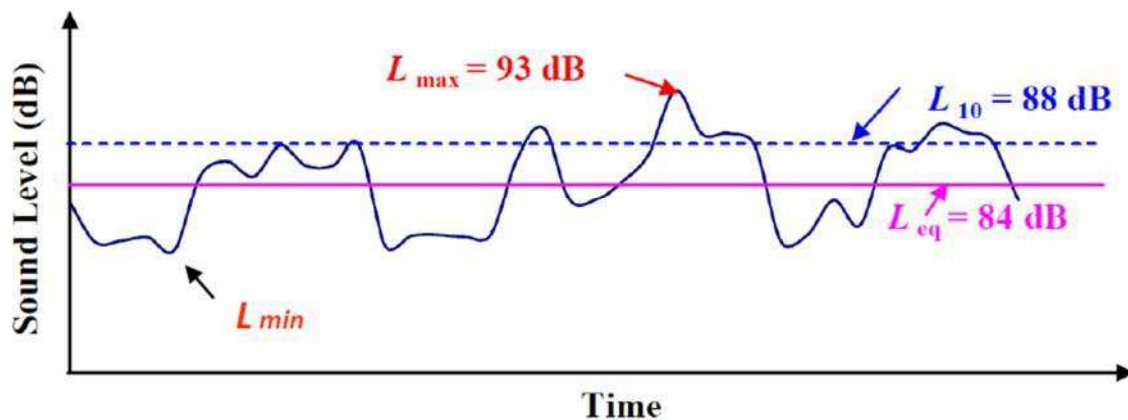
Figure 16 Sound Level Terminologies [33]

- L_{eq} : This level is the equivalent sound level during the measurement time. In Figure 1, this is 84 dB. It is calculated by adding up all the sound energy during the measurement period, and then dividing it by the measurement time.
- L_{max} / L_{min} : Denotes the maximum and/or minimum level of sound during a particular duration of sound measurement. In the case of L_{max} it represents a single event of the loudest sound over the measurement duration and corresponds to the moment when the vehicle is at the closest point to the microphone.
- L_n : Statistical descriptor of the measured sound level and represents the magnitude that is exceeded for only XX% of time during the full measurement duration.

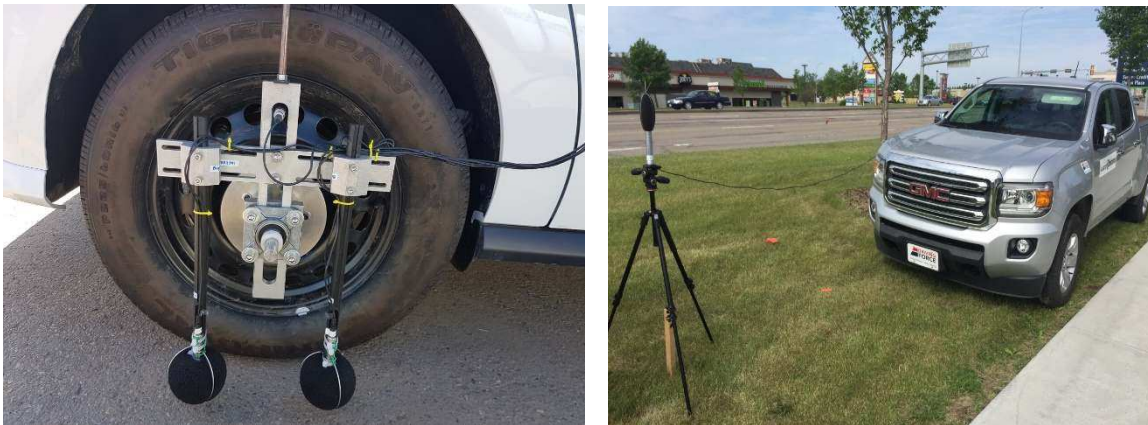
Figure 17a, 17b OBSI Measurement Set Up and Road Side Sensors along Corridor

The Road Side Sensors are a series of several microphones attached to individual data loggers linked on the side of the road. The meter is a class 1 sound measurement device capable of real time analysis of sound using fast and impulse response. The Bruel & Kjaer 4189 microphone was used in conjunction with said noise meters. A type 4231 calibrator was used in the meter calibration before and after the noise tests [33]. A photo of the equipment is found in the Figure 17a & 17b.

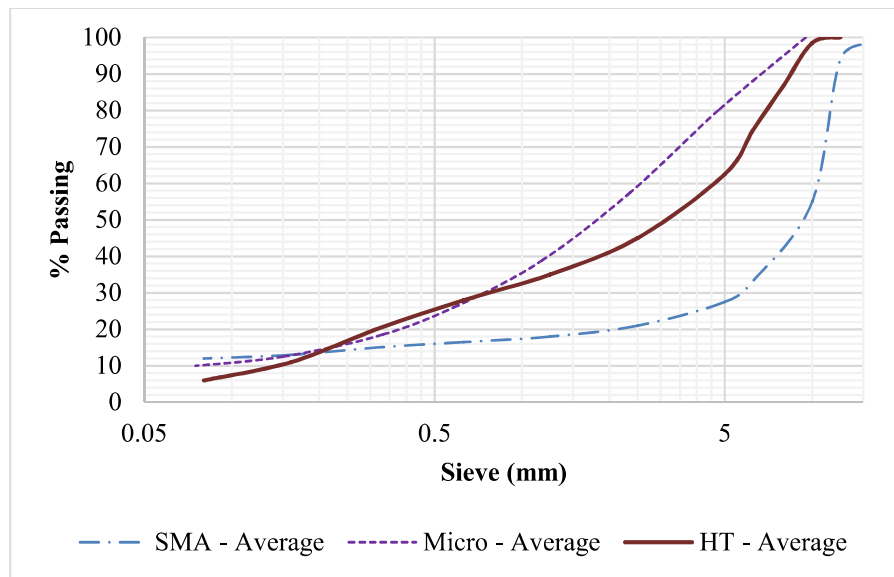
Figure 18 - SMA, Microsurfacing and HT Gradations

For the SMA, a 16 mm aggregate mix was used in conjunction with a PG 76-28 binder to create a gap graded asphalt. The HT is a dense graded asphalt using a PG 64-28 binder. Finally, the microsurfacing was a Type III, 5 mm aggregate mixed with emulsion and water. The grain size distribution of each material can be found in the Figure 18.

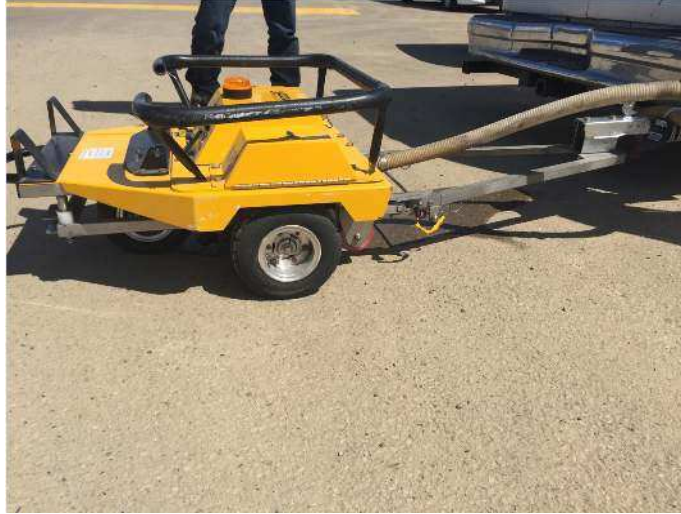
Figure 20 - MK2 Grip Tester

Grip testing was completed using an MK2 Grip Tester manufactured by Findlay Irvine. Equipment (Figure 21) is based on ASTM E 2340-06 “Test Method for Measuring the Skid Resistance of Pavements and other Trafficked Surfaces using a continuous reading, fixed-slip technique”.

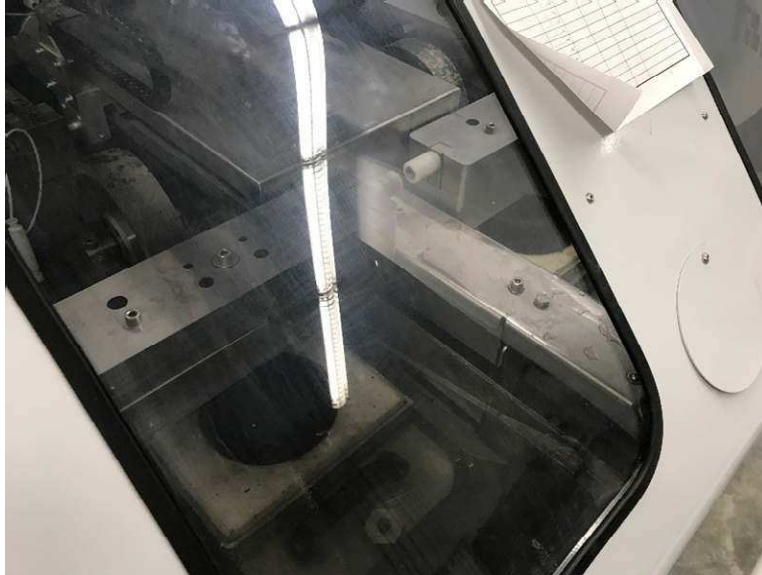
Figure 21 - University of Alberta Hamburg Wheel Tracker [40]

The Hamburg wheel is a wheel tracking test that applies a constant 700 N load applied 10,000 cycles to a sample of asphalt. Normally this test occurs under water to help assess moisture sensitivity in asphalts as well [39]. This test is very severe on the samples, using a steel wheel, the wheel will not deform. To complete this test, two 6-inch core samples are placed side by side and run under the machine, see figures below:

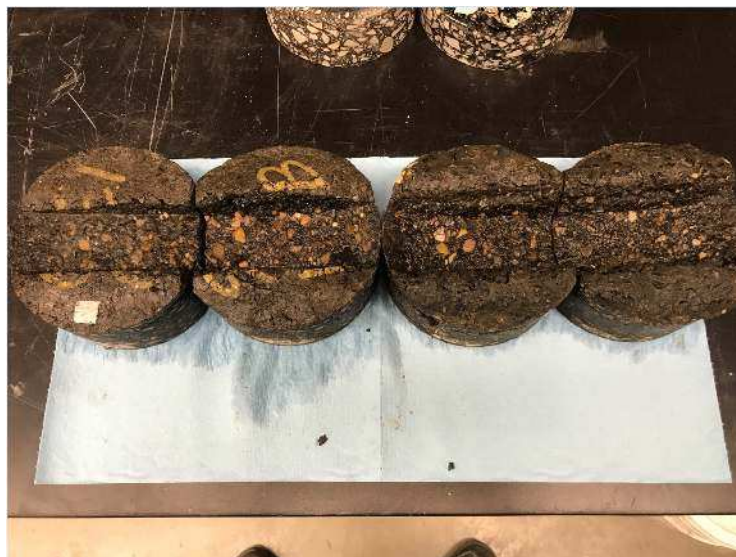
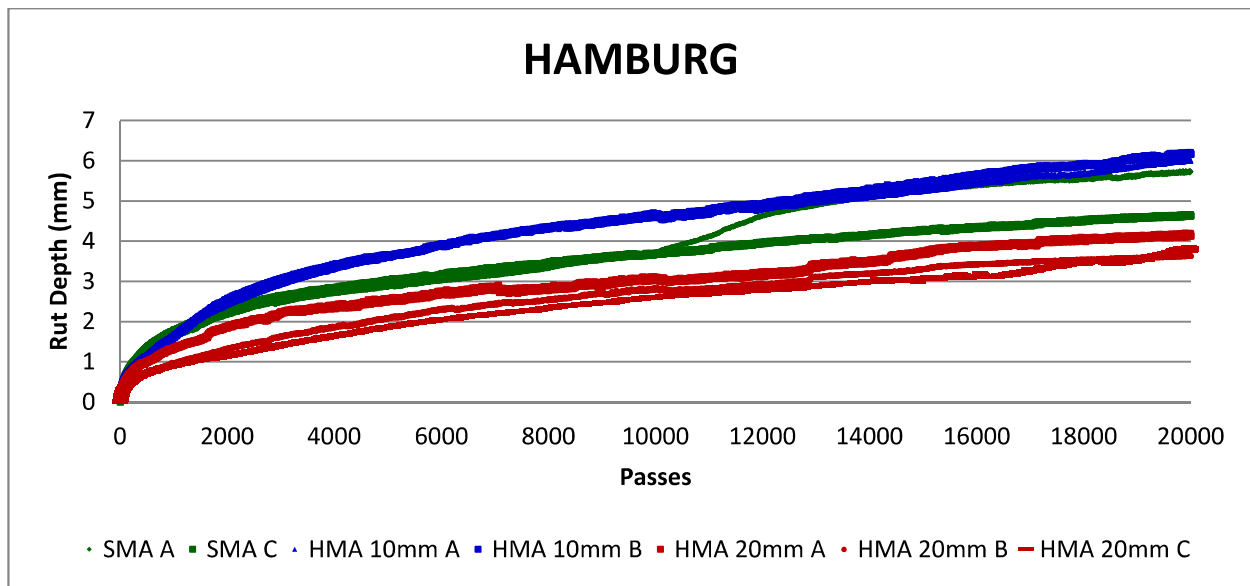
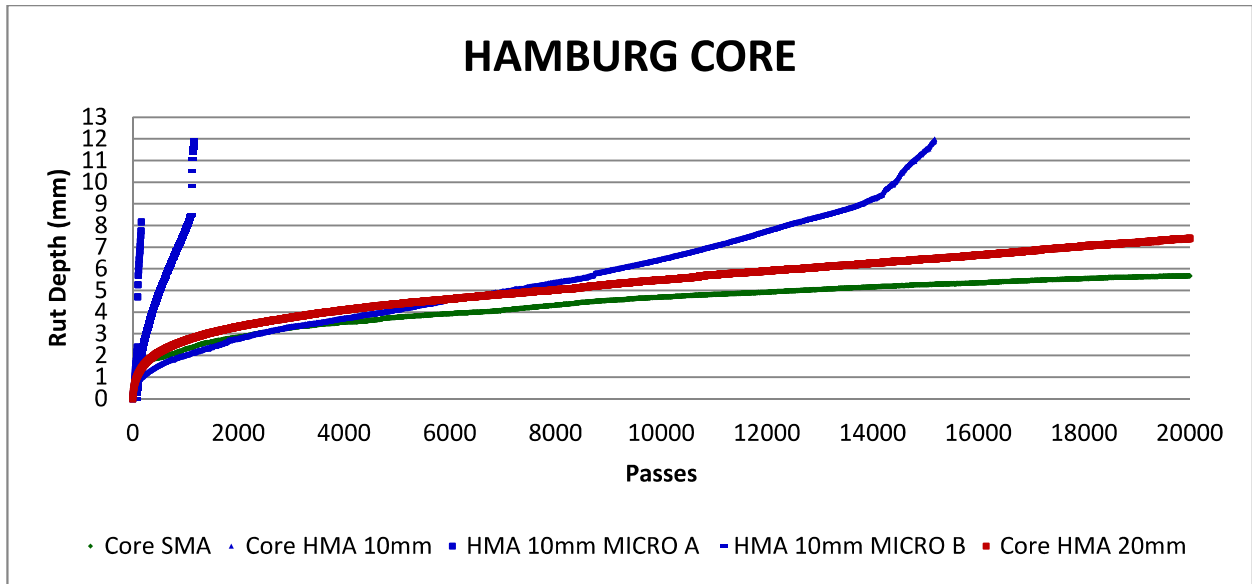
Figure 22 - Hamburg Wheel Results [40]

<u>Sample</u>	<u>Rut Depth (mm)</u>	<u>Cycles</u>	<u>City (APA)</u>
HMA 10 mm A	6.00	20,000	3.6
HMA 10 mm B	4.86	20,000	3.6
HMA 10 mm CORE	12.00	15,178	3.6
HMA 20 mm A	4.13	20,000	1.4
HMA 20 mm B	3.64	20,000	1.4
HMA 20 mm C	3.82	20,000	1.4
HMA 20 mm CORE	7.40	20,000	1.4
SMA B	2.24	20,000	2.9
SMA C	4.63	20,000	3.2
SMA Core	5.67	20,000	3.1
Micro CORE A	12.00	170	-
Micro CORE B	12.00	1,088	-

Figure 23 - Hamburg Wheel Graph Results - Gyrotory Compactor [41]

Figure 24 - Hamburg Wheel Graph Results - Cores [41]

- All core samples from field have lower performance than their lab counterparts. Including one HT core sample that did not complete the test
- Materials that were compacted in gyratory compactor did perform better
- Microsurfacing cores did not complete the test

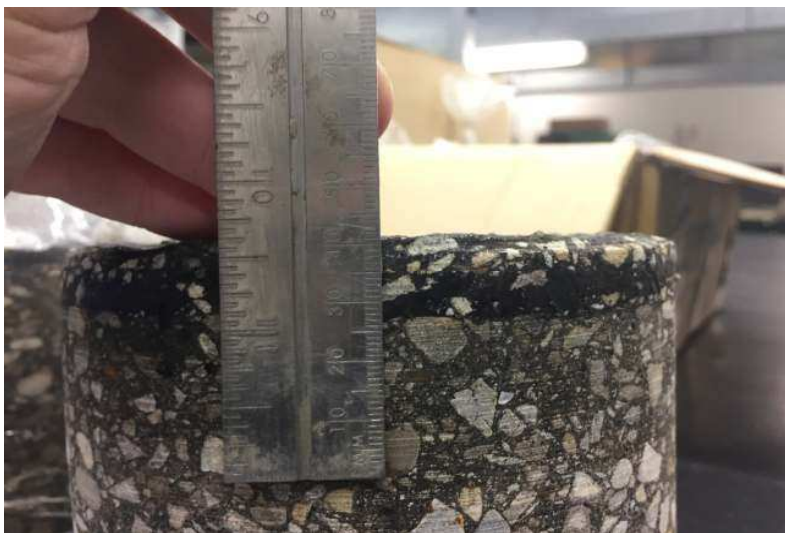
Figure 25 - Microsurfacing Core (16 mm of Microsurfacing)

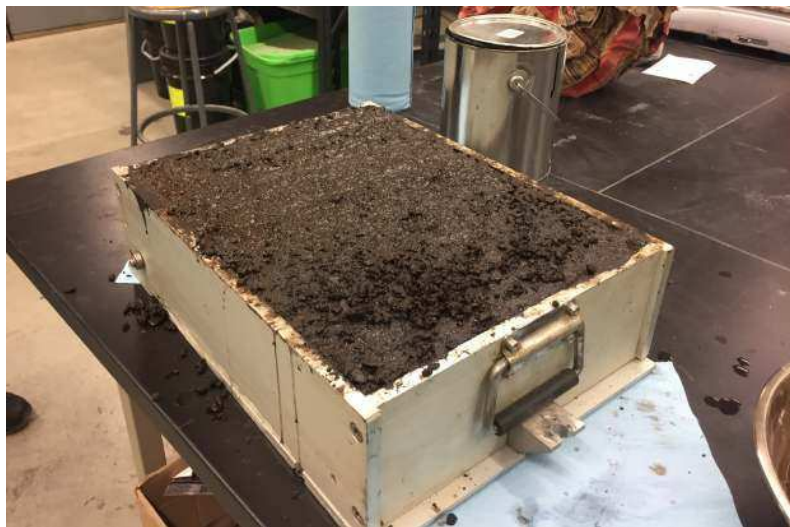
Figure 26 - SMA/Microsurfacing Lab Sample [41]

The Hamburg wheel's initial results with the SMA proved to be much lower than expected. Given that the cores could not handle being in the testing unit more than 700 cycles. One theory was that the insitu asphalt was so aged, that the microsurfacing material was unable to get a fair test with this apparatus. In an effort to remove the aged asphalt from the test environment, a slab of SMA was cast and microsurfacing was placed in the lab on top. The Microsurfacing sample was mixed in lab to as close to field spec as possible using materials provided by the contractor at time of application. In addition to the Hamburg wheel, this test also introduced a British pendulum, to measure the sample's friction before and after the Hamburg wheel test. See figure below:

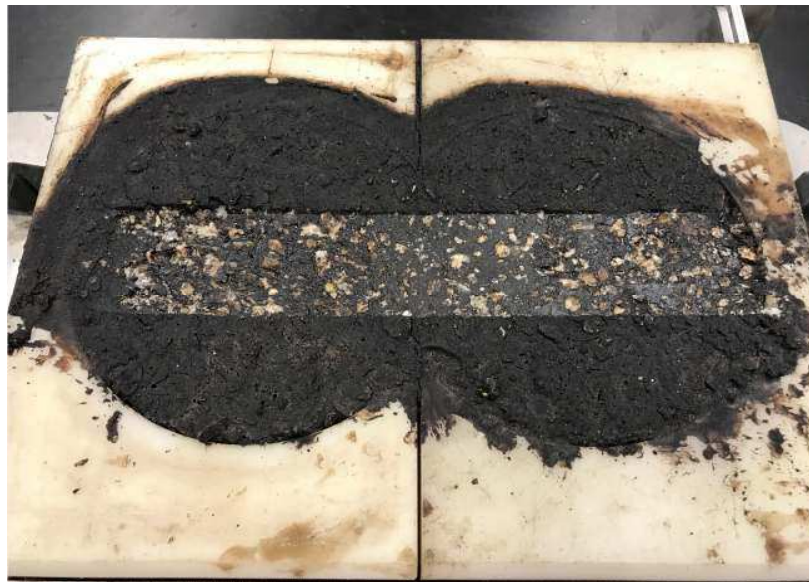
Figure 28 - SMA/Microsurfacing Sample After Hamburg Wheel [40]

When the Hamburg wheel was run on the new sample, the results were better than previous. However, the test was run without water to help avoid any premature delamination. The results showed that the microsurfacing was almost completely run through in ~8,000 passes, see graph and results below:

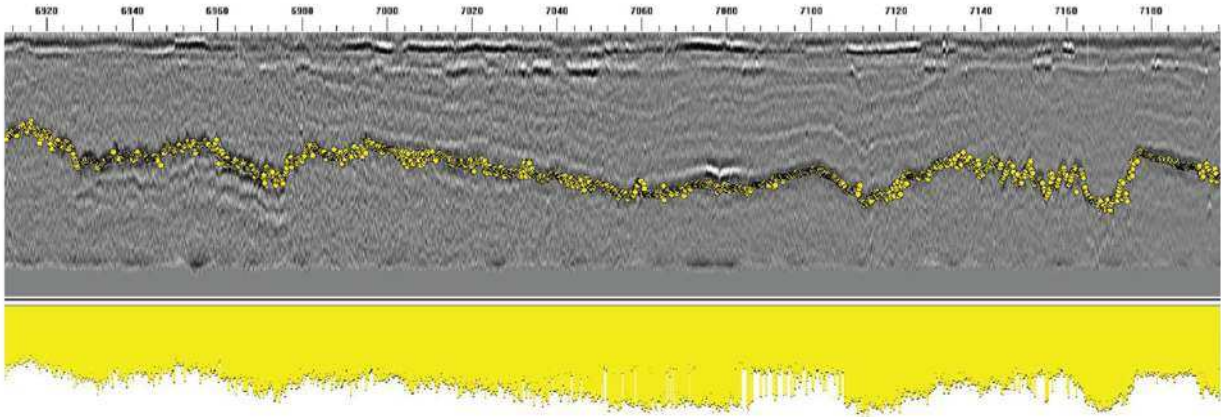
The City also collected Ground Penetrating Radar Data (GPR) data along the corridor. The goal of this test was to attempt to confirm the layer depths post construction. The data showed the depths of the new asphalt (Yellow line). The GPR was collected by Stantec with some relevant screen shots below:

Figure 40 - GPR: Hebert/SAT Intersection to Petro Canada Station [30]

Figure 41 - GPR: Hebert/SAT Petro Canada to Old Parking Lot [30]

Figure 42 - GPR: Gate/SAT from parking lot to just past Gate Ave Intersection [30]

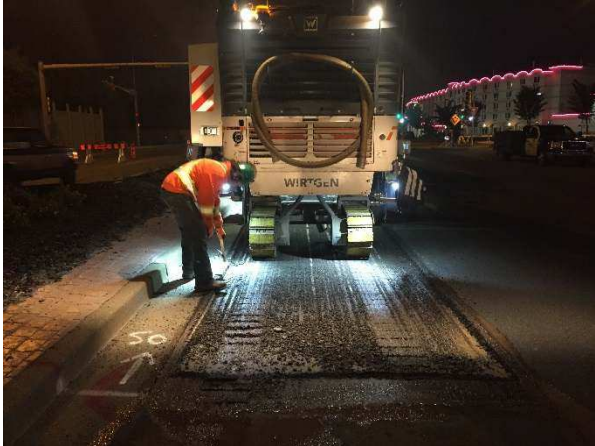
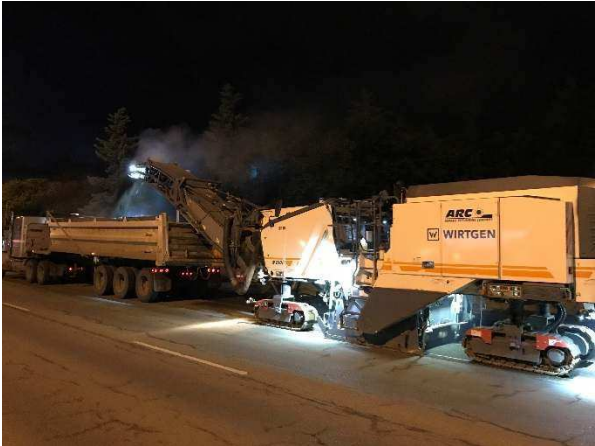
Figure 46a & 47b - Milling 50 mm depths

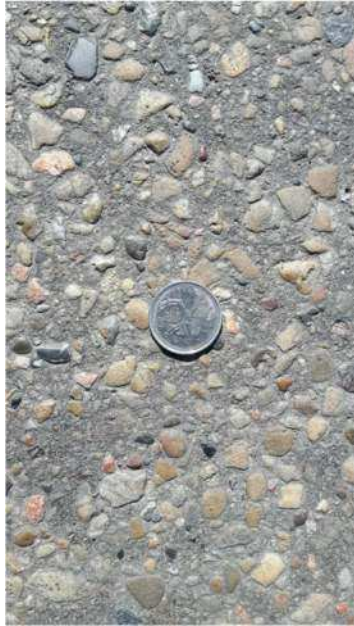
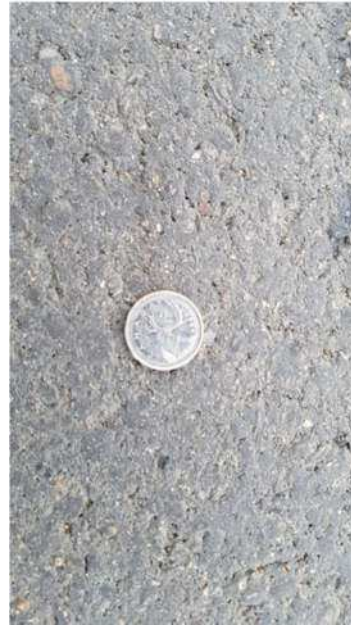
Figure 51a & 52b – (Left) Existing Asphalt Surface Prior to Construction, (Right) HT Surface after construction [46]

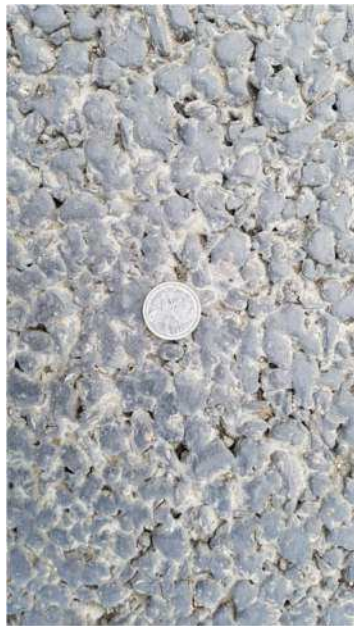
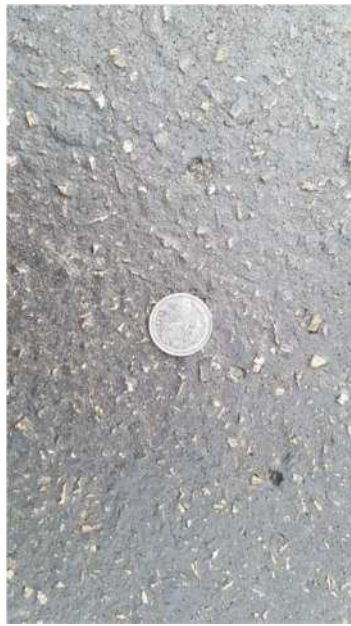
Figure 52a & 53b – (Left) SMA Surface Following Construction, (Right) Microsurfacing Surface Following Construction [46]
