Investigation and Analysis of the New Walterdale Bridge to Develop a Structural Health  
Monitoring System

Aimee De Laurentiis

Structural Engineering

University of Alberta

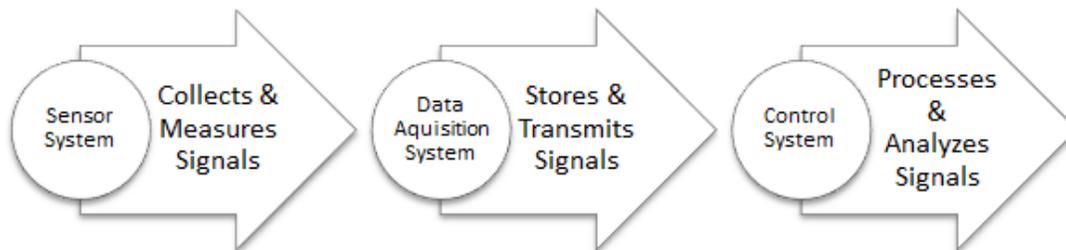
Figure 1-1: A Typical SHM System

SHM is commonly defined as a method that uses three main components to collect, store and process data, as shown in Figure 1-1. The first is a sensory system that is applied to the structure. The sensors are capable of measuring different signals regarding structural response such as vibration, stress and displacement. The second component is a data acquisition system that temporarily stores the information collected by the sensors, converts the signals to digital measurements that can be transmitted to the central control system, which is the final component of the system. The data goes through many procedures in the control system, including processing and control, management and evaluation in order to assess the data for potential damage to the structure. This complete system is capable of both measuring the ongoing, real time performance of structures, as well as conducting off-line data analysis. In real-time measurement, data can be compared with design values, analysis results and pre-determined thresholds. Using off-line measurements, data is managed through data management and damage detection algorithms (Xu and Xia 2011). Connection between the sensory system, data acquisition system and the control office can be either completely wired, wireless or a combination of the two (Figure 1-1).

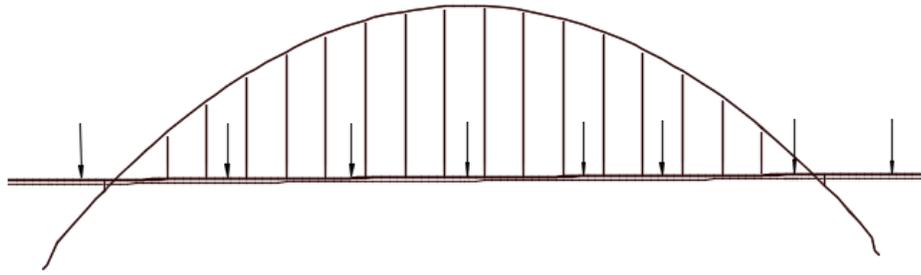
a. A load is applied to the bridge deck

3-20a), the load is transferred from the deck to the cables in tension (Figure 3-20b). The load is then distributed to the arch above in compression (Figure 3-20c), and resolved at the thrust-blocks into horizontal, vertical and moment reactions, as shown in Figure 3-20d (Steelconstruction.info 2015). It should be noted that the cables are tension-only members, and must be analyzed using geometric nonlinearity in order to obtain meaningful results (CSI Analysis Reference Manual 2013). In order to capture the tension experienced in the cables, geometric nonlinear static analysis for static loads and nonlinear time-history analysis for moving loads were the two best options available in the analytical software, CSiBridge, that could generate the most accurate results considering the geometric nonlinearity limitations.

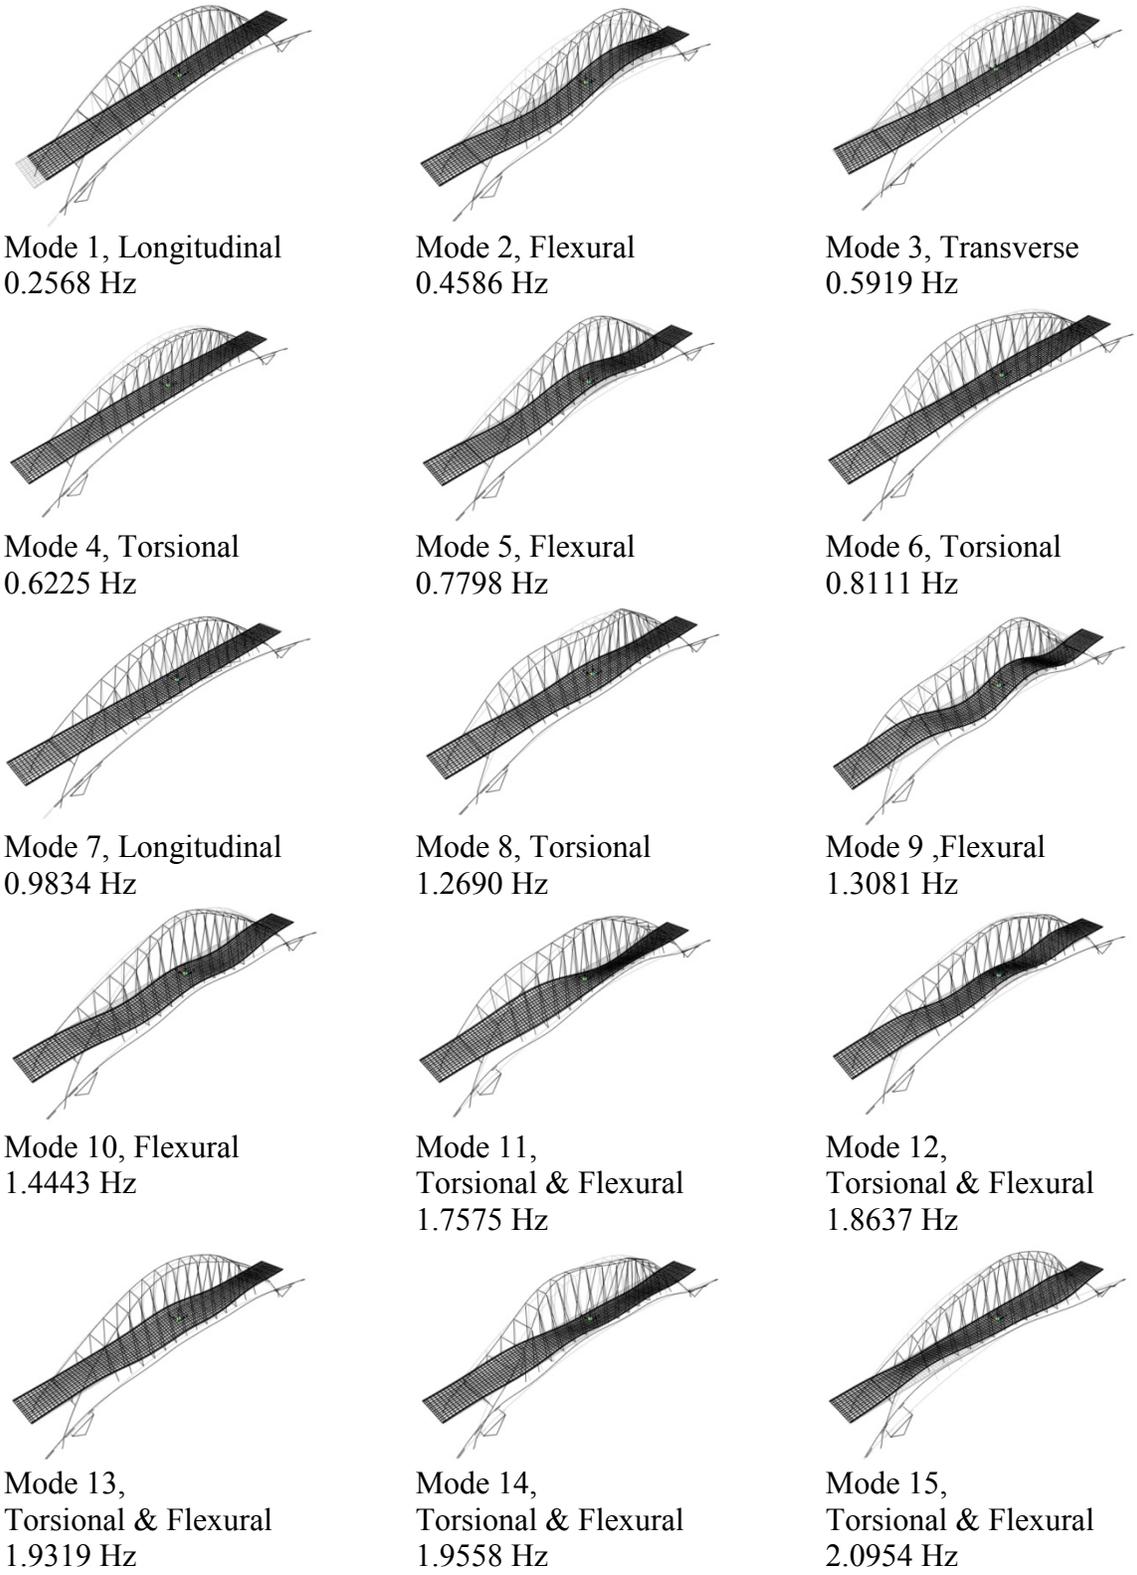
Figure 4-1: Natural Frequencies and Mode Shapes of the Waltherdale Bridge

The natural frequency of the structure, measured in Hz, refers to the frequency at which the system oscillates. The mode shapes of the structure describe the natural pattern of oscillation associated with a mode's natural frequency that the structure experiences. The natural frequency and mode shapes of the first 15 modes are shown in Figure 4-1. The higher modes are combined modes of vibration.

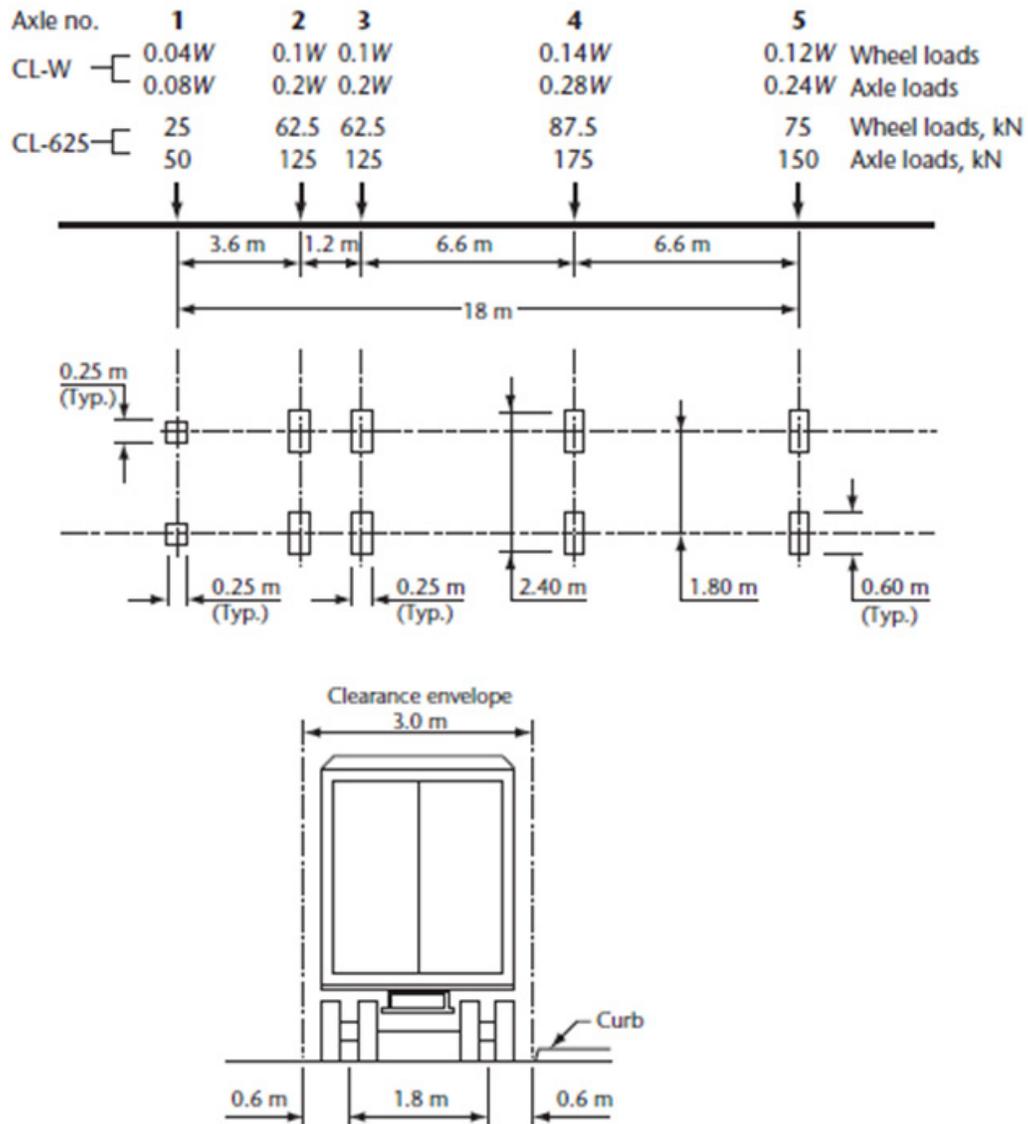
**Figure 3.2**  
**CL-W Truck**  
 (See Clause 3.8.3.2.)

In order to perform nonlinear moving load analysis in the CSiBridge software, time-history moving load analysis was used. In this case a constant force with a time step of 0.02 seconds and damping of 2%, with no DLA applied to the truck loading, as the load applied can be considered dynamic. Although a DLA typically incorporates the effects of irregularity of riding surface, bridge static and dynamic deflections, and the interaction between a moving vehicle and the bridge, CSiBridge time-history analysis includes the effects of vibrations only. For SLS1, a loading envelope was created for CL-W800 Truck and Lane loading to produce the maximum effects from either CL-W800 load type.

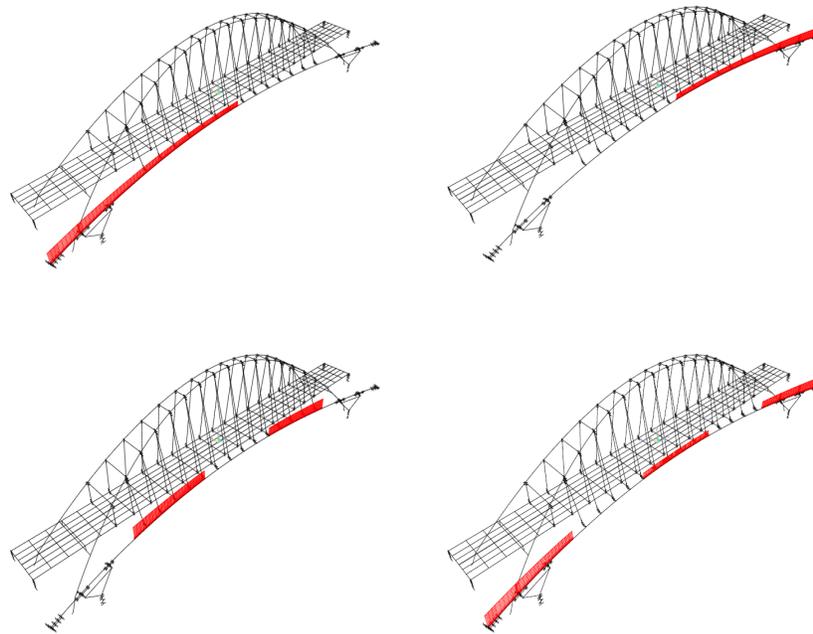
Figure 4-7: Load Patterns of SUP Pedestrian Load

With the use of influence lines created at locations of critical bending moment and shear, multiple load patterns were produced, and the SUP was analyzed under a loading envelope of the load patterns in order to determine locations that experience the highest amount of deflection and stress. The influence lines used were extracted from the FE model. In addition to a uniformly distributed load along the SUP, the following load patterns shown in Figure 4-7 were also applied to the structure.

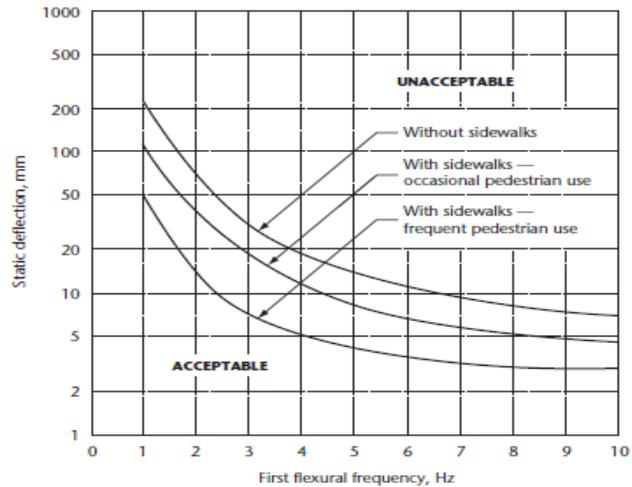
**Figure 3.1**  
**Deflection limits for highway bridge superstructure vibration**  
 (See Clause 3.4.4.)

For SHM purposes, SLS load combination gives a good indication of areas that may be more prone to high stresses and areas of occupant discomfort. SLS load combination can also be used for areas that are susceptible to fatigue failure. These are areas that can be monitored to ensure the structure fulfills its function under everyday use and continues to meet the SLS limits in CSA-S6-06.

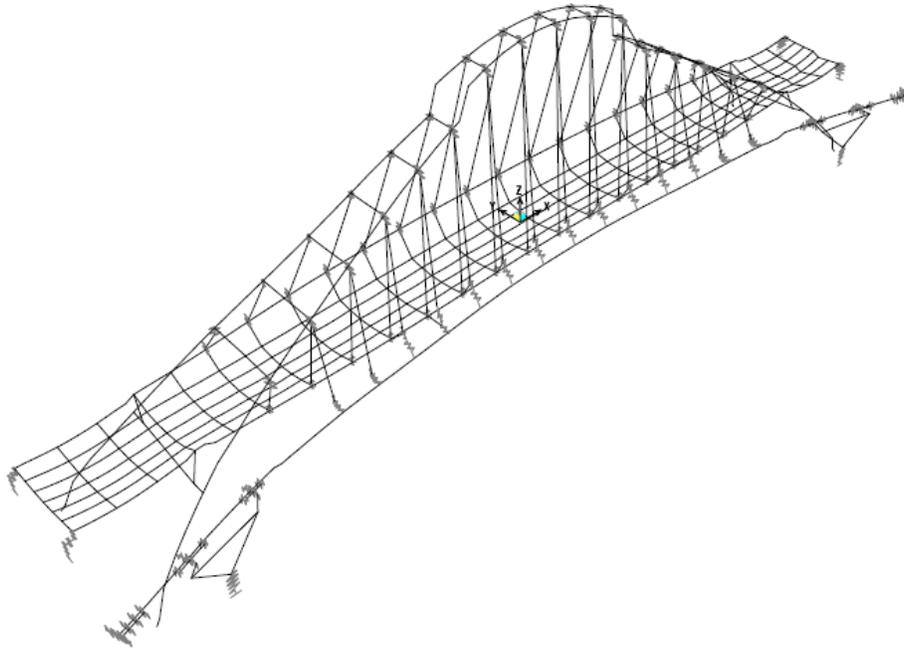
Figure 4-9: Deflected Shape Envelope under SLS2 Load

Since vibration limitations are based on SLS2, the following will present the displacements given by Equation 4-6 only. The first flexural frequency of the structure is 0.4586 Hz, which can be interpreted in Figure 4-8 as a static deflection maximum of 50 mm at both the SUP and west walkway, since it should be expected that both walkways will experience frequent pedestrian usage, considering the location of the bridge. Since the west edge girder is part of the west walkway, the deflections of the west edge girder are shown. The deflection envelope, showing the maximum displacements experienced on the bridge is shown in Figure 4-9. From Figure 4-10 and Figure 4-11, both walkways meet the criteria necessary for deflections. The largest displacements are seen at 91 m and 143 m along the SUP, and at 85 m and 140 m along the west walkway.

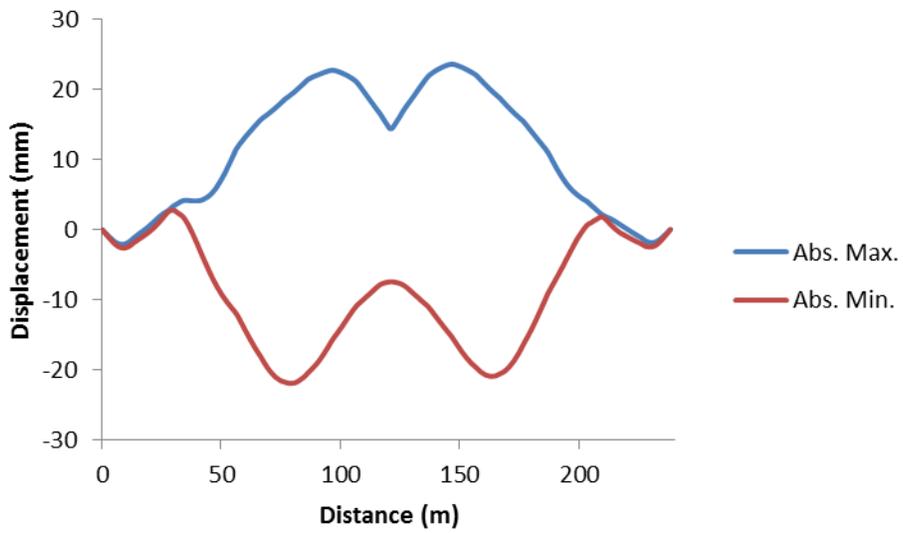
Figure 4-10: SLS2 SUP Displacement Envelope

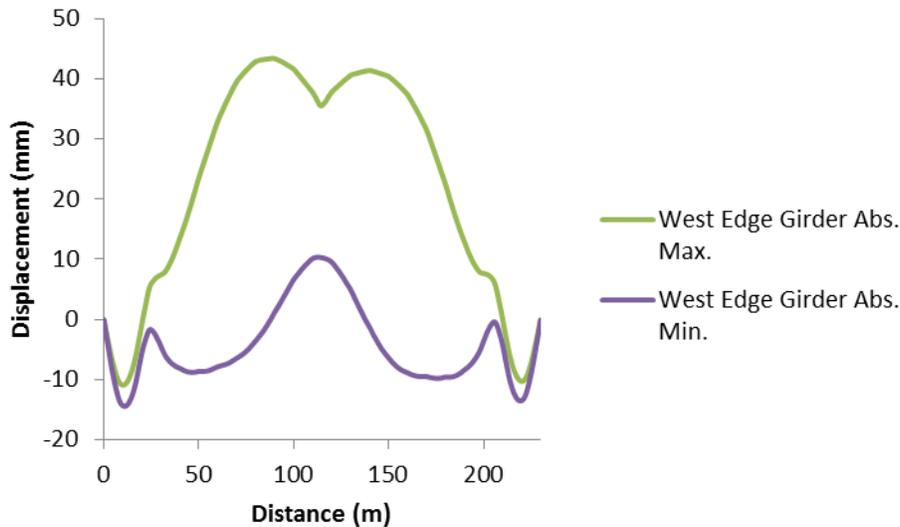
Figure 4-11: SLS2 West Walkway Displacement Envelope

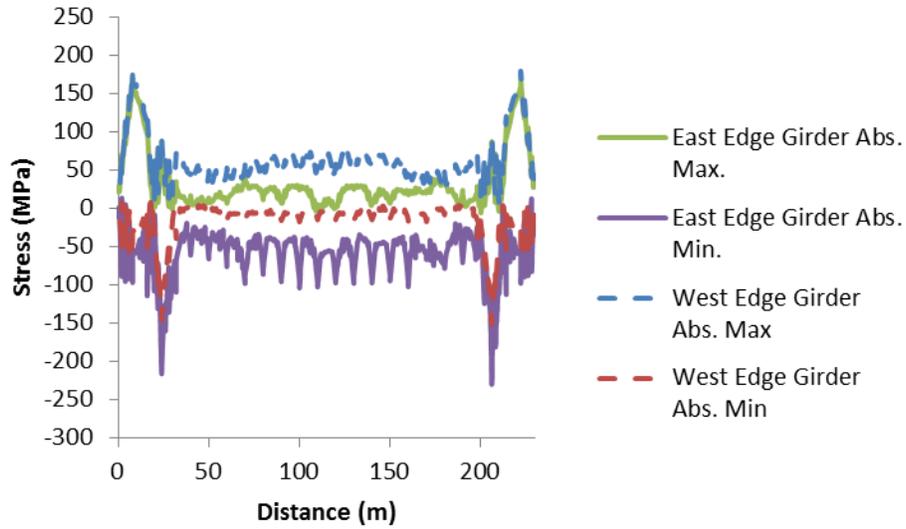
Figure 4-12: Normal Stress Envelope of Edge Girders under SLS1 Load

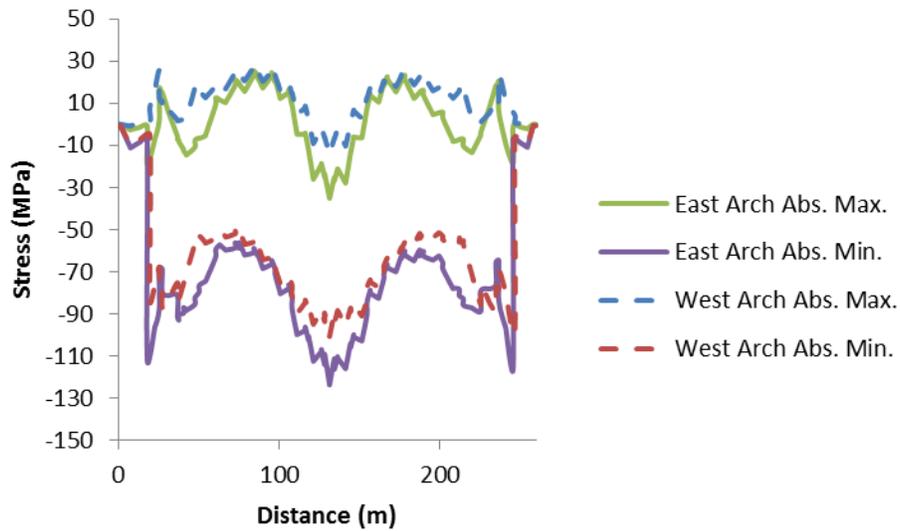
Figure 4-13: Normal Stress Envelope of Arches under SLS1 Load

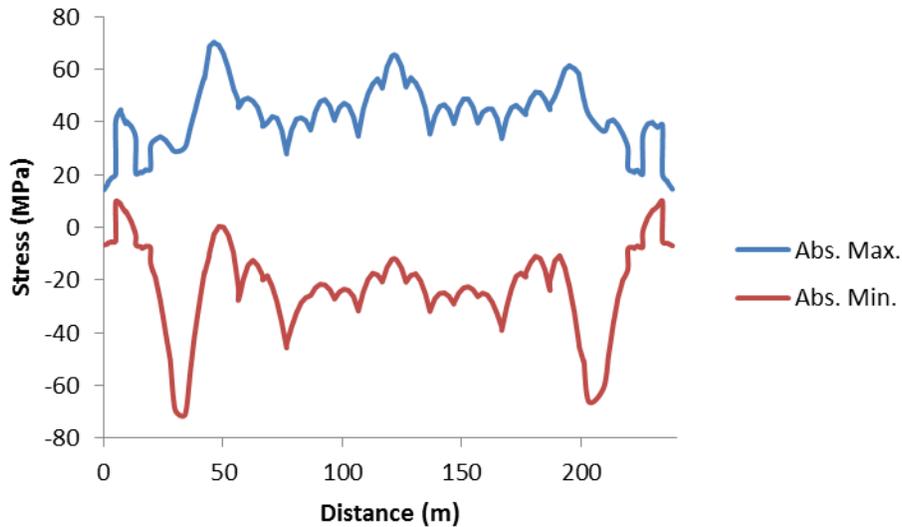
Figure 4-14: Normal Stress Envelope of SUP under SLS1 Load

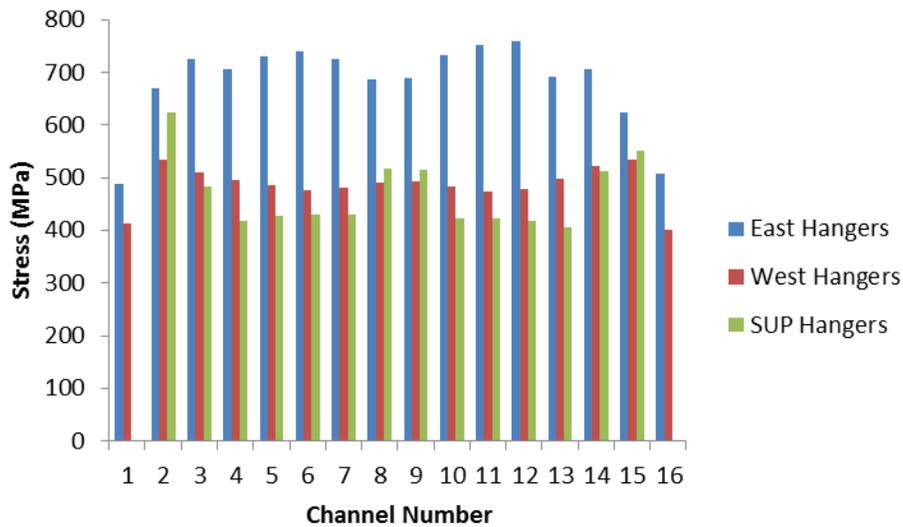
Figure 4-15: Normal Stress of Hangers under SLS1 Load

the higher share of load as compared to the west hangers. Appendix C provides an investigation into this concept.

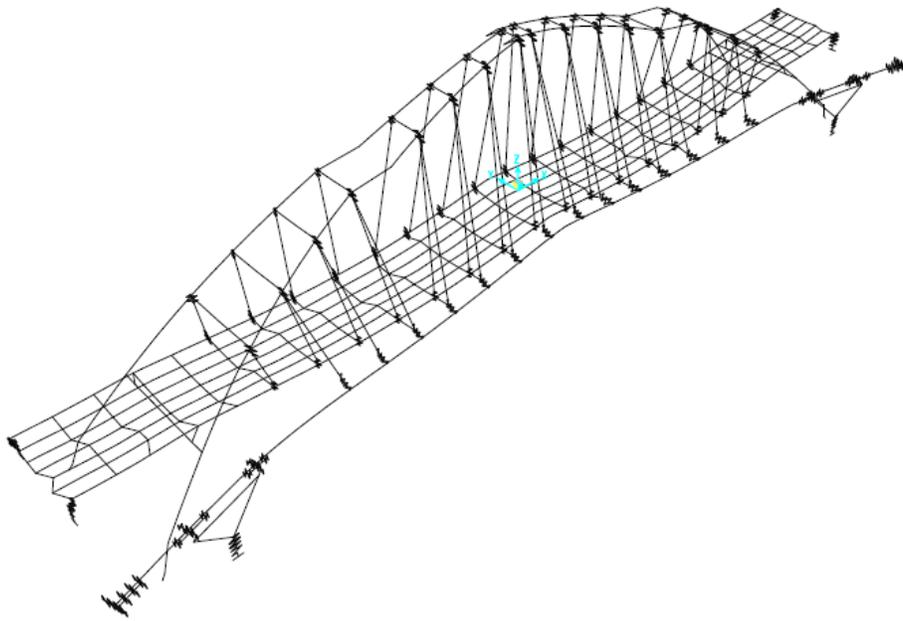
Figure 4-18: Deflected Shape Envelope under Predicted Traffic Load

The deflected shape of the Walterdale Bridge under predicted traffic load is shown in Figure 4-18. Maximum negative vertical displacement of the edge girders of -10 mm occurs at 50 m and 180 m of the east edge girder, along its length (Figure 4-19). Maximum positive vertical deflection of the edge girders occurs at mid-span of the west edge girder, with a deflection of 30 mm. The bridge deck experiences the highest transverse displacement of 35 mm at mid-span, which is expected, since the bridge deck is the least transversely restraint at mid-span (Figure 4-20). From Figure 4-21, the maximum longitudinal displacement of the bridge deck is approximately 10 mm. The highest vertical displacement of the SUP occurs at 102 m and 132 m along its length (Figure 4-22).

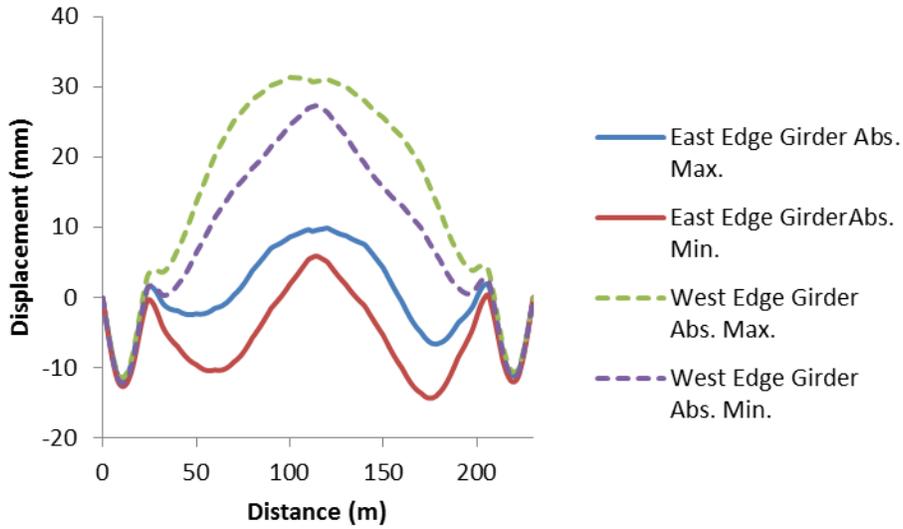
Figure 4-19: Vertical Displacement Envelope of the Bridge Deck under Predicted Traffic

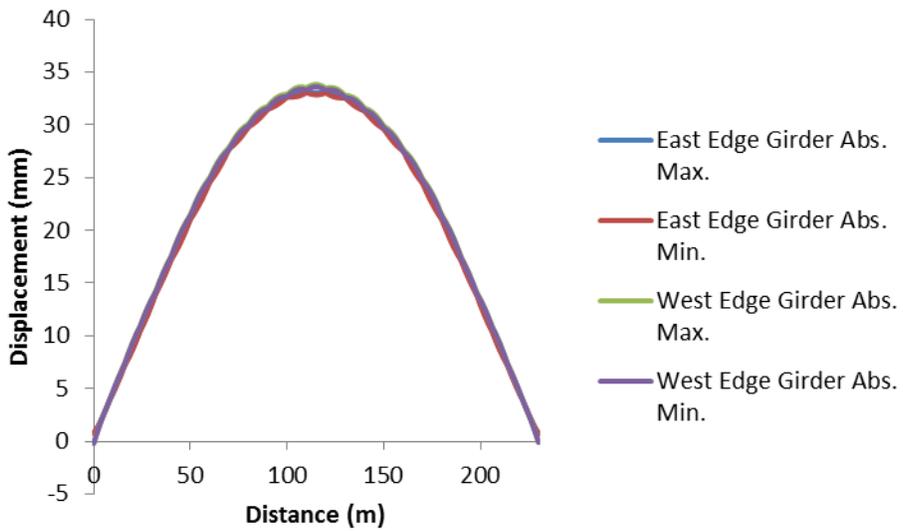
Figure 4-20: Transverse Displacement Envelope of Bridge Deck under Predicted Traffic

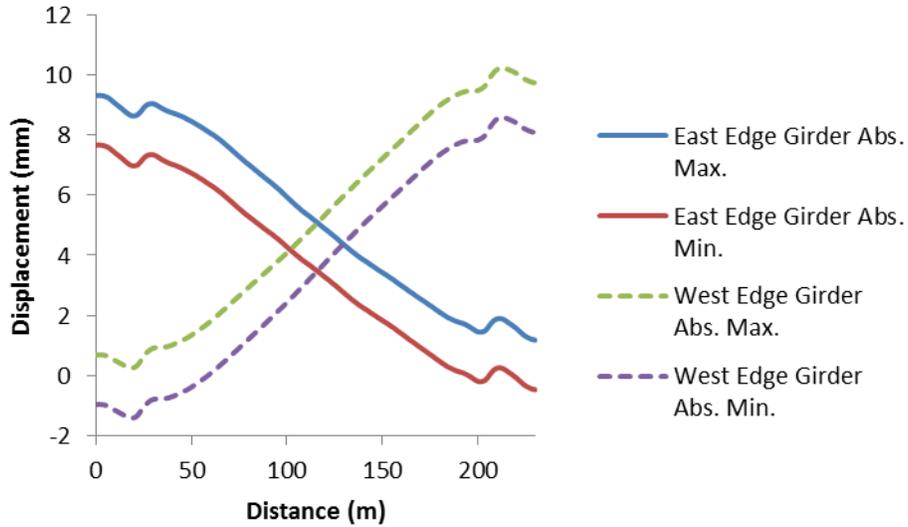
Figure 4-21: Longitudinal Displacement Envelope of the Bridge Deck under Predicted Traffic Load

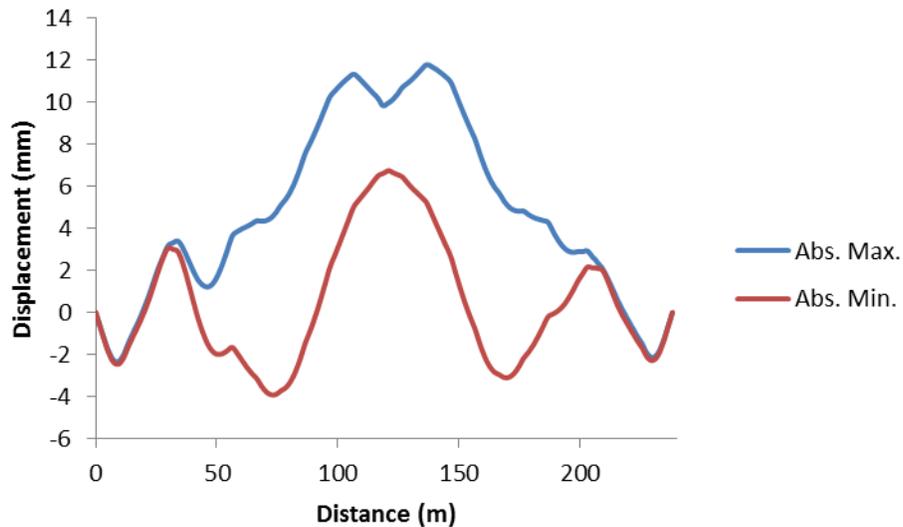
Figure 4-22: Vertical Displacement Envelope of SUP under Predicted Traffic Load

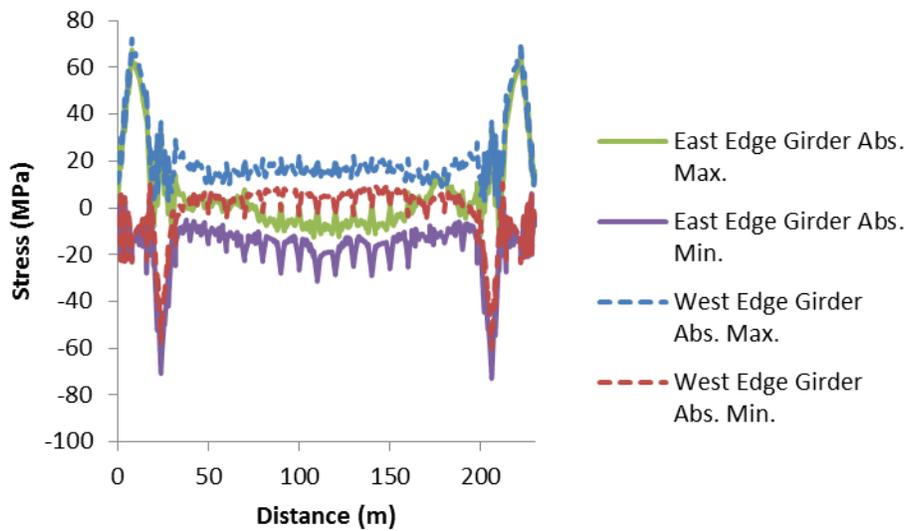
Figure 4-23: Normal Stress Envelope of the Edge Girders under Predicted Traffic Load

The mid-span of the edge girders, which are connected to hangers, experiences a relatively constant stress throughout its length. The inner girders experience the largest amount of normal stress at inner girder 3, which is the stringer located directly below the middle traffic lane, with a relatively constant value of 100 MPa throughout its length. Peaks occur at locations of the floor beams that run through the inner girder, as this is where the loads are transferred to the floor beam locations. The stresses of inner girder 3 only are displayed in Figure 4-24 for clarity. Maximum normal stress of -80 MPa in the east arch occurs at mid-span (Figure 4-25). The largest normal stress of approximately 640 MPa in the bridge hangers occurs at east hanger 12 (Figure 4-26).

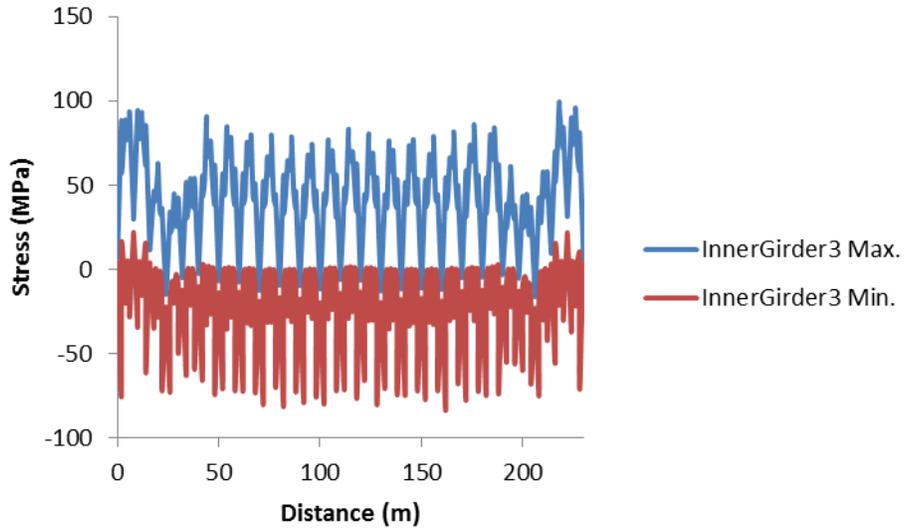
Figure 4-24: Normal Stress Envelope of Inner Girders under Predicted Traffic Load

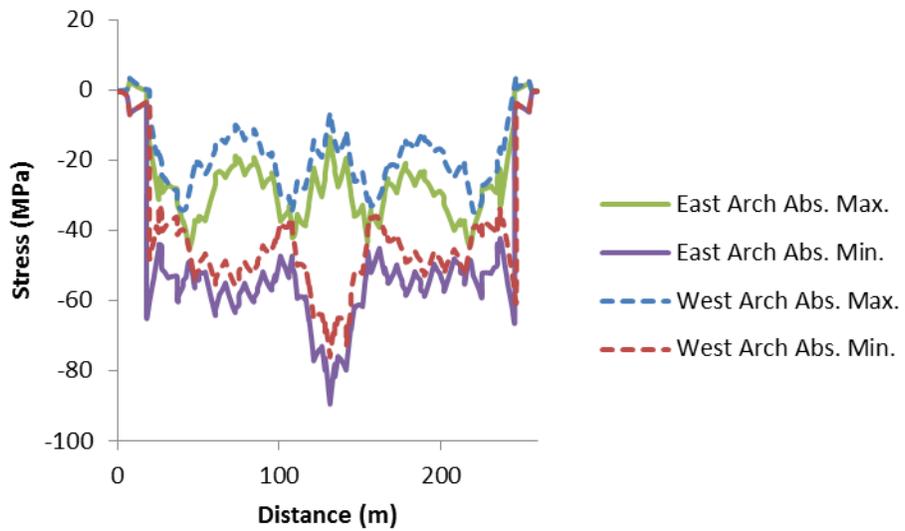
Figure 4-25: Normal Stress Envelope of Arches under Predicted Traffic Load

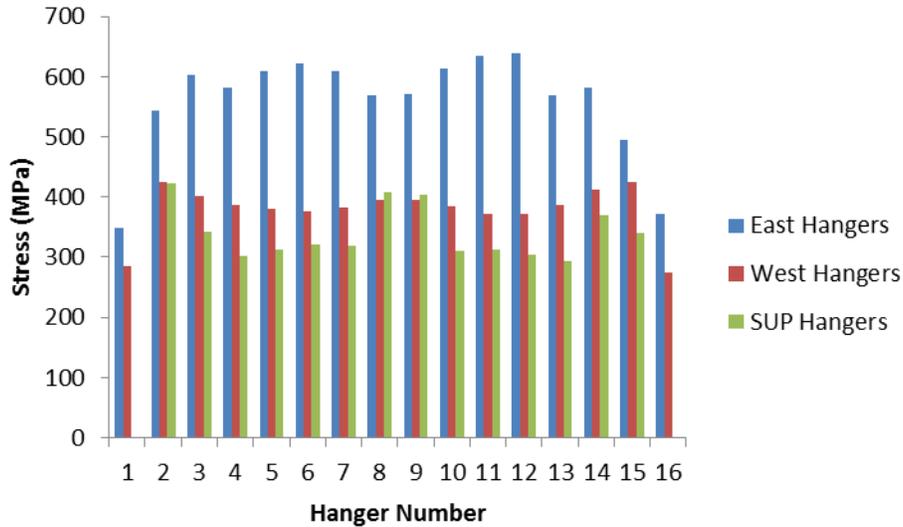
Figure 4-26: Normal Stress of Hangers under Predicted Traffic Load

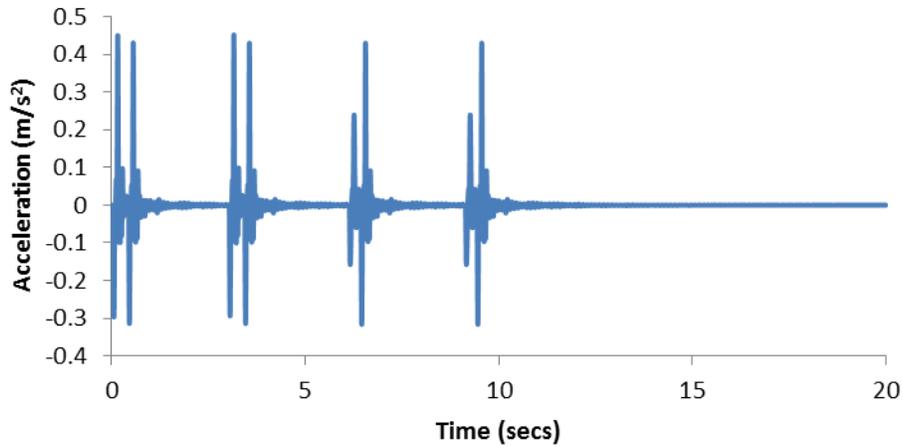
Figure 4-27: Vertical Acceleration of Bridge Deck at South End due to Predicted Traffic Load

The results show that maximum positive and negative vertical accelerations under vehicle loading occur at the south and north ends of the bridge deck. Figure 4-27 shows the maximum vertical accelerations at the south end, with a maximum positive and negative acceleration of  $0.4515 \text{ m/s}^2$  and  $-0.3163 \text{ m/s}^2$ , respectively. It is evident from this figure that each vehicle passing the bridge deck causes a spike in accelerations. Examining vertical accelerations at the mid-section of the bridge deck, the accelerations are a 10 times smaller than the accelerations at the end spans (Figure 4-28). Peaks in accelerations are still present when vehicles drive over that section. Maximum horizontal acceleration of the bridge is  $0.0218 \text{ m/s}^2$  and maximum longitudinal acceleration is  $-0.0161 \text{ m/s}^2$ , both occurring on the bridge deck.

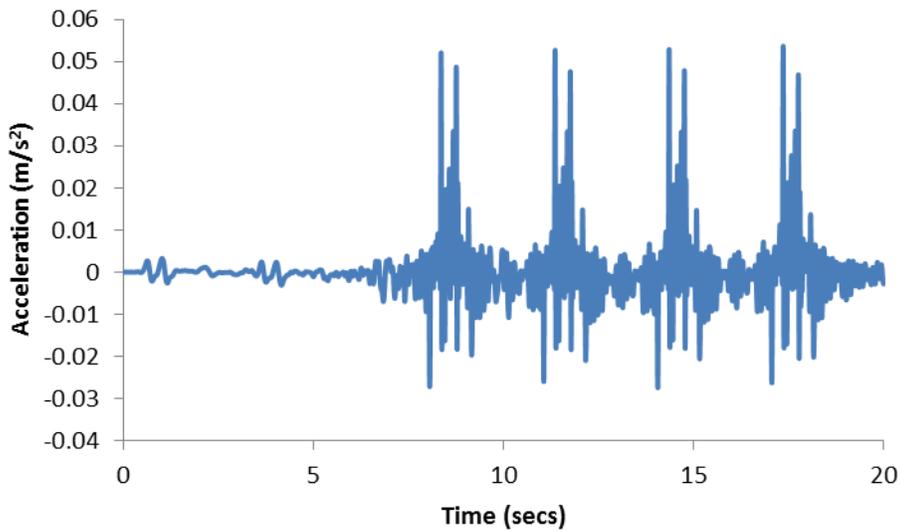
Figure 4-28: Vertical Acceleration of Bridge Deck at Mid-span due to Predicted Traffic Load

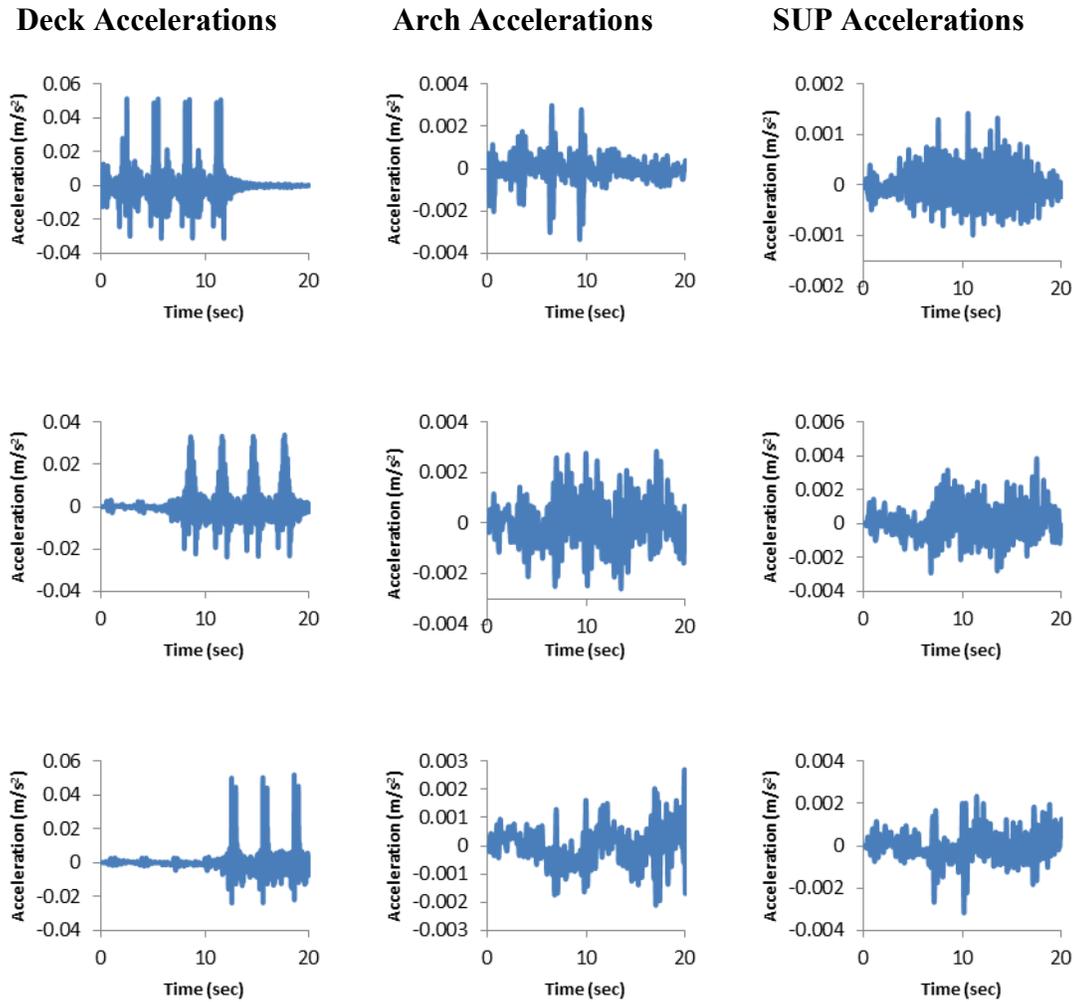
Figure 4-29: Accelerations at 30 m, mid-span and 170 m along the Walterdale Bridge under Predicted Vehicle Loading

and 170 m from the south end of the bridge, shown from top to bottom in the figure columns respectively. From this figure, it is evident that the arches and SUP experience considerably less acceleration than the bridge deck, which is expected, since the source of accelerations is applied directly to the bridge deck and should be excited more than the surrounding members.

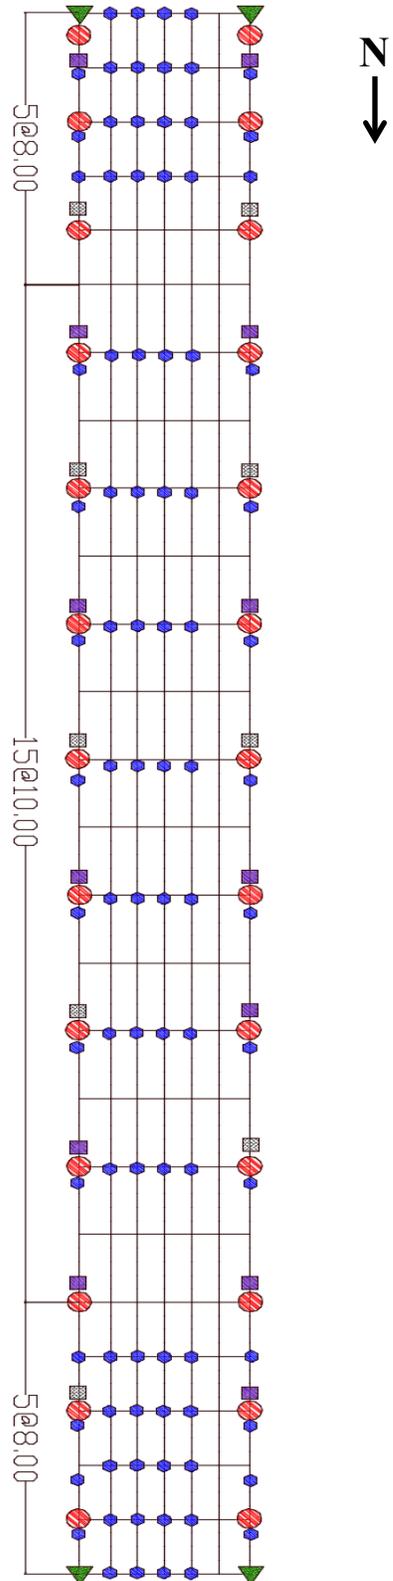
Figure 5-1: Bridge Deck Sensor Layout (Plan View)

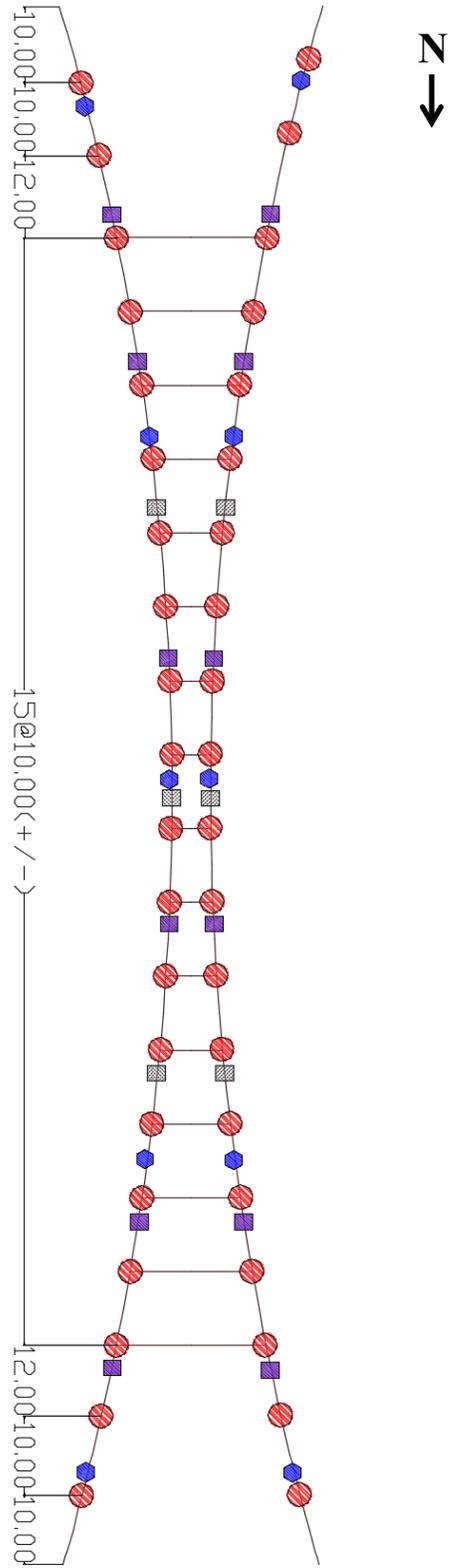
Figure 5-2: Arch Sensor Layout

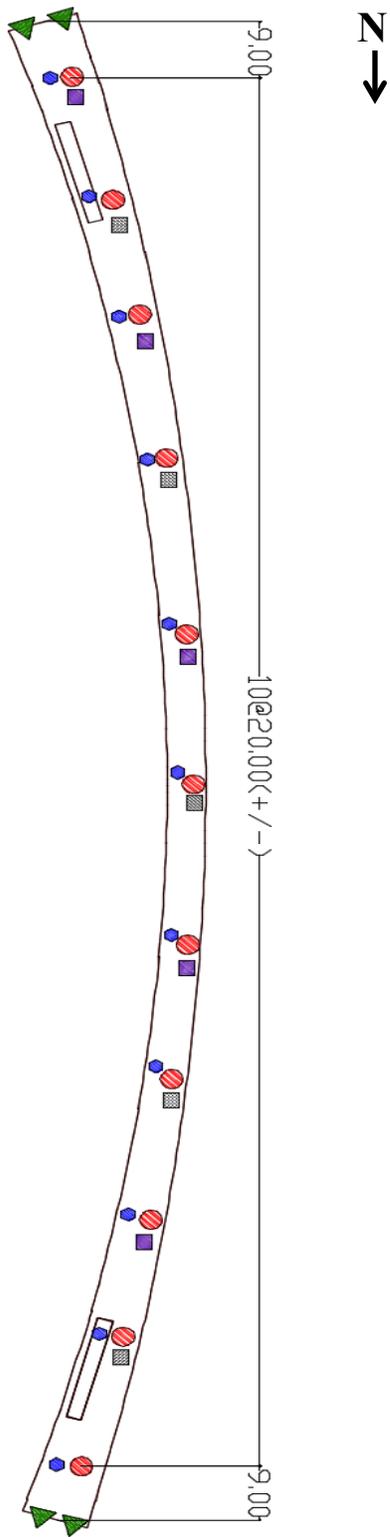
Figure 5-3: SUP Sensor Layout

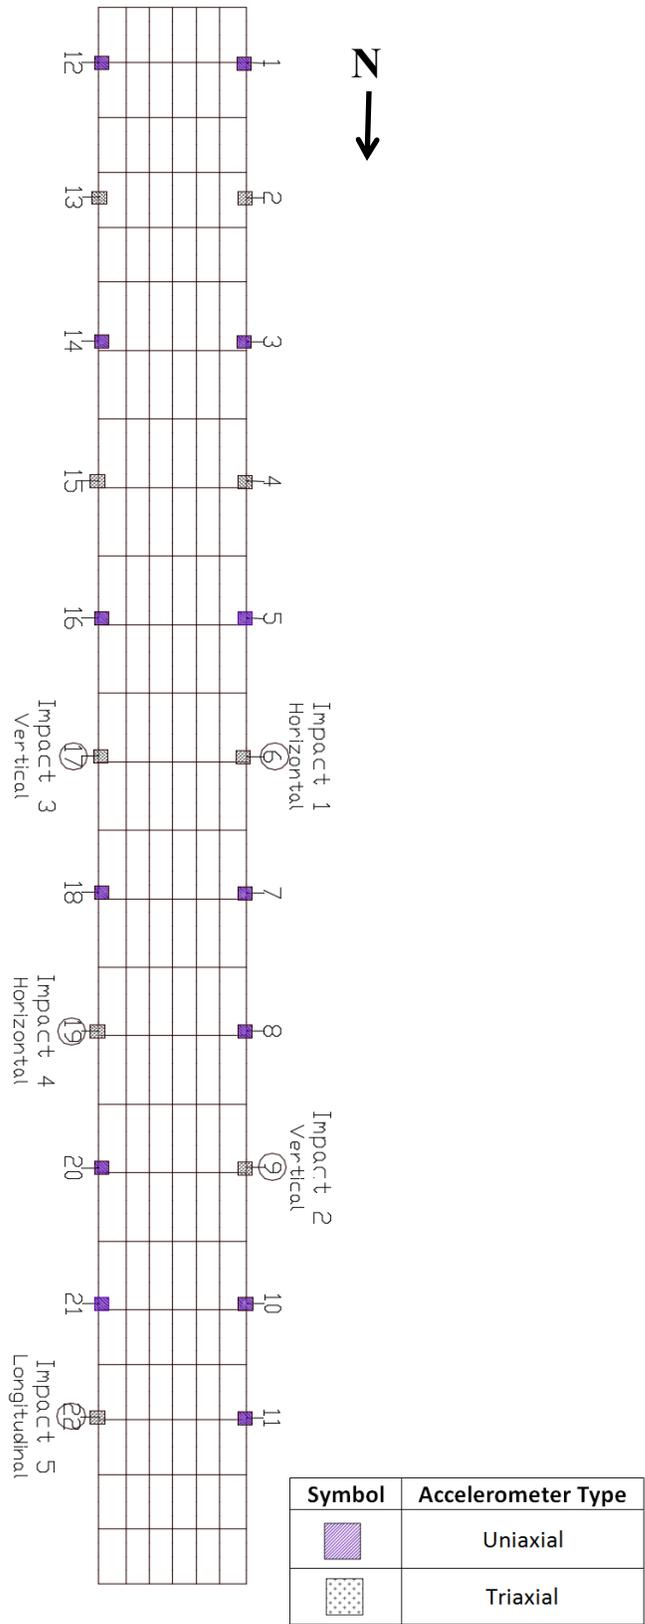
Figure 6-1: Top View of Bridge Deck Accelerometer Layout and Impact Locations

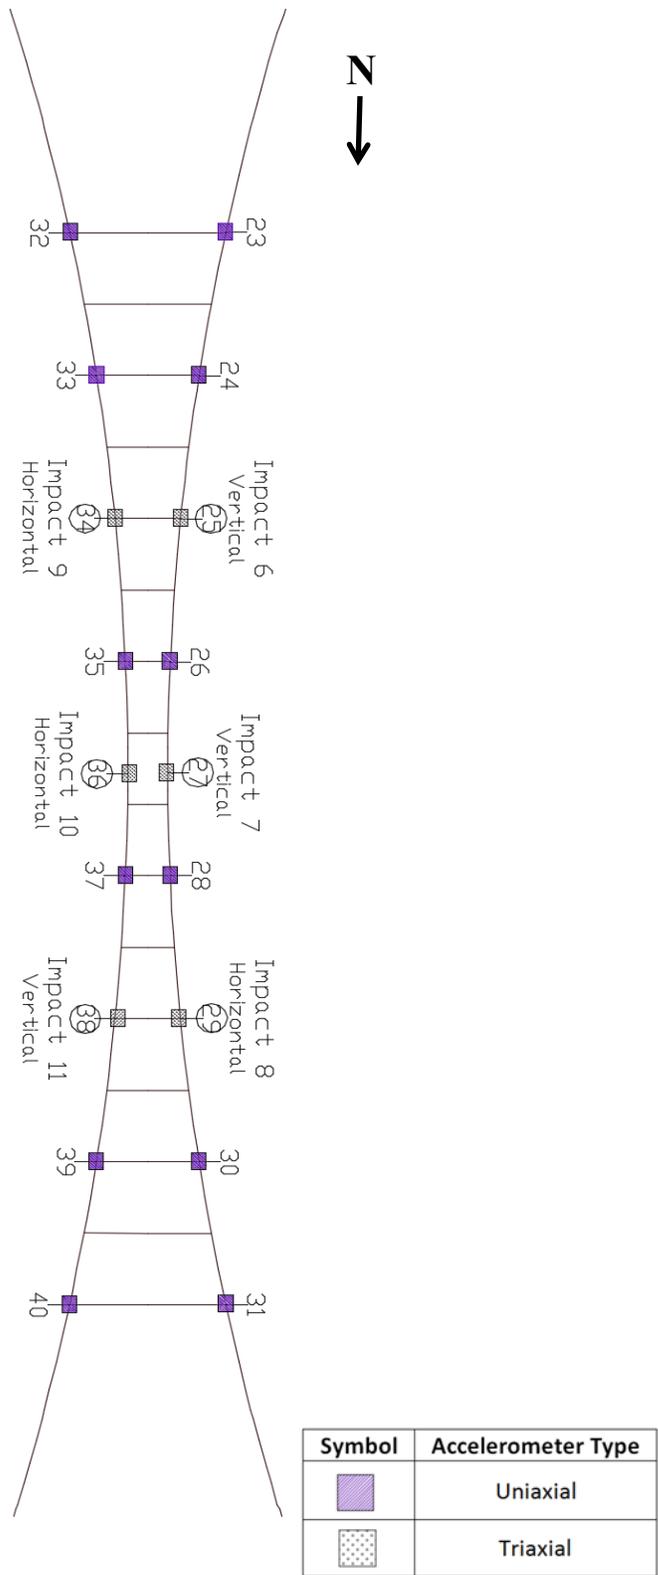
Figure 6-2: Top View of Steel Arches Accelerometer Layout and Impact Locations

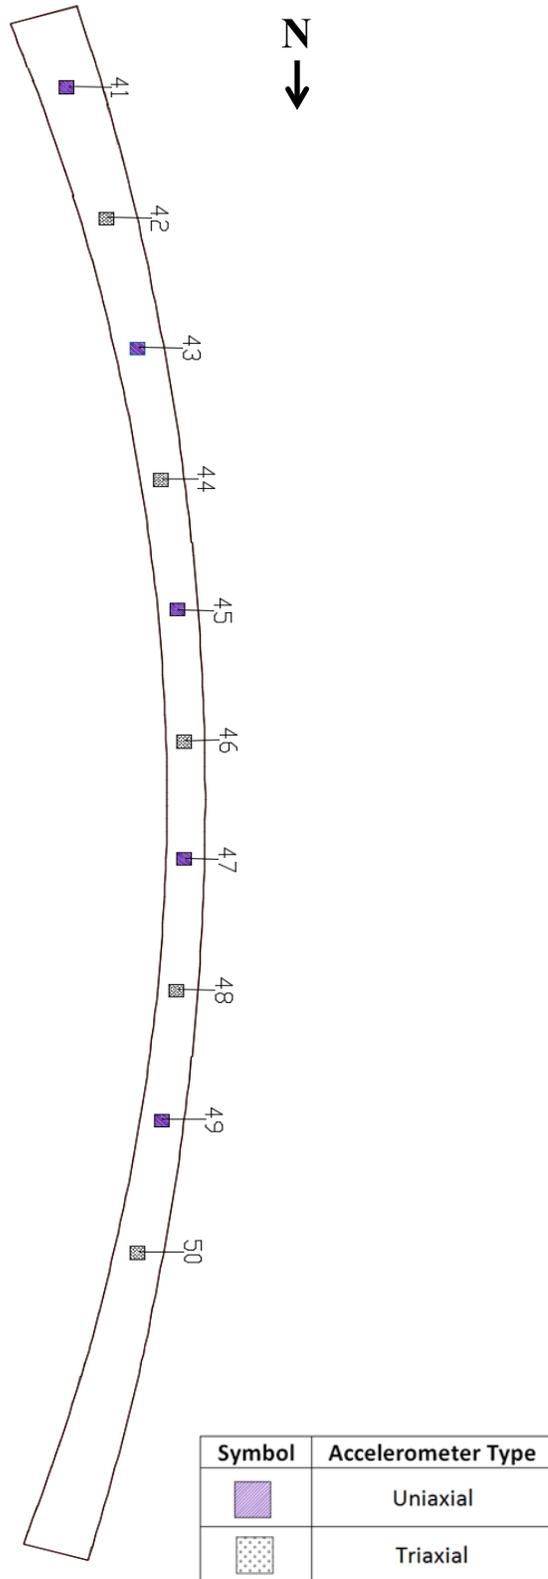
Figure 6-3: SUP Accelerometer Layout

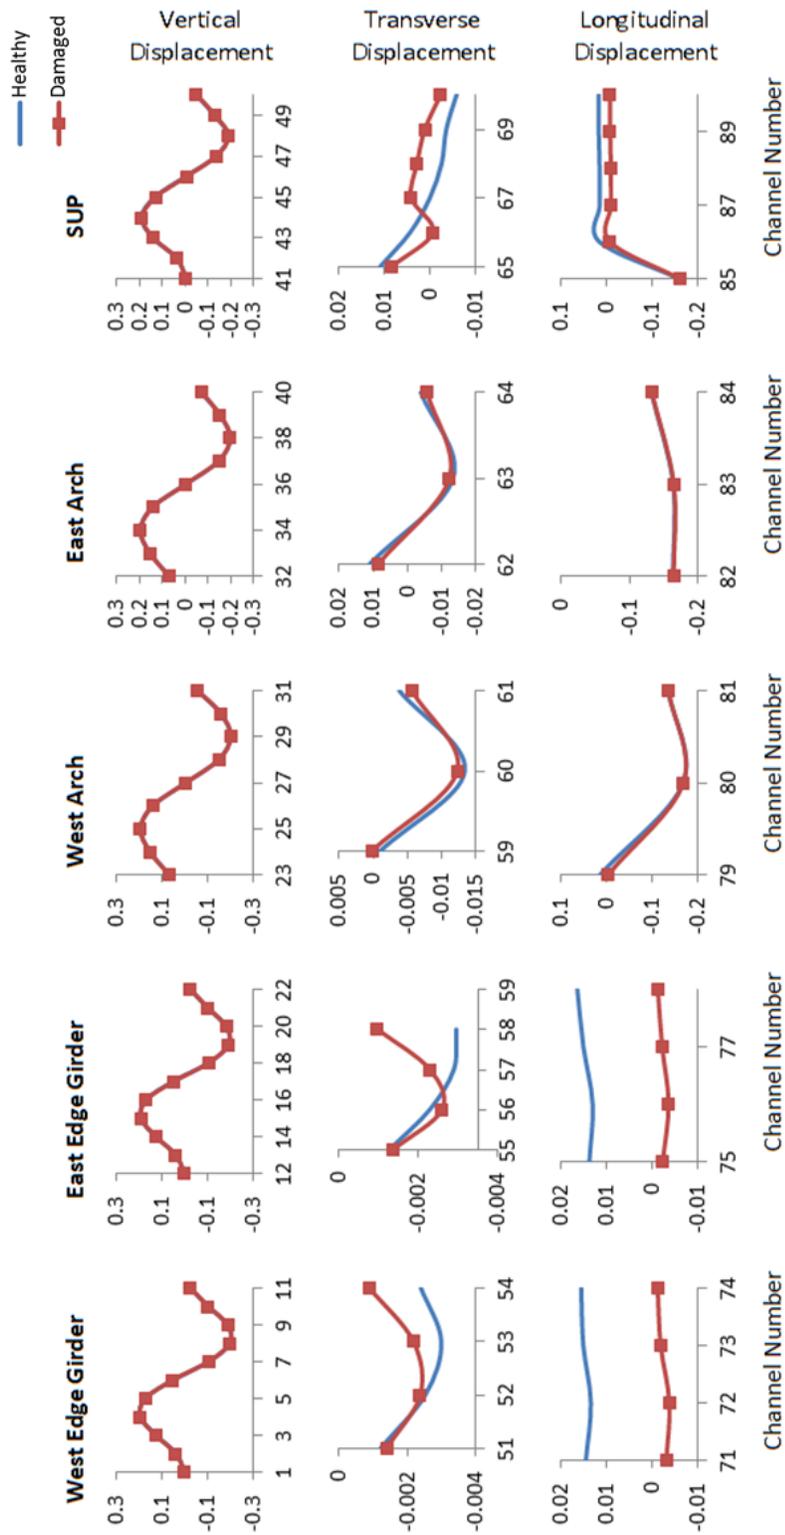
Figure 6-4: Full Bearing Stiffness Mode Shape 2 Comparison
