Investigation and Analysis of the New Walterdale Bridge to Develop a Structural Health  
Monitoring System

Aimee De Laurentiis

Structural Engineering

University of Alberta

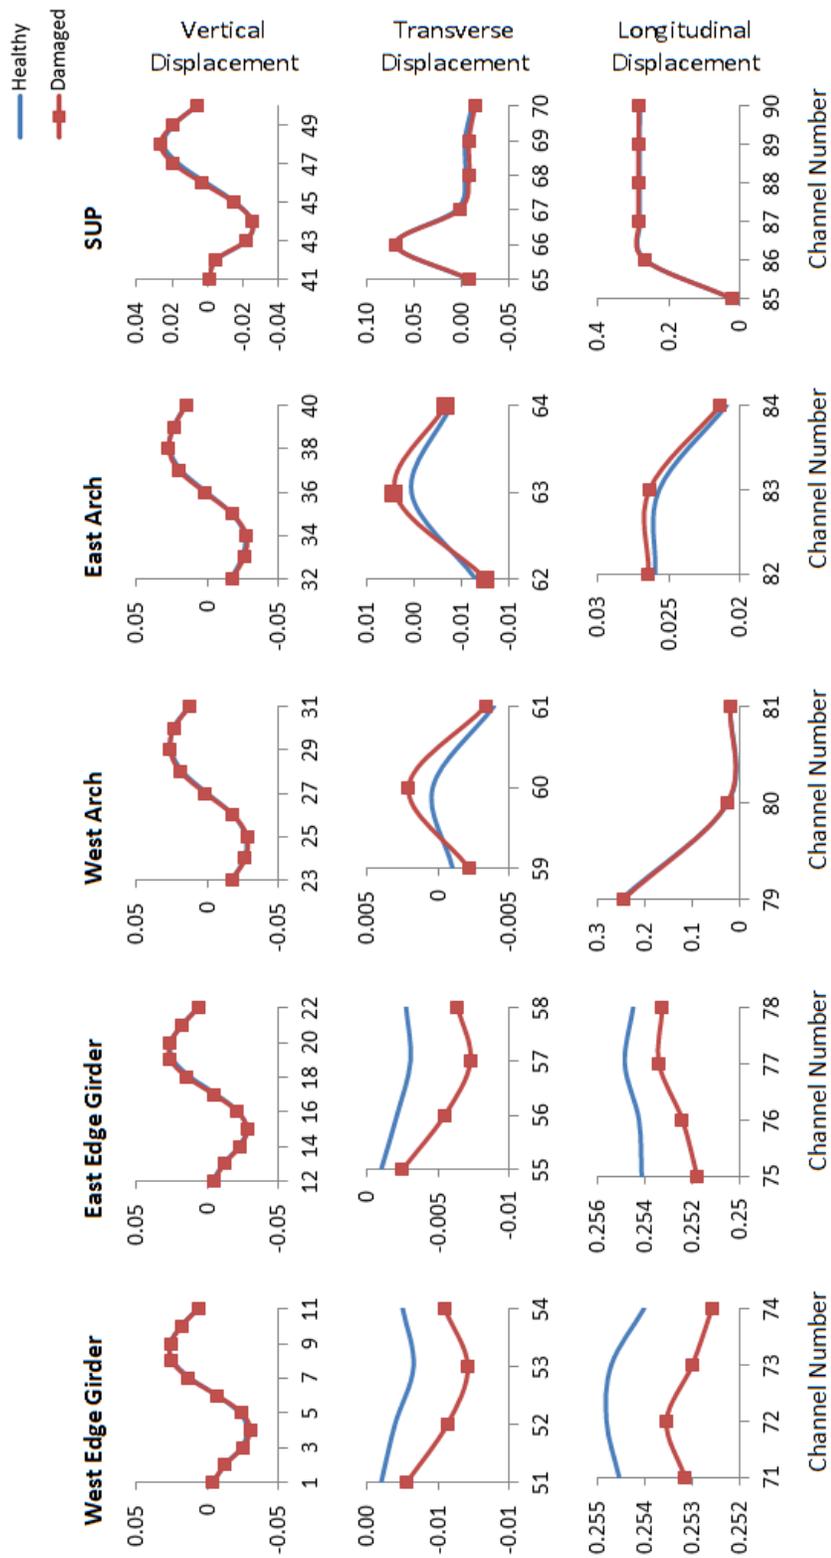
Figure 6-5: 2X Bearing Stiffness Mode Shape 1 Comparison

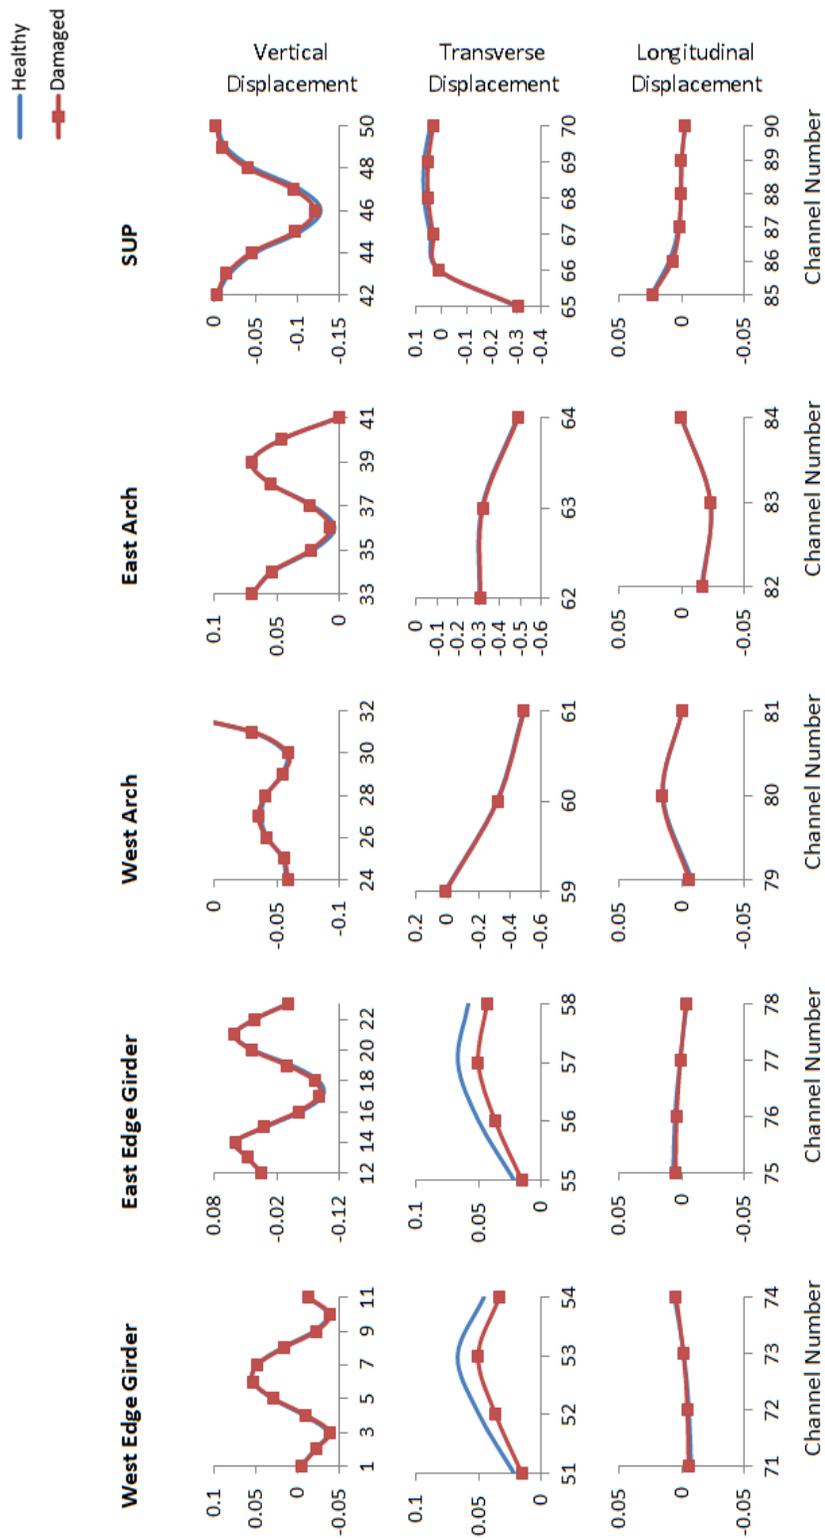
Figure 6-6: Full E12 Hanger Removal Mode Shape 4 Comparison

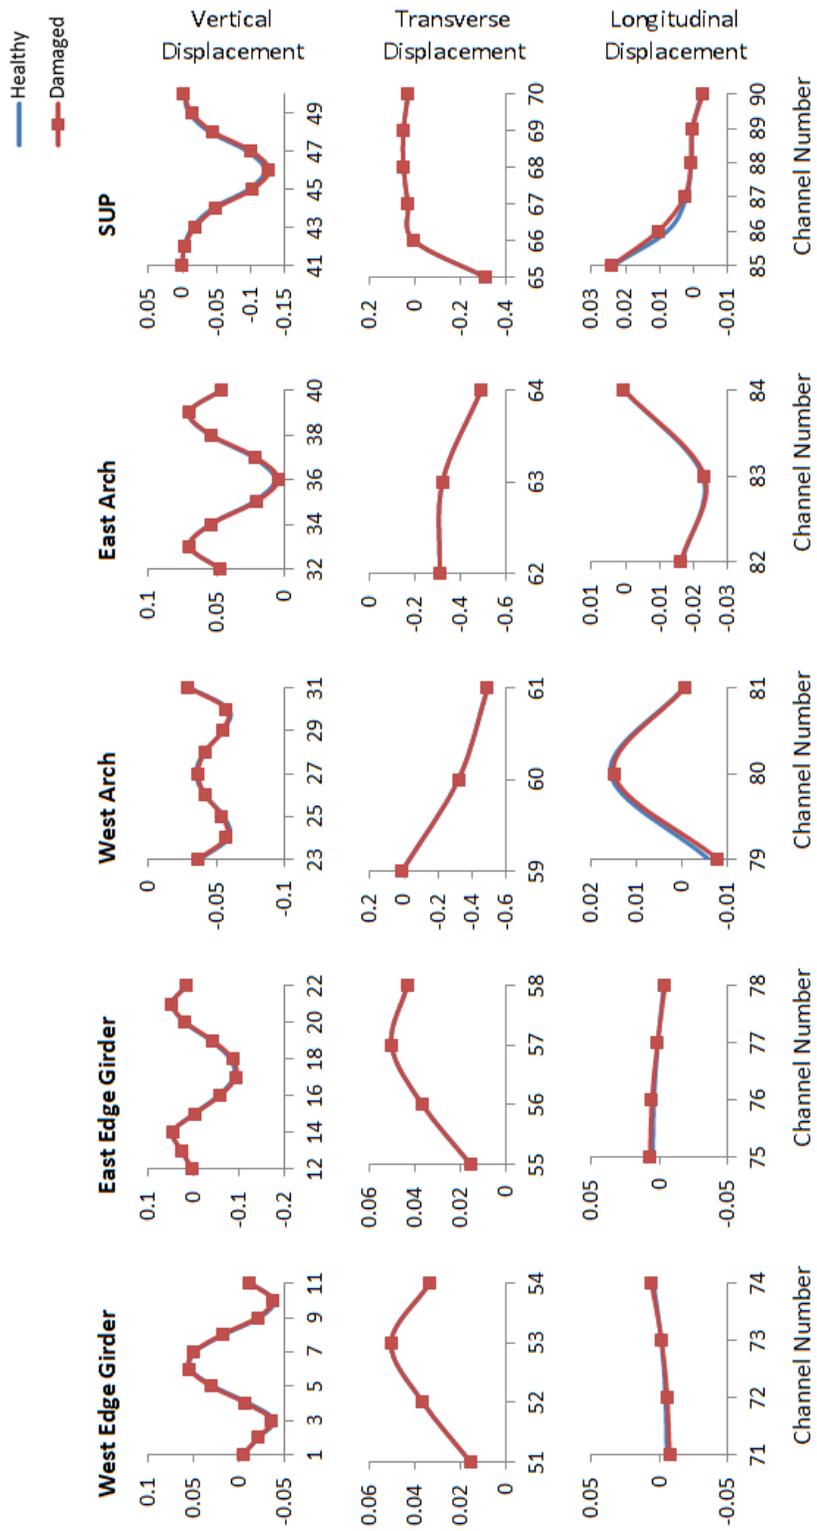
Figure 6-7: 20% Reduction in Stiffness of E12 Hanger Mode Shape 4 Comparison

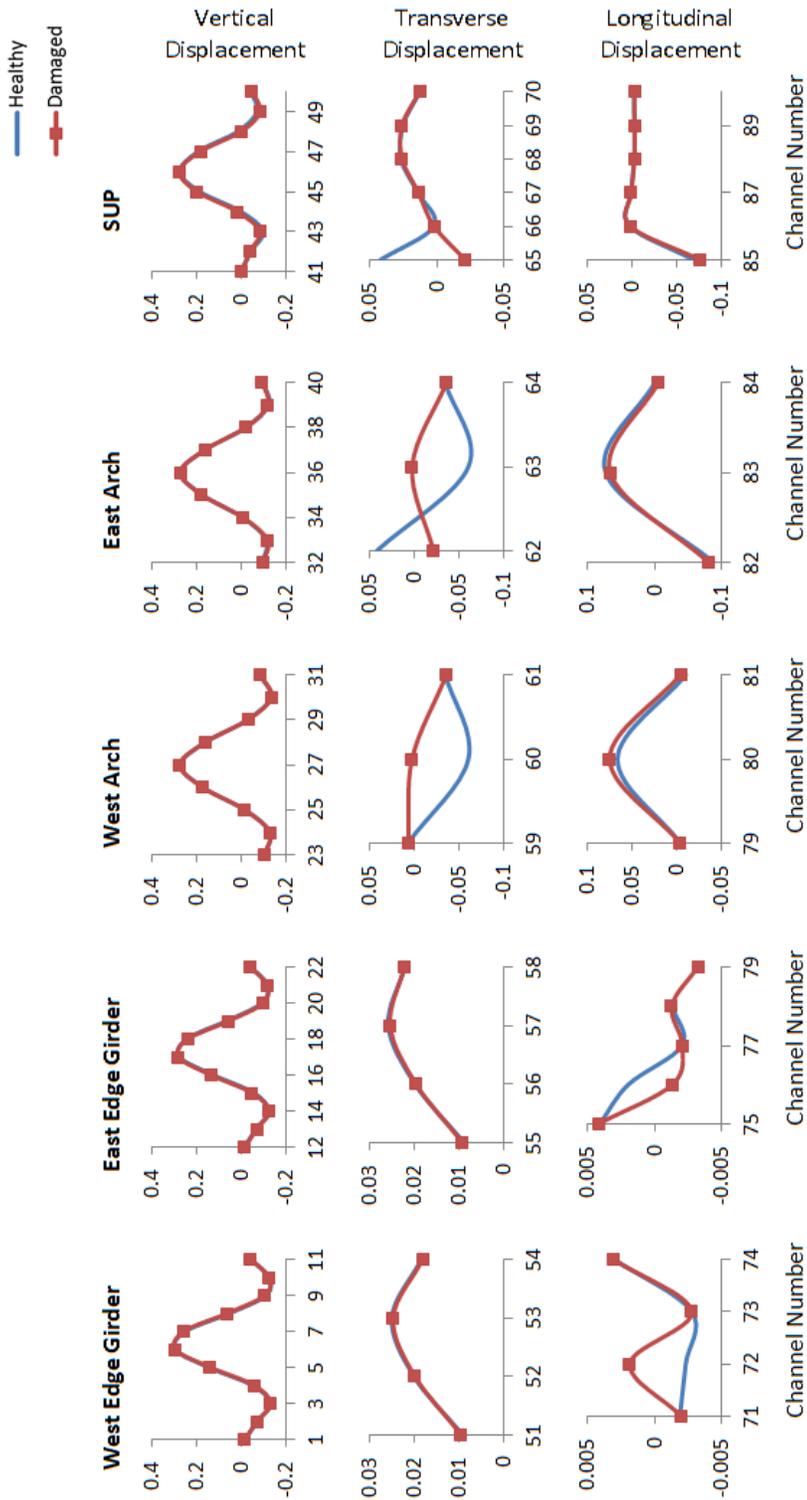
Figure 6-8: 80% Stiffness Reduction of Full Arch Strut 4 Member Mode Shape 5 Comparison

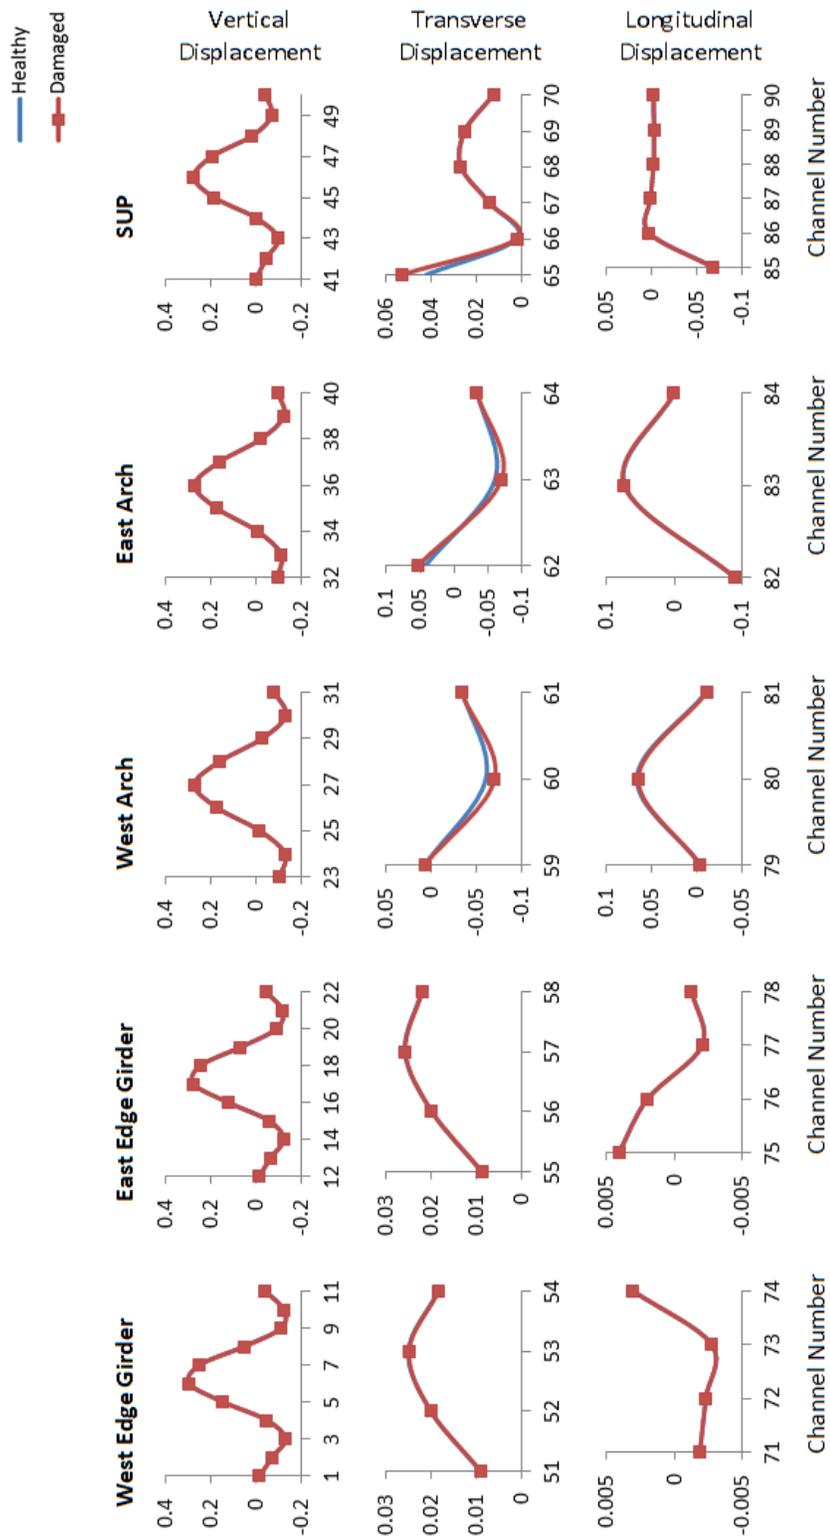
Figure 6-9: 20% Stiffness Reduction of Half Arch Strut 4 Member Mode Shape 5

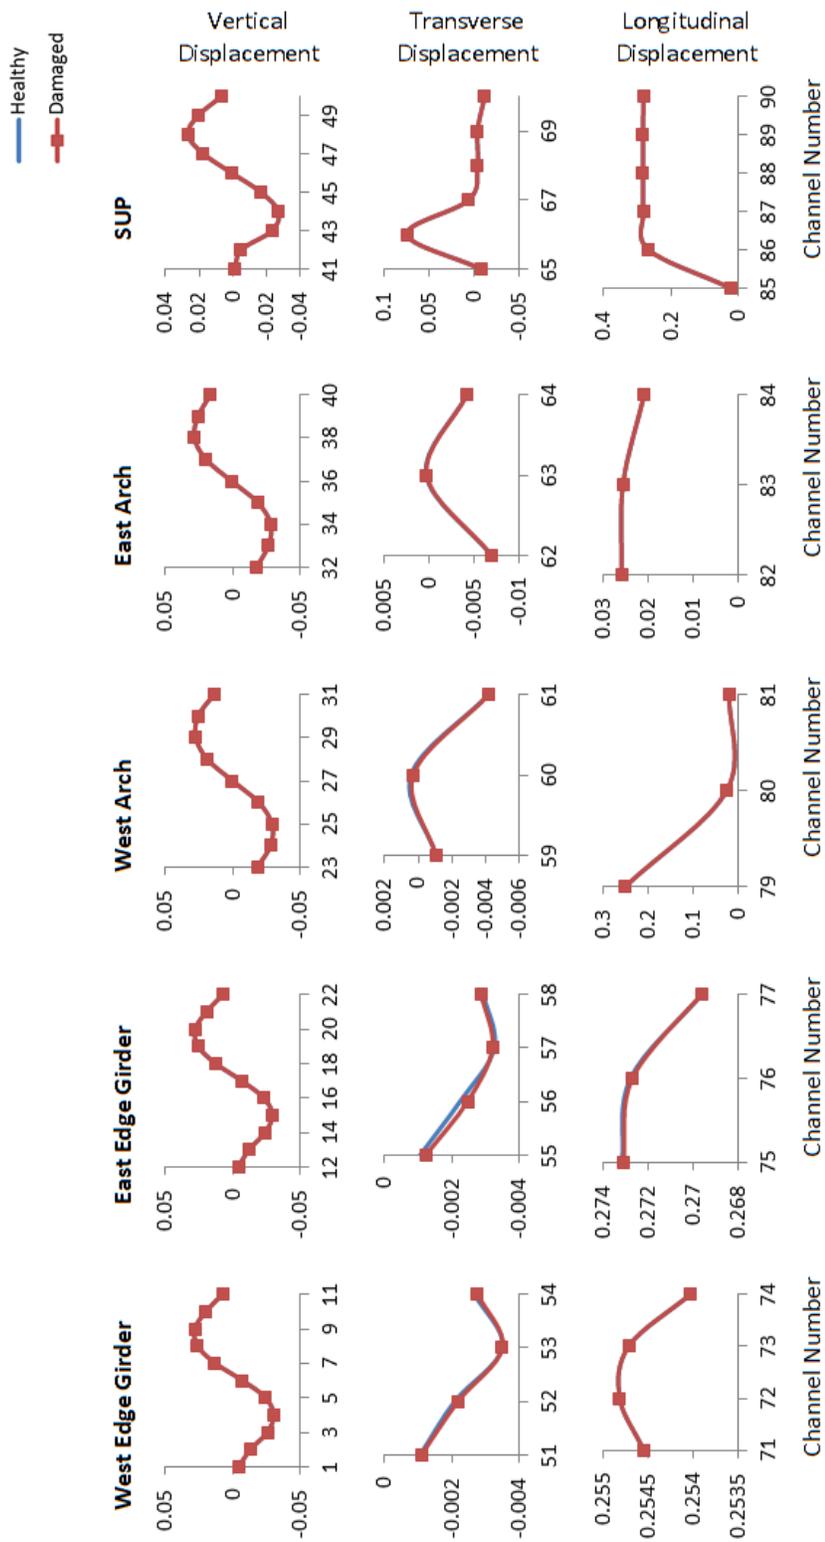
Figure 6-10: Connection Damage at East Edge Girder Mode 1 Comparison

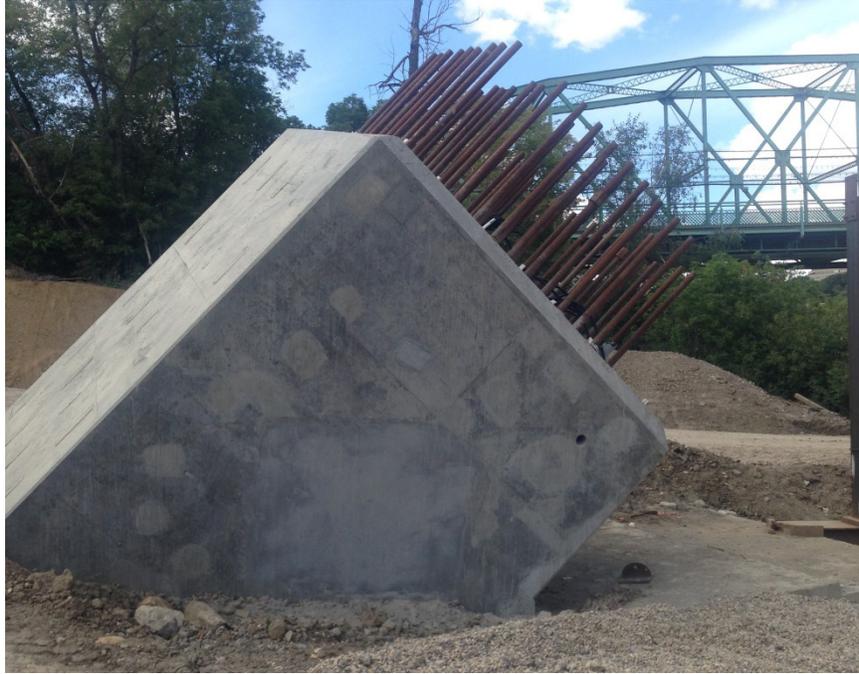
Figure A-1: South-West Thrust Block Construction (August 20<sup>th</sup>, 2015)

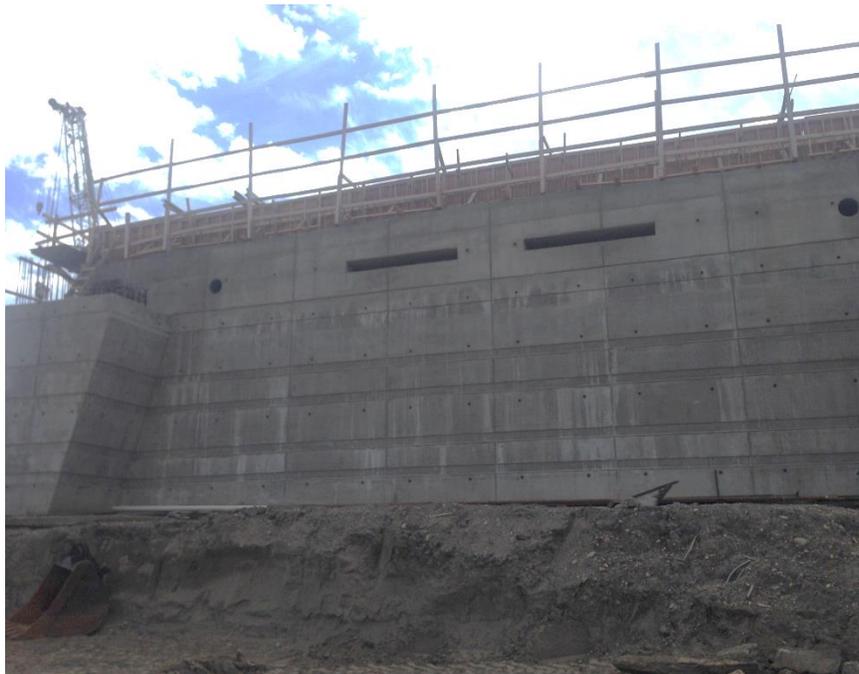
Figure A-2: South Abutment Construction (August 20<sup>th</sup>, 2015)

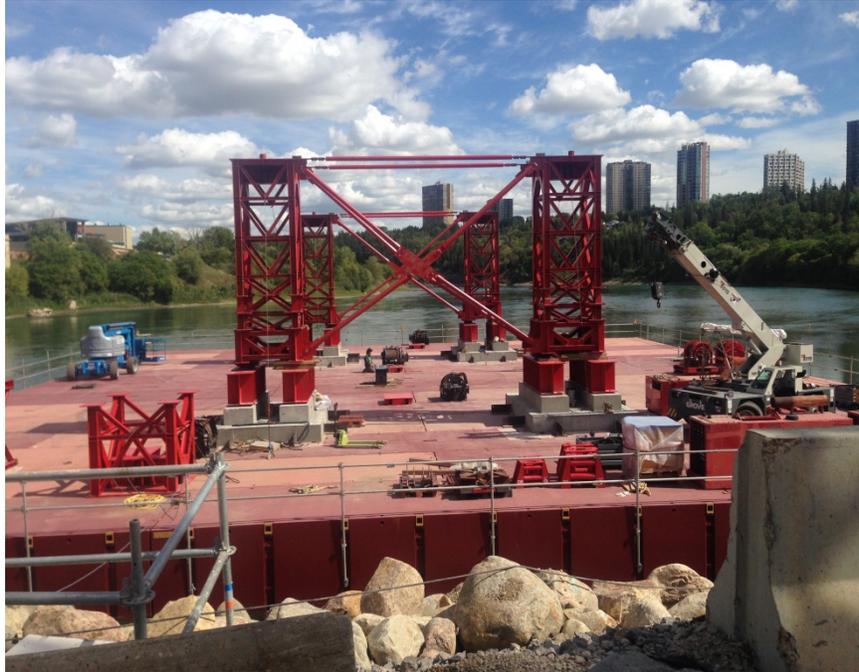
Figure A-3: Temporary Modular Barge (August 20<sup>th</sup>, 2015)

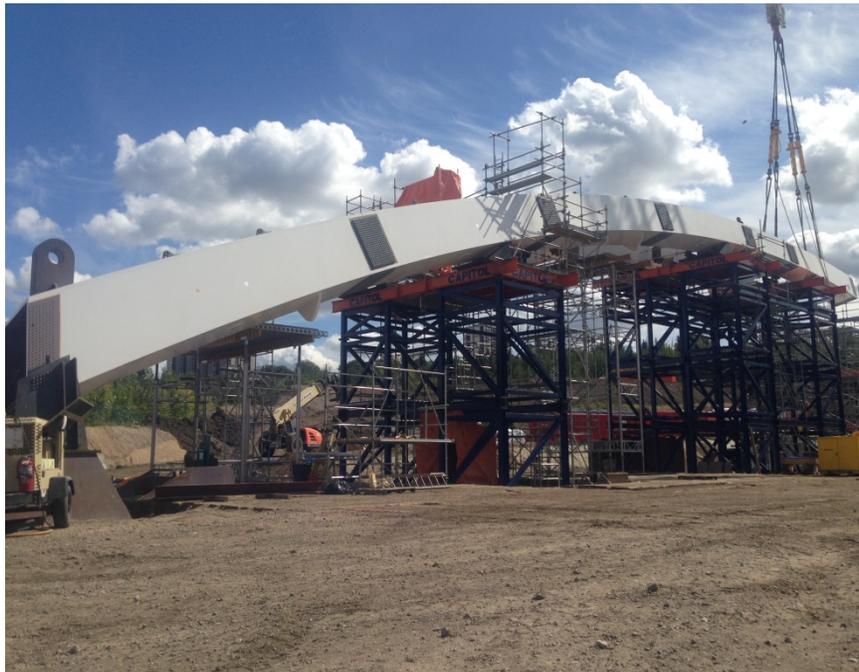
Figure A-4: Mid-arch Section Construction (August 20<sup>th</sup>, 2015)

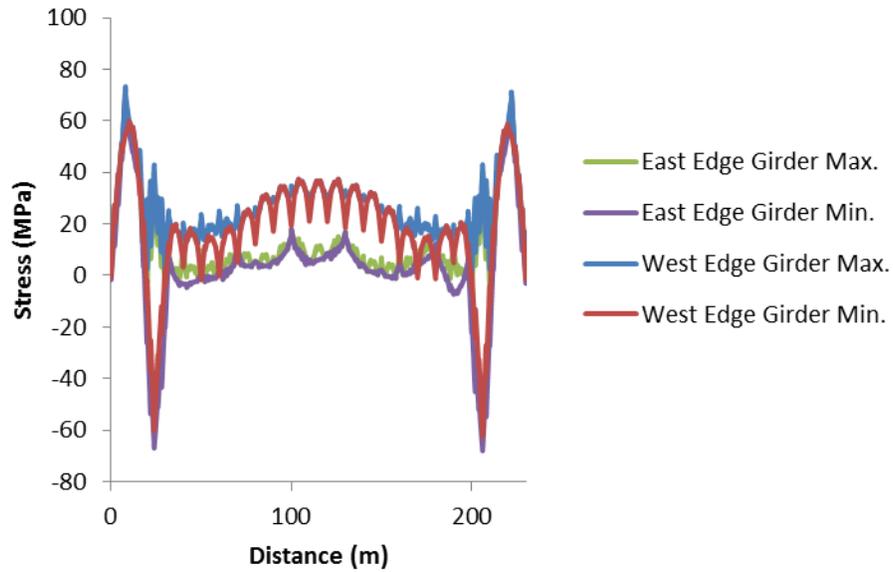
Figure B-1: Edge Girder Normal Stress under Negative Effective Temperature

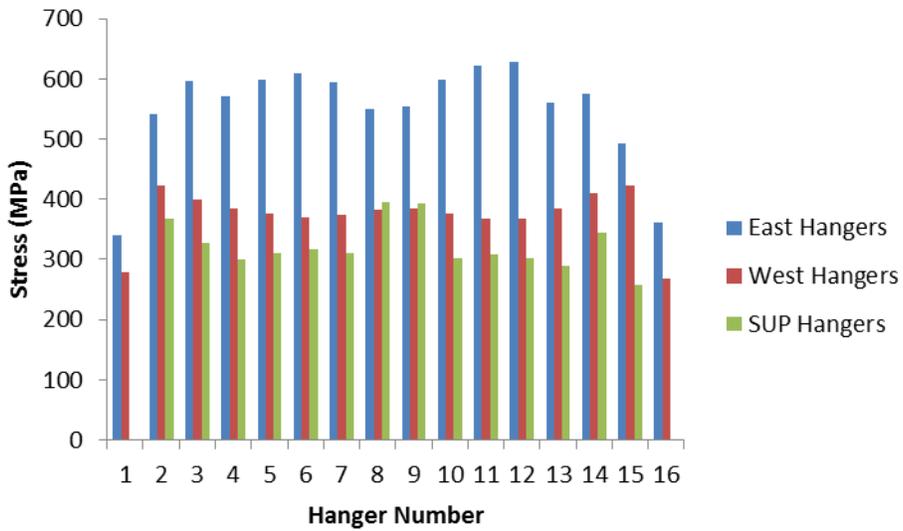
Figure B-4: Hanger Normal Stresses under Negative Effective Temperature

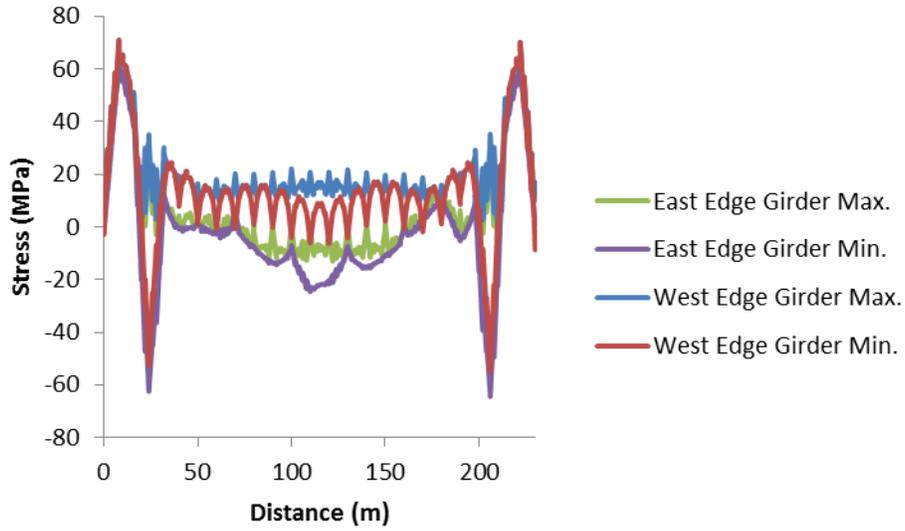
Figure B-5: Edge Girder Normal Stresses under Negative Thermal Gradient

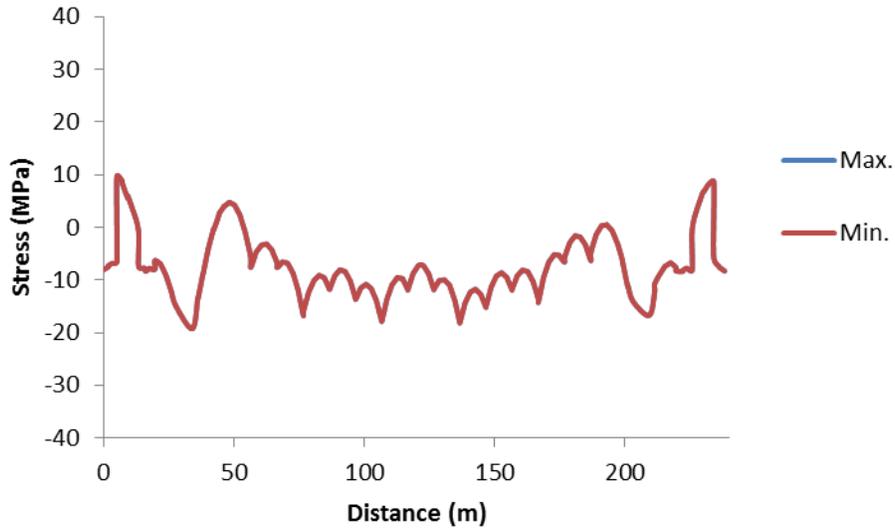
Figure B-7: SUP Normal Stresses under Negative Thermal Gradient

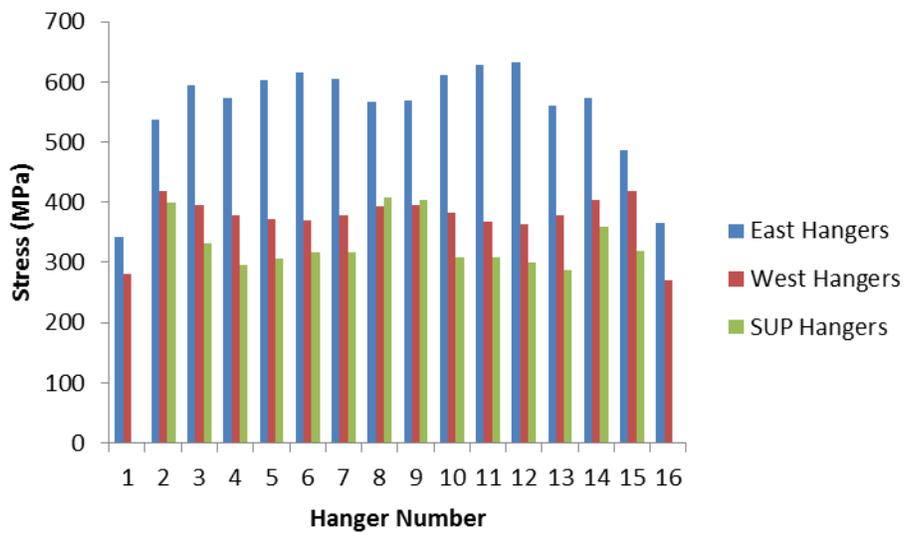
Figure B-8: Hanger Normal Stresses under Negative Thermal Gradient

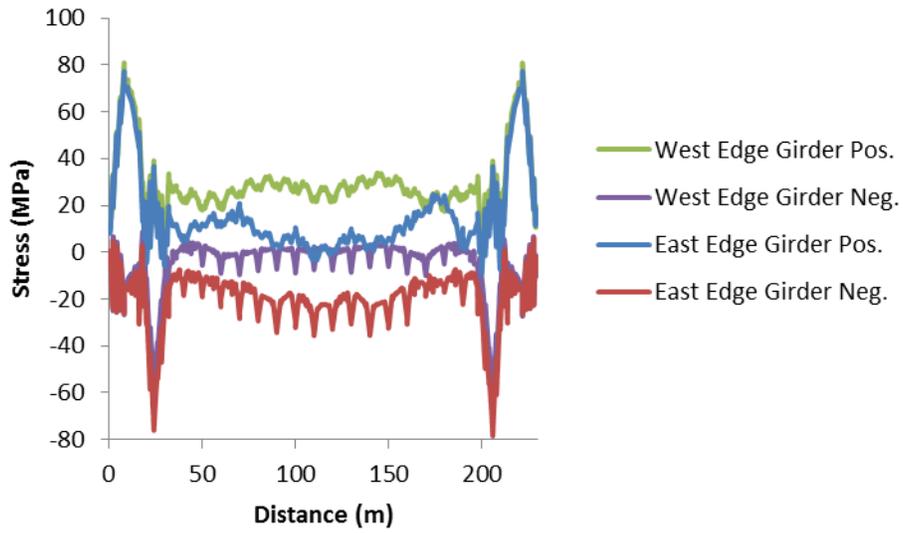
Figure B-9: Edge Girder Normal Stresses under CL-W800 Truck

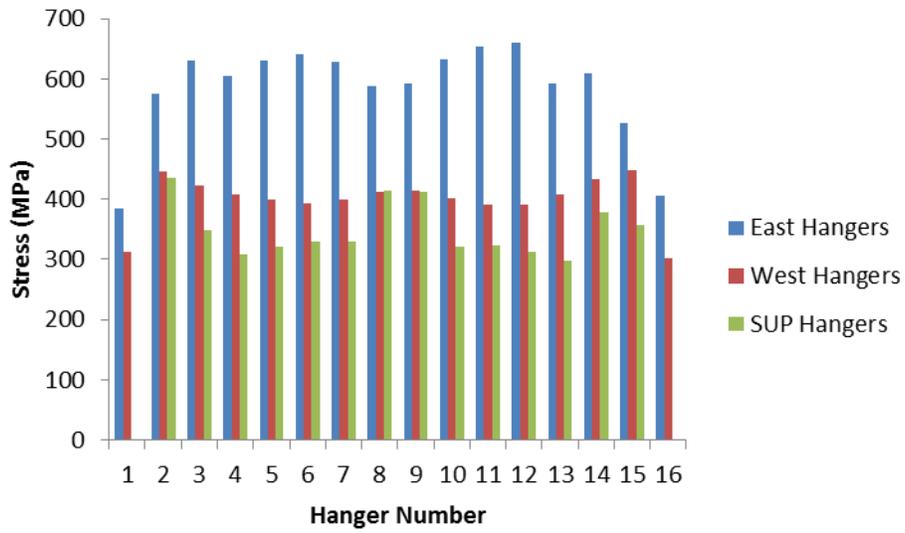
Figure B-12: Hanger Normal Stress under CL-W800 Truck

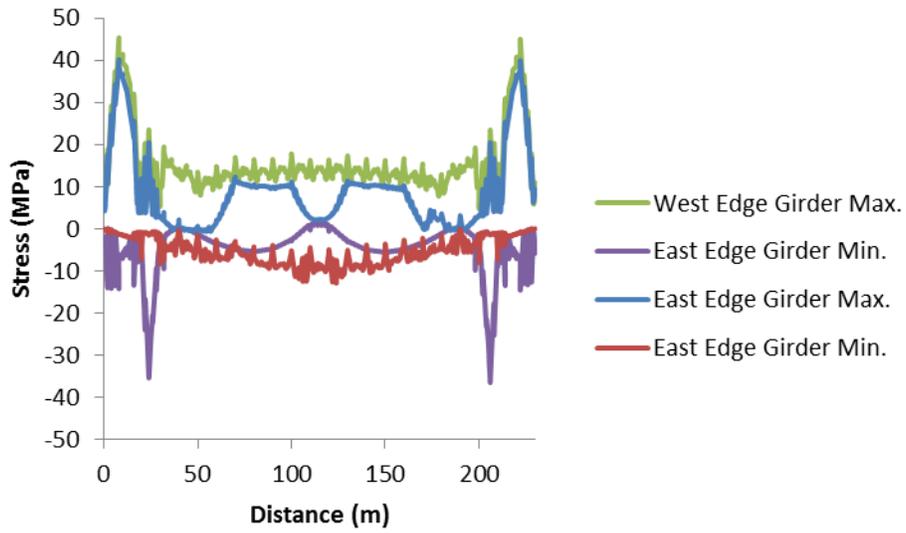
Figure B-13: Edge Girder Normal Stress under SUP Pedestrian Load

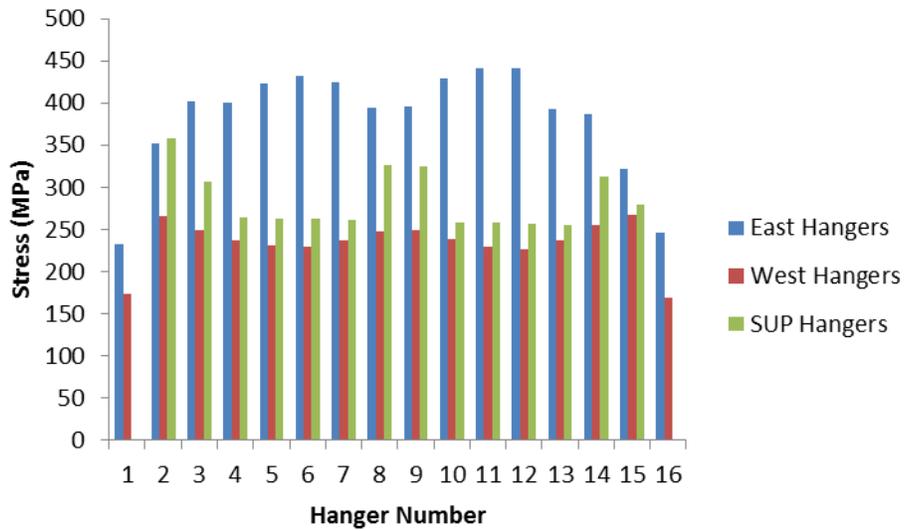
Figure B-16: Hanger Normal Stress under SUP Pedestrian Load

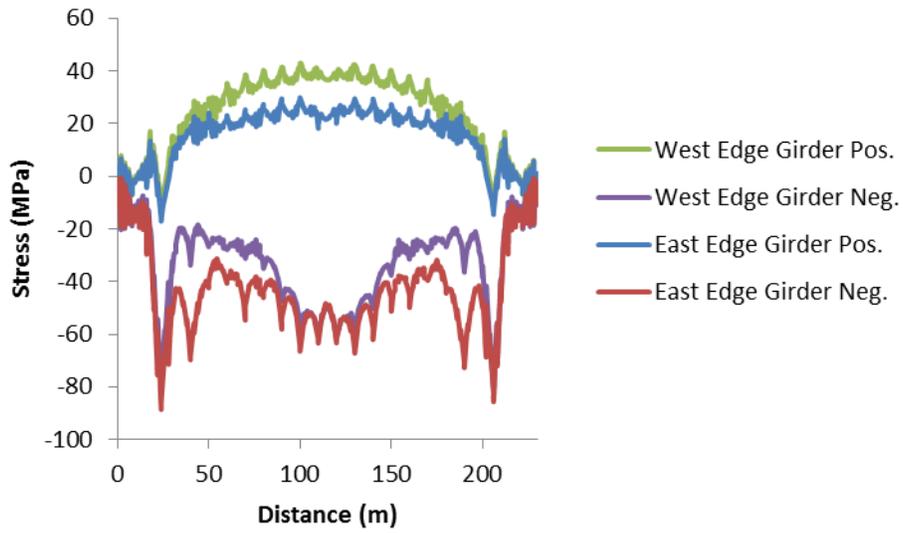
Figure B-17: Edge Girder Normal Stress under Wind Load Envelope

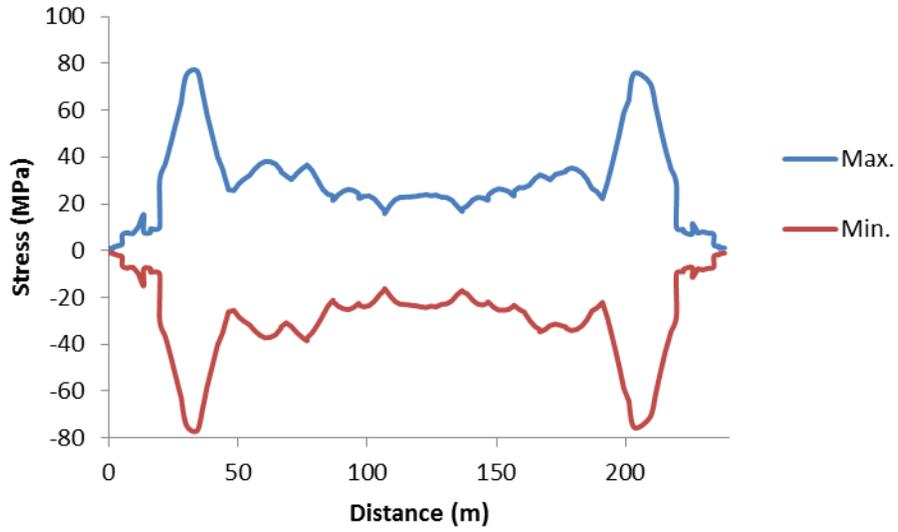
Figure B-19: SUP Normal Stresses under Wind Load Envelope

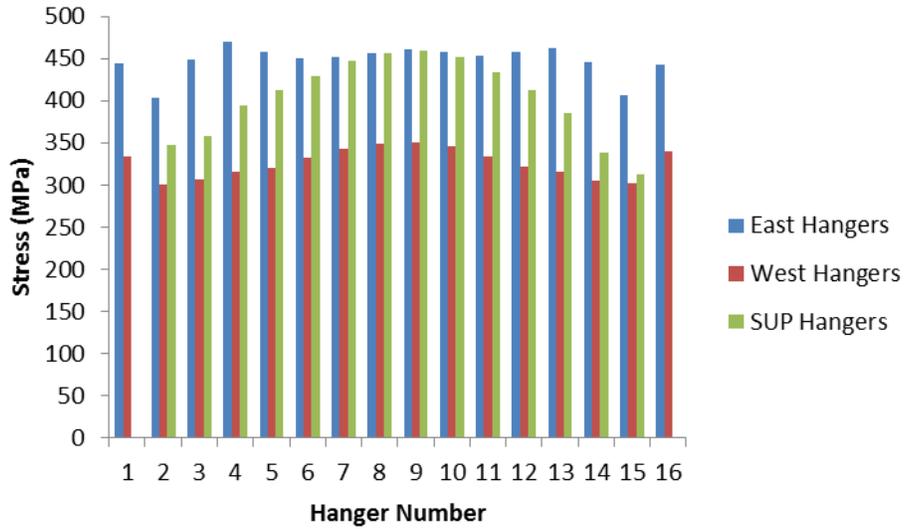
Figure B-20: Hanger Normal Stresses under Wind Load Envelope

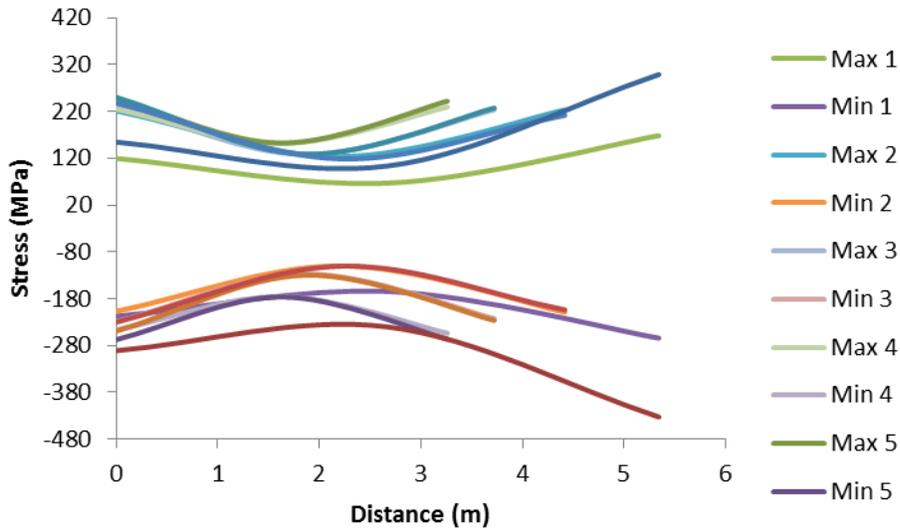
Figure B-21: Floor Beam Extension Normal Stress under SLS1 Load Combination

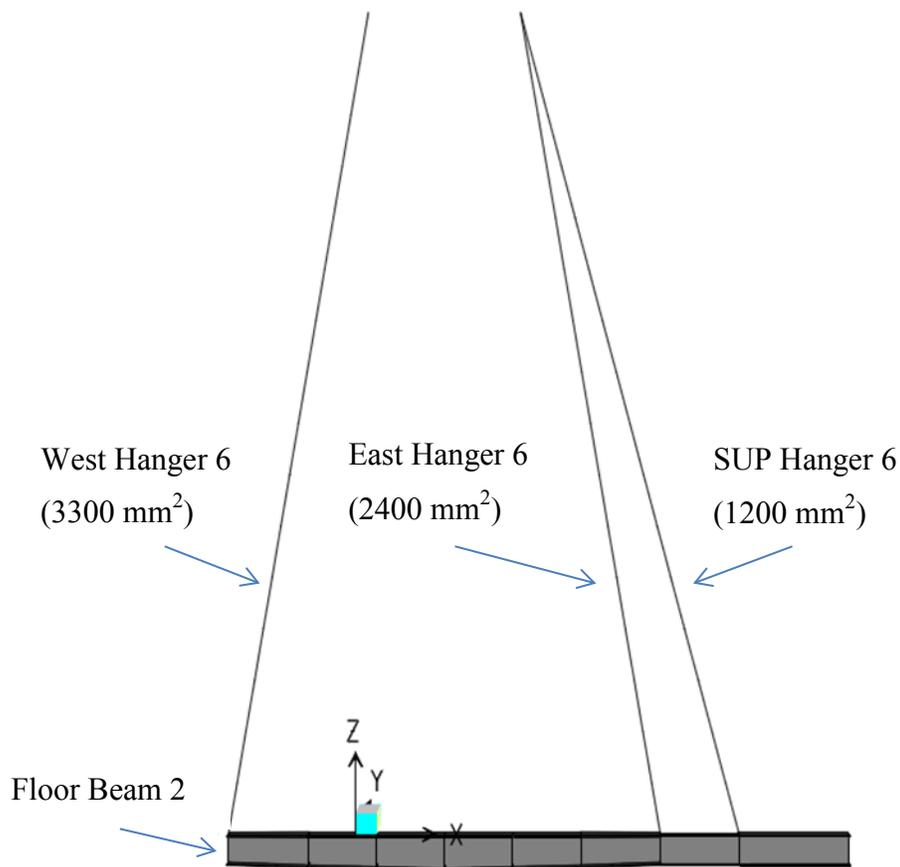
Figure C-1: Cross-Section at Hanger 6 Location

A simple structure was simulated under dead load analysis in order to investigate the effects of rigidity on the load carried by the cables. The structure has the same cross-sectional properties of the Walterdale Bridge deck at the “Hanger 6” location. The cross section was then analyzed under dead load and dead load + live load using a modulus of elasticity of 200 GPa and again simulating a fully rigid beam.

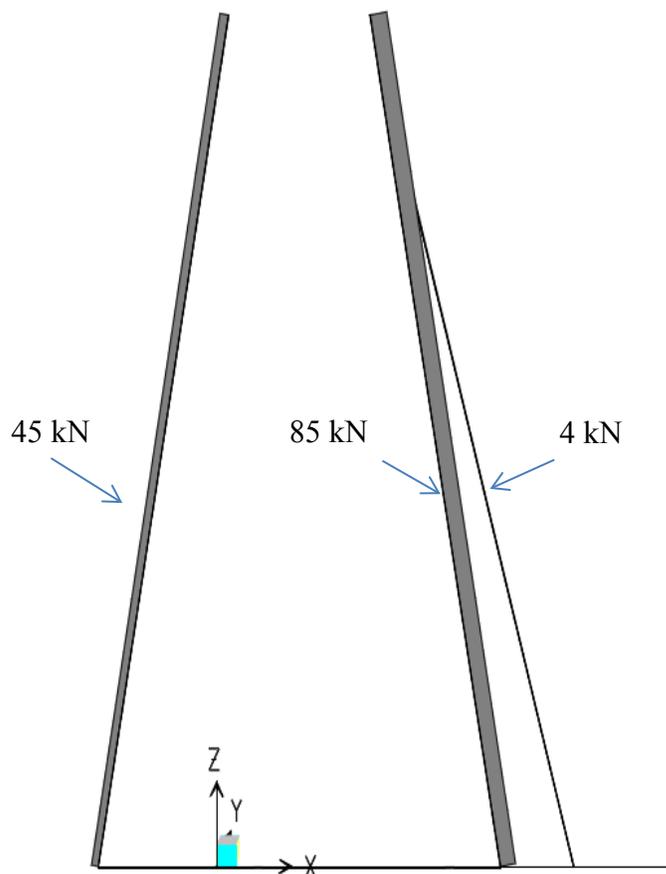
Figure C-2: Nonlinear Dead Load Analysis Results of 200 GPa Member

Under dead load only, the cables experience the axial forces as demonstrated below. From this, it is evident that the east hanger carries the largest amount of loading, since the deflected shape of the beam is an important factor in how the load is distributed.

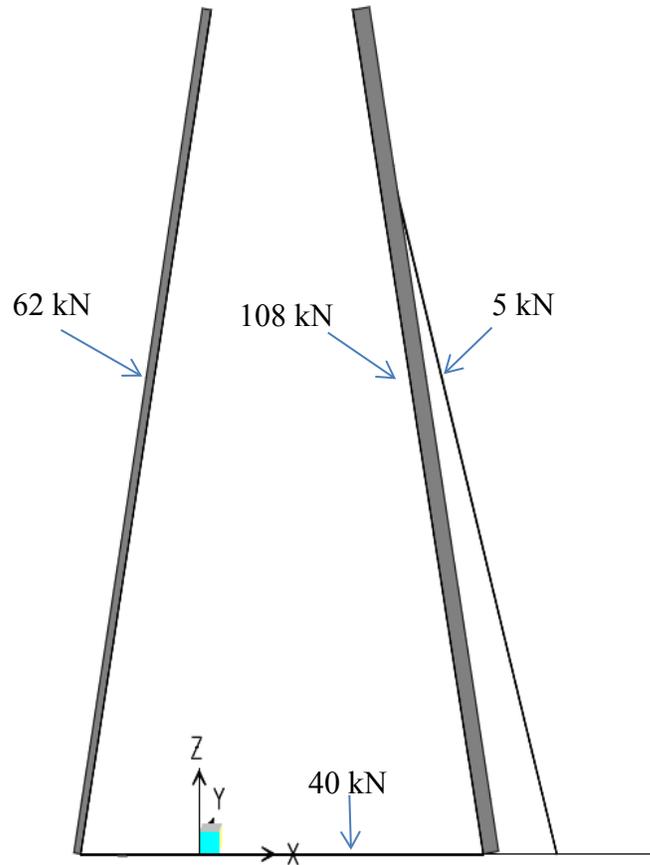
Figure C-3: Nonlinear Dead Load + Live Load Analysis Results of 200 GPa Member

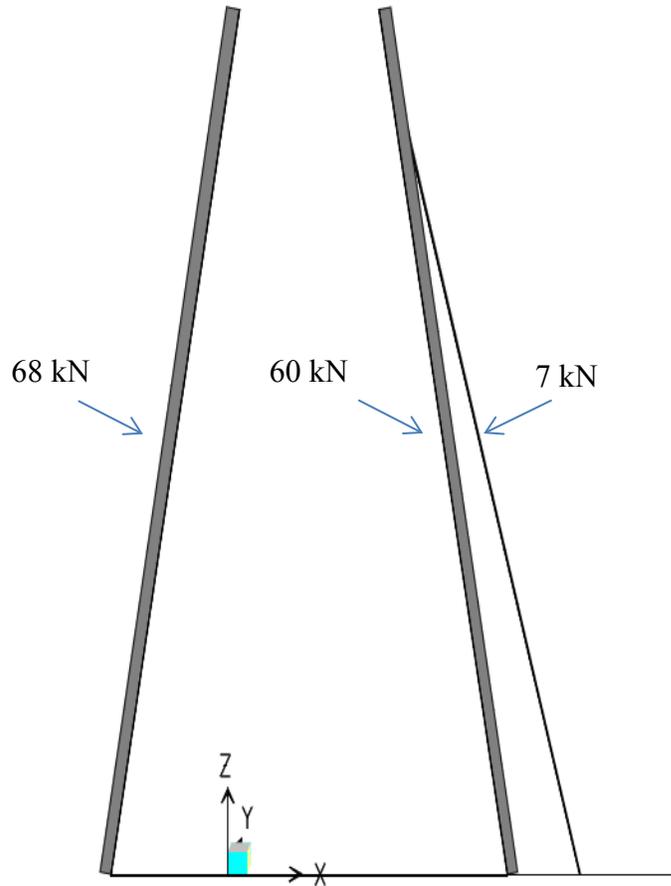
Figure C-4: Nonlinear Dead Load Analysis Results of Fully Rigid Member

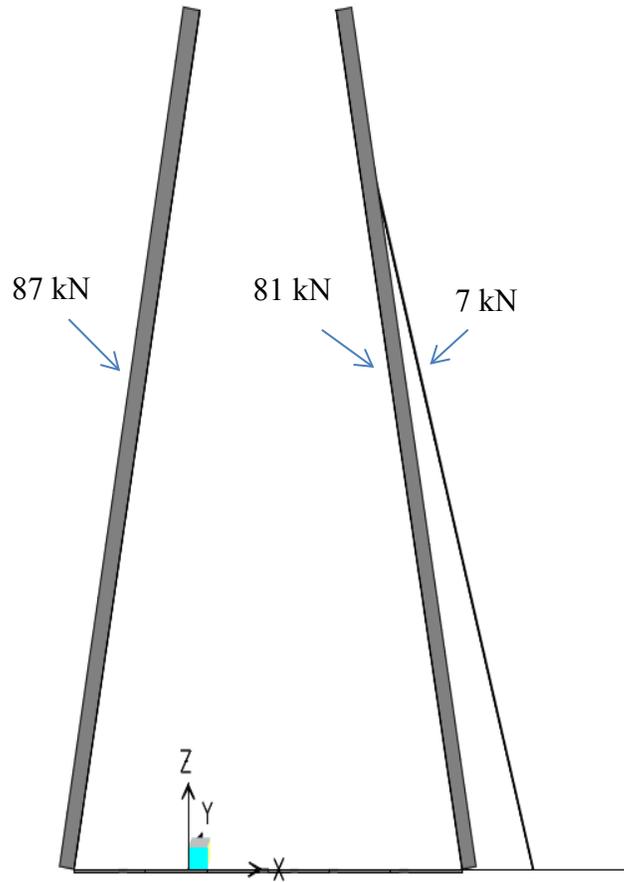
Figure C-5: Nonlinear Dead Load + Live Load Analysis Results of Fully Rigid Member

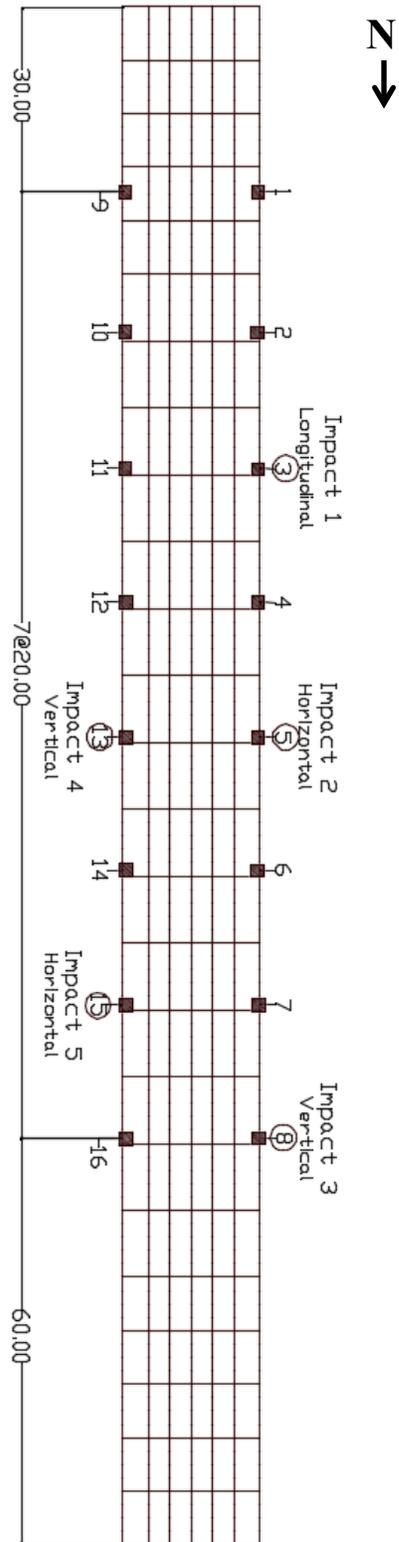
Figure D-1: Bridge Deck Top View of Layout Plan 1

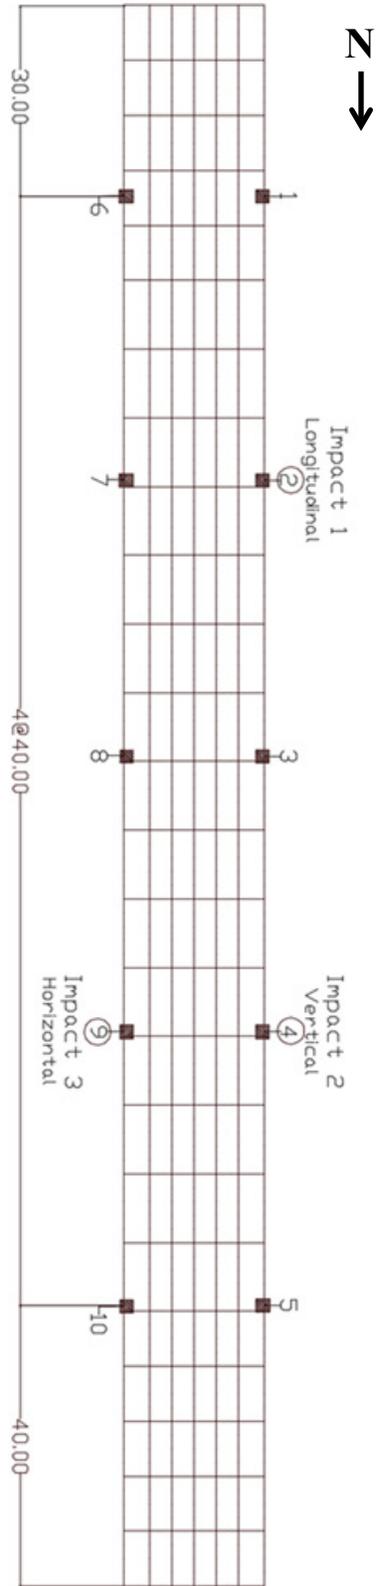
Figure D-2: Bridge Deck Top View of Layout Plan 2

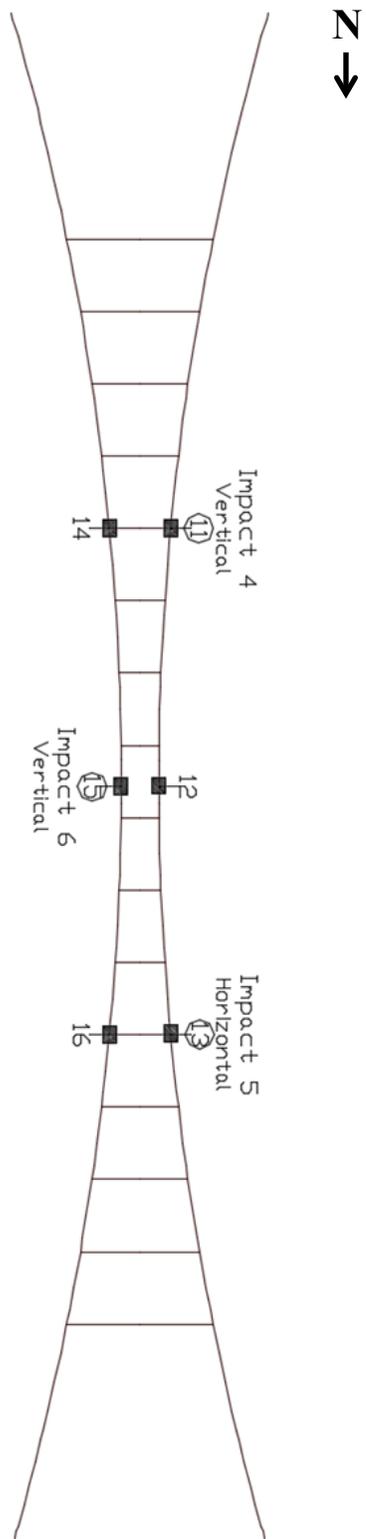
Figure D-3: Steel Arch Top View of Layout Plan 2

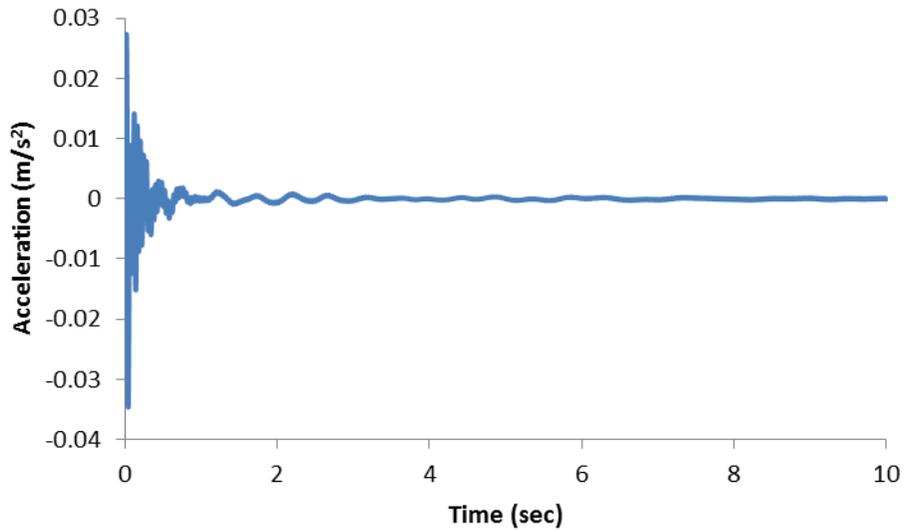
Figure E-1: Impact 1 Channel 6 - Vertical Acceleration

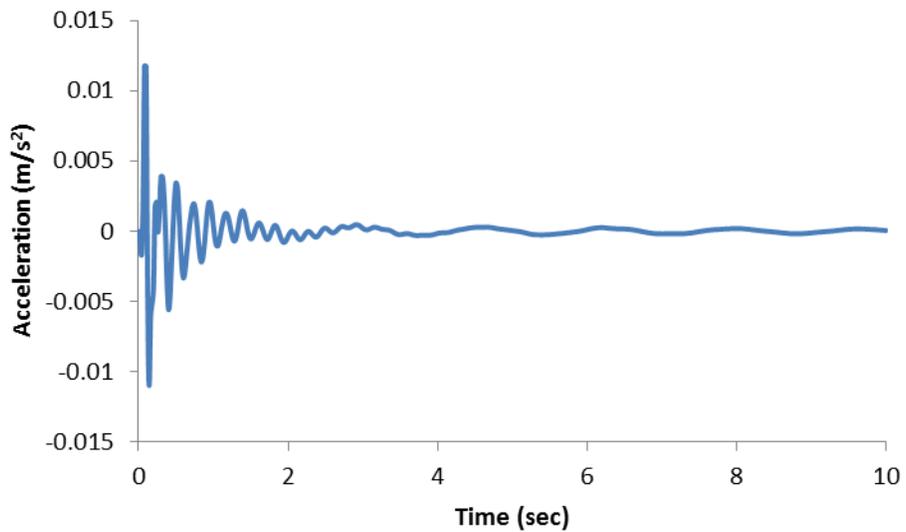
Figure E-2: Impact 1 Channel 56 - Horizontal Acceleration

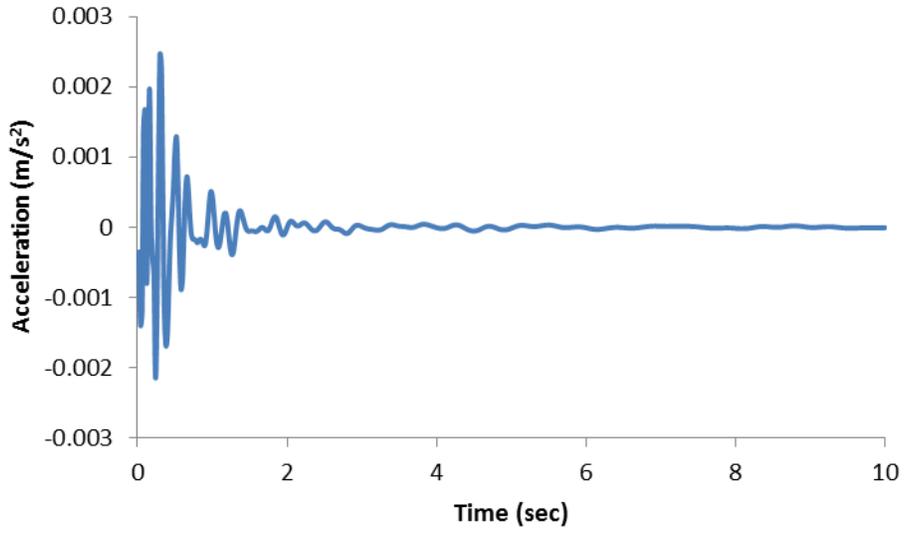
Figure E-3: Impact 1 Channel 88 - Longitudinal Acceleration
