Investigation and Analysis of the New Walterdale Bridge to Develop a Structural Health  
Monitoring System

Aimee De Laurentiis

Structural Engineering

University of Alberta

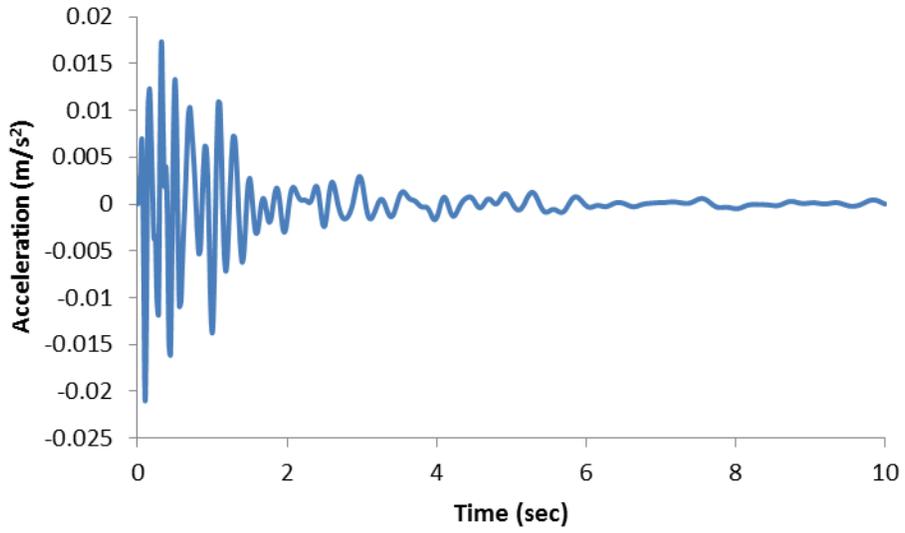
Figure E-4: Impact 2 Channel 28 - Vertical Acceleration

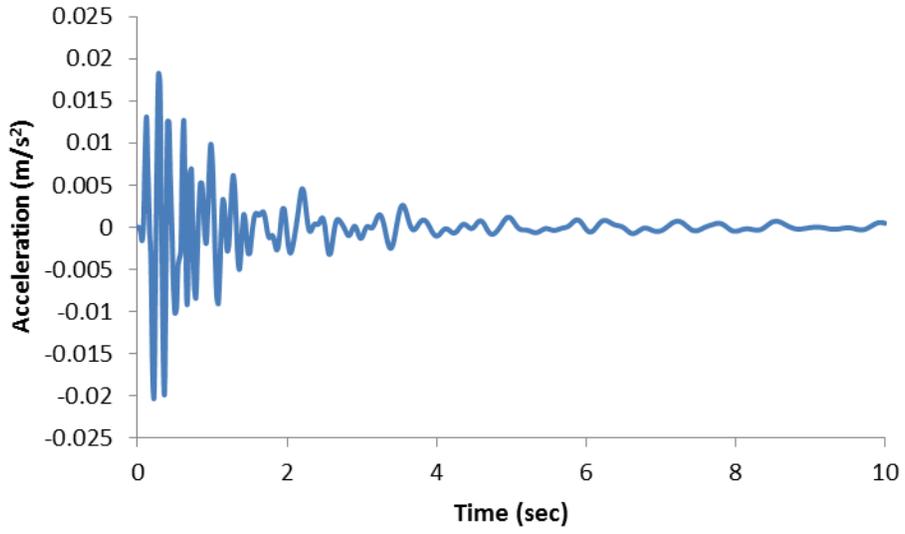
Figure E-5: Impact 3 Channel 20 - Vertical Acceleration

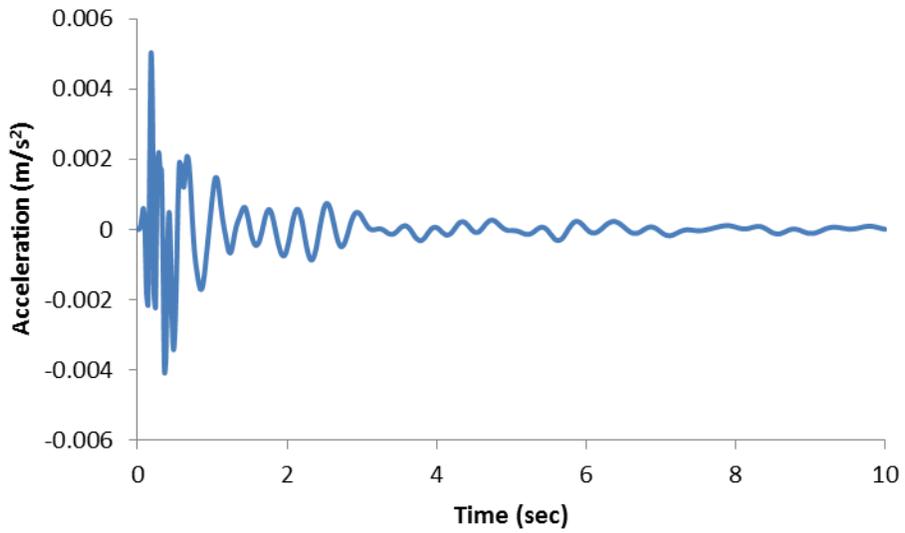
Figure E-6: Impact 4 Channel 65 - Horizontal Acceleration
