ICE JAM ANALYSIS, IN A COMPLEX REACH: A CASE STUDY

STEPHEN J. STANLEY

SUBMITTED TO THE FACULTY OF GRADUATE STUDIES AND RESEARCH IN PARTIAL
FULFILMENT OF THE REQUIREMENTS FOR THE DEGREE
OF MASTER OF SCIENCE

FALL, 1988

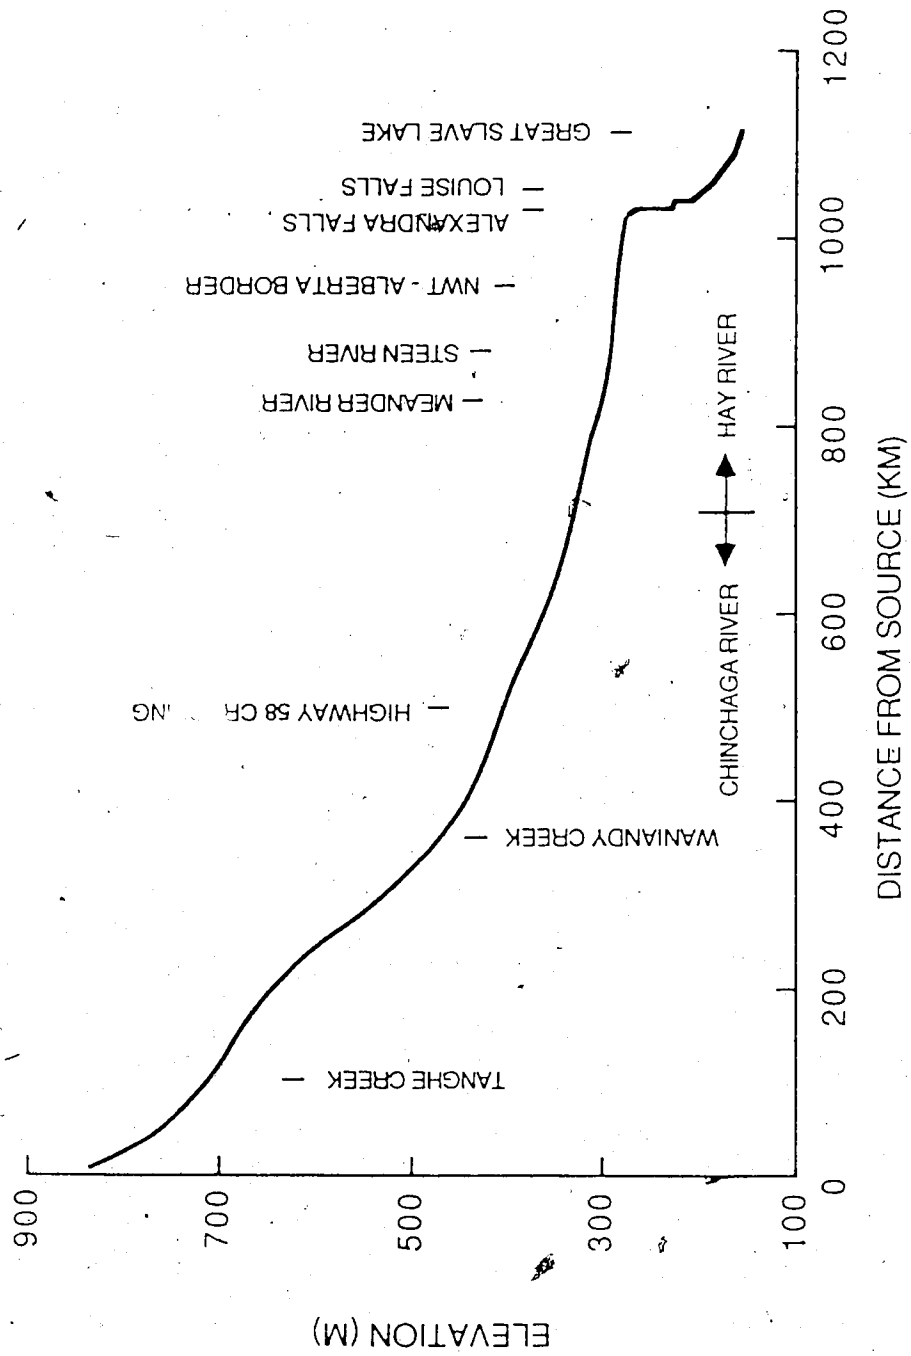
Figure 2.4 Profile of the Hay River.

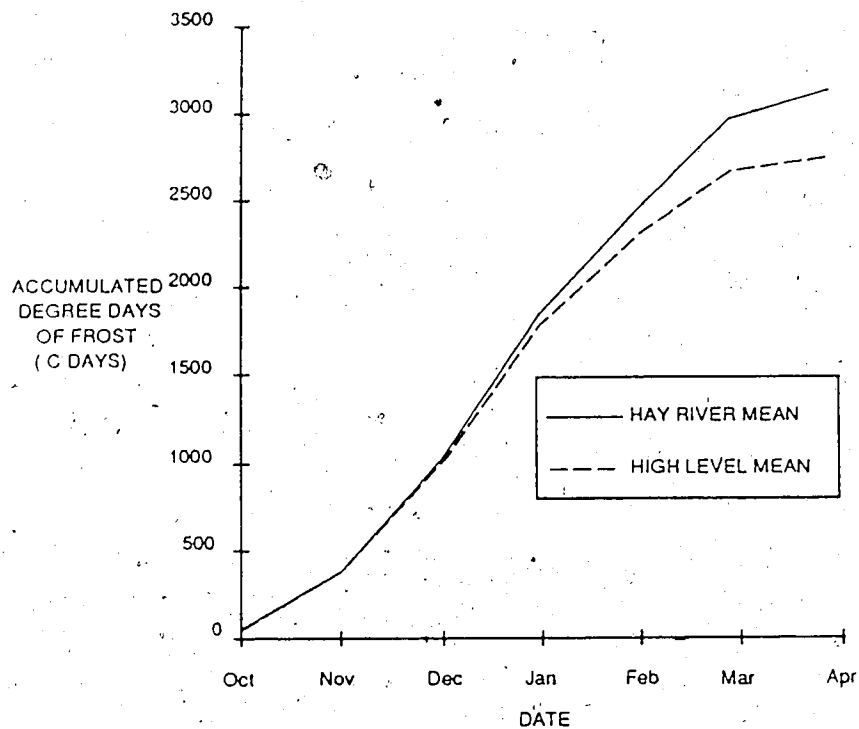
Figure 2.11 Average degree days of frost for the winter.

The basin climate is classified as boreal. As such it is characterized by long, severely cold winters and short cool summers. The yearly average temperature for the region is 1.3 °C. Monthly averages of mean daily temperatures at the Town of Hay River fall below 0 °C in October, reach a minimum of -21 °C in January and return to zero in April, giving an average of 3150 °C of frost over the winter. The average accumulation of degree days of frost for Hay River and High Level are presented in Figure 2.11.
