**FULL-SCALE INVESTIGATION OF CRACK GROWTH BEHAVIOUR UNDER VARIABLE
PRESSURE FLUCTUATIONS IN NEAR-NEUTRAL PH ENVIRONMENTS**

by
Joshua J. Knechtel

Master of Science
in
Materials Engineering

University of Alberta

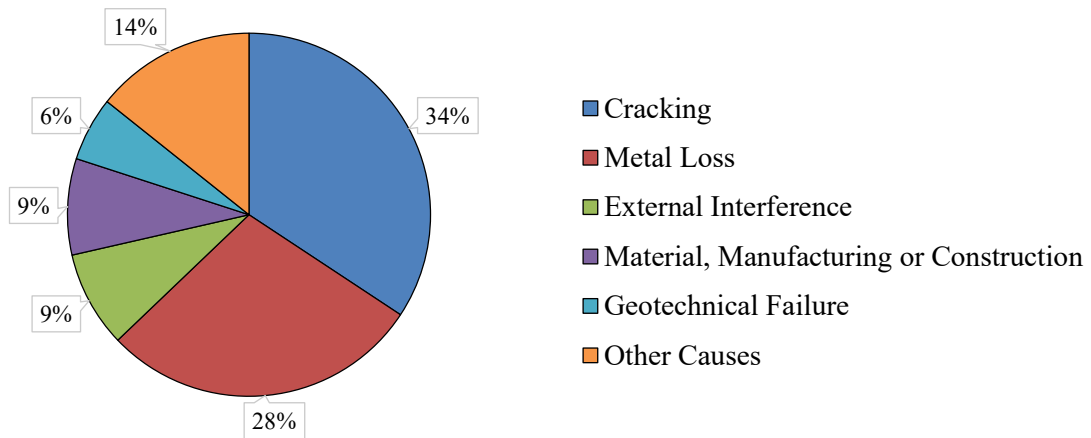
Figure 2.2 Distribution of the primary cause of CER-regulated pipeline ruptures from 1992 – 2012.

The Canadian Energy Regulator (CER), formally known as the National Energy Regulator (NEB), mandates that regulated Oil and Gas companies falling under the CER’s jurisdiction must follow the Event Reporting Guidelines. The most severe incidents fall into the immediately reportable events category. This category includes incidents that harm people or the environment, ruptures or toxic plumes. A pipeline rupture is defined by the CER as “an instantaneous release that immediately impacts the operation of a pipeline segment such that the pressure of the segment cannot be maintained” [17]. The primary causes of CER-regulated pipeline reportable ruptures from 1992 – 2012 were cracking (34 %) and metal loss (28 %) [18]. A distribution of the total primary causes of rupture failure of CER-regulated pipelines is shown in **Figure 2.2**.

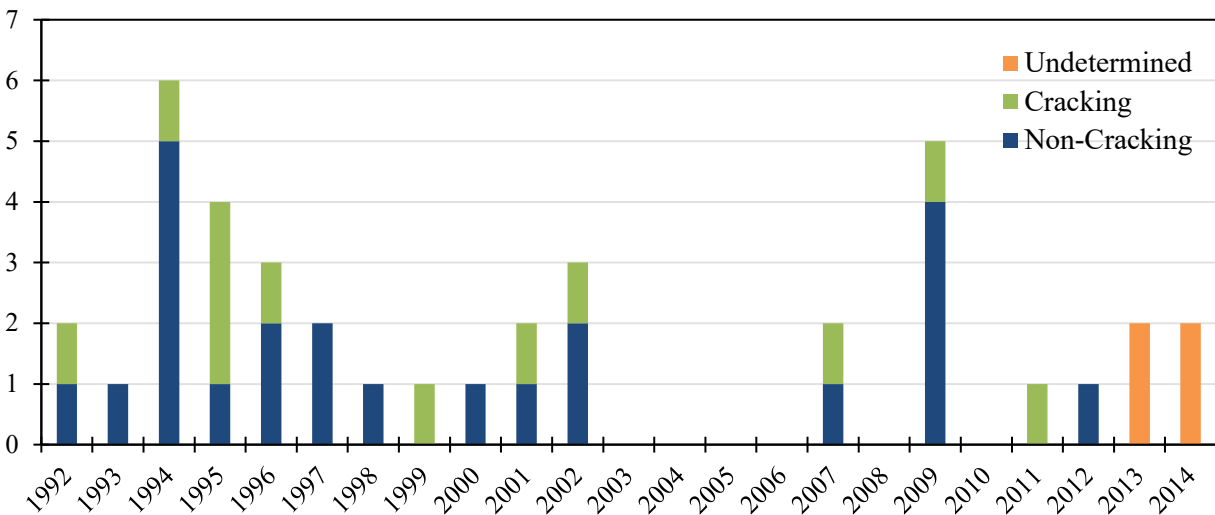
Figure 2.3 Number of ruptures on CER-regulated pipelines from 1992 – 2014.

Cracking is the primary cause of rupture for CER-regulated pipelines and is a major concern for Oil and Gas operators and **Figure 2.3** shows the occurrence of these ruptures. The sub-causes of cracking are hydrogen induced cracking (HIC), fatigue and stress corrosion cracking (SCC). There has been a gradual decline in annual ruptures since 1994 (except for 2009), which can be attributed to the mandated development of pipeline integrity and mitigation programs that Oil and Gas operators must meet [18]. For example, the Canadian Energy Pipeline Association (CEPA) has published a recommended practice for SCC management. Within this document is a series of investigative methods that can be used to develop an SCC investigative program. The three methods of detection that will be discussed are hydrostatic testing, in-line inspection and direct assessment.

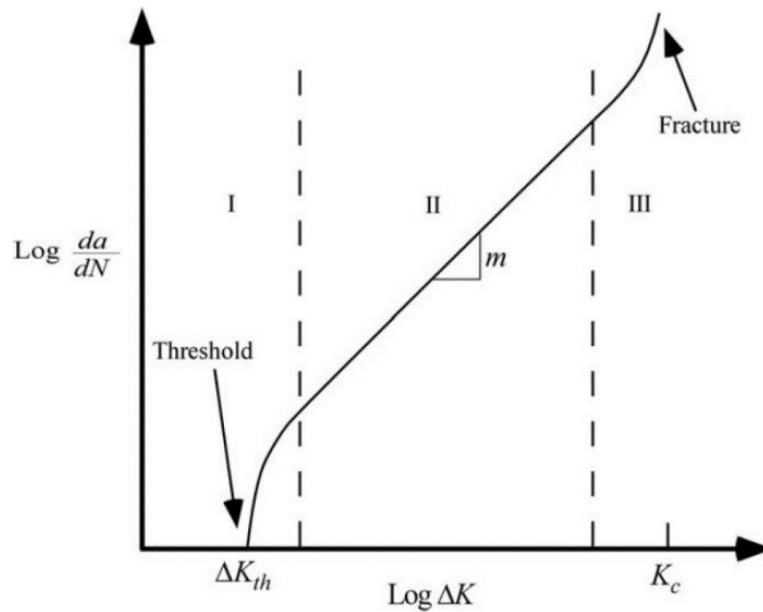
Figure 2.4 Typical fatigue crack growth in metals [32].

(**Figure 2.4**) of the crack growth rate per cycle as a function of the stress intensity factor range, ΔK ($\Delta K = K_{\max} - K_{\min}$).

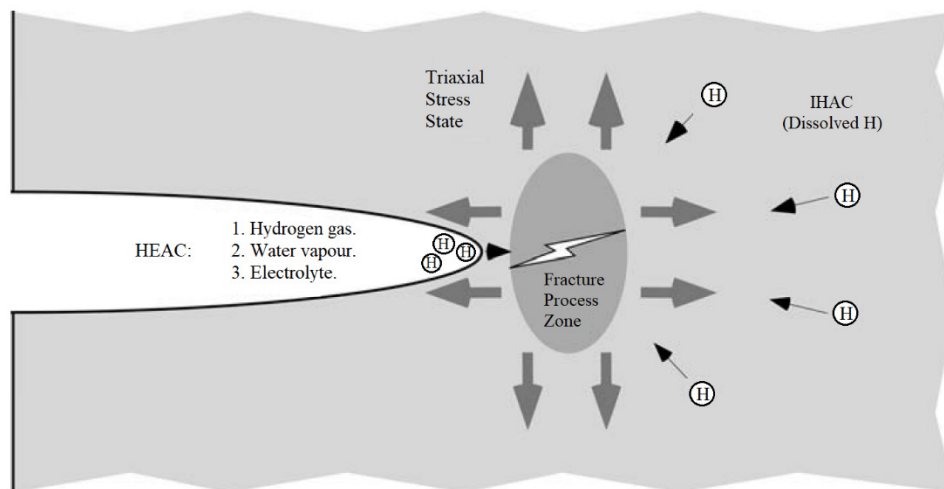
Figure 2.5 Schematic showing the two forms of hydrogen assisted cracking: hydrogen environment-assisted cracking (HEAC) and internal hydrogen-assisted cracking (IHAC) [32].

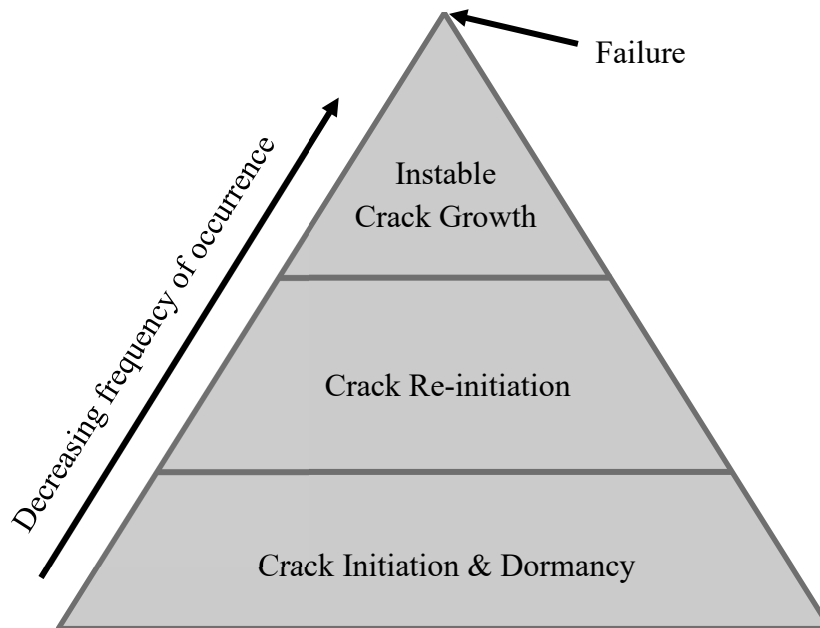
Figure 2.6 The frequency of occurrence of SCC lifecycle events [5]. Crack initiation and subsequent dormancy is the most common occurrence. Next, a fraction of the cracks will re-initiate after a period of dormancy. Finally, of the re-initiated cracks, one will enter the instable growth phase leading to failure.

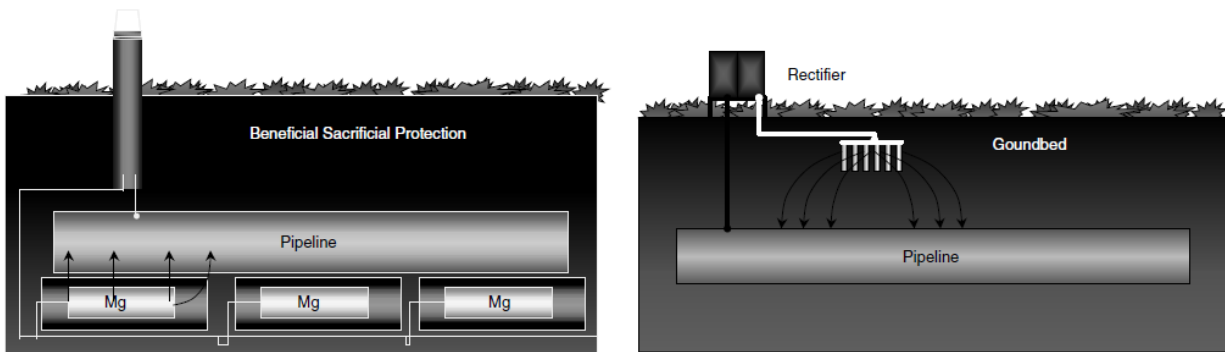
Figure 2.7 (Left) a sacrificial anode CP system with distributed magnesium anodes and an above-ground test station and (right) an impressed current CP system with an above-ground rectifier and a single remote anode ground bed [52].

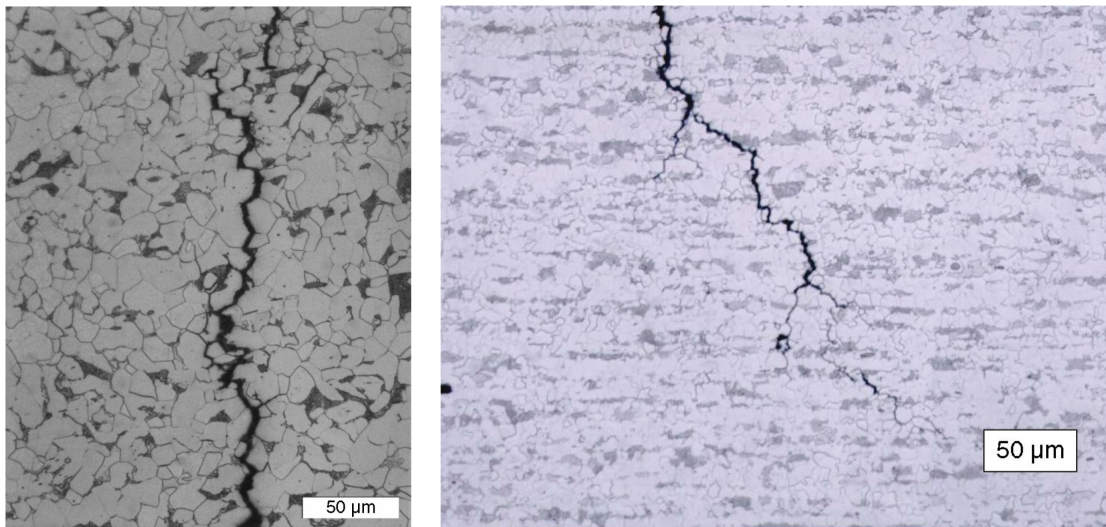
Figure 2.8 Cross sectional images of High *pH* stress corrosion cracks in a gas transmission pipeline [55].

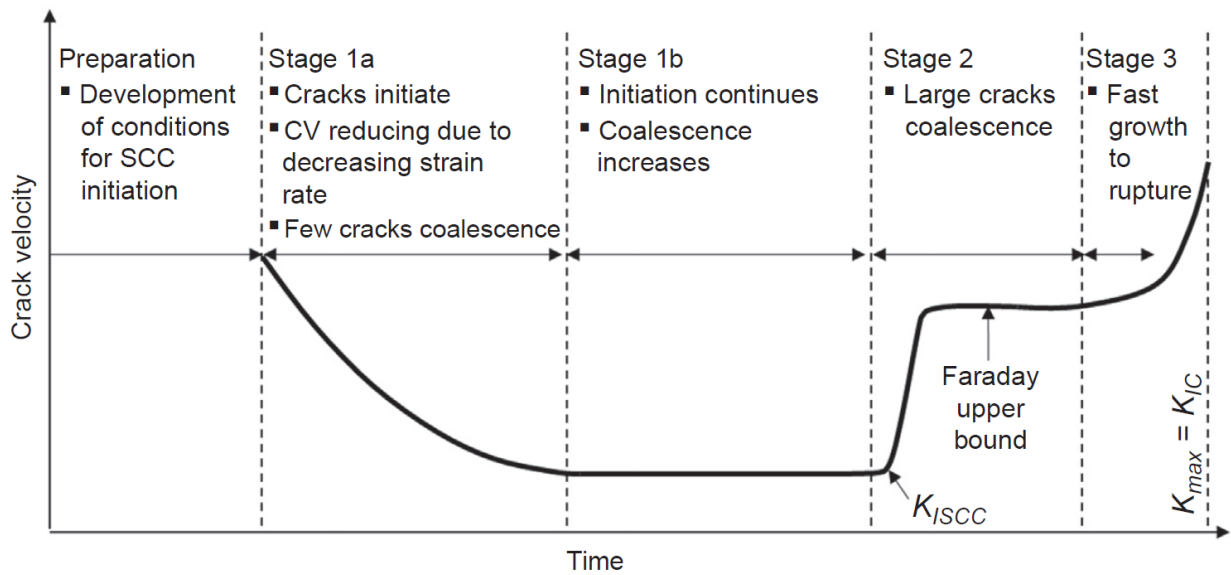
Figure 2.9 Visual representation of the stages of SCC growth during the lifetime of a pipeline failure [65, 66].

The three stages of HpHSCC growth are often described by the bathtub model (**Figure 2.9**) proposed by Parkins [65, 66], where the crack velocity is plotted as a function of time. Prior to initiation, the conditions of SCC must be met. This usually involves pitting, and development of an aggressive chemical environment. Crack initiation (Stage 1) can be divided into two sections with respect to crack growth: (a) initiation by grain boundary selective dissolution [67] and (b) continuous initiation and microcrack coalescence. Pipeline steel spends most of its lifetime in Stage 1 SCC. Eventually, a threshold stress intensity value that will allow SCC (K_{ISCC}) is reached, and Stage 2 rapid growth begins. Finally, when the crack dimensions become severe, accelerated crack growth (Stage 3) begins, leading to abrupt failure. Stage 3 has little engineering significance as it cannot be controlled; pipelines should be replaced prior to reaching Stage 3 crack growth. The other form of SCC will be discussed in the following section.

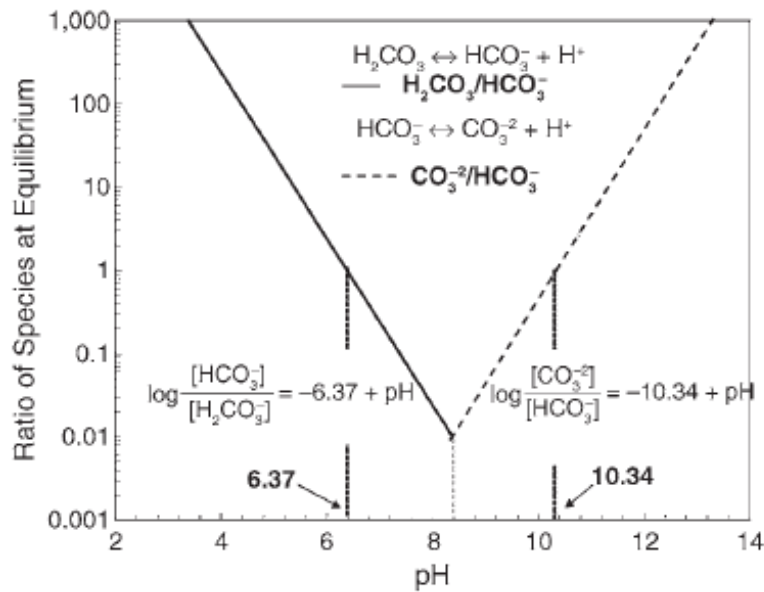
Figure 2.10 Calculated equilibrium constant values as a function of the ratio of species at equilibrium and [70].

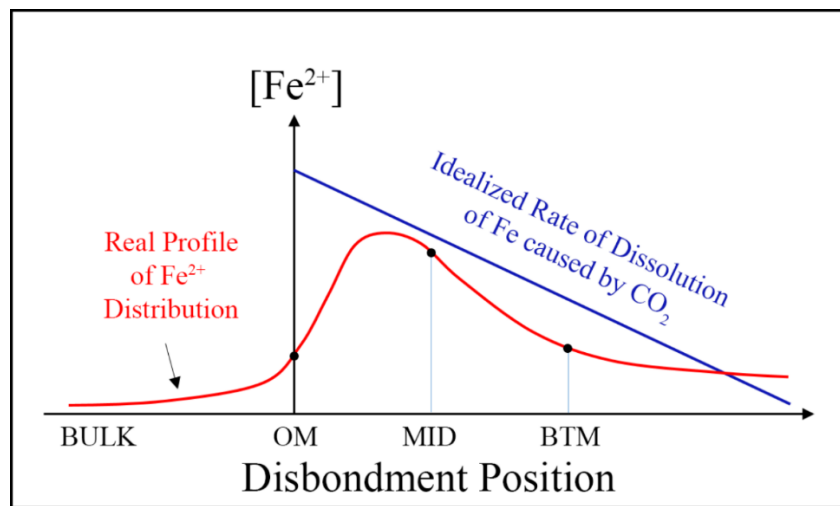
Figure 2.11 Iron distribution at various points of the coating disbondment within a corrosion cell [72].

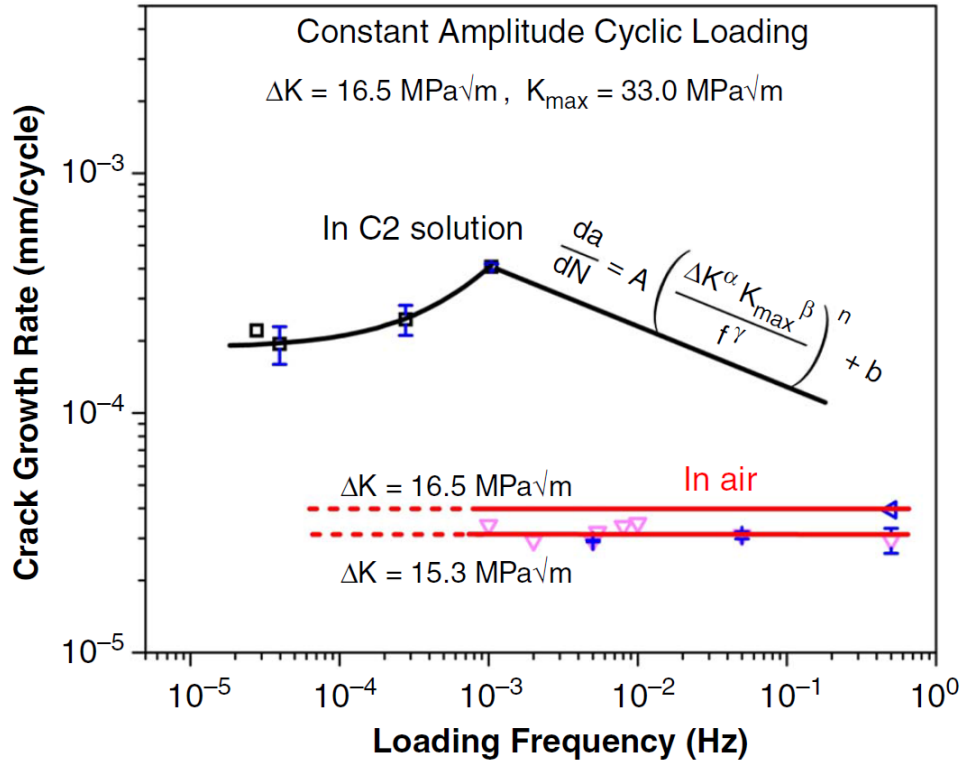
Figure 2.12 Crack growth rate as a function of the loading frequency of constant amplitude cyclic loading of CT specimens in C2 solution and in air [77].

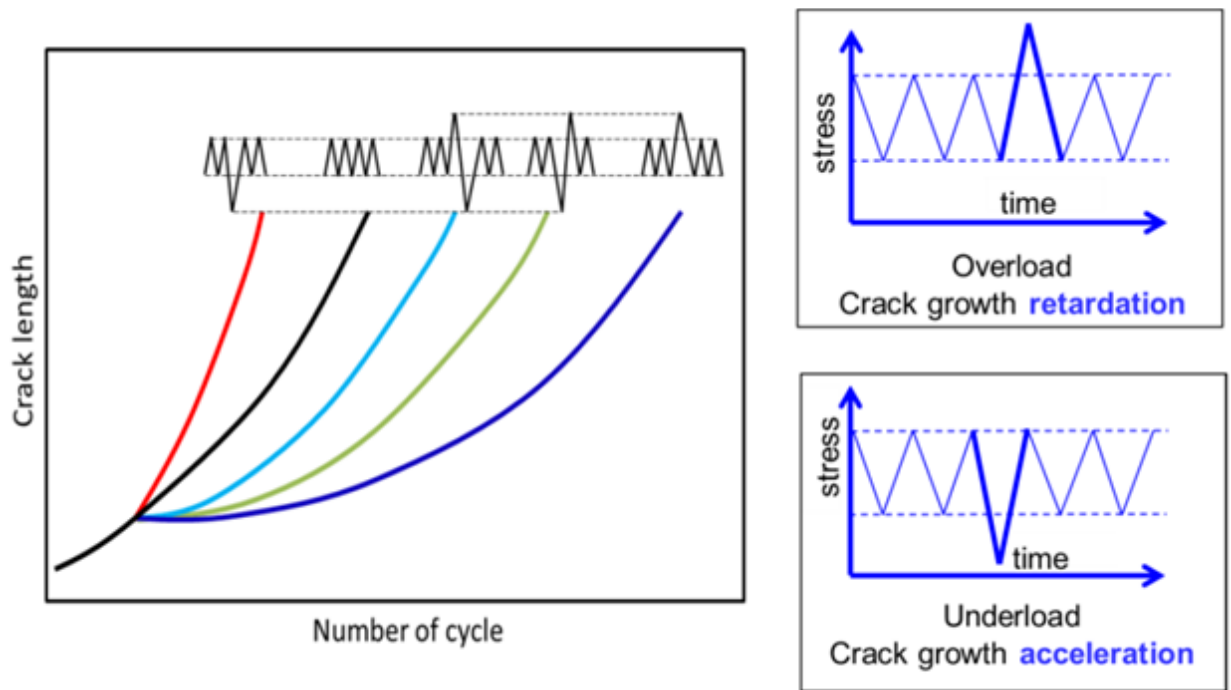
Figure 2.14 Generalized crack growth behaviour of various combinations of Type I and III pressure fluctuations, compared to the crack growth contribution of the minor cycles [79].

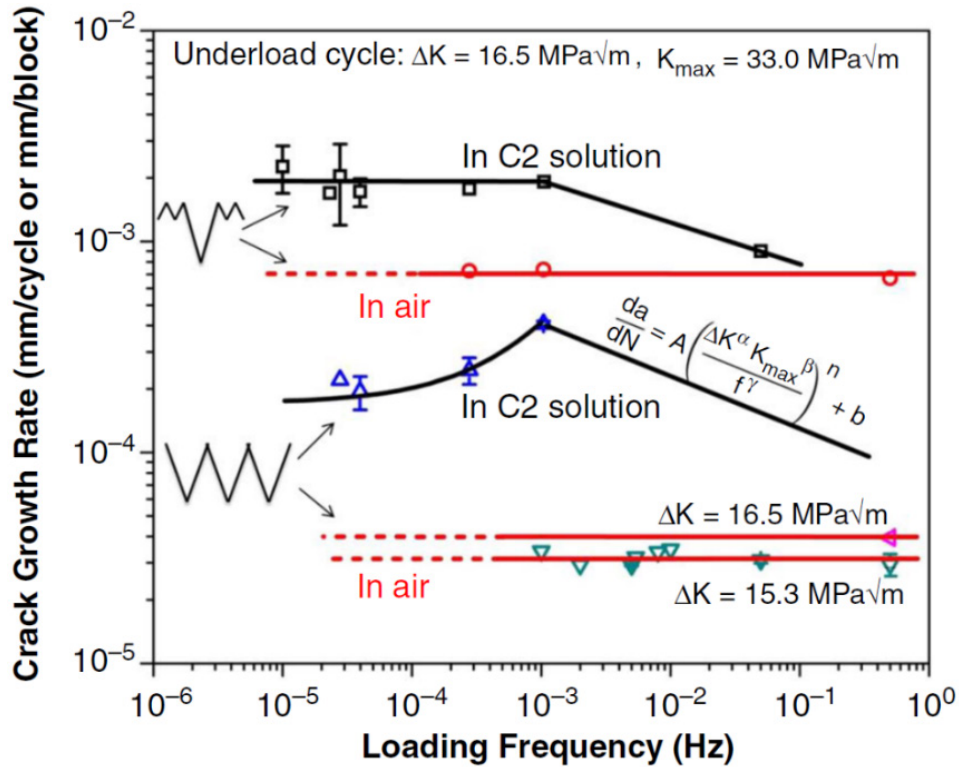
Figure 2.15 CT specimen crack growth rate of Type I and Type II fluctuations in C2 solution and in air over a variety of underload frequencies [77].

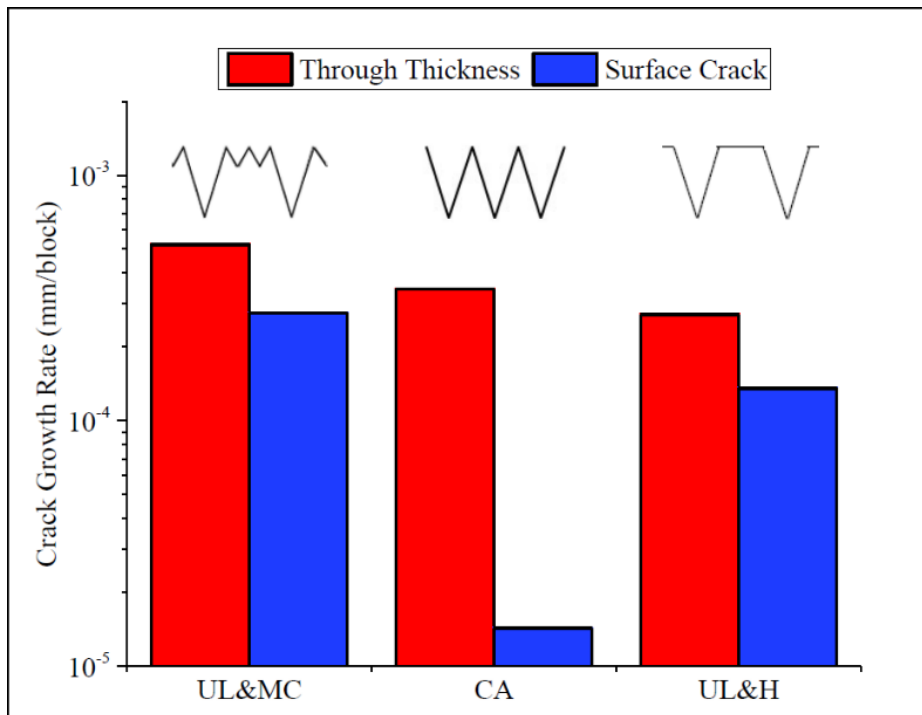
Figure 2.16 Log plot of the crack growth rate of CT [42] (red) and SCT [72] (blue) specimens under three loading conditions: (left) underload and minor cycle, (center) constant amplitude and (right) underload and hold.

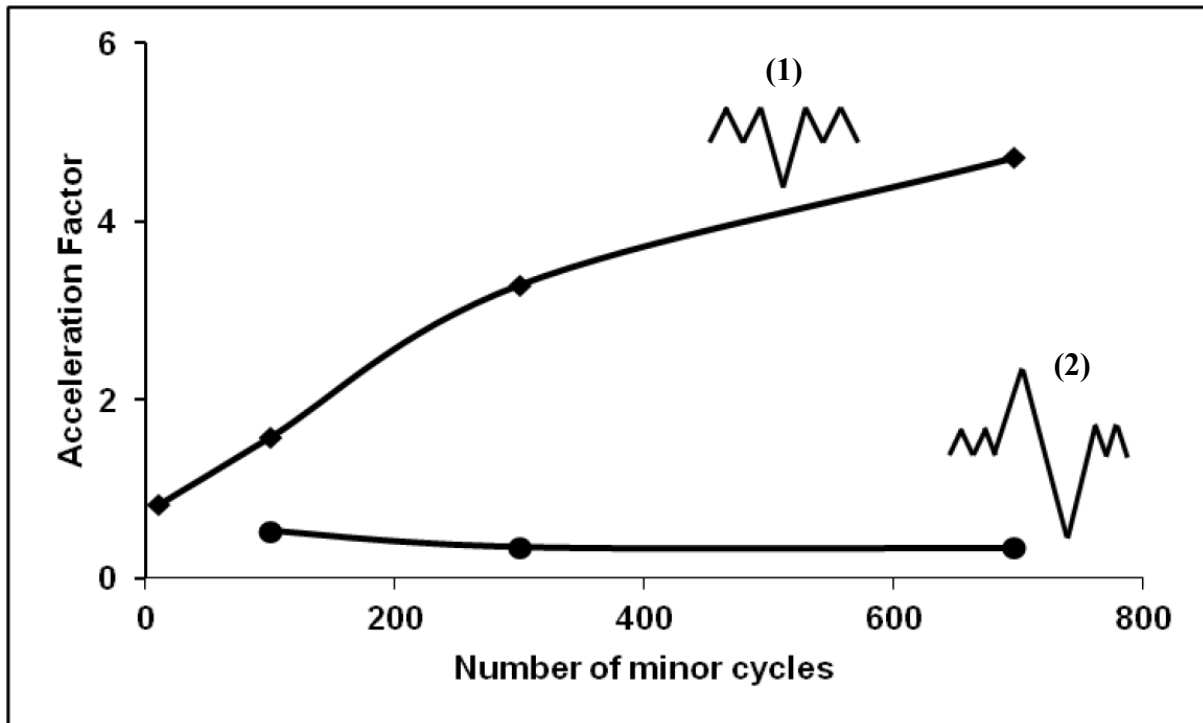
Figure 2.17 CT specimen crack growth rate showing the effect of the number of minor cycles on Type I fluctuation crack growth (1) and overload preceding underload fluctuation crack growth (2) [88].

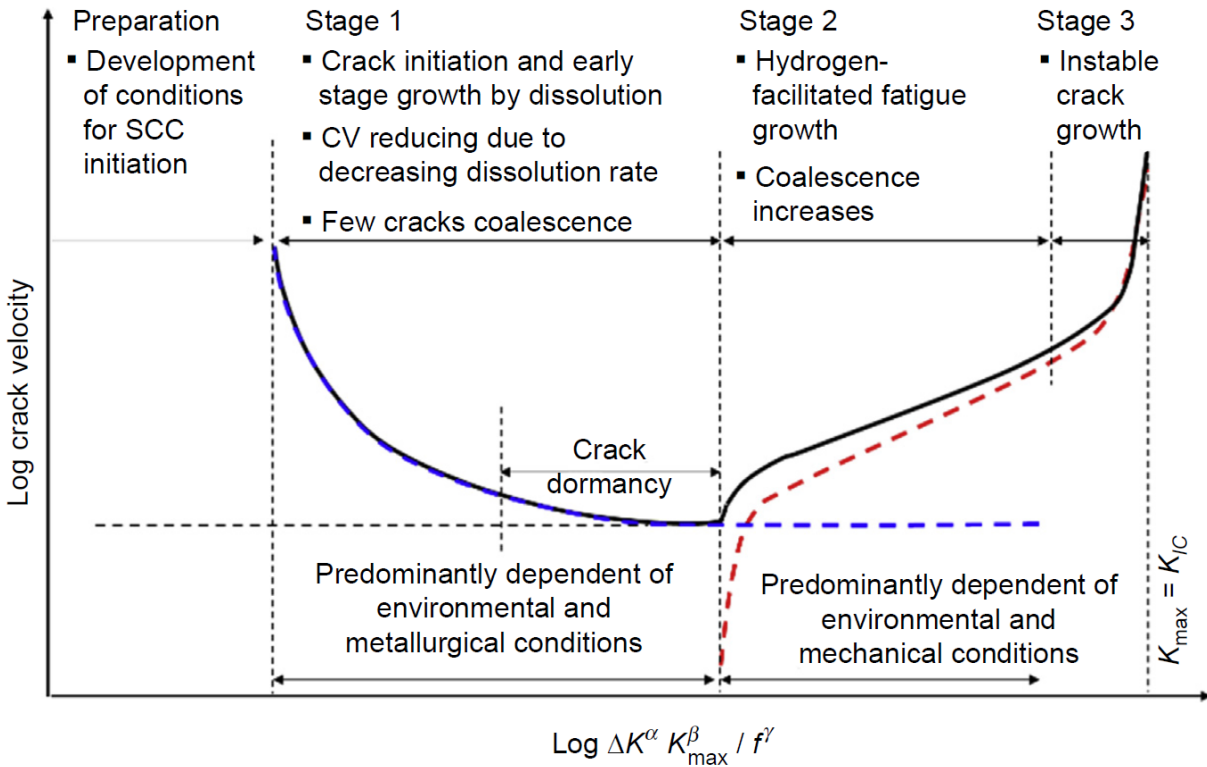
Figure 2.18 Schematic illustration of the effect of the combined factor upon SCC growth in pipeline steel exposed to NNpH solution [6].

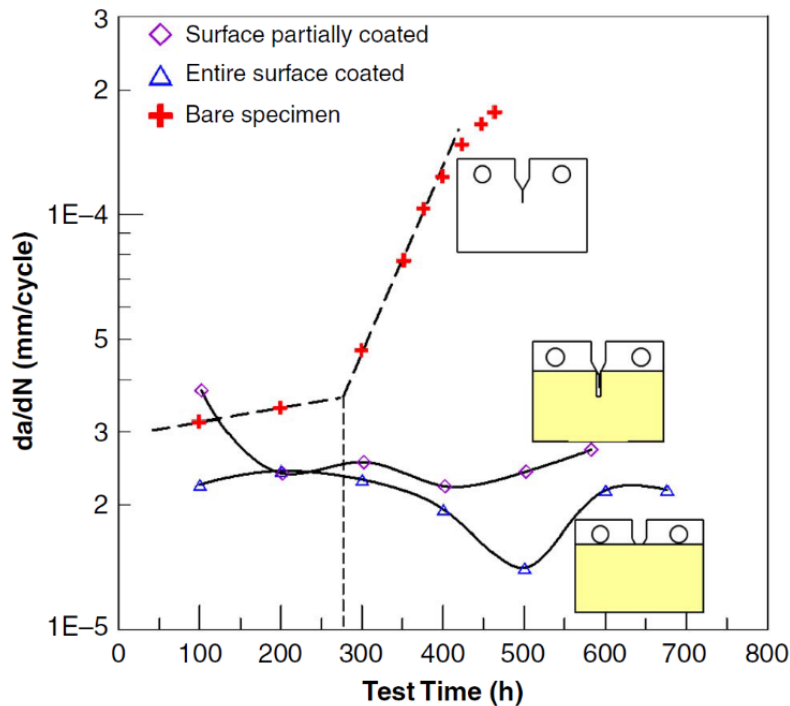
Figure 2.20 Crack growth rates of three CT specimens tested in C2 solution. All the tests were performed at the same starting conditions [86].

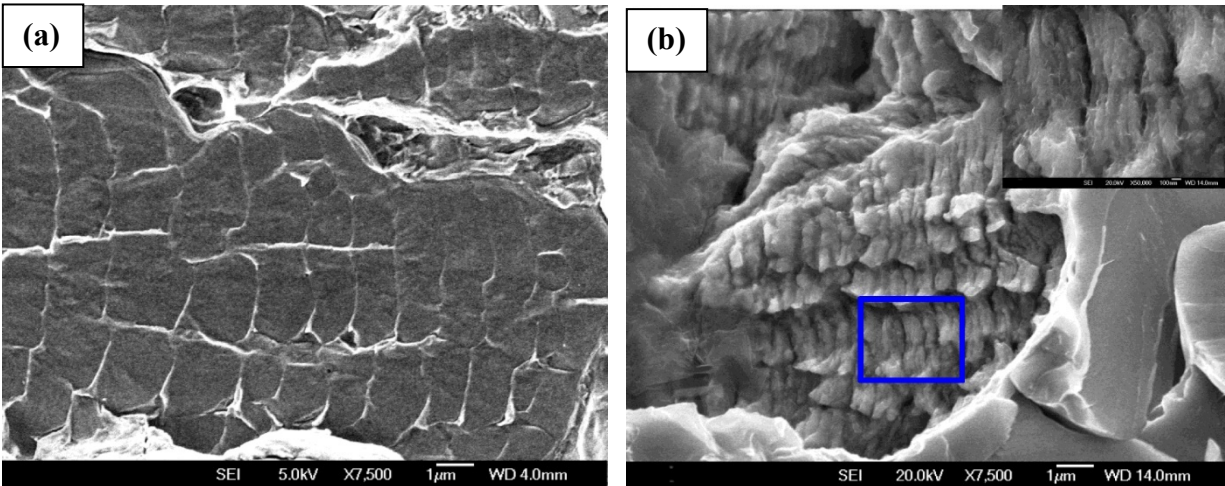
Figure 2.21 Fracture surface morphology of X-60 pipeline steel CT specimens after testing in C2 solution subjected to constant amplitude loading (a) and underload with minor cycle loading (b). Crack propagation is from left to right [42].

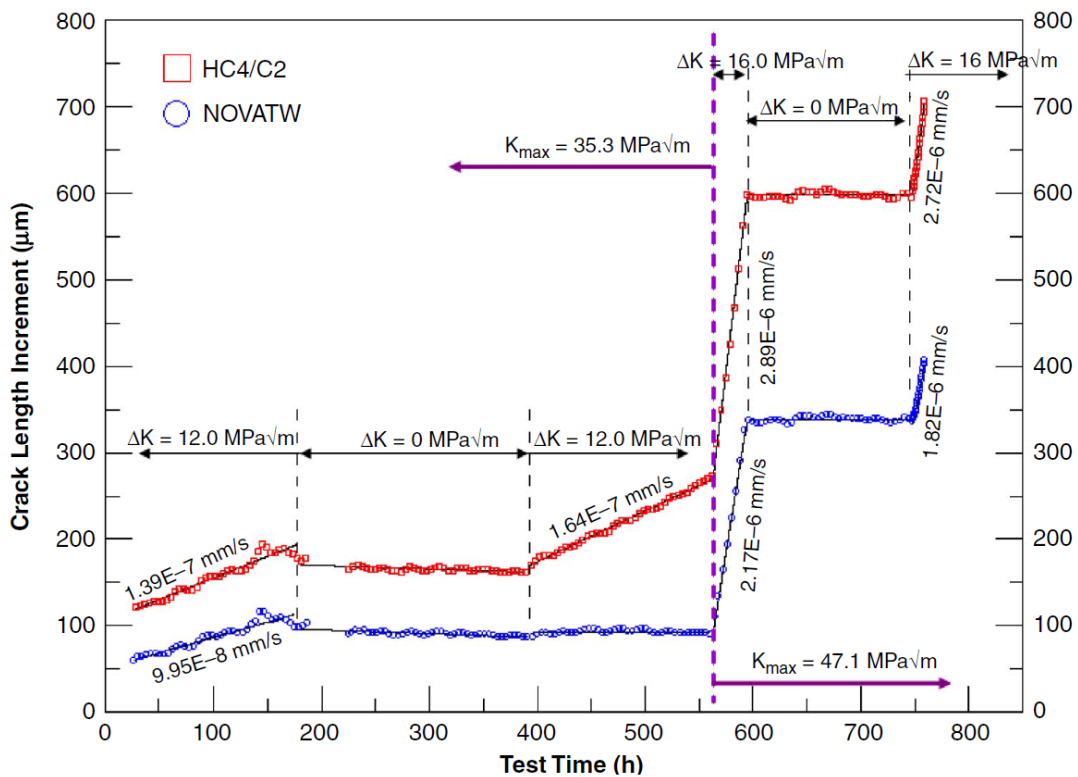
Figure 2.22 CT specimen crack growth rates in two laboratory simulated NNpH environments [86].

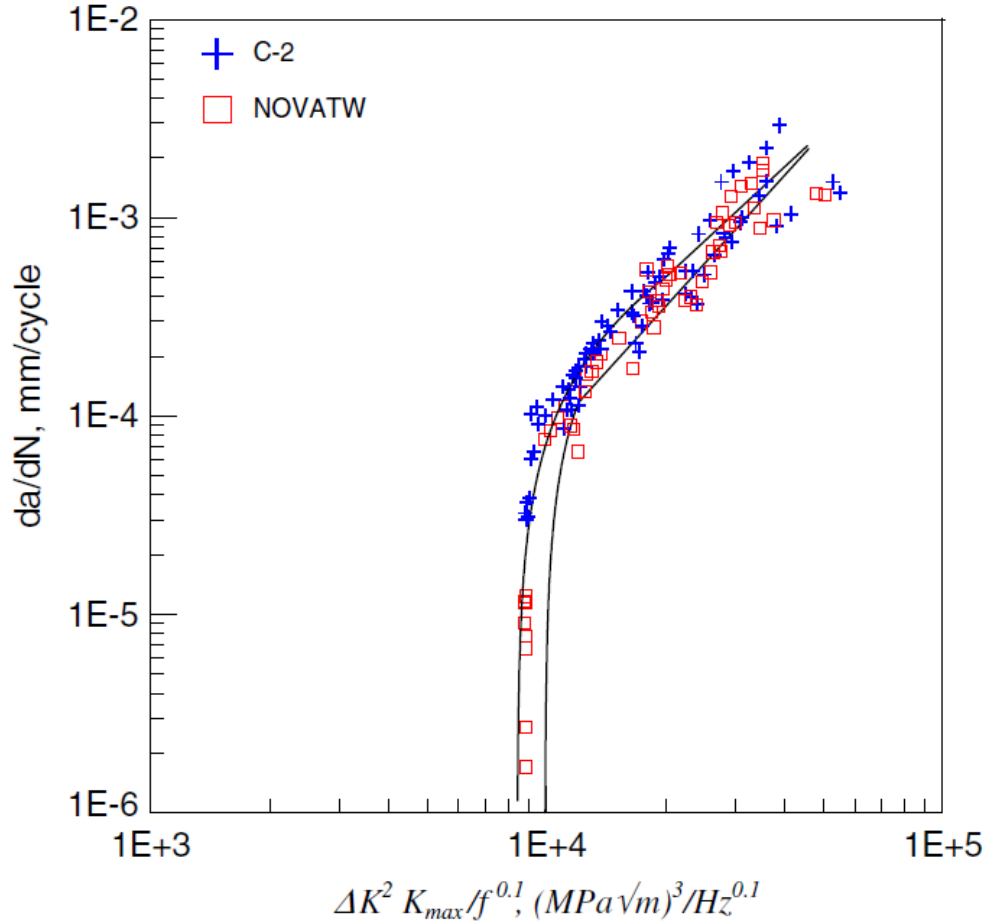
Figure 2.23 Comparison of CT specimen crack growth rate da/dN as a function of the combined factor $\Delta K^2 K_{max}/f^{0.1}$, showing the threshold for crack growth in two different NNpH solutions [85].

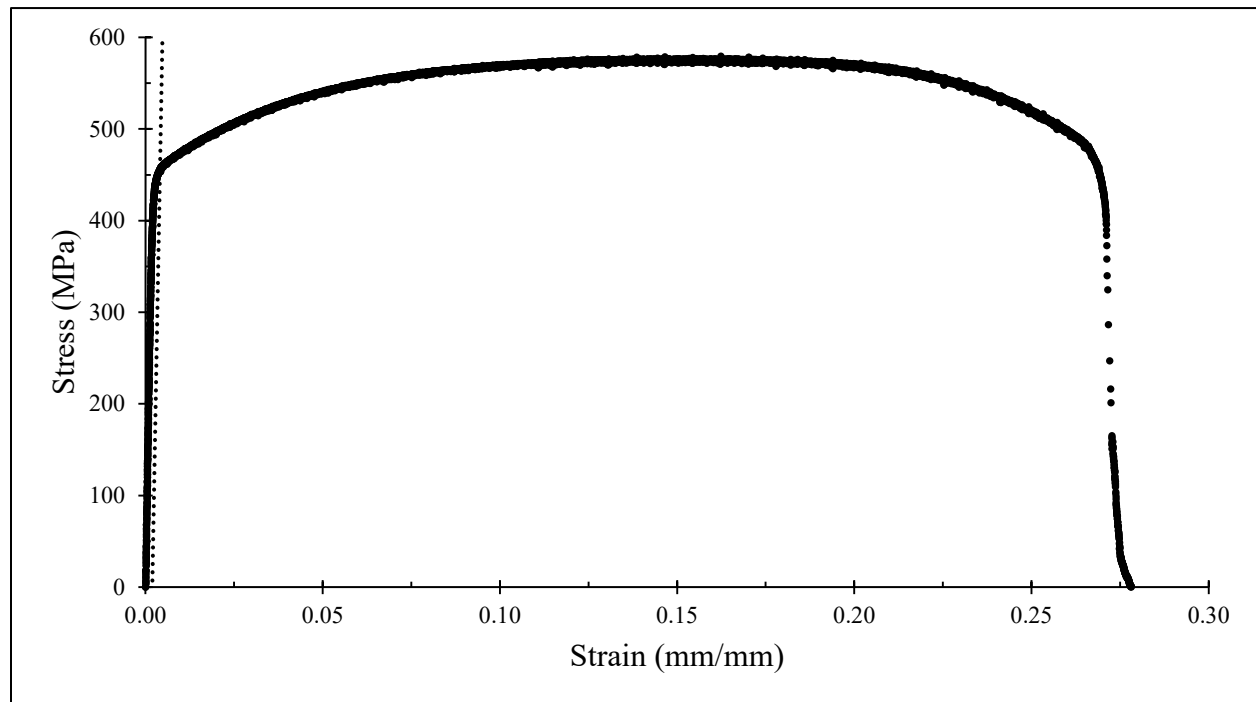
Figure 3.1 The stress-strain curve of the X-60 pipeline steel used for the full-scale test.

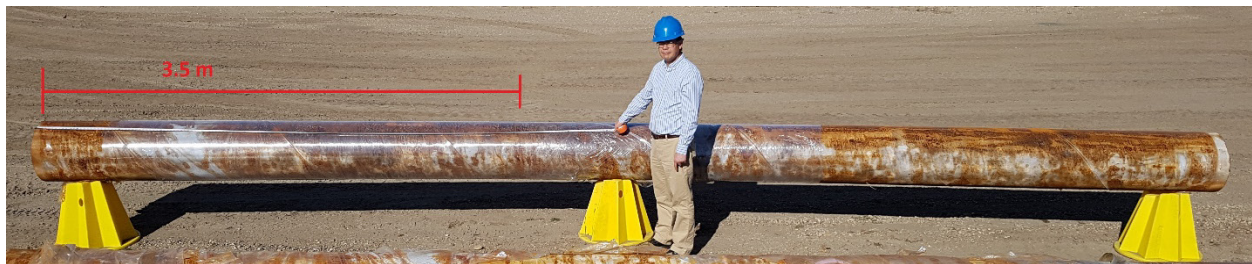
Figure 3.2 Image of the pipe that was designated for testing, taken before it was cut down to the full-scale specimen length showing the external surface condition.

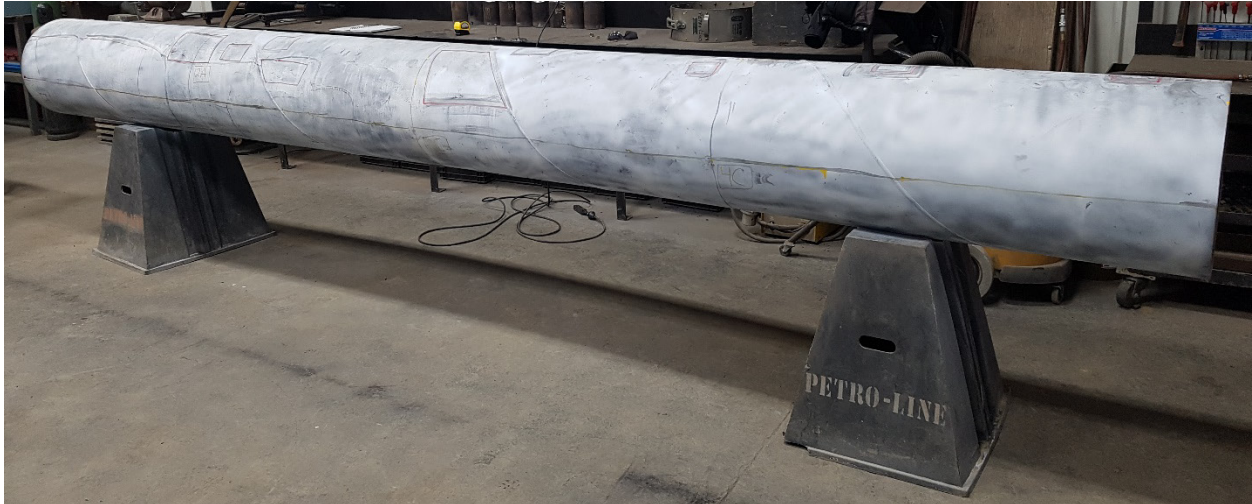
Figure 3.3 4.77 m pipe segment after pre-test MPI, with SCC colony borders drawn in red.

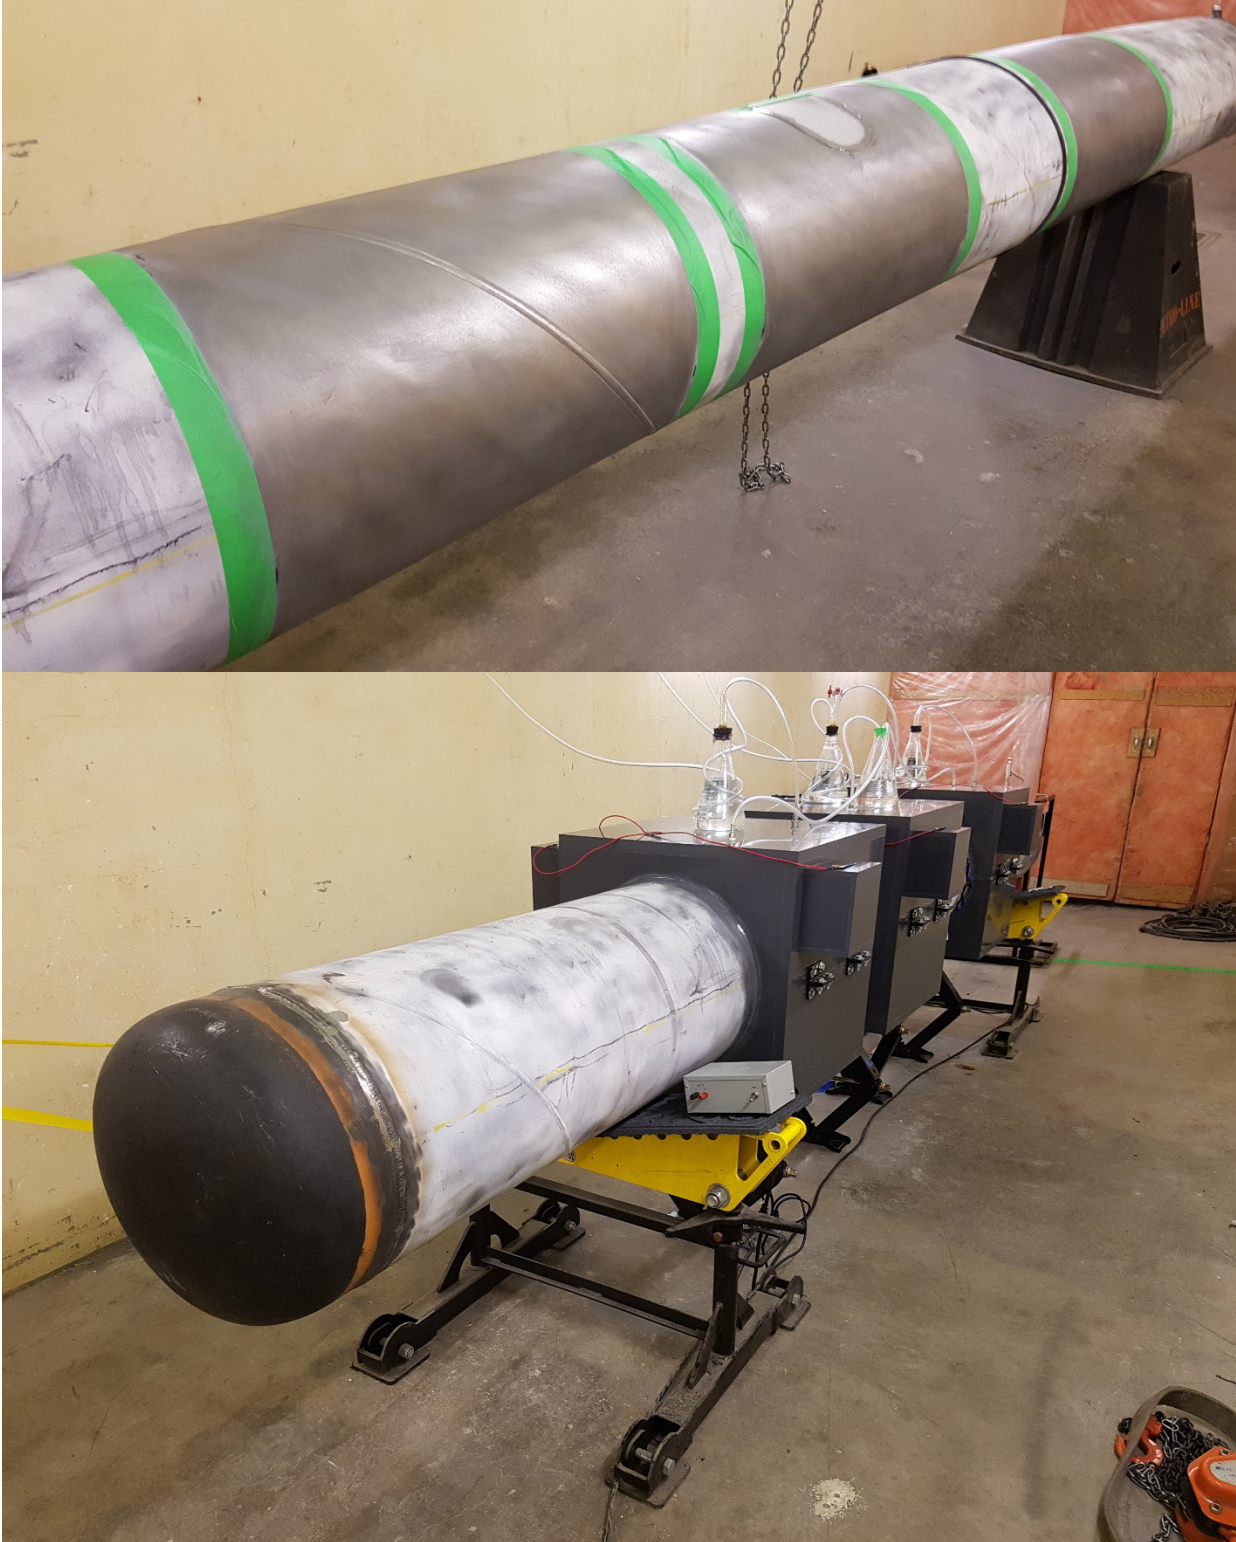
Figure 3.4 (Top) final metal surface preparation of selected areas of the pipe segment and (bottom) pipe segment during live testing.

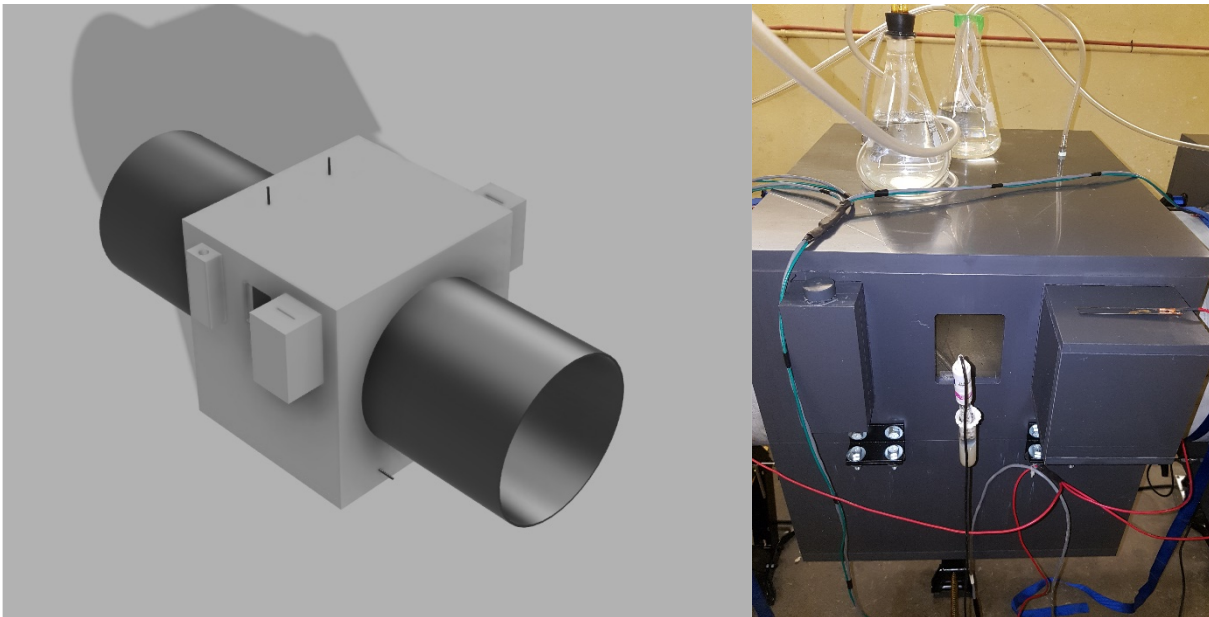
Figure 3.5 (Left) computer rendered drawing of the corrosion cell and (right) the actual corrosion cell in use.

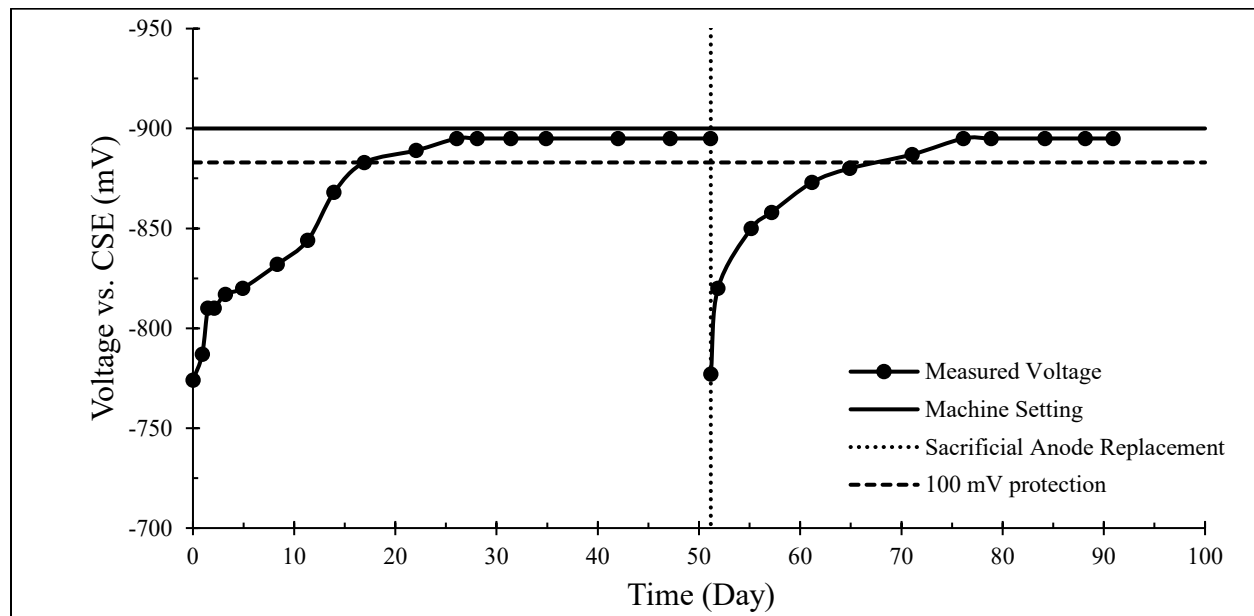
Figure 3.6 Structure-to-electrolyte potential readings with respect to a CSE reference, measured using a digital multimeter.

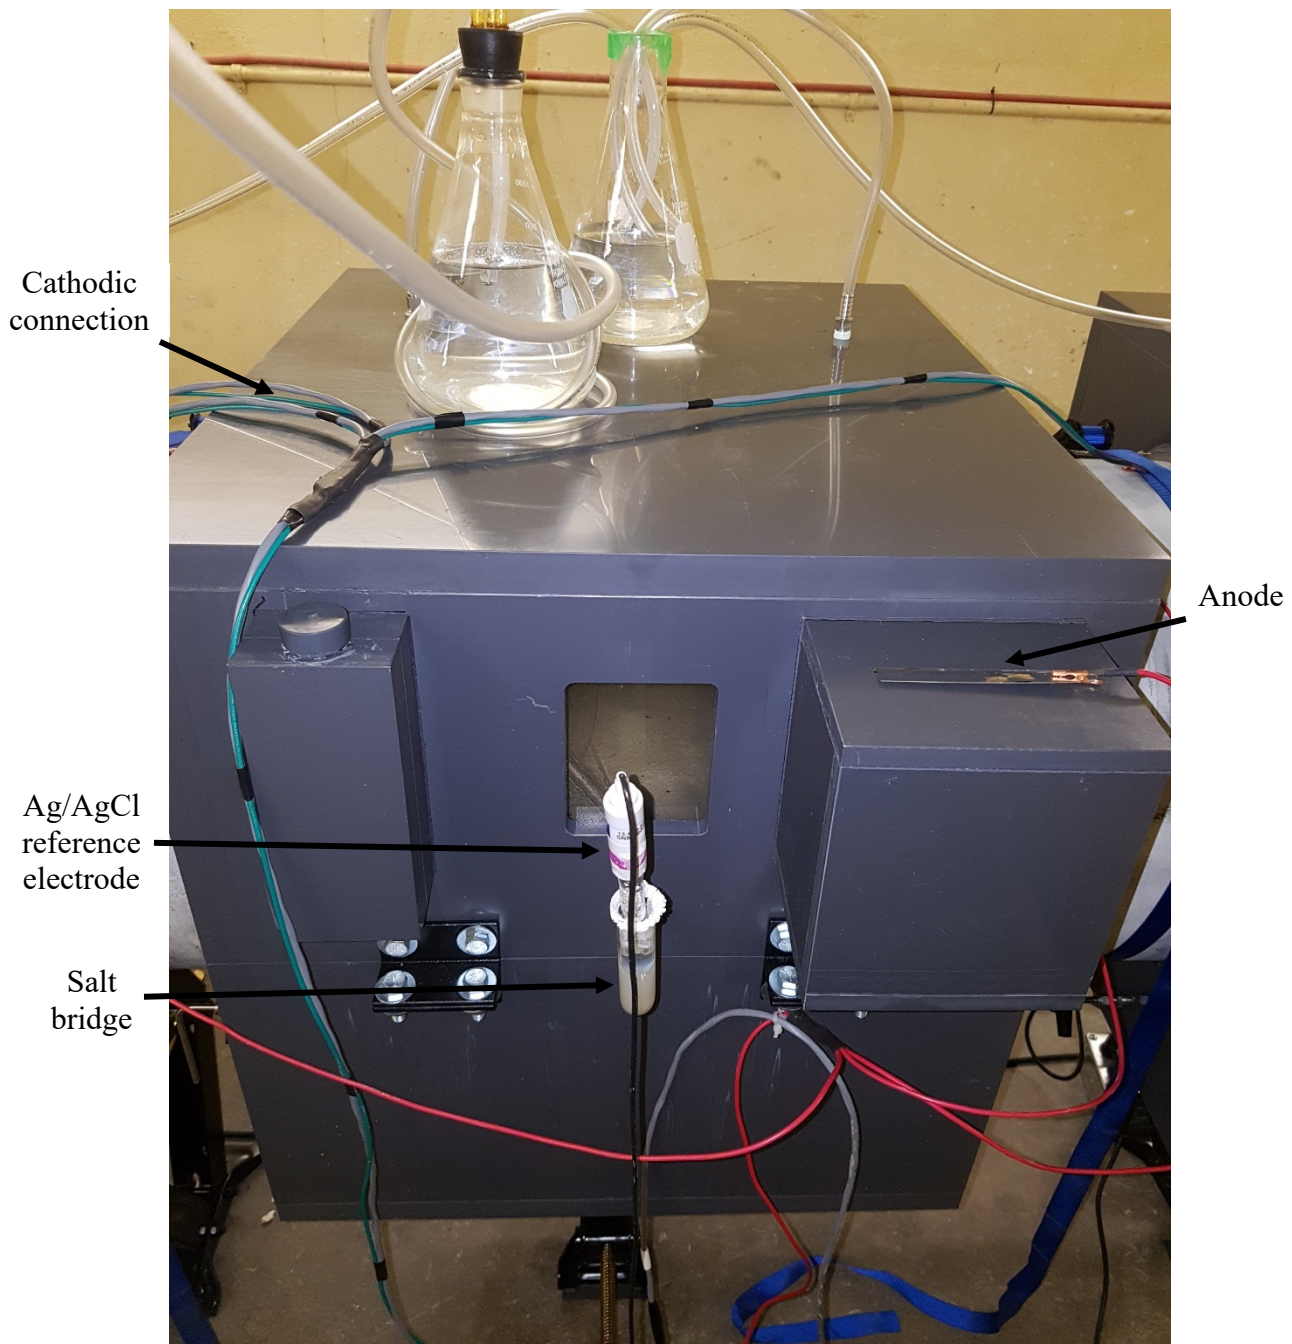
Figure 3.7 Image of Box B with annotations describing the CP system.

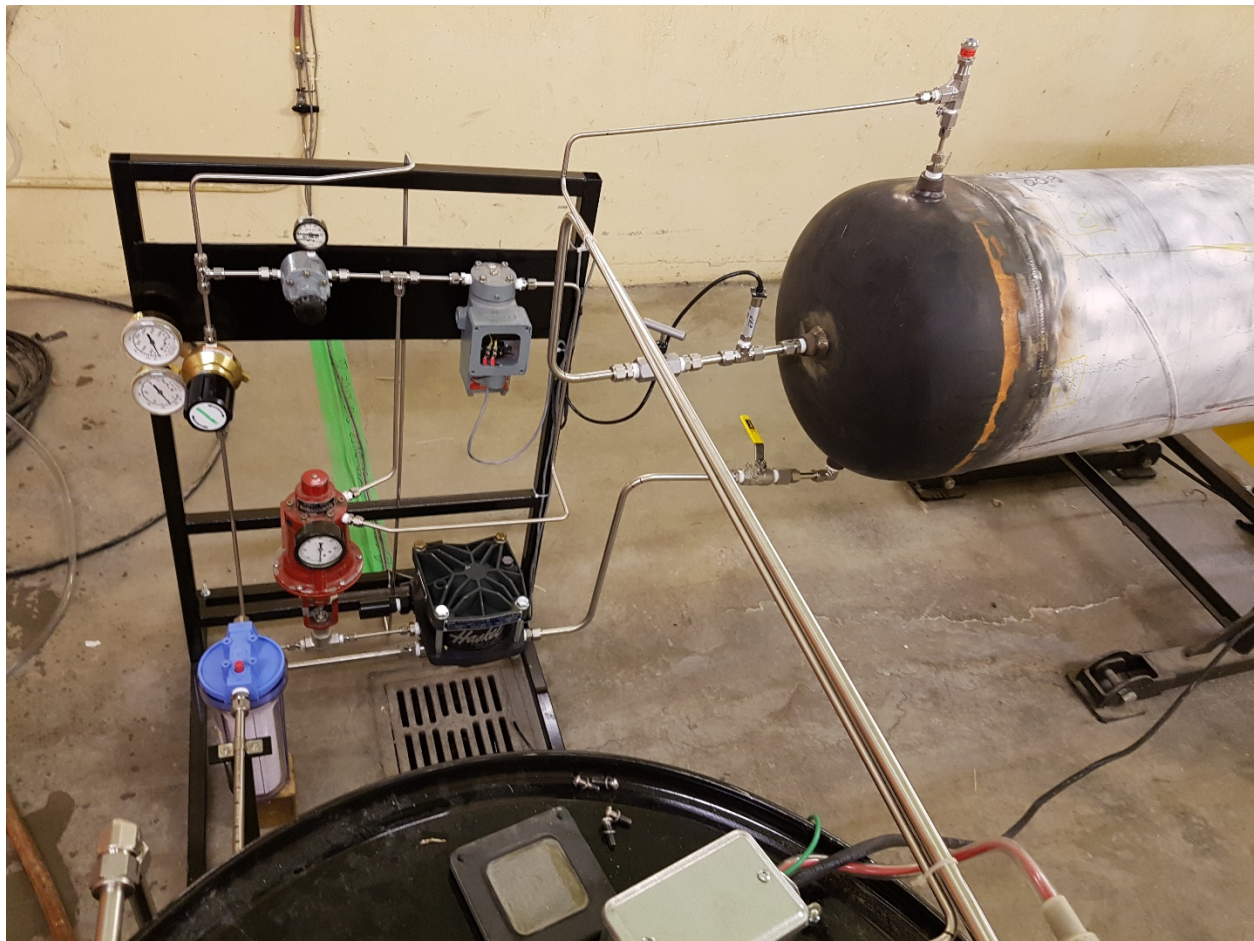
Figure 3.8 Photograph of the plumbing system built for the full-scale test.
