**FULL-SCALE INVESTIGATION OF CRACK GROWTH BEHAVIOUR UNDER VARIABLE
PRESSURE FLUCTUATIONS IN NEAR-NEUTRAL PH ENVIRONMENTS**

by
Joshua J. Knechtel

Master of Science
in
Materials Engineering

University of Alberta

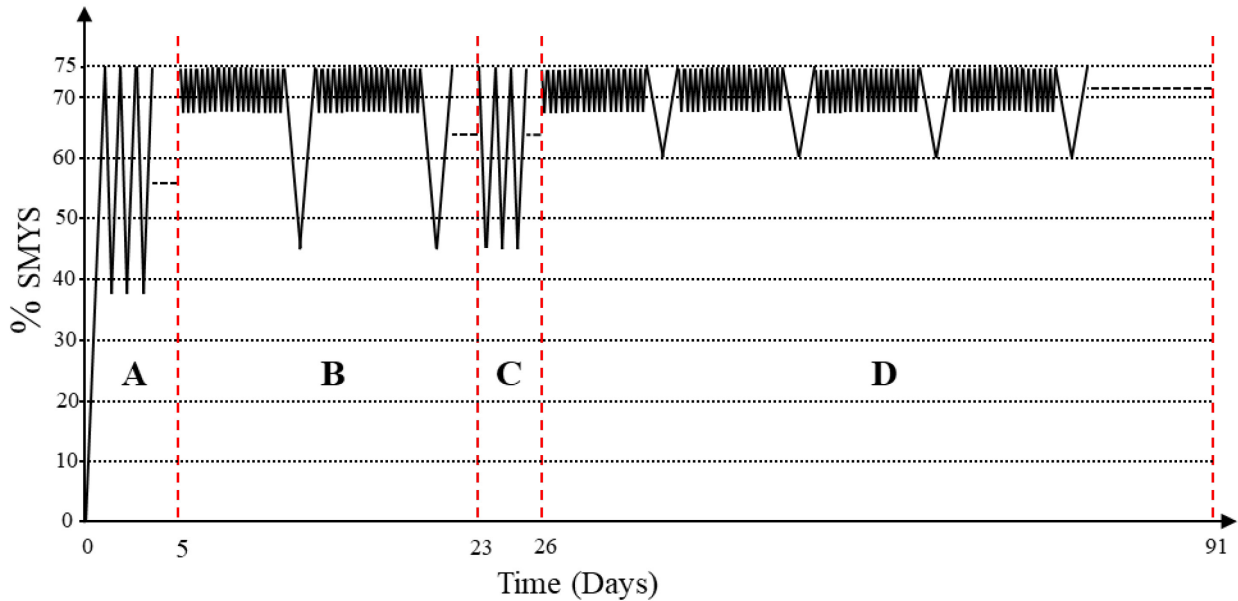
Figure 3.9 Visualization of the variable amplitude pressure scheme used during testing. Sections A, B, C and D correspond to Regions I, II, III and IV respectively.

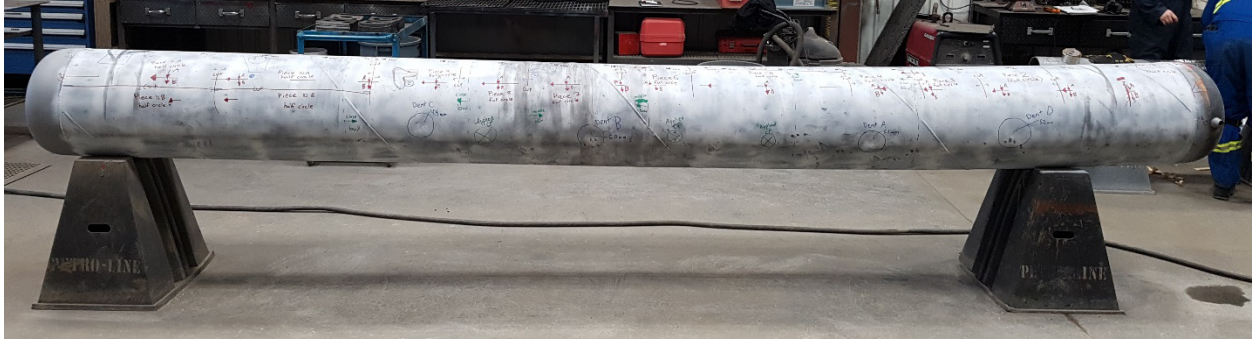
Figure 3.10 Pipe segment after post test NDE.

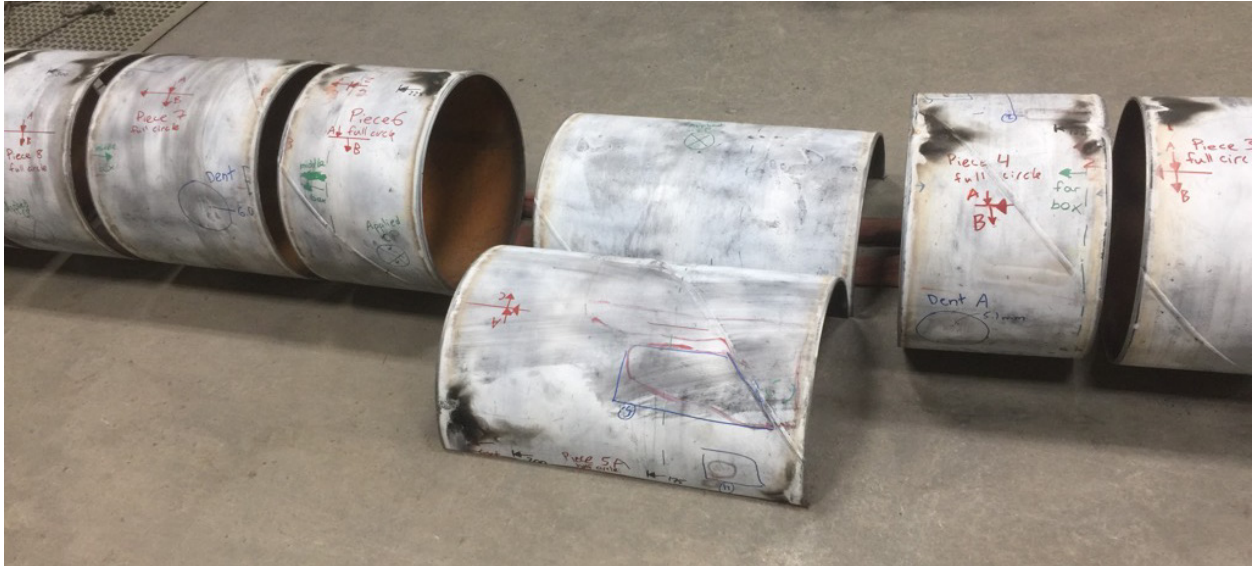
Figure 3.11 Pipe segment cut into small sections after completion of the full-scale test.

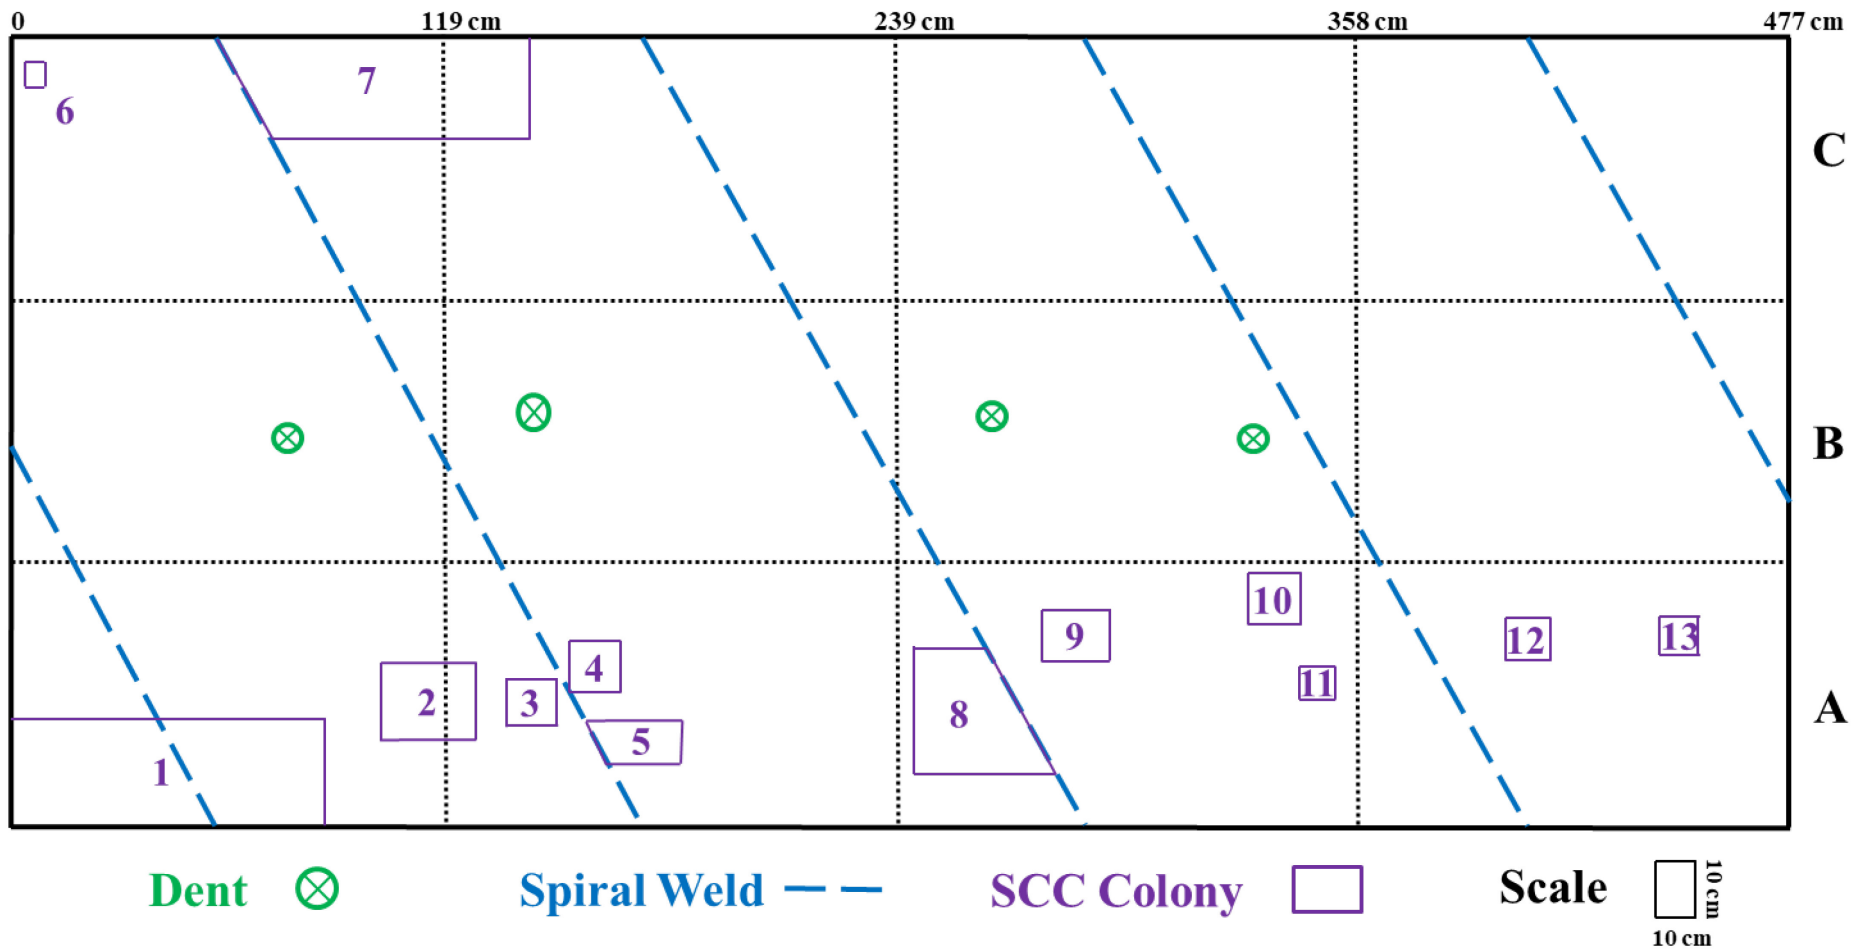
Figure 3.12 Diagram of the pipe outer surface illustrating the boundaries of the SCC colonies and dents.

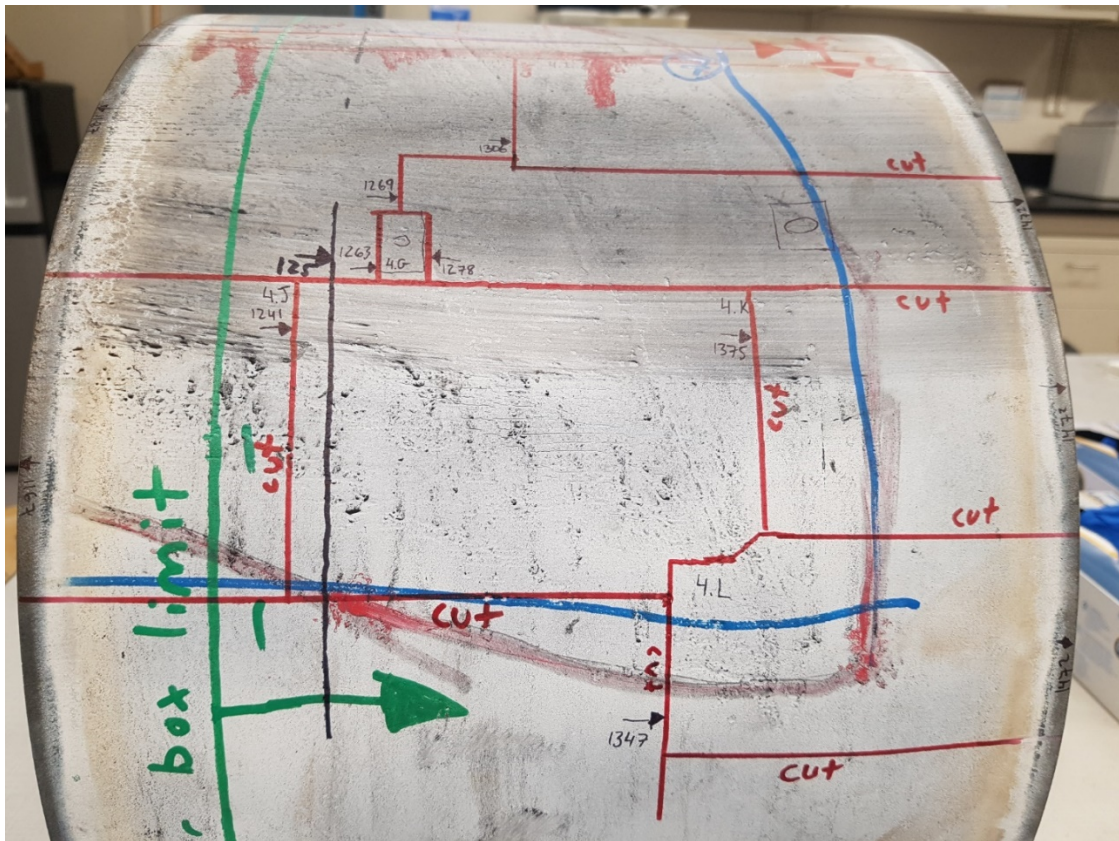
Figure 3.13 Post-test section of pipe after MPI, multiple SCC colonies marked up for cutting.

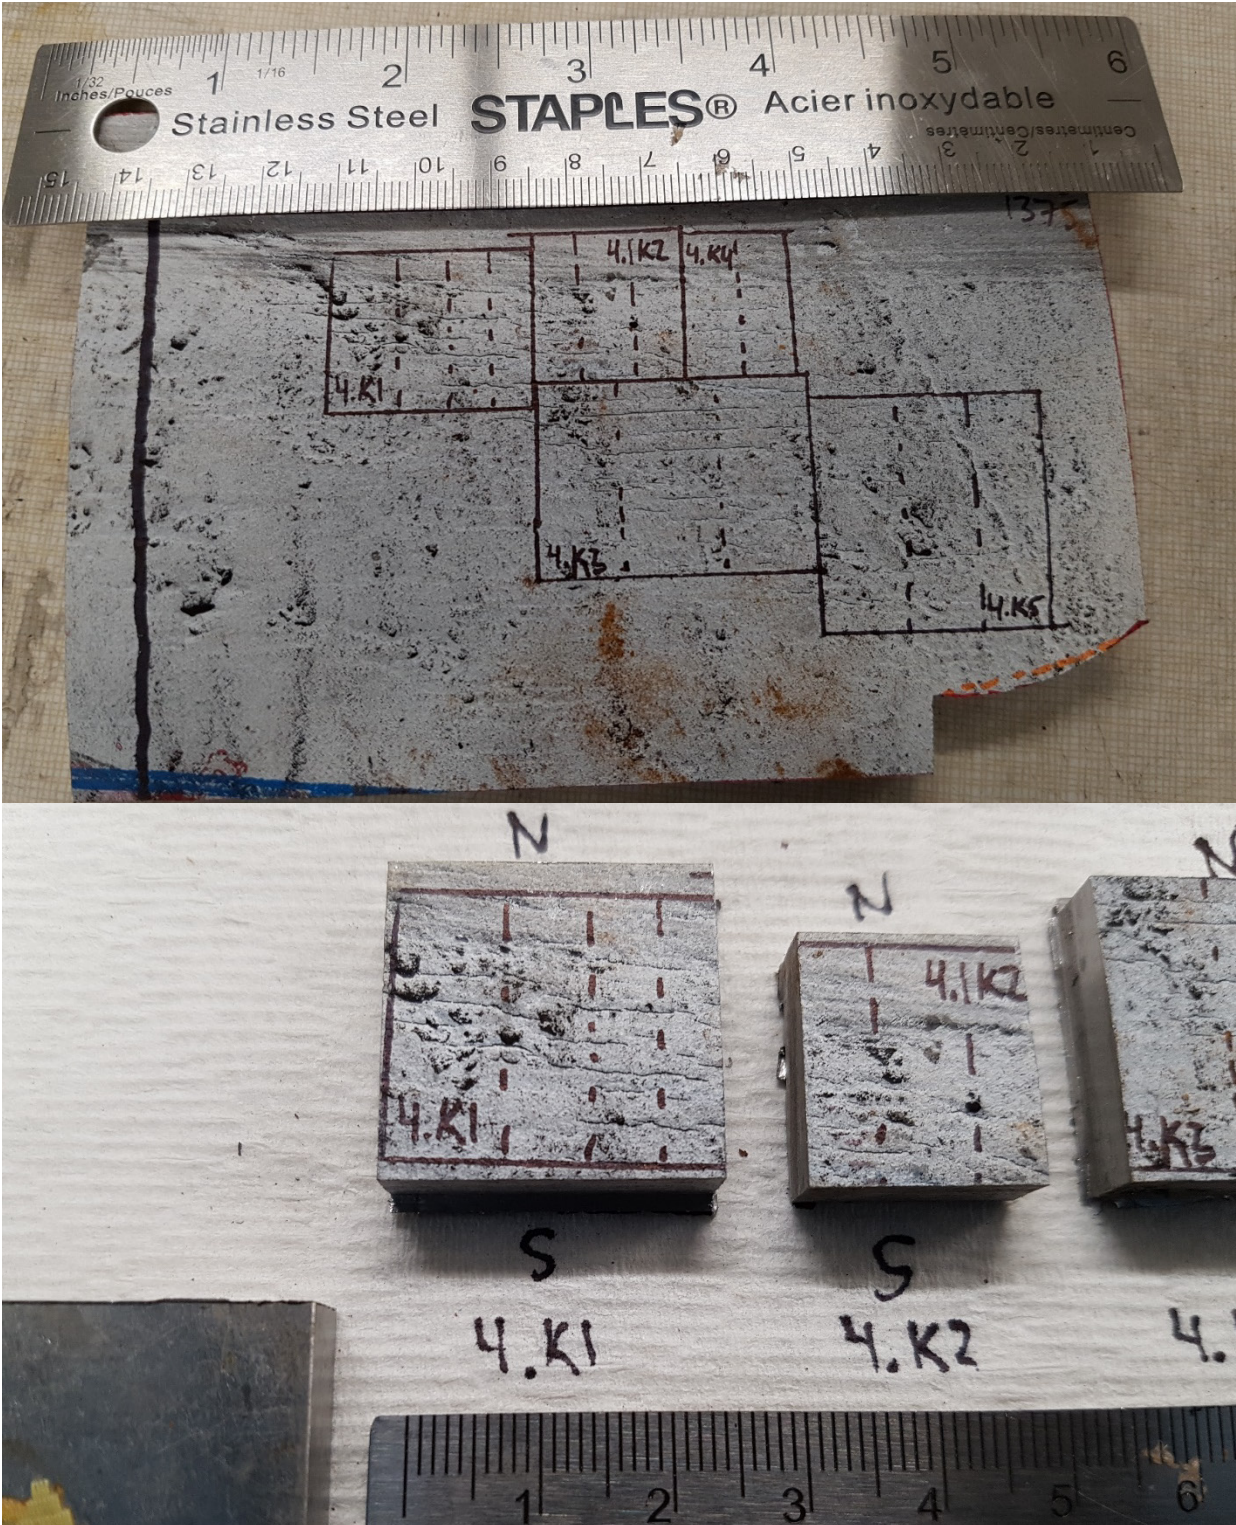
Figure 3.14 (Top) a group of cracks cut out using a commercial band saw and (bottom) individual cracks prior to cross-sectional analysis.

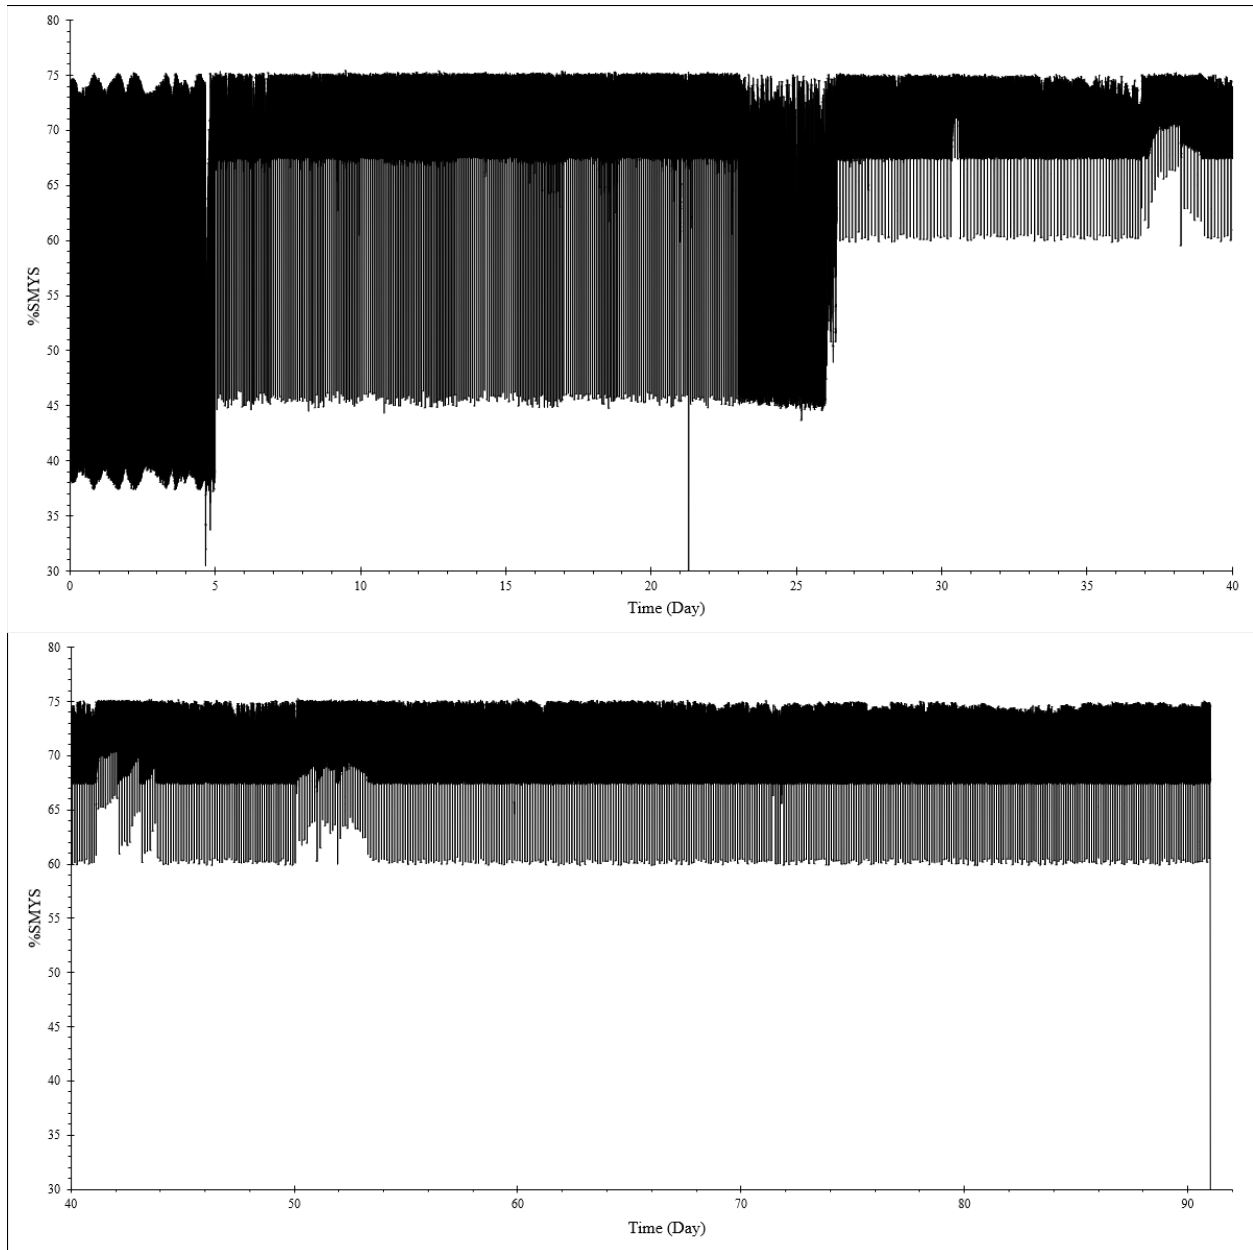
Figure 4.1 Pressure data collected during the full-scale test for (top) day 0–40 and (bottom) day 40–91. The dark black zones of the plot are the areas of CA fluctuation or zones of MC. The UL fluctuations can be seen in the areas of Region II and IV below 67.5 % SMYS.

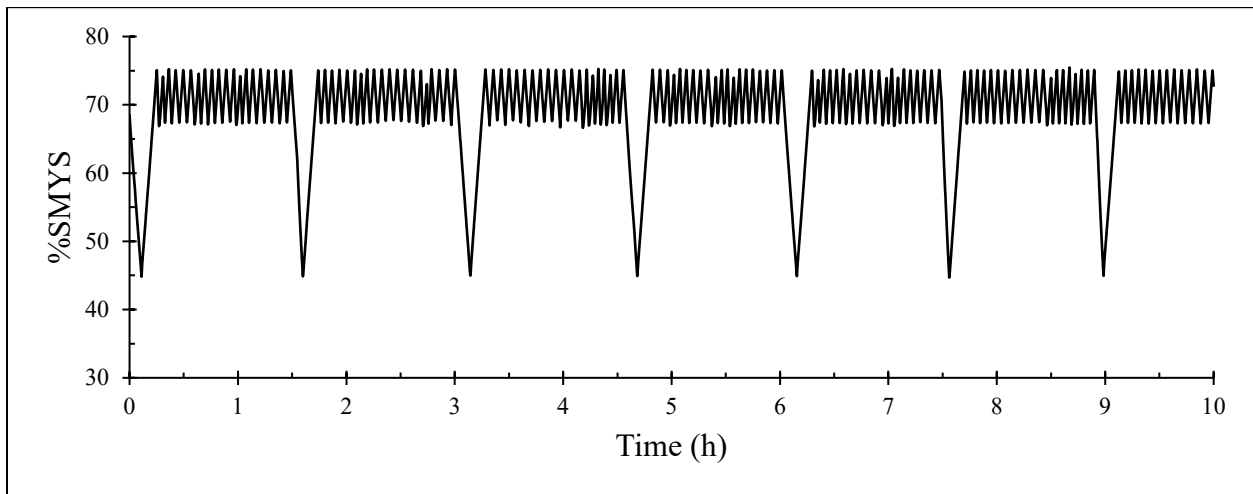
Figure 4.3 Ten-hour sample of Region II pressure data from the full-scale test using a five second sampling interval ($P_{\max} = 8.62$ MPa, $f_{UL} = 0.001$ Hz, $R_{UL} = 0.6$ and $R_{MC} = 0.9$).

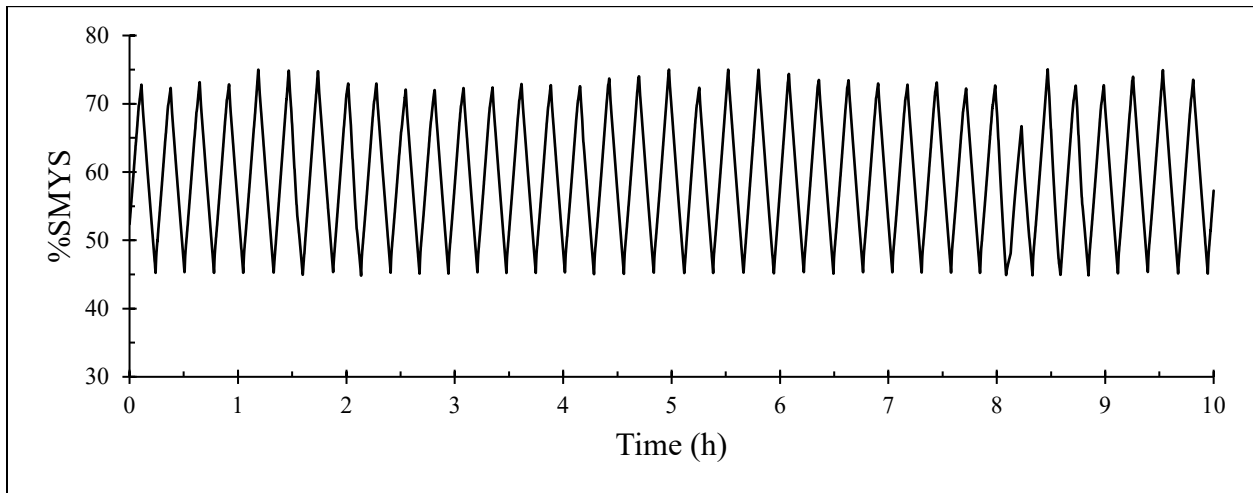
Figure 4.4 Ten-hour sample of Region III pressure data from the full-scale test using a five second sampling interval ($P_{\max} = 8.62$ MPa, $f = 0.001$ Hz and $R = 0.6$).

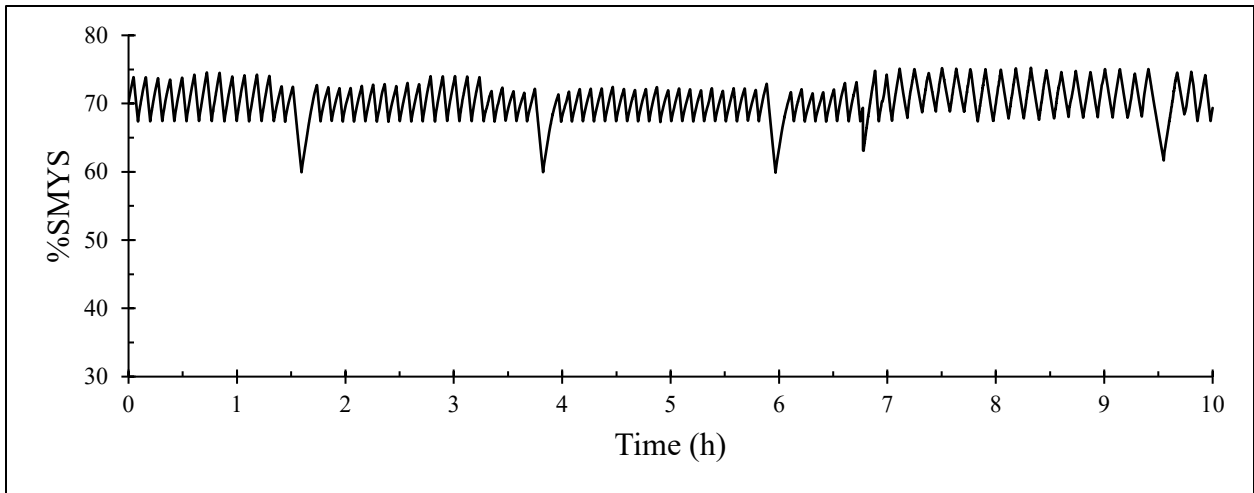
Figure 4.6 Ten-hour sample of Region IV pressure data using a five second sampling interval showing deviation from the target pressure (P_t) in the first eight hours.

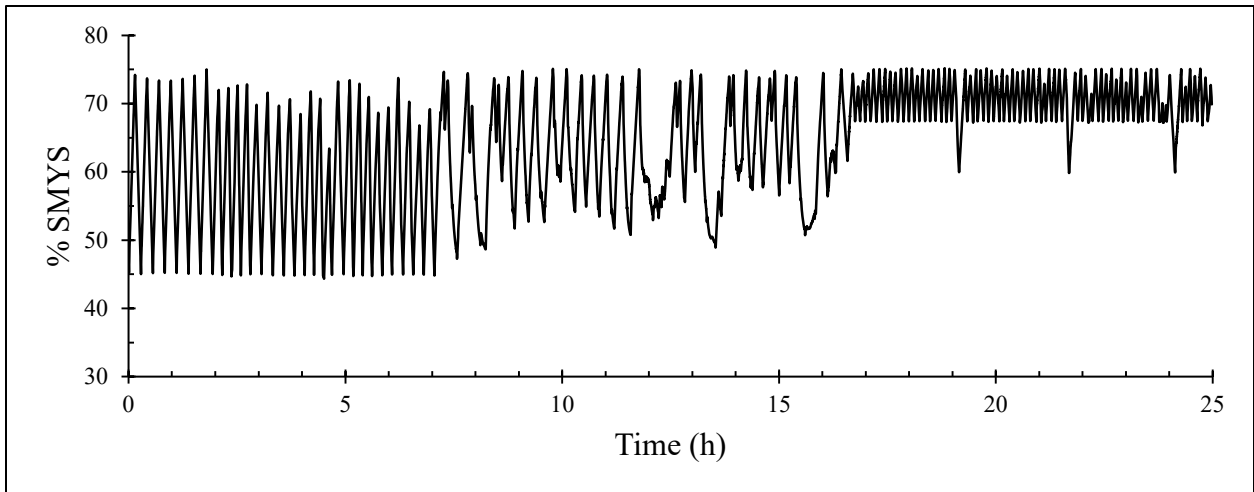
Figure 4.7 One-day sample of pressure data using a five second sampling interval showing deviation from P_t caused by the transition from Region III to Region IV.

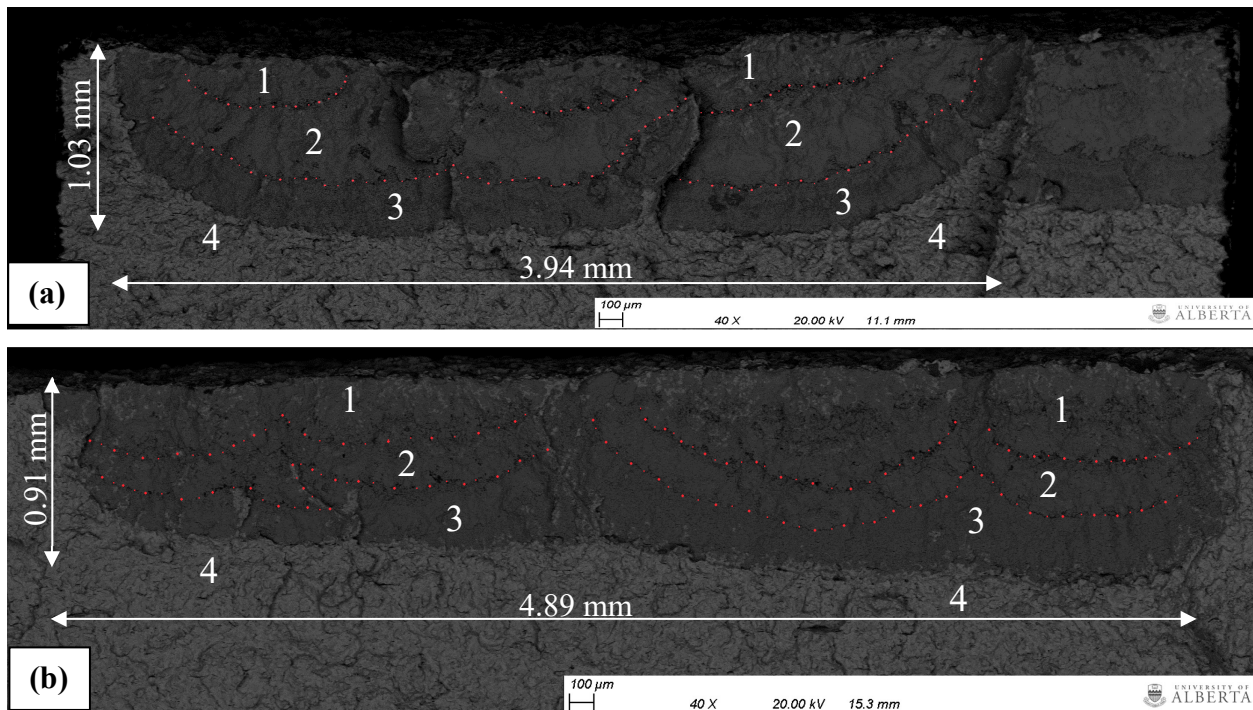
Figure 4.8 SEM images of the crack fracture surface exposed to (a) the NNpH environment and (b) atmospheric conditions during testing. The regions identified in both images are: three crack growth zones attributed to growth in the field, denoted 1-3, and the brittle fracture surface produced from fracture in liquid nitrogen, denoted 4. The crack growth zones are separated by bands enhanced with red dotted lines.

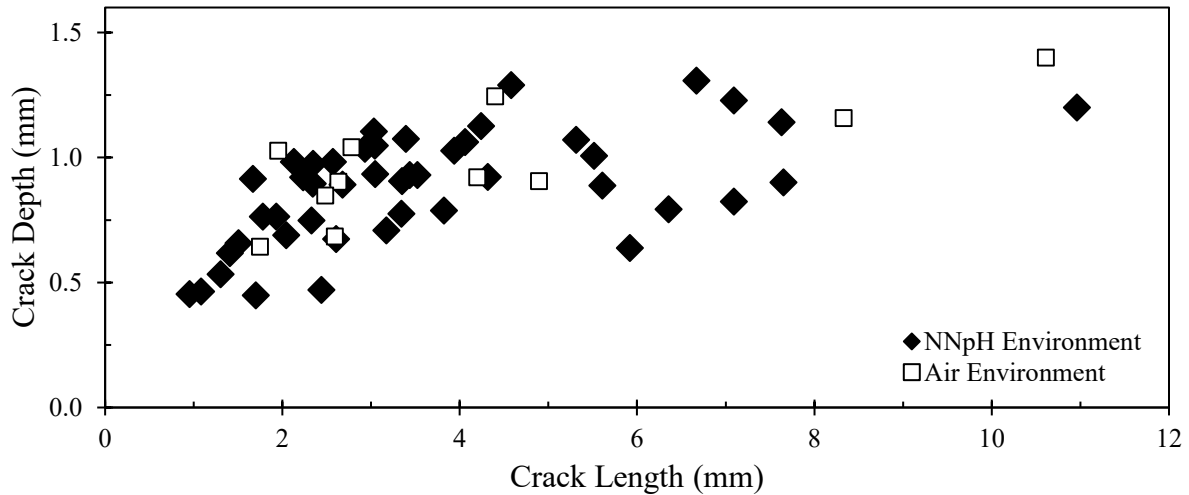
Figure 4.9 Individual crack depth as a function of crack length for the 57 cracks analyzed after testing.

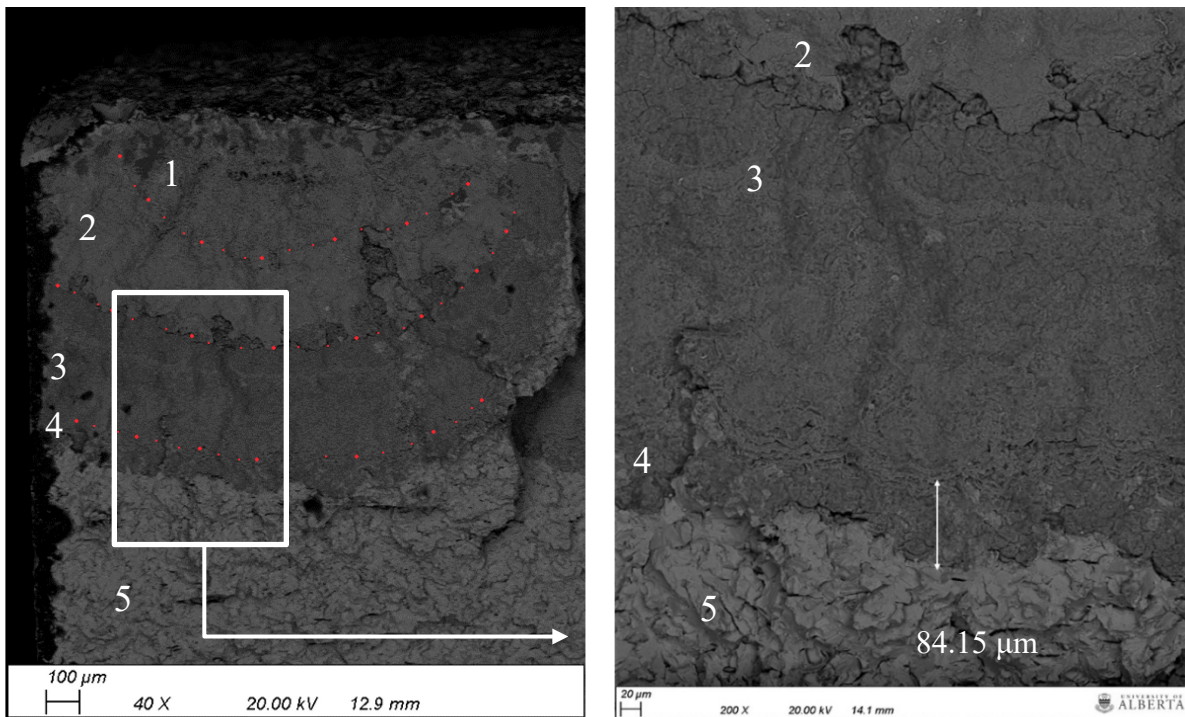
Figure 4.10 Crack fracture surface exposed to the NNpH environment during testing. Three crack growth zones attributed to growth in the field (1-3); one crack growth zone attributed to growth during the full-scale test (4); and brittle fracture in liquid nitrogen (5). The crack growth zones are separated by bands enhanced with red dotted lines.

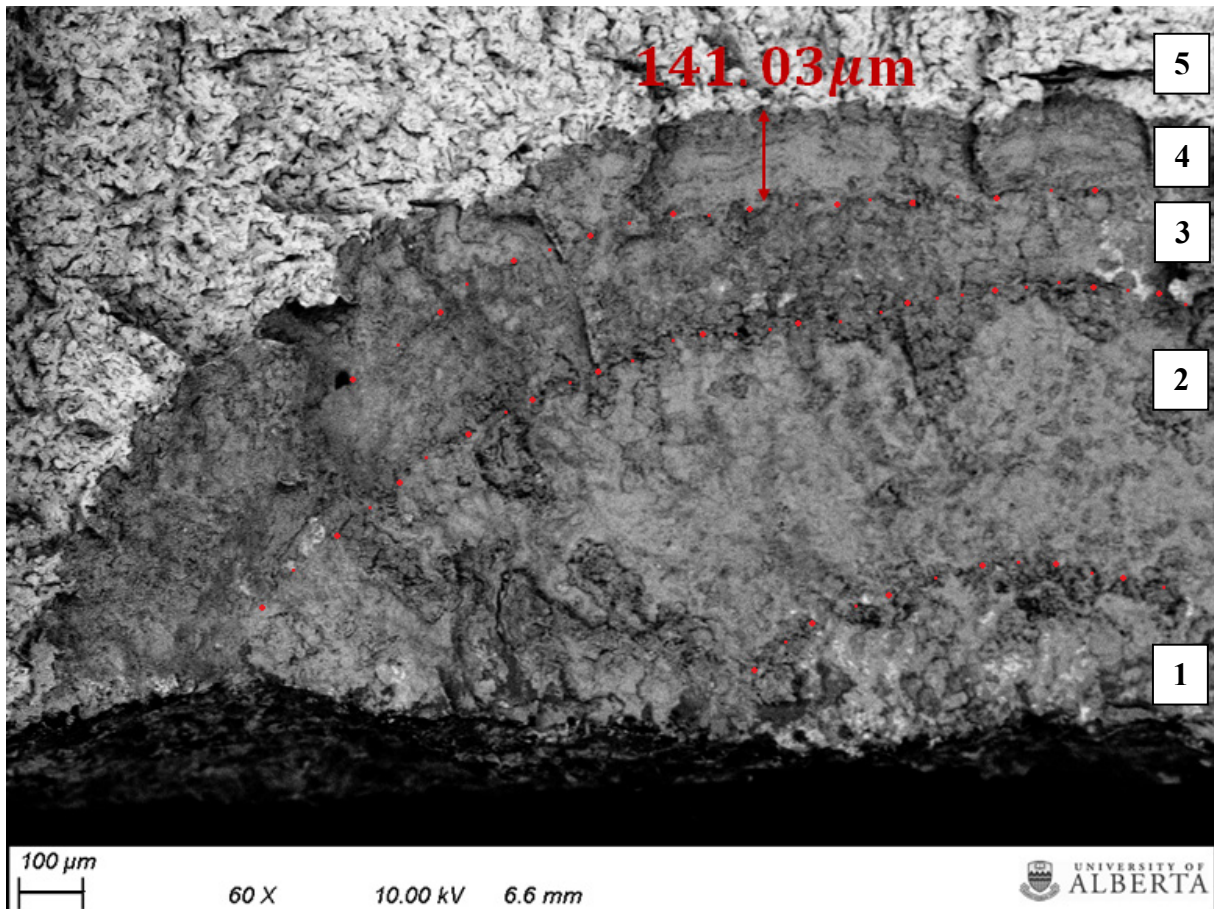
Figure 4.11 Etched crack fracture surface exposed to the NNpH environment during testing. Three crack growth zones attributed to growth in the field (1-3); one crack growth zone attributed to growth during the full-scale test (4); and brittle fracture in liquid nitrogen (5). The crack growth zones are separated by bands enhanced with red dotted lines.

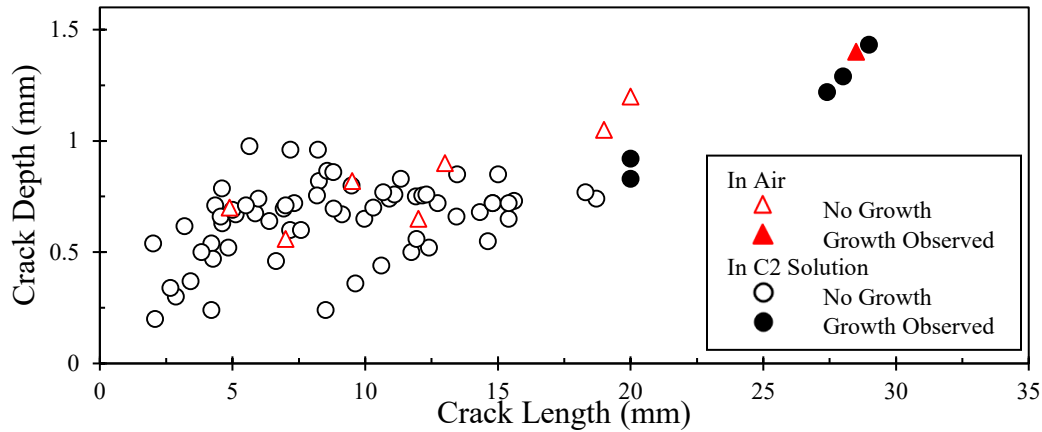
Figure 4.12 Crack dimensions of the cracks analyzed from the full-scale test.

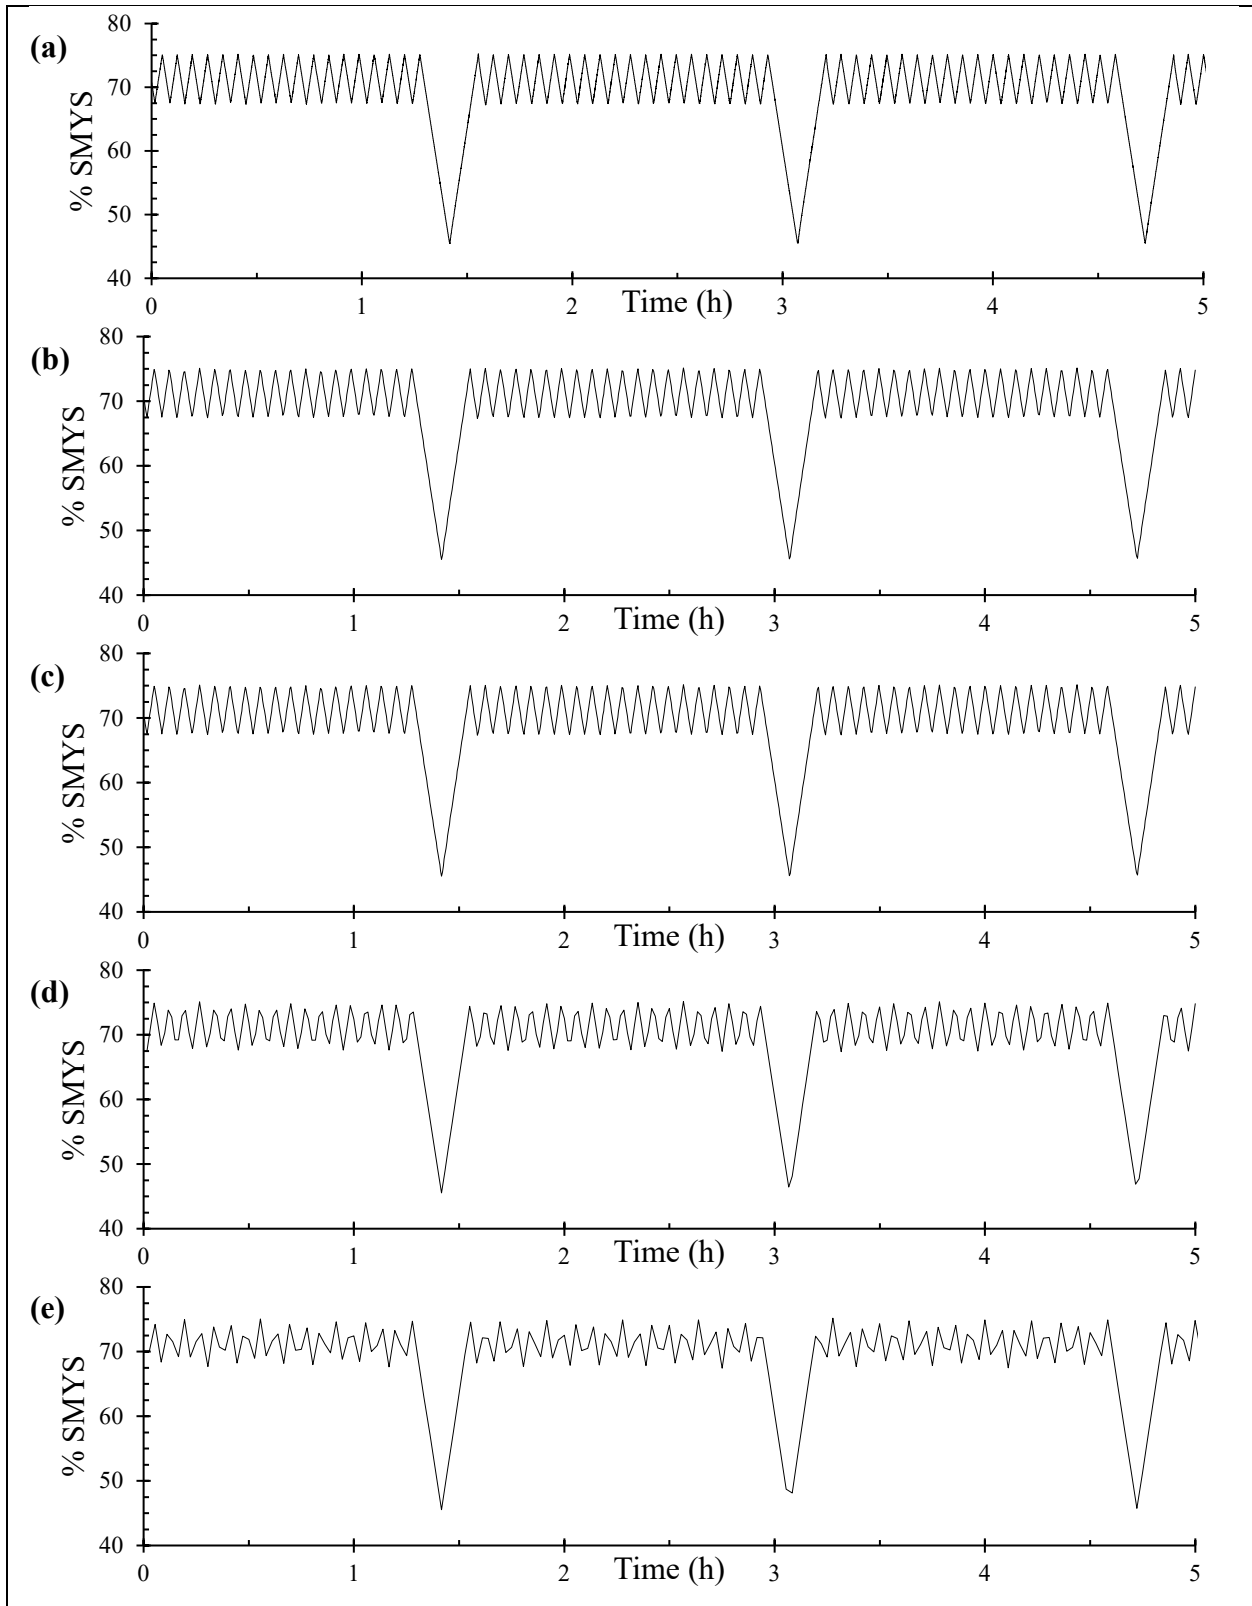
Figure 5.1 Five-hours of test data collected during Region II of the full-scale test plotted using a data sample interval of (a) 1 s, (b) 15 s, (c) 30 s, (d) 60 s and (e) 100 s.

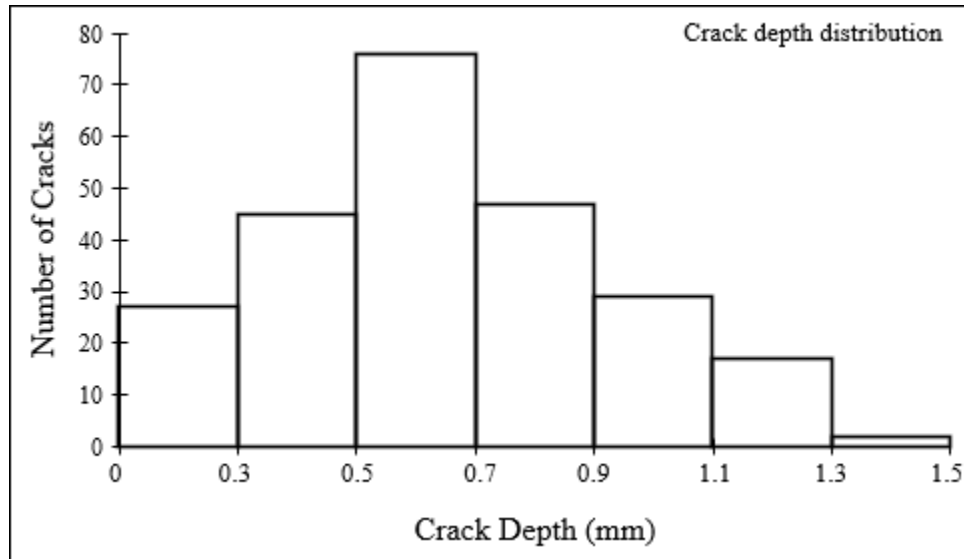
Figure 5.2 Analyzed total crack depth distribution measured using destructive testing techniques. The pipe segment was in service for 46 years prior to being cut-out and tested for 91 days. Crack depths were measured after testing was complete.
