**Assessing The Benefits Of Cost-Effective Monitoring Technology On Unstable Slopes
Sensitive To Weather**

A thesis submitted in partial fulfillment of the requirements for the degree of

Geotechnical Engineering

Department of Civil and Environmental Engineering
University of Alberta

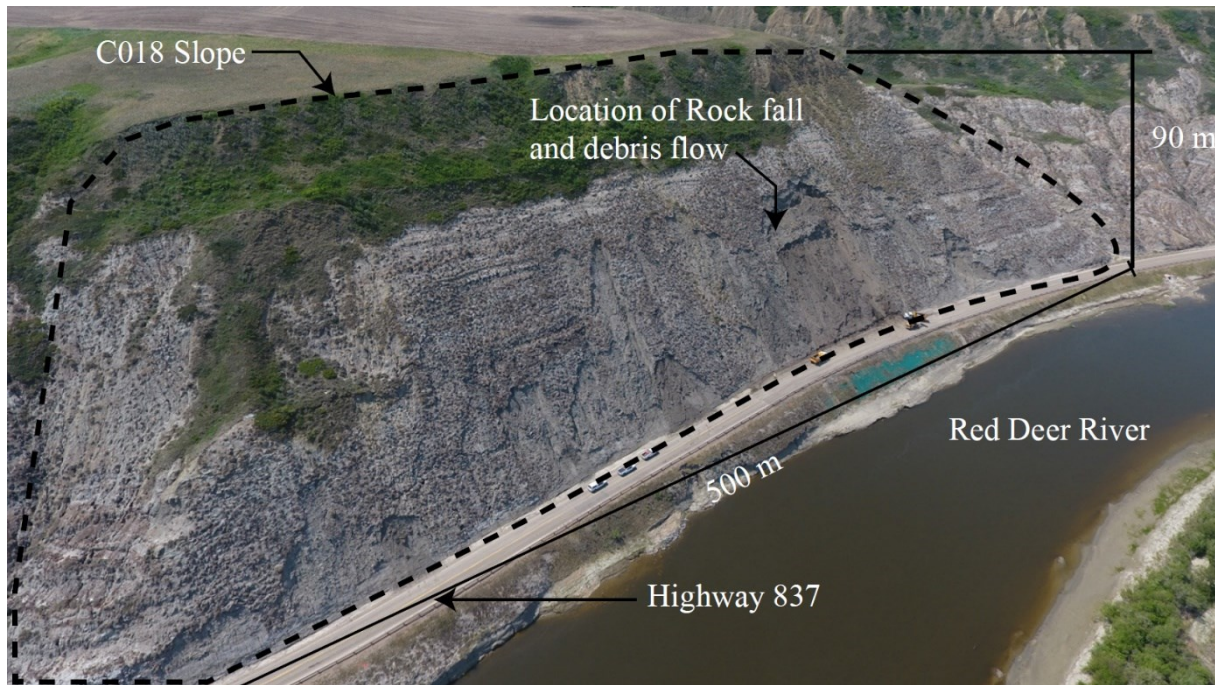
Figure 1-1 Photograph of the C018 slope taken by UAV inspection following a slope failure on May 23, 2018 (Klohn Crippen Berger 2018a).

The C018 slope requires a rapid and accurate assessment of the unstable sections to reduce the risk to the public road users. However, the location and geometry of the site imposed a challenge to observe the location and conditions of the slope high above the highway. The C018 slopes provides an opportunity to assess the effectiveness low-cost UAV to provide detail information of the surface ground conditions, especially on upper areas with difficult access.

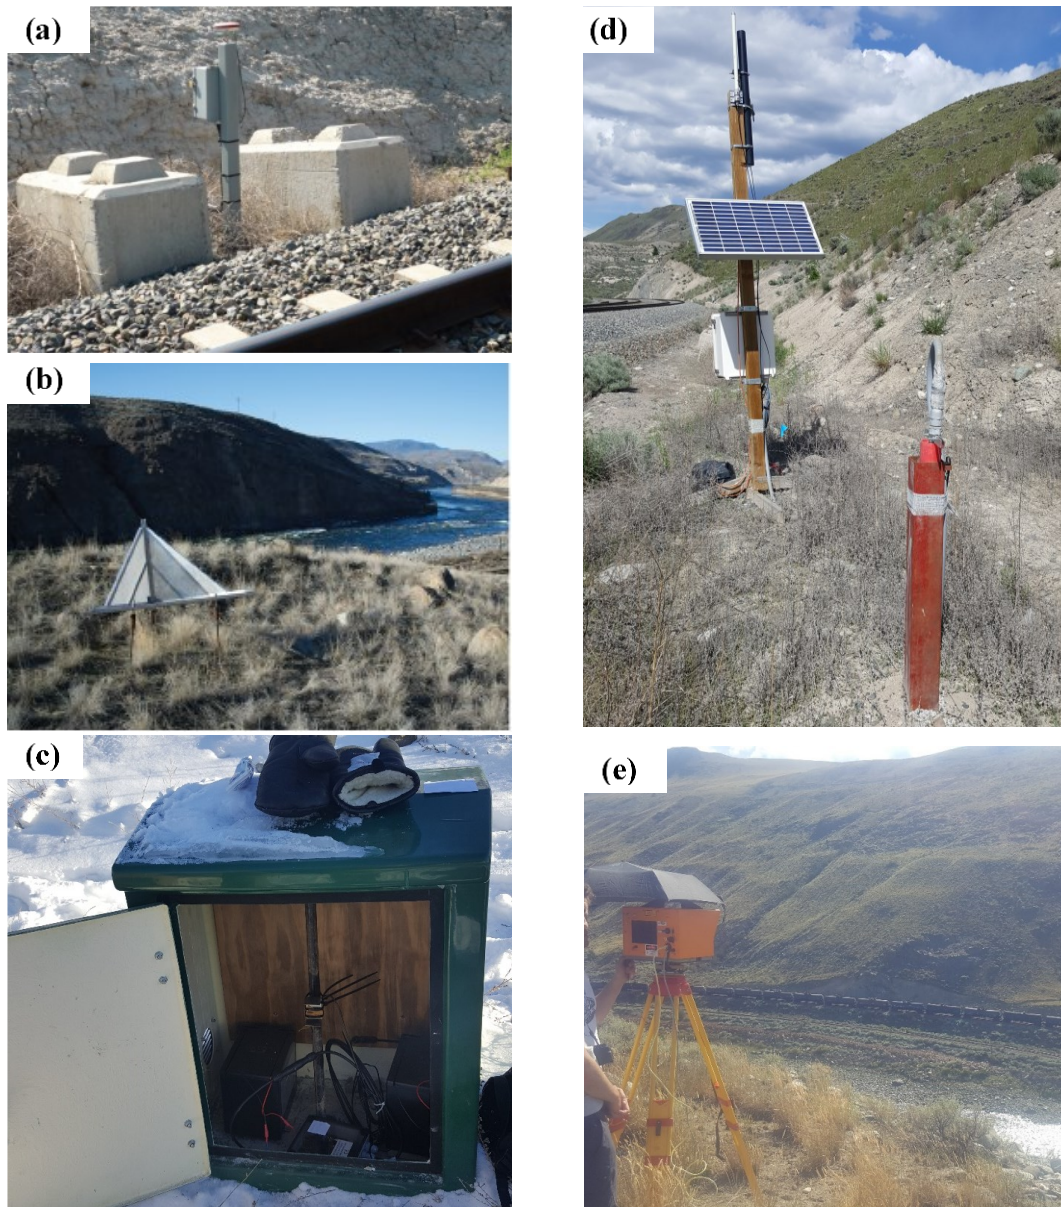
Figure 2-1 Instrumentation at the Ripley Landslide: a) multi-frequency GNSS receiver; b) reflector for InSAR measures; c) acoustic monitoring system; d) location of piezometer, Shape Accel Array, and data acquisition system; e) terrestrial LiDAR.

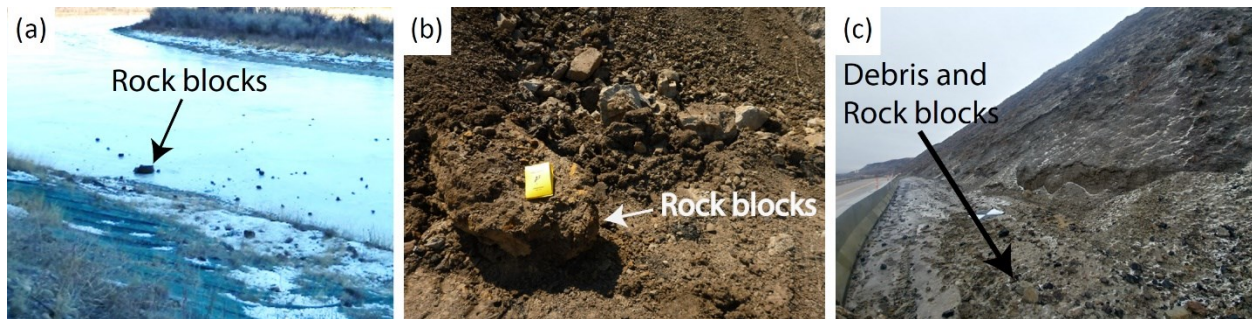
Figure 3-3 Slope failures at the C018 slope; (a) rock blocks found on the frozen Red Deer River on December 2017; (b) rock blocks found across the Highway on May 2018; (c) accumulation rock falls and debris slide behind jersey barrier on November 2018.

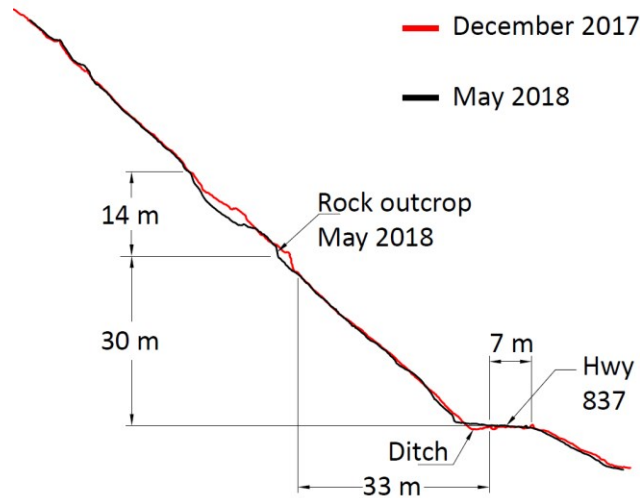
Figure 3-9 Cross-section A-A for the Rock fall trajectory analysis at the study site .

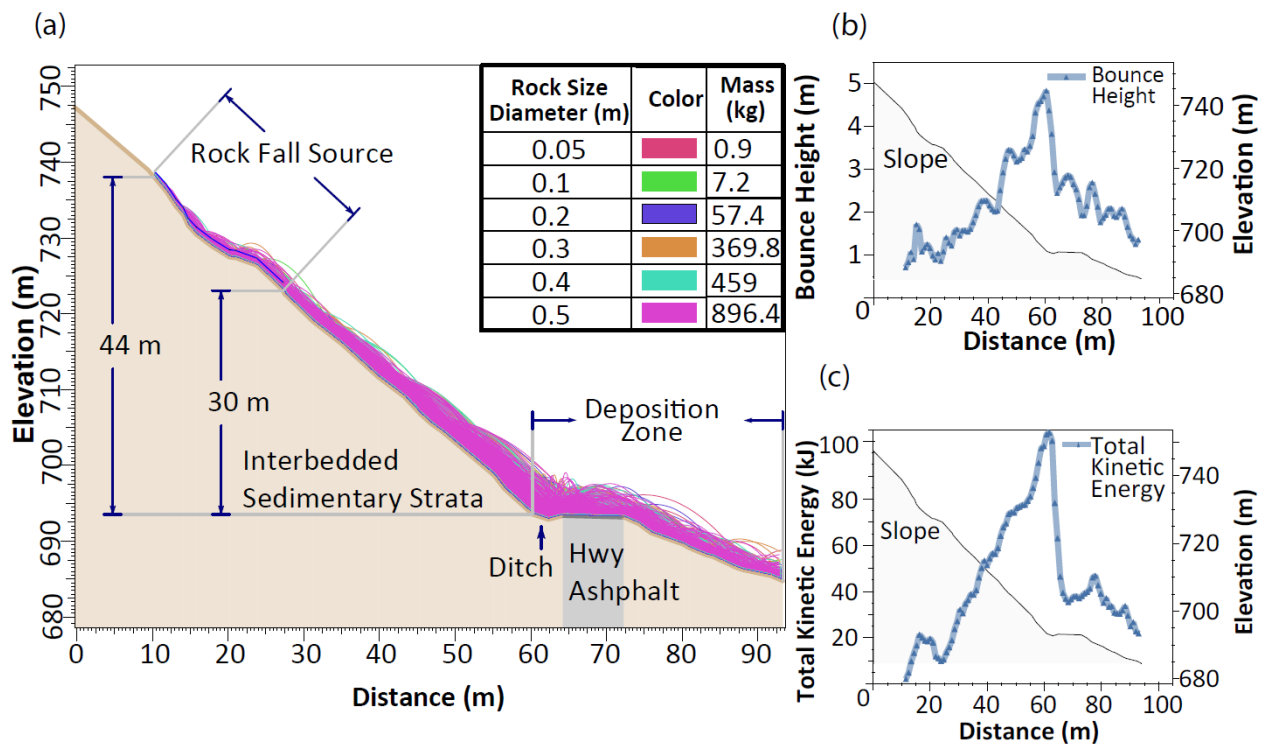
Figure 3-12 2D Rock fall simulation on section A-A (a) Trajectories from 1000 blocks using Monte Carlo Method; (b) bounce height from 95% percentile of rock fall trajectories; (c) total kinetic energy from 95% percentile of rock fall trajectories.

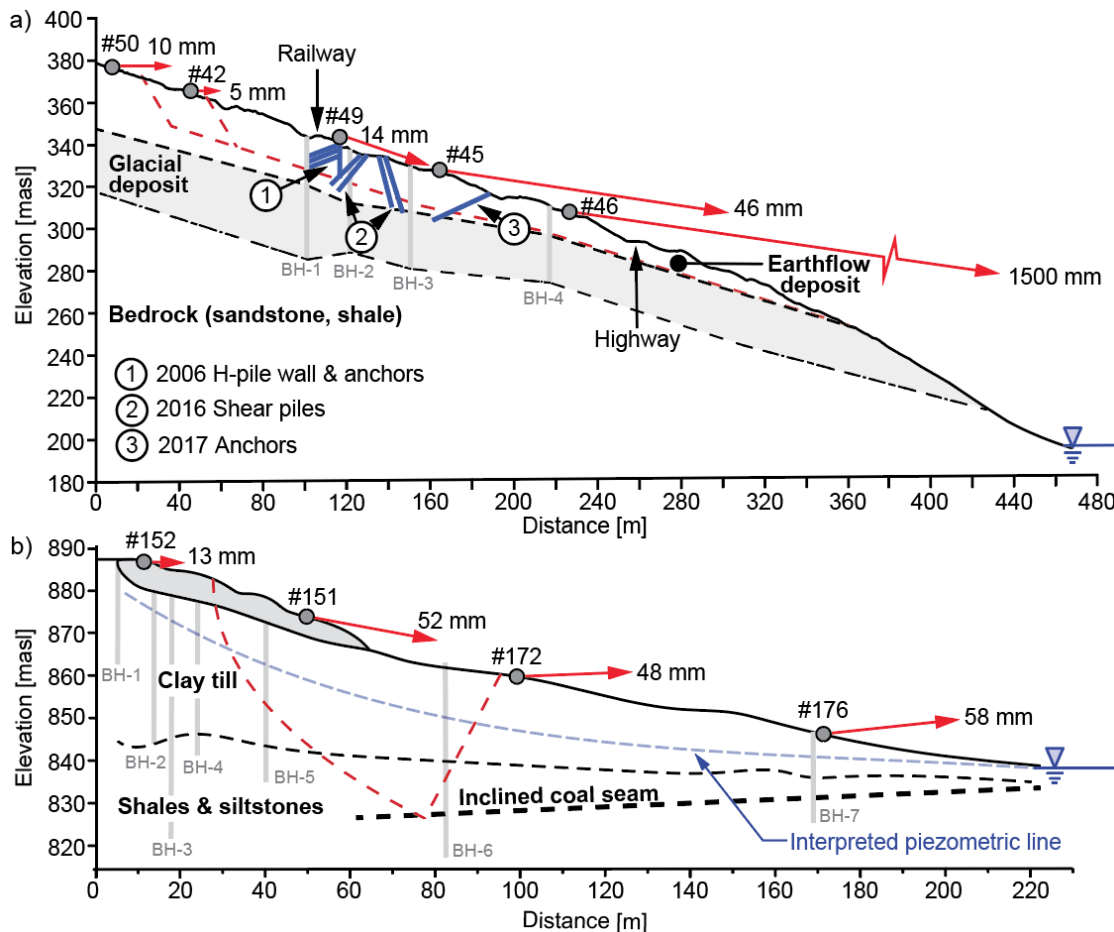
Figure 4-9 Cross-sections A-A of (a) the Ten-mile landslide (location of section shown in Figure 4-6), and (b) the Chin Coulee (location of section shown in Figure 4-7) derived from LiDAR obtained from these sites and showing the inclination of the measured displacements.

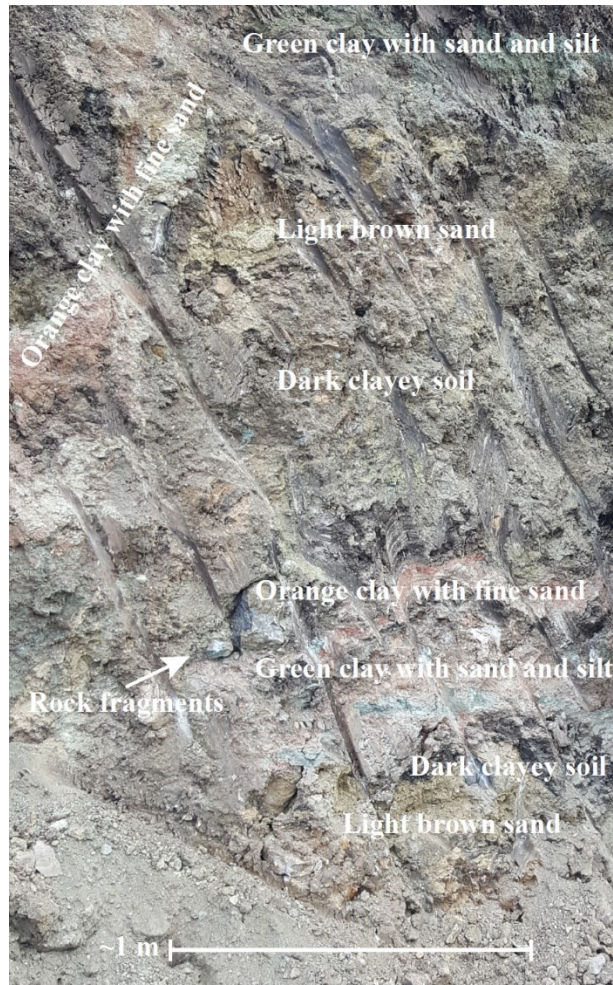
Figure 5-2 Photographs of the earthflow showing the churned strata from a cut adjacent to the access road located between the highway and the railway at the Ten-mile landslide (October 2016).

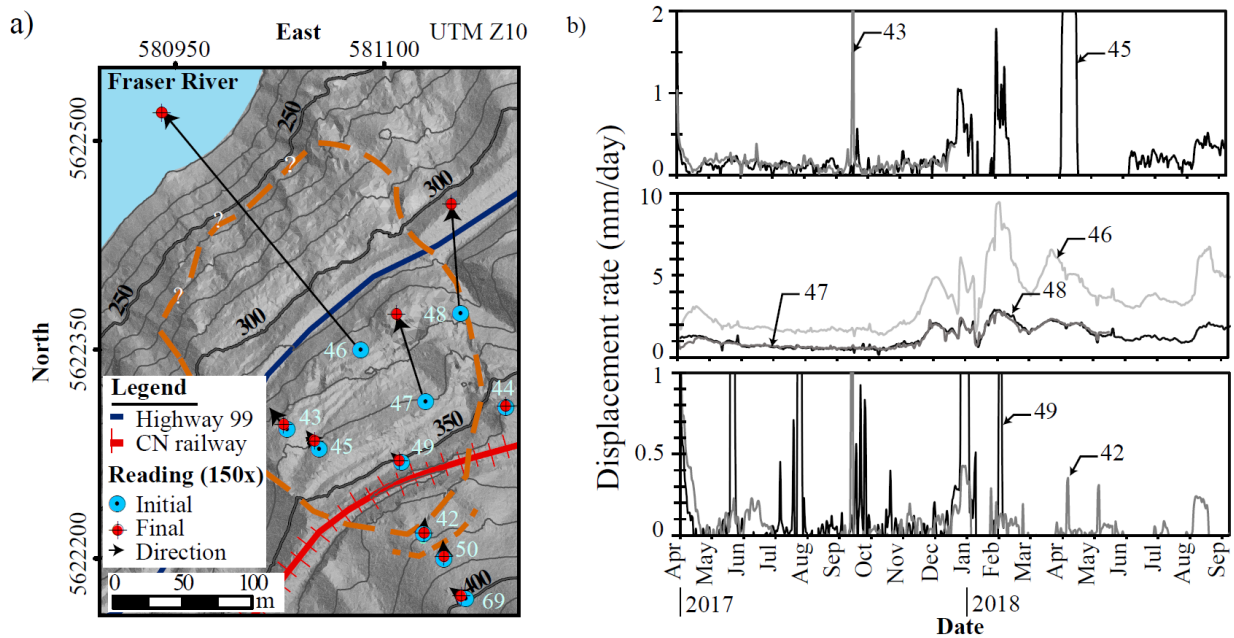
Figure 5-4 dGNSS measurements of landslide displacement from ten Geocube units scattered across the site. (a) Vector plot showing the trend in horizontal orientation of each dGNSS unit based on initial and final readings scaled 150 \times . (b) 15-d moving average of the displacement rates between April 2017 and November 2018 from dGNSS units within the sliding mass.

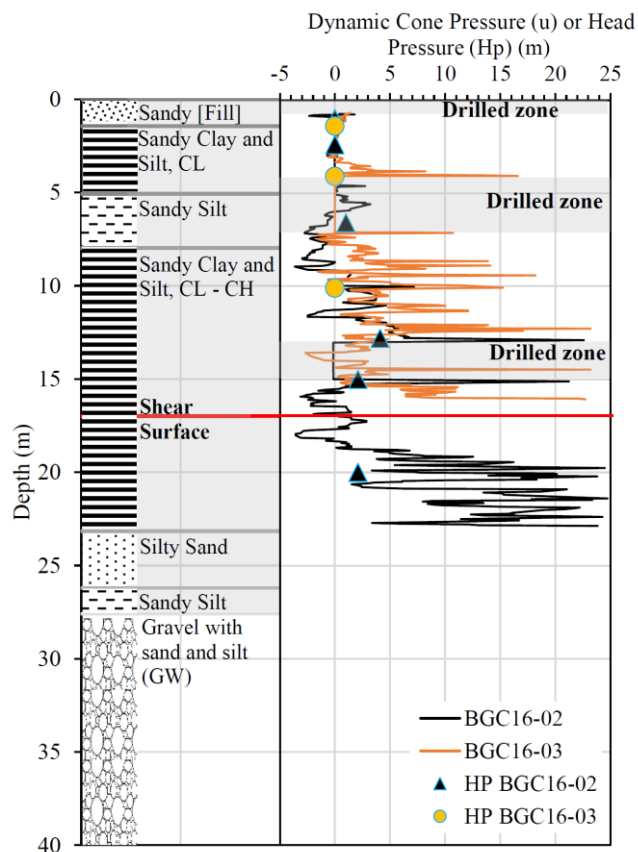
Figure 5-5 Dynamic cone pressure and head pressure from CPTu and dissipation test (BGC Eng. 2016a).

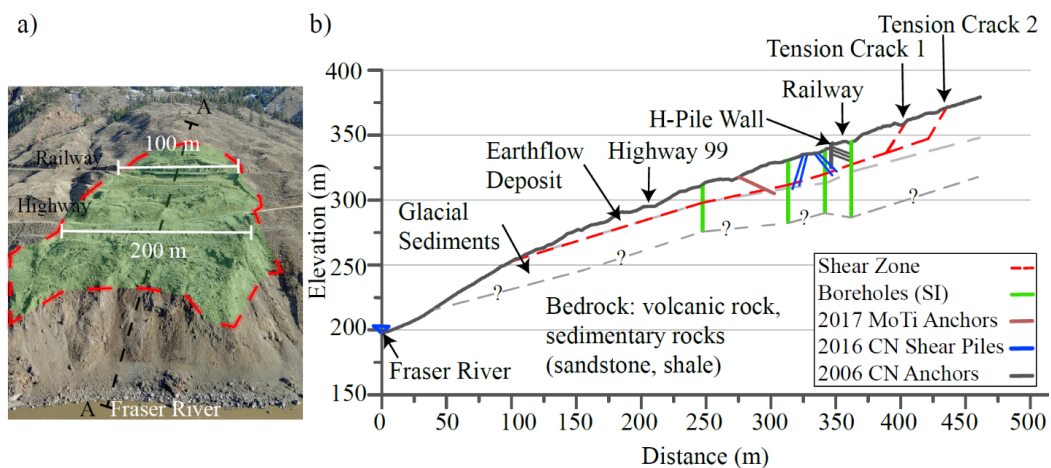
Figure 5-6 Active zone at the Ten-mile landslide: (a) frontal view from March 2018; (b) typical cross-section A-A. The width of the glacial sediments is inferred from previous site investigations.

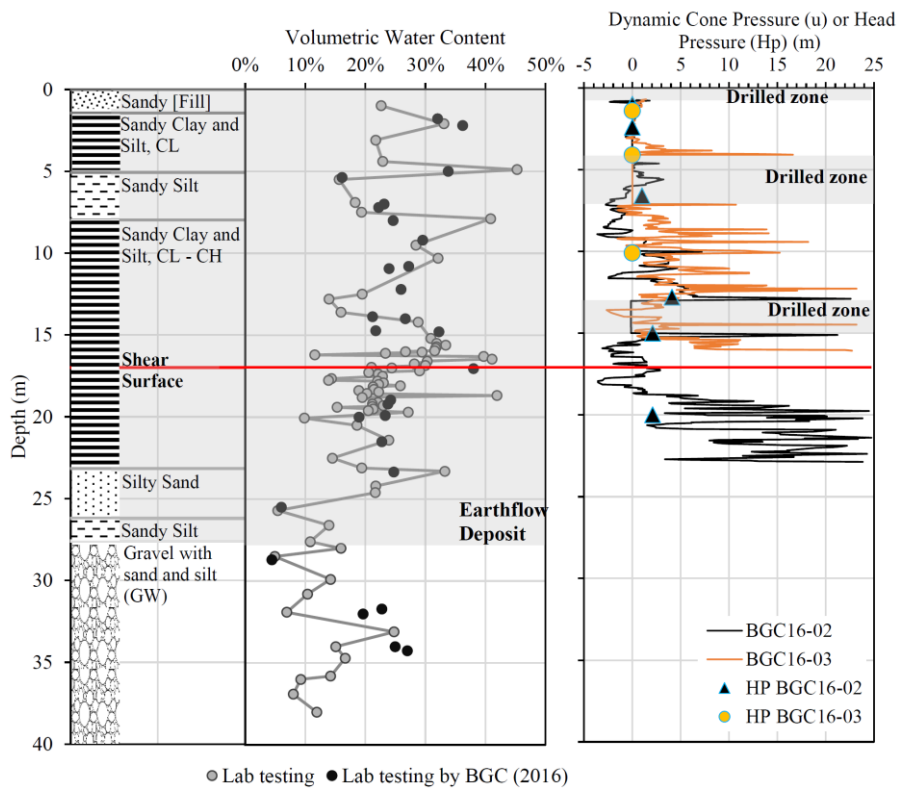
Figure 5-7 Changes in the volumetric water content from earthflow deposit samples at the Ten-mile landslide (including testing carried out by BGC Eng. 2016a); and, dynamic cone pressure and head pressure from CPTu and dissipation test (BGC Eng. 2016a).

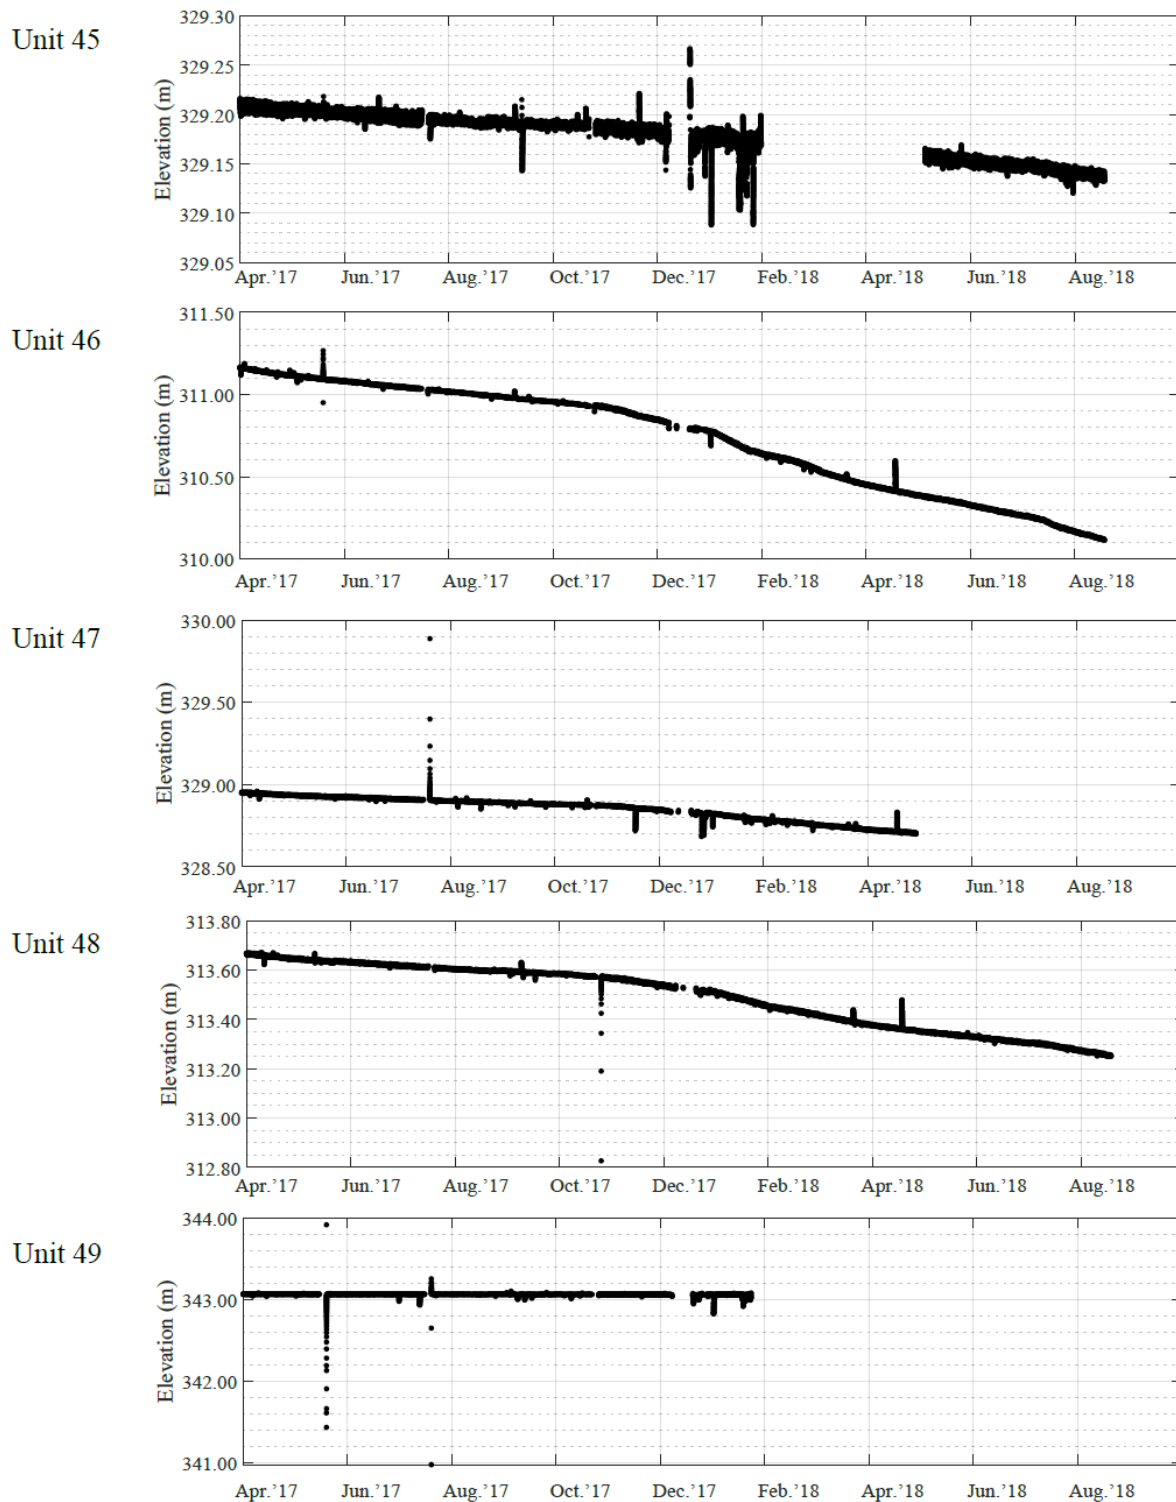
Figure B-8 Raw data recorded of the changes in elevation for units #45, #46, #47, #48, #49 at the Ten-mile landslide.

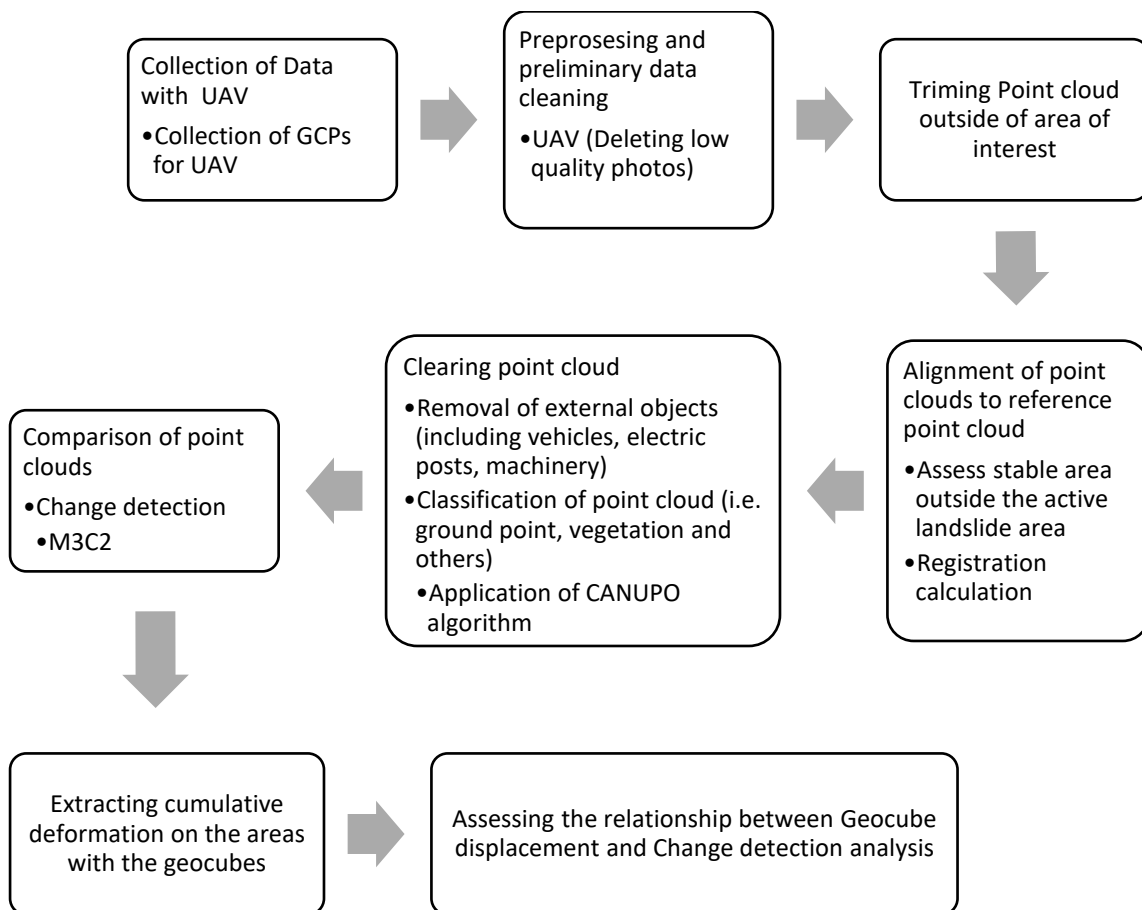
Figure H-1 Methodology implemented to assess the kinematics of the 10-mile slide using the data from the monitoring campaign between 2017 to 2018.
