**35 Years Activity at the Lesueur Landslide  
Edmonton, Alberta**

**D.M. Cruden<sup>1</sup>  
A.E. Peterson<sup>1</sup>  
S. Thomson<sup>1</sup> and  
P. Zabeti<sup>2</sup>**

**For the Canadian Geotechnical Journal**

**November, 2000**

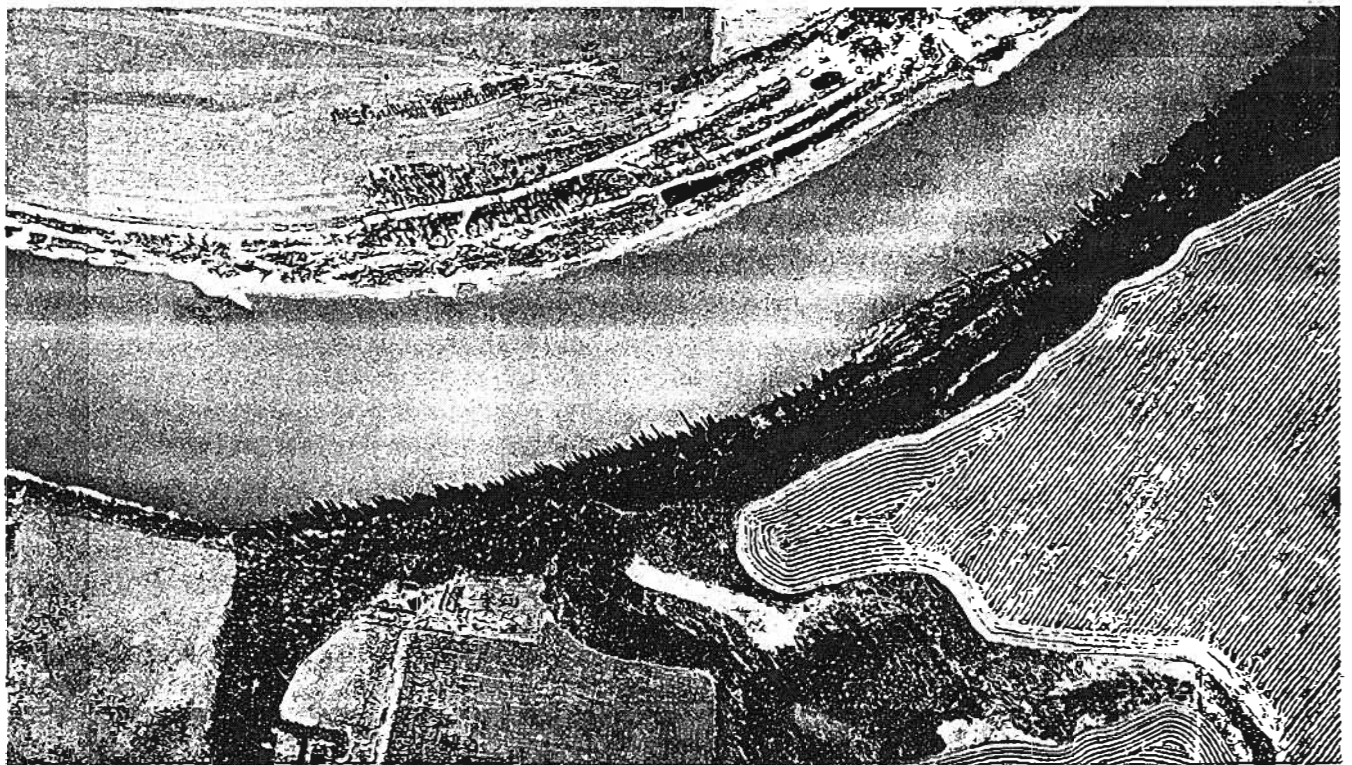
Figure 2. Part of City of Edmonton airphoto YC479-81, nominal scale 1:6000 taken in 1962.  
Location shown on Figure 1.

The 1962 photographs, Figure 2, taken in the year before the landslide, record further upstream expansion of mining activity on the inside of the meander; tailings have been placed in the river, perhaps as embankments to protect pits from flooding by the river. Landsliding has extended upstream on the south bank.

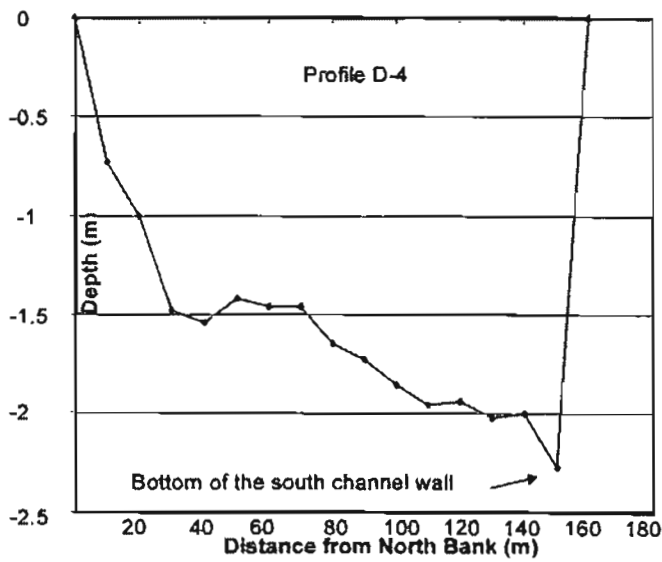
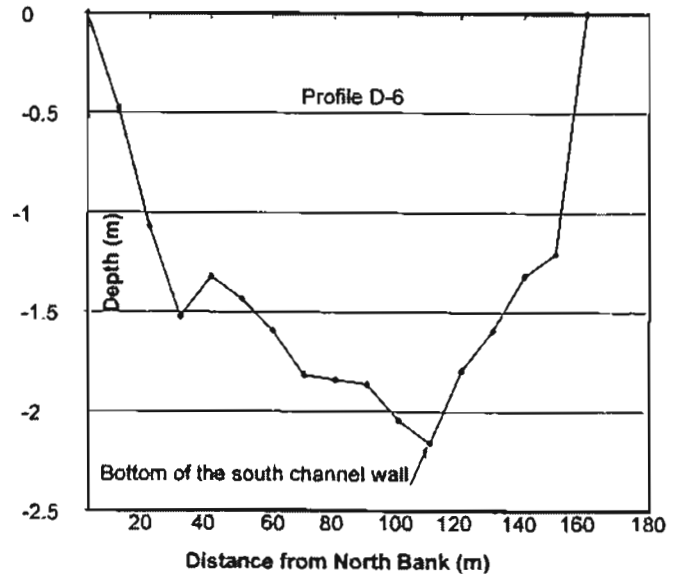
Figure 8. Channel profiles along lines D-4 and D-6 on Figure 6. Vertical exaggeration is 52x.. The south wall of the channel slopes at 13°, the north wall at 3°.

The river channel was investigated by echo sounding, obtaining 6 profiles of the river bed (Zabeti, 1998, Figure 3.5). Two typical profiles, located on Figure 4, are shown on Figure 8. The large exaggeration of the vertical scale emphasizes that on the inside of the meander, the river bed slopes steepen northwards. Their steepness is a reflection of the river being forced northward by the advance of the toe into the river. So, the widening of the river shown on Figure 5 is accompanied by erosion of both banks.
