SHEAR REHABILITATION OF G GIRDER BRIDGES USING CFRP SHEETS

A thesis submitted to the Faculty of Graduate Studies and Research in partial fulfillment of
the requirements for the degree of Master of Science

Structural Engineering

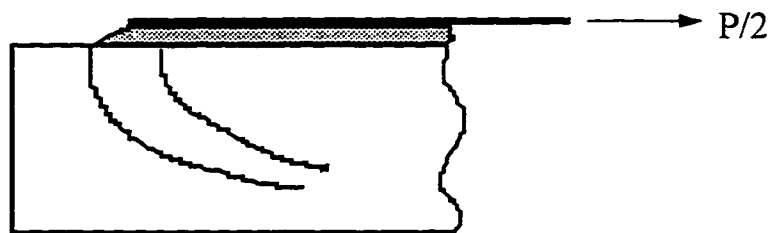
Fig. 3.18 Shear Cracking at end of CFRP Sheet

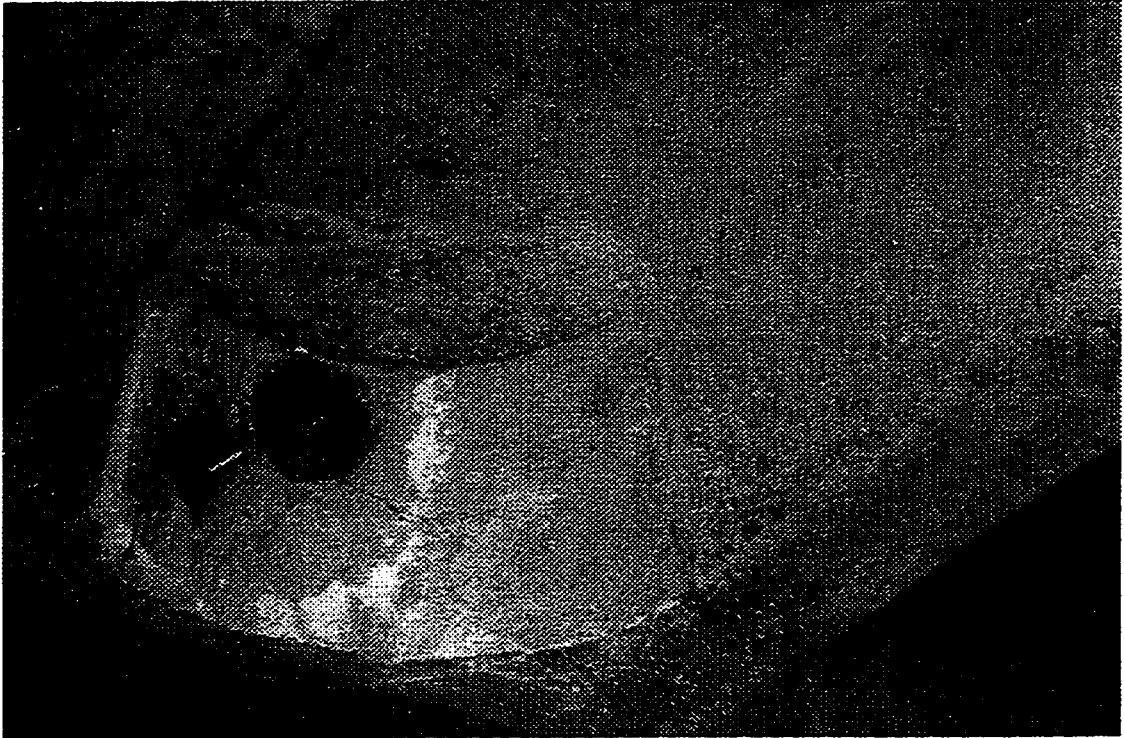
Fig. 7.2 Photo Showing Grout-filled Holes in Girder Diaphragms

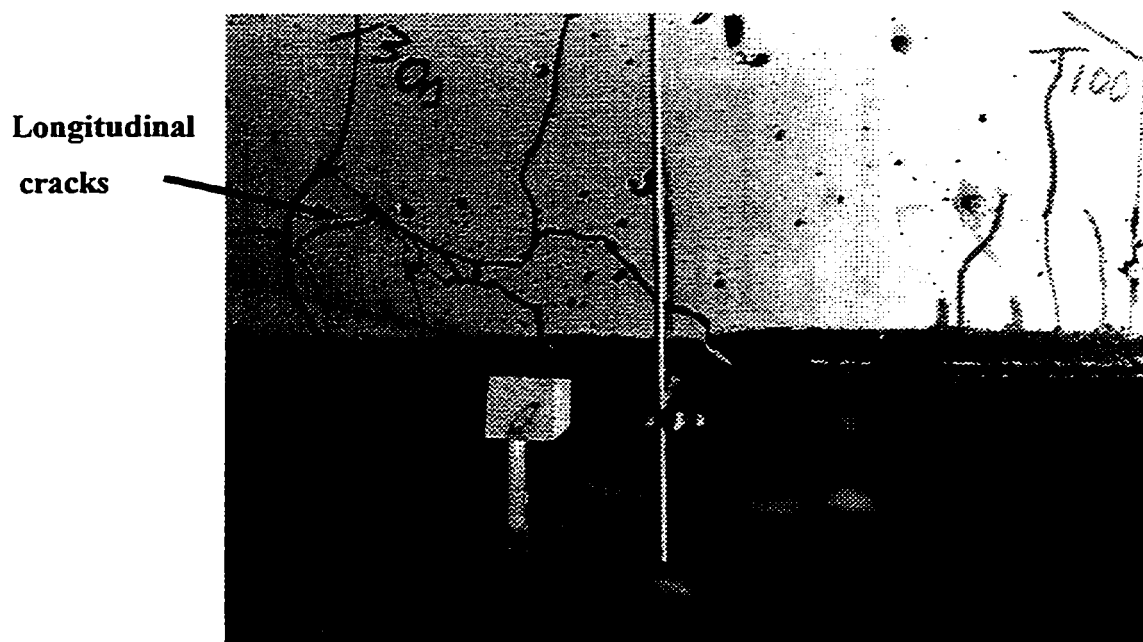
Fig. 8.3 Photo of Longitudinal Cracks due to Flexural CFRP Sheets
