Structural Engineering Report No. 226

# **Rehabilitation of Unreinforced Masonry Walls with Externally Applied Fiber Reinforced Polymers**

by  
M. L. Albert  
J.J.R. Cheng  
and  
A.E. Elwi

October, 1998

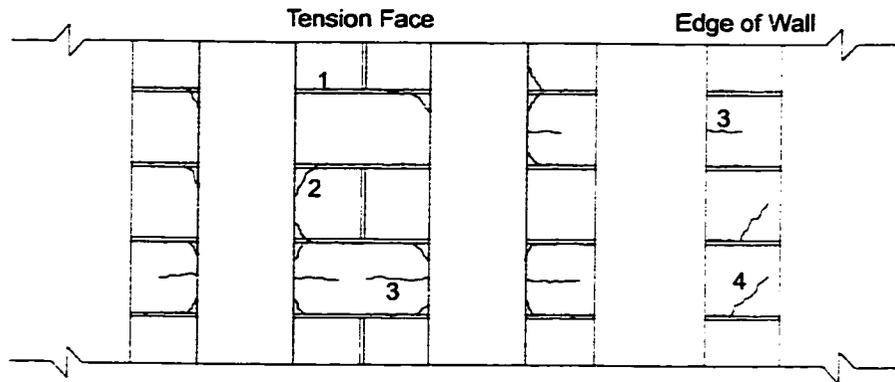
**Figure 4.31 Progression of Cracks During a Typical Test**

- 1 Mortar separation between load points
- 2 Diagonal cracks from fiber reinforcement to mortar joint
- 3 Horizontal cracks within the block
- 4 Flexure-shear cracks in the edge blocks

Each reinforced specimen followed a series of steps before failure occurred. The first event that happens is the progressive separation of the horizontal mortar joints in the constant moment region. Once every joint has fully separated diagonal cracks begin to appear in random locations. The cracks begin at the edge of the reinforcement strips and angle up or down to the nearest horizontal joint. The difference in strain between the reinforcement and the adjacent joint, as shown in the section on strain behaviour, explains the formation of these diagonal cracks. In the tests which experienced mid-span deflections over 70 mm, the reinforcement would begin to pull the face of the masonry block away from the wall. This occurred when diagonal cracks had fully formed around a joint location. Next, horizontal flexure cracks would form in random locations. The cracks would typically start from the center of a block at the edge of the reinforcement strip and progress outwards towards the edge of the wall or towards the center of the wall. In some cases the flexure cracks spanned completely between the strips of reinforcement. Not all joints and blocks experienced these diagonal cracks and flexure cracks. Finally, if flexure failure had not occurred, flexure-shear cracks would form on the edge blocks of the wall. These cracks formed between the 5<sup>th</sup> and 7<sup>th</sup> courses from the base of the wall, just below the lower load point, as well as between the 14<sup>th</sup> and 16<sup>th</sup>

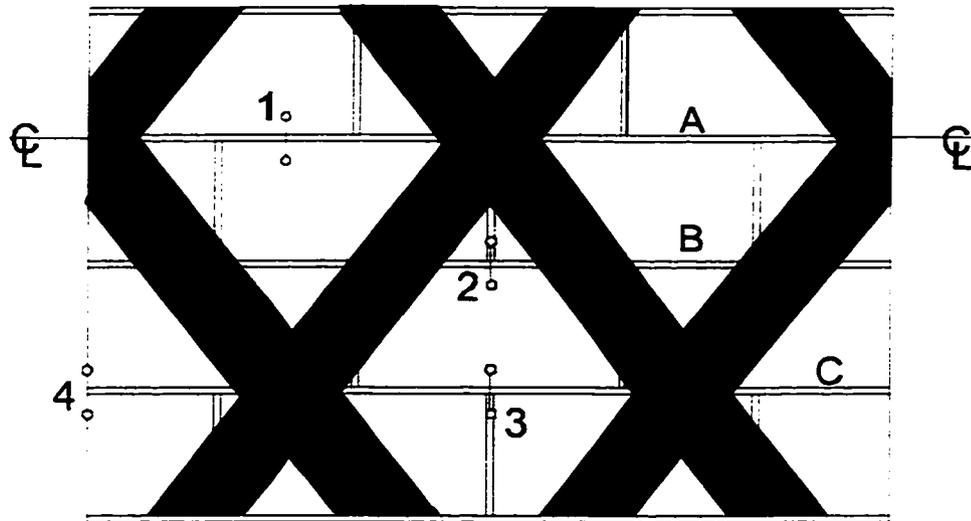
**Figure 5.4 Effect of Reinforcement Layout - ICST 12**

1. 18000  $\mu\epsilon$  = 0.9 mm
2. 12000  $\mu\epsilon$  = 0.6 mm
3. 26000  $\mu\epsilon$  = 1.3 mm
4. 35000  $\mu\epsilon$  = 1.8 mm

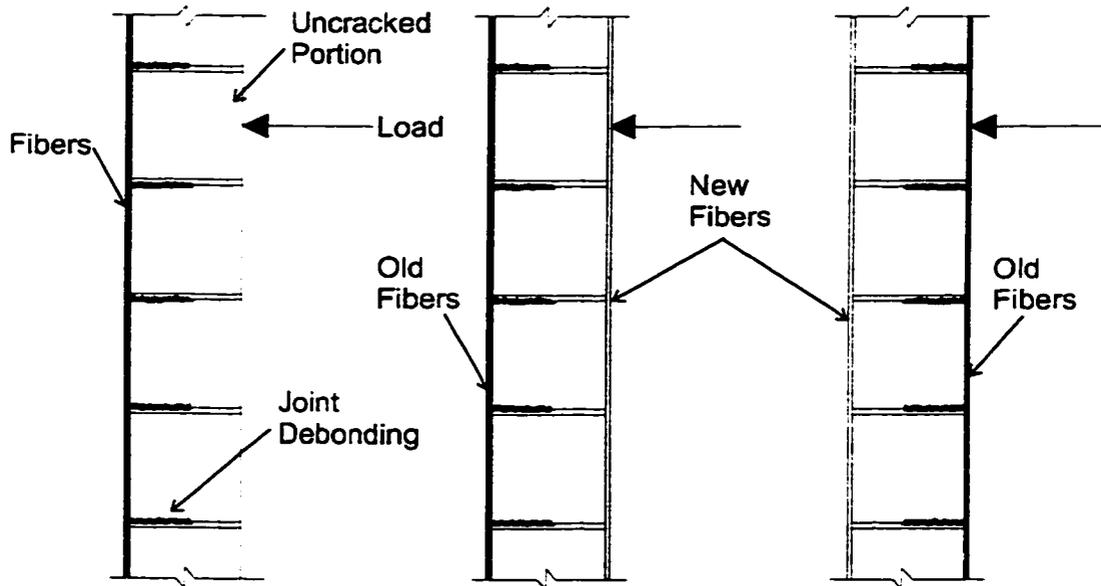
**Figure 5.6 Preparation of Specimen MCST 7-4**

Original specimen cracks on tension face. (MCST 4)

Carbon fibers applied to compression face.

Specimen is rotated and tested with the uncracked section now in tension.
