Title of Thesis: The MacKay River Terrain
Analysis and Landslide Inventory

The MacKay River Terrain Analysis and Landslide Inventory

Department of Civil Engineering

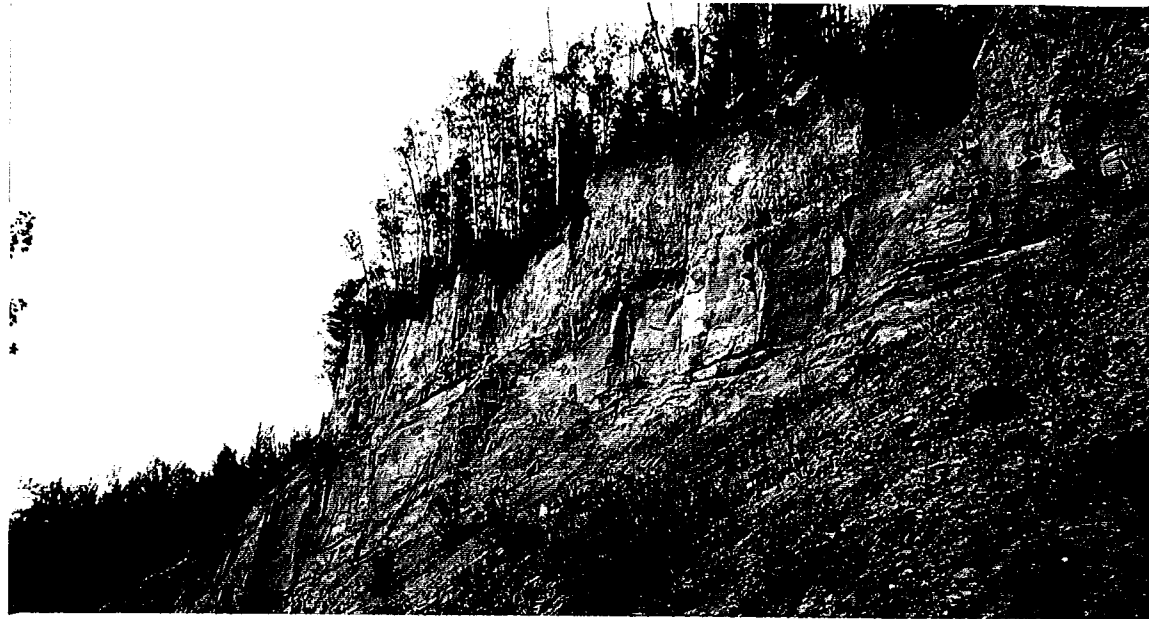
Figure 3.2.1b Photograph of the sand outcrops in the centre of Channel 2 that are below 5m of glacio-lacustrine deposits.

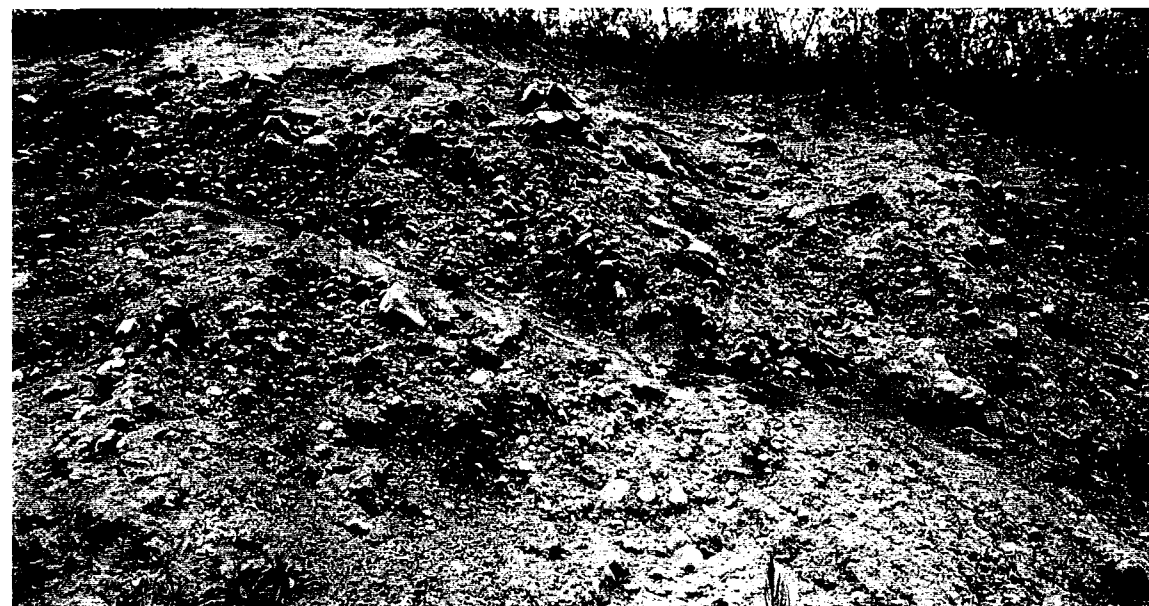
Figure 3.2.1c. Photograph of the gravel deposits of Channel 2. Figure 3.2.1.a. shows the location of the outcrop. The outcrop is 5m high for scale.

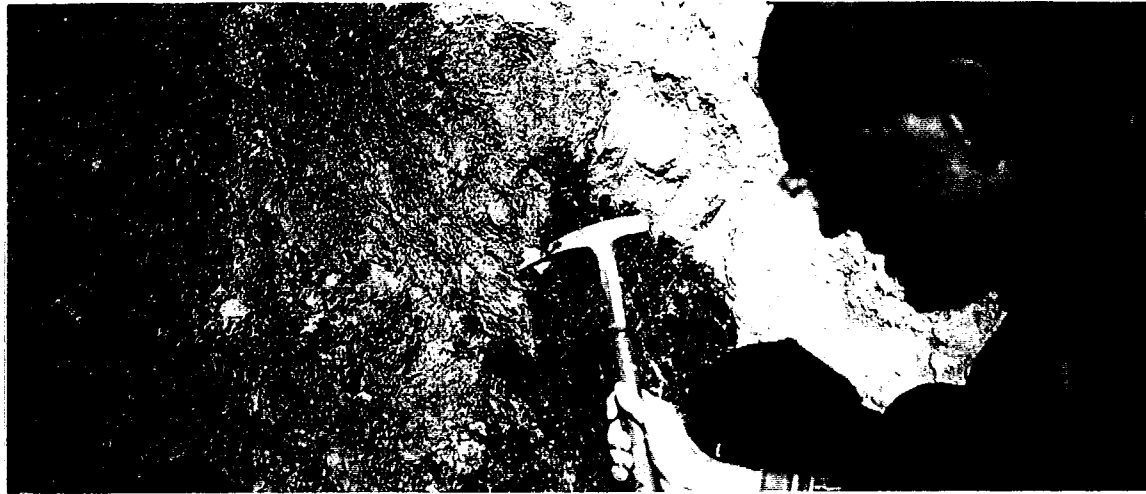
Figure 3.2.2a. Photograph of rip-up clast of till in gravelly sand of Channel 5. The head of the rock hammer marks the contact.

boulders observed in any of the outcrops. Rip-up clasts of till are present in the sediments indicating that it could have been deposited during the Lake Livingstone megaflood. Figure 3.2.2a is a photograph of a rip-up clast of till in the pebbly sand and Figure 3.2.2b is a photograph of the Channel 5 deposits taken from river level. Channel 5 is deposited on Kcw member of the Clearwater bedrock and possibly on top of the McMurray Formation oil sands in the northern most outcrops.

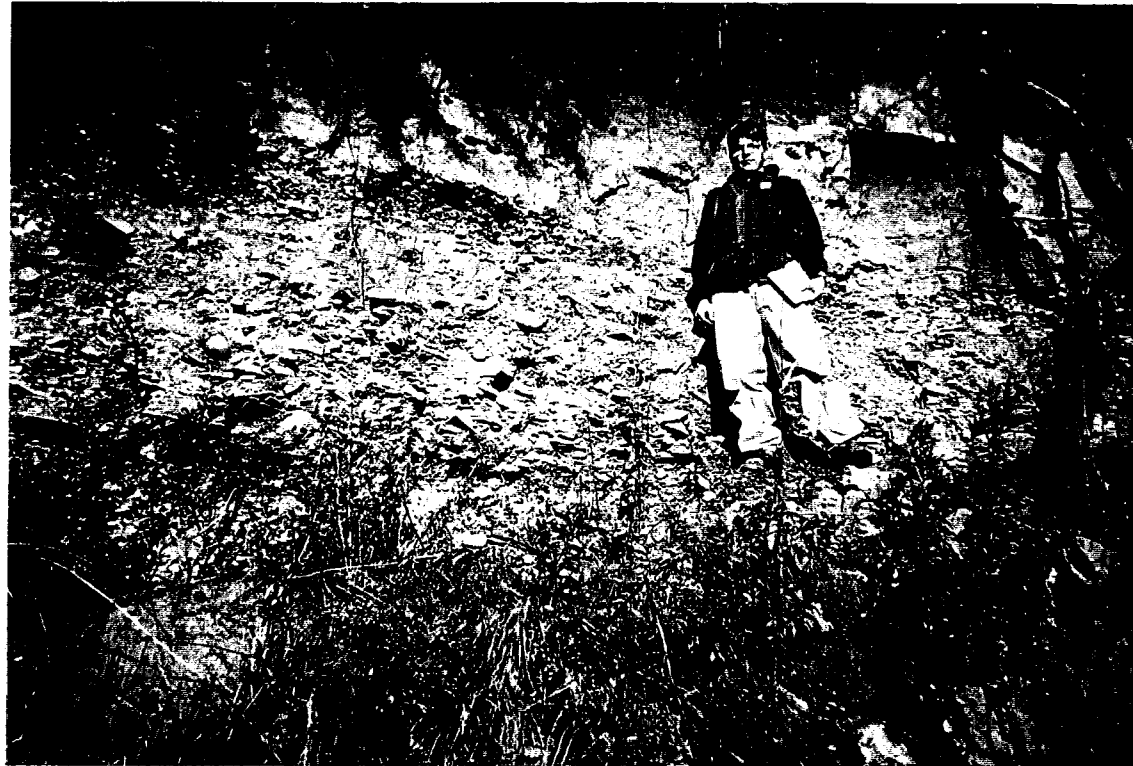
Figure 3.3.1b. Photograph of the fluvial terrace deposits from the 7 to 10m terrace (T3).

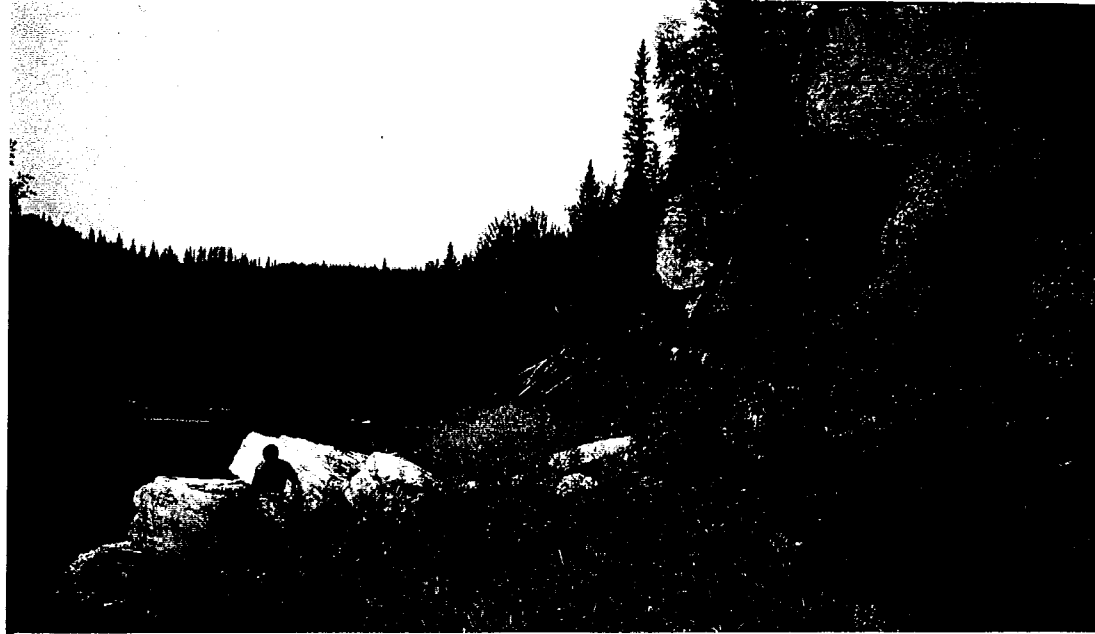
Figure 3.5.2a. Rock fall in the Waterways Formation. The black dot marks the same location on Figures 3.5.2a and b. Philip Lobo is in the photograph for scale.

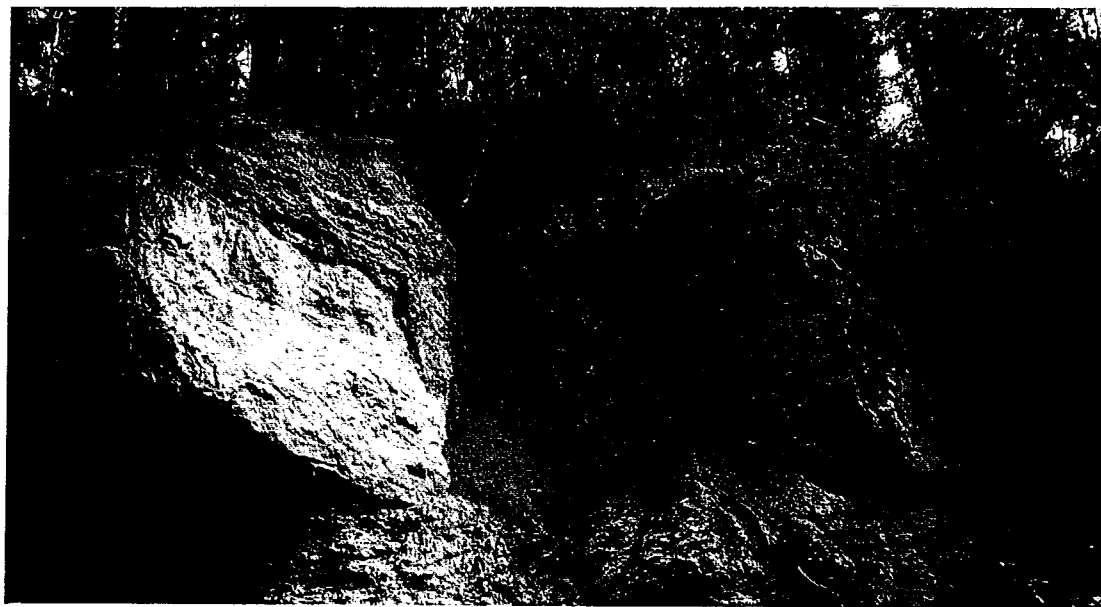
Figure 3.5.2b. The section of cliff the block fell from. The vertical field of view is approximately 4m for scale.

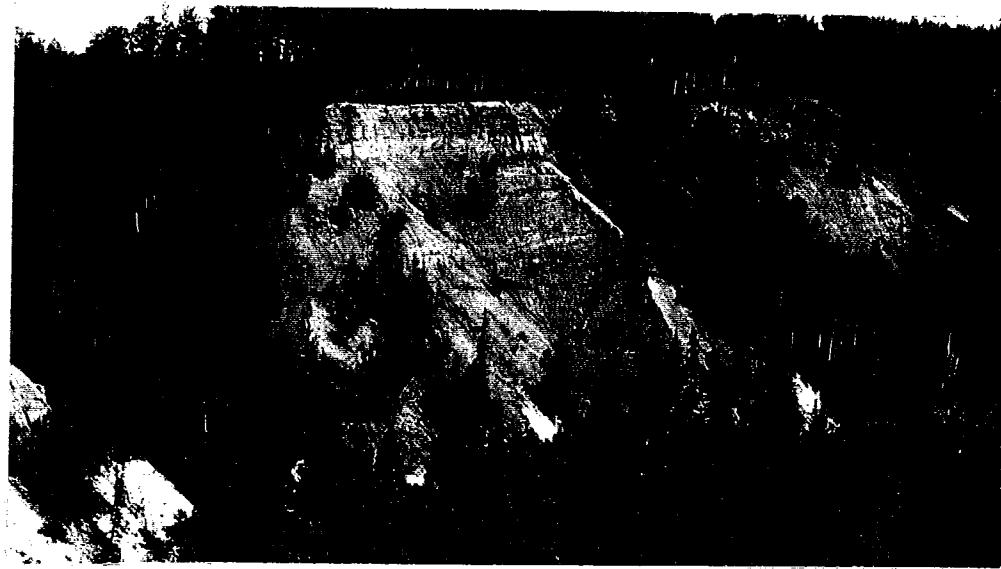
Figure 5.2.1. Photograph of Slide 1953aa. The overlay of the photograph shows the features of the Slide 1953aa. Profile and stratigraphy on Figure 5.2.2b.

Figure 5.2.1 is a photograph of Slide 1953aa taken from a helicopter by on August 20, 1995. Three sets of air photographs are discussed in this section. They are summarized in Table 4.2.1. The air photographs were obtained from Alberta Photo Services (Maps Alberta). Other sets of air photographs were examined, but are not necessary for the interpretation because there are no visible changes between 1953 and 1988.

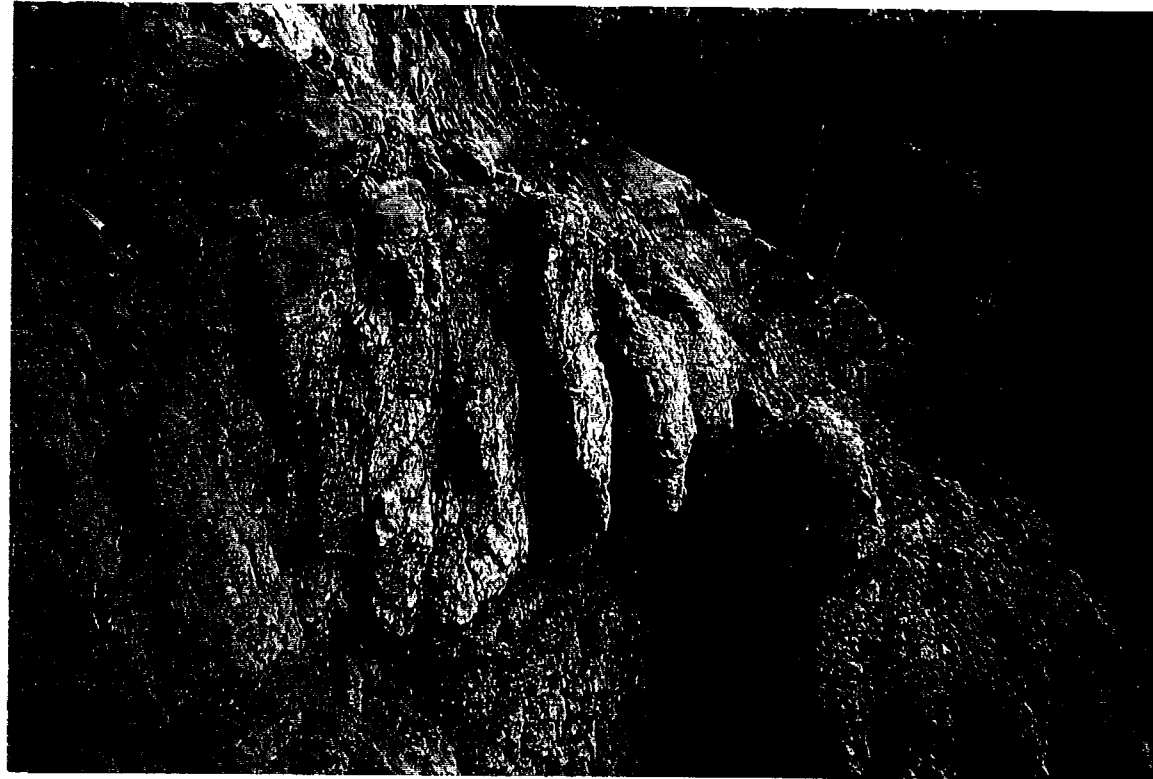
Figure 5.2.2a. Exfoliation fractures in the oil sands on the upstream flank of Slide 1953aa. The tape on the left side of the photograph is for scale.

The main scarp of the landslide is scalloped because the seepage at the centre of the slide would trigger movements at the centre of the slide. Rock-slides and rock-topples will start above the seepage and slowly radiate out, enlarging the landslide. Most of the material moved is at the centre of the slide and less at the flanks. The slopes on site have probably been moving for thousands of years. Vegetation cannot re-establish because the south-facing slopes are very hot during the summer and very steep. Another explanation is that the light oils in the bitumen evaporates leaving an asphalt-like coating

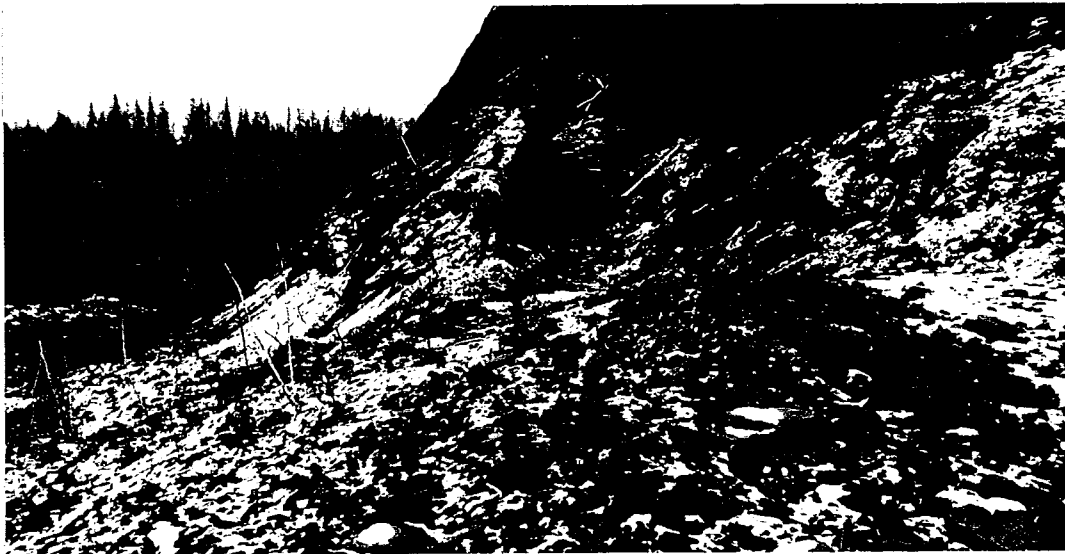
Figure 5.4.2b. Photograph of the block of oil sands that slide off the upper slope of Slide 22-773e. I am in the centre of the photograph for scale.

Figure 5.4.2b is a photograph of a large slab of oil sands about 3m thick, 20m wide and 5m long. The photograph was taken on October 25, 1995.

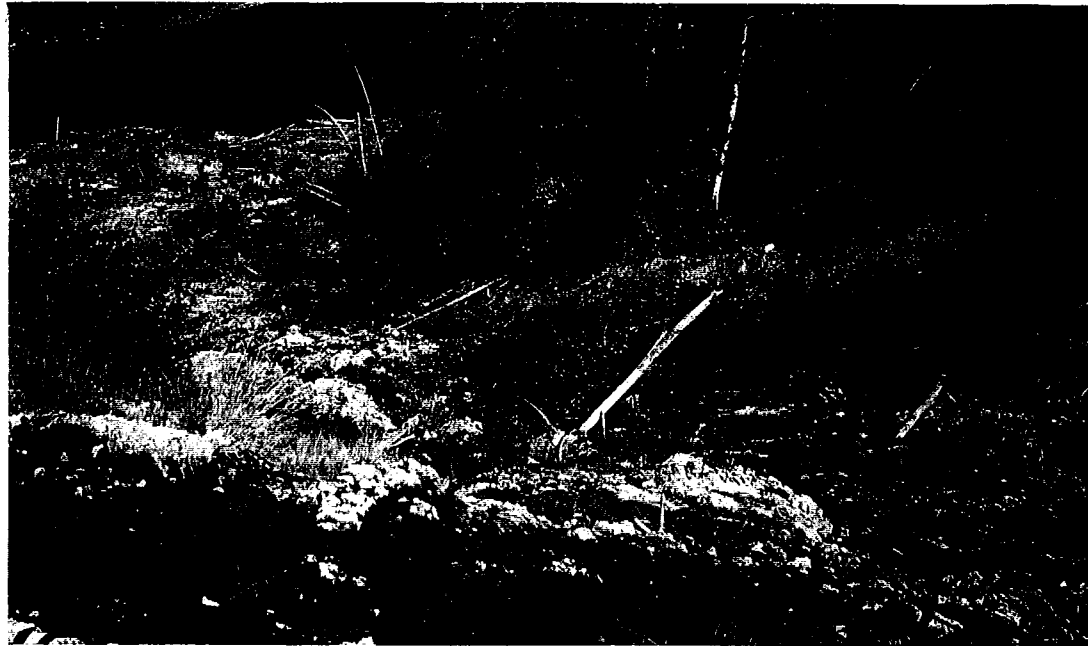
Figure 6.3.1a. Photograph of the zone of accumulation and narrowest portion of Slide 23-806c taken from halfway up the profile. The log in the centre of the photograph is approximately 8m long for scale.

The field investigations revealed that since 1991 there have been no new deposits in the zone of accumulation, but there has been some minor retrogression of the top scarp of the landslide in the glacial deposits. Figure 6.2a shows that there are a minimum of 2 flows that deposited colluvium in the zone of accumulation. Small trees have grown on the edges of the zone of accumulation, but the centre portion of the zone of accumulation has been covered with the colluvium from the most recent flow that occurred between 1972 and 1981. In the centre of the zone of accumulation is a dead 1m diameter pine tree that was not uprooted by the earth flow, indicating that the flows were relatively wet and did not contain large blocks of debris. The pine tree died after the shallow roots were covered by colluvium.

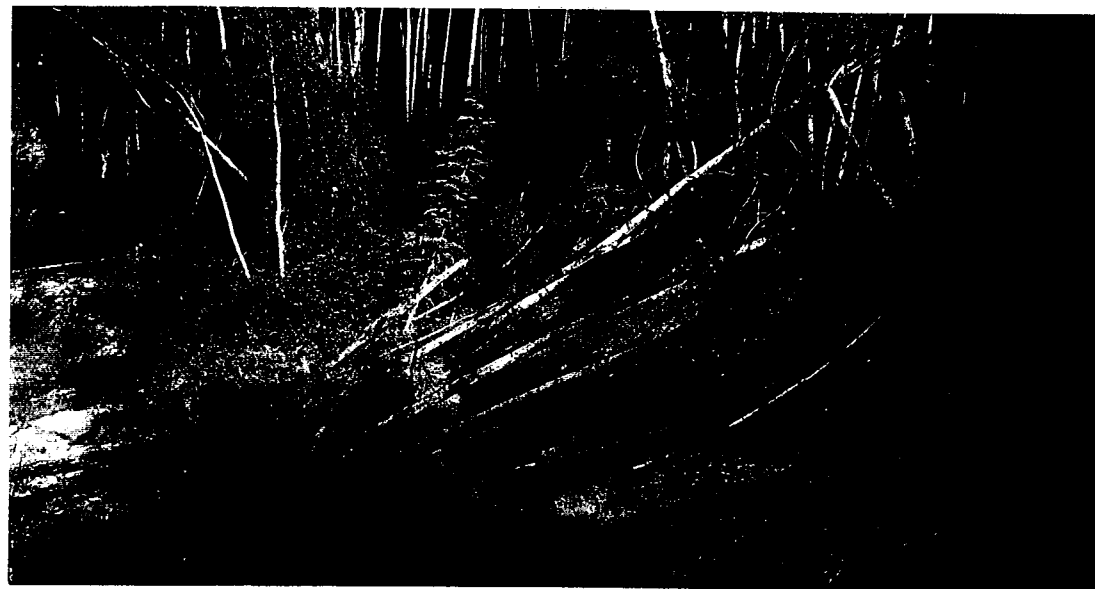
Figure 6.3.1b. Photograph of the earth-slide earth-flows on the main scarp of Slide 23-806c. The main scarp is 1-2m high for scale.

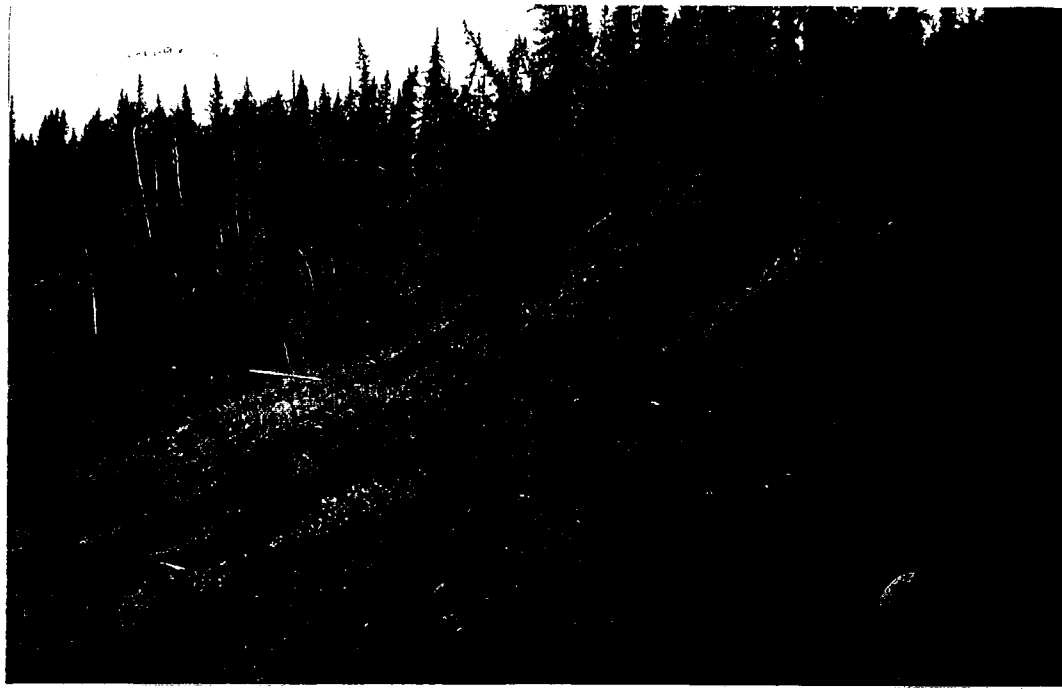
Figure 7.3.1a. Photograph of the slope below the shelf. Colluvium deposited by shallow earth-slide earth-flows in weathered Clearwater Formation bedrock is at the base of the slope. The tree in the middle of the photo is 2m high for scale

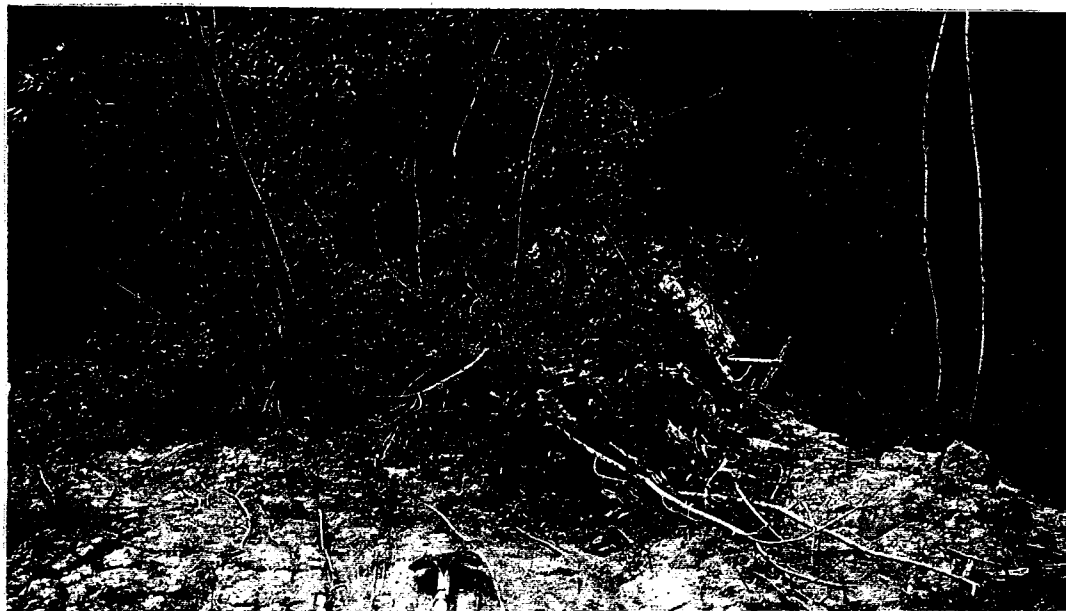
Figure 7.3.1b. photograph of a block of root-reinforced colluvium sliding on weathered glacial sediments. The head of the shovel at the bottom of the picture is for scale.
