LONG TERM PERFORMANCE OF DEVON GEOGRID  
REINFORCED CLAY EMBANKMENT

A thesis submitted to the Faculty of Graduate Studies and Research in  
partial fulfillment of the requirements for the degree of Master of Science

Geotechnical Engineering

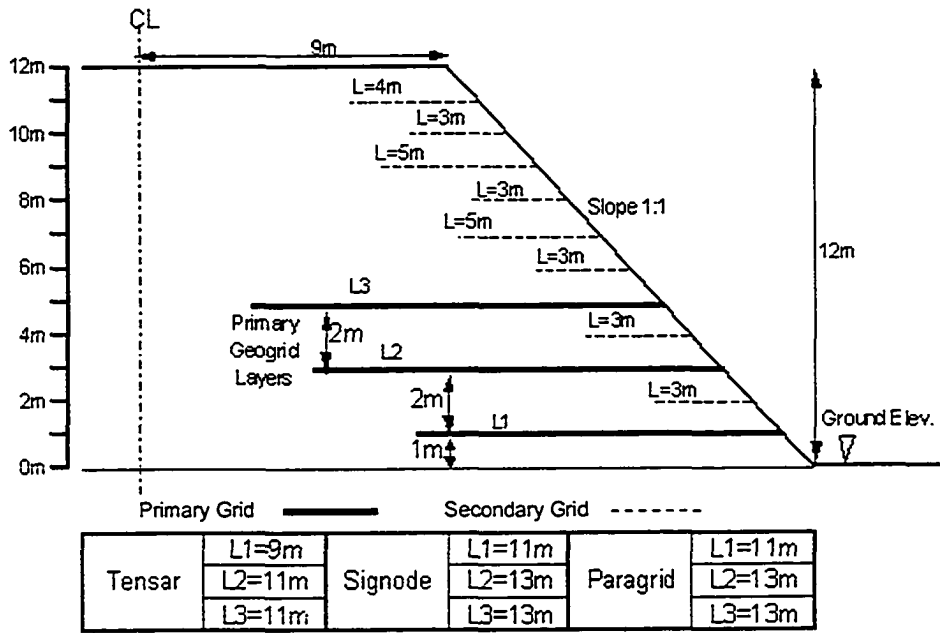
Figure 4. Layout of Geogrids in Devon Test Fill

Other than the above primary reinforcing materials, Tensar SR1 and SS1, Signode TNX250 and Paragrid 5T grids were used in the three reinforced sections of the test fill as the secondary reinforcing materials to provide additional reinforcement against shallow slope failures. These secondary geogrids were not instrumented and detailed discussion on the properties of the secondary reinforcing materials is beyond the scope of this thesis. A typical cross section and layout of primary and secondary geogrid layers in the reinforced slopes is illustrated in Figure 4. Some tertiary reinforcing grids were also placed every 0.33 m between

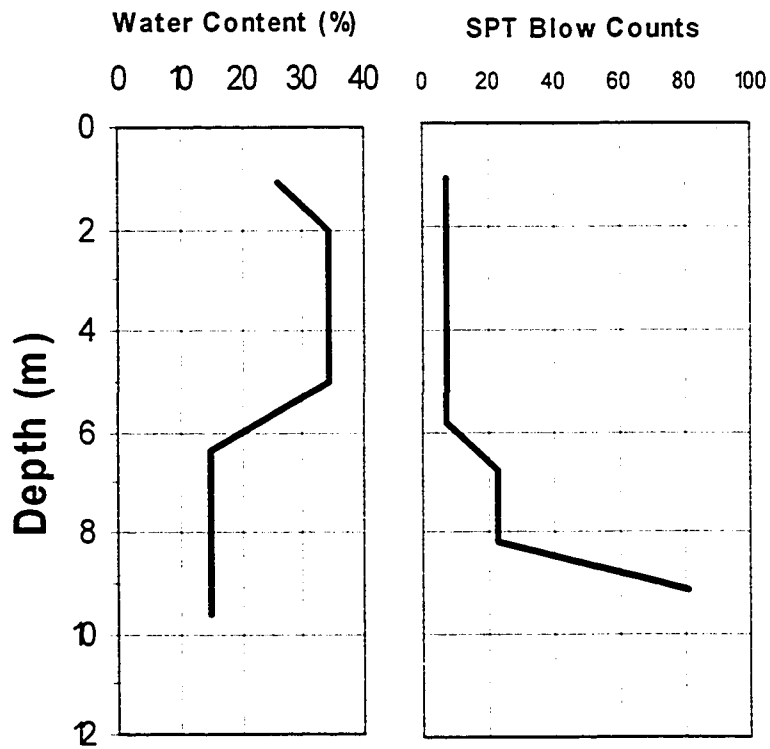
Figure 6. Profile of SPT blow count and water content variation in foundation soil (modified from Hofmann, 1989)

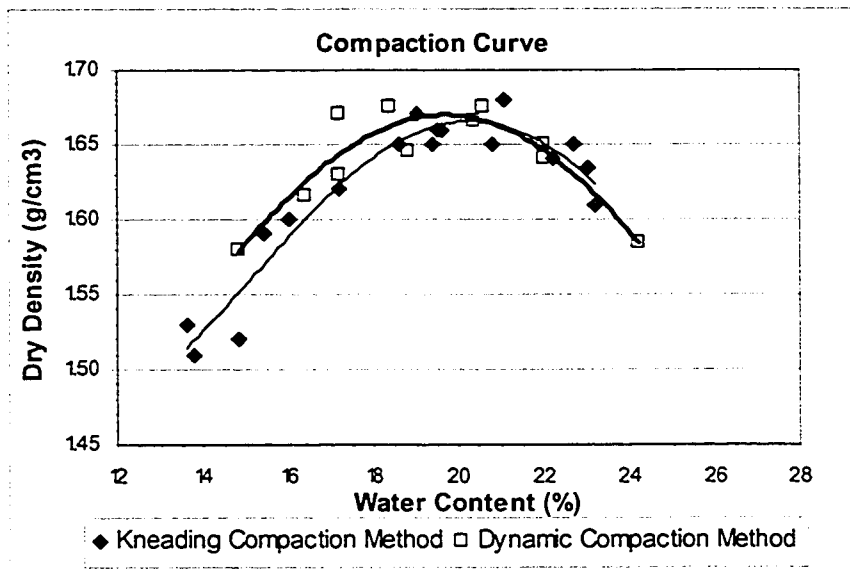
Figure 7. Compaction curves of fill soil (modified from Hofmann, 1989)

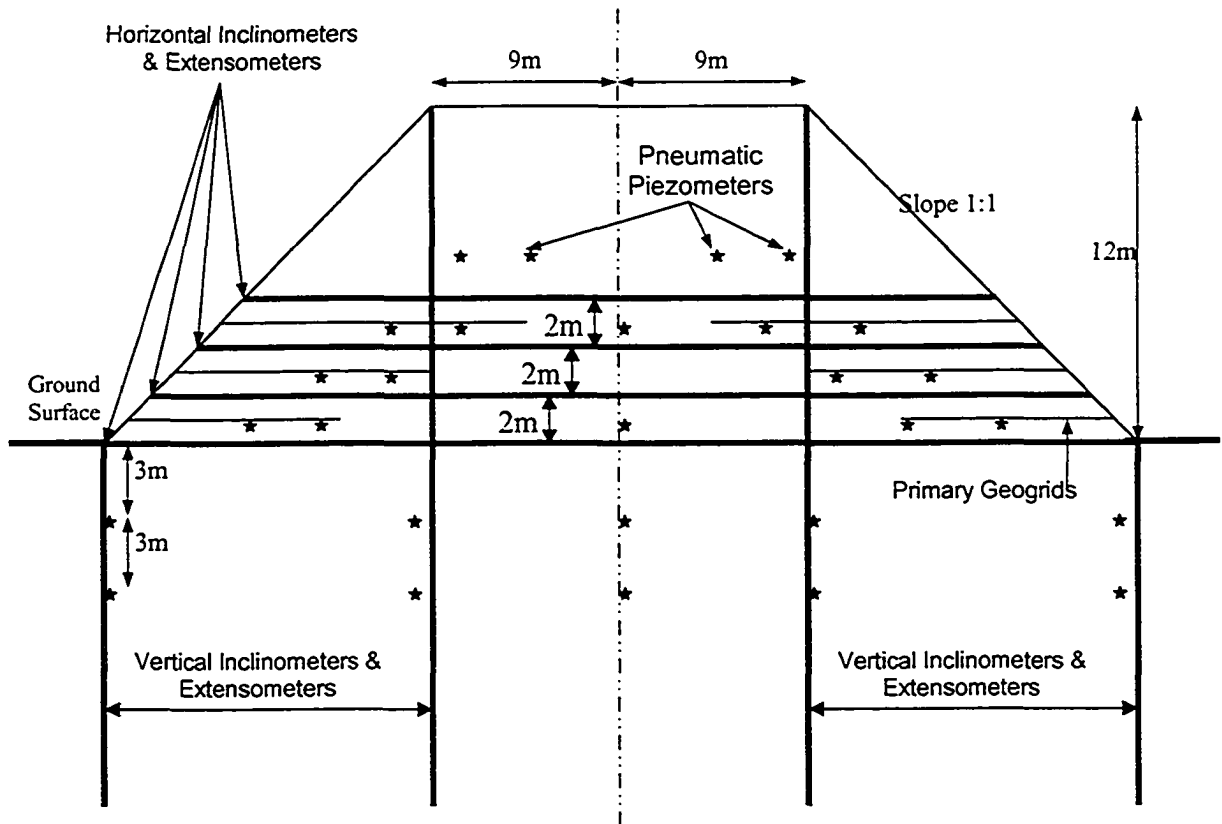
**Figure 14. Instrumentation Layout in the Foundation and Fill Soil**

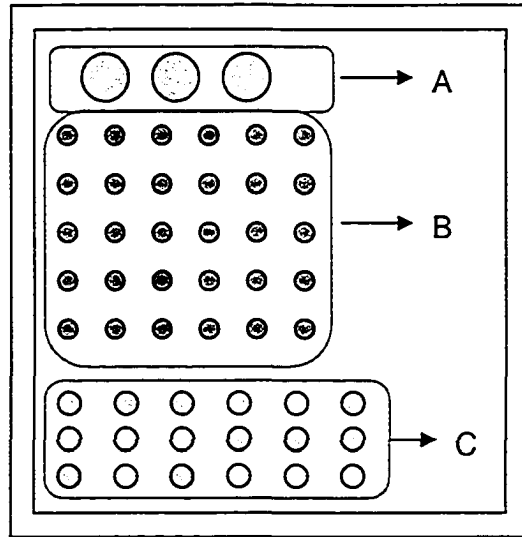
**Figure 15. Front view of the connection box with different plugs; A=Thermocouples, B=EWR strain gauges, C=Bison strain gauges (number of plugs may vary for “B” and “C”)**

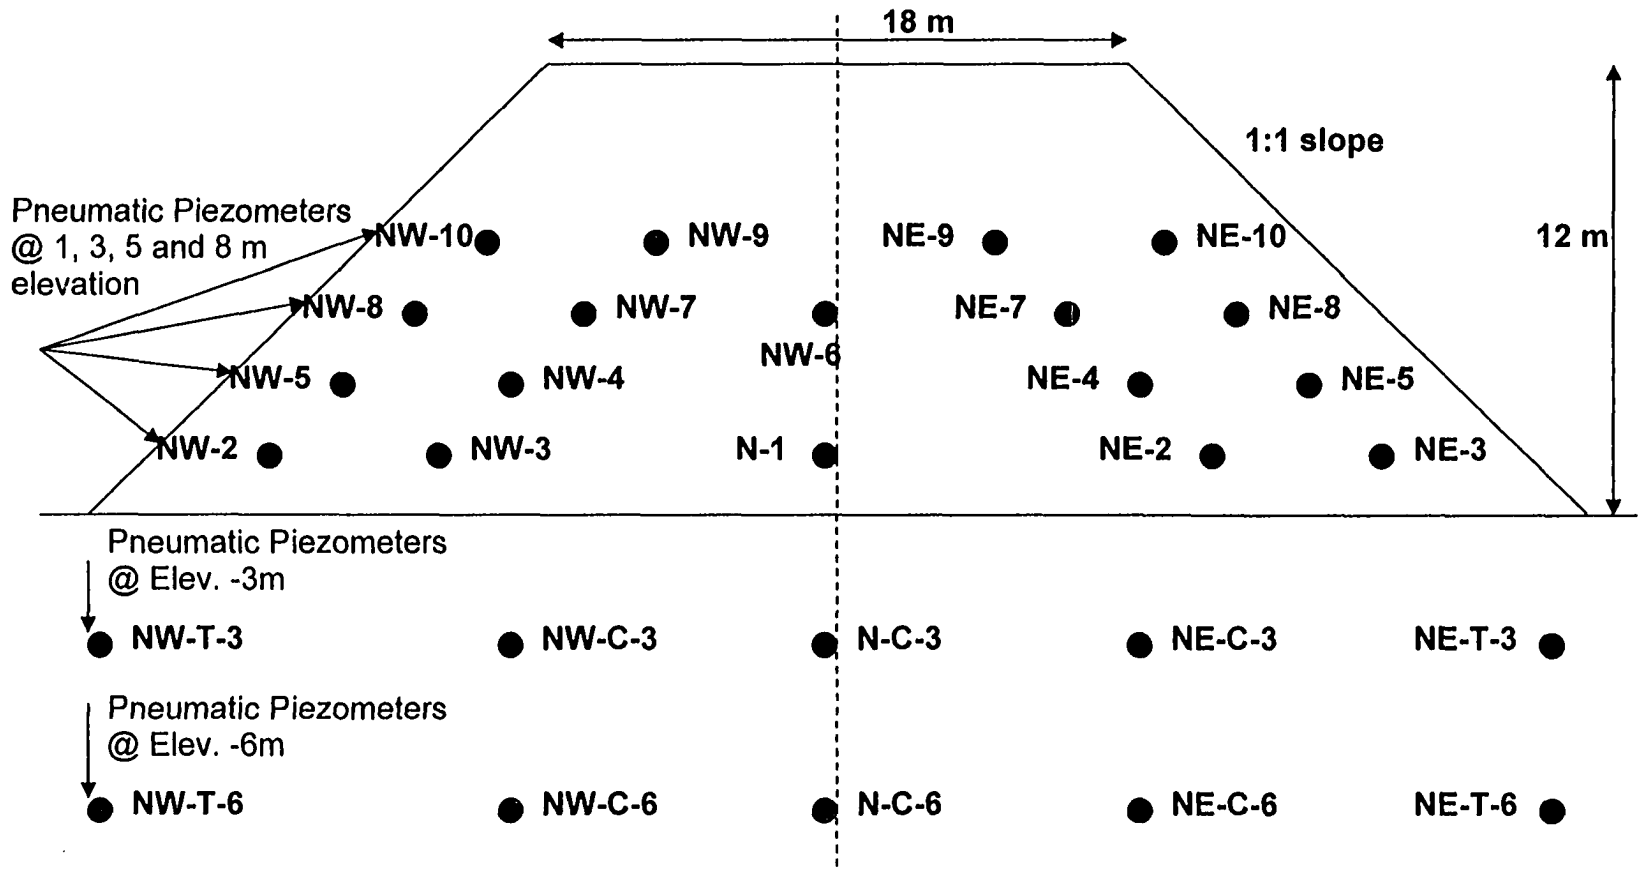
Figure 4. Lay out of pneumatic piezometers in the northern half of the test embankment (not to scale)
