Structural and Hydrologic Characterization of Two Historic Waste Rock
Piles

A thesis submitted in partial fulfillment of the requirements for the degree
of

Geoenvironmental Engineering

Department of Civil and Environmental Engineering
University of Alberta

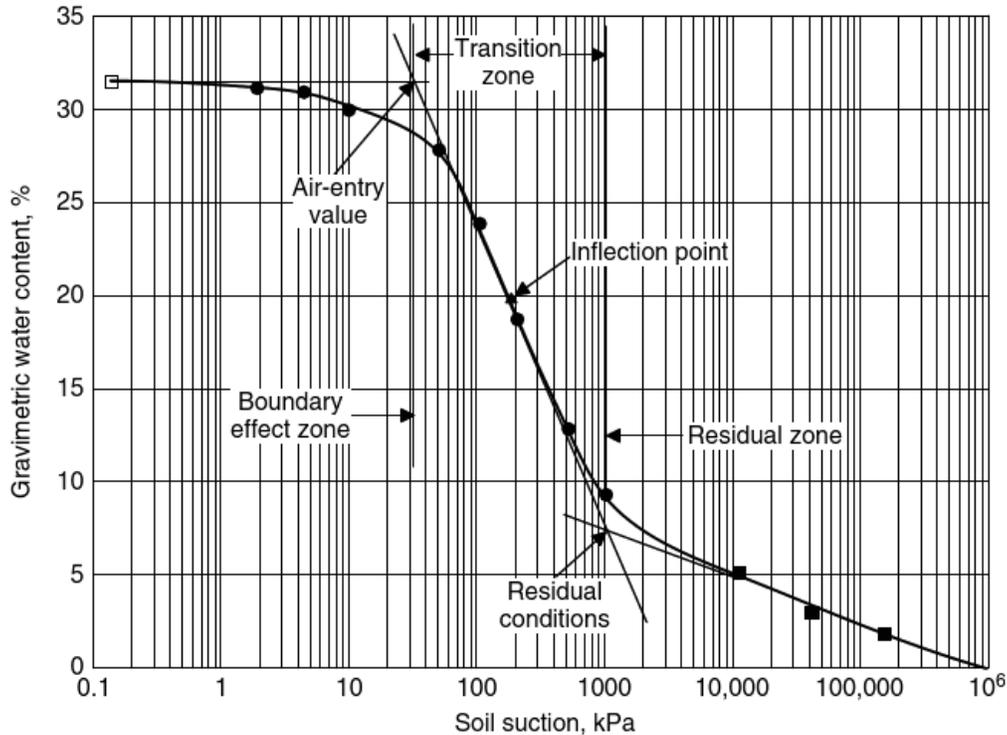
Figure 2.1- Typical Soil Water Characteristic Curve showing major zones of desaturation (from Fredlund et al., 2012)

A SWCC has three distinct zones, including the boundary effect zone, the transition zone, and the residual zone (Figure 2.1). At the intersection of the boundary effect and transition zone is the air-entry value (AEV) that represents the point at where water in the largest pores begin to drain and allow air entry. Residual conditions occur at the boundary of the transition and residual zones (Fredlund et al., 2012). All pore sizes that can drain have lost water and have been replaced by air, resulting in a discontinuous water phase around the soil particles. The residual zone ends at a soil suction of 10^6 that corresponds to oven dry.

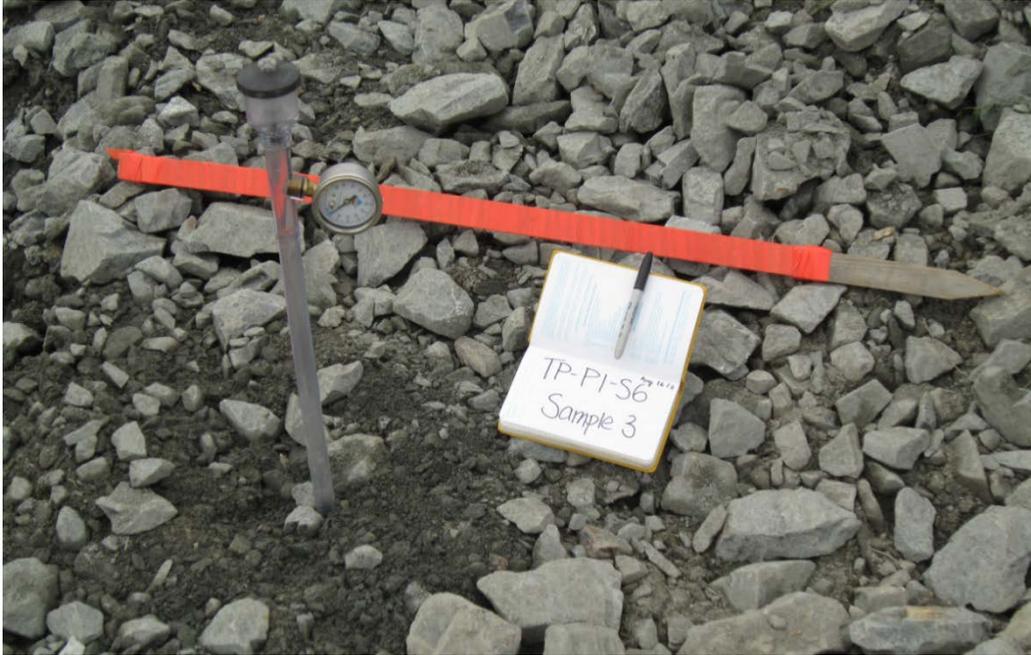
Figure 3.4 - Typical tensiometer installation in fine material.

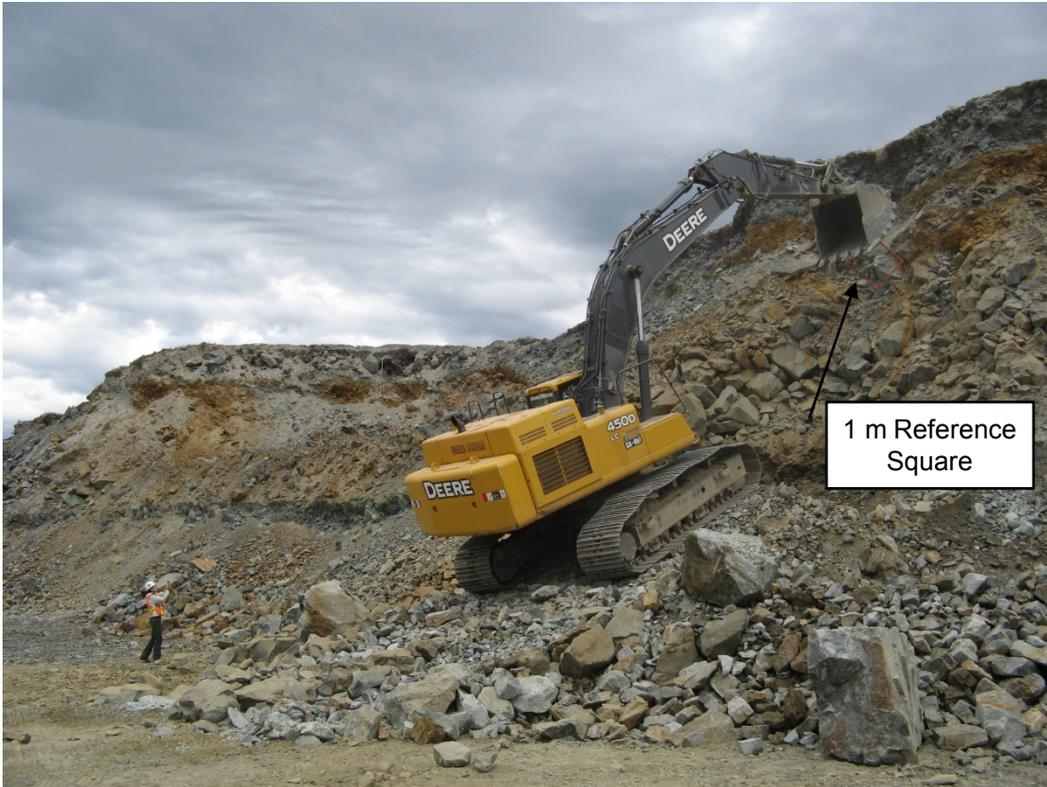
Figure 3.9 – Profile investigation on Waste Rock Stockpile 1 using an excavator. Note the person for scale and excavator holding reference square for photos taken.

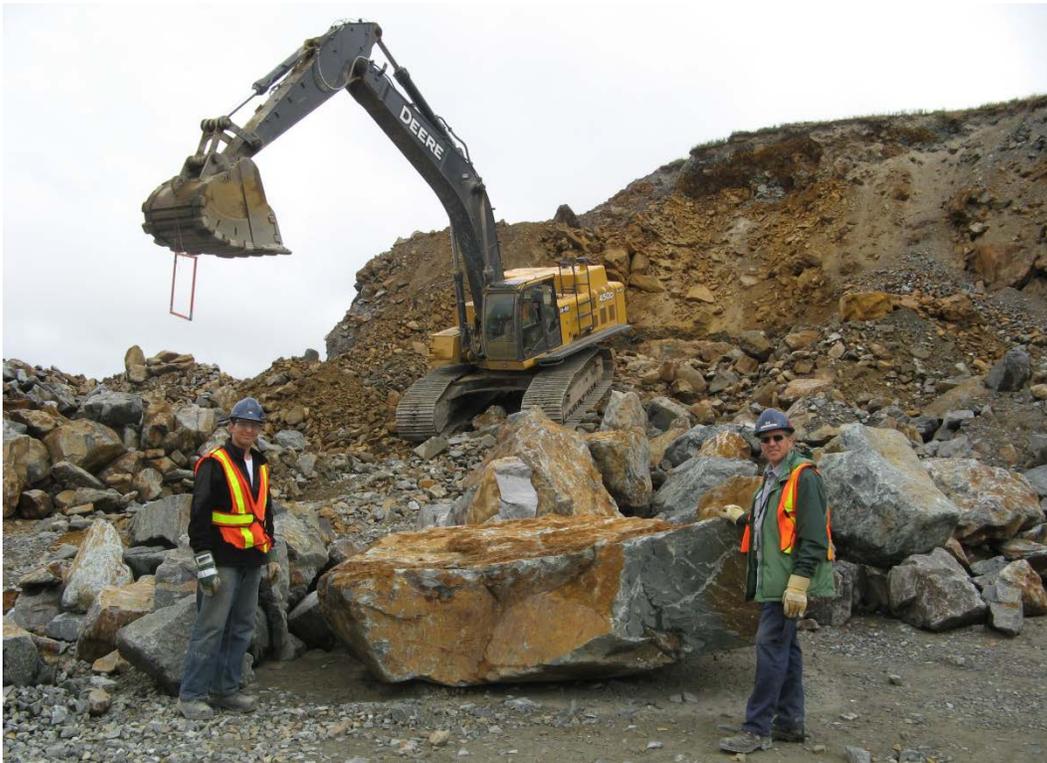
Figure 3.11 - 20-L pail samples were limited to fine material. Grain size was observed in excess of 1 m.

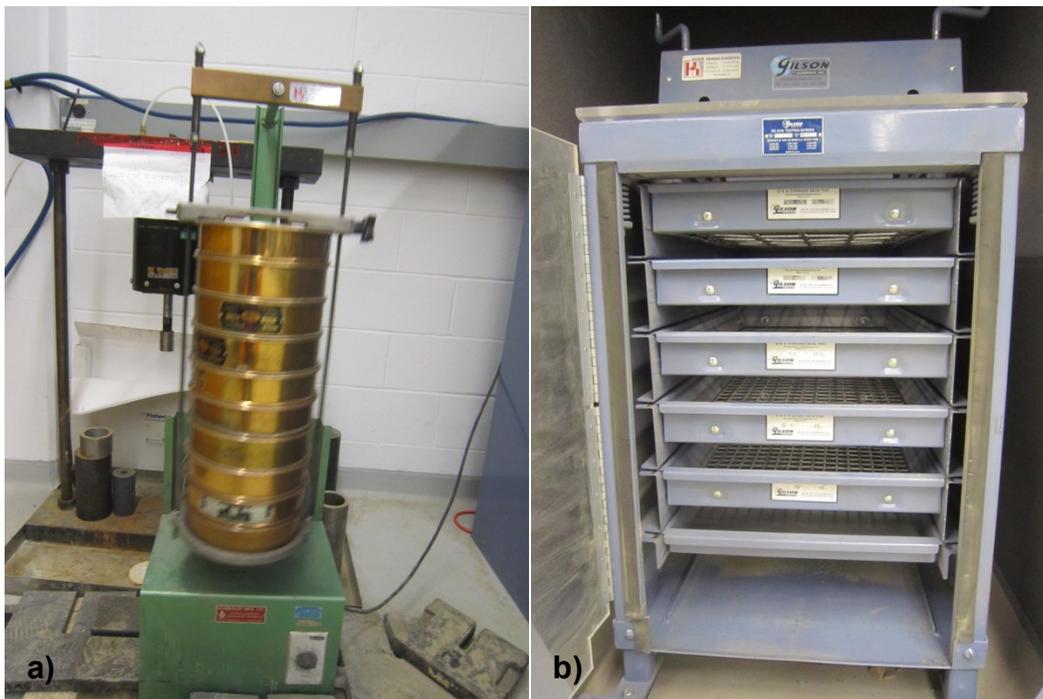
Figure 3.12 - Sieve analysis a) Standard mesh sieves for fine grained fraction, b) TS-2 Gilson Testing Screen for coarse fraction

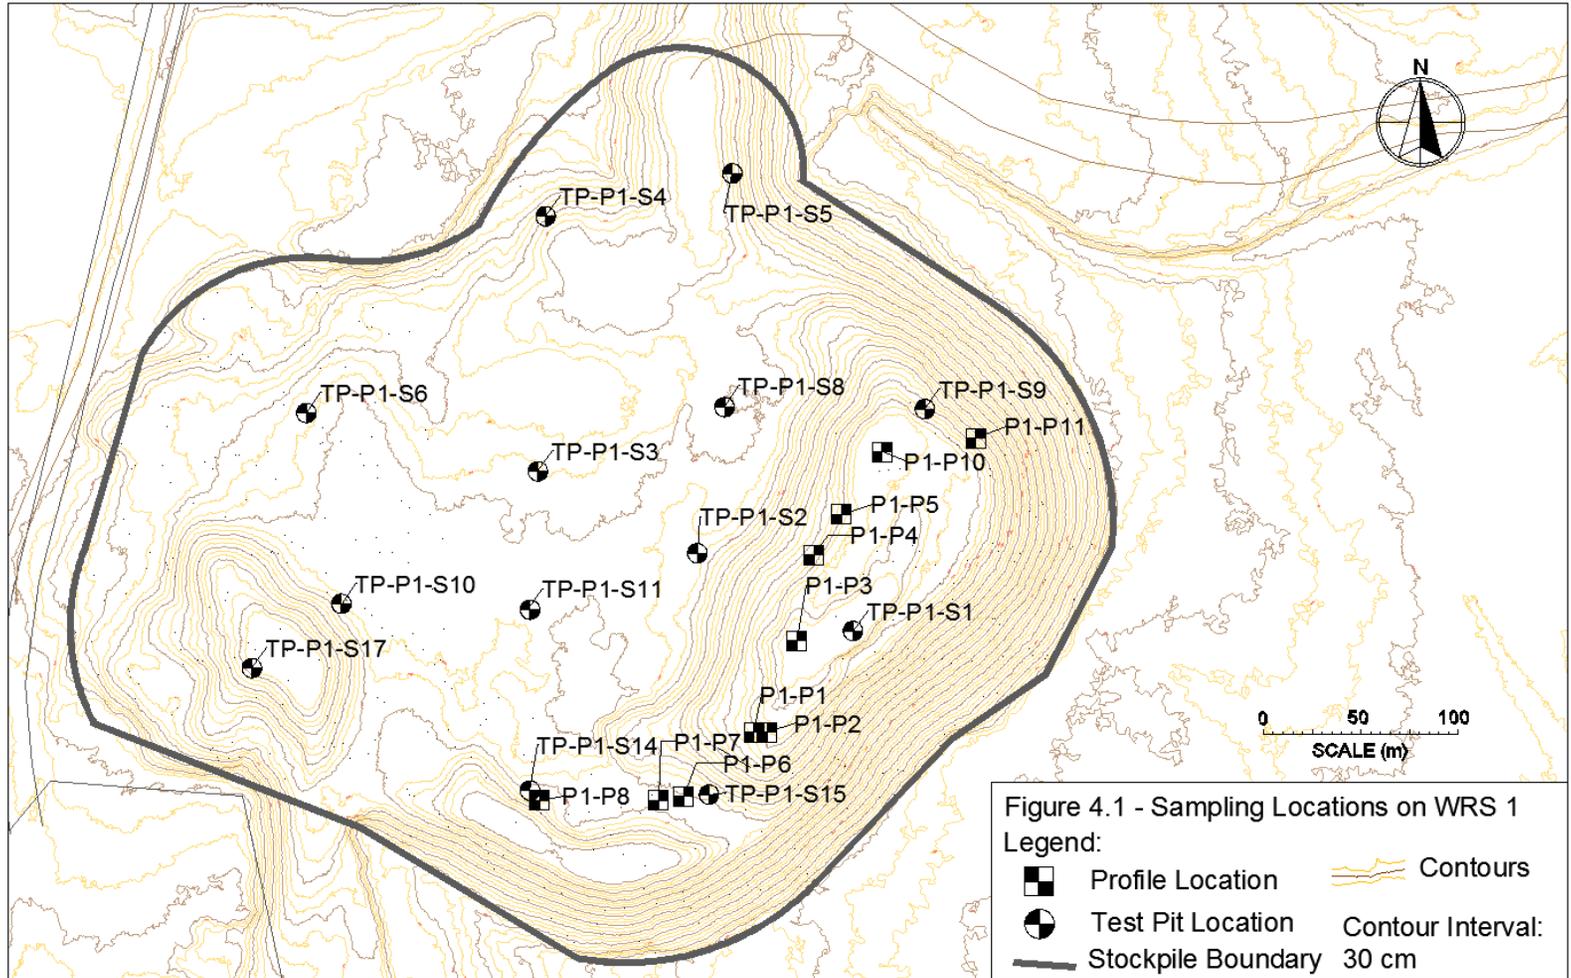
Figure 4.1 - Test pit and profile sampling locations on WRS 1

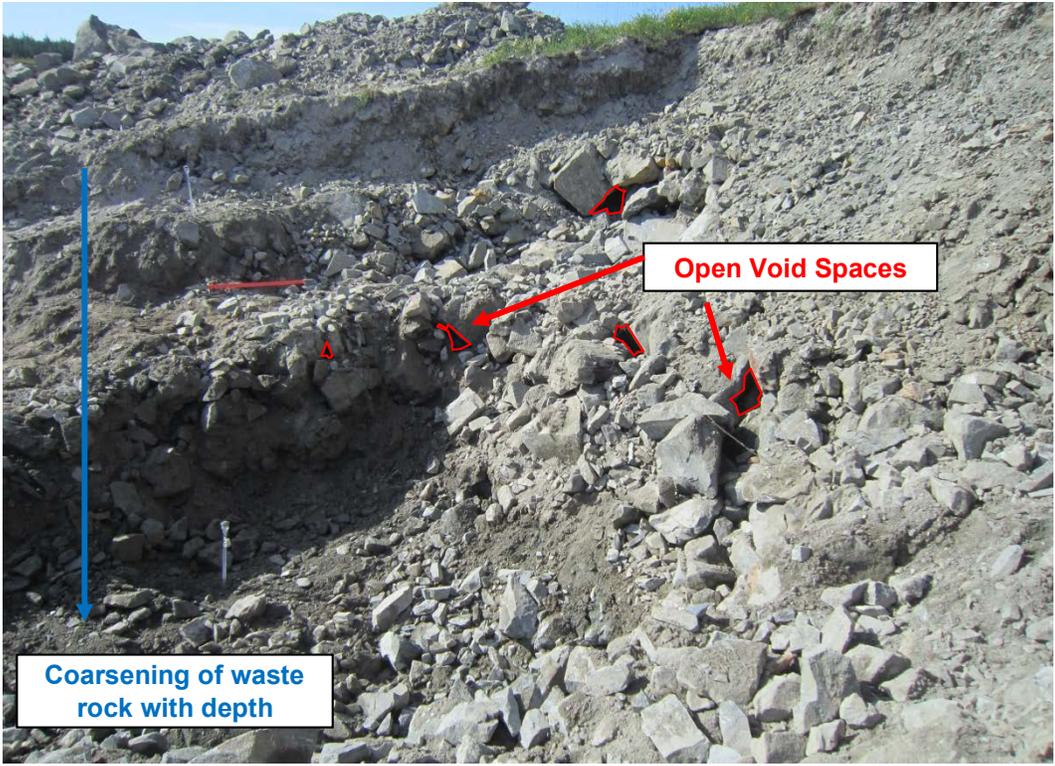
Figure 4.5 – Test pit TP-P2-S16 showing a coarser waste rock as depth increases with open void spaces in clast supported structure

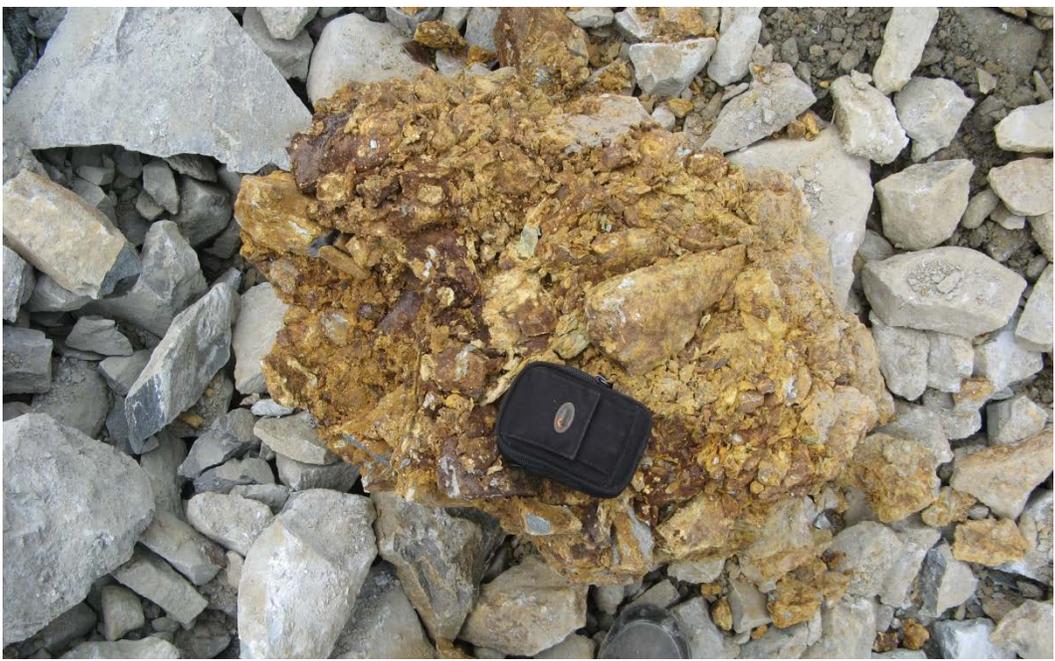
Figure 4.6 - Oxidation of waste rock on WRS 1 resulting in agglomeration and cementation of smaller particles

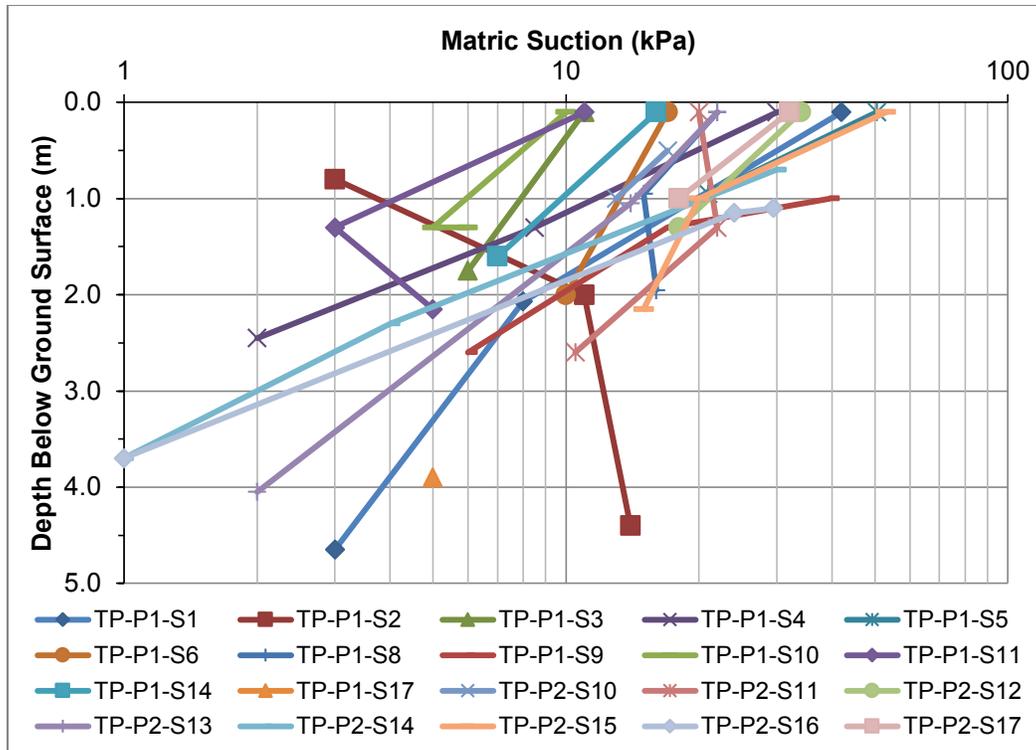
Figure 4.7 - In-situ soil suction with increasing depth for test pit samples

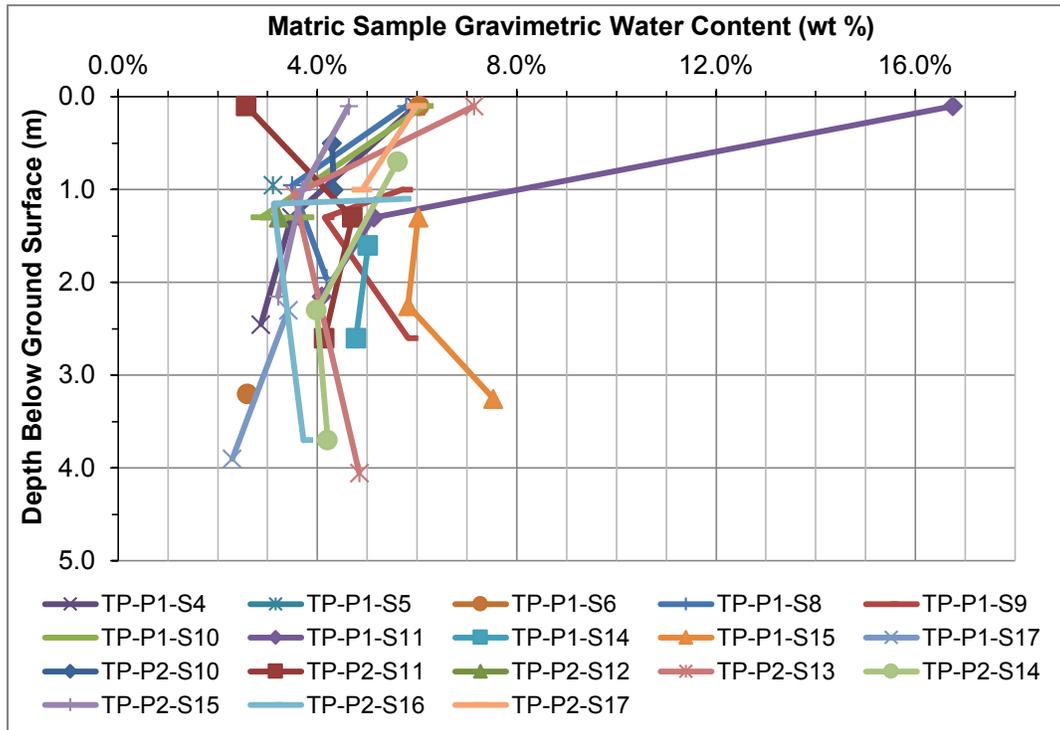
Figure 4.8 –Moisture content profile with increasing depth for test pit matric samples

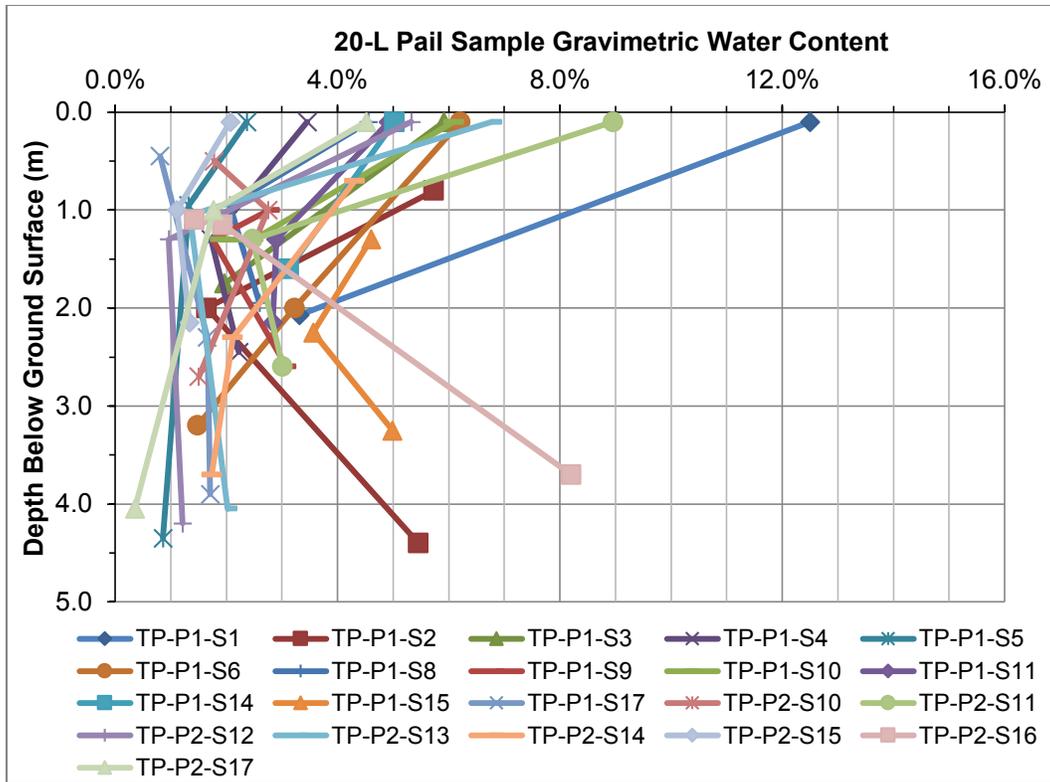
Figure 4.9 - Moisture content profile with increasing depth for test pit 20-L pail samples

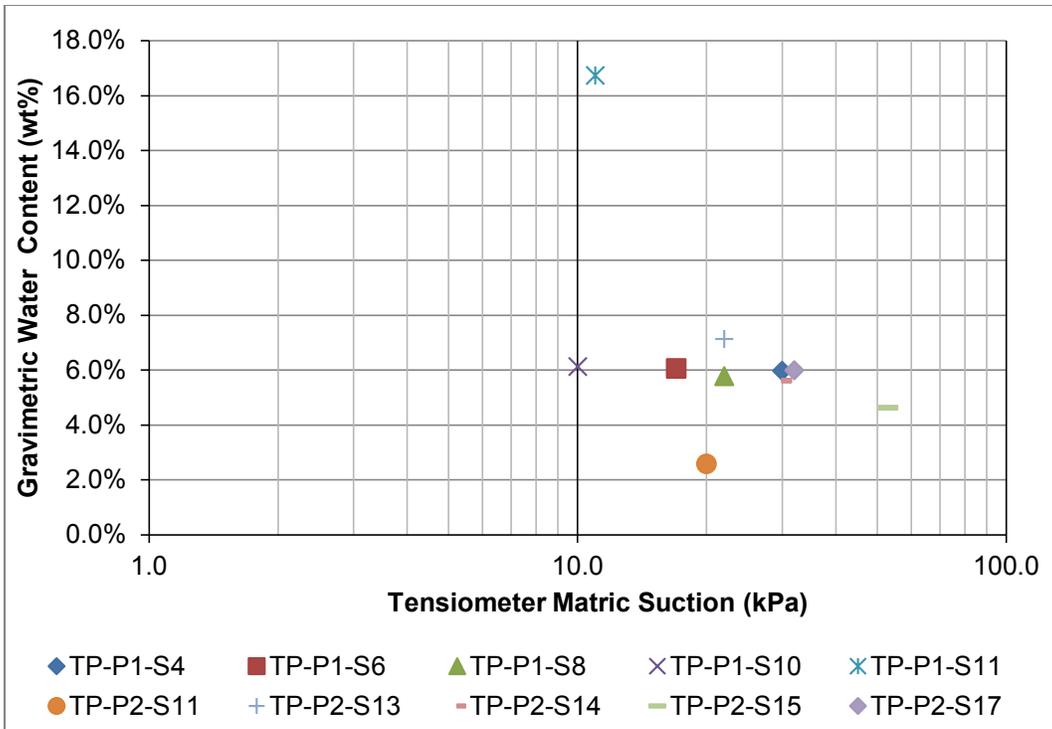
Figure 4.10 – Gravimetric moisture content versus matric suction for field readings from test pit program

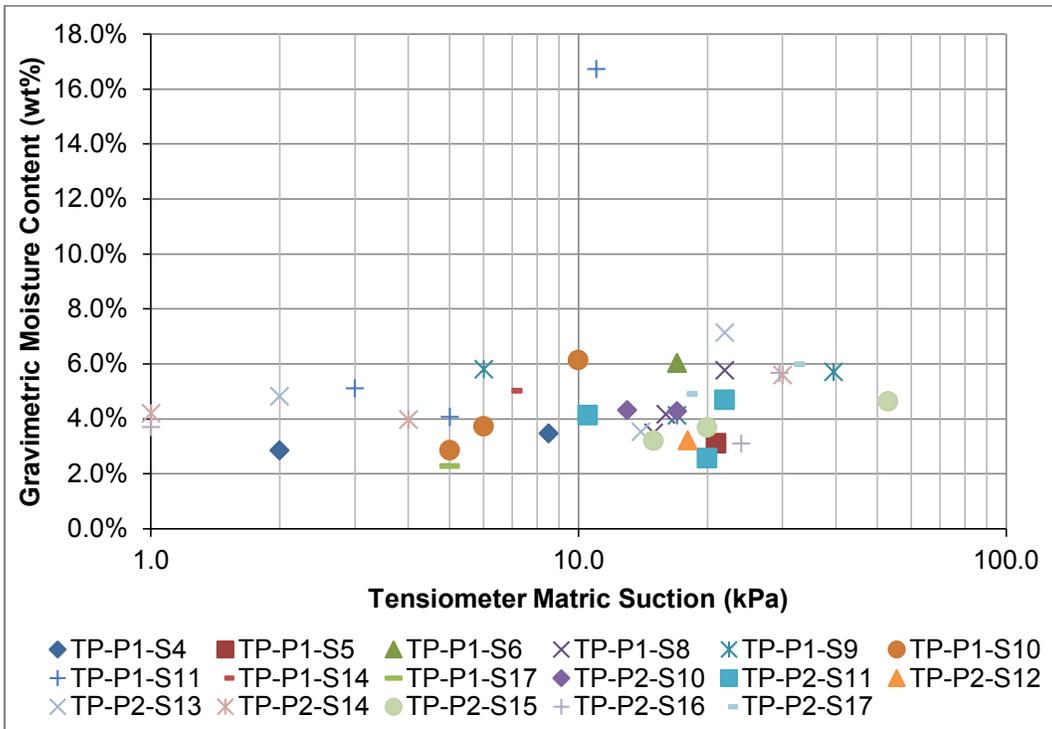
Figure 4.11 - Gravimetric moisture content versus matric suction for field readings from test pit program

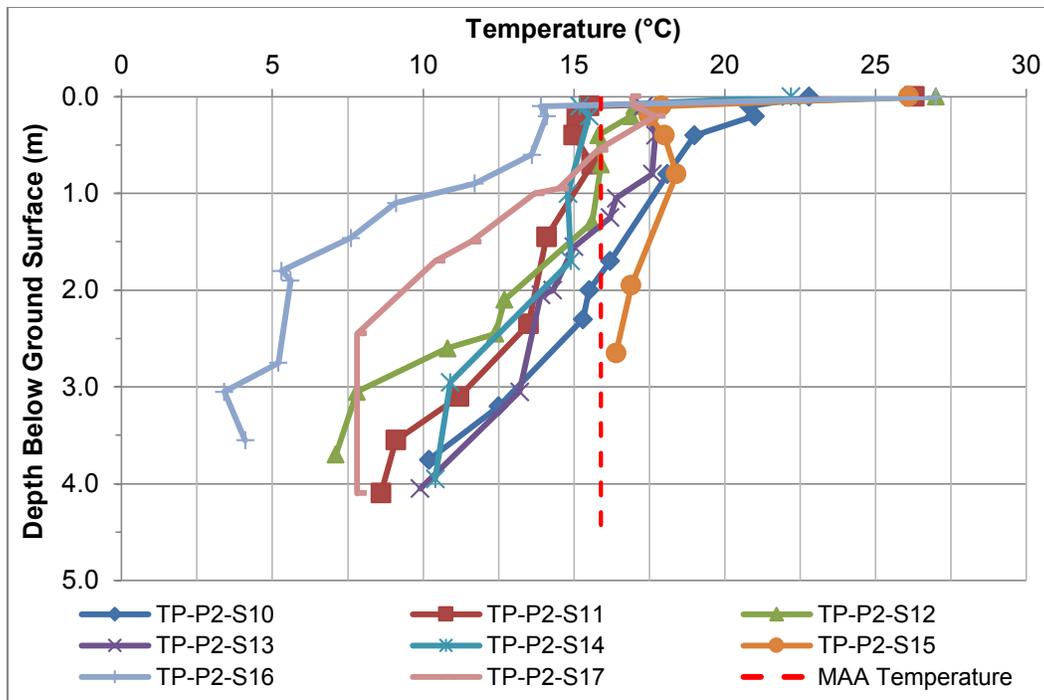
Figure 4.12 – Waste rock temperature with depth below ground surface for WRS 2 test pits

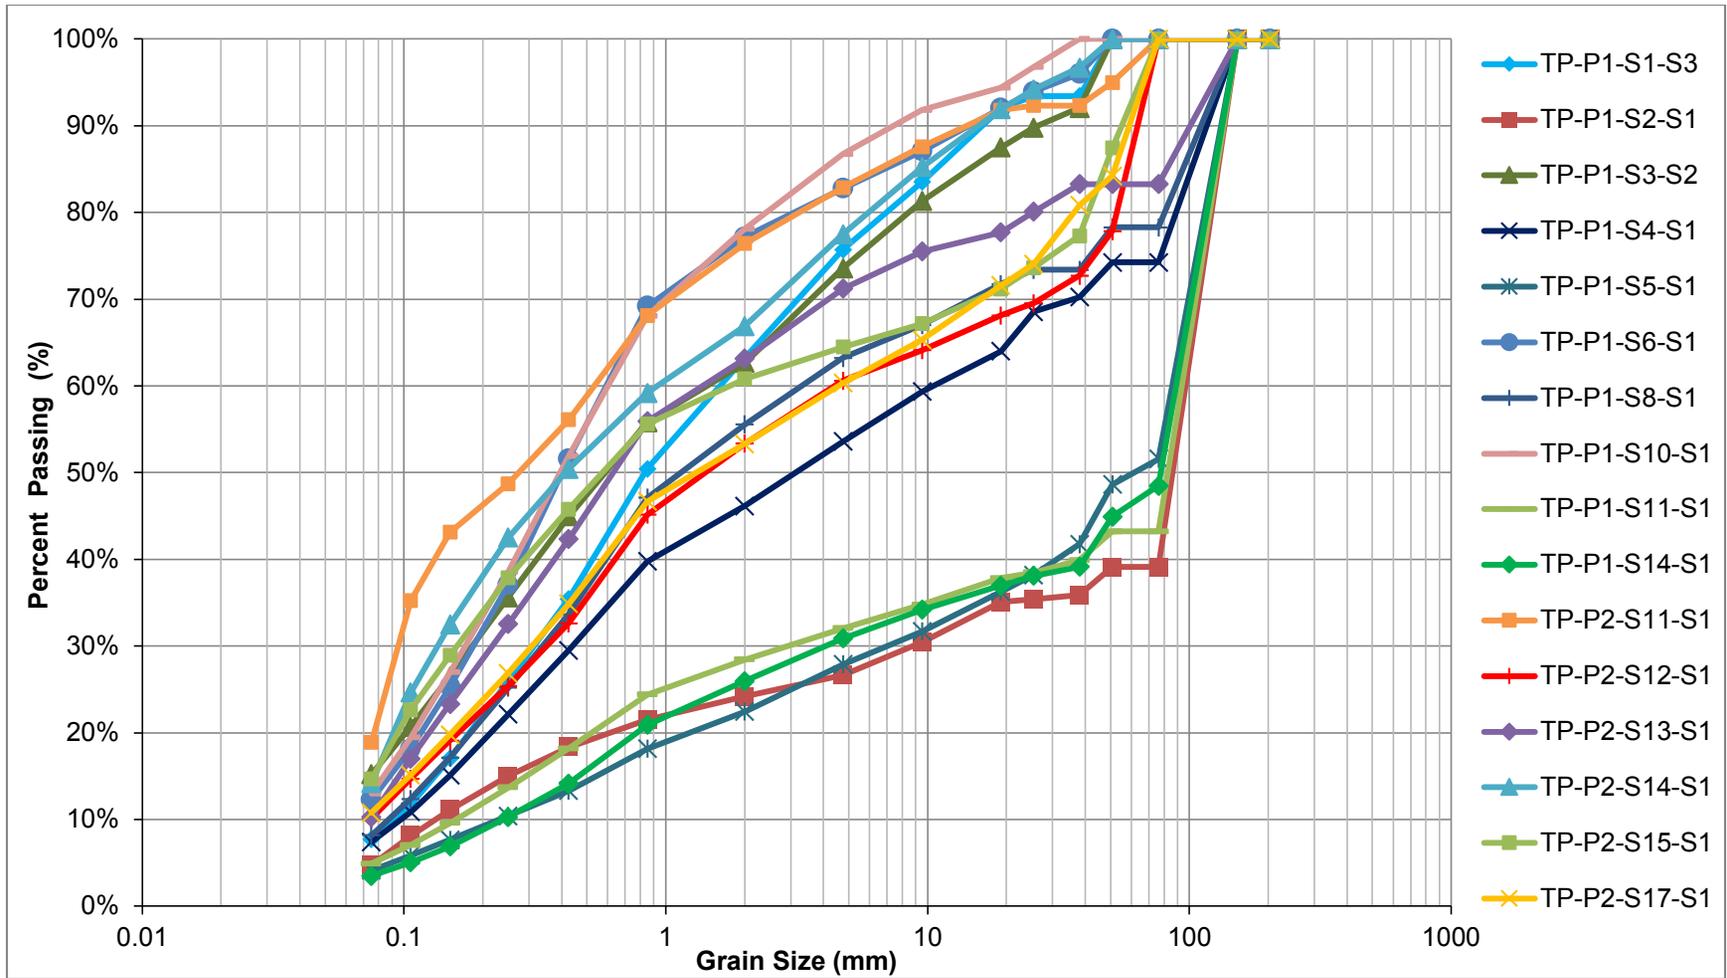
Figure 4.16 - Particle size distribution curves for all 16 cover samples on WRS 1 and WRS 2

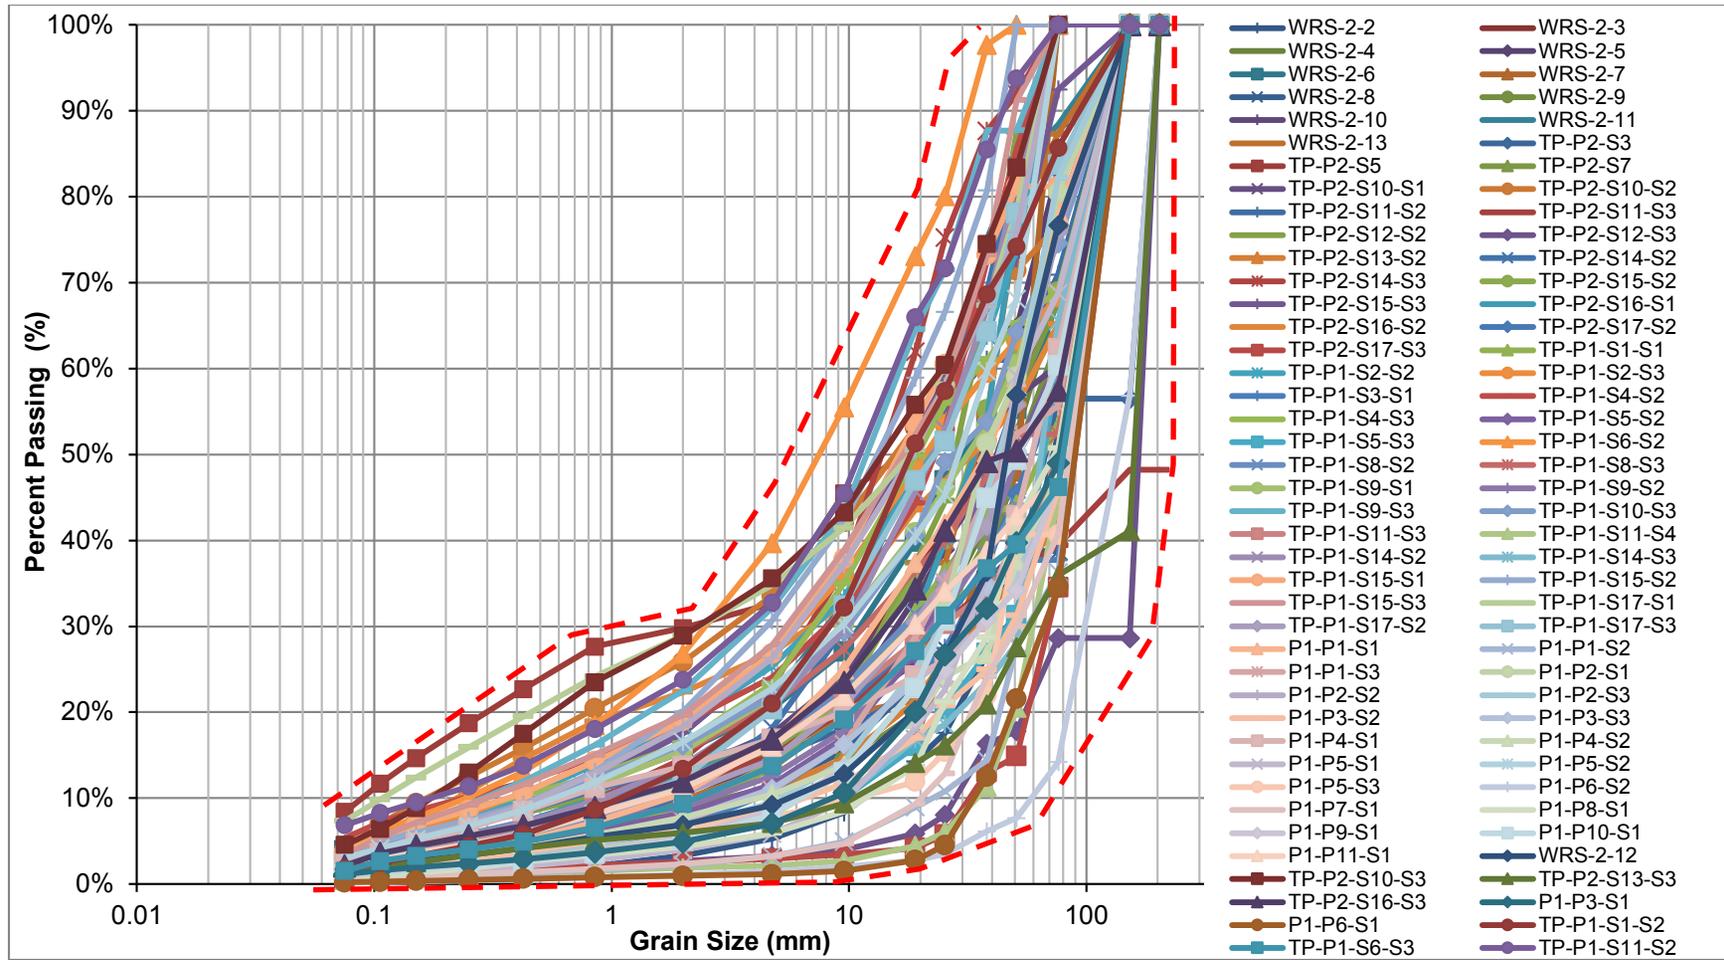
Figure 4.17 - Particle size distribution curves for 84 waste rock samples on WRS 1 and WRS 2

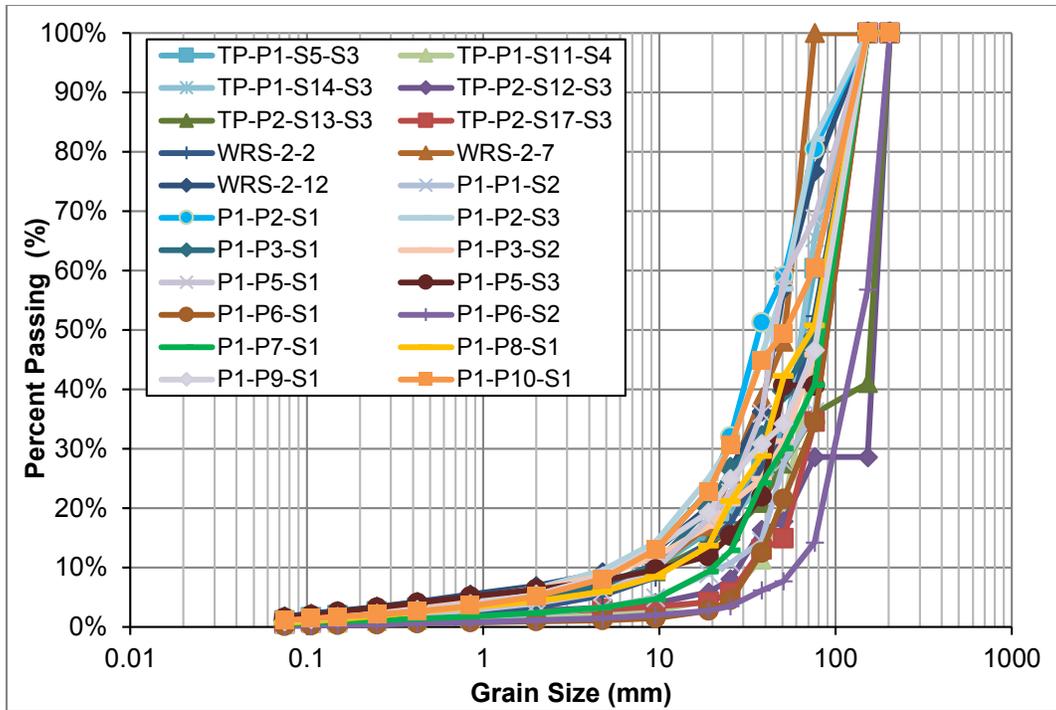
Figure 4.18 – Particle size distribution curves containing less than 10% passing the #4 sieve

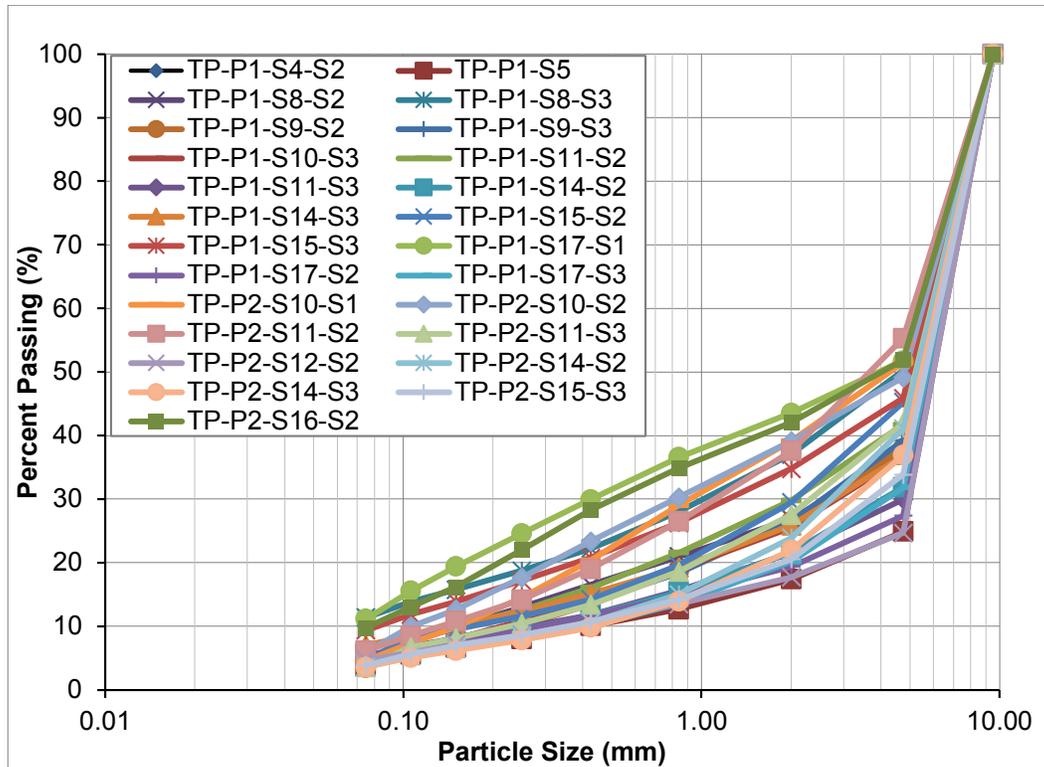
Figure 4.23 - Particle size distribution curves for waste rock material passing the 9.5 mm sieve

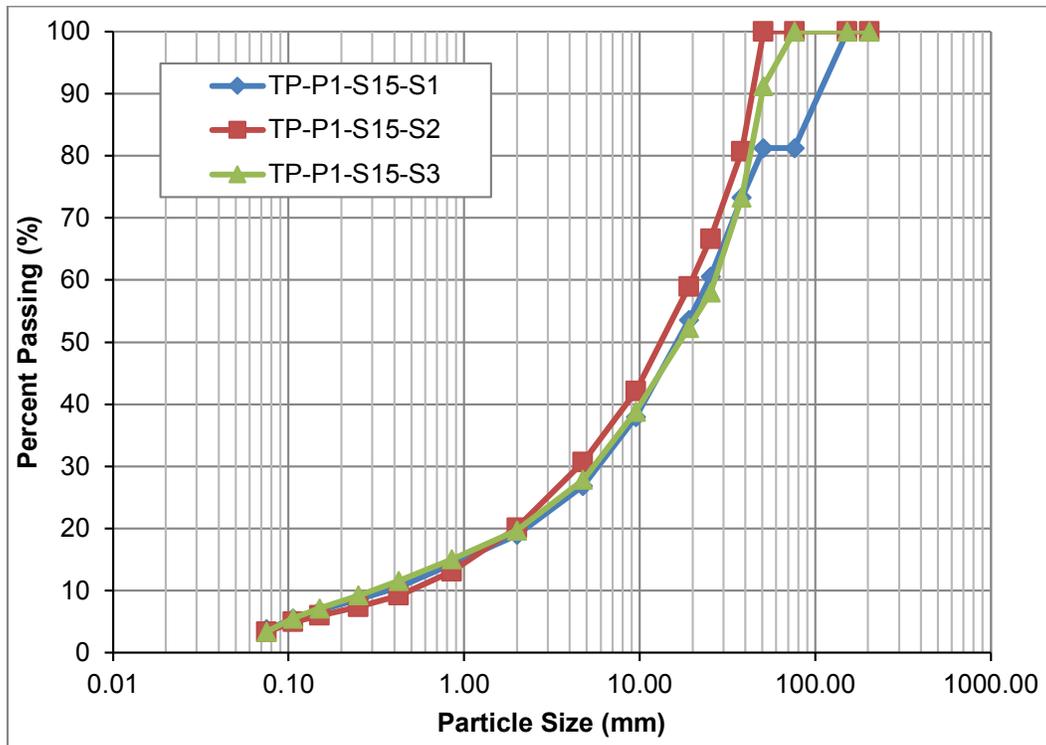
Figure 4.24 – Particle size distribution curves for TP-P1-S15

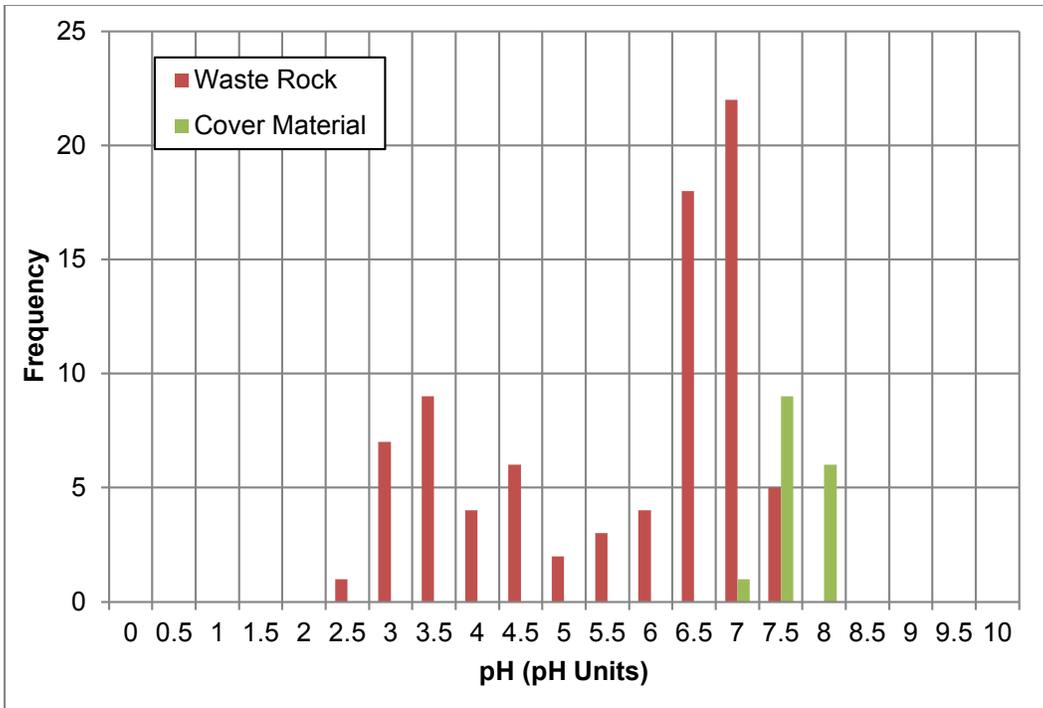
Figure 4.25 - Frequency distribution of paste pH results for waste rock and cover samples

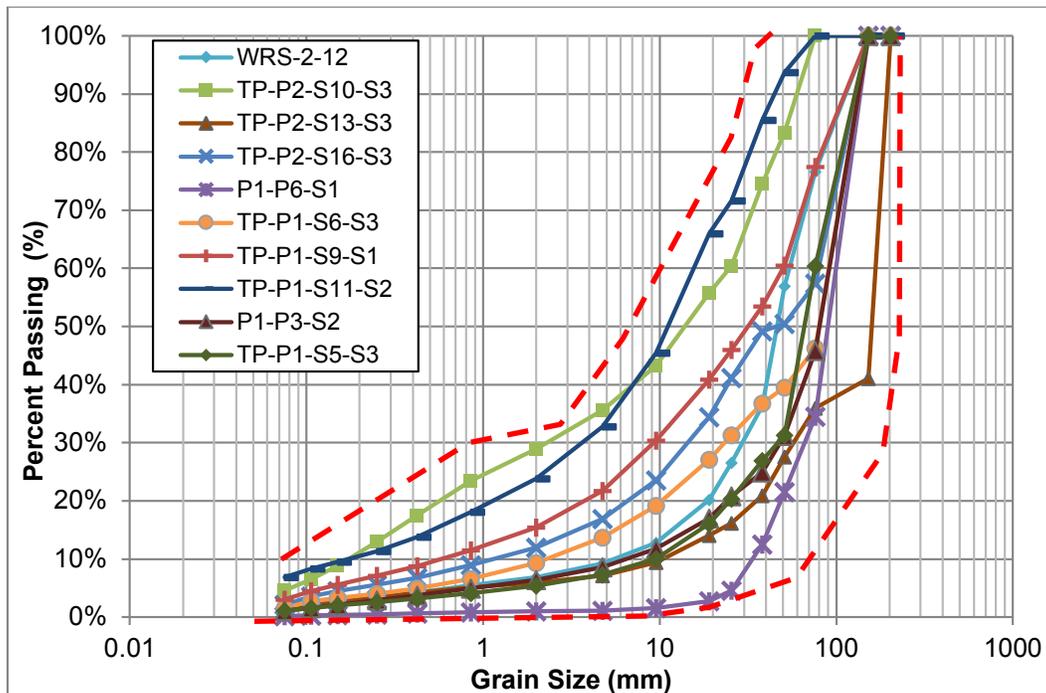
Figure 4.32 – Ten select 20-L pail samples selected to represent both the range of grain size distributions range and physical properties

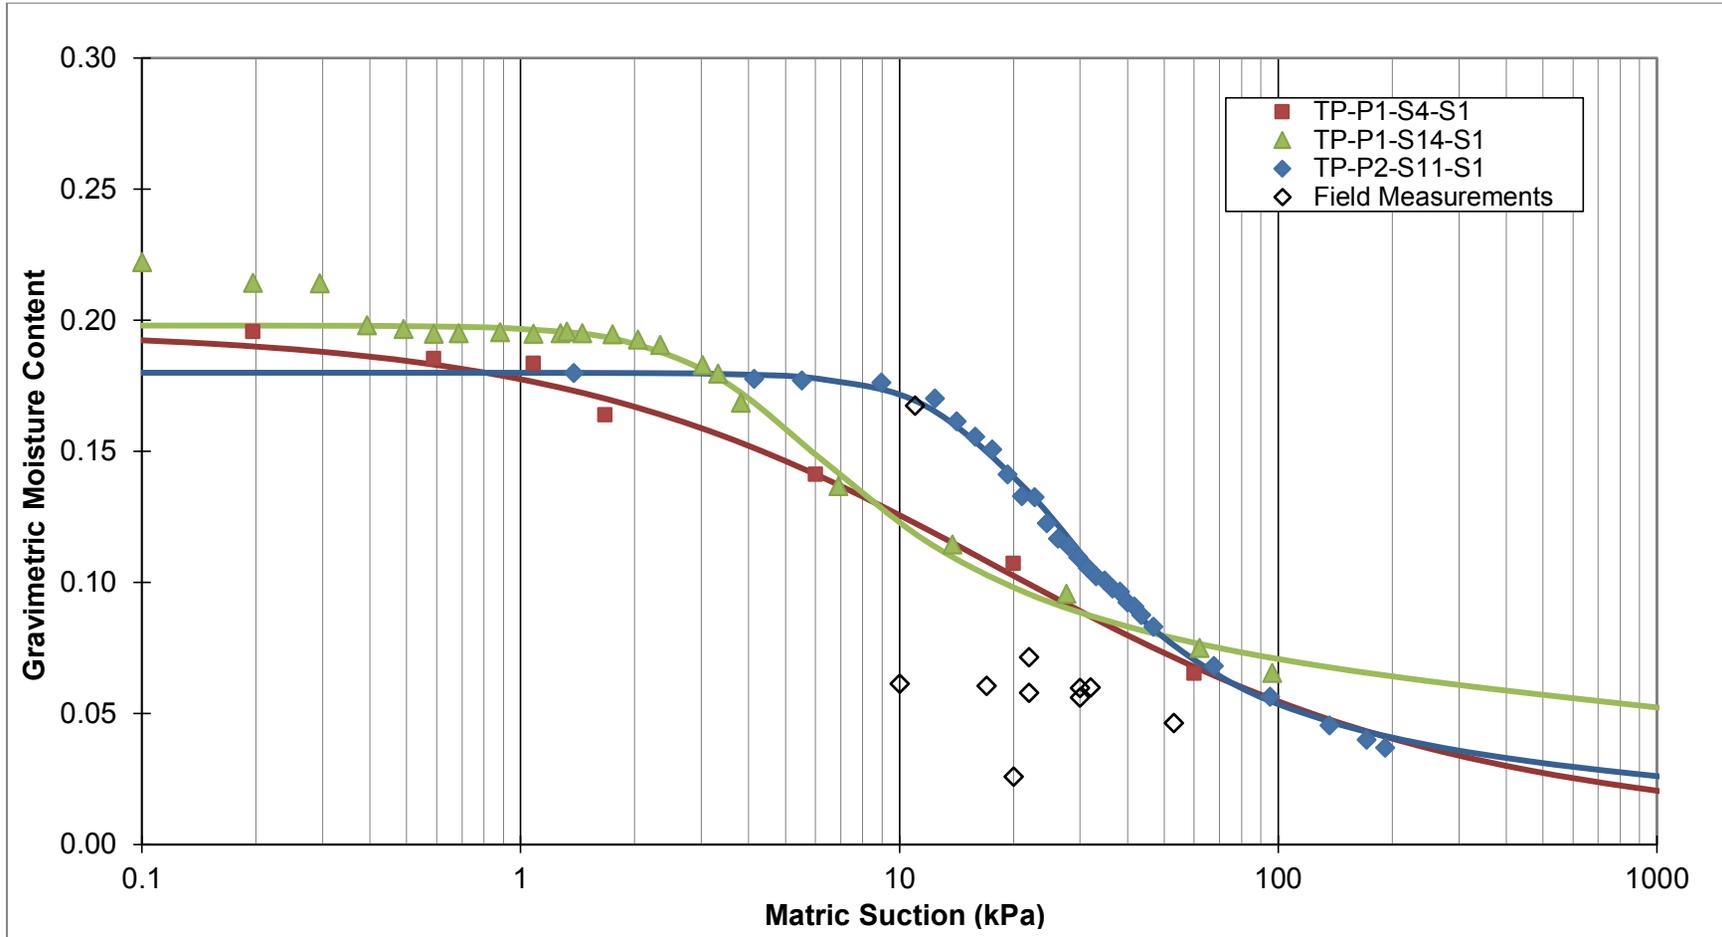
Figure 4.36 - Soil water characteristic curves of gravimetric water content and suction with field measurements for cover samples

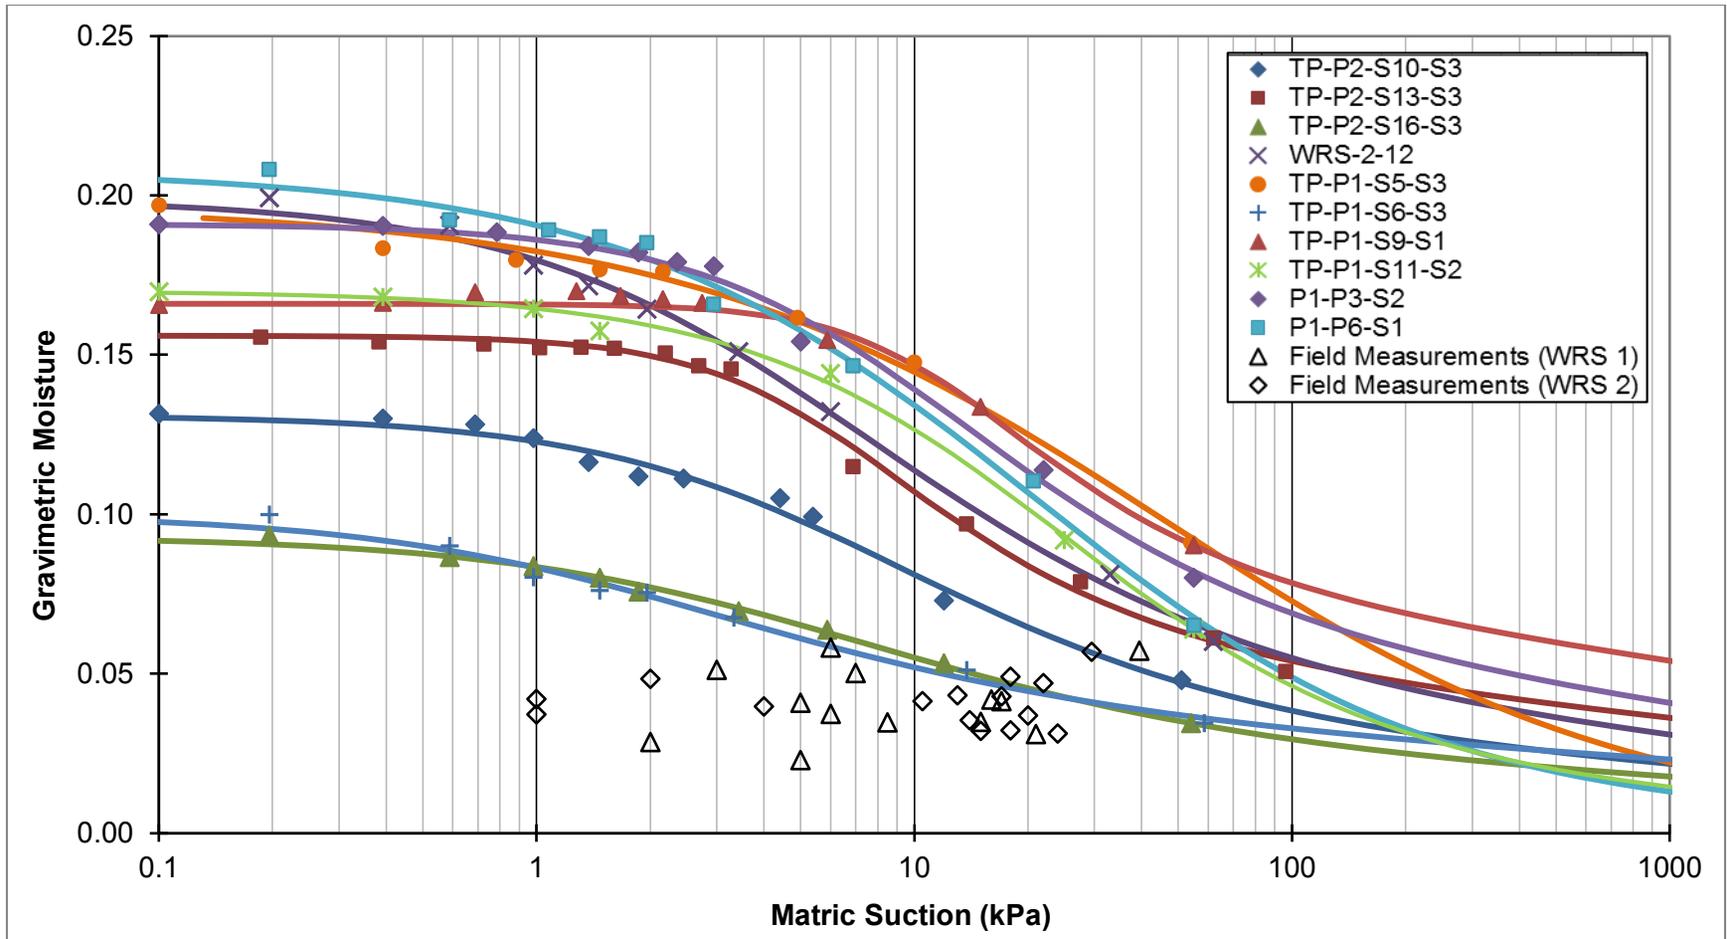
Figure 4.37 - Soil water characteristic curves of gravimetric water content and suction with field measurements for waste rock samples
