Structural and Hydrologic Characterization of Two Historic Waste Rock
Piles

A thesis submitted in partial fulfillment of the requirements for the degree
of

Geoenvironmental Engineering

Department of Civil and Environmental Engineering
University of Alberta

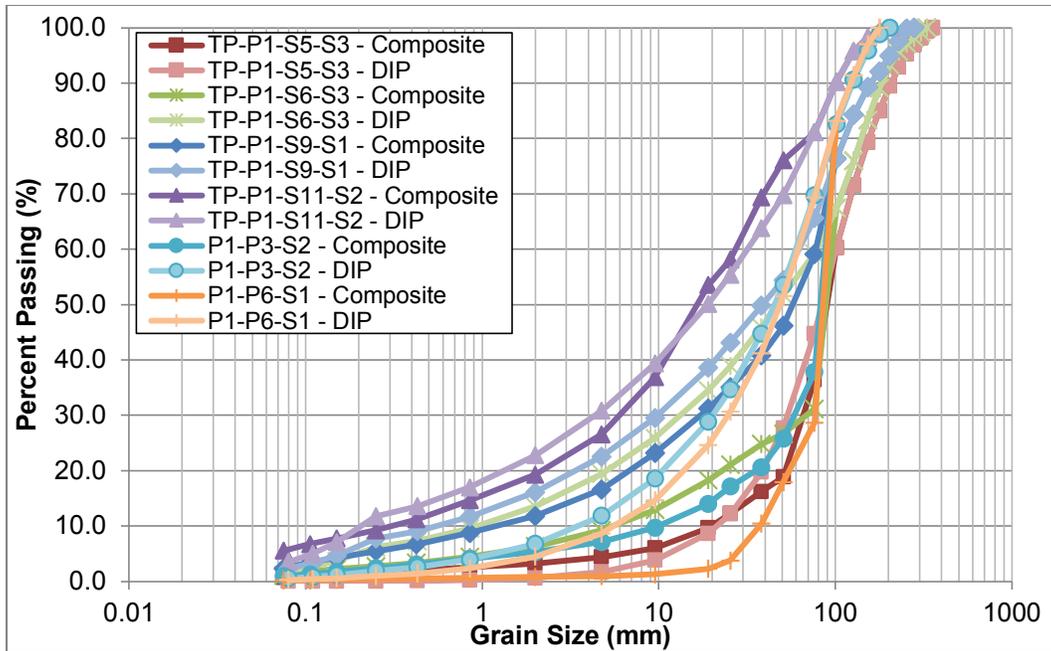
Figure 5.5 - Digital image processing curves from Split Desktop and combine curves using sieve and image data for select samples from WRS 1. 'Composite' indicates the combine sieve results and digital image data and DIP indicates results from image analysis.

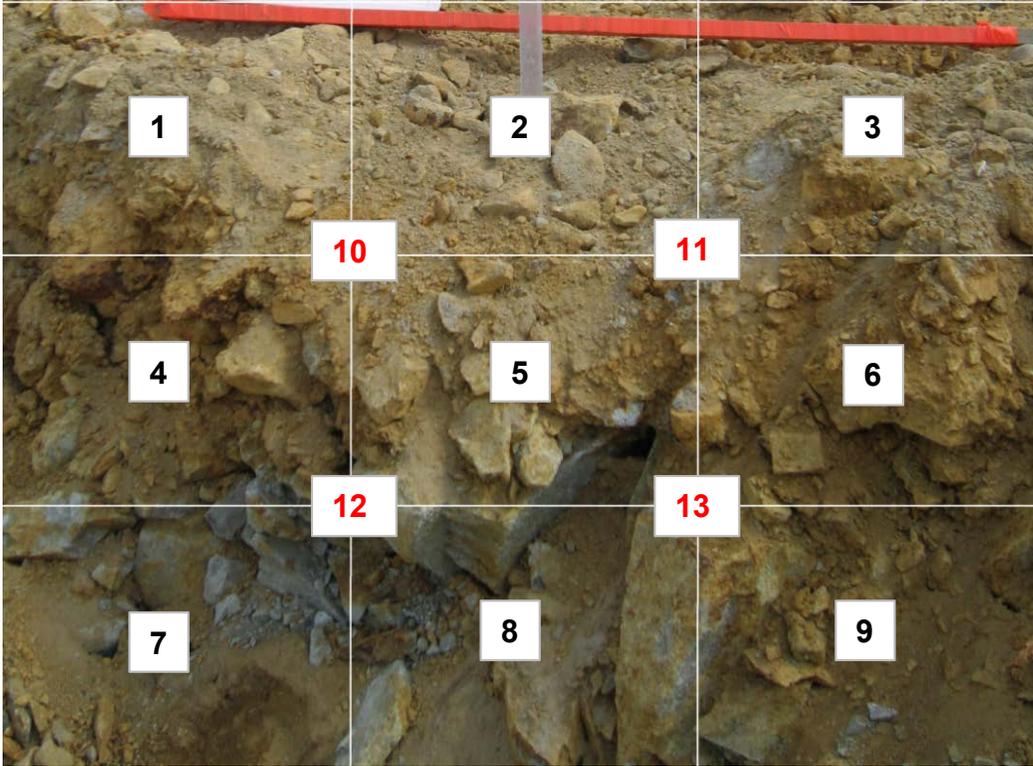
Figure 5.7 - Image of sample location TP-P1-S9-S1. Numbers indicate sections of the photograph that were analyzed individually.

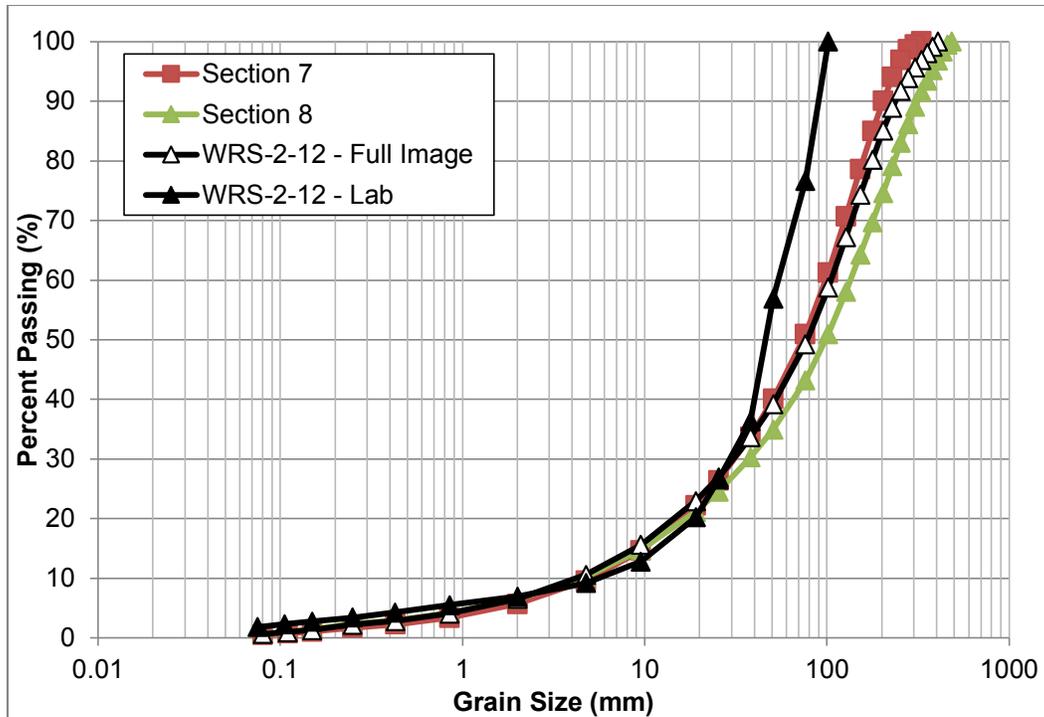
Figure 5.26 - Digital image processing grain size curves for WRS-2-12 Sections 7 and 8 with laboratory data and full image results.

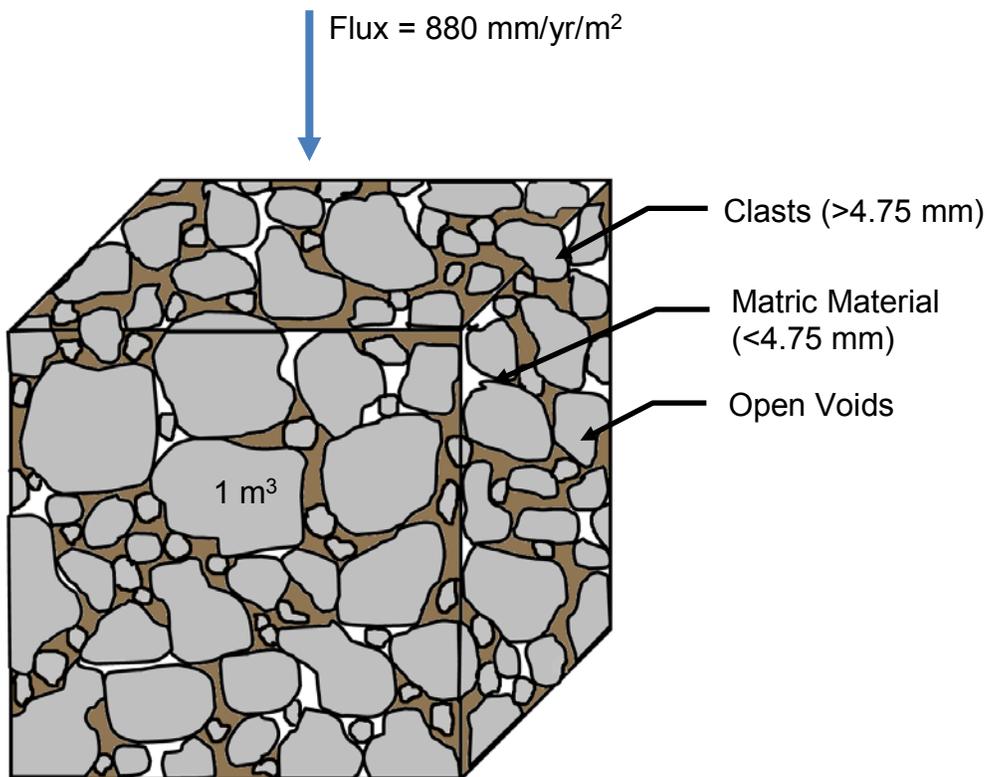
Figure 5.28 – Representative Elemental Volume of 1 m³ of waste rock material

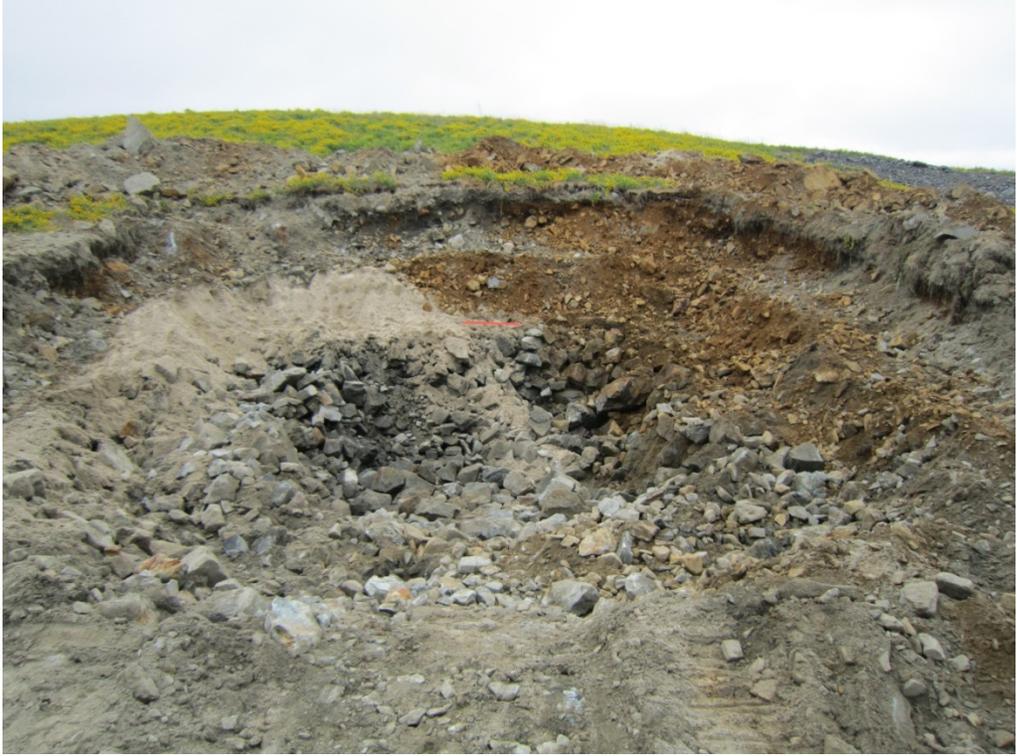
Photo 2 - TP-P1-S10 test pit profile looking east showing sand lens in test pit

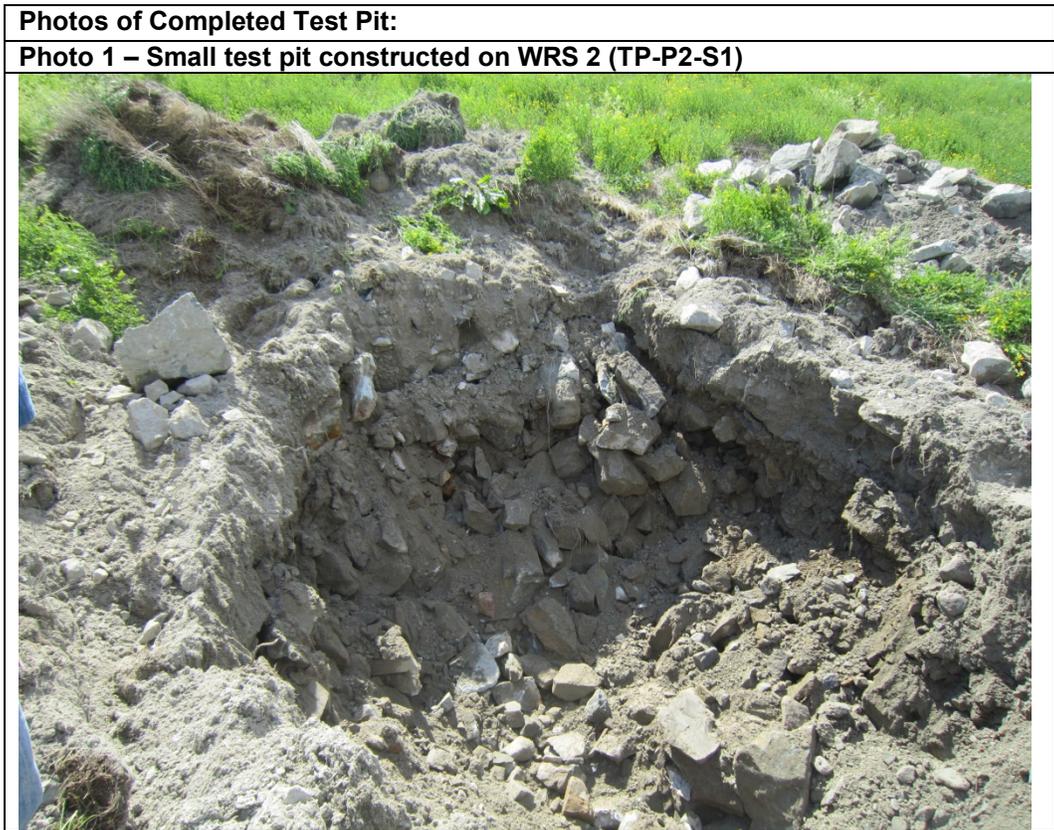
Photo 2 – Photograph showing the presence of oxidation in the test pit

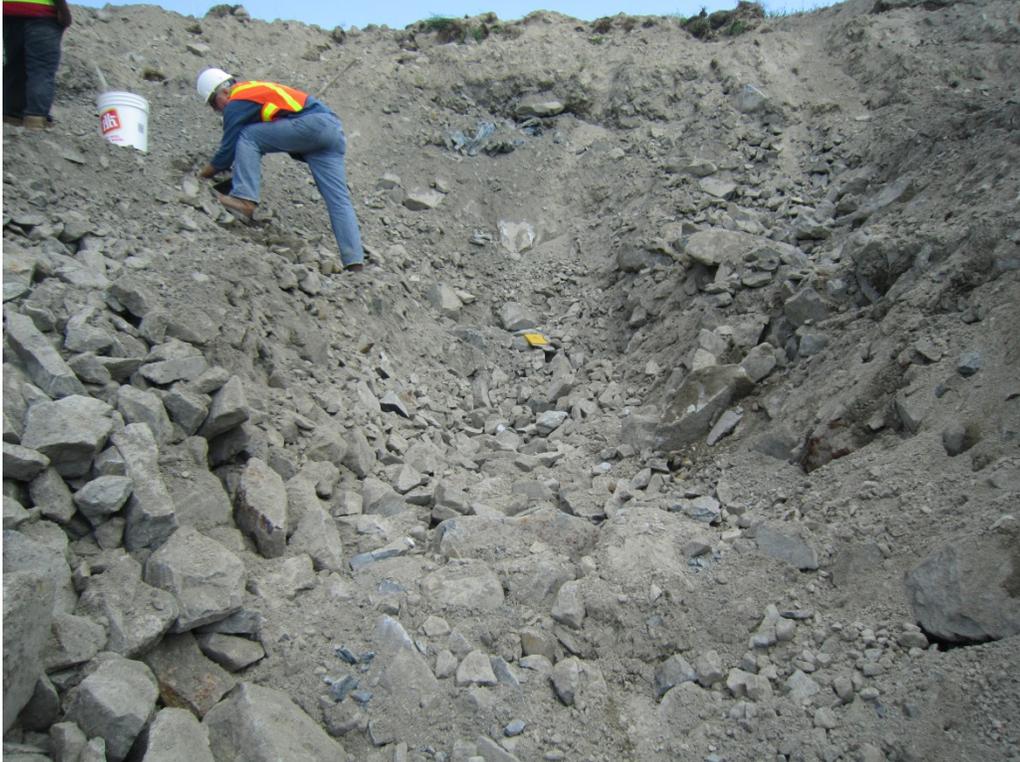
Photo 4 – Grain size range found in test pit, some orange oxidation on particles surfaces
