The undersigned certify that they have read, and recommend to the Faculty of Graduate Studies and Research, for acceptance, a thesis entitled THE INTERACTION OF MASONRY VENEER AND STEEL STUDS IN CURTAIN WALL CONSTRUCTION submitted by William Mark McGinley in partial fulfilment of the requirements for the degree of Masters of Science.

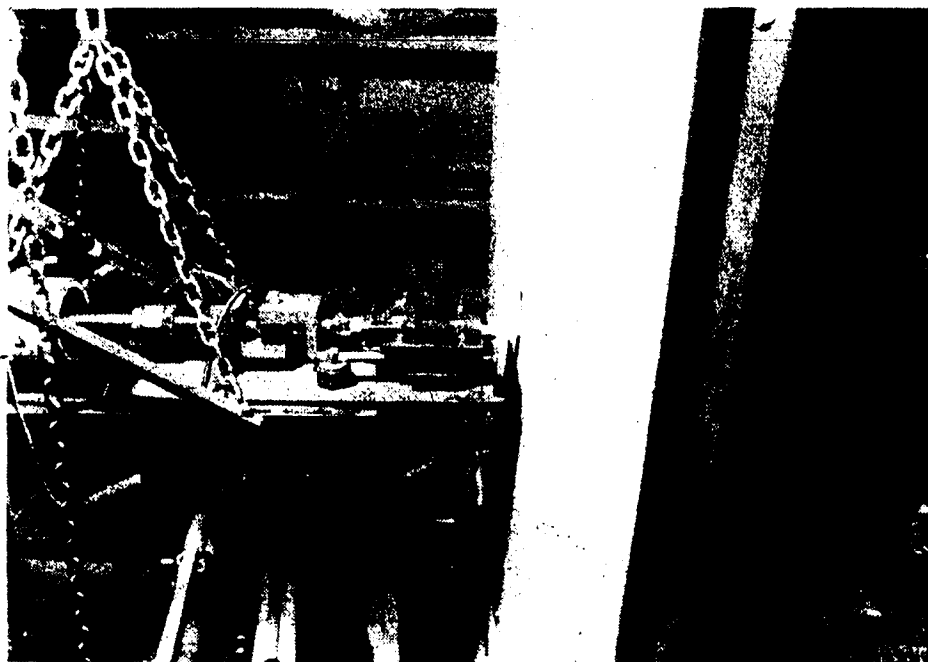
Figure 3.5 Tie and Wall Section Testing Apparatus

The apparatus used to test the veneer ties and wall sections is shown in Figure 3.5. This testing frame consisted of a double-acting jack, tie clamp, adjustable clamp guide, load cell, two linear variable differential transducers, and the supporting channels for the wall sections.

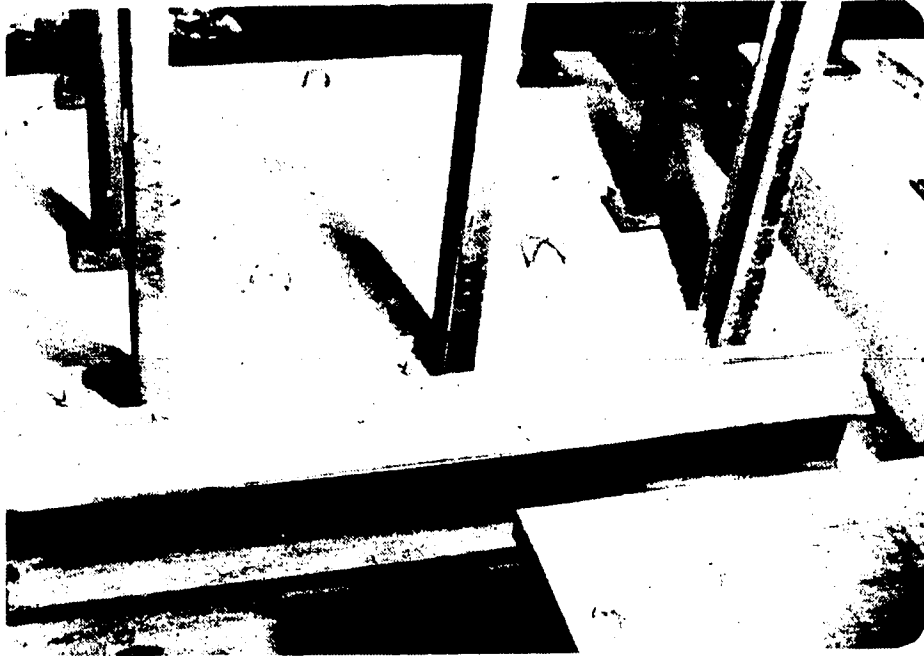
Figure 3.10 Full Sized Wall Steel Track Secured

The construction of all the wall specimens followed the same sequence. The support track was fastened to the slabs using three expansion anchors on each track. Three steel studs were then attached to the track at a spacing of 400 mm on centre. The studs were held in position by number 14 self-tapping sheet metal screws, one to each end. Two lines of 12 mm. channel bridging were brazed to the steel studs. This bridging was run through the two centre service cutouts. Both of the 12 mm. gyproc panels were then fastened to the studs by 38 mm., self-drilling, "Teck" screws spaced at 600 mm. After the backing wall was completed, the butyl flashing and the brick ties were attached. The ties were fastened in the same manner as in the small tests. Finally, the brick veneer wall was built. Each wall was then cured for a minimum of 28 days. After twenty days of curing, the top expansion joint was filled with 12 mm. Styrofoam rope and Mono brand caulking. Figures 3.10 to 3.14 show a wall specimen at various stages its construction.

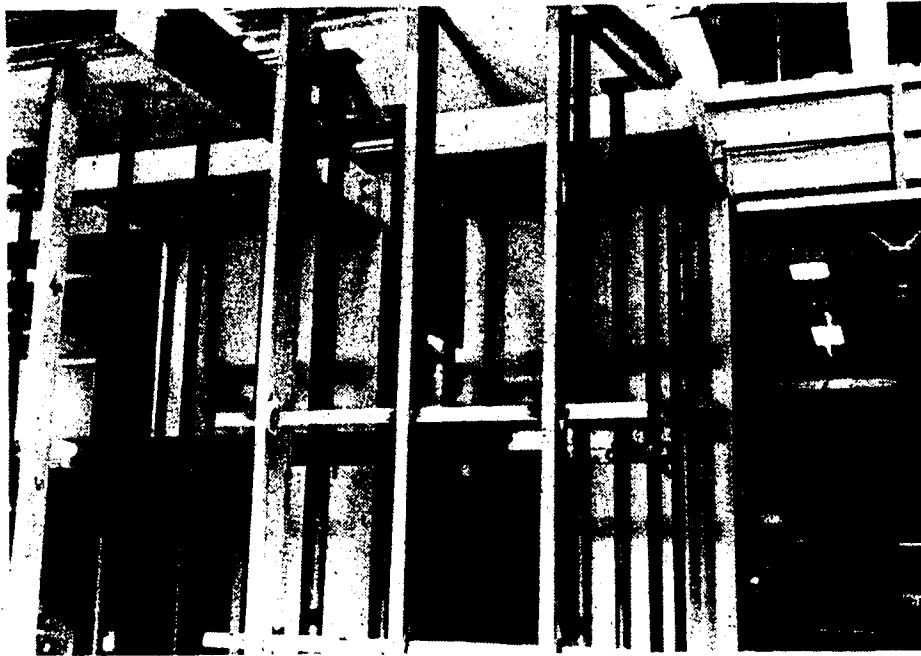
Figure 3.11 Full Sized Wall Studs and Bridging Assembled

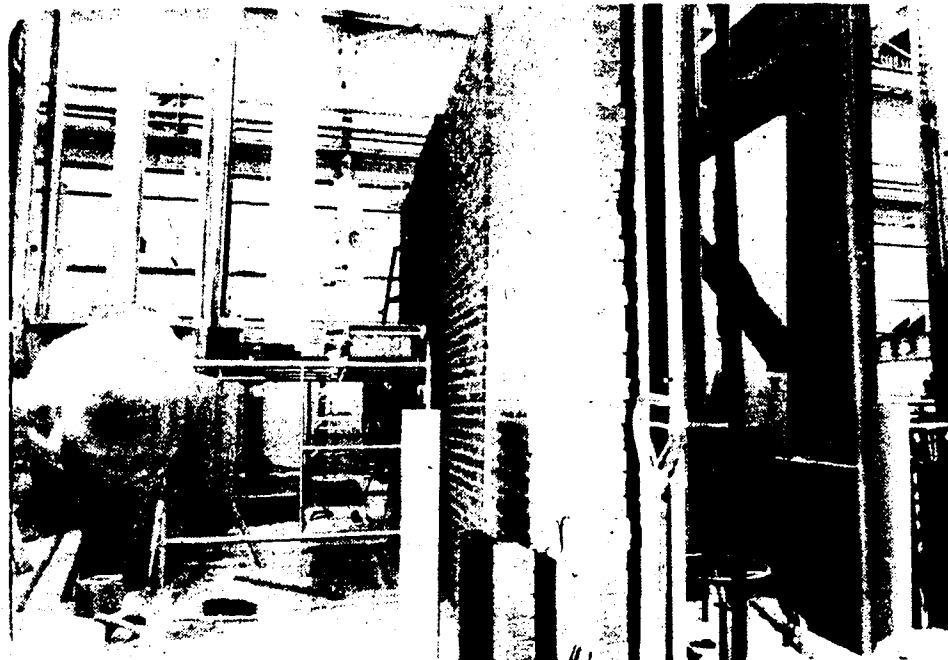
Figure 3.14 Full Sized Wall Specimen Completed

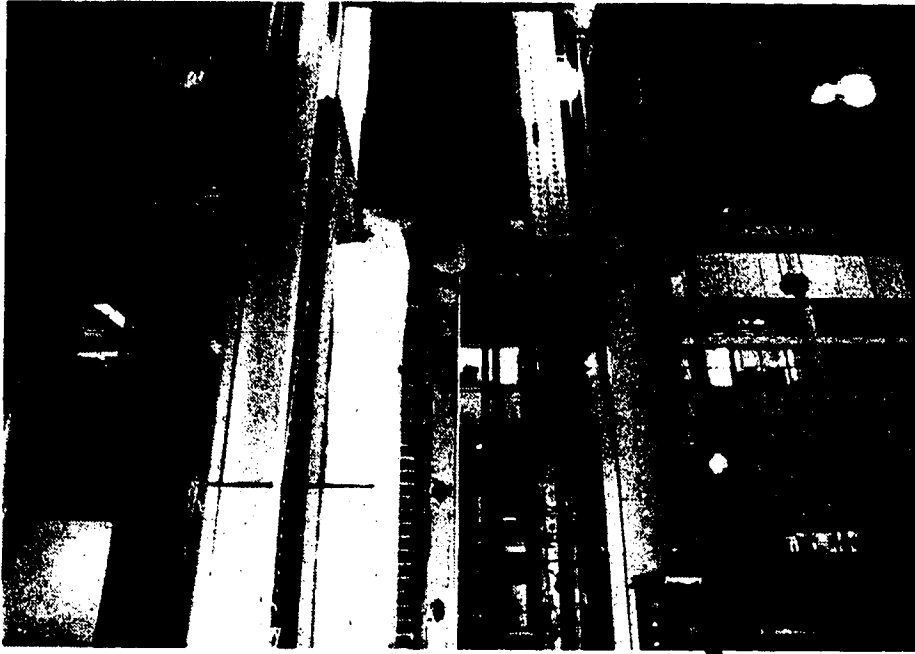
Figure 3.16 Full Sized Wall Test Frame ,

The full sized wall sections were tested in the apparatus shown in Figure 3.16. The testing frame consisted of four W shape columns, four connecting beams, a backing wall comprised of a fluted steel deck and 12 mm plywood, and an air bag.

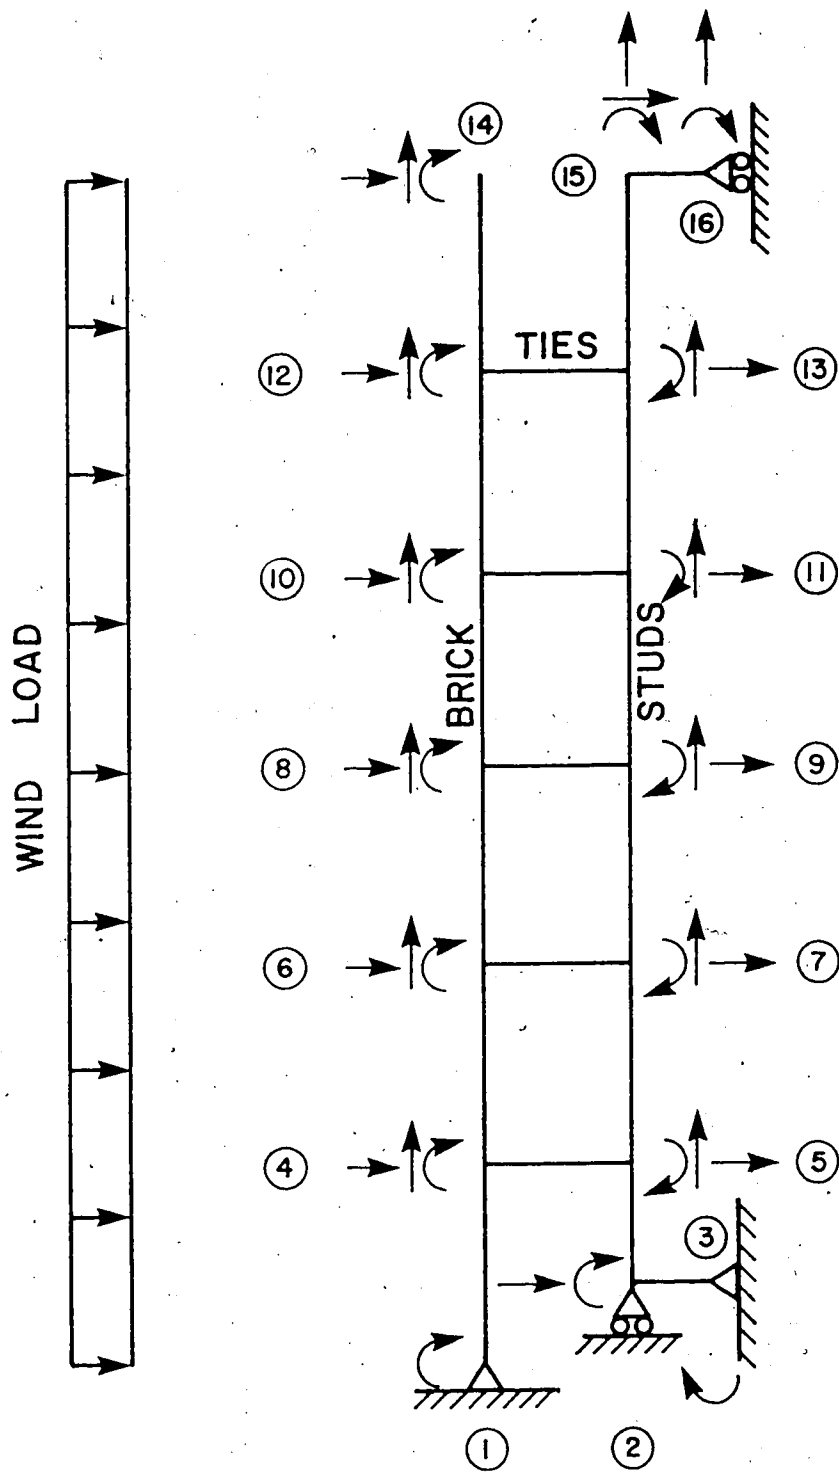
An effective area was calculated by setting P/Δ equal to the average slope obtained from tests on each of the track types, L equal to 50 mm. and the Young's Modulus (E) equal to 210,500 MPa. The effective area used for the dummy

Figure 5.8 Curtain Wall Direct Stiffness Model

members was 0.409 mm^2 , for the 18 gauge track and 0.200 mm^2 , for the 20 gauge track.
