University of Alberta

**LONG-TERM STRUCTURAL HEALTH MONITORING OF THE
CROWCHILD TRAIL BRIDGE**

A thesis submitted to the Faculty of Graduate Studies and Research in partial fulfillment
of the requirements for the degree of Master of Science

Structural Engineering

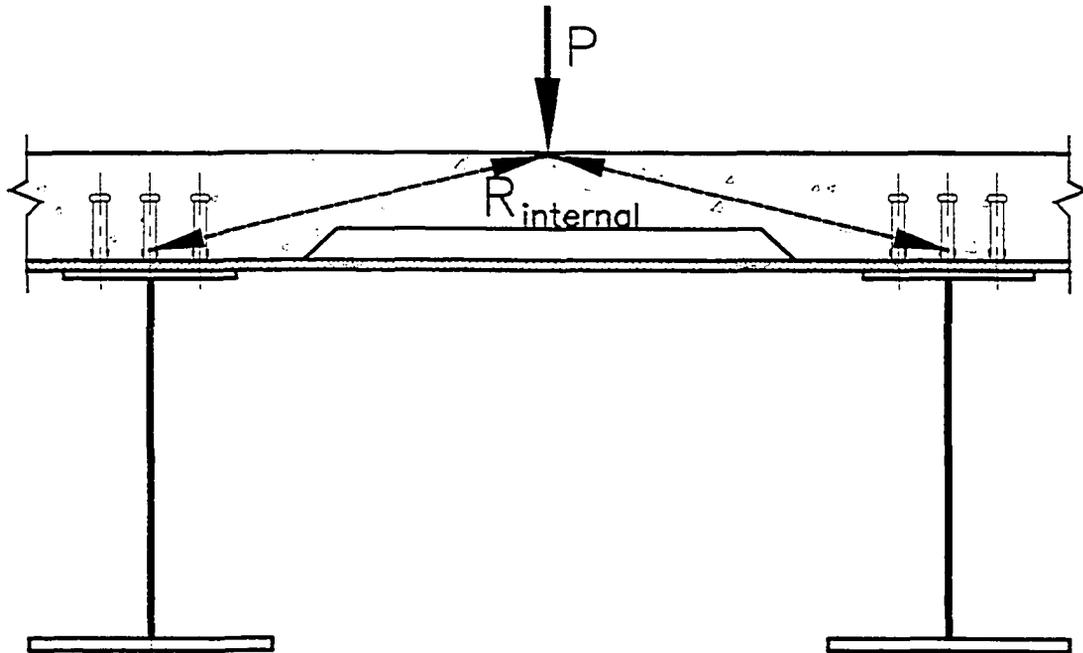
Instead of pure bending, arching action within steel-free decks enable the structure to carry traffic loads. Figure 2.1 shows the basic method for internal arching. A typical

Figure 2.1 – Bridge Arching Action Model

wheel load, P , is resisted by two compressive struts, which form in the concrete deck. Through this mechanism, the load is transferred to the neighbouring steel girders. The steel strap, connected to the upper flanges of the neighbouring girders, acts as the tension tie to resist tensile stresses in the transverse direction as shown.

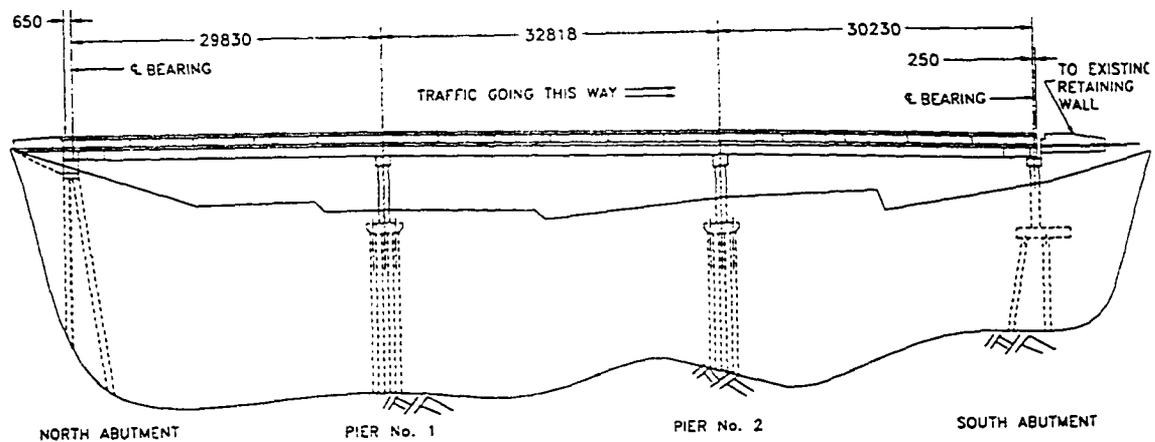
Constructed in June 1997, the new Crowchild Trail Bridge superstructure replaced the old bridge deck. As a result of economic and durability concerns, a steel-free deck design was selected. Existing piers, abutments, and foundations constructed for the original bridge were reused without any modifications. The new bridge consists of three continuous spans over two pier supports measuring 29.830 m, 32.818 m, and 30.230 m for a combined total length of 92.878 m. The layout of the bridge is shown in Figure 3.1.

Figure 3.1 - West Elevation of Crowchild Trail Bridge

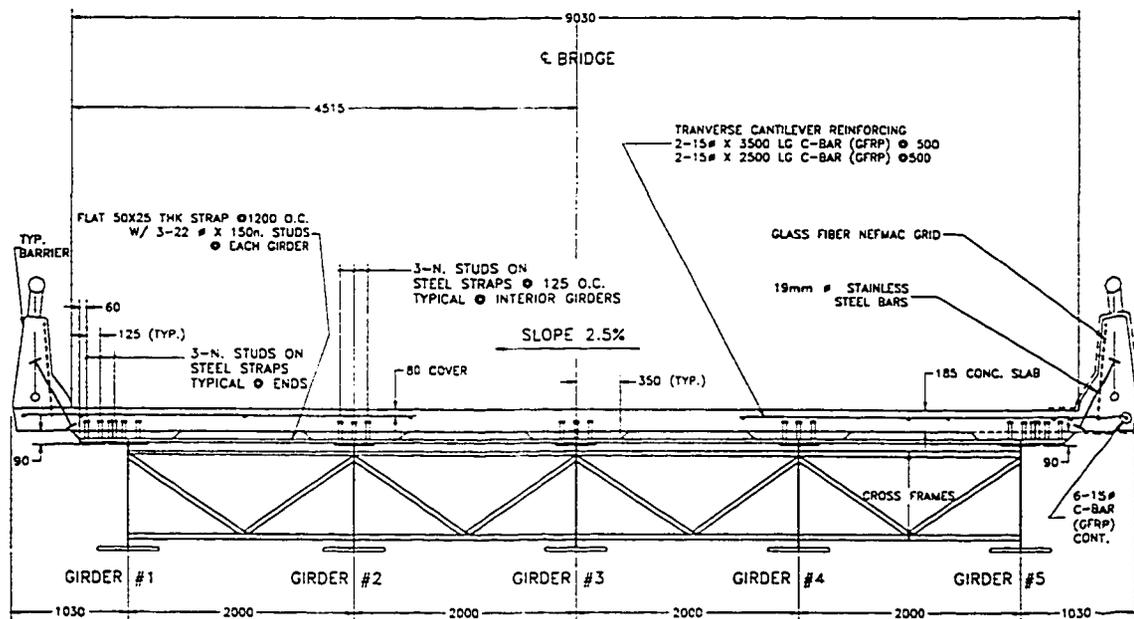
430 kg cement, 1080 kg coarse aggregates, 680 kg fine aggregates, 50 ml / 100 kg air entrainment, and 290 ml / 100 kg superplastizer. An asphalt-riding surface covers the top of the concrete deck. The typical deck cross-section is shown in Figure 3.2.

Figure 3.2 - Crowchild Trail Bridge Deck Cross-Section

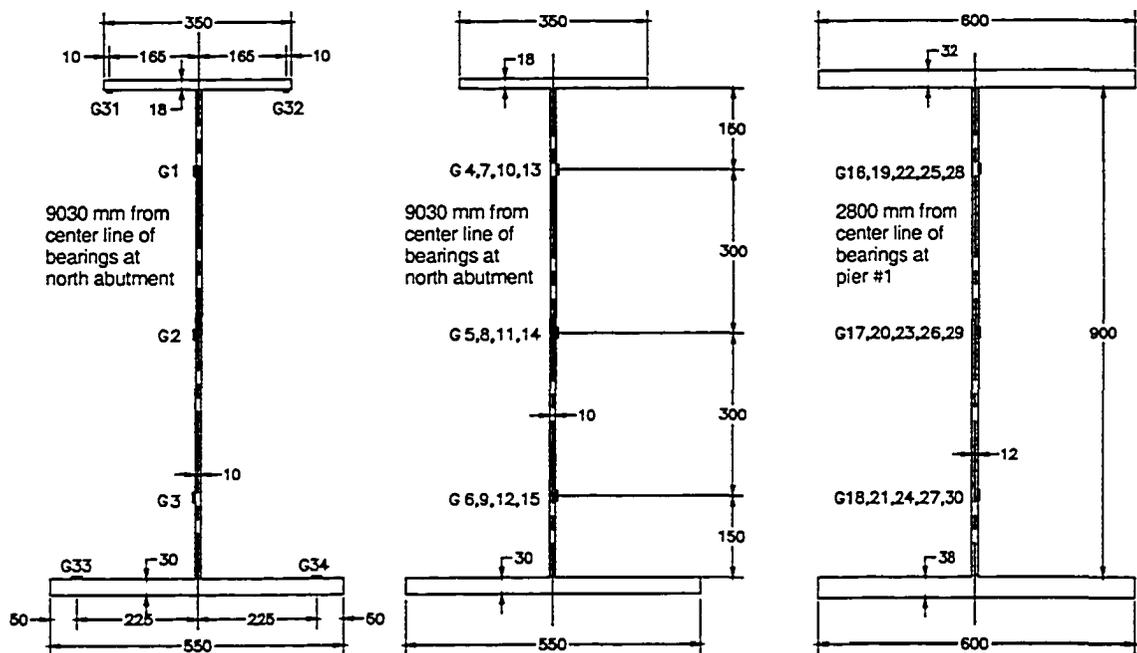
Figure 3.3 - Steel Girder Strain Gauge Configurations

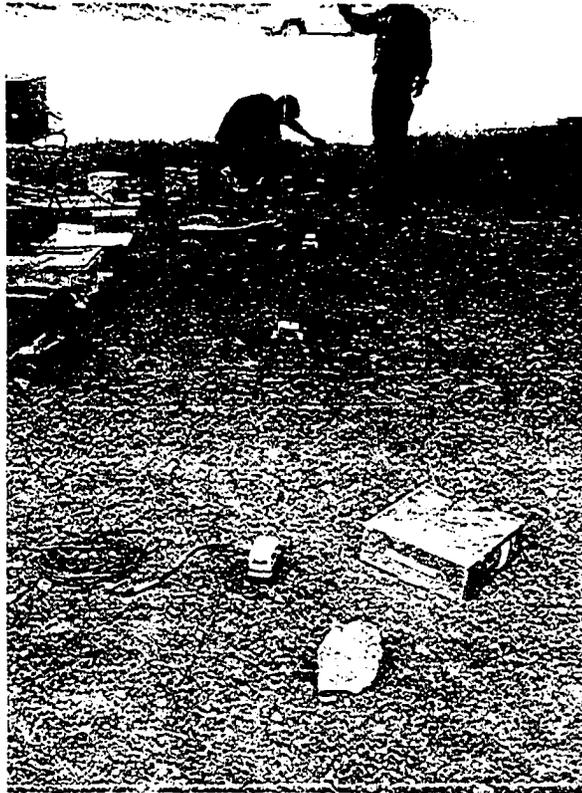
Figure 3.4 - 2004 Cable Transducer Layout

Additional equipment was required to measure deflections. All of the deflection measuring equipment is temporary and was only setup during load testing. During the first load tests in 1997, deflections at various points on the bridge deck were measured using surveying equipment. However, this methodology was very tedious, time consuming, and was subject to human error. In the 1998 load tests, ten cable transducers were used to measure girder deflections in two areas: near the north midspan and near Pier 1. This method was quicker and more accurate compared to the surveying method used in 1997. During the 2004 tests, five cable transducers connected to five voltage channel outputs were used to measure girder deflections. Vertical deflections of the girders were measured at a section 14.43 m from the centreline of the north abutment. This location was chosen so that deflection results from 2004 tests could be compared with 1998 deflection results taken at the same location. The cable transducer setup is shown in Figure 3.4.

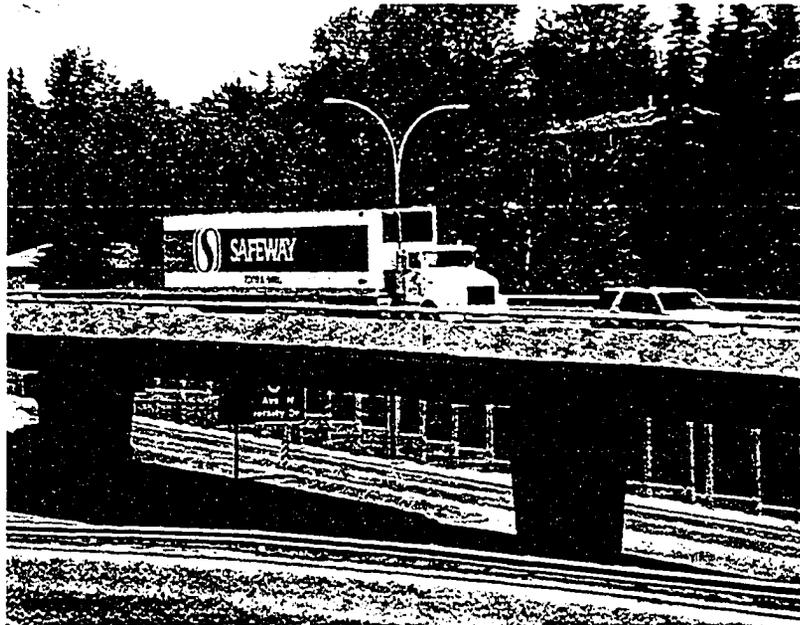
Next, strain gauge data was collected from the bridge when heavier trucks were present. Special care was taken to collect data as a truck would approach the bridge deck, while a truck was on a bridge, and a brief period when the truck was off the bridge. A typical truck crossing can be seen in Figure 4.1. While SET A strain gauges were still

Figure 4.1 - Preliminary Tests: Typical Truck Loading

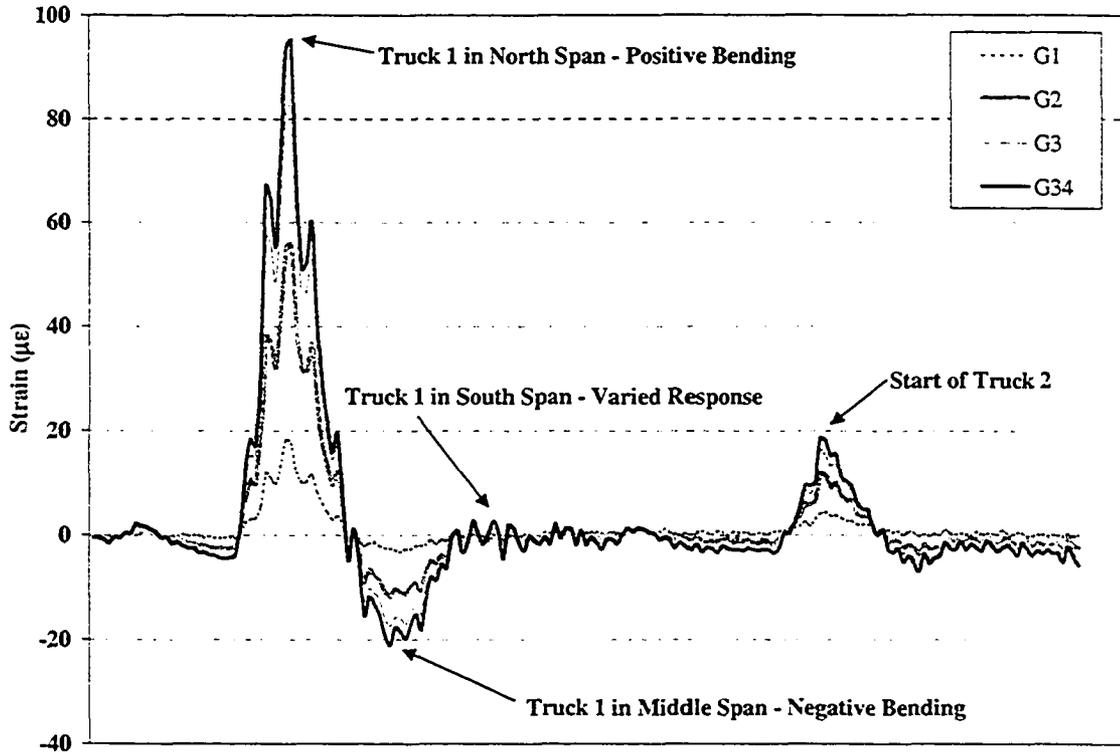
Only dynamic readings of the strain gauges were taken during the preliminary tests; no static strain gauge readings were obtained. During the preliminary testing, no time stamp was applied to the data; therefore, all of the following figures do not indicate an exact time along the main x-axis. Figure 4.2 shows the typical dynamic response of strain gauges as a truck passes over the bridge. All of the four gauges shown in Figure 4.2 are located on Girder 1 near the middle of the north span. Strain gauges G1, G2, and G3 are located at various heights on the girder web while G34 is located on the bottom girder flange. As shown in the figure, the strain gauges situated lower on the girder experience the highest levels of strain. When the truck is located on the north span, the girder is in positive bending, and the girder strain gauges experience positive tensile stresses. However, as the truck moves over the first pier into the middle span, the girder experiences negative bending upward and the strain gauges experience negative compression stresses. Strains are relatively low once the truck moves onto the south span. Upon closer inspection of the strain readings, it is evident that three smaller peaks

Figure 4.2 - Bridge Dynamic Behaviour: SET A Girder Strain Gauges

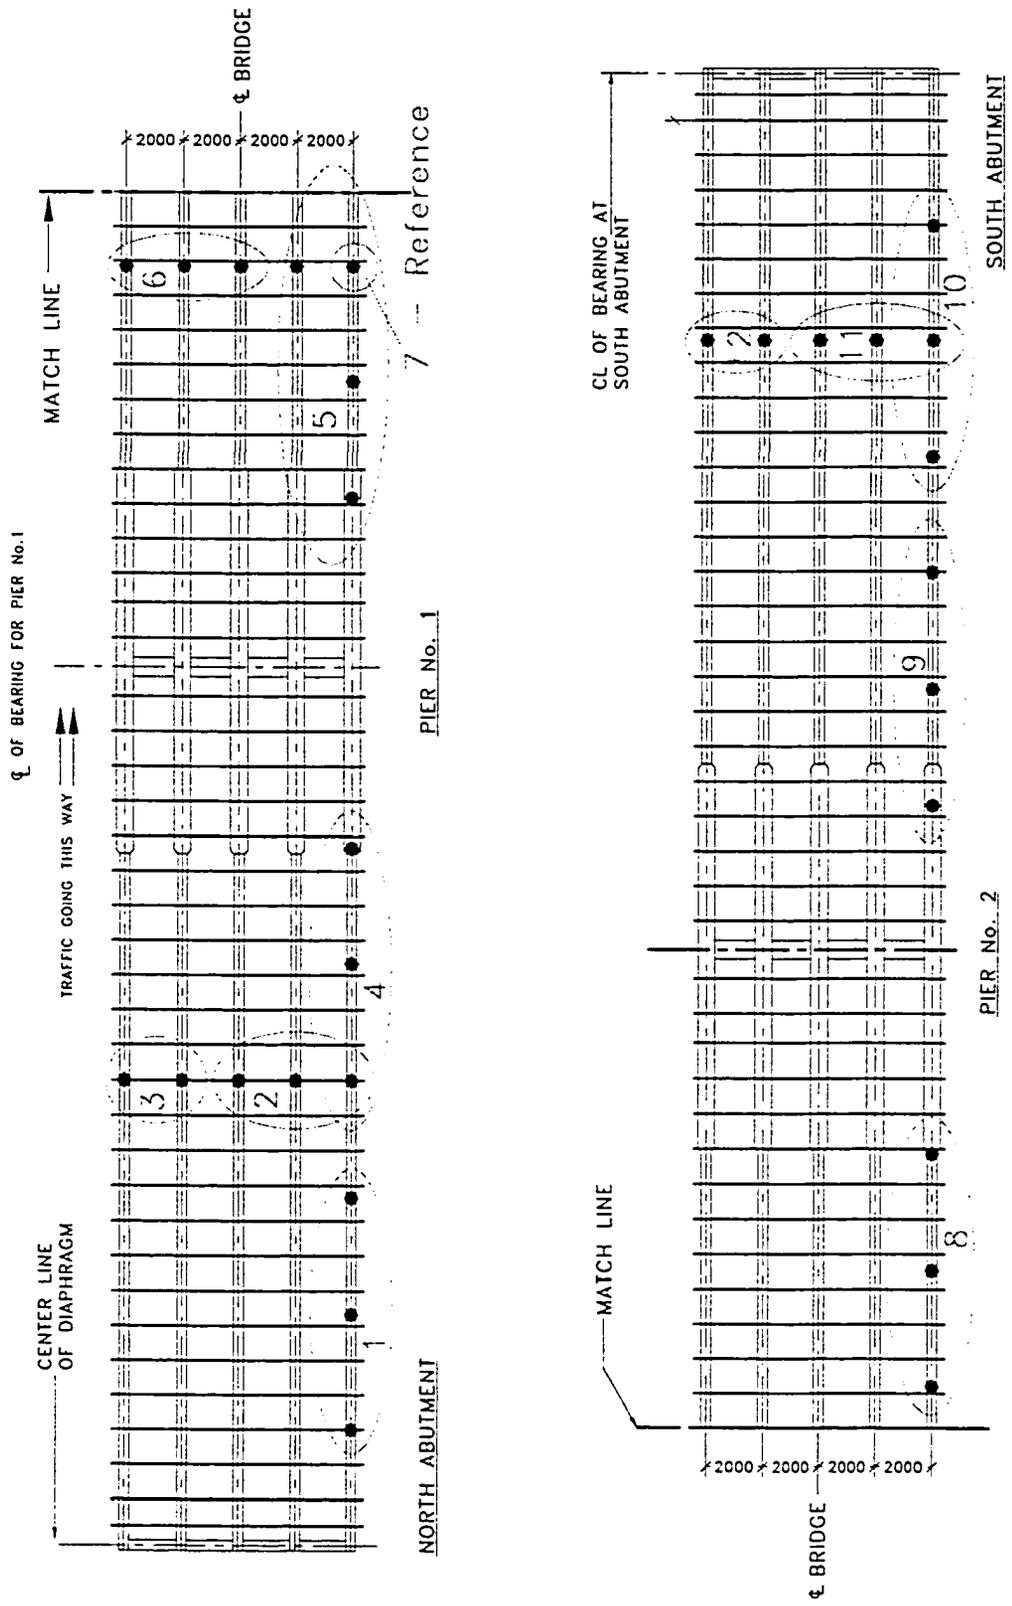
During the test set-up, one lane of traffic on the Crowchild Trail Bridge was continuously closed to traffic and the second lane was periodically open to allow traffic to pass through. When the accelerometers were in place and vibration data was being collected no vehicular traffic was permitted on the bridge. This process would allow the bridge and its vibrational modes to become excited by external ambient sources only. Accelerometers were attached to the concrete deck surface using two-way heavy-duty carpet tape. For each accelerometer set-up, data was collected for a total of 90 seconds at a scan rate of 200 Hz.

Figure 4.4 – 2004 Ambient Vibration Tests: Accelerometer Locations

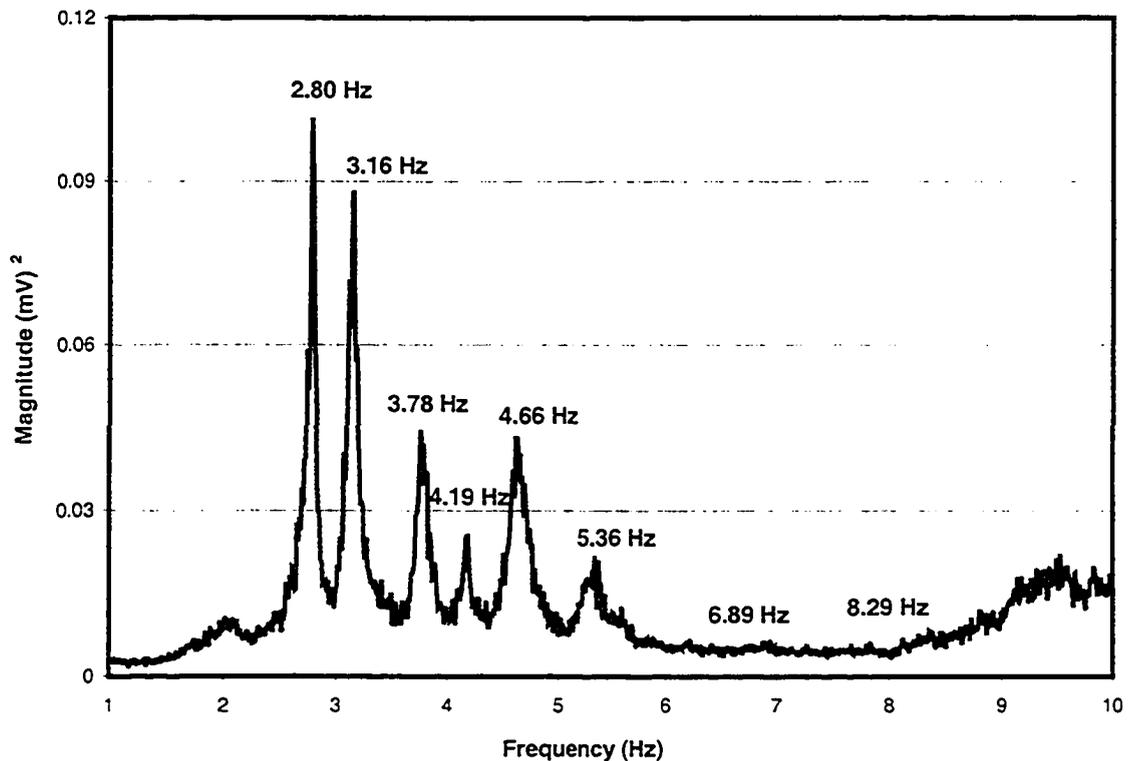
Summing the power spectrum results from each individual accelerometer test set-up also identified natural frequencies. By summing all the results, the natural frequencies of the bridge were more easily identified. Figure 4.5 graphs the sum of the power spectrum results of the two 8306 accelerometers. Figure 4.5 contains the results from all of the test

Figure 4.5 - Power Spectrum Results: 2004 Crowchild Trail Bridge Natural Frequencies

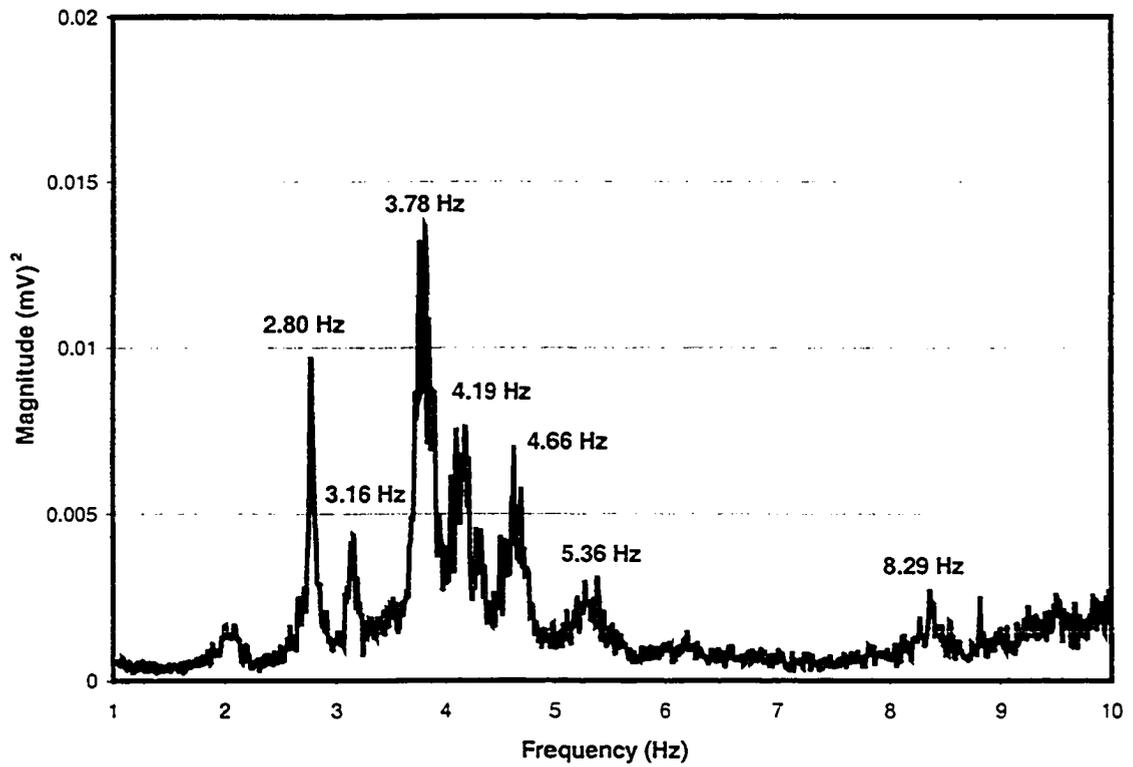
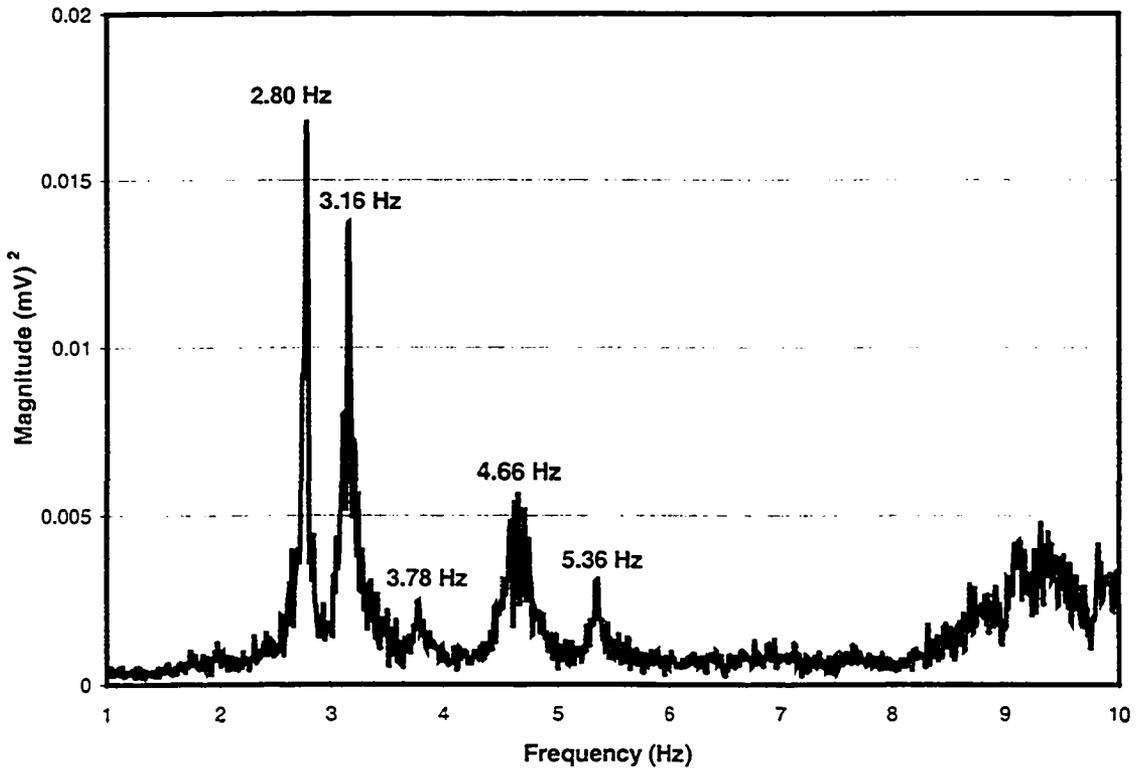
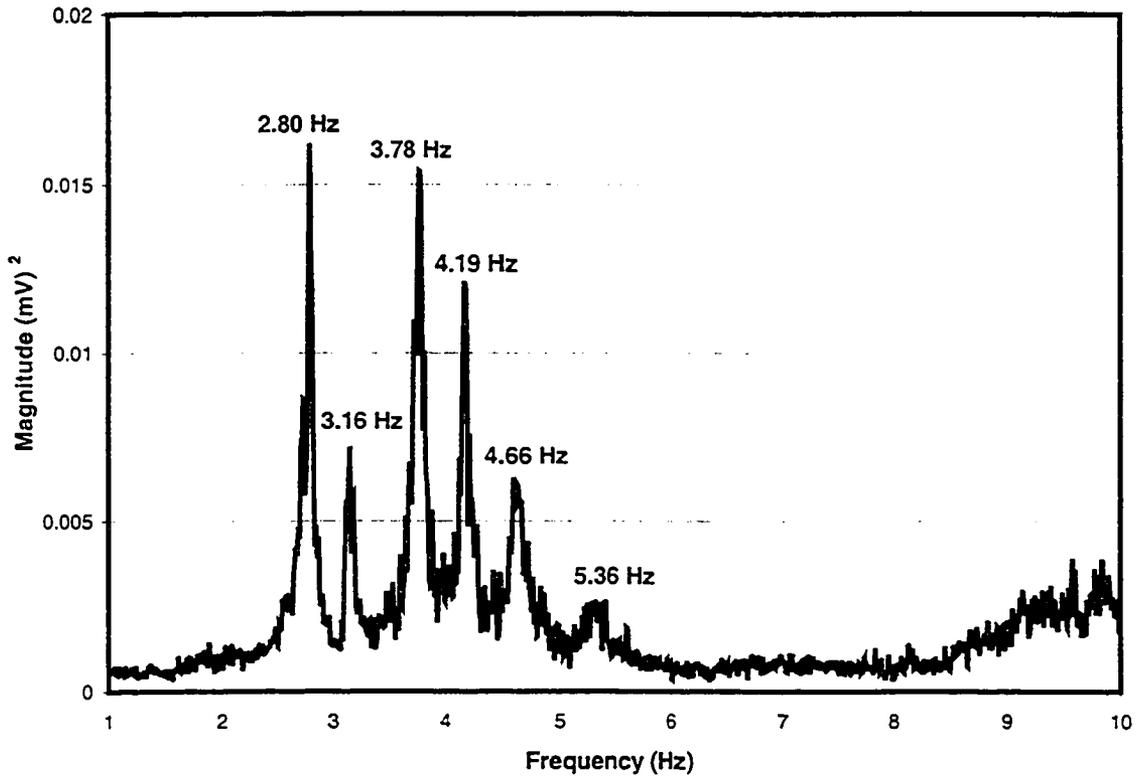
accelerometer. Finally, Figure 4.8 sums all of the power spectrum results from the Type 8306 accelerometer set-ups in the south span.

Figure 4.6 - North Span: Sum of 8306 Accelerometer Power Spectrums

Figure 4.7- Middle Span: Sum of 8306 Accelerometer Power Spectrums

Figure 4.8 - South Span: Sum of 8306 Accelerometer Power Spectrums

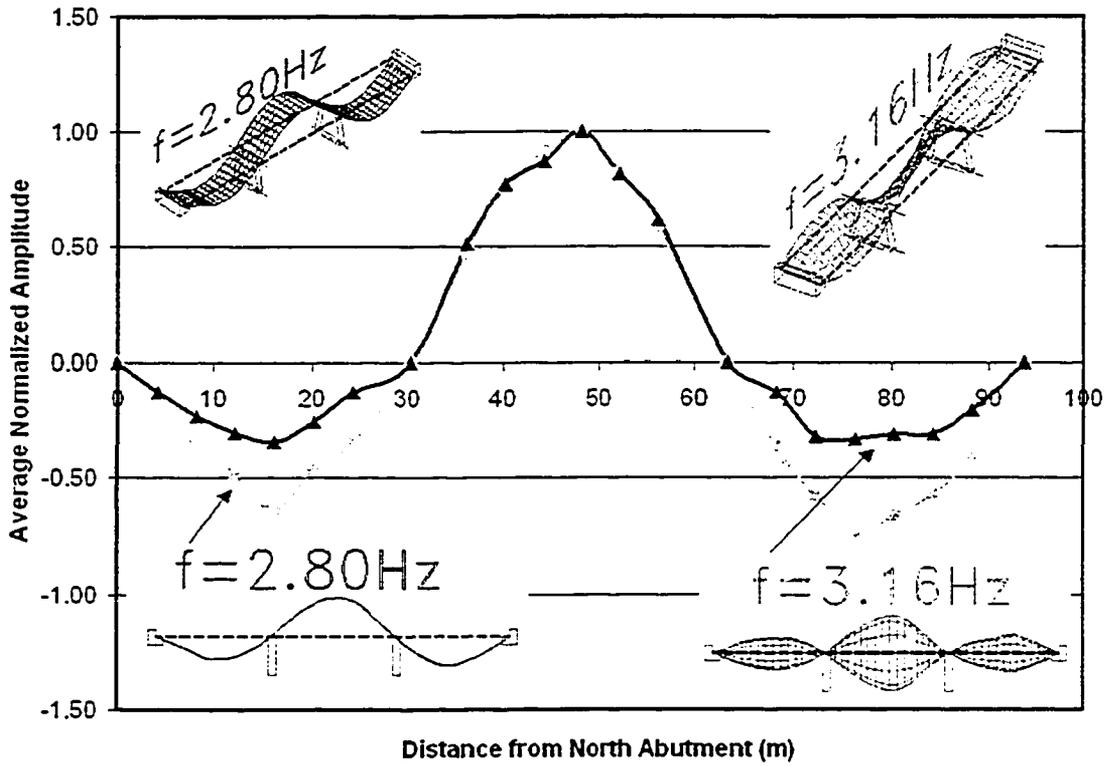
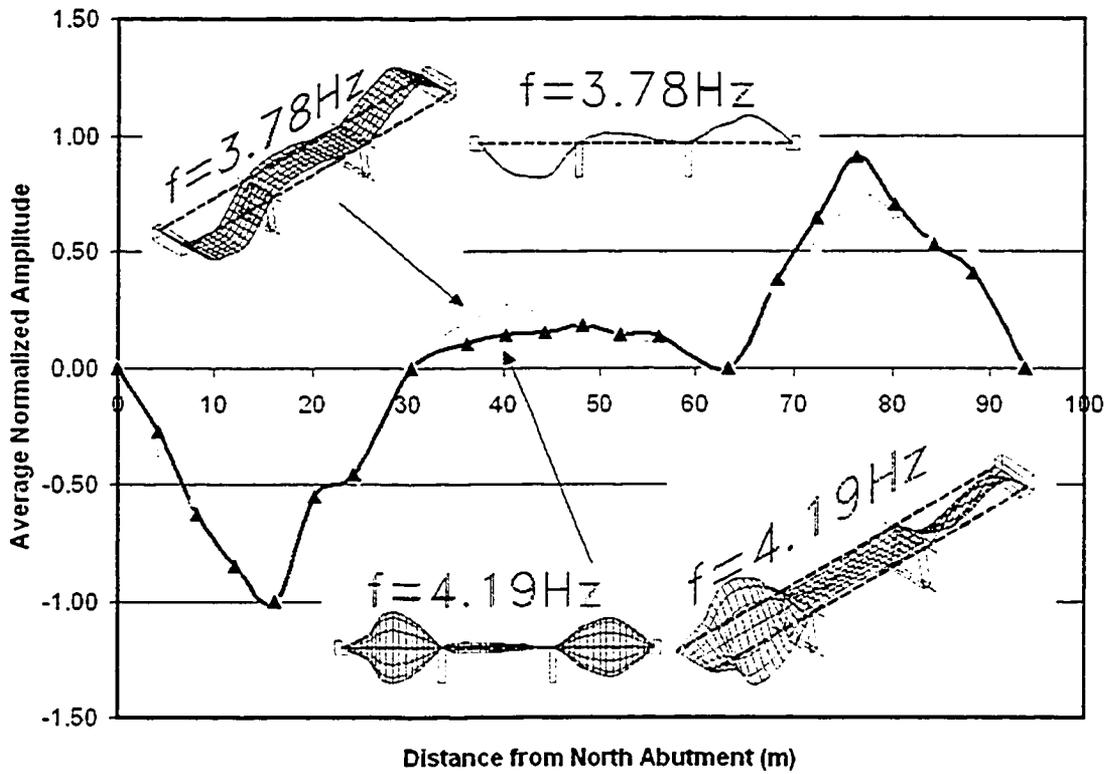
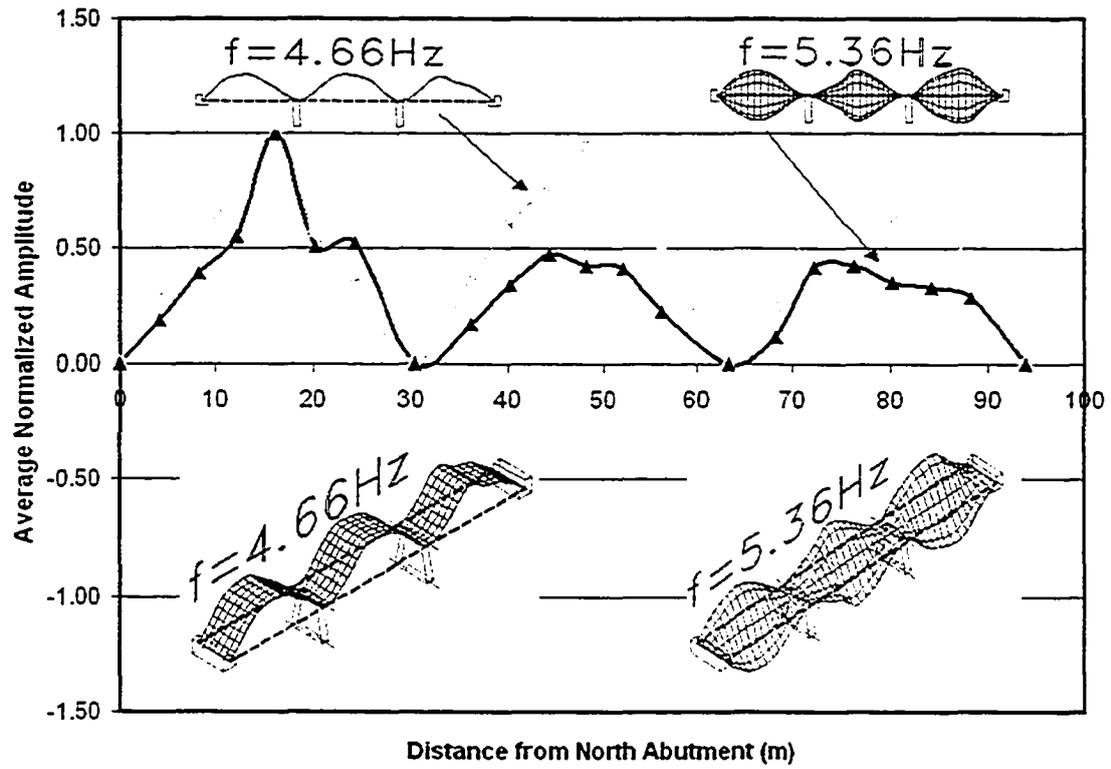
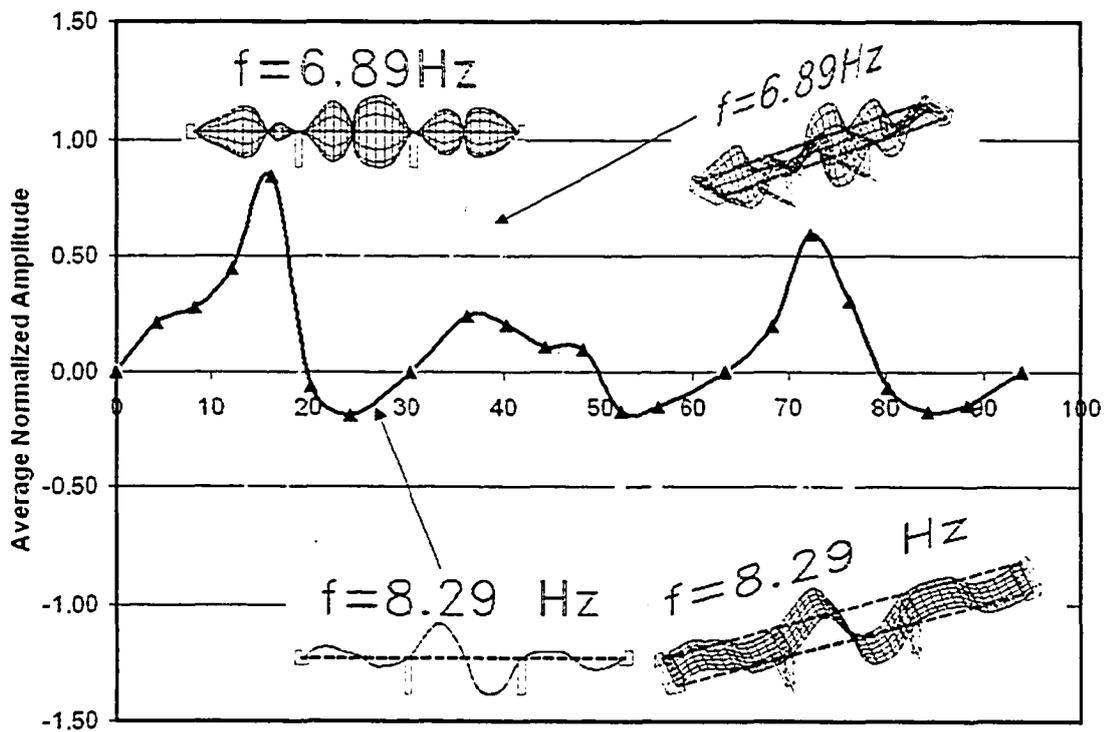
neighbouring girders vibrate in phase with each other, thus producing 3D vertical mode shapes as seen in the figures. However, if the mode shape direction was not horizontal, then it was considered to be a torsional mode shape. This indicates that neighbouring girders vibrate out of phase relative to each other, thus producing 3D torsional mode shapes as seen in the figures.

Figure 4.9 - First Vertical and Torsional Mode Shapes

Figure 4.10 - Second Vertical and Torsional Mode Shapes

Figure 4.11 - Third Vertical and Torsional Mode Shapes

Figure 4.12 - Fourth Vertical and Torsional Mode Shapes

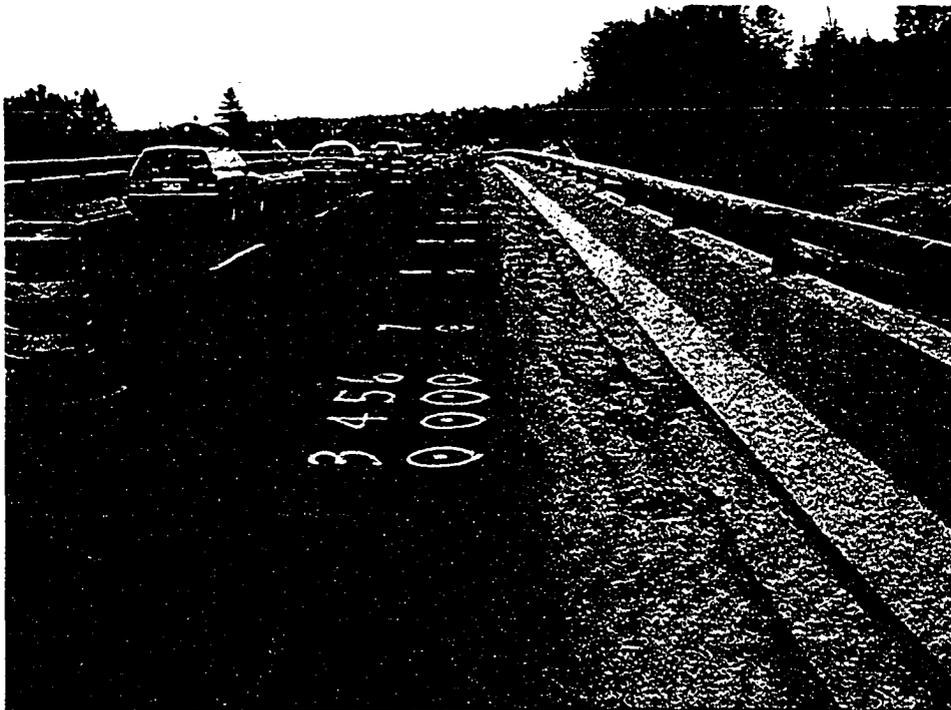
Figure 4.13 - Static Load Point Location Markings

Static load tests were completed on Sunday, June 6 2004. Testing set-up began at approximately 6:30 AM. The City of Calgary provided an electrical generator, a ladder, and traffic control. Similar to the ambient vibration tests, the west-facing traffic lane was completely closed for the duration of the tests and the east-facing lane was open intermittently between tests when data was not being collected. Pavement markings were laid out to indicate static load points as shown in Figure 4.13. However, before the individual load points were marked out on the bridge deck, the location of both bridge piers was determined. The location of both piers was measured

from both the north and south abutments. Once these benchmark locations were determined, the actual loading points were marked. Figure 4.14 indicates the static load point locations on a plan view of the Crowchild Trail Bridge Deck. The front passenger-side truck axle would be positioned above these points. As seen in Figure 4.14, all of the

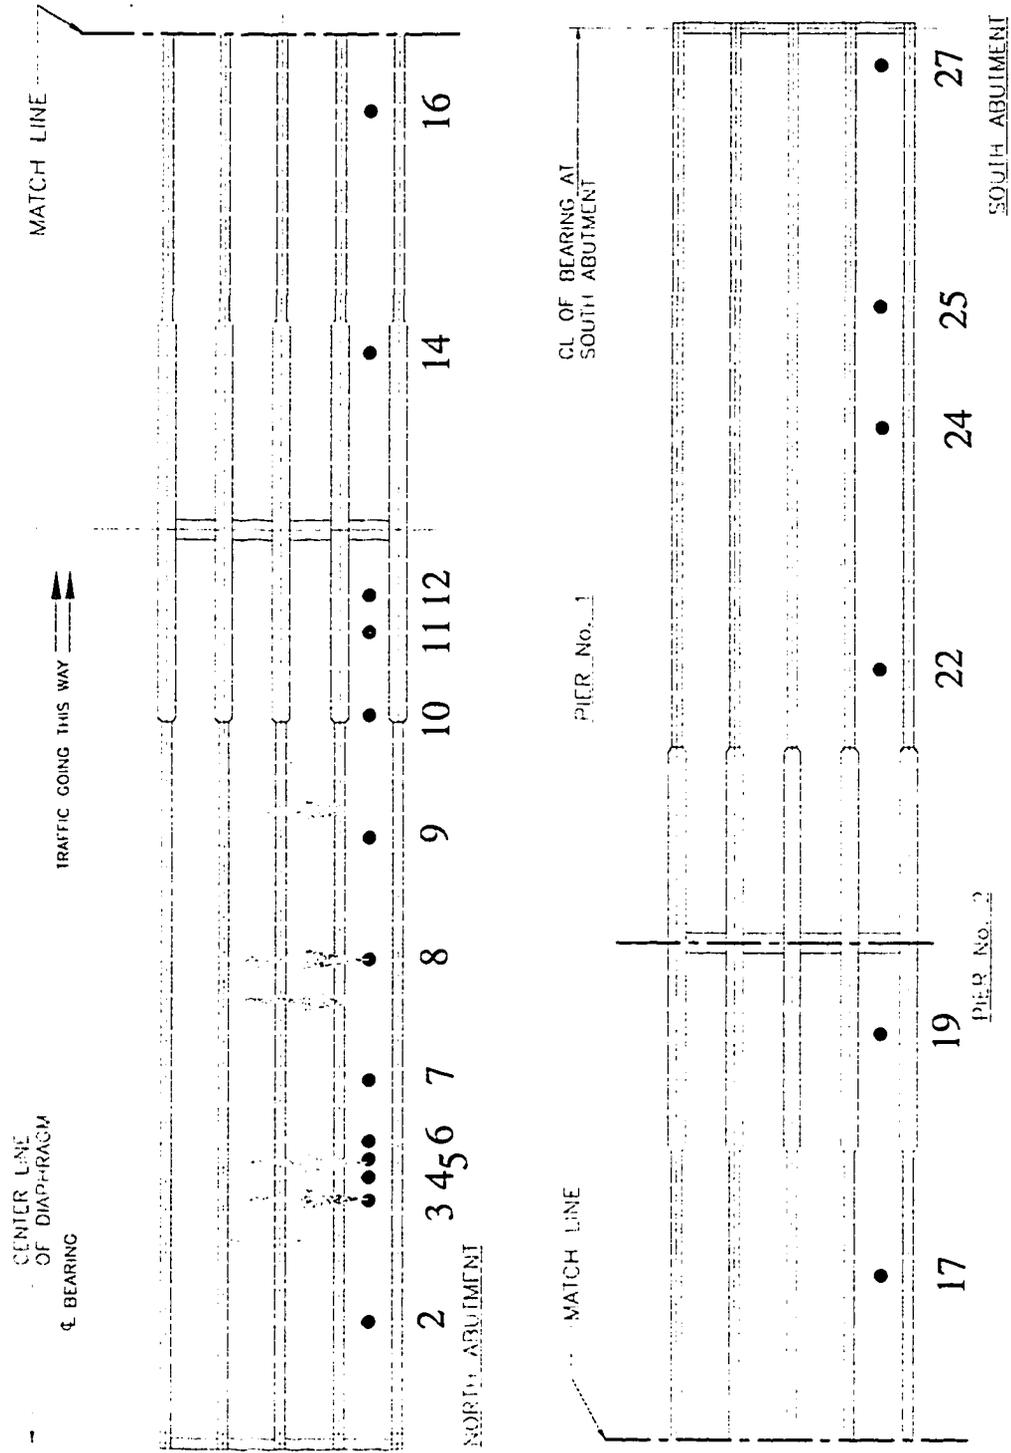
static loading points were located exactly midway between Girder 1 and Girder 2. This location was chosen to investigate load sharing between girders in addition to other bridge properties. For comparison with previous static loading results, the load point location numbers were left the same. As indicated in Figure 4.14, some of the loading points were omitted in order to save time during field testing.

Figure 4.14 – 2004 Static Loading Point Locations

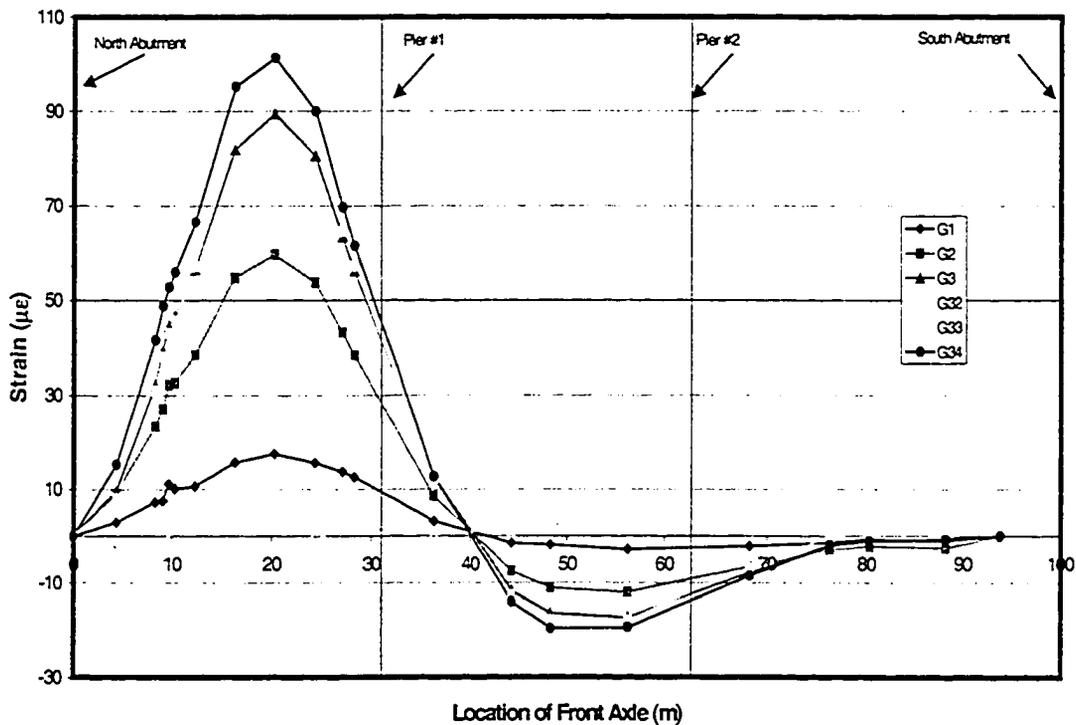
Influence lines were constructed from strain results of all the different truckload points. Figure 4.15 shows the influence lines for several strain gauges located on Girder 1.

Figure 4.15 Static Response: Influence Lines of Girder Strains

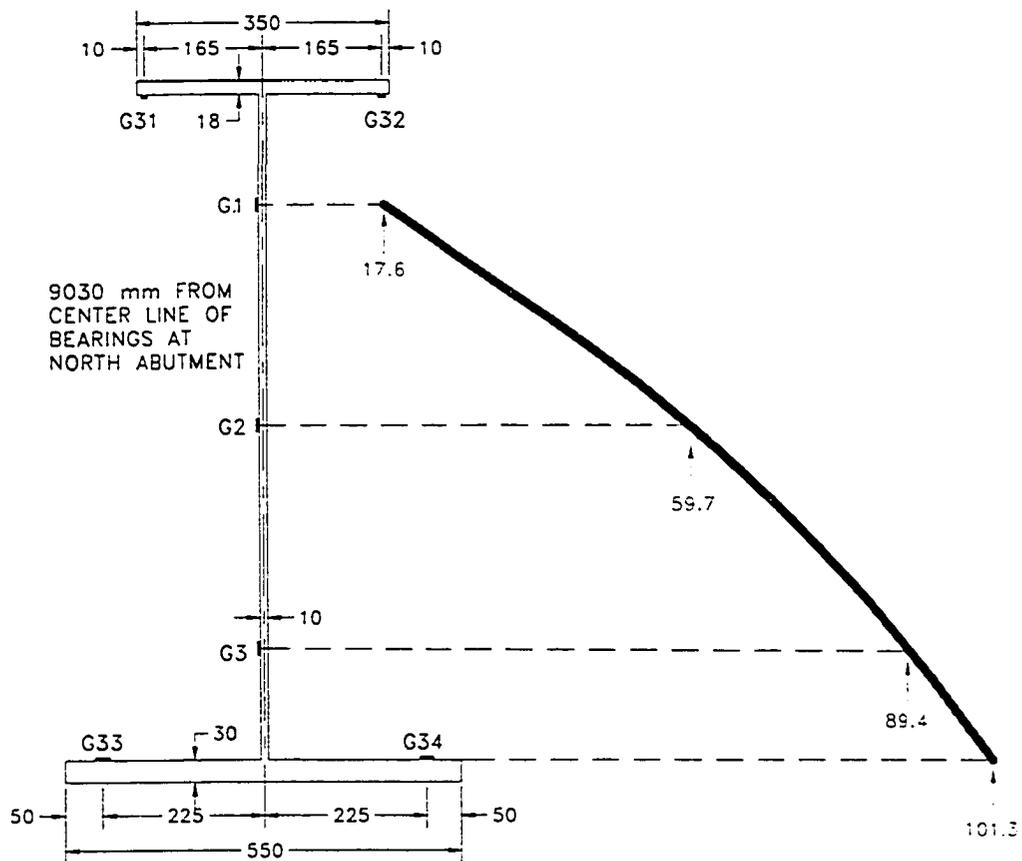
Strain profiles in the positive and negative moment regions can also be analyzed from the static test results. Strain Gauges G1 - G3, and G31-G34 were mounted on Girder 1 at the same cross section. At 9030 mm from the centre line of north abutment bearings, these gauges are located in the positive moment region of the plate girder. Figure 4.16 shows the maximum strains recorded at this cross-section during the static load tests.

Figure 4.16 - 2004 Positive Moment Region Strain Distribution

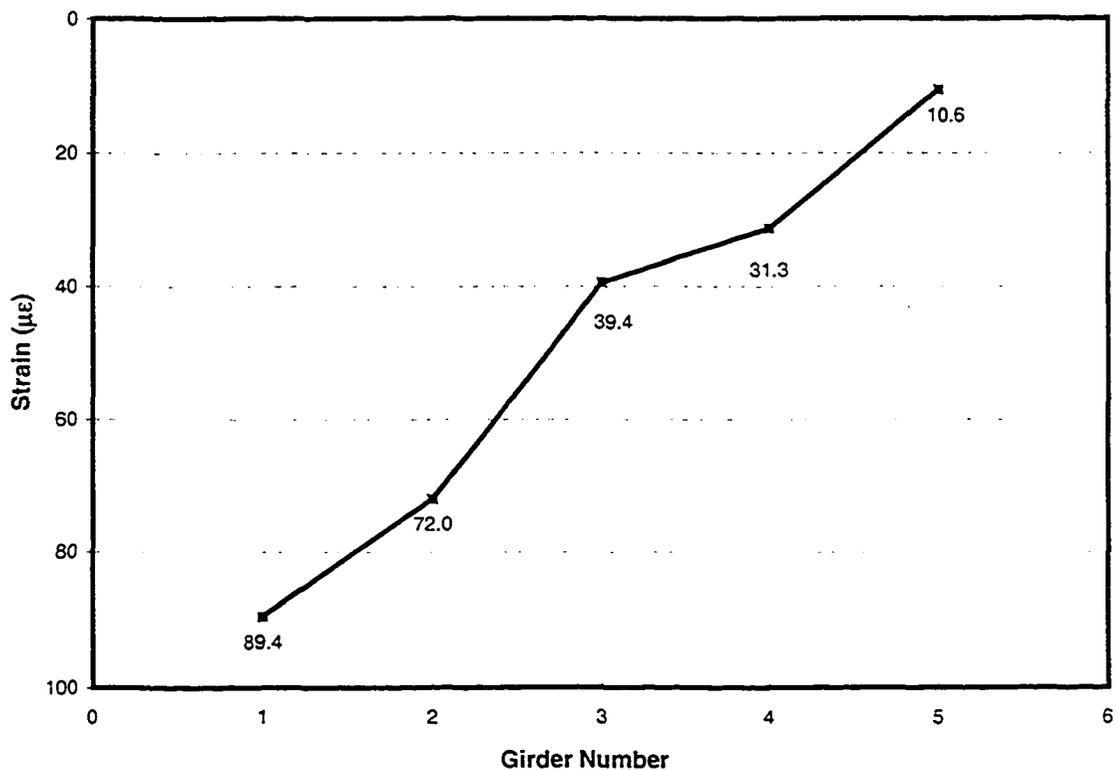
Load sharing between the five girders was also analyzed by looking at the tension strain results. Results were compared from the lowest strain gauge position on each girder web. These gauges included G3, G6, G9, G12, and G15 from Girders 1, 2, 3, 4, and 5 respectively. Figure 4.18 shows the maximum strains recorded from each gauge. All of

Figure 4.18 - Load Sharing Indicated By Girder Strains

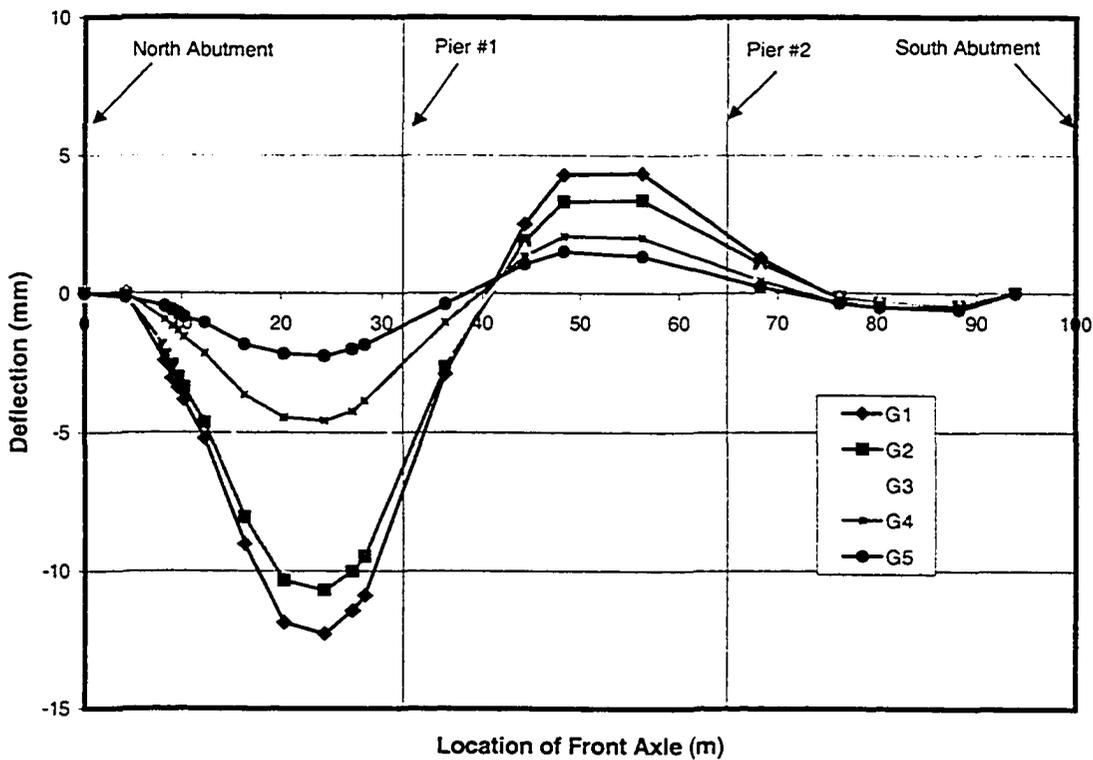
Figure 4.19 shows the influence line for the north span girder deflection as the position of the loaded truck changed during the static tests. All of the girders deflect downward as

Figure 4.19 - Girder Deflection Influence Line

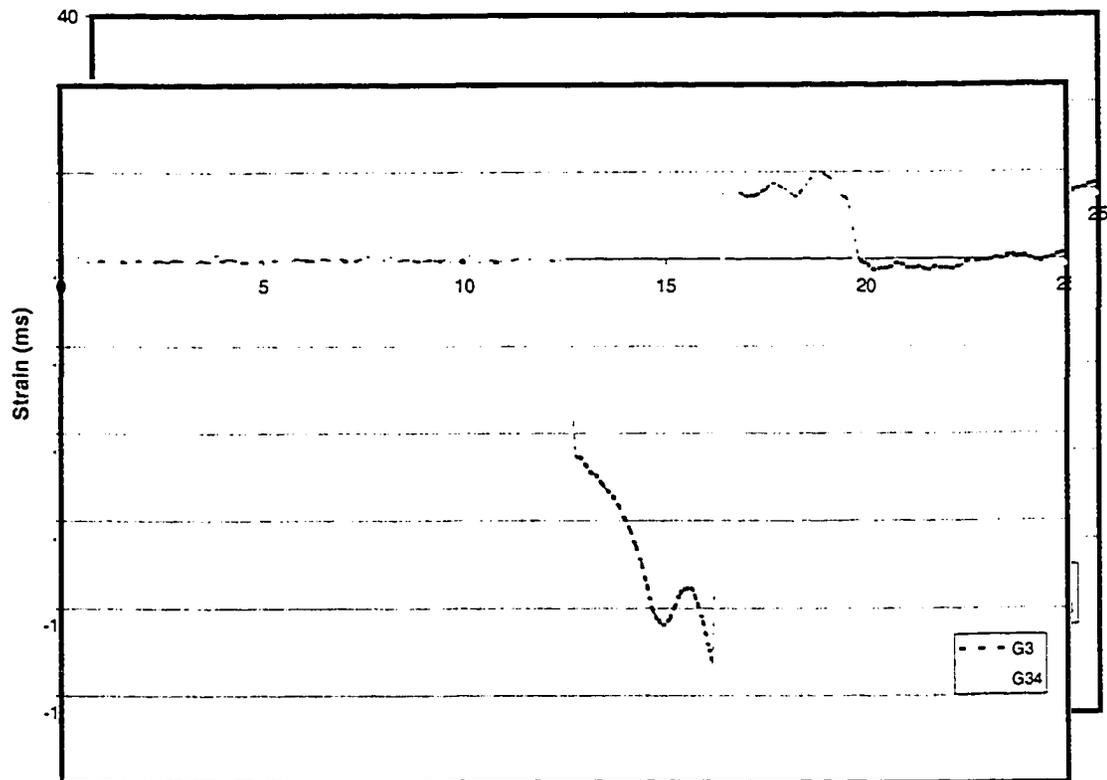
Influence lines for several of the bridge components were plotted. Figure 4.20 shows the typical dynamic response of strain gauges G3 and G34 as the loading truck passed over

Figure 4.20 - Dynamic Response of Girder Strain Gauges
