University of Alberta

**LONG-TERM STRUCTURAL HEALTH MONITORING OF THE
CROWCHILD TRAIL BRIDGE**

A thesis submitted to the Faculty of Graduate Studies and Research in partial fulfillment
of the requirements for the degree of Master of Science

Structural Engineering

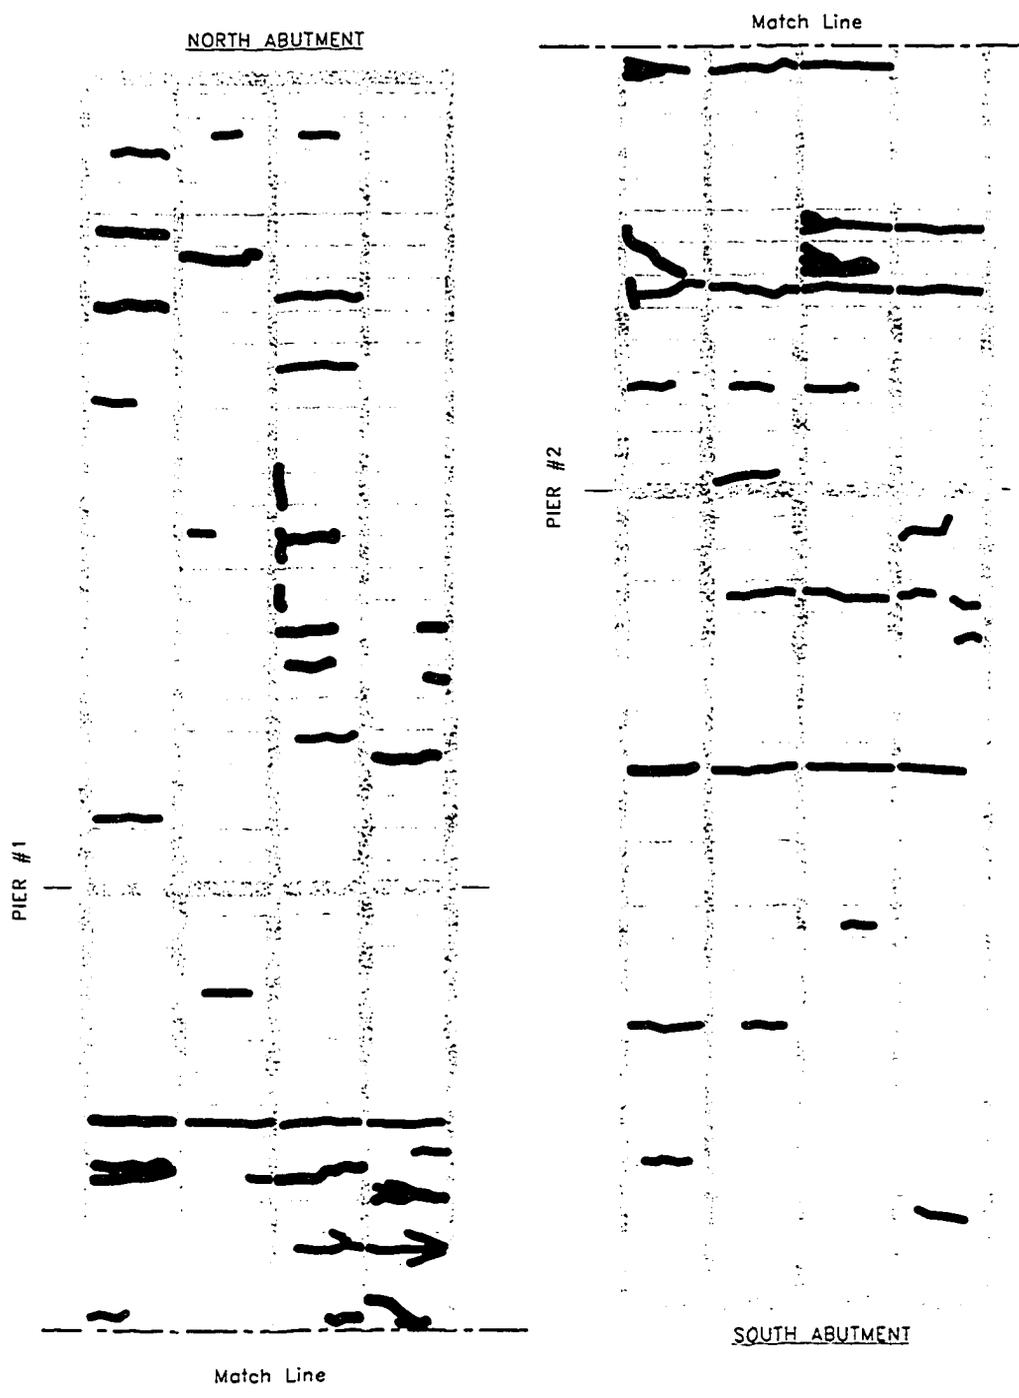
Figure 4.23 on the following page shows the approximate locations of these water leaks and water stains on the underside of the deck. Please note that this drawing is not drawn to scale to accurately represent the relative sizes of the steel girders and straps. Also, the water-stained areas on the bridge deck were intentionally drawn larger than what was actually observed in the field. From the figure, it is noticed that the middle span, which was reinforced internally with only GFRP bars, contained the most amount of areas affected by water leakage. The south span, which was the only span to contain a small amount of internal steel reinforcement, contained the fewest affected areas. Most of the water leakage occurred at cracks orientated in the transverse direction. Water leakage was noted to occur at several cold joint locations.

Figure 4.23 - Bridge Deck Leak Locations

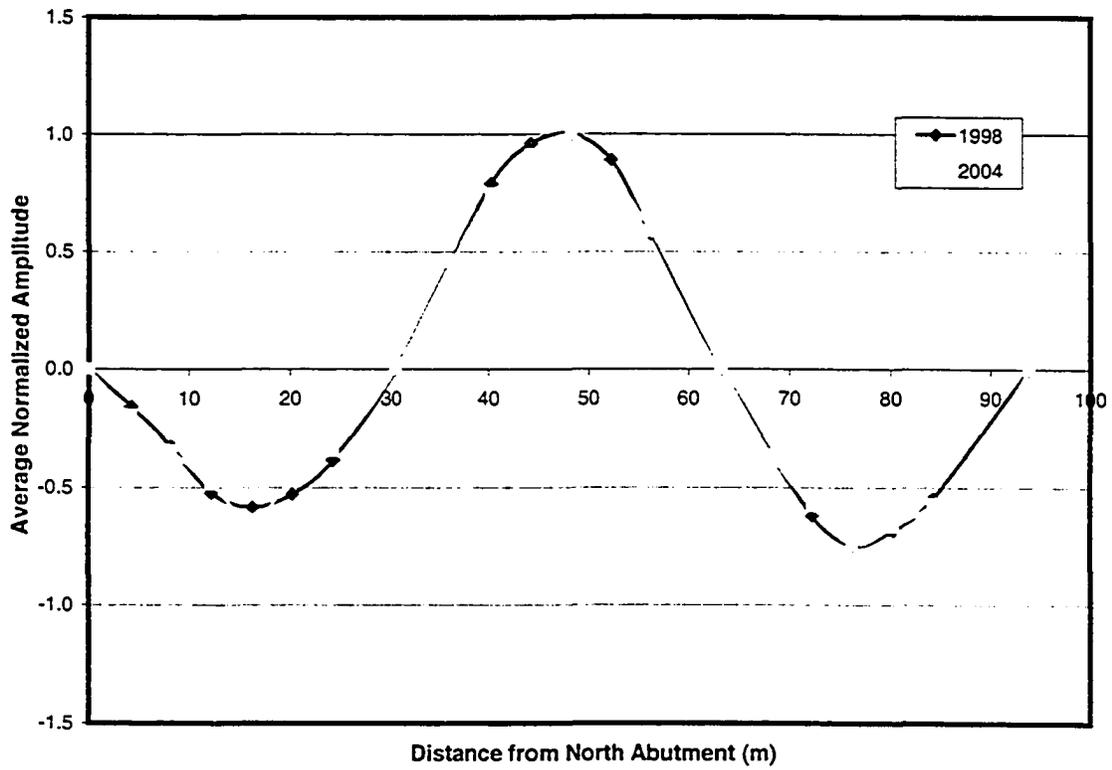
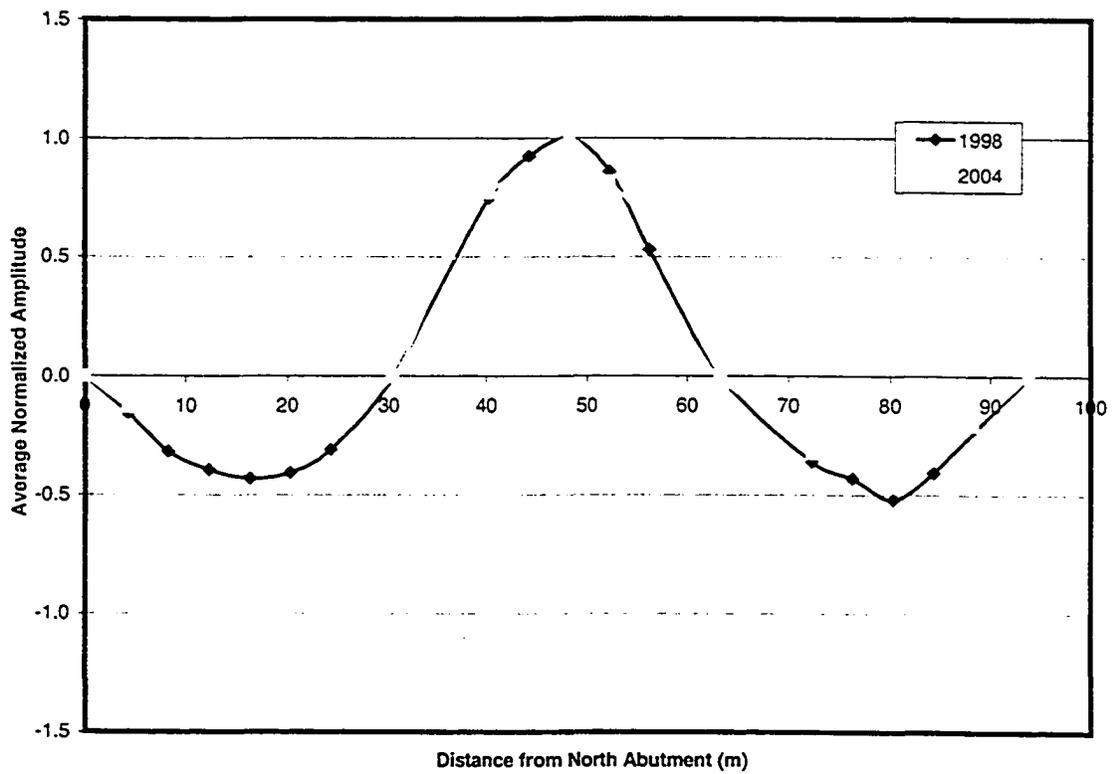
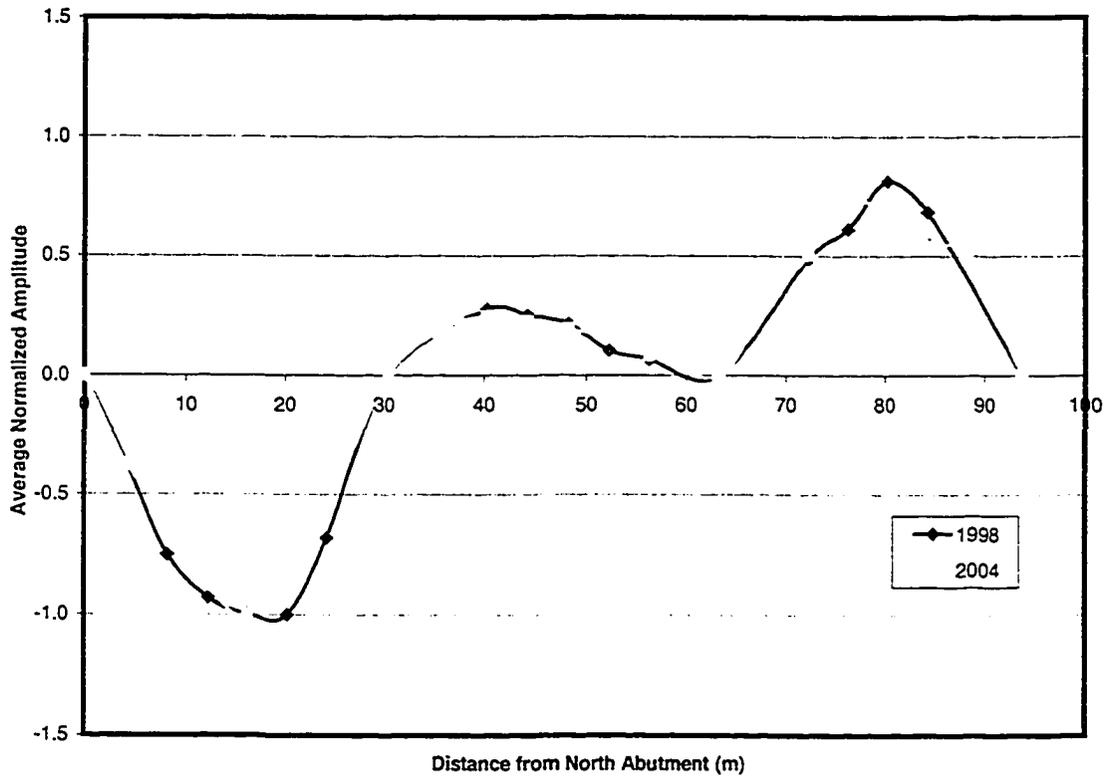
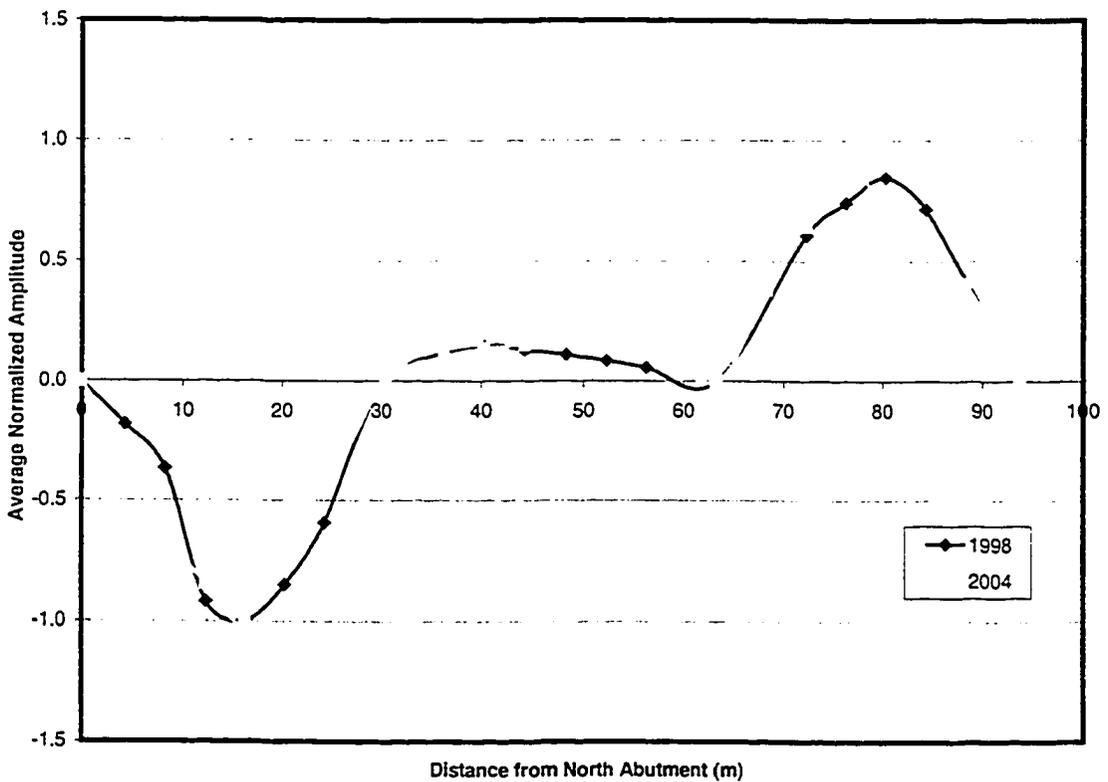
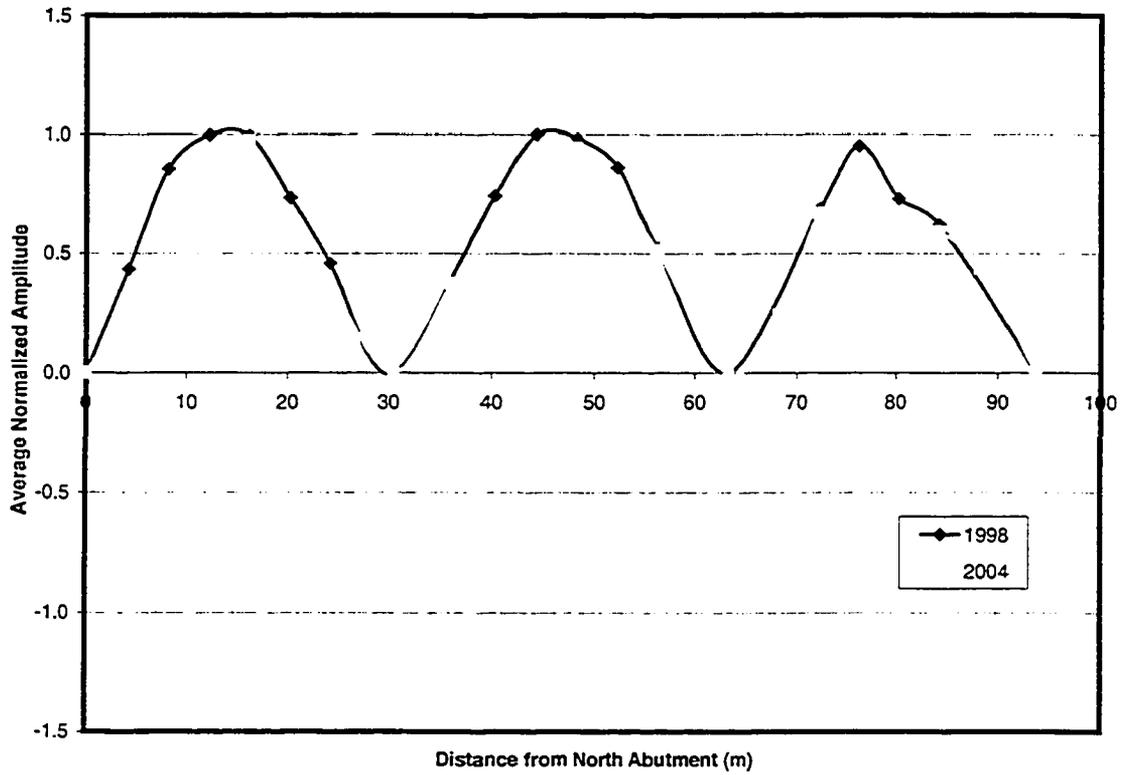
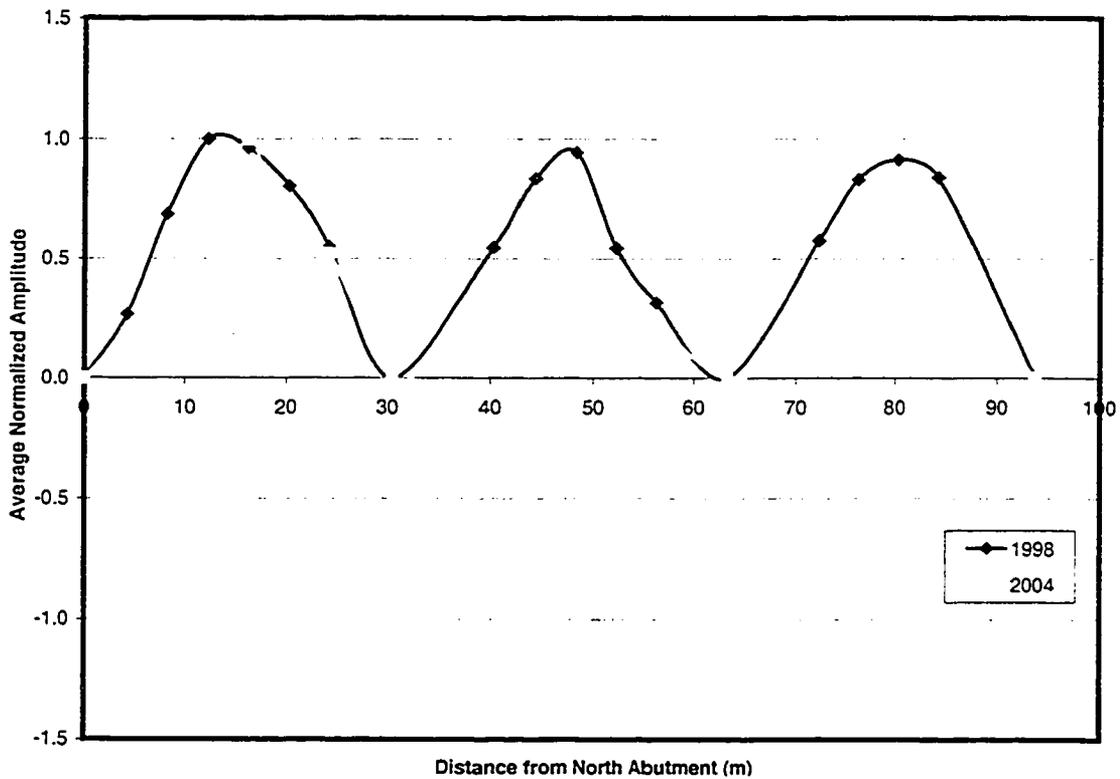
Figures 5.1 to 5.8 compare the first eight mode shapes captured in 1998 and 2004. From the results, it is evident that the first vertical and torsional 1998/2004 mode shapes are nearly identical. The second vertical and torsional 1998/2004 mode shapes are very similar as well, however, they do not match as close compared to the first two mode shapes. The general shapes of the third vertical and torsional 1998/2004 mode shapes are similar, however the magnitude of the 2004 mode shape is consistently lower compared to the 1998 mode shape. It is also interesting to note the third torsional mode shape from the 2004 results. The 2004 mode shape in the north span is nearly the same compared to the 1998 results. However, the 2004 mode shape magnitude gradually declines in the middle span and again in the south span. Magnitudes from the 1998/2004 fourth vertical and horizontal mode shapes are generally the same. However, the last two (4th vertical and 4th torsional) mode shapes were the most difficult to obtain from the raw data. Although the general shapes of the modes are similar, the results from the 4th vertical and 4th torsional modes exhibited the least compatibility.

Figure 5.1 - 1st Vertical Mode Shape: Comparison of 1998 and 2004 Results

Figure 5.2 - 1st Torsional Mode Shape: Comparison of 1998 and 2004 Results

Figure 5.3 - 2nd Vertical Mode Shape: Comparison of 1998 and 2004 Results

Figure 5.4 - 2nd Torsional Mode Shape: Comparison of 1998 and 2004 Results

Figure 5.5 - 3rd Vertical Mode Shape: Comparison of 1998 and 2004 Results

Figure 5.6 - 3rd Torsional Mode Shape: Comparison of 1998 and 2004 Results

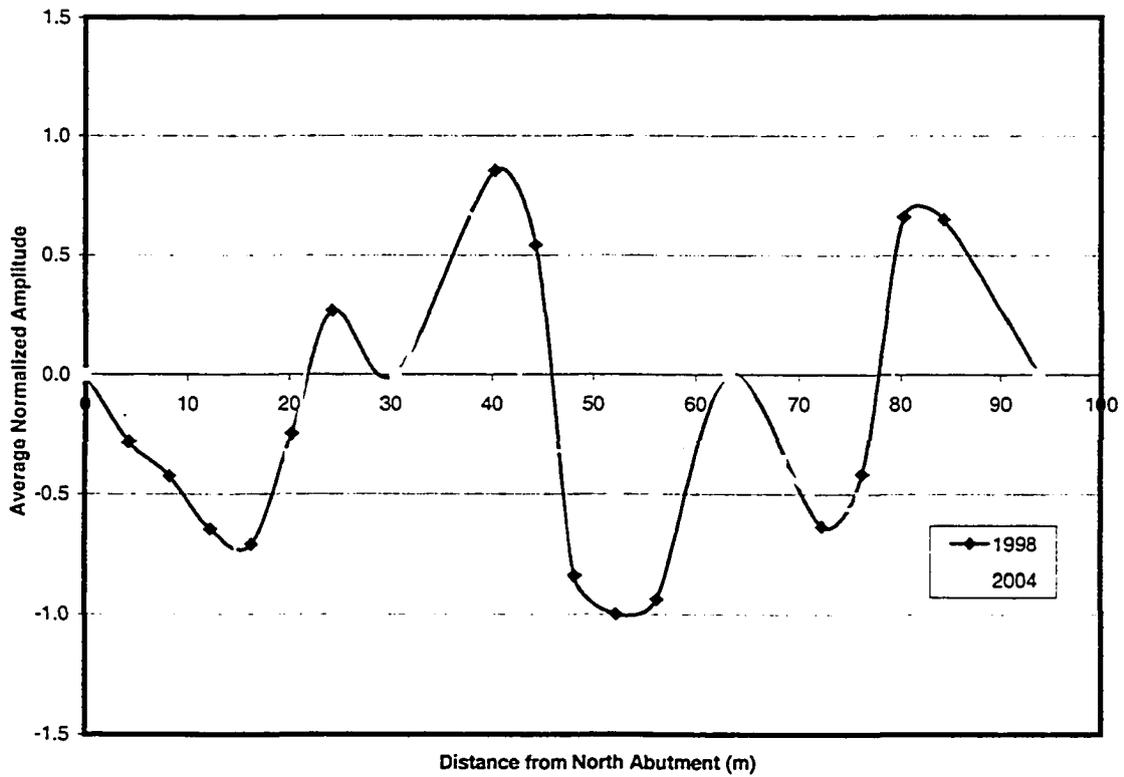
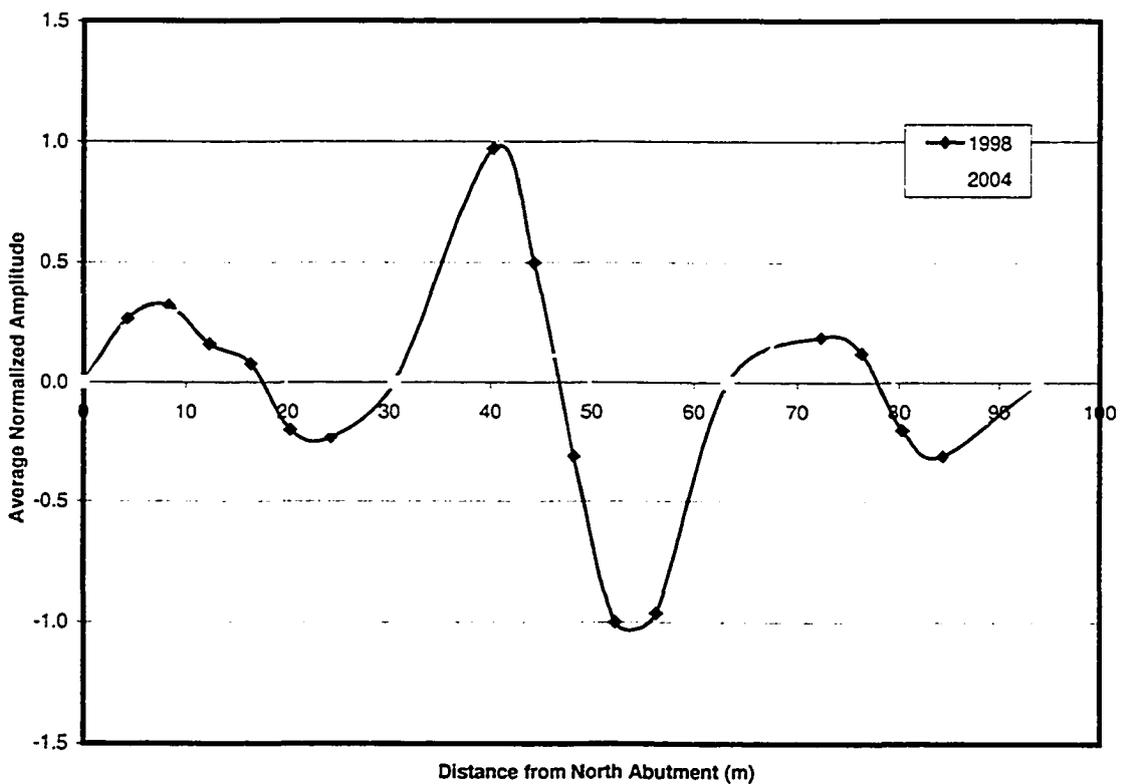
Figure 5.7 - 4th Vertical Mode Shape: Comparison of 1998 and 2004 Results

Figure 5.8 - 4th Torsional Mode Shape: Comparison of 1998 and 2004 Results

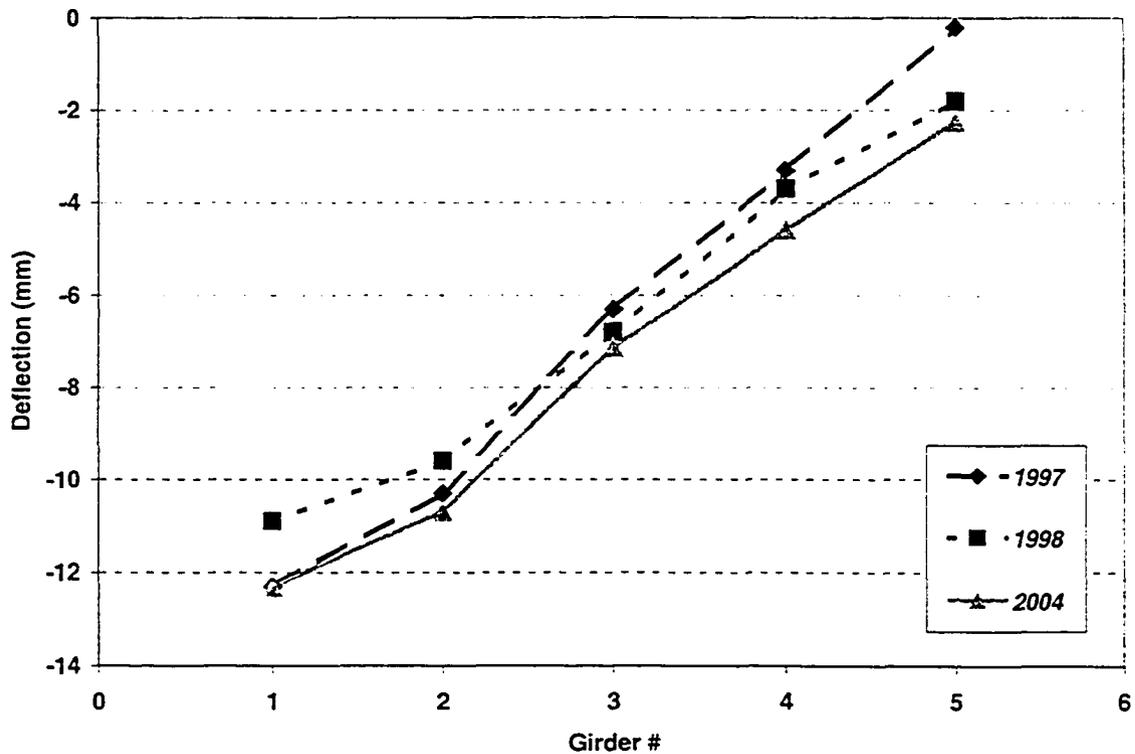
Figure 5.9 highlights the load sharing between girders based on the deflection measurements from 1997, 1998, and 2004. As seen in the figure the load sharing characteristics among the girders had not changed significantly from 1997 to 2004. At a transverse section, the deflected shape of the girders is very close to a straight line. Load sharing is characterized by the load-carrying contribution of girders not directly loaded by the truck. Adequate load sharing among the girders suggests a relatively stiff deck in the transverse direction from 1997-2004. Within the first year of service, no deterioration had been observed in load sharing among the girders. Since the truck was positioned closer to Girder 1 during the 1997 load tests, the deflection under Girder 1 is slightly larger compared to the 1998 load tests. Due to the eccentricity of load, however, the deflection under Girder 5 was less in 1997 compared to 1998 and 2004.

Figure 5.9 - Girder Deflection Comparisons

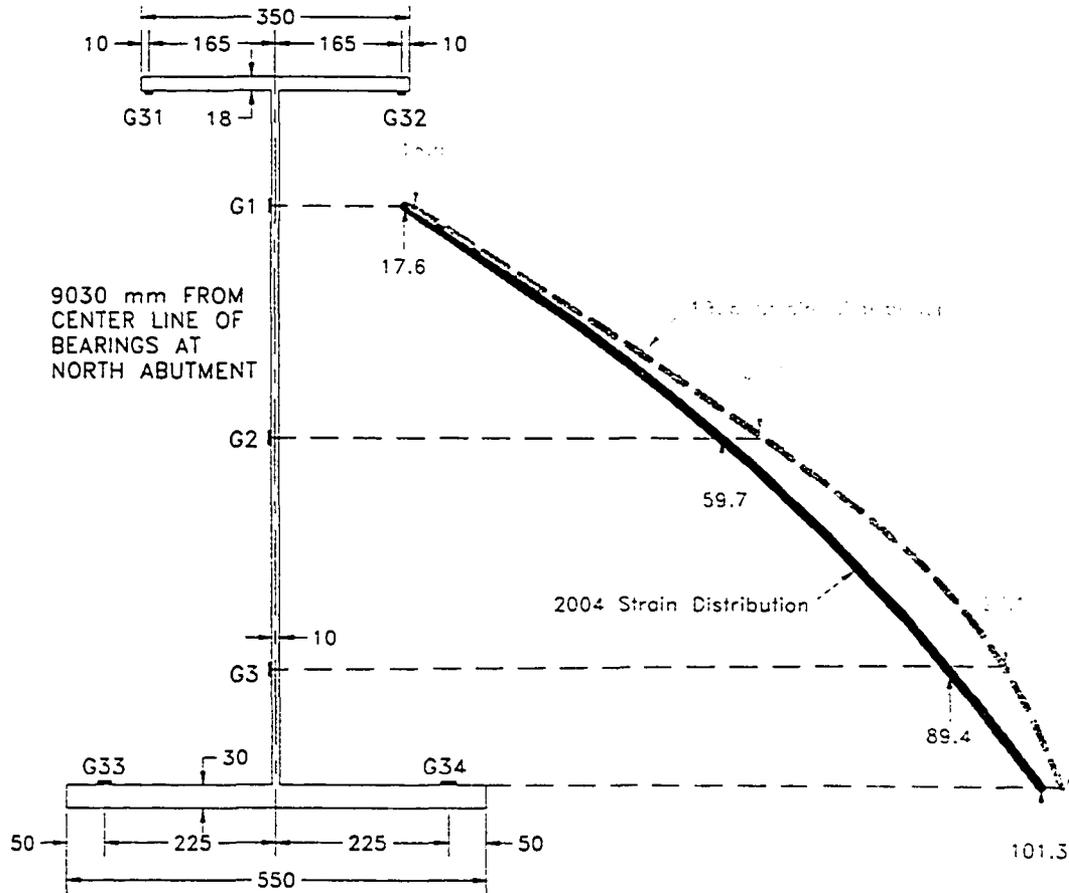
One of the most important aspects that can be observed from the health monitoring data is the girder strain distribution. Figure 5.10 shows the strain distribution across Girder 1

Figure 5.10 - 1998 vs. 2004 Positive Strain Region Comparison

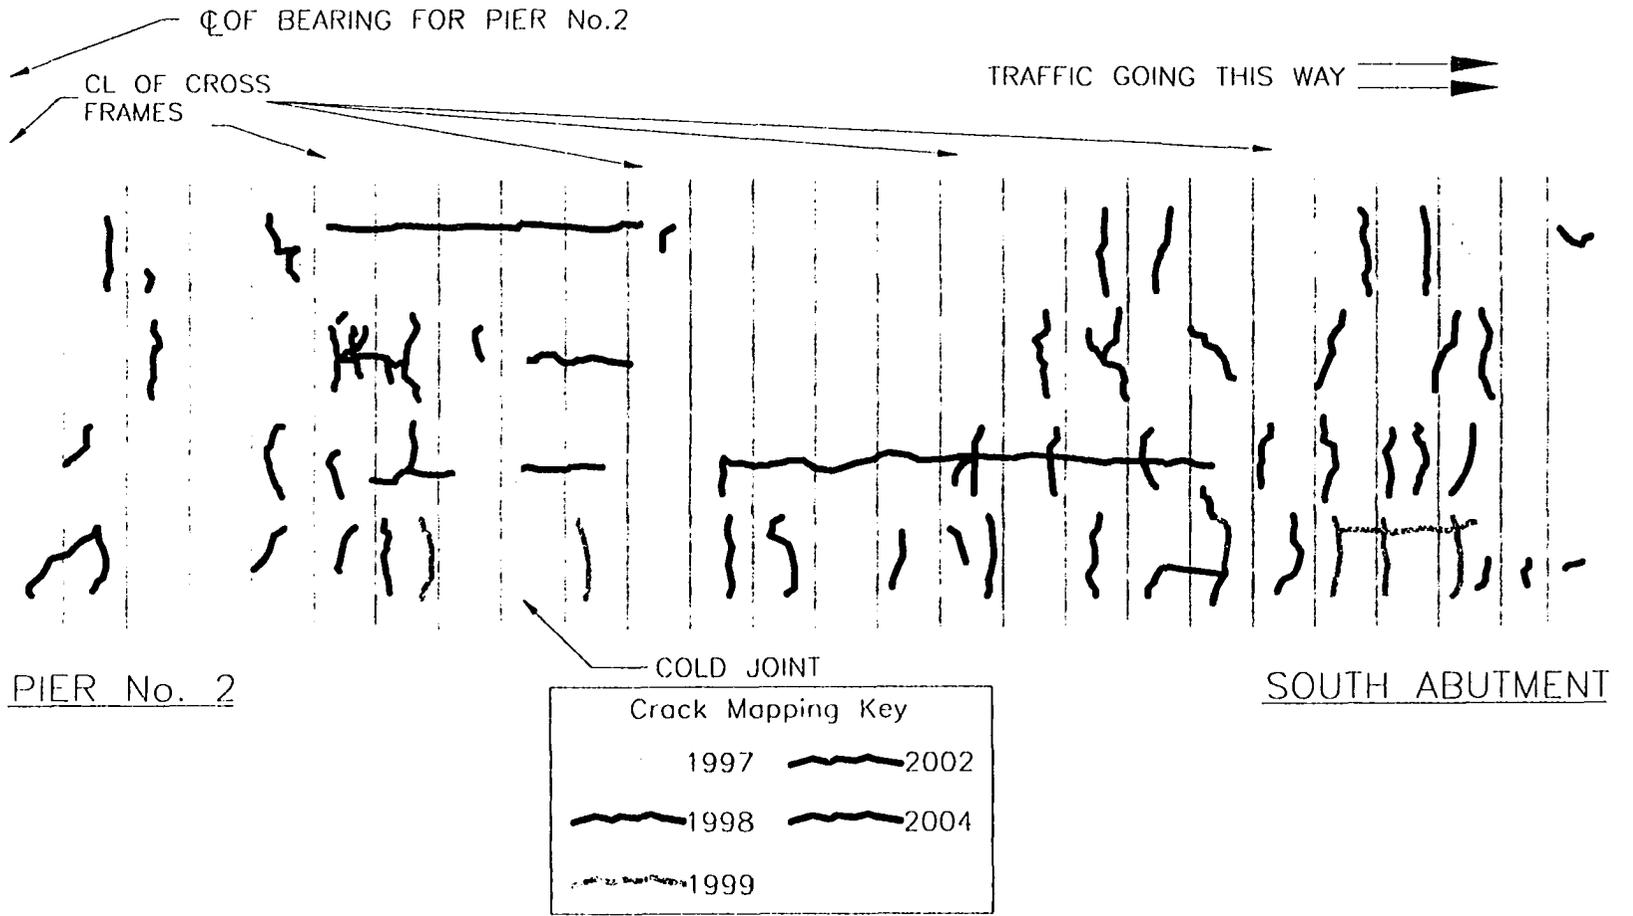
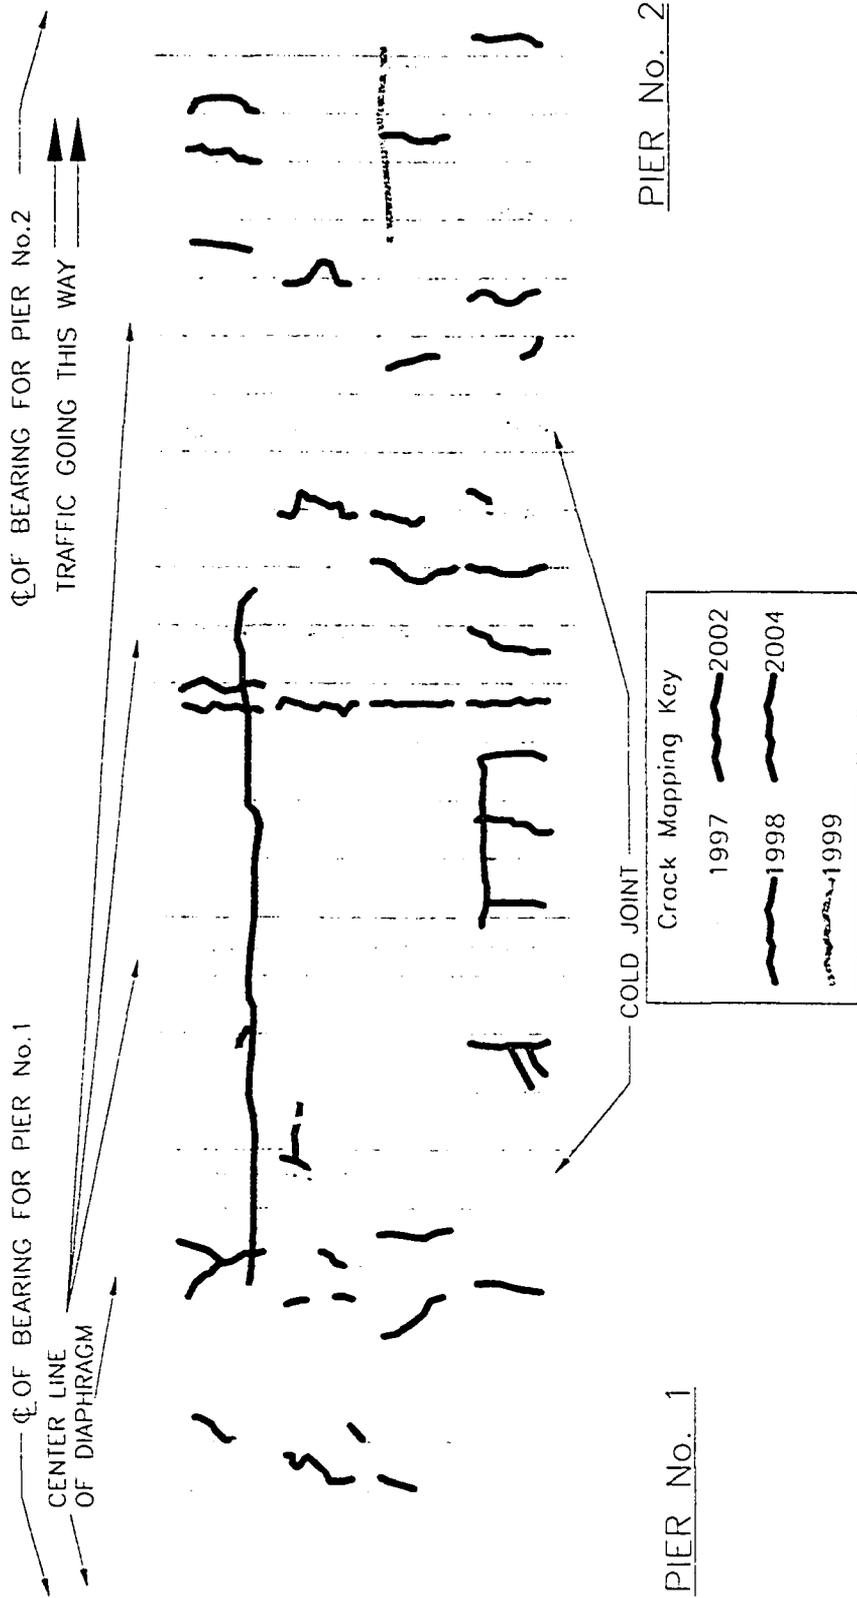
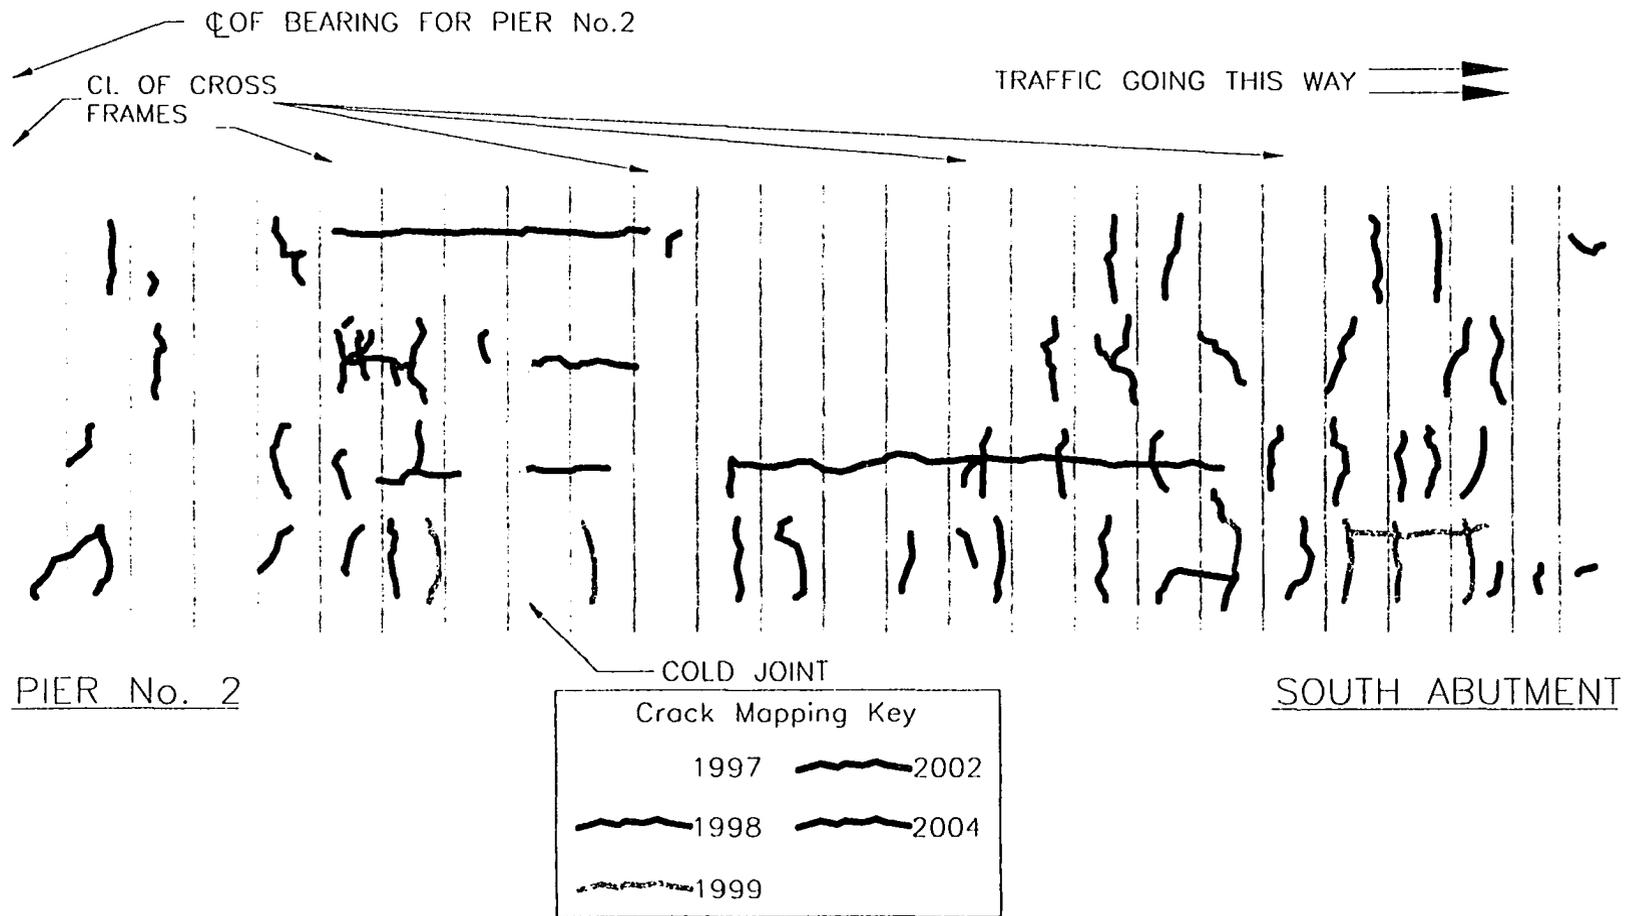
Over the first seven years of service life, crack mapping of the underside of the Crowchild Trail Bridge deck has been inspected and recorded five times. The first complete crack mapping was documented in August 1997 immediately before the bridge was opened to traffic. The crack mapping was completed again in August 1998 after one year of operation. Crack mapping was completed three more times in June 1999, July 2002, and most recently in June 2004. As a result, the location, size, and rate of crack growth has been documented throughout the life of the bridge. Each of the bridge spans was constructed using different materials and, therefore, the crack behaviour is slightly different for each span. With the existence of longitudinal cracks in the deck in 1998, it was concluded that the contribution of concrete in transferring shear had reduced after one year of operation. Crack patterns of the south, middle, and north spans are presented in Figures 5.12, 5.13, and 5.14 respectively.

Figure 5.12 - South Span Crack Pattern

Figure 5.13 - Middle Span Crack Pattern

Figure 5.14 - North Span Crack Pattern

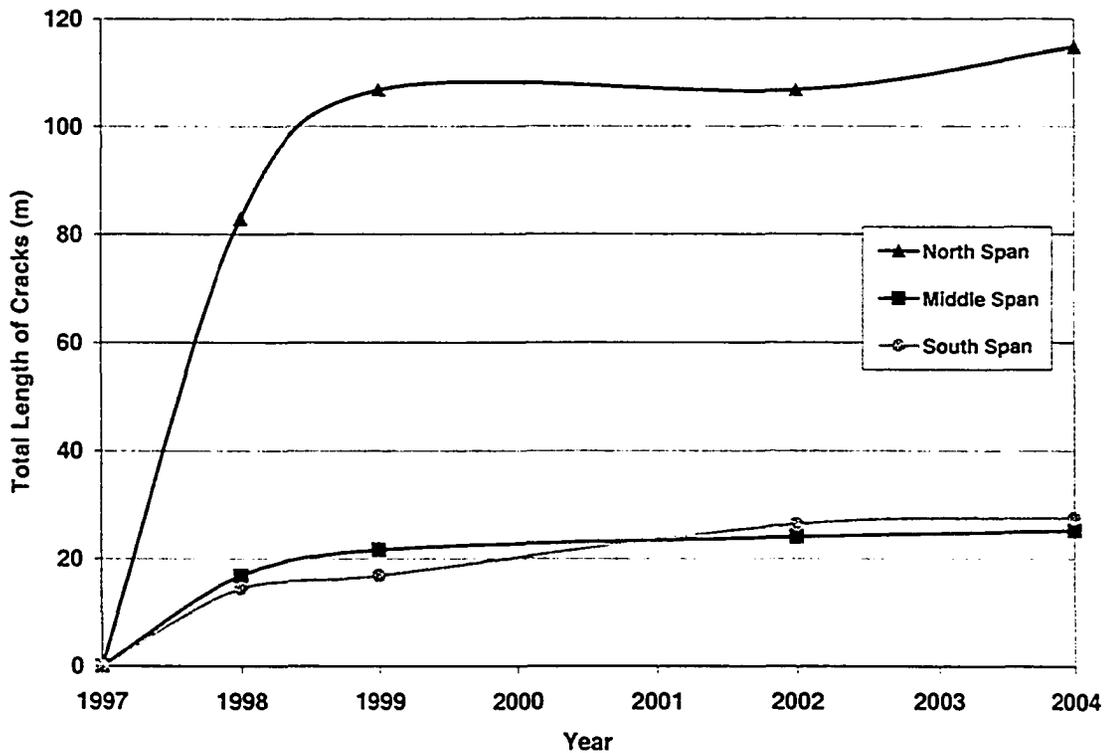
Figures 5.15 and 5.16 summarize the rate of longitudinal and transverse crack formation respectively in each of the spans. The crack lengths were estimated from the crack

Figure 5.15 – Rate of Longitudinal Crack Formation

mapping plots. As shown in Figure 5.15, most of the longitudinal crack formation occurred within the first two years of service. During the last five years of service, relatively few new longitudinal cracks have formed. The north span contained significantly more longitudinal cracks compared to the other two spans. Approximately 25 meters of longitudinal cracks were observed in the middle and south spans by 2004. As shown in Figure 5.16, the amount of transverse cracking was relatively the same in all the spans. The north span contained the least amount of transverse cracks by 2004. However, both the middle and south spans contained approximately 100 meters of transverse cracks by 2004.

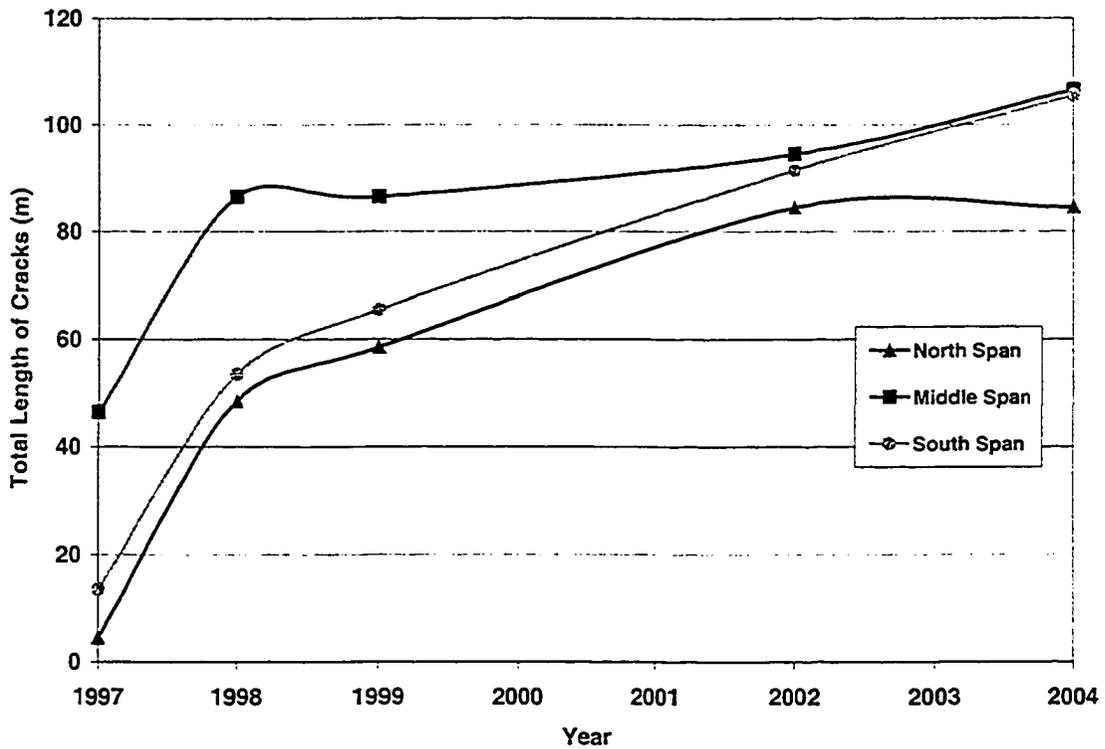
Figure 5.16 – Rate of Transverse Crack Formation
