THE UNIVERSITY OF ALBERTA

REFLECTION CRACKING ON ASPHALTIC CONCRETE RUNWAY OVERLAYS IN  
COLD AREAS

SUBMITTED TO THE FACULTY OF GRADUATE STUDIES AND RESEARCH  
IN PARTIAL FULFILMENT OF THE REQUIREMENTS FOR THE DEGREE  
OF MASTER OF SCIENCE IN CIVIL ENGINEERING

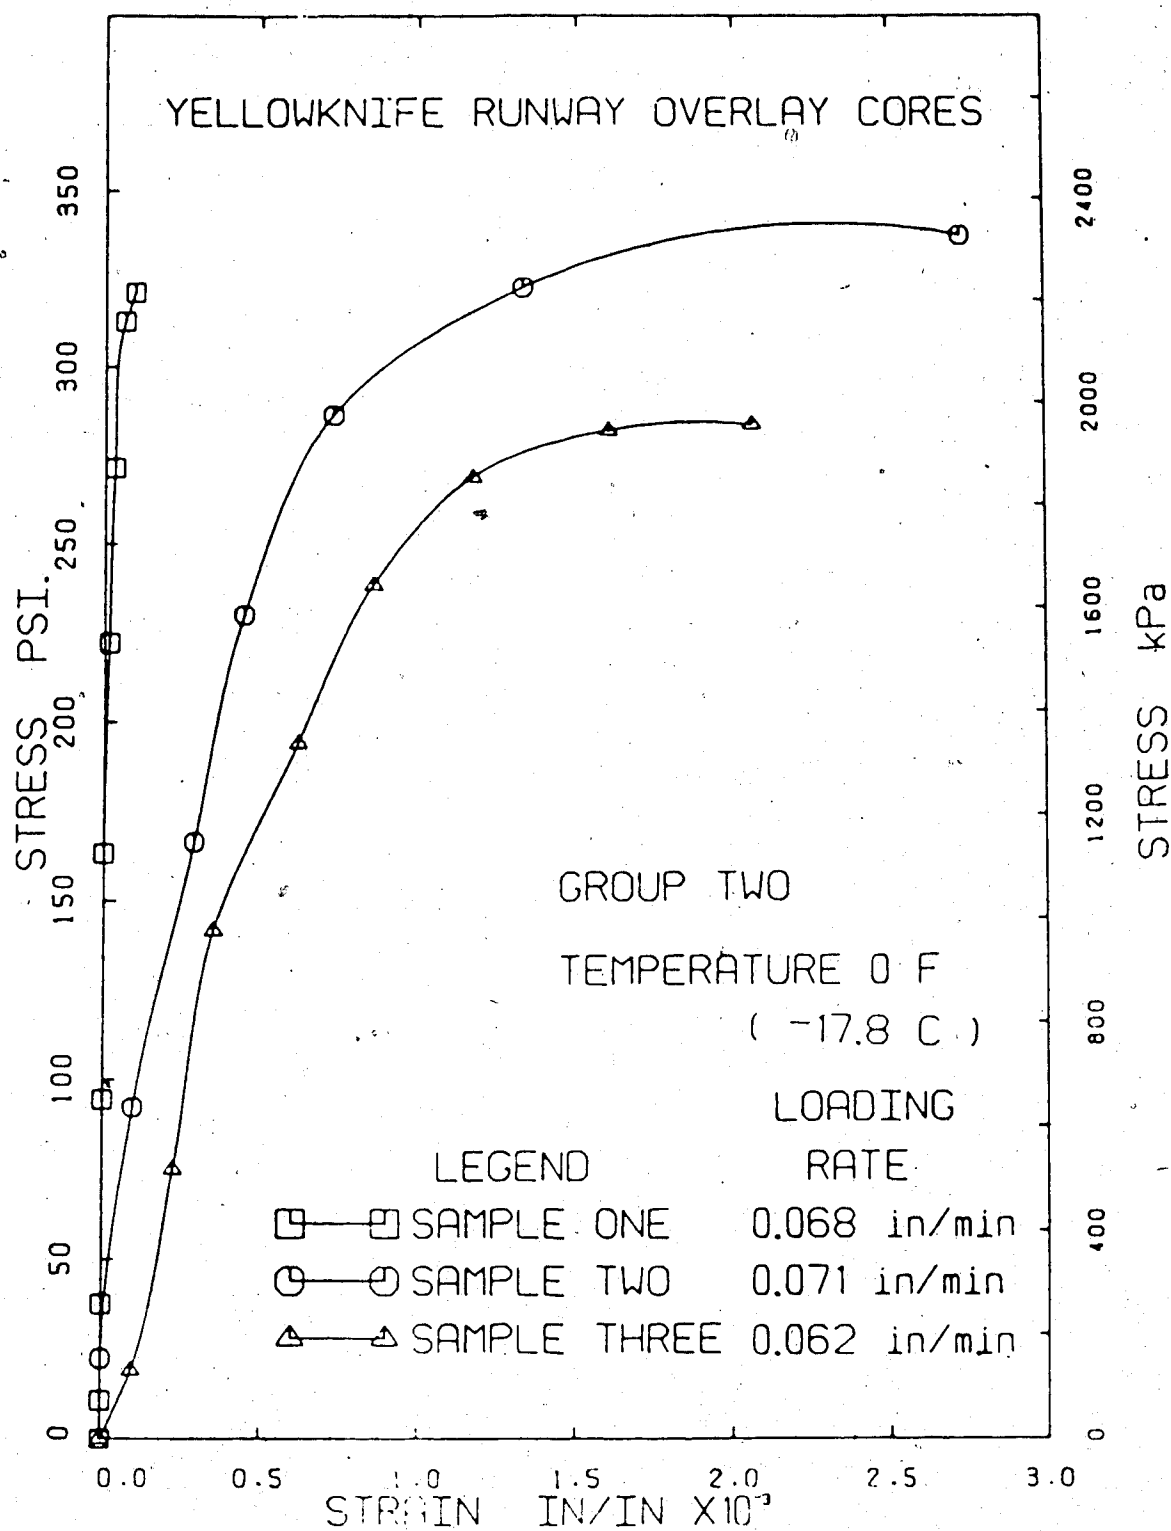
FIG. 6.2 STRESS-STRAIN RELATIONSHIP, GROUP TWO
