An Investigation on Micro-Trenching Technology for FTTH Deployment

A thesis submitted in partial fulfillment of the requirements for the degree of

Construction Engineering and Management

University of Alberta

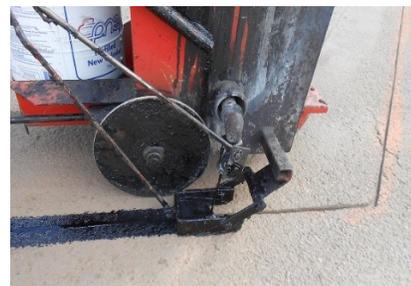
Figure 2-2: MTT process

In the first step, micro-trenches are dug along the marked line by using a specified trenching equipment, as shown in Figure 2-2. The trench cutting process can be in either dry conditions or wet conditions, depending on the requirement of water use. Trenching is always preferable in dry conditions since the cleaning process using a dry vacuum cleaner is easier, resulting in dry and mud-free trenches. Trenching in wet conditions may cause water stagnation in the trench and mud-covered trench walls. Hence, after wet trenching, ITU (2003) recommends a high-pressure water jet for cleaning the trench and a compressed air or blowpipe for drying it. Sometimes, a trench

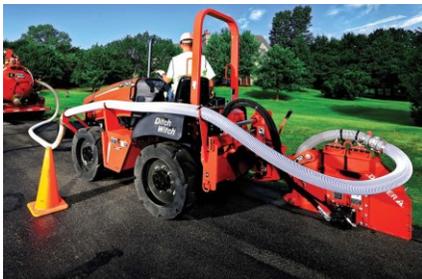
Figure 2-4: MTT equipment of Ditch Witch (Ditch Witch 2010)

Ditch Witch has designed an advanced piece of trenching equipment (i.e., the MT12) for MTT on asphalt pavement. The MT12 can precisely cut narrow trenches (1.9–3.2 cm wide and 16.5–31.8 cm deep) on asphalt concrete in congested urban areas using a specially designed diamond blade while ensuring high efficiency. Since the MT12 is capable of cutting in dry conditions, the spoils are dry and mud-free. A separate dry vacuum excavation system (i.e., FX 60) is attached with the MT12 cutting system so that the cutting debris can be collected simultaneously from the trench (Ditch Witch 2010).

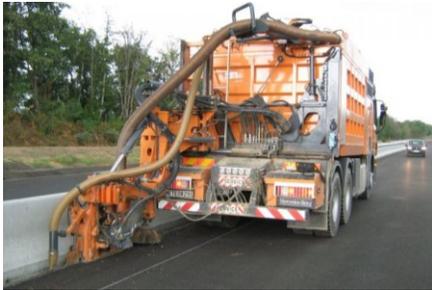
Figure 2-5: Meteor for MTT machines (Marais 2012a)

Marais has also developed two advanced machines (i.e., Cleanfast and Meteor) for MTT on asphalt and concrete pavement surfaces. Unlike the Husqvarna floor saw and Ditch Witch MT12, Marais MTT machines have a simultaneous cutting, cleaning, and spoil collection system. The Cleanfast can dig a 6 cm × 25–50 cm trench while maintaining productivity of 600 linear meters per day. In contrast, the Meteor can create a 1 cm × 10 cm trench at a higher productivity (2,400 linear meters per day) on a motorway (Marais 2012a and 2012b).

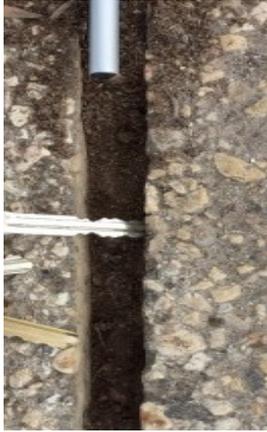
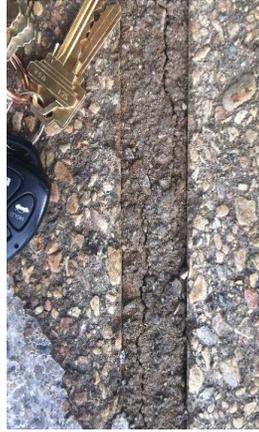
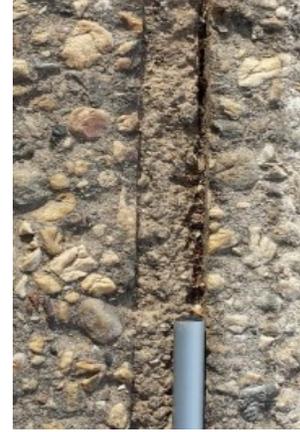
Figure 3-5: Failures of VIF technology

Visual observations of VIF technology are shown in Figure 3-5. As this figure shows, the observed failures are raveling, cracking, edge disintegration, and settlement. Raveling failure was severe in many locations and extended 1–2 cm deep, which could be due to several factors such as cold mix asphalt with poor cohesion, excessive fine aggregates (passing the No. 200 sieve), and poor aggregate interlock inside the material (Anderson et. al. 1988). Cracking failures were found in a few places; these cracks were typically 0.2–0.5 cm wide and opened the window for water ingress inside the trench. Since cracks usually happen due to poor cohesion inside the patching materials, cohesive materials are preferred for crack prevention. Edge disintegrations were also identified; these occur when there is a poor adhesion between the original pavement and patching material (Anderson et. al. 1988). Moreover, poor adhesion of a mixture may happen due to the mud-covered trench walls of MTT, which are a result of insufficient cleaning of the trench walls after saw cut. Since edge disintegration creates hollow slots between existing asphalt and trench backfill, water can easily penetrate into this gap, causing vertical displacement of FO cable during freeze and thaw cycles. Settlement of backfilling materials in some places was also prominent. The settlement may have been caused by inadequate compaction and unstable sand base. In other places, it was observed that cold mix asphalt material was completely washed out from the trench. This could be because of poor stability and high sensitivity of the selected cold mix asphalt to the freeze-thaw cycles.

Settlement and Material Washing Out

Raveling and Cracking

Edge Disintegration

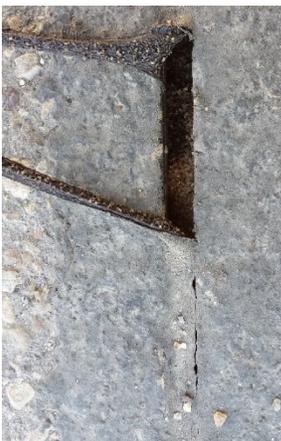
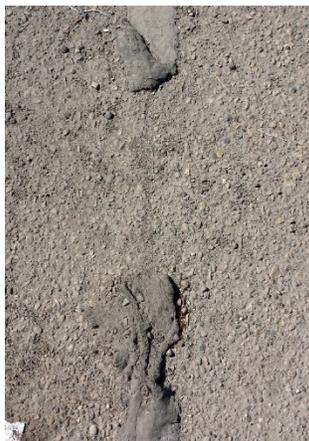
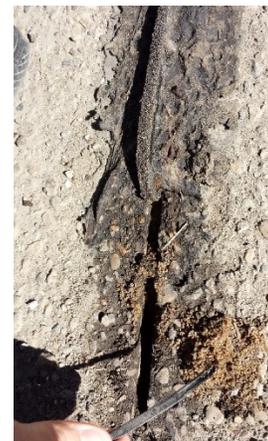
Figure 3-6: Failures of SMCI technology

SMCI visual inspection results are presented in Figure 3-6. Backfilled material in some areas experienced settlement, poor bonding, and pulling-out failures. Settlement was the dominant failure, which could be due to either choosing a soft sealant or further densification of the play sand under traffic load. Poor bonding was identified in a few places since sand and the existing asphalt edges made a weak bonding with the bitumen sealant, resulting in pulling out of the sealant. In these areas, water can easily penetrate into the trench, and freeze-thaw cycles will cause quick deterioration of this trench and backfilling. These failures can further be accelerated by traffic loads and severe weather conditions.

Settlement and Crack

Poor Bonding

Pulling Out

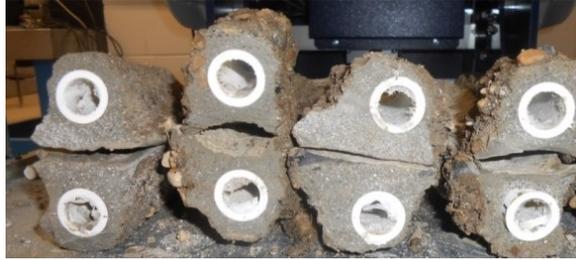
Figure 3-8: Grout for MTT conduit stabilization in the base layer

Grout-1 from left mixed at 25%, 37%, 31%, and 50% of water moisture
