Growth behavior of surface cracks in pipeline steels exposed to near-neutral pH environments

AFOLABI TAIWO EGBEWANDE

Doctor of Philosophy

Materials Engineering

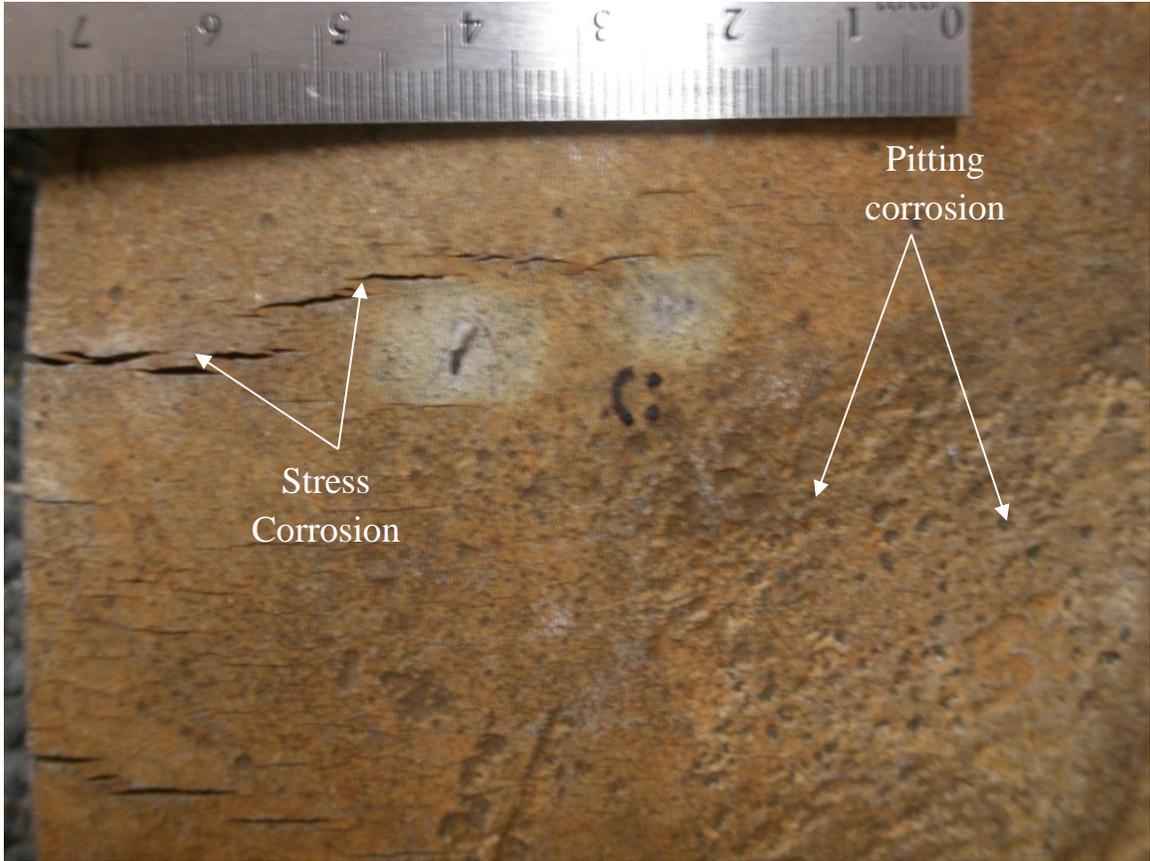
Figure 2.2: Showing SCC cracks and pitting corrosion on a pipeline

A pitted pipeline surface is shown in Figure 2.2. Pitting corrosion occurs as a result of localized attack of an otherwise resistant metal surface that results in the formation of holes (pits) on the metal surface [1, 3]. It usually occurs as a result of localized/non-uniform dissolution at the metal surface, possibly because of differences between the rate of dissolution of precipitates/inclusions and the adjacent matrix. Pitting corrosion is a very insidious form of corrosion as it may cause a material to fail as a result of perforation with an otherwise little loss of mass. Pits may be widely spaced or may occur very close together, in which case neighbouring pits may coalesce to form a bigger one. Pits are sites for stress concentration, hence cracks may initiate from such sites at applied stress levels below the yield strength of the alloy. This is of particular significance in SCC of pipeline steels as will be discussed later.

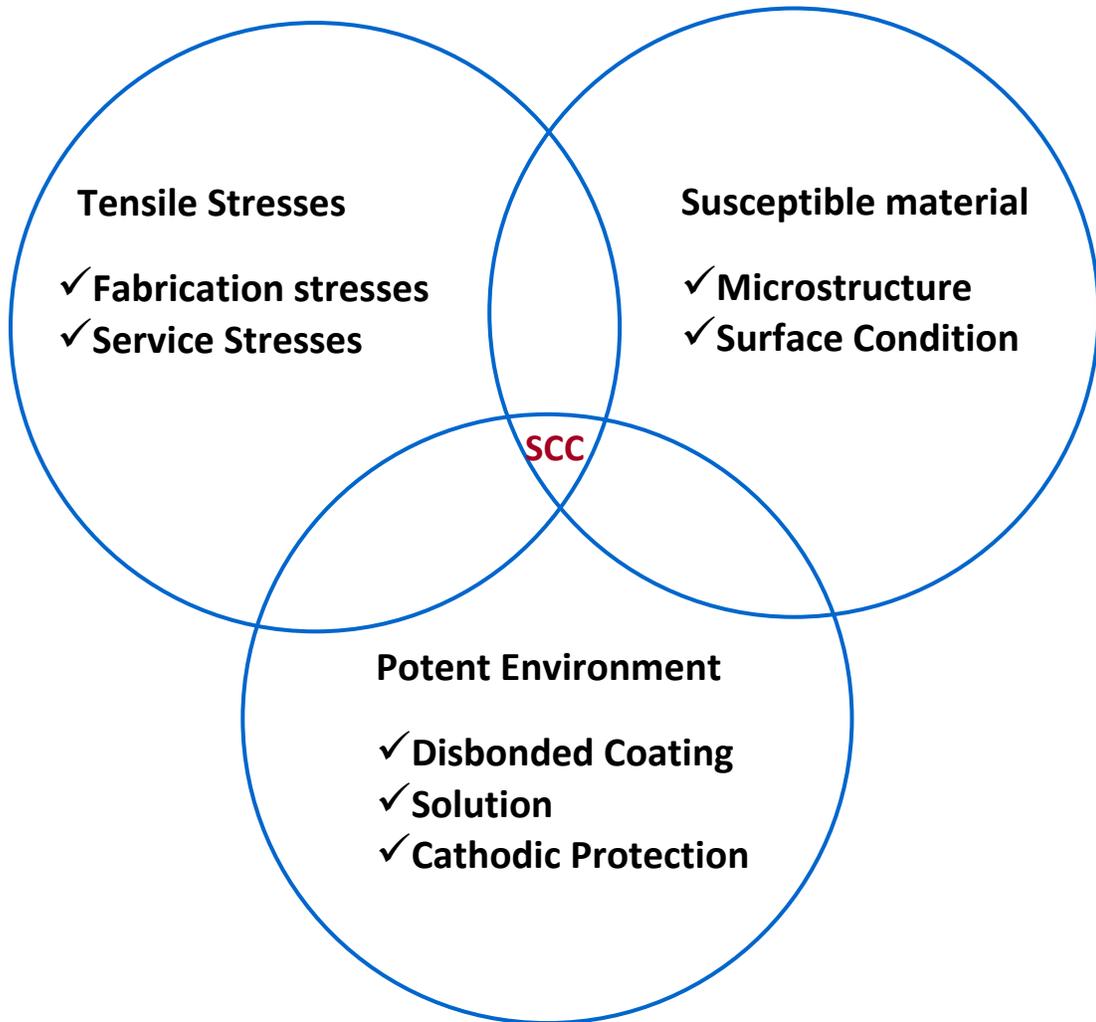
Figure 2.3: Factors required for SCC to occur

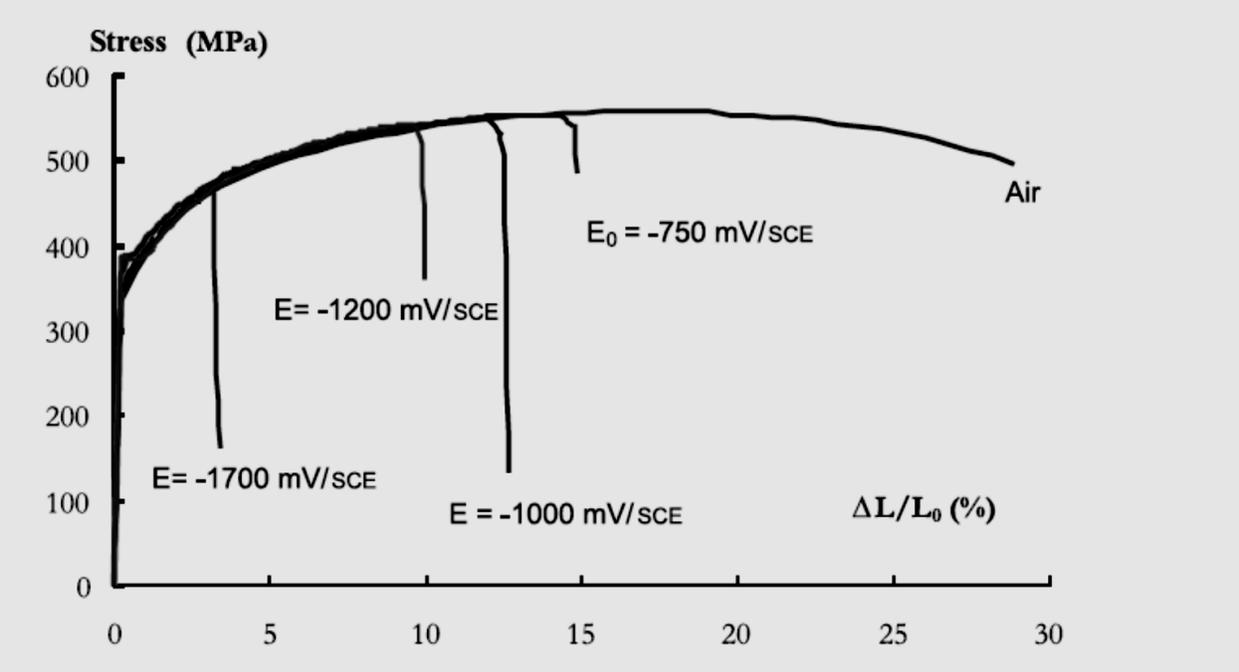
Figure 2.7: Variation of elongation to failure with applied cathodic potential [79]

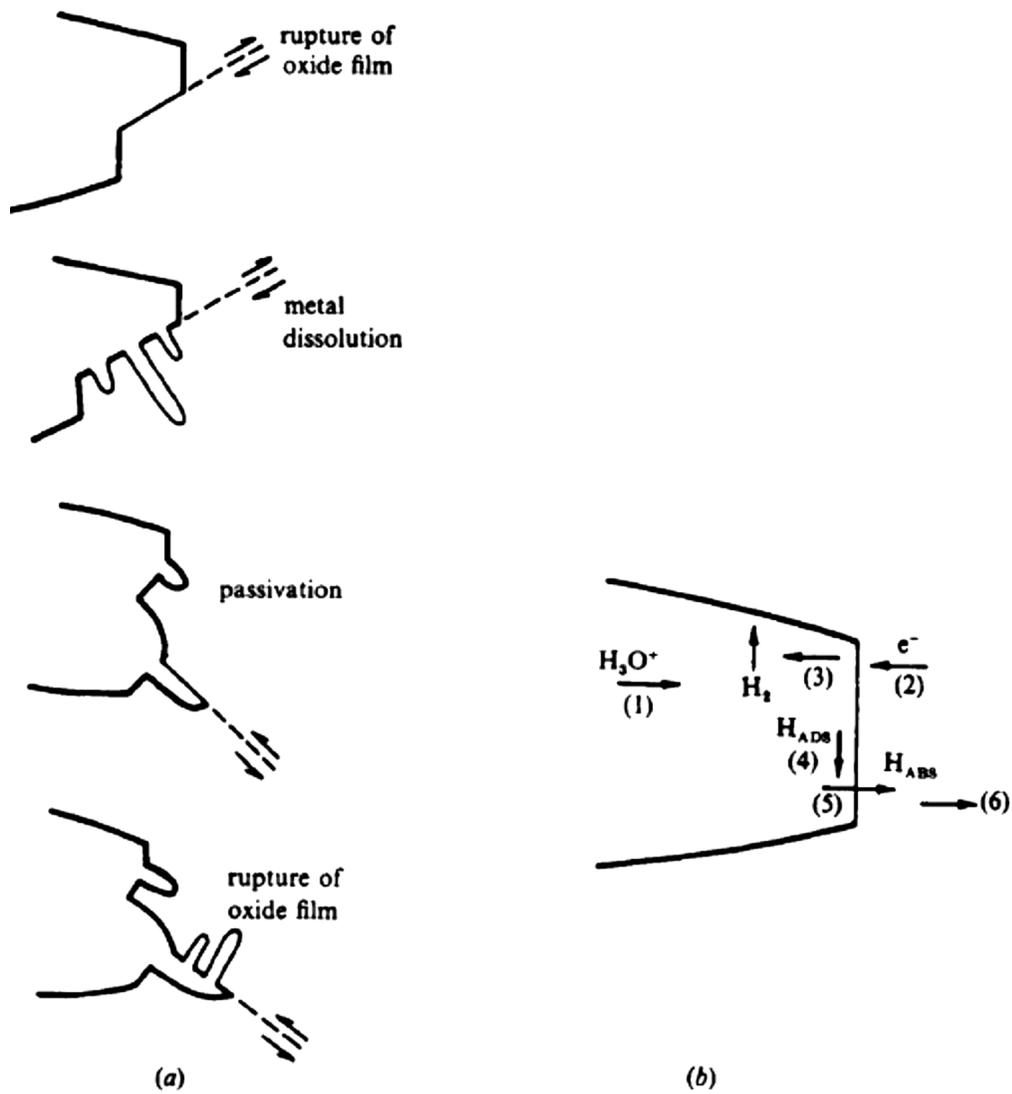
Figure 2.12: Schematic illustration of (a) slip dissolution mechanism (b)hydrogen embrittlement in aqueous media[101]

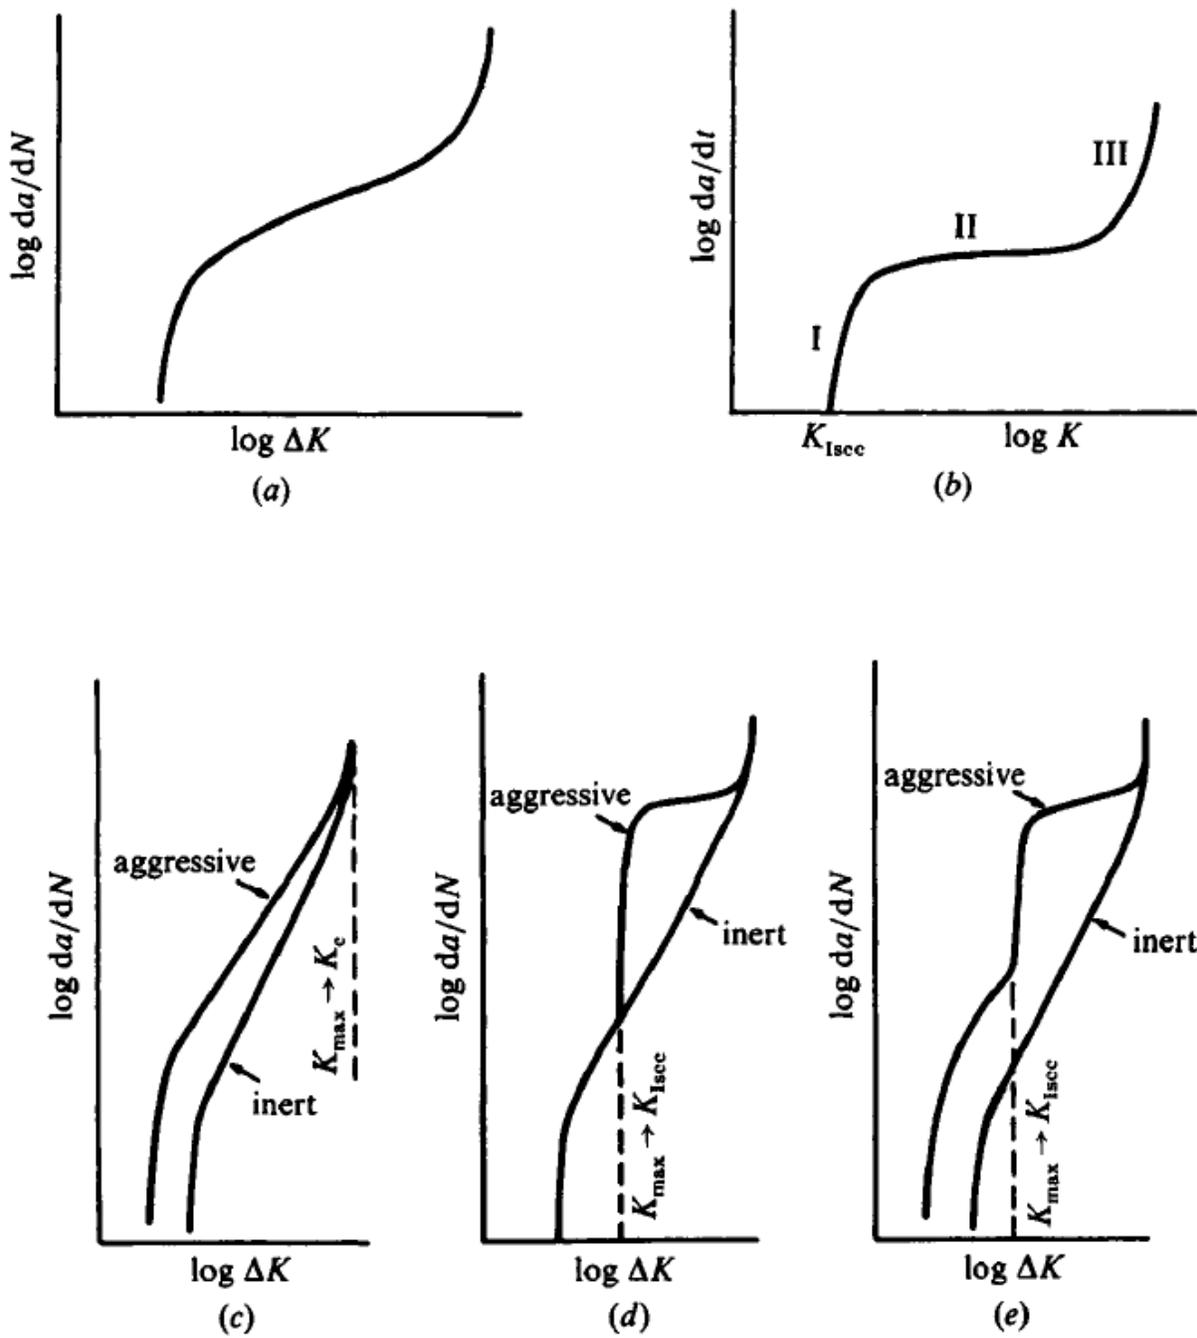
Figure 2.13: Schematic representations of possible combinations of mechanical fatigue and environmentally enhanced crack growth (a) fatigue crack growth in inert environment (b) stress corrosion cracking under sustained loading (c) True corrosion fatigue (d) superposition of (a) and (b), (e) superposition of (b) and (d) [101]

As already mentioned, CF can be cycle dependent, time dependent, or purely cycle-time dependent. To understand this categorization, it is important to consider the effect of the aggressive environment on the growth of CF by separately considering the crack growth under pure mechanical fatigue and under SCC conditions. Figure 2.13a shows a typical sigmoidal variation of crack growth rates with stress intensity factor under pure fatigue conditions while figure 2.13b plots a typical data as crack velocity vs stress intensity factor. This figure shows a unique stress intensity (K_{ISCC}), called the stress intensity threshold, below which the environment has no effect and no crack propagation will occur. Just above this stress is region I, in which crack propagation rapidly increases with stress intensity. In region II, steady crack growth occurs and crack propagation is relatively independent of stress intensity. When the maximum stress intensity approaches the fracture toughness of the material, crack propagation increases rapidly in region III. Figure 2.13c depicts true corrosion fatigue, where cyclic plastic deformation and the environment interact synergistically to produce a cycle and time dependent crack propagation. Time dependent fatigue crack propagation is depicted in figure 2.13d, showing a simple superposition of mechanical fatigue and the effect of the environment. Here stress corrosion fatigue only occurs when $K_{max} > K_{ISCC}$. In this form of CF, the cyclic waveform is unimportant. Figure 2.13e depicts cycle-time dependent corrosion fatigue which involves complete cycle-time dependent crack propagation over the entire life cycle of the crack. This behavior is the most general form of corrosion fatigue.

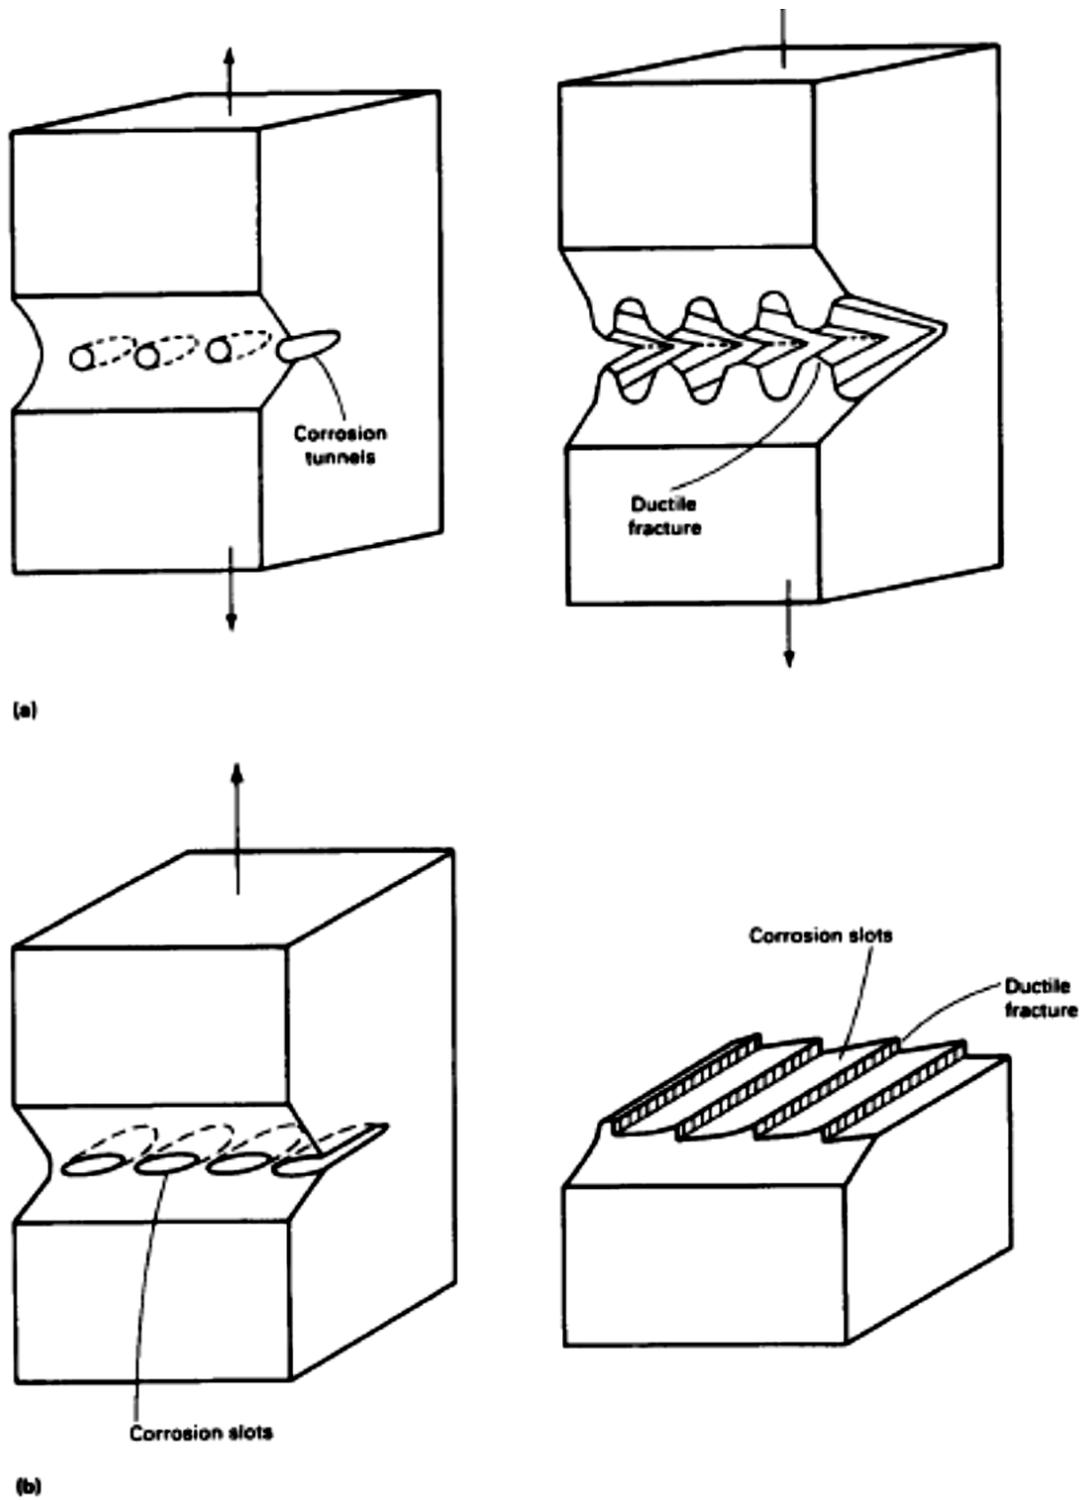
Figure 2.15: Crack propagation mechanism by tunnel mechanism (a) by formation of tunnel at slip steps and ductile deformation and fracture of remaining ligament (b) schematic representation of tunnel mechanism of SCC and flat slot formation [34]

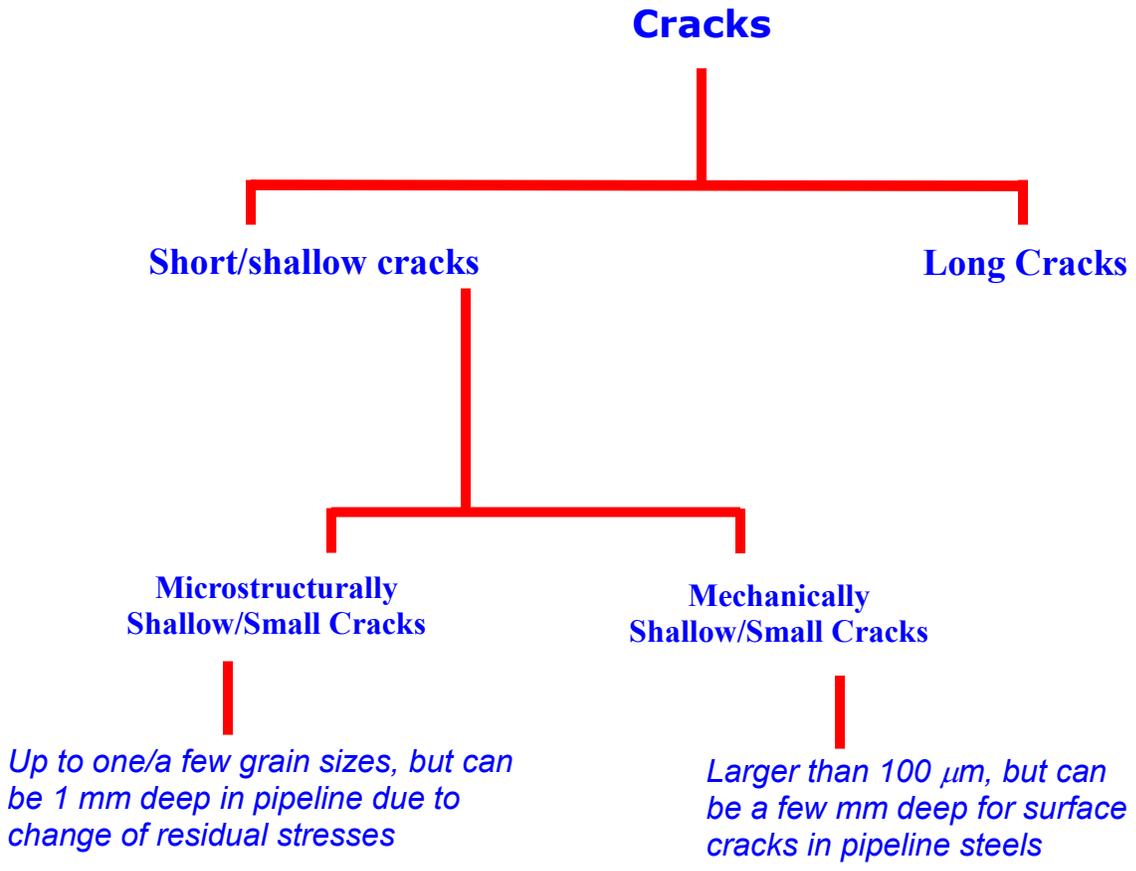
Figure 2.21: Classification of cracks

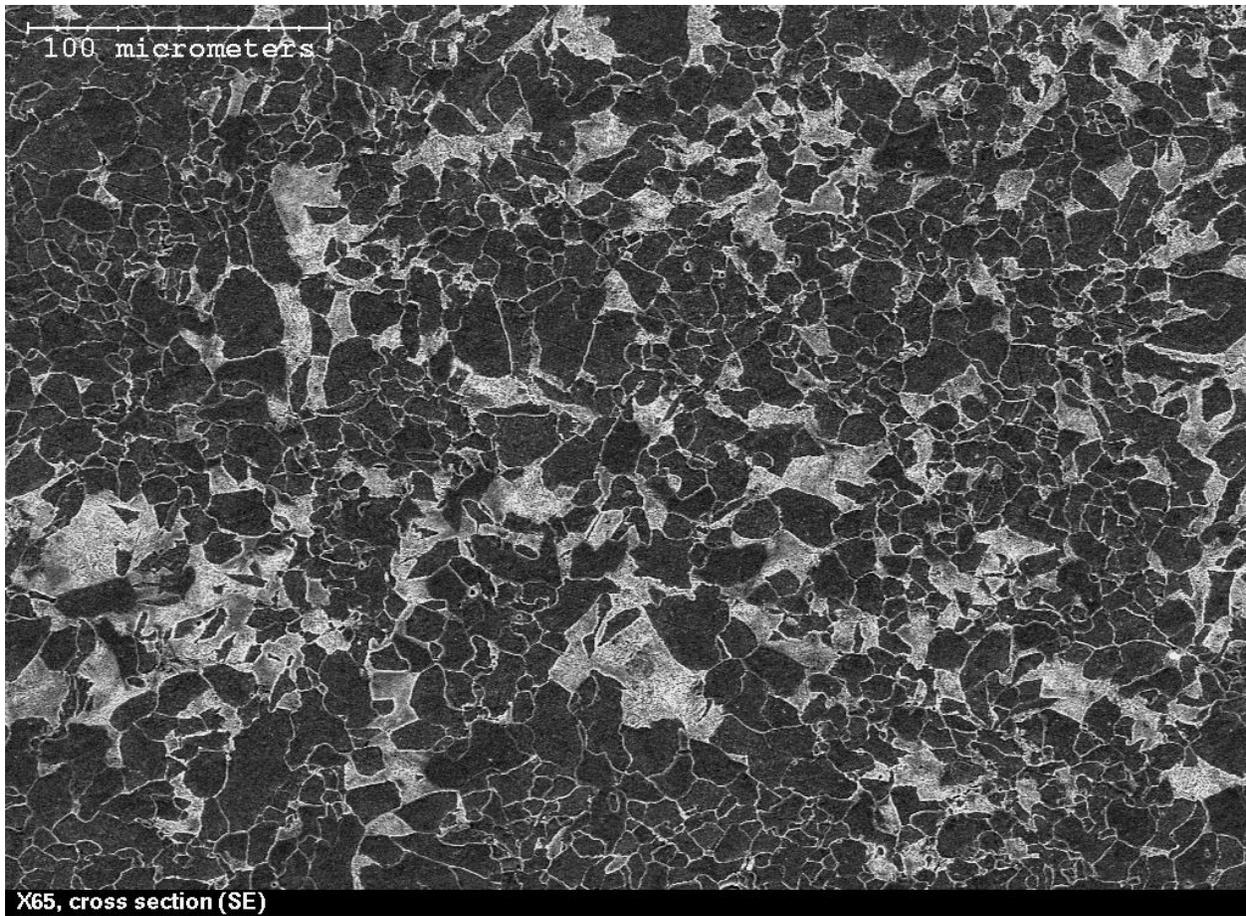
Figure 3-1: Typical microstructure of the alloy X65 used in this study

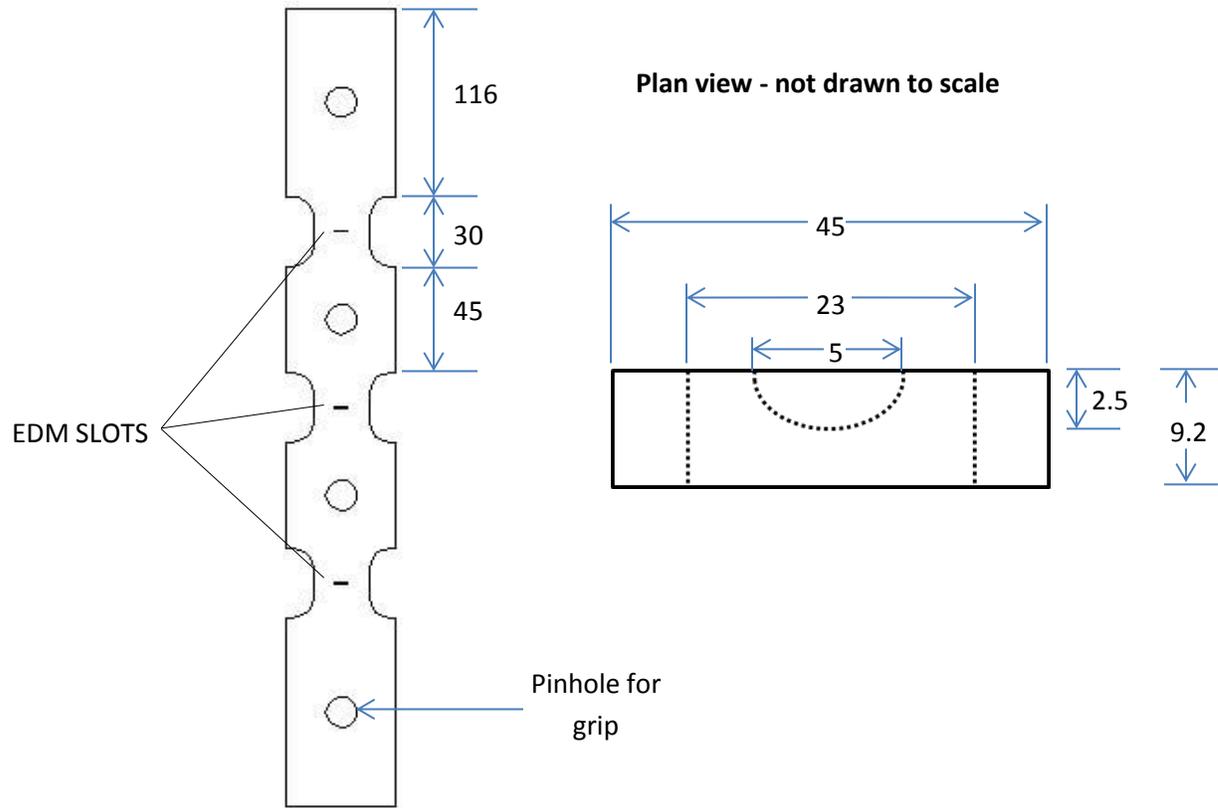
Figure 3-2: Test sample designed for this study

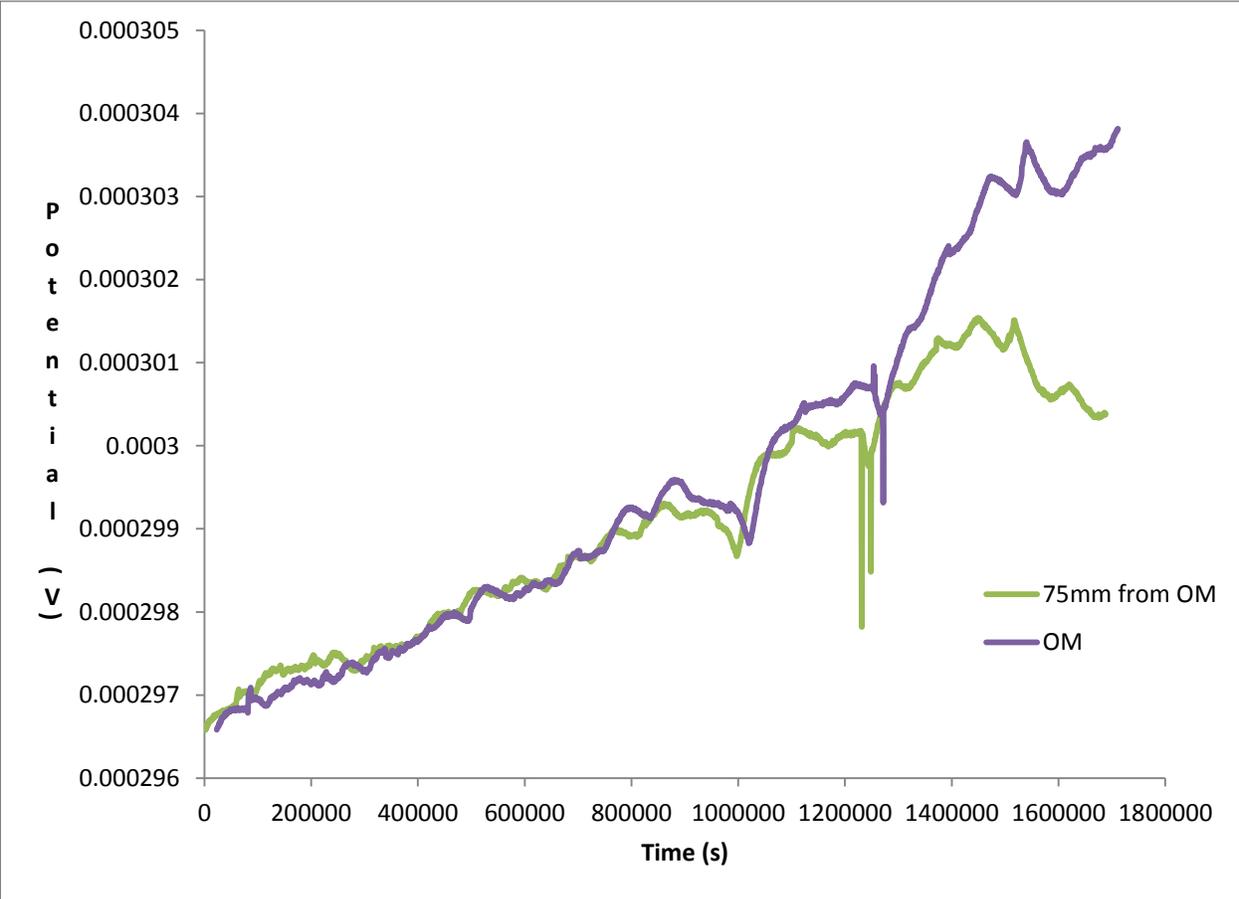
Figure 3-4: Potential drop data showing crack propagation during test

The potential drop curves indicating that crack propagation was not preceded by any period of dormancy are shown in Figure 3-4. Only two of the three curves are shown because there were several interruptions in the third recording due to equipment failure. Although the magnitude of potential change in the two curves seems to indicate that crack growths are similar, we have often found that it is impossible to determine the relative amount of growth from the potential drop readings themselves. Hence, a curve fitting technique had to be adopted for individual curves. The serrations in the curves are often indications of processes that interfere with the measured potential, such as static charges, formation of corrosion deposits inside the crack, and little power surges from equipment being turned on and off in the building in the evenings and over the weekends. Although crack growth was indicated by the rising potential curve at 75 mm from the open mouth, the final drop at the end of the curve (which is not replicated at the open mouth) indicates that the crack had stopped growing towards the end of the test.

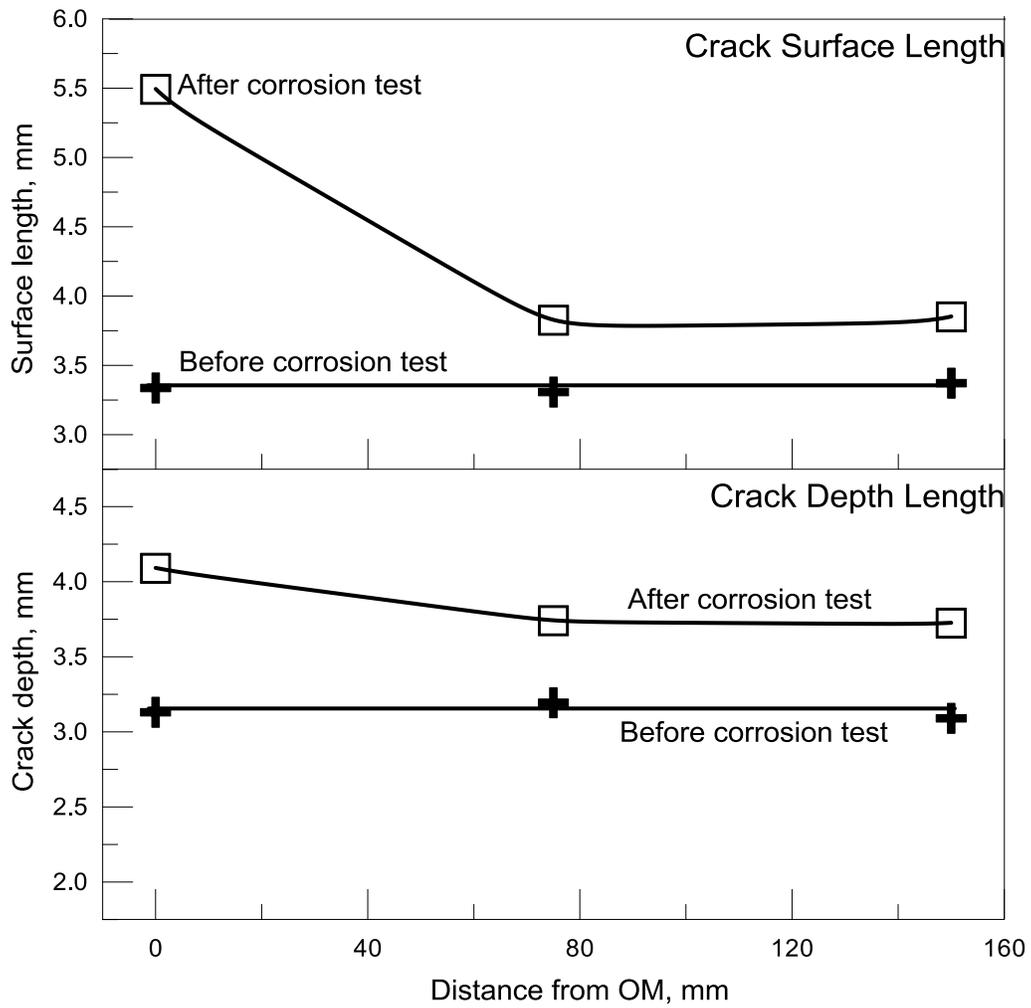
Figure 3-12: (a) Pre- and post-crack sizes at sample surface (b) Pre- and post-crack sizes in depth direction

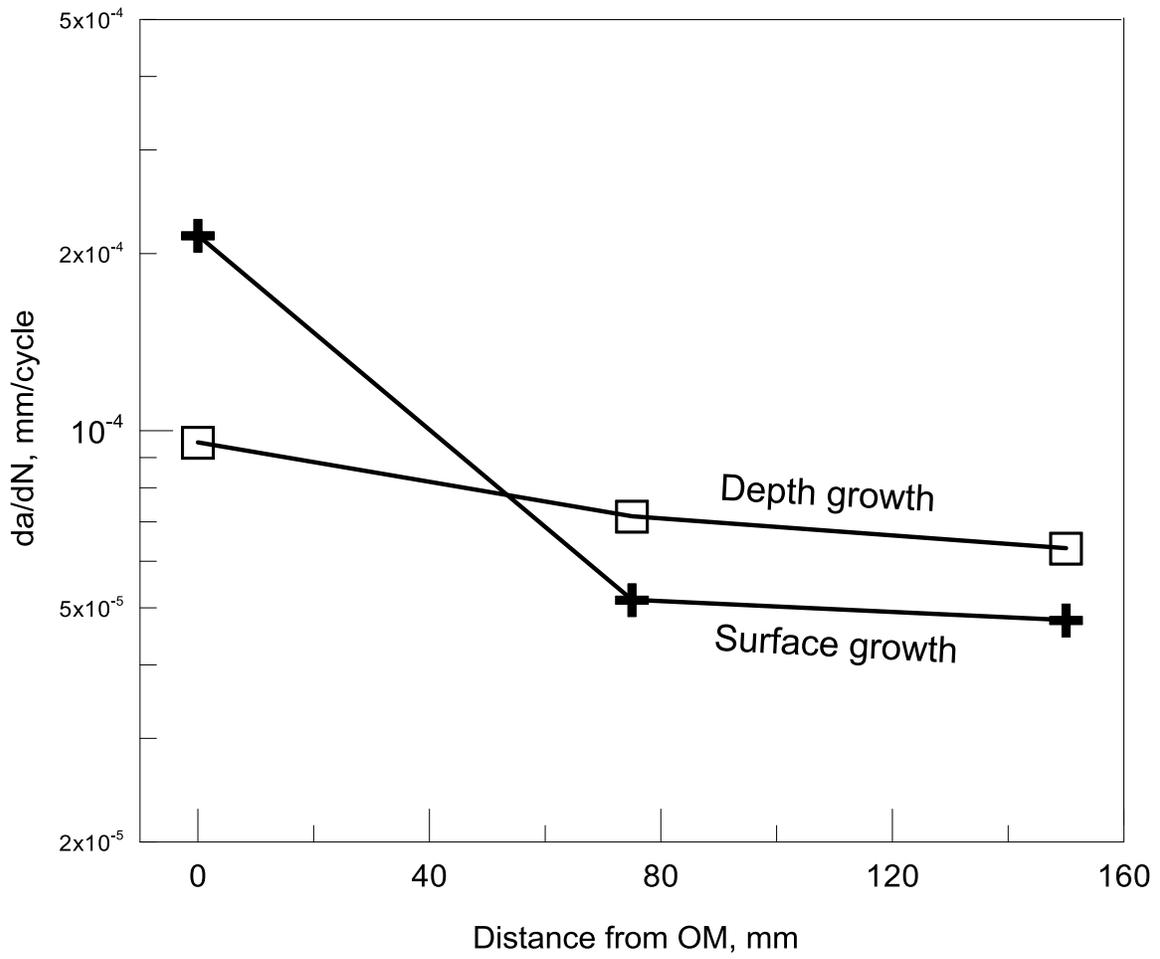
Figure 3-13: Variation of average growth rates with distance from the open mouth

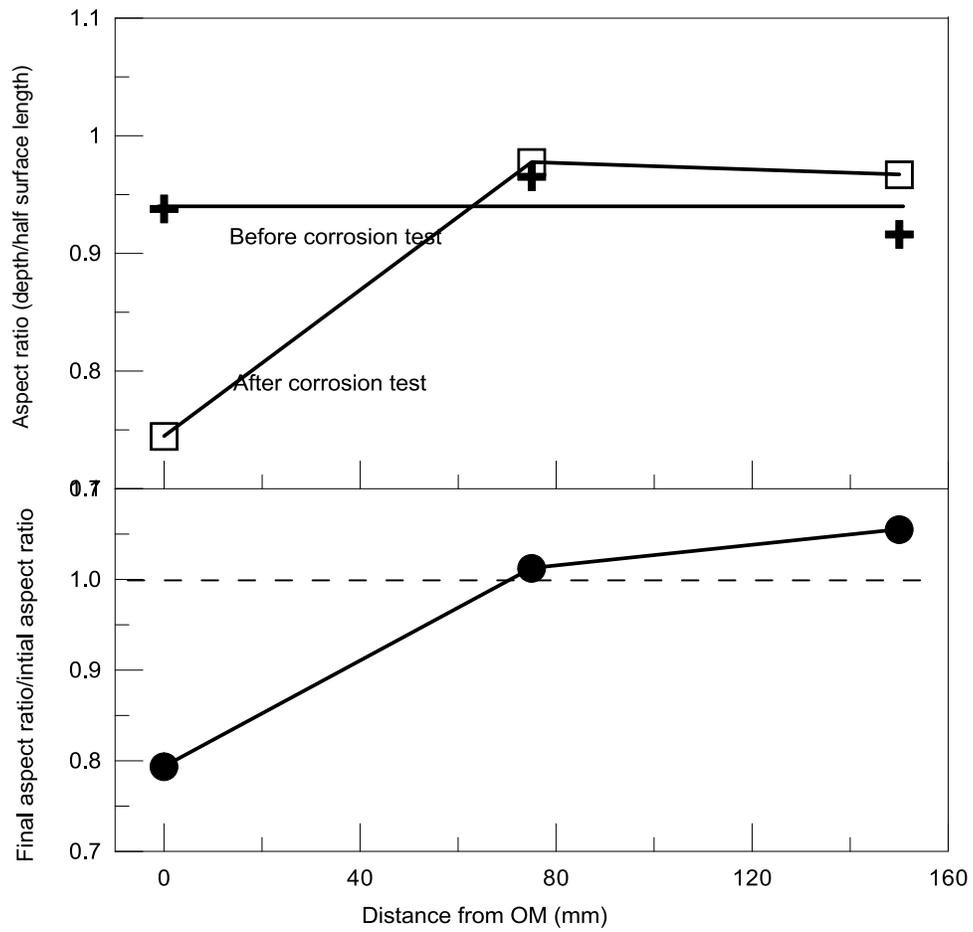
Figure 3-14: Variations in crack aspect ratio with distance from the open mouth of the disbondment

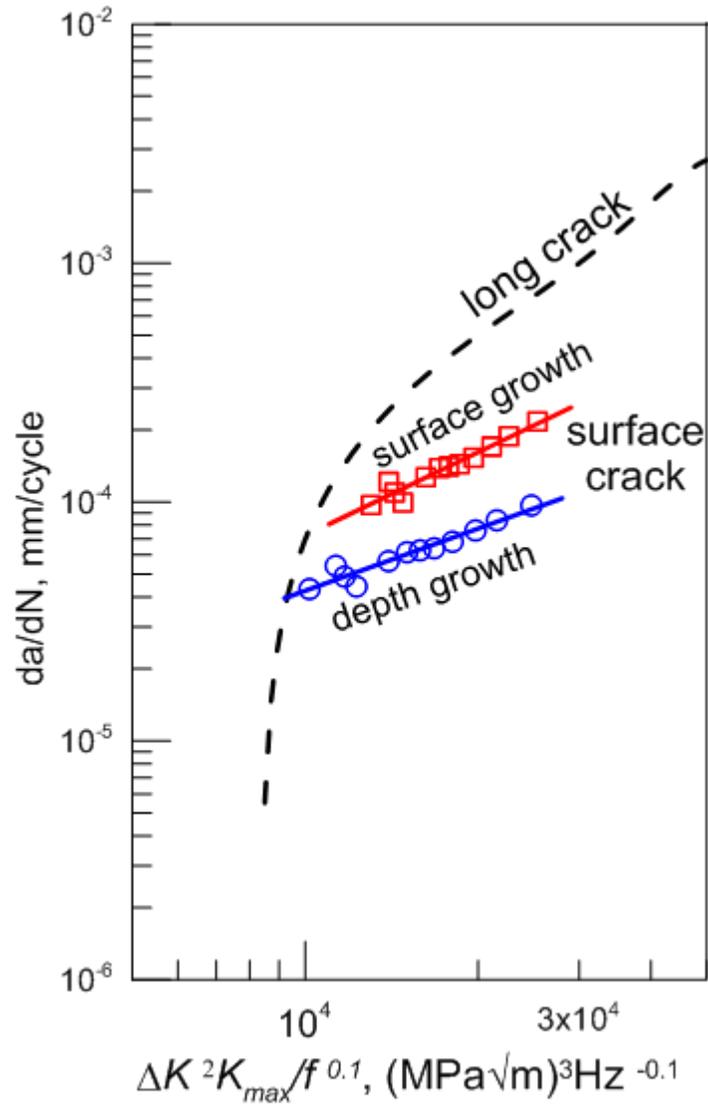
Figure 3-15: Comparison of the corrosion fatigue behavior of crack growth data at the open mouth to that of a through-thickness crack.

function of the combined factor with $\gamma = 0.1$ in Figure 3-15. In this figure, the crack growth in the depth direction was assumed to occur during the entire period of exposure despite that dormancy at the depth direction at the open mouth may have occurred.

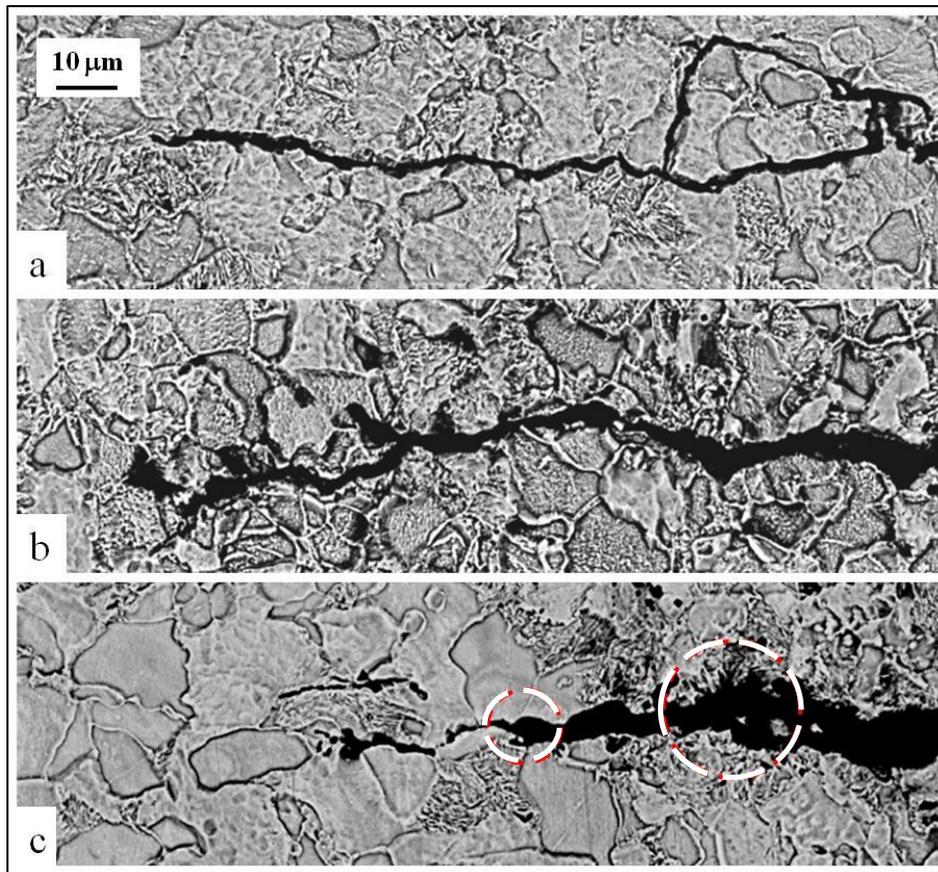
Figure 4-8: Crack tip Morphology at the sample surface in Test II (a) OM (b) 75 mm from OM, (c) 150 mm from OM

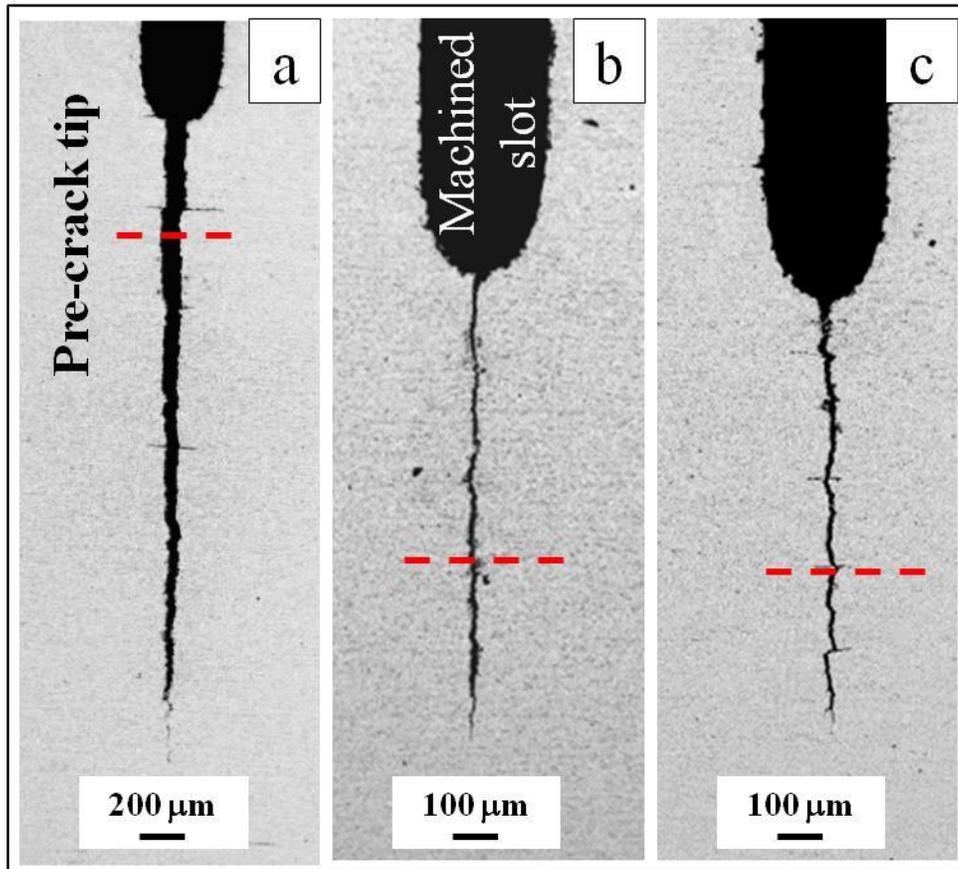
Figure 4-9: Crack morphology in the depth direction for test II (a) Open mouth, (b) 75 mm from OM, (c) 150 mm from OM

In the depth direction, in test II, the crack was much longer at the open mouth than the other two locations (Figure 4-9). There is a mild wedge-shaped morphology along the crack for the crack from the open mouth, probably because of its long length. The crack crevice along the depth direction was similar for the cracks at the 75 mm and 150 mm positions. The crack tip morphologies are shown in Figure 4-10, which remained generally blunt, especially when compared to the sharp crack tip morphology seen in Figure 4-5a). There is hardly any observable difference in the crack openings behind the crack tip. However there is significant crack branching at 150 mm from the OM. Also, some of the branches at 150 mm from the OM tended to have very sharp crack tips. However, the main crack front itself has a tip comparable to those at the OM and 75 mm from the OM. Crack widths are significantly wider than in test I. The sharp changes in crack width as indicated earlier are also observed in the depth cracks, as marked in Figures 4-9b) and 4-9c).

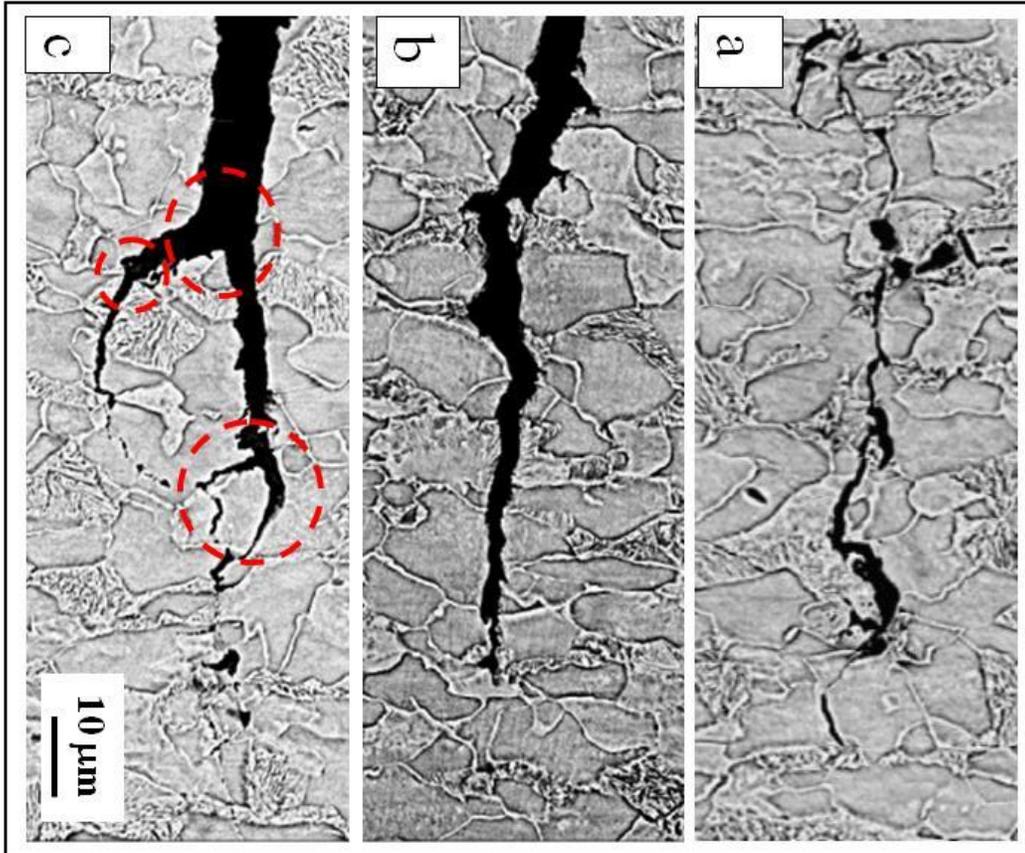
Figure 4-10: Crack tip morphology in depth direction at higher magnification for test II
(a) Open mouth, (b) 75 mm from OM, (c) 150 mm from OM (d) higher magnification of (c)

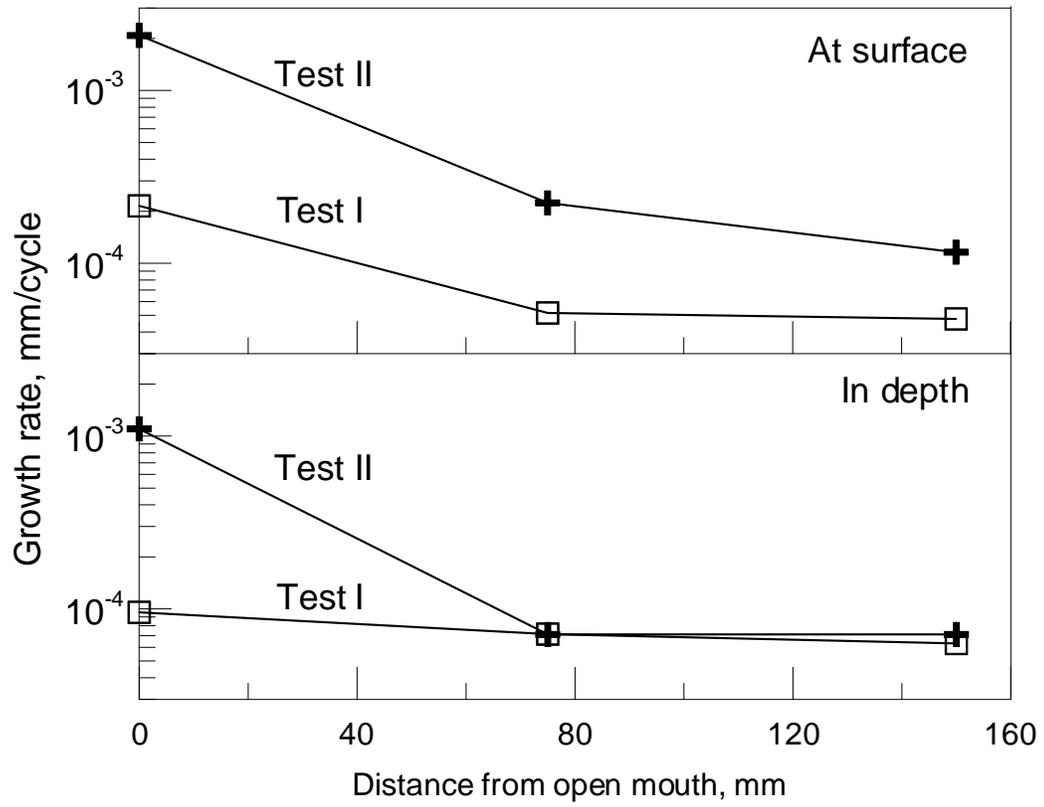
Figure 4-12: Average crack growth rates measured at sample surface

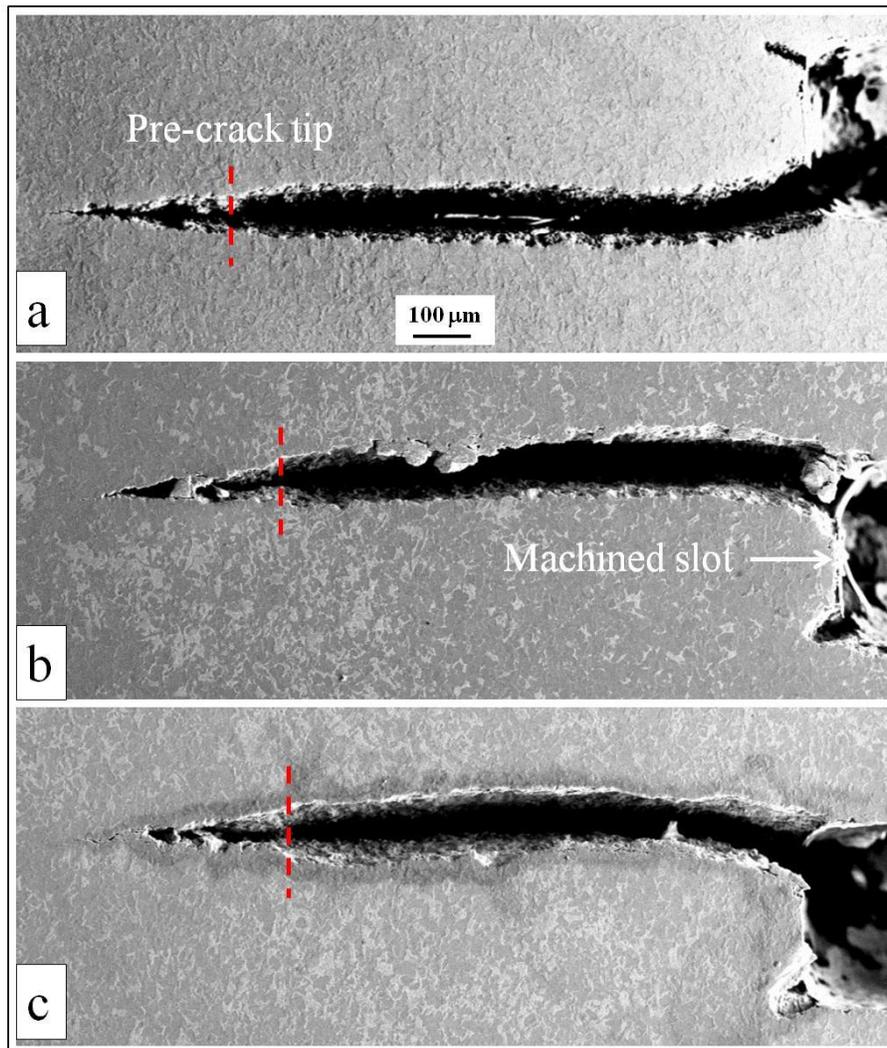
Figure 4-13: Pre-fatigue crack and post-test crack tips in the 20% CO₂ environment - test III (a) open mouth, (b) 75 mm from open mouth and (c) 150 mm from open mouth

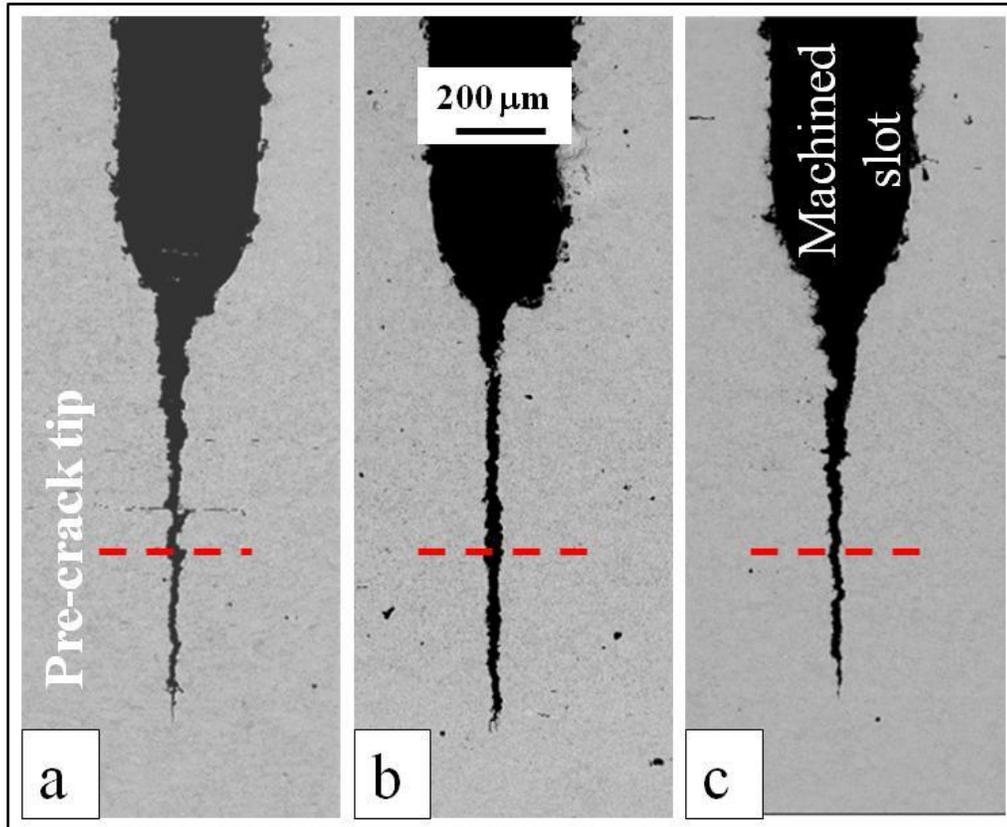
Figure 4-15: Low magnification image of crack tip in the depth direction for test III (a) open mouth, (b) 75 mm from open mouth, (c) 150 mm from open mouth
